# Rogers Park Restoration Project Final Report

Boulder Flycasters, a Chapter of Trout Unlimited

February, 2006 – July, 2009

AS BUILT PLAN

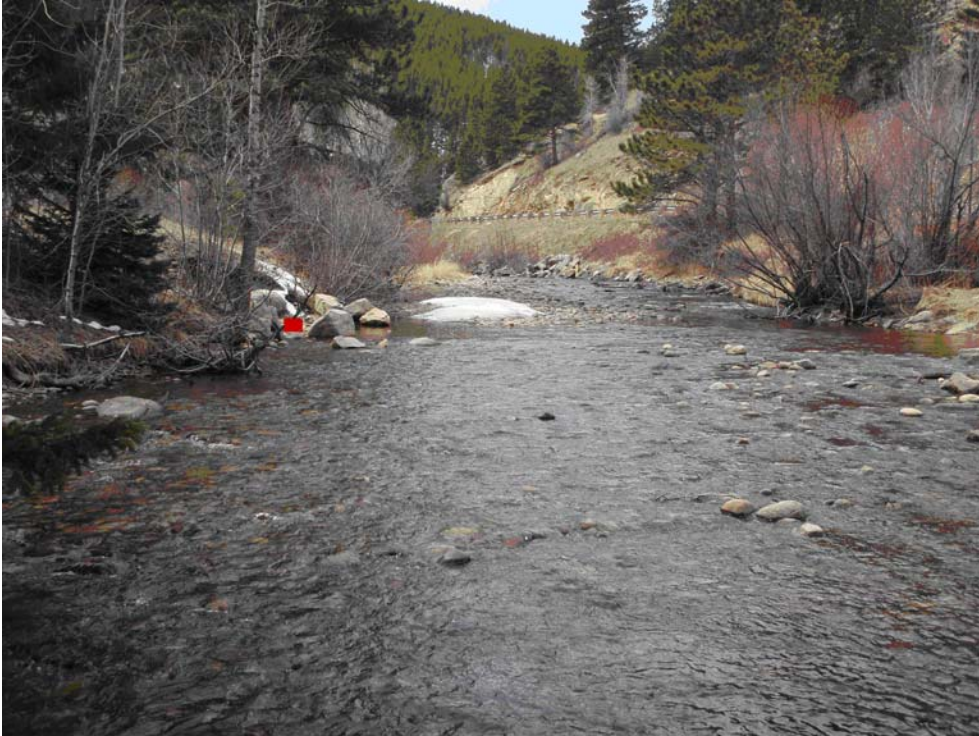
**Photo Point 4  
Looking Upstream**

*Before*

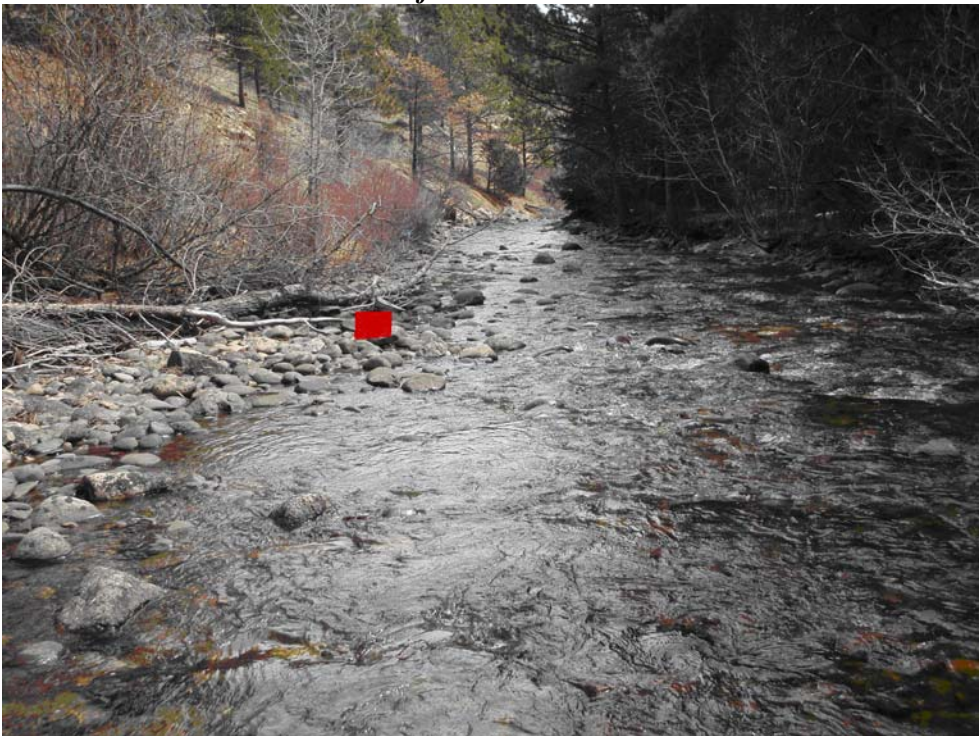
**Photo Point 6  
Looking Downstream**

*Before*

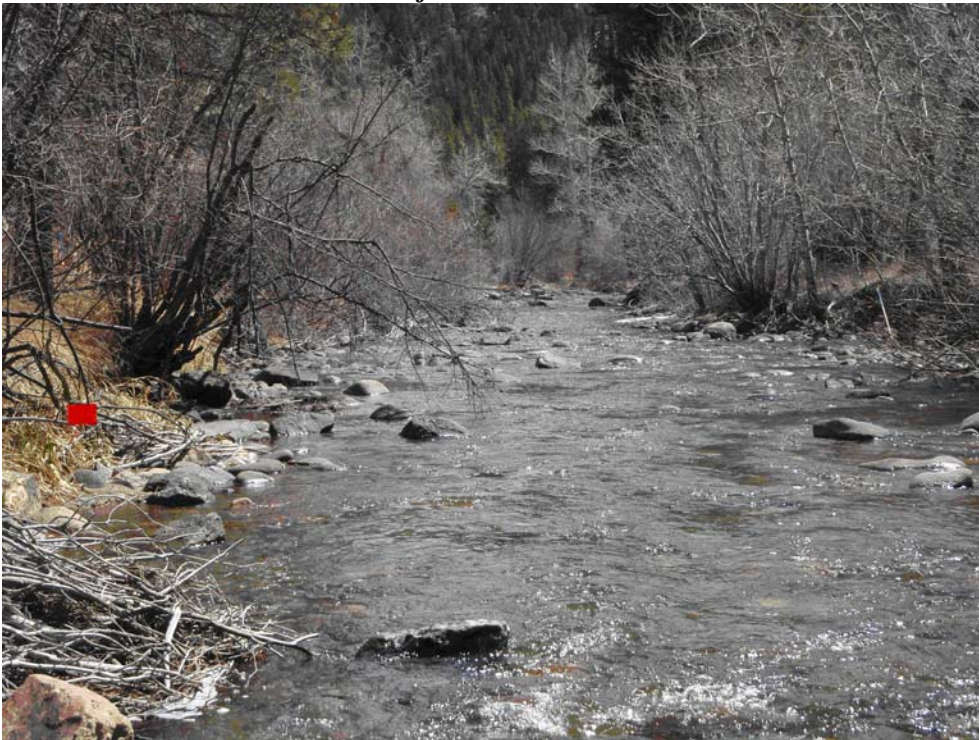
**Photo Point 7  
Looking Downstream**

*Before*

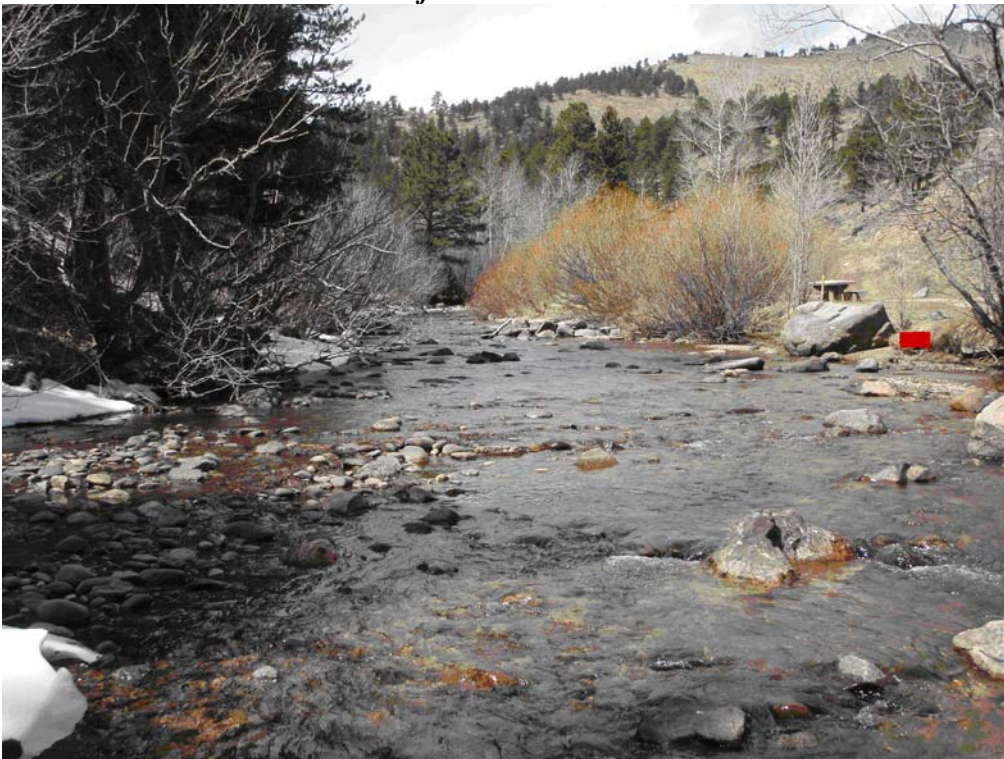
**Photo Point 10  
Looking Upstream**

*Before*

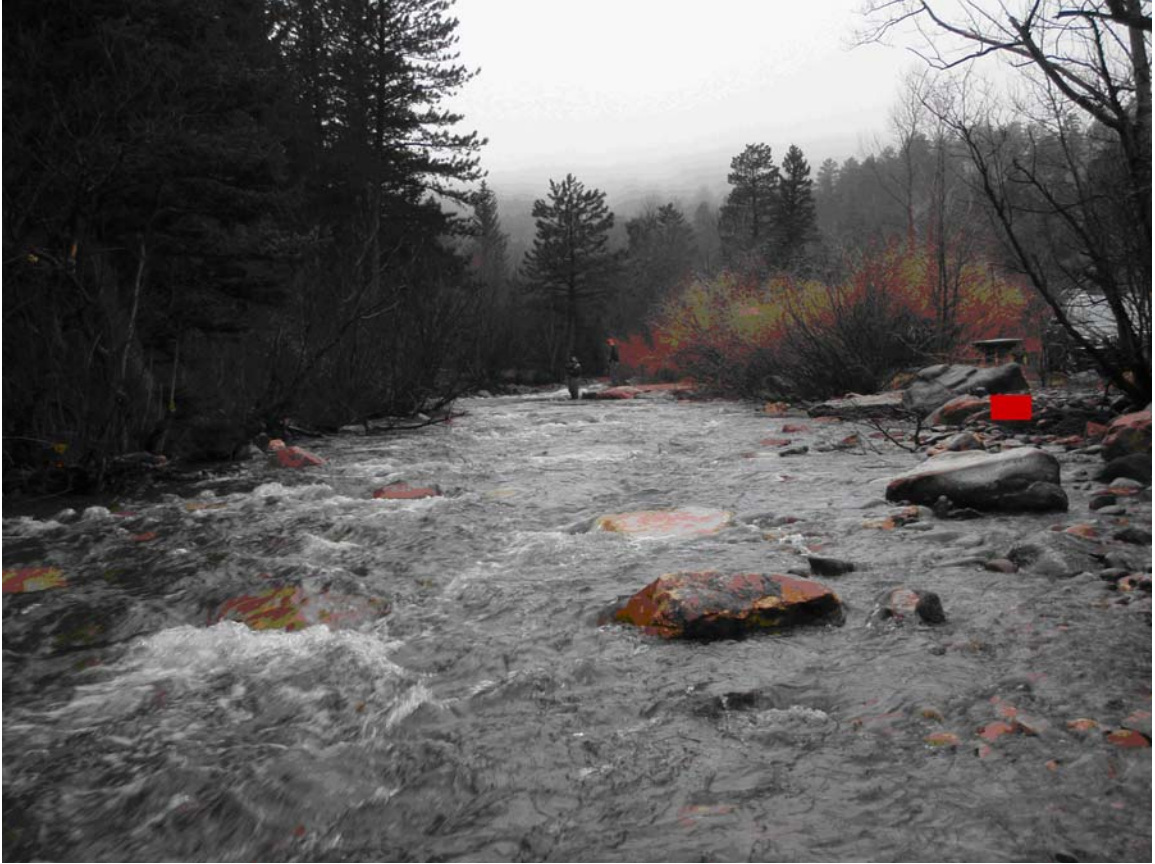
**Photo Point 10  
Looking Upstream**

*After – At High Water in Late May*

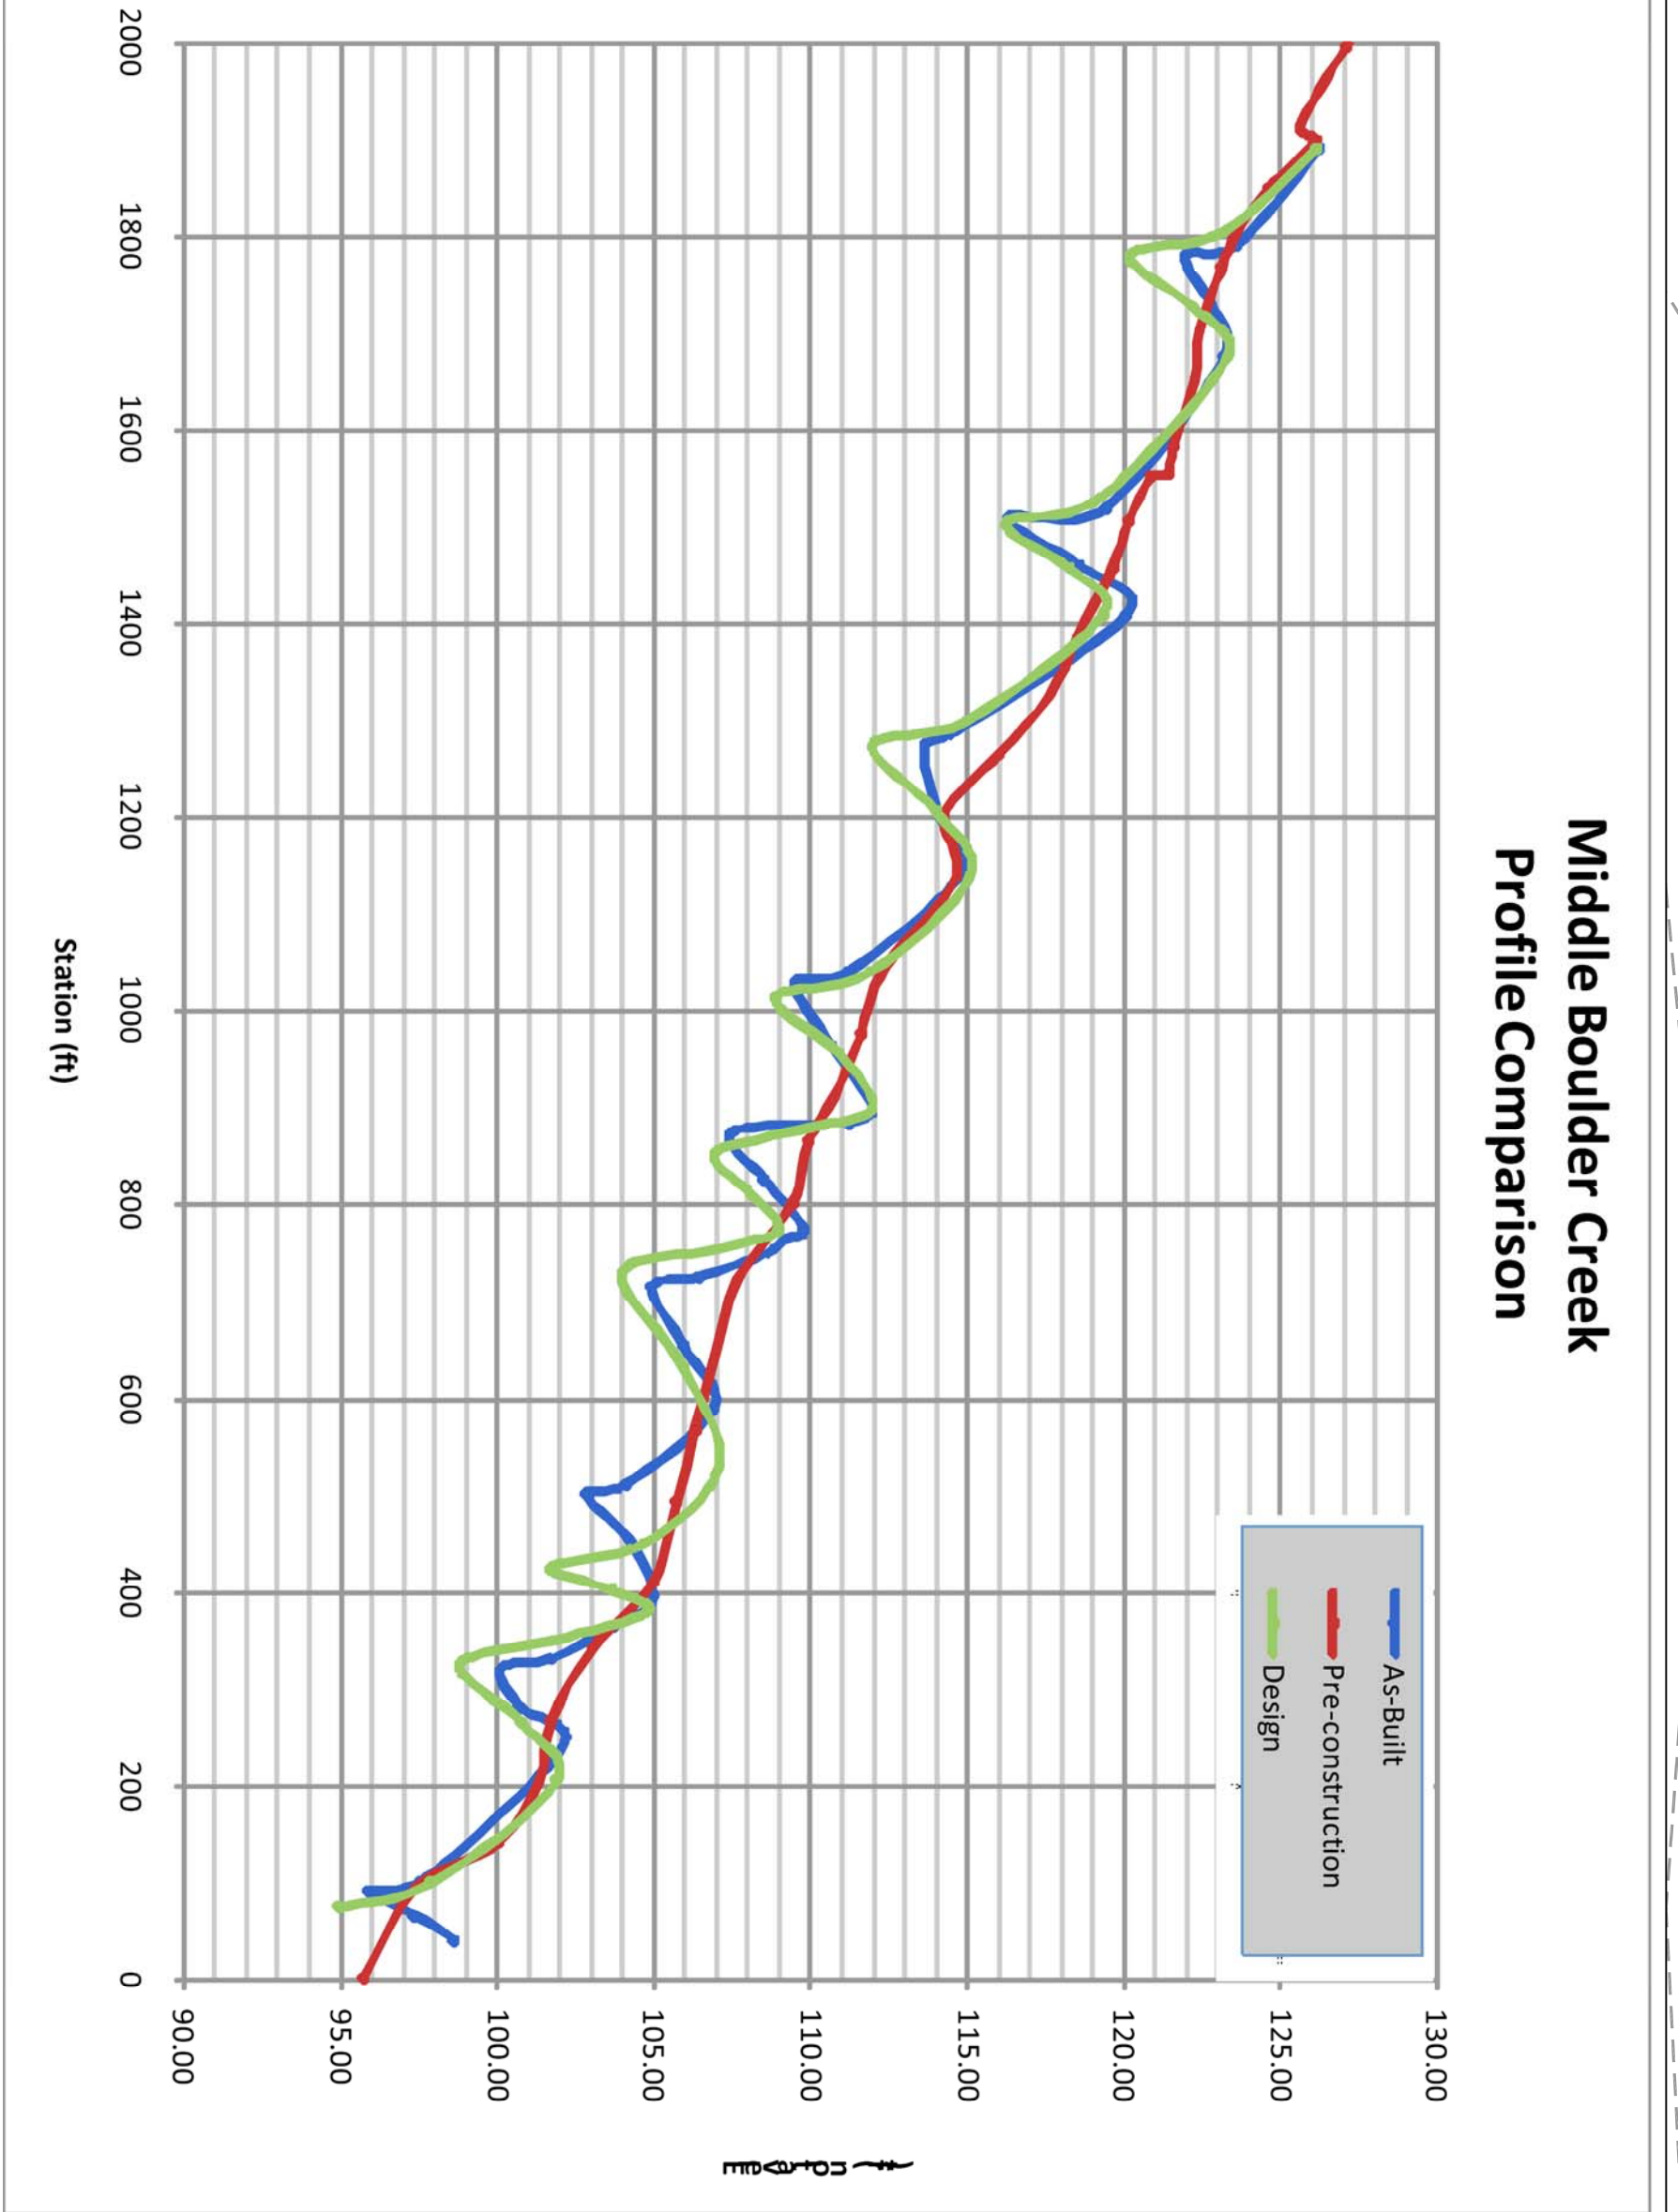
Verified per survey completed by  
Ecological Resource Consultants, Inc. on May 5, 2009.
