PHASE II FINAL REPORT  
RIVER RESTORATION PROJECT 2008  
BLANCO RIVER  
NEAR PAGOSA SPRINGS, CO

Submitted To:  
Colorado Water Conservation Board  
July 28 , 2009

Submitted By:  
LOWER BLANCO PROPERTY OWNERS ASSOCIATION

## **Lower Blanco River Restoration Project Summary 2008 Phase IV**

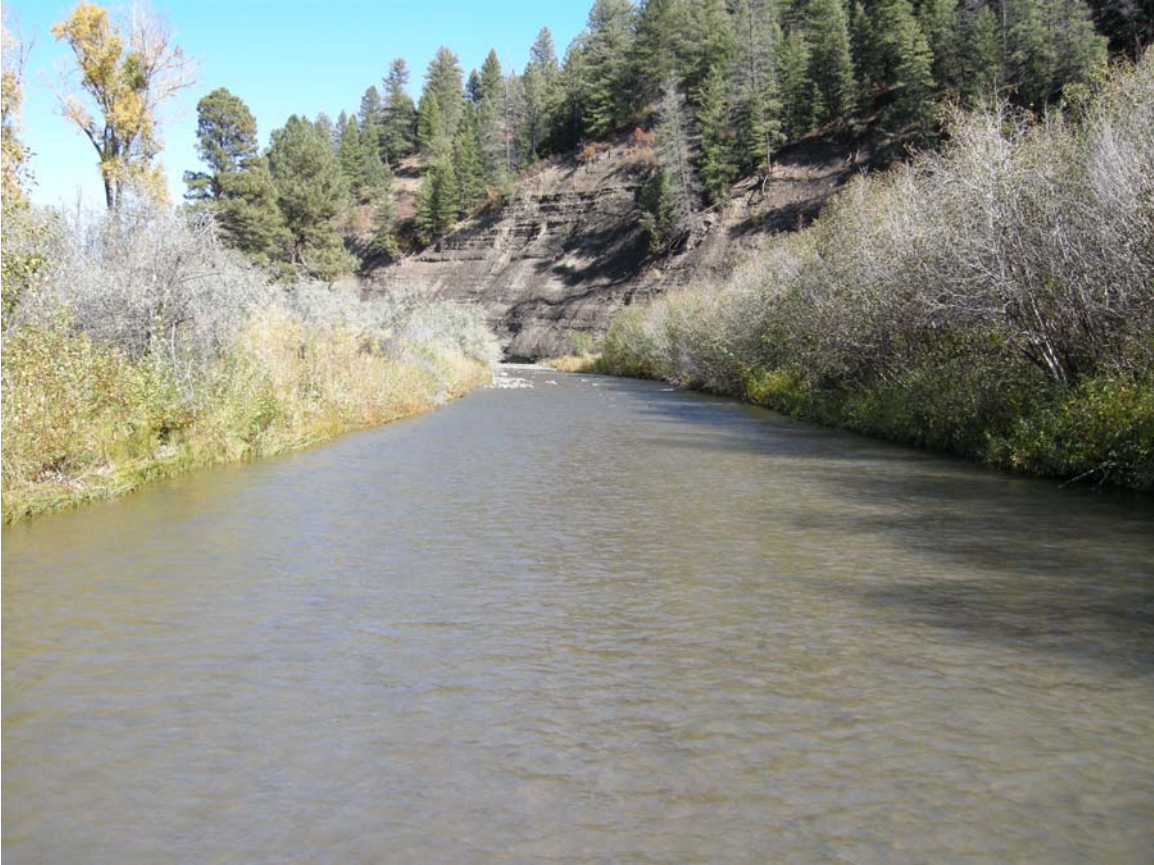
Photo 1. Wide shallow channel.

The change in the river hydrology has had a significant impact on the overall health of the Blanco River system. The wide shallow channel lacks the shear stress required to move the larger sediment particles in the system. This has contributed to sediment deposition, increased erosion, and could potentially increase flood stages. The water quality is compromised by an increase in temperature due to wide shallow stream segments. Increased water temperatures lead to a decrease in dissolved oxygen. The fish habitat is negatively affected due to lack of deep cool water and the accumulation of fine sediment in potential spawning gravels during low flow. To offset the effects of the change in river hydrology and resulting changes in river form, the project design consists primarily of channel shaping and fish habitat construction.

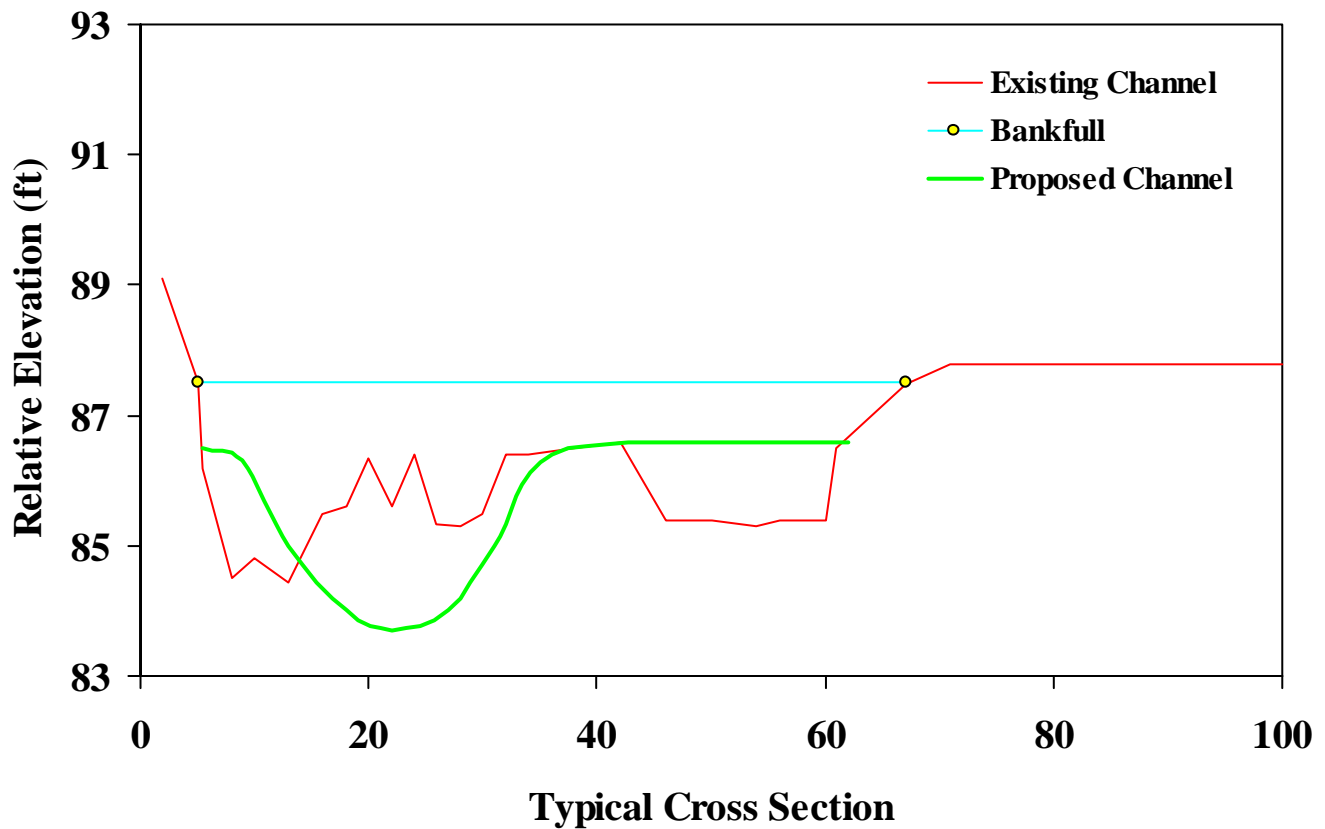
Within the river's cross section, channel shaping will not result in a decrease of the effective cross section for flood conveyance purposes. As depicted in the graphic above, the channel shaping will simply re-arrange the distribution of material to create better use of the available water at low flow conditions. With reduced width of flow and increased depth, we expect to see decreased summer water temperatures and increased holding capacity for fish. A narrower/deeper channel form will help with sediment movement in the system, because when higher flows do occur, the shear stress will be concentrated in areas where sediment can be routed through the system.

The channel shaping will rearrange the river alluvium at locations where a deeper pool form is likely to be sustained. This could be near a rock structures convergence of flow creates a scouring condition, or where secondary currents cause by the turning of water on the outside of natural bend maintains a deeper water condition.

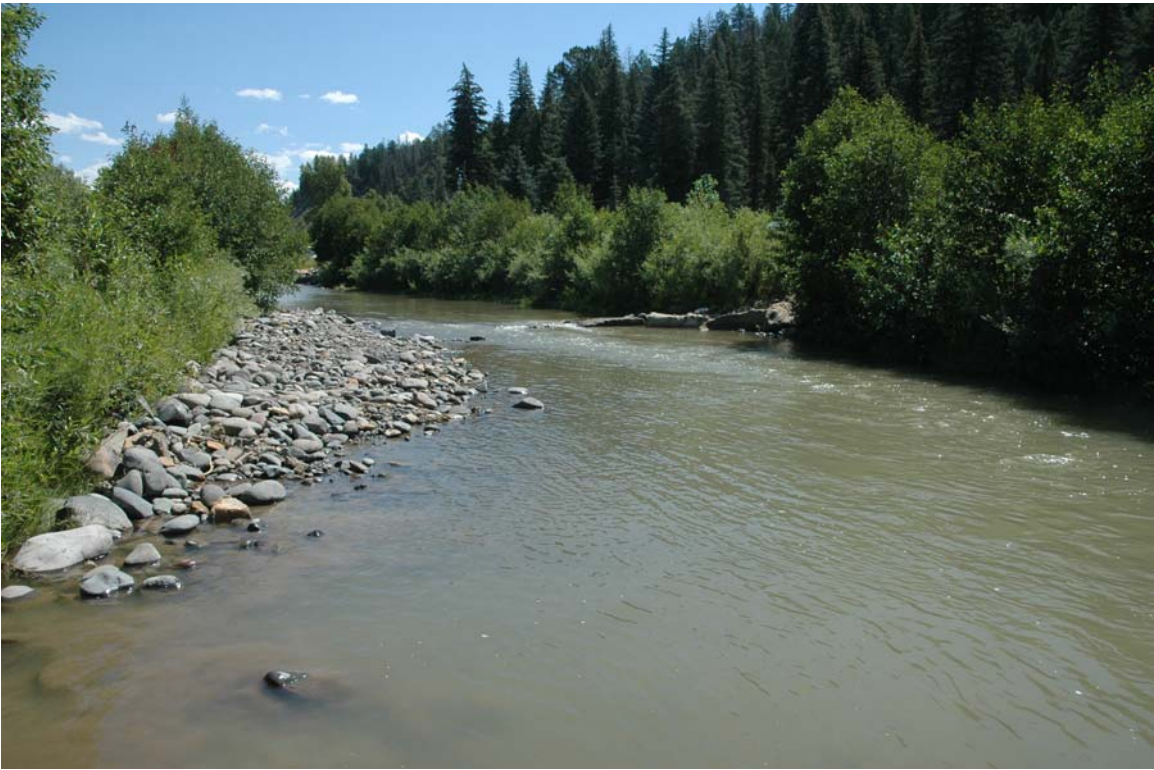
Photo 2. Photo of newly constructed alternating bar with dense bank vegetation. Note the rock structure and deeper water river-left, creating good fish holding potential beneath the overhanging Alder bushes.

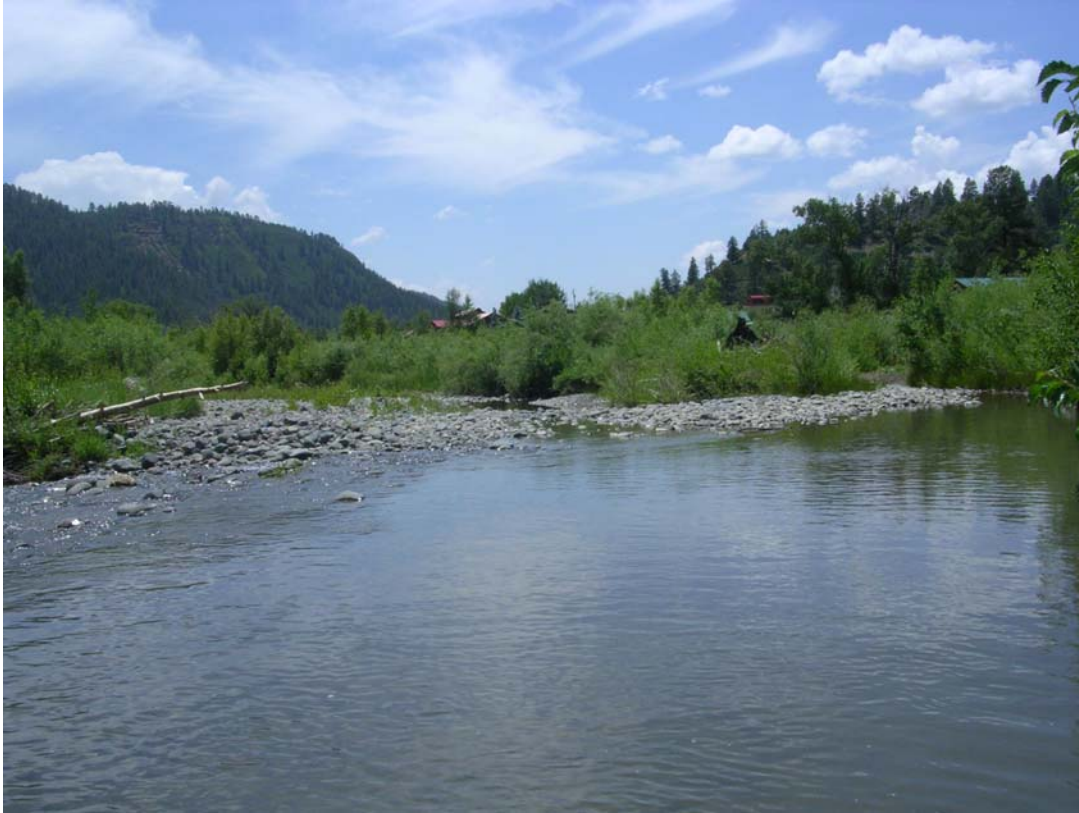
**BEFORE: Over-wide braided into 3 channels**

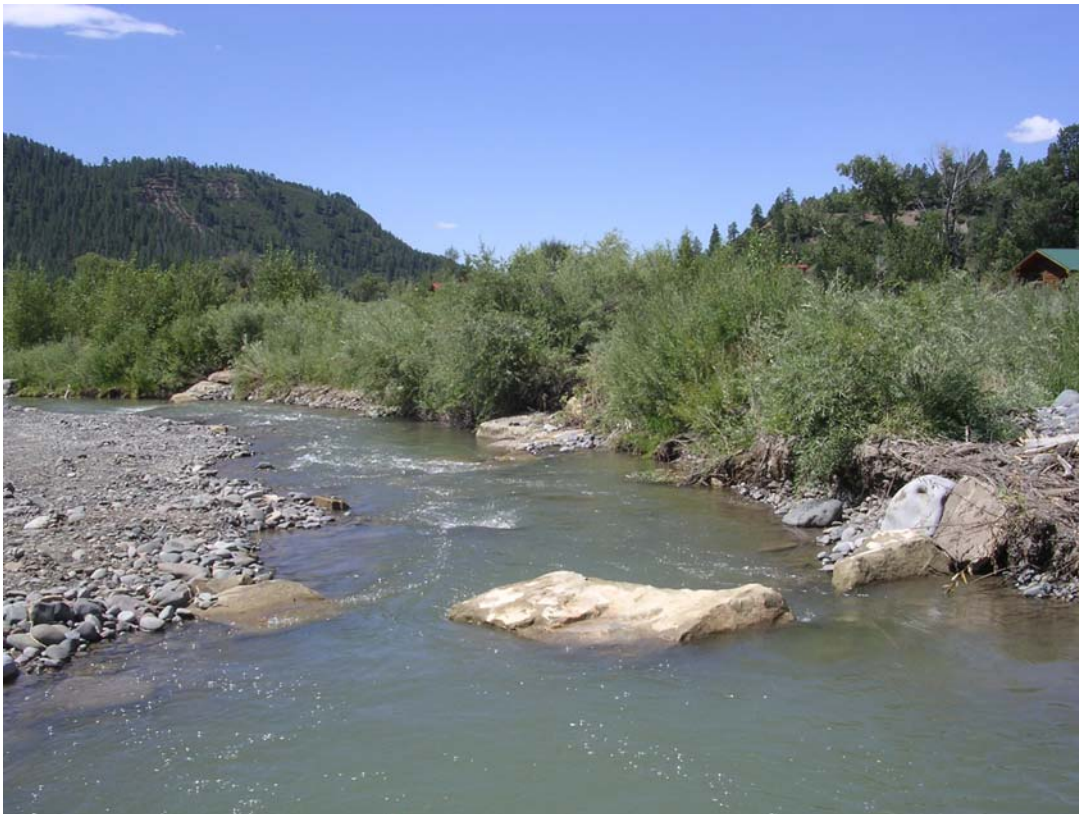
**AFTER: Single channel with rock bank protection and habitat rock**

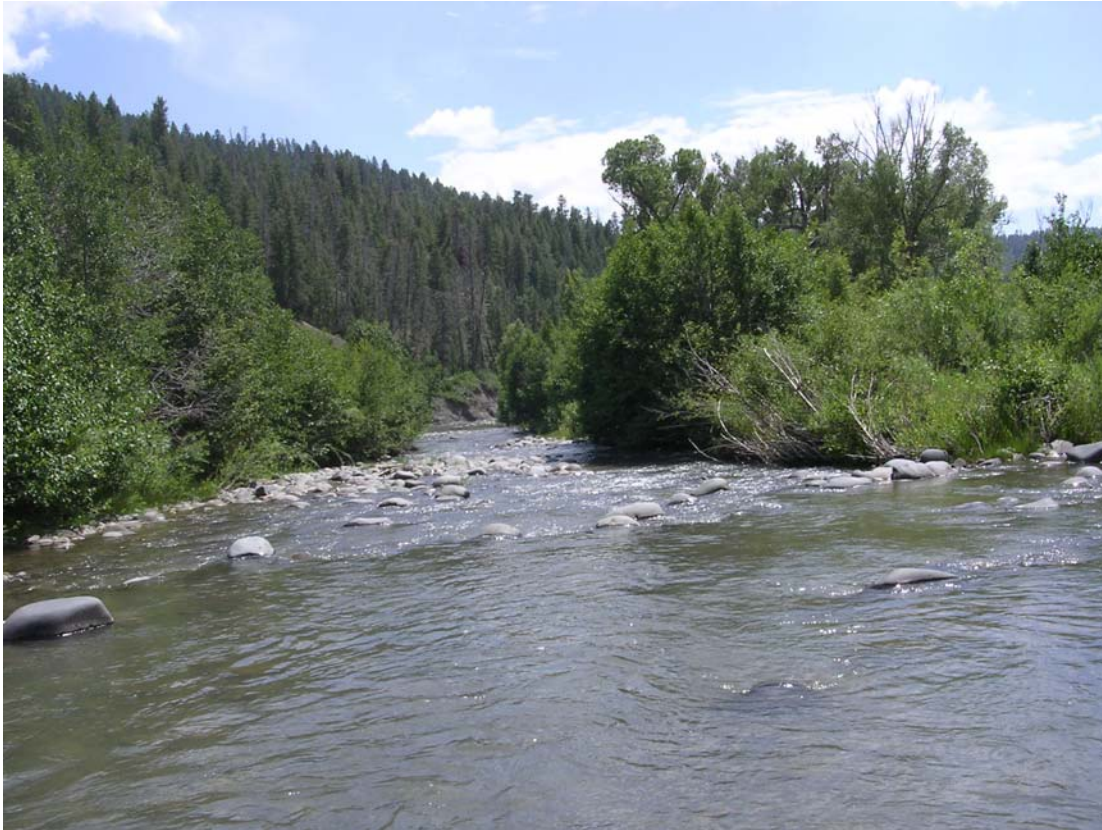
**BEFORE: Wide shallow and straight low flow channel**

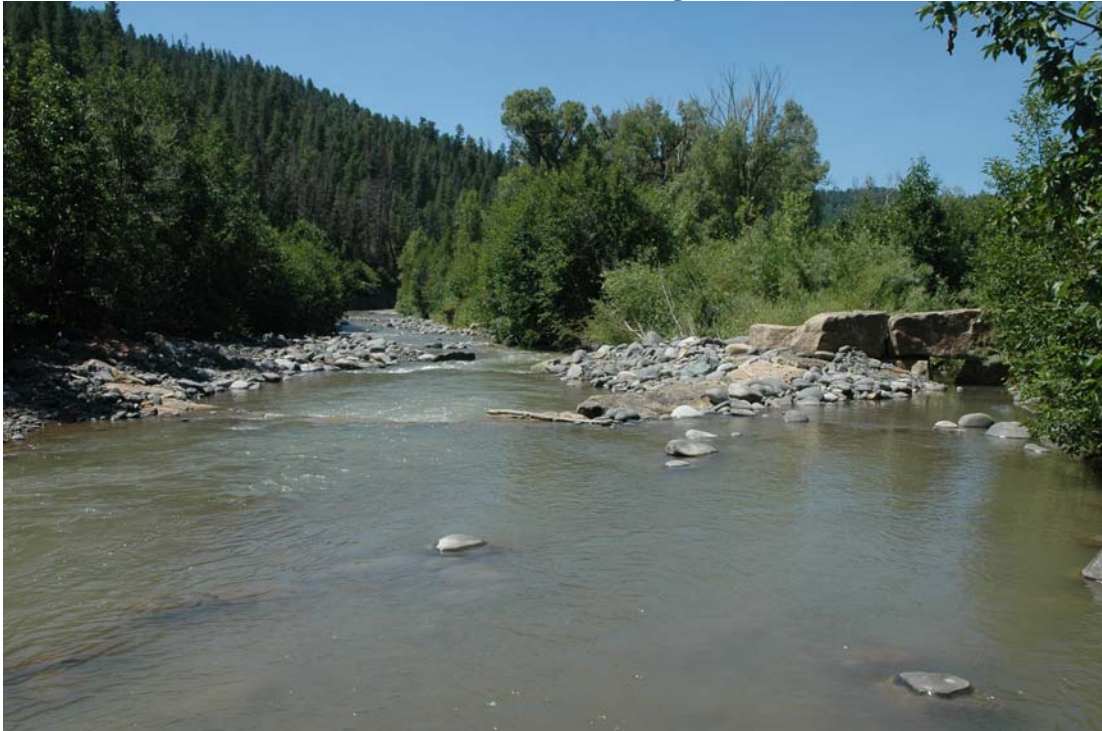
**AFTER: Rock diversion controlling flood water into side channel, channel narrowing and induced meandering downstream**

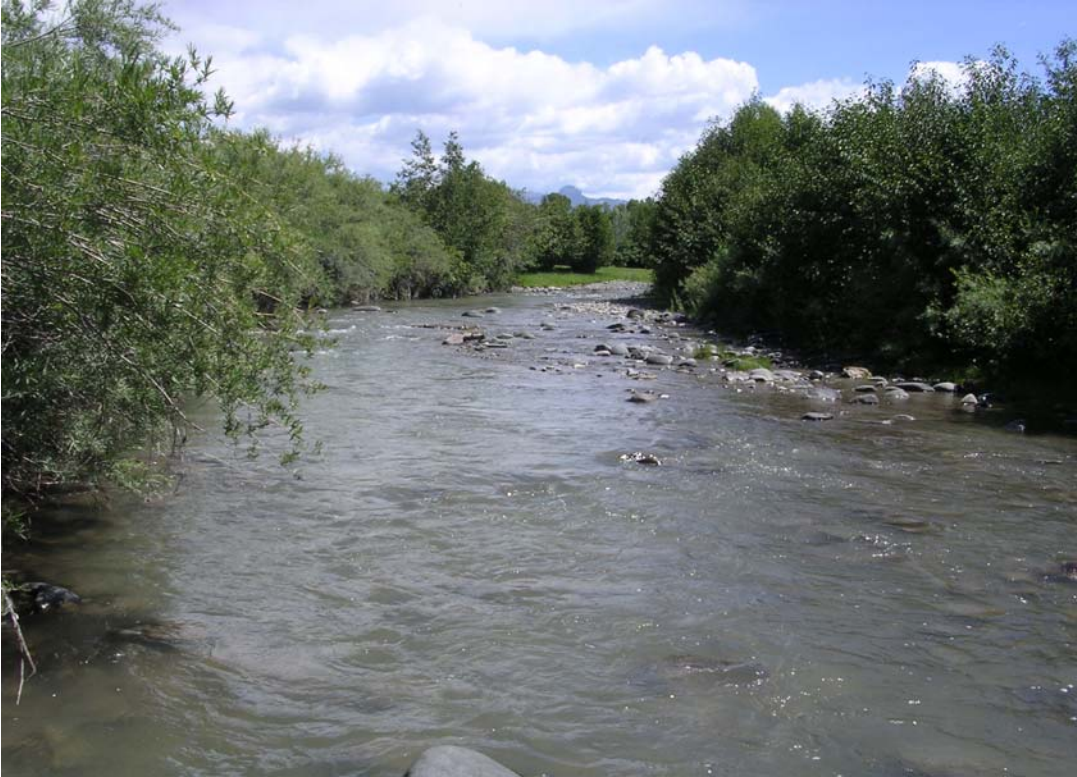
**BEFORE: Over-wide low flow channel with shallow flow and limited habitat**

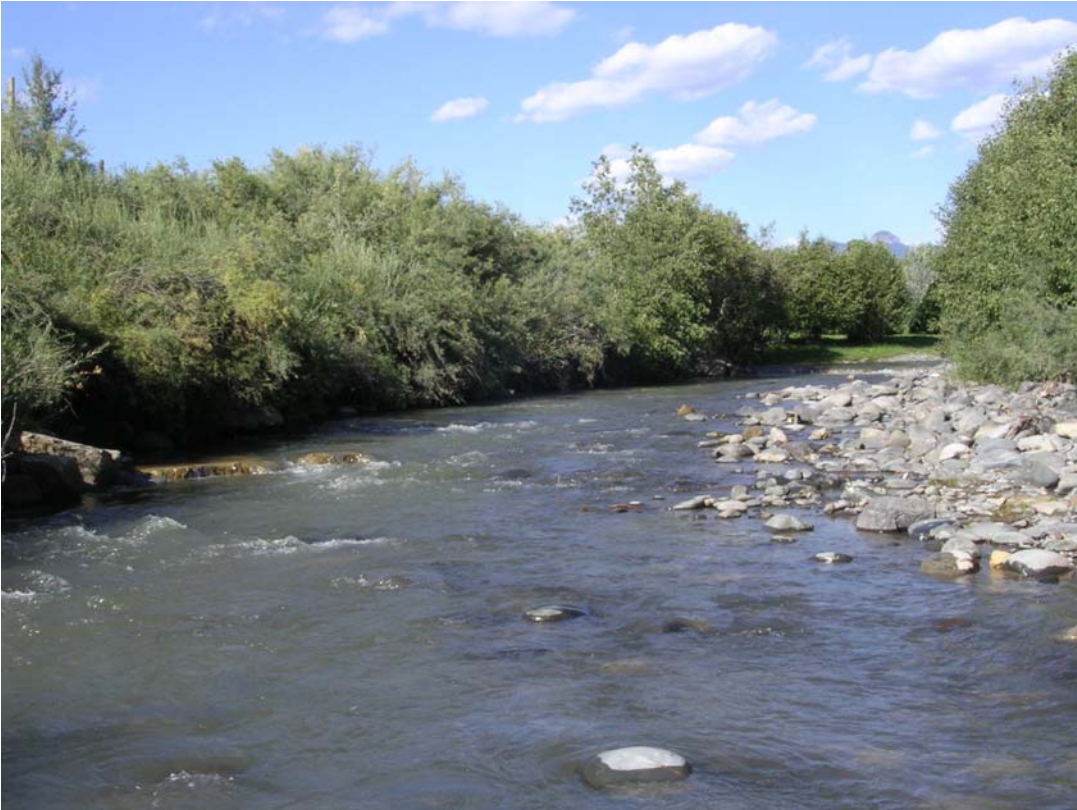
**AFTER: Enhanced point bar to promote deeper narrower channel with short rock vane for habitat and increased bank stability.**

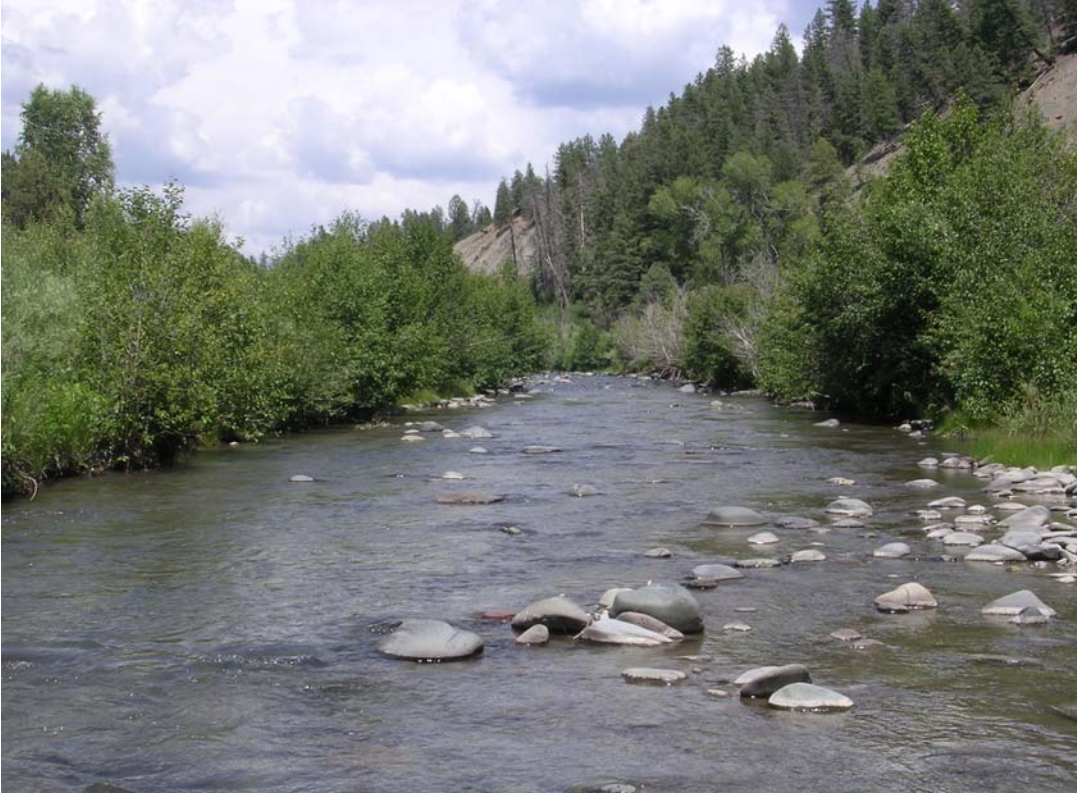
**BEFORE: Over-wide low flow channel limited habitat**

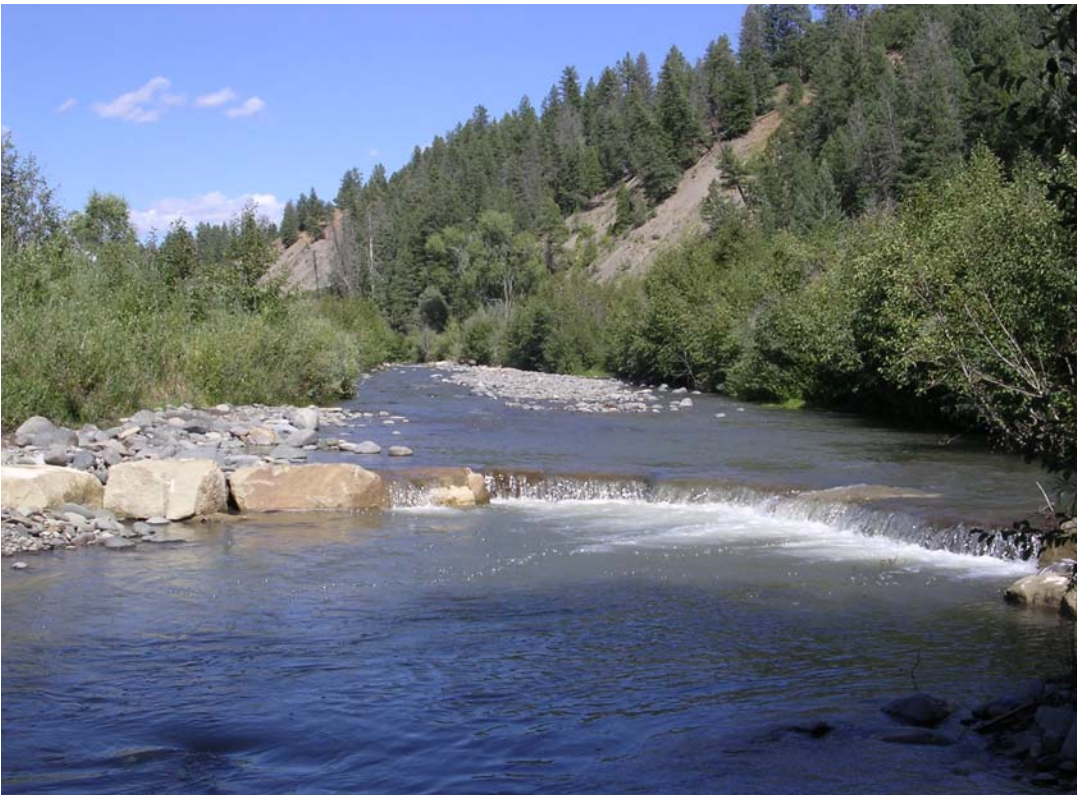
**AFTER: Constructed channel bar to promote deeper narrower channel with cross vane for habitat and bank stability.**
