#### FINAL REPORT

Paonia Ditch Diversion Adaptive Management Project

**Submitted by: North Fork River Improvement Association**

Date: September 8, 2009

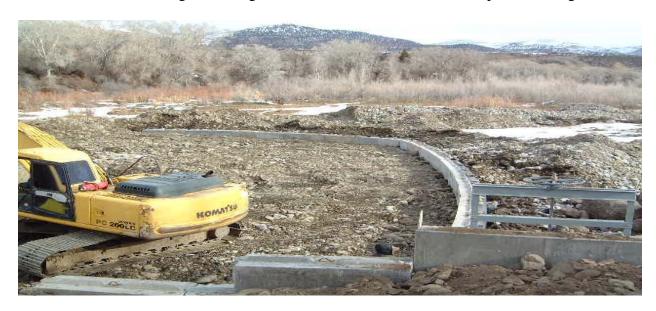
Photo 1. Diversion footing under original diversion construction, 2008. Upstream to right.

The Company's reconstruction of the diversion was completed during February and March of 2009. The initial project completed by NFRIA in 2008 was designed to create an efficient, low-maintenance permanent concrete head gate and a low-head rock weir at the diversion point for the ditch (Photo 1). The diversion also created a low-flow channel through the diversion structure (Photo 2) and energy-dissipating plunge pools below the diversion (Photo 3) to provide for fish migration and boater passage during low-flow conditions. These 2008 low-flow objectives were consistent with watershed management goals and needs assessments of the North Fork Water Conservancy District, the North Fork Gunnison Action Strategy (2000), and the Statewide Water Supply Initiative Findings and Key Recommendations. The Company's pre-2008 diversion structure prevented fish migration and ready boater passage.

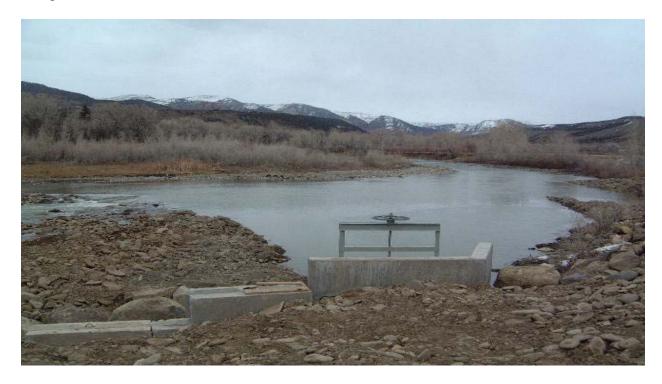
Photo 2. Paonia Ditch headgate, foreground center, with completed original low-flow channel mid-ground left, 2008

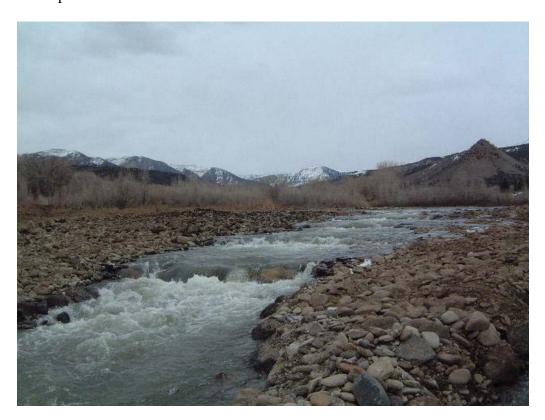
Photo 3. Completed low-flow channel and energy-dissipating plunge pools below diversion, view upstream. 2008.

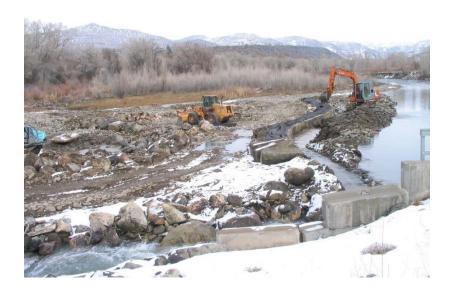
Photo 4. Realigned diversion structure under construction by the Company, February 2009.

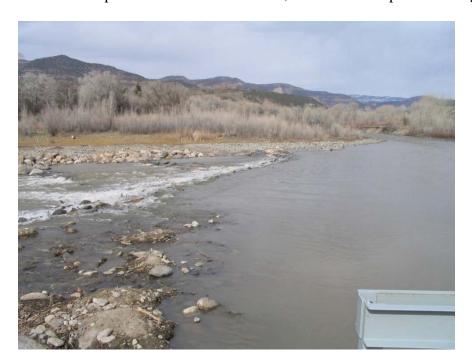
Photo 5. Completed diversion at low flow, March 2009. Upstream to right.

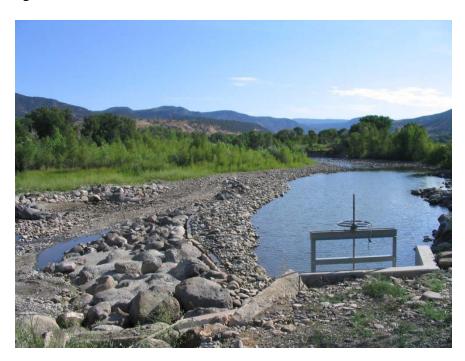
Photo 6. Diversion structure completed by Company, summer 2009. All flow is directed toward the headgate (right foreground); water not entering the Paonia Ditch is diverted back to the main river channel through a concrete "drop-chute" (not visible) adjacent to the headgate. Upstream to right.

During the Company's construction activities in 2009, NFRIA asked the Company to again incorporate a low-flow channel into the diversion structure, and a Company representative stated a willingness to do so. More recently, a Company representative wrote that the rebuilt "... structure will continue to offer fish passage and safe boat passage...." NFRIA observations since the reconstruction was completed, and following 2009 runoff, reach different conclusions, however. The most significant departure from NFRIA's 2008 original design and construction is that the Company did not reconstruct a low-flow channel through the diversion. Photos 5 and 6 differ markedly from Photo 2. Field measurements likewise provide little or no evidence that a low-flow channel was incorporated into the Company's final reconstructed diversion.
