Kerber Creek Watershed Restoration Project

Squirrel Creek Restoration - 2009

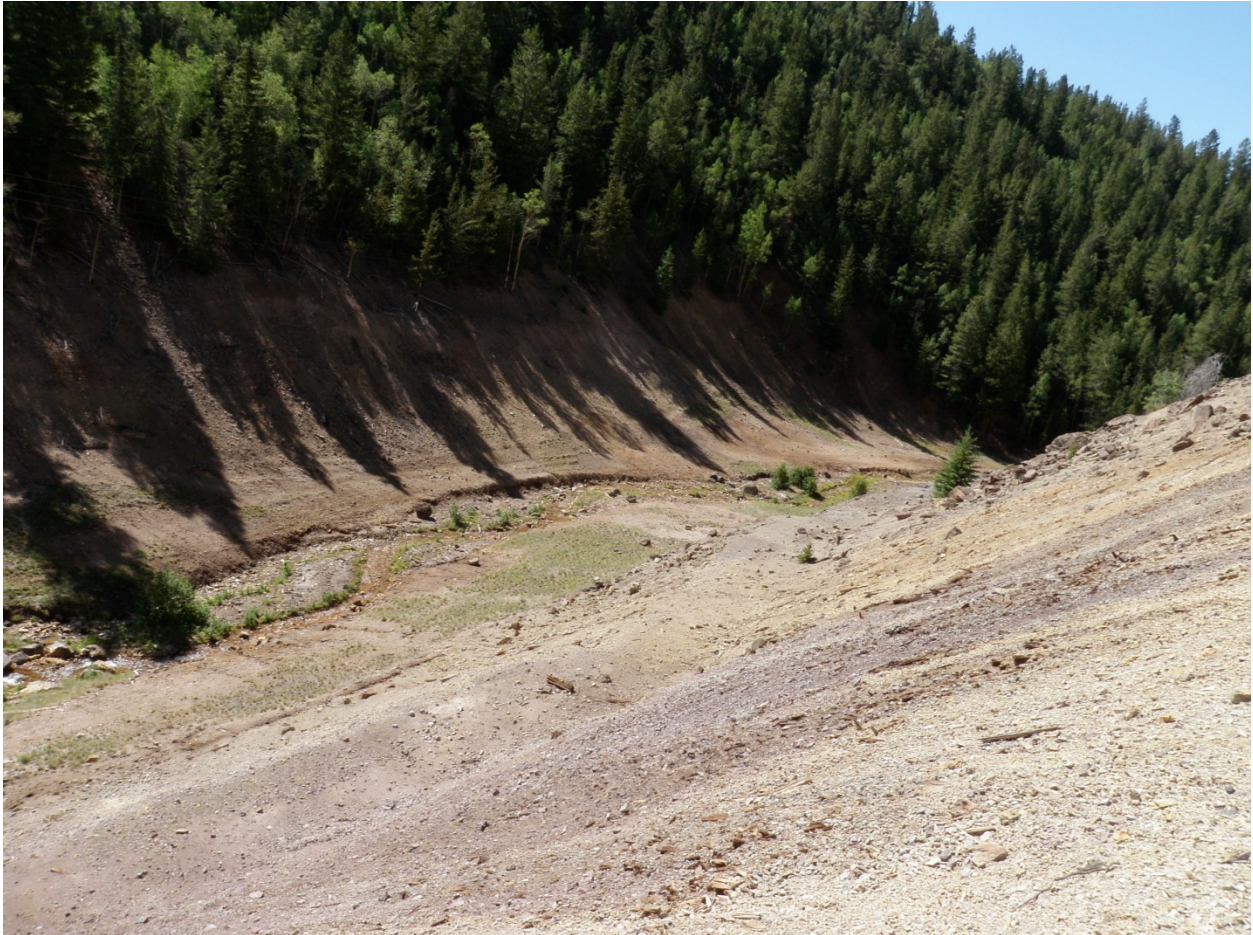
One major contributing factor to stream degradation is the un-vegetated slopes adjacent to the streams (see Squirrel Creek in the photo below). Along Squirrel Creek, the hillsides downstream of the Rawley 12 mine are extremely steep (% 60-70 slopes). The hillsides are void of vegetation and are contributing sediment and excessive flows to the stream channel. This project

is expected to help restoration efforts by rebuilding the A horizon with captured upslope sediment and organic material.

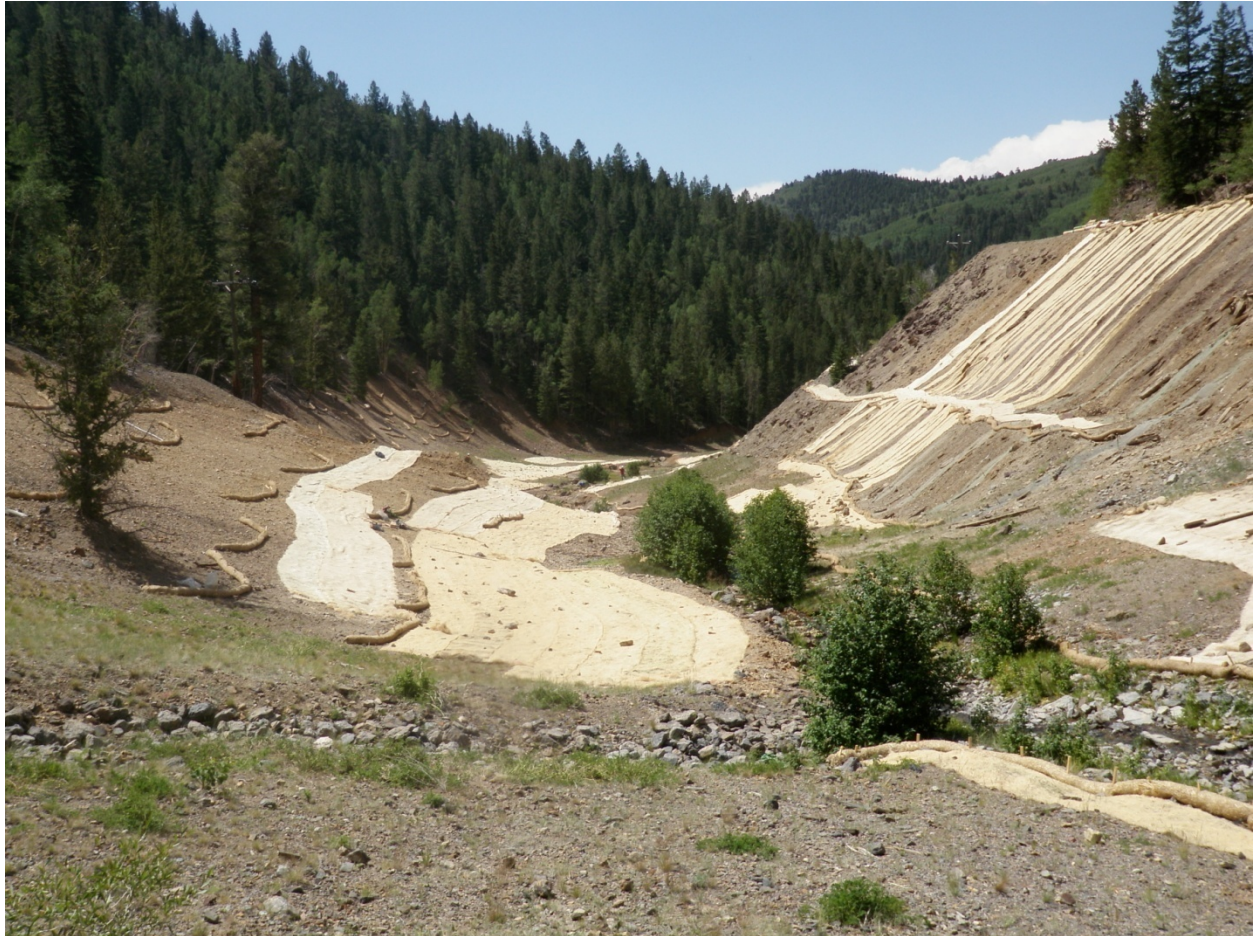
Work completed with the 2009 Colorado Watershed Restoration Program (CWRP) Project Grant included stabilization of over 10.5 acres. Work included installation of 5700 feet of wattles, and 300,000 feet² of erosion blankets on approximately eight acres. See the photo below.

Wattles were installed with 2' wooden stakes that were pounded into the ground until they hit refusal or only 6" of the stake remained out of ground. Stakes were spaced in two foot intervals. Wattles were placed in concave fashion to optimize the potential for collection of upslope soil and organic material. Wattles were staggered as per the manufacture guidance to allow proper passage of water and snow.

Prior to placement of the blankets, seeds were broadcast on the ground surface. A native seed mix for the Kerber Creek watershed was utilized to optimize growth. The erosion blankets were secured with 6" metal stakes at 2' intervals. Erosion Blankets were placed on flat surfaces and also on the steep rocky hillside on the west end of the site. The erosion blankets placed on flat surfaces should provide wind shear and moisture protection for seedlings. Those on the steep

west slope are expected to help encourage shrub and tree recruitment plus reduce runoff and sediment to the immediate stream banks.
