SQUIRREL CREEK CROSS-SECTION MONITORING October 23-25, 2009

This narrative report addresses channel monitoring of Squirrel Creek downstream of slope stabilization treatments constructed just below the _____ Mine. Steep sideslopes left behind after removal of an old tailings dam were treated with a variety of geotextile configurations during the summer or 2009 to minimize upslope erosion and sediment loading of the stream channel. Although the timeframe for channel response may be slow at this elevation, the intended outcome is establishment of bank vegetation along Squirrel Creek, with associated changes in channel morphology and ecology.

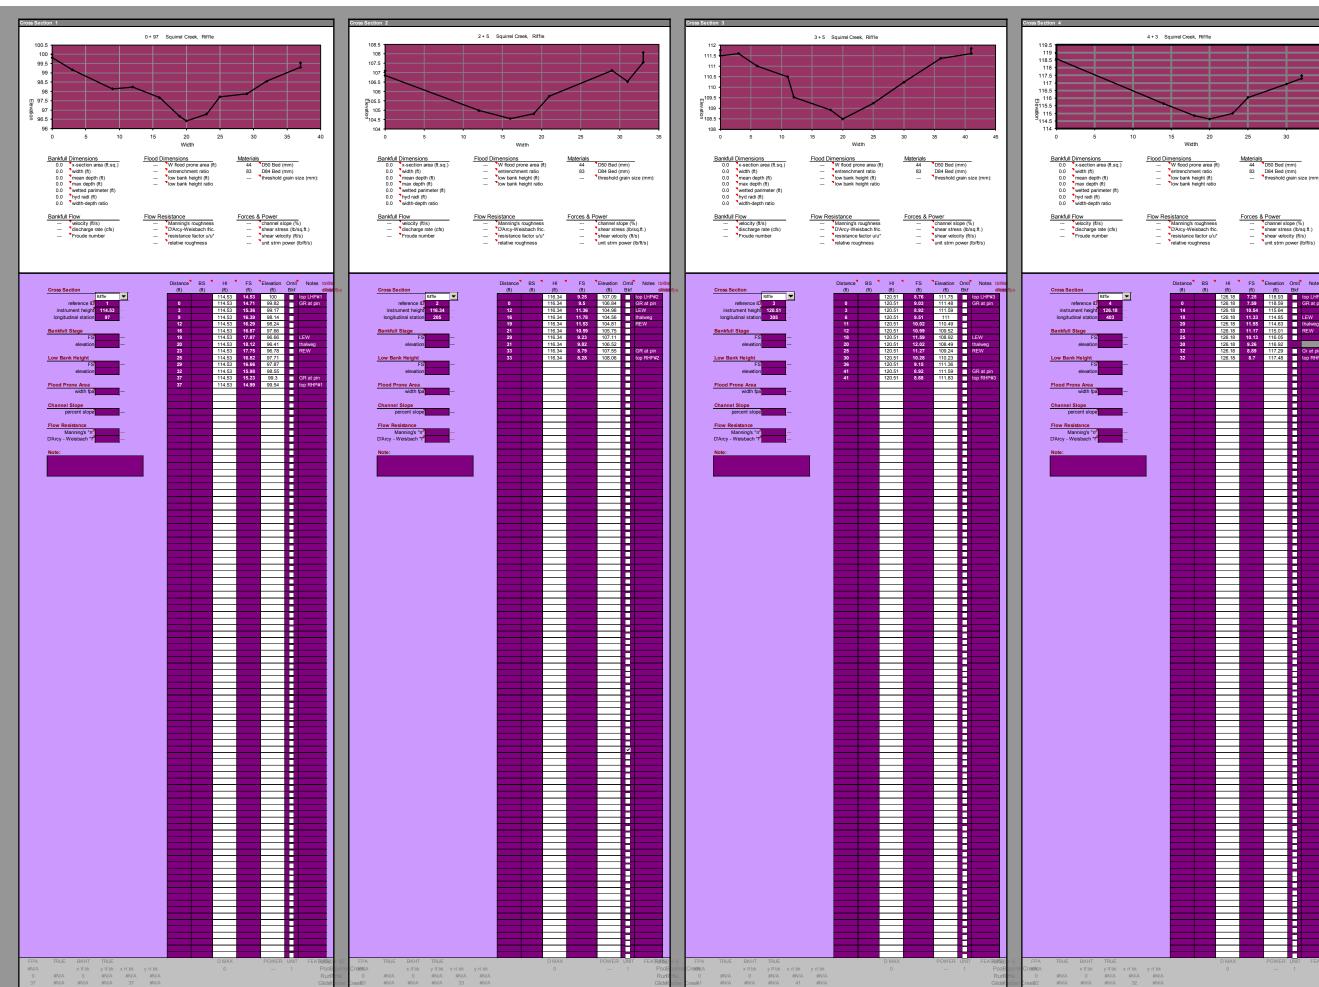
Bed	
	Surface	
D16 (mm)	9	
D35 (mm)	29	
D50 (mm)	44	
D65 (mm)	58	
D84 (mm)	83	
D95 (mm)	130	
mean (mm)	27.3	
dispersion	3.4	
skewness	-0.21	
Shape Facto		
% Silt/Clay	0%	
% Sand	0%	
% Gravel	68%	
% Cobble	27%	
% Boulder	2%	
% Bedrock	3%	
% Clay Harc		
% Detritus/V		
% Artificial		
Largest Mob

Material S	Size Range (mm)	Count	
silt/clay	0 - 0.062		
very fine sand	0.062 - 0.125		
fine sand	0.125 - 0.25		
medium sand	0.25 - 0.5		
coarse sand	0.5 - 1		
very coarse sand	1 - 2		
very fine gravel	2 - 4	5	
fine gravel_	4 - 6	2	
fine gravel	6 - 8	6	
medium gravel	8 - 11	7	
medium gravel	11 - 16	4	
coarse gravel	16 - 22	3	
coarse gravel	22 - 32	10	
very coarse gravel _	32 - 45	12	
very coarse gravel	45 - 64	19	
small cobble	64 - 90	18	
medium cobble	90 - 128	6	
large cobble	128 - 180	2	
very large cobble	180 - 256	1	
small boulder	256 - 362	1	
small boulder	362 - 512	1	
medium boulder_	512 - 1024		
large boulder	1024 - 2048		
very large boulder	2048 - 4096		
	total particle count:	97	
bedrock -		3	
clay hardpan			
detritus/wood			
artificial -			
2	total count:	100
