# Dominguez Canyon Wilderness

## Fisheries Report

## Hydrologic Modeling Report

## Hydrology Report

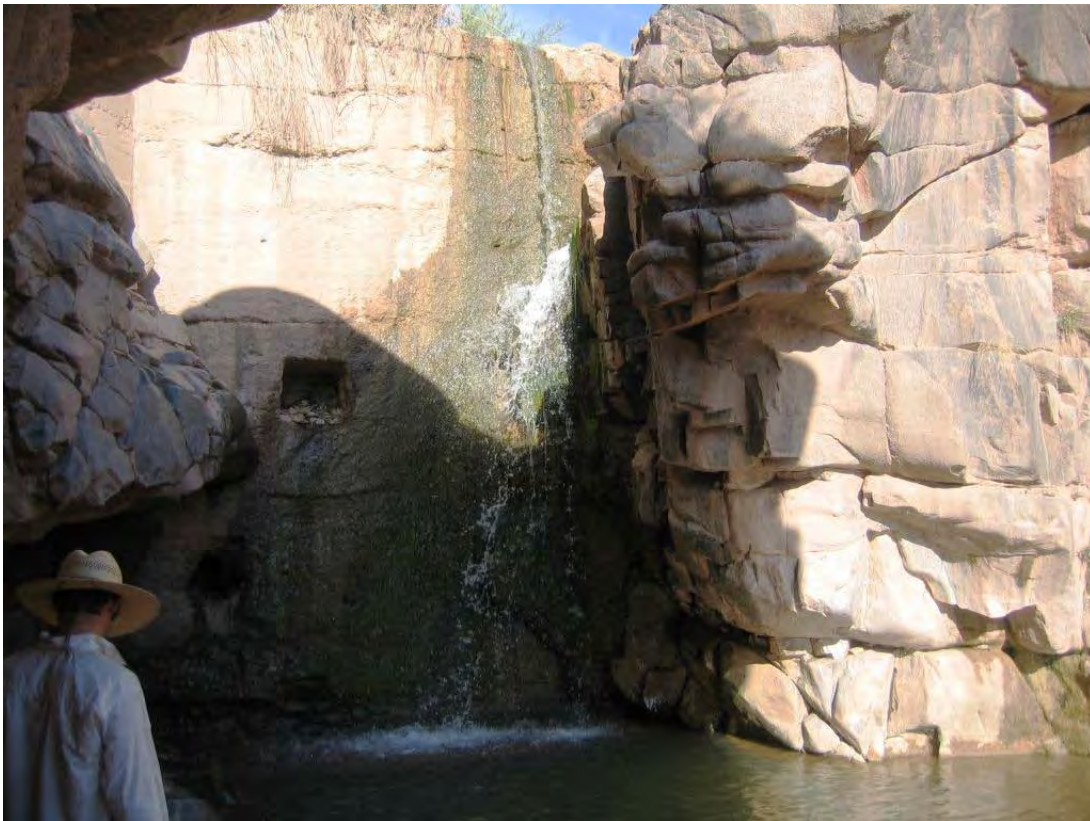
**Reach 1 Diversion Barrier**

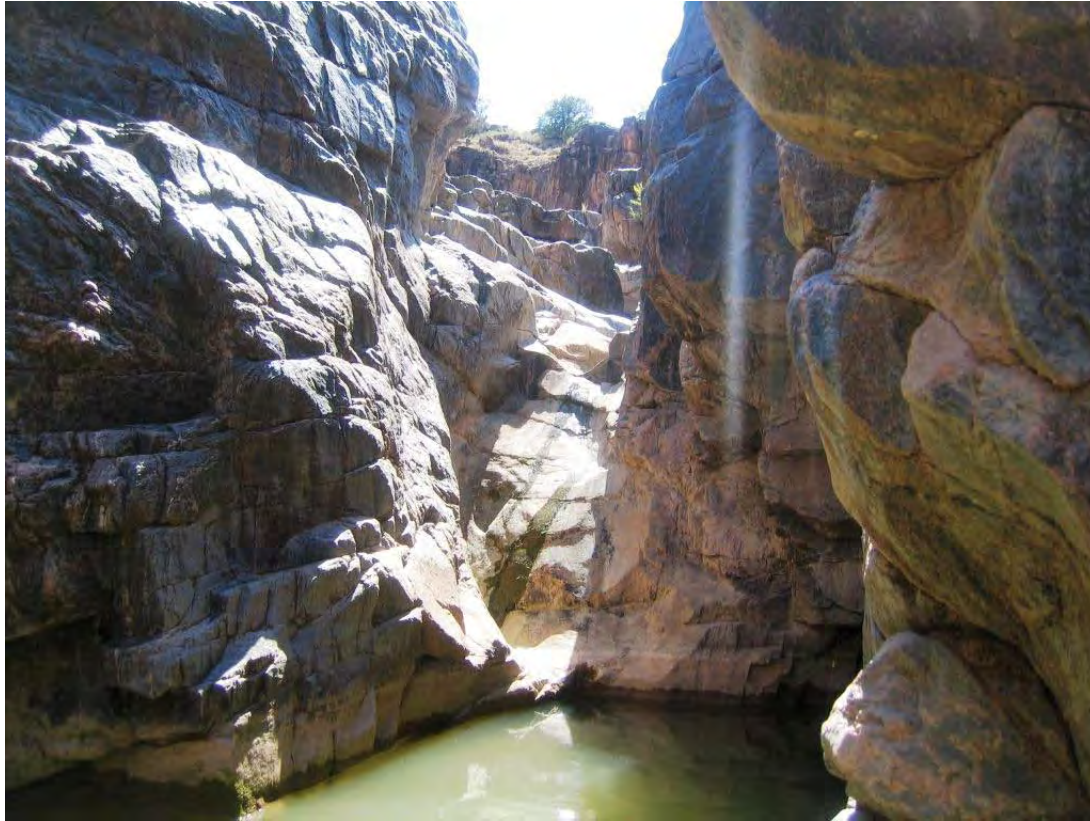
**Reach 3 Isolated Pool**

This reach was sampled to determine species composition and relative abundance. The entire reach was sampled from the confluence with Little Dominguez Creek up to the point where the crew gave up looking for perennial flow. Only a few isolated pools were present in this reach because of extraordinarily dry conditions (lack of monsoonal flow) during late summer 2009. During normal water supply conditions, speckled dace would be expected to be present in this reach.

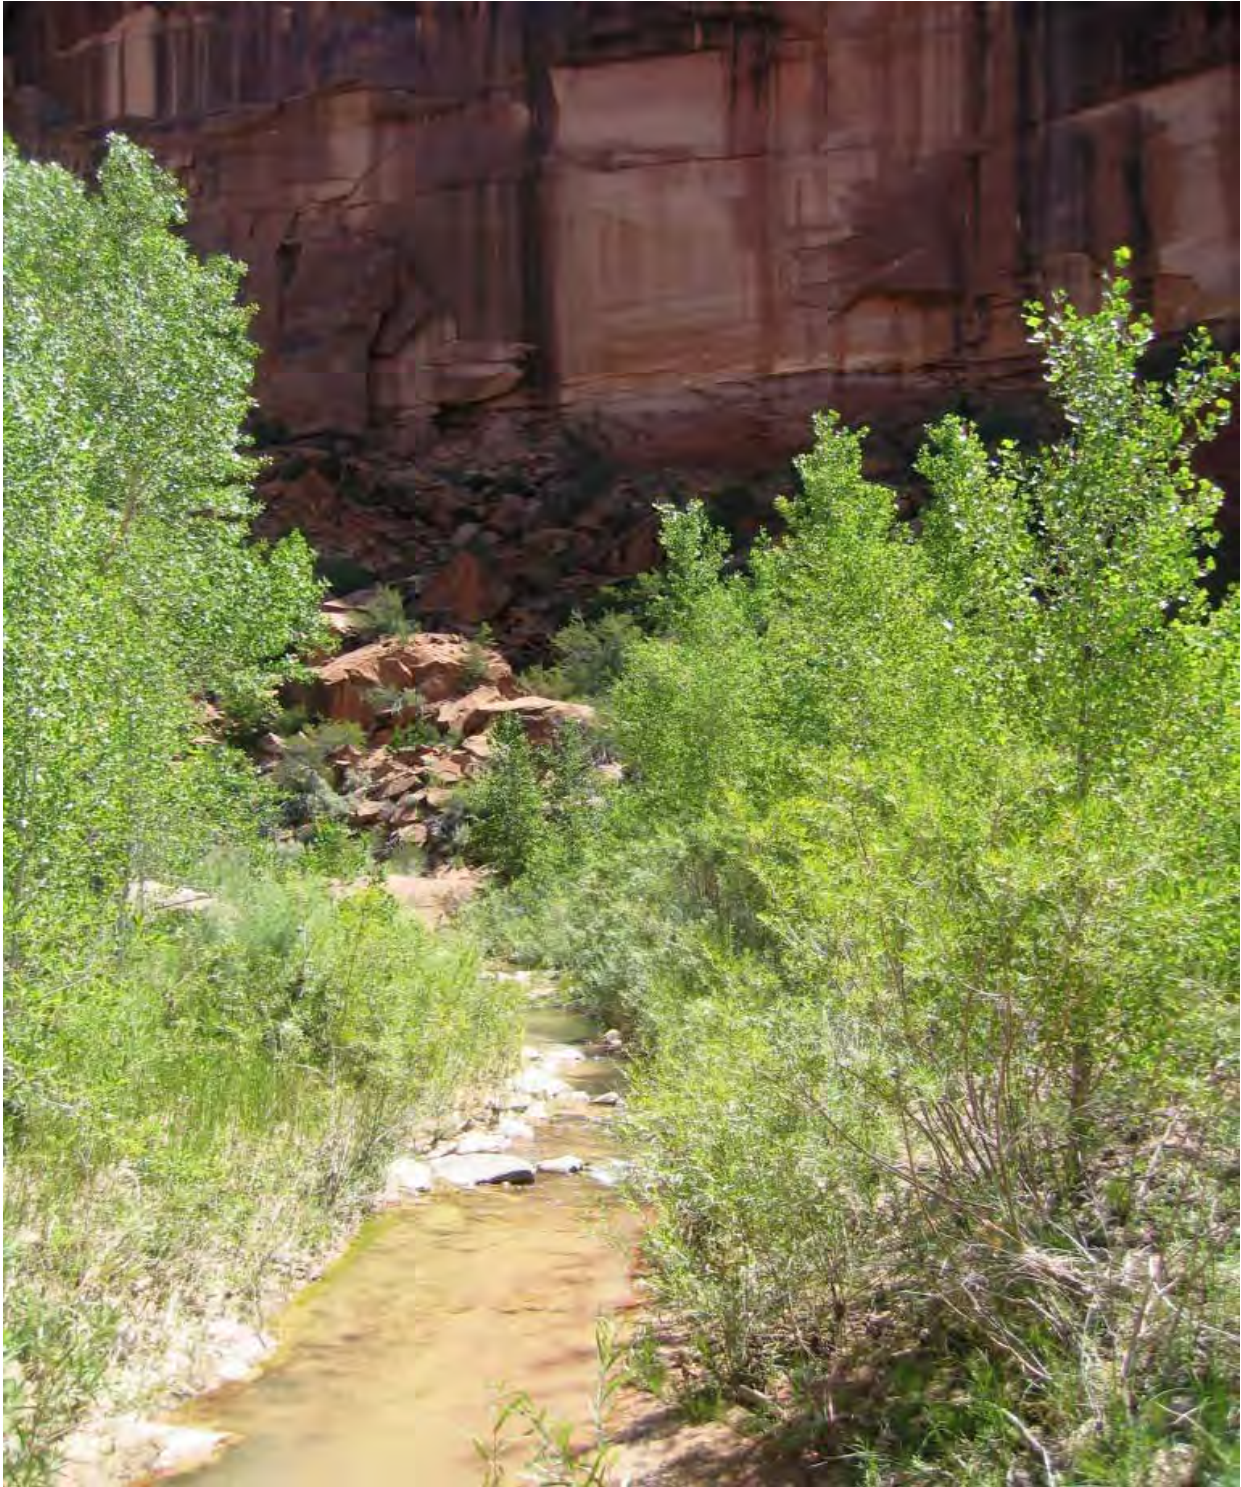
**Little Dominguez Creek - lower reach Speckled Dace Habitat**

Only speckled dace were seen or collected from the confluence of Big Dominguez Creek upstream to a small natural barrier - see photo and map. Fish were abundant with hundreds of fish captured and several hundred more seen. Fish ranged in size from approximately 40 millimeters up to 110 millimeters.

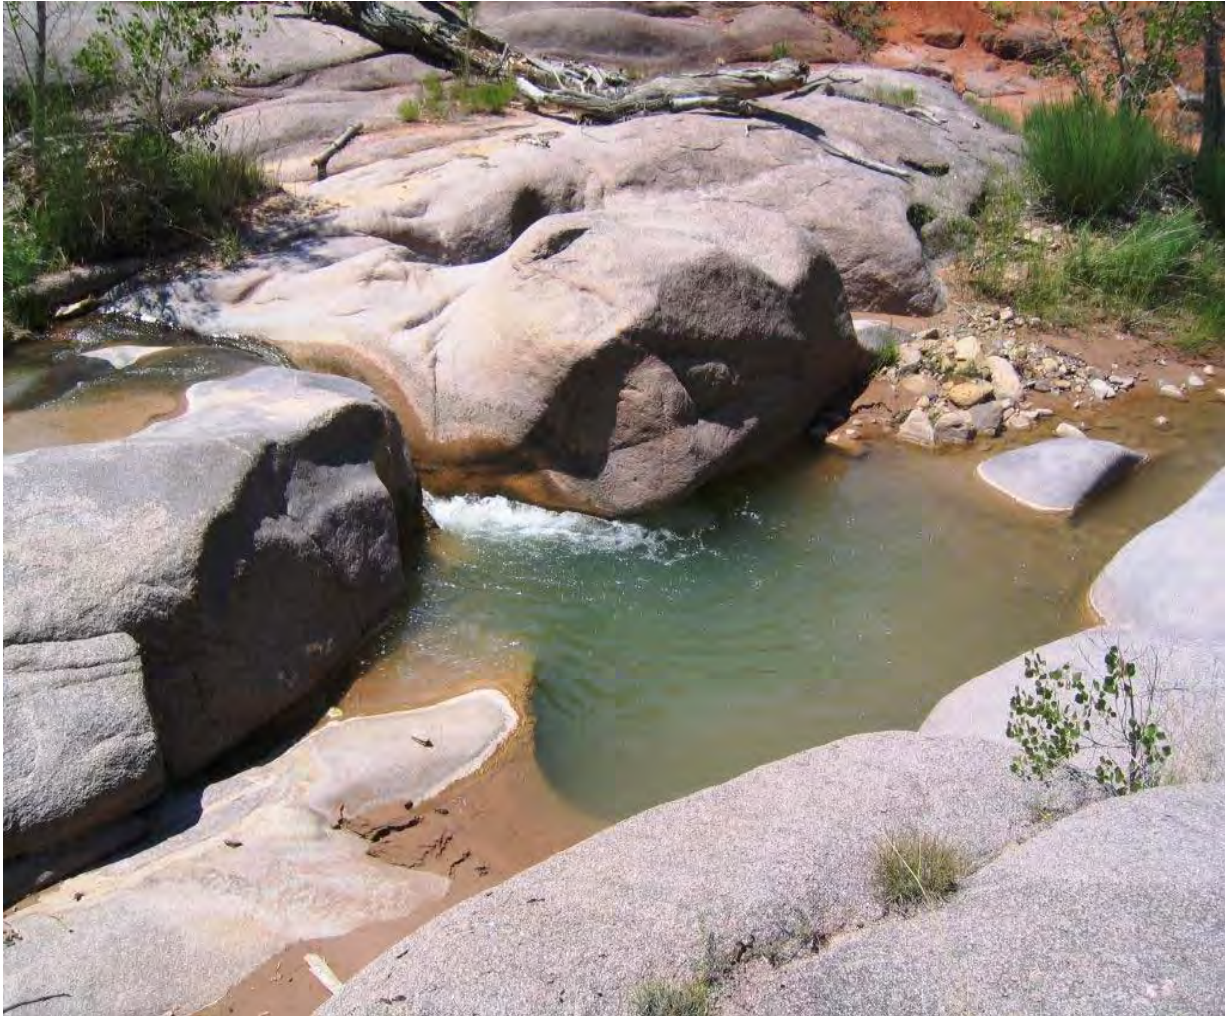
**Apparent natural barrier to speckled dace movement upstream**

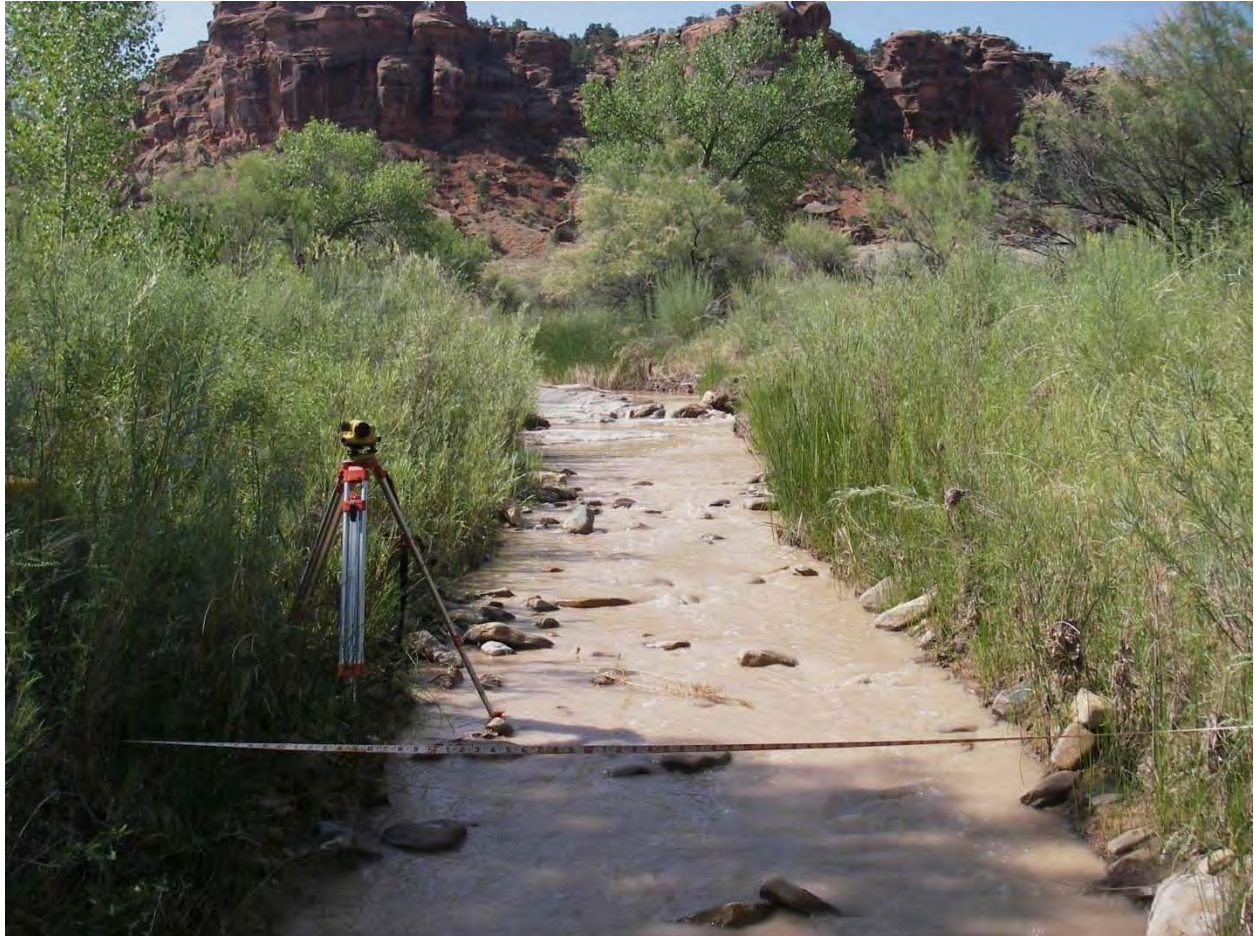
*R2Cross data collection site on Little Dominguez Creek*

Cross section measurements taken by BLM at low and high elevations along both streams revealed that the channel width doesn't change dramatically between the top and the bottom of the stream system. This indicates that large, channel forming events are mainly derived from snowmelt runoff or from large thunderstorms high in the watershed. Input from tributaries lower in the system may contribute significant sediment to the system, but typically are not significant enough to be channel-forming events.

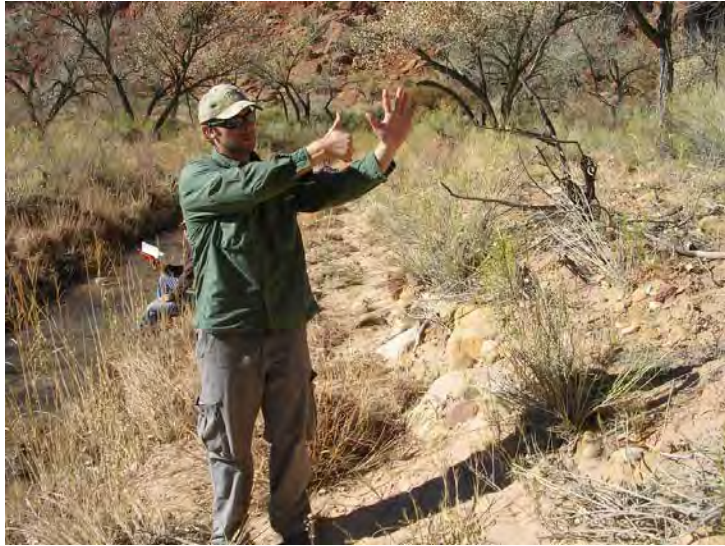
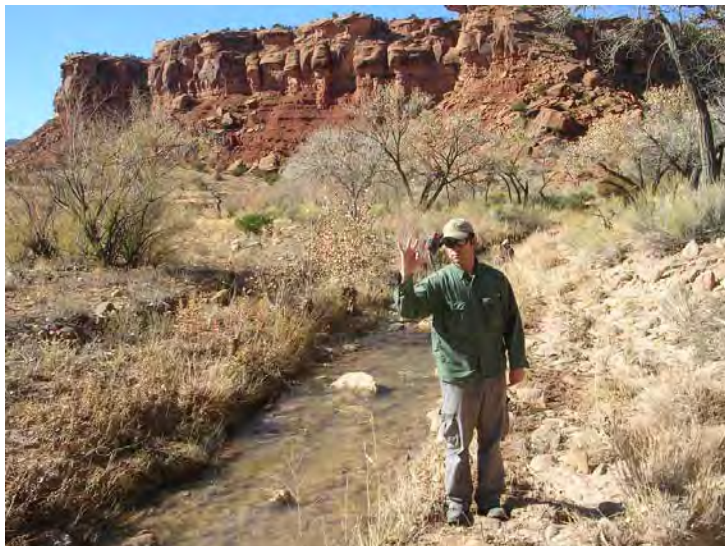
*In the photos above, note the willow community close to the active channel and intermediate size riparian shrubs on the floodplain above bankfull. The large, older cottonwoods that are a significant distance from the channel were established during large flood events.*

**Lower Little Dominguez Creek.** The first stream reach was selected on lower little Dominguez Creek, slightly upstream from the confluence with Big Dominguez Creek. This stream reach was selected because it represents a broad floodplain with a cottonwood community containing multiple age classes. BLM utilized elevation and roughness data from six cross sections within this stream reach. Representative photographs from this reach are displayed below.

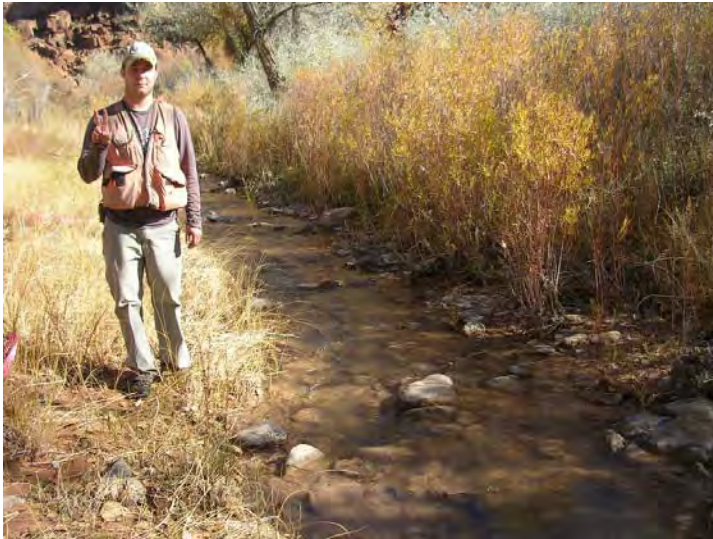
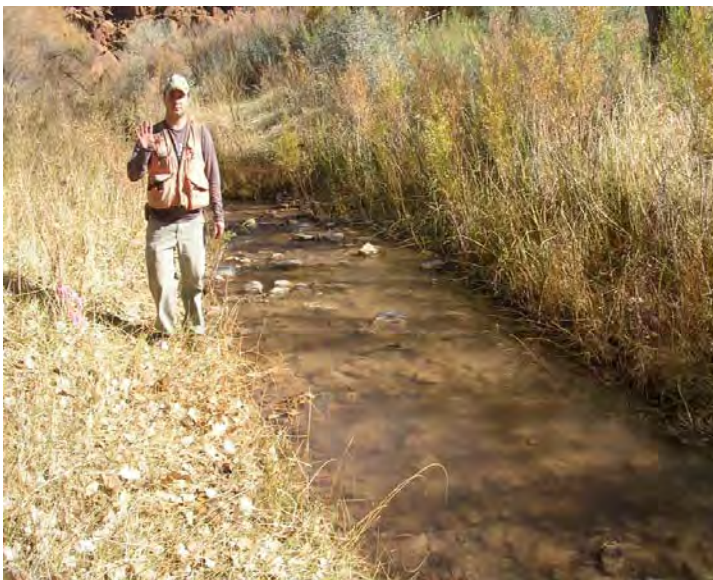
*In the photos above, note the high density of the willow community adjacent to the creek. Also note that the mature cottonwoods (upper photo, at the center top of the photo) are closer to the active channel because of the narrower floodplain available to the creek.*

**Lower Big Dominguez Creek.** The second stream reach was selected on lower Big Dominguez Creek, slightly upstream from the confluence with Big Dominguez Creek. This stream reach was selected because it represents a floodplain with a cottonwood community containing multiple age classes, but it has a narrower floodplain than Little Dominguez Creek and also has a higher gradient. BLM utilized elevation and roughness data from three cross sections within this stream reach. Representative photographs from this reach are displayed below.

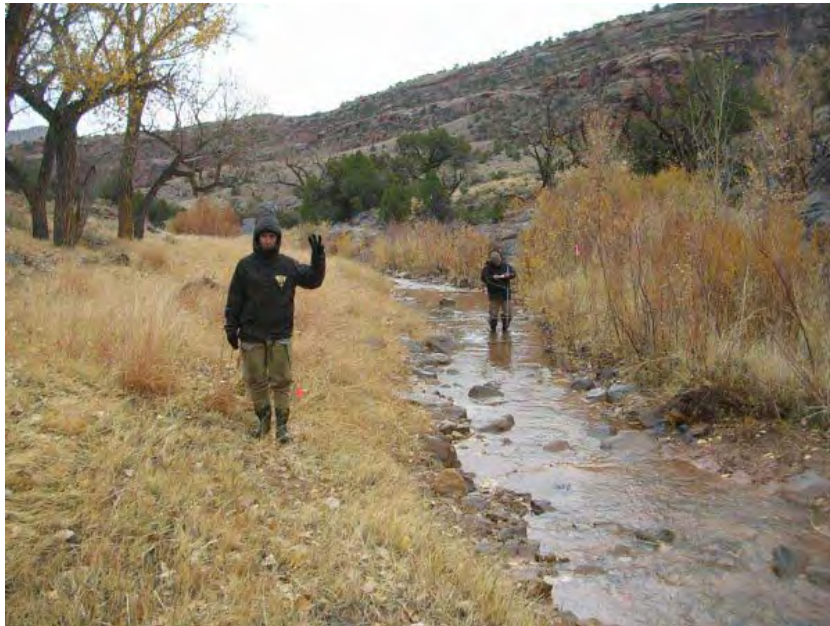
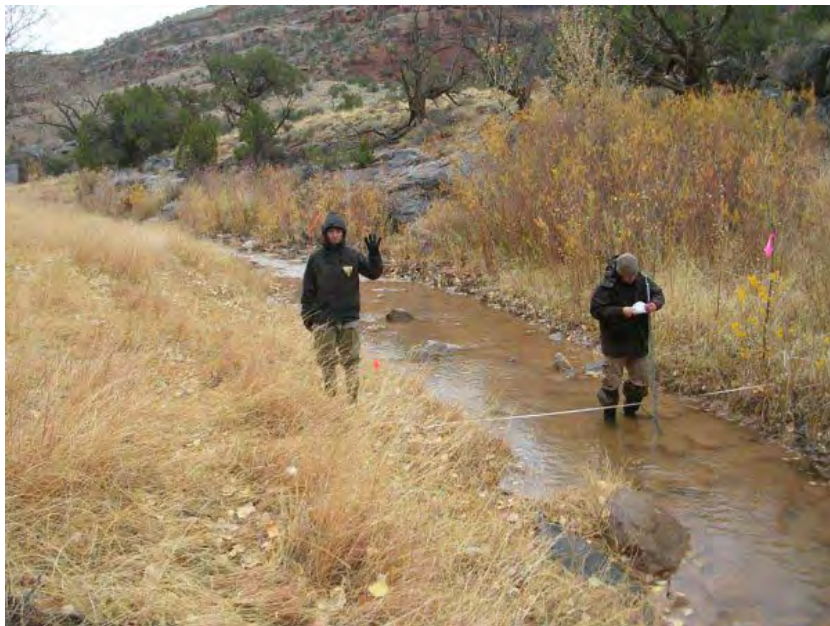
*In the photographs above, notice the black granite (behind the yellow willows) that acts to confine this stream channel. Also note the very distinct line of mature cottonwood trees on the left side of the upper photo.*

**Big Dominguez Creek Above Falls.** The third stream reach was selected on Big Dominguez Creek approximately one mile upstream from the confluence of Big Dominguez Creek and Little Dominguez Creek. This stream reach was selected because it represents a stream reach confined by canyon geology that supports a cottonwood community. BLM collected elevation and roughness data at six cross sections within this stream reach. Representative photographs from this reach are displayed below.

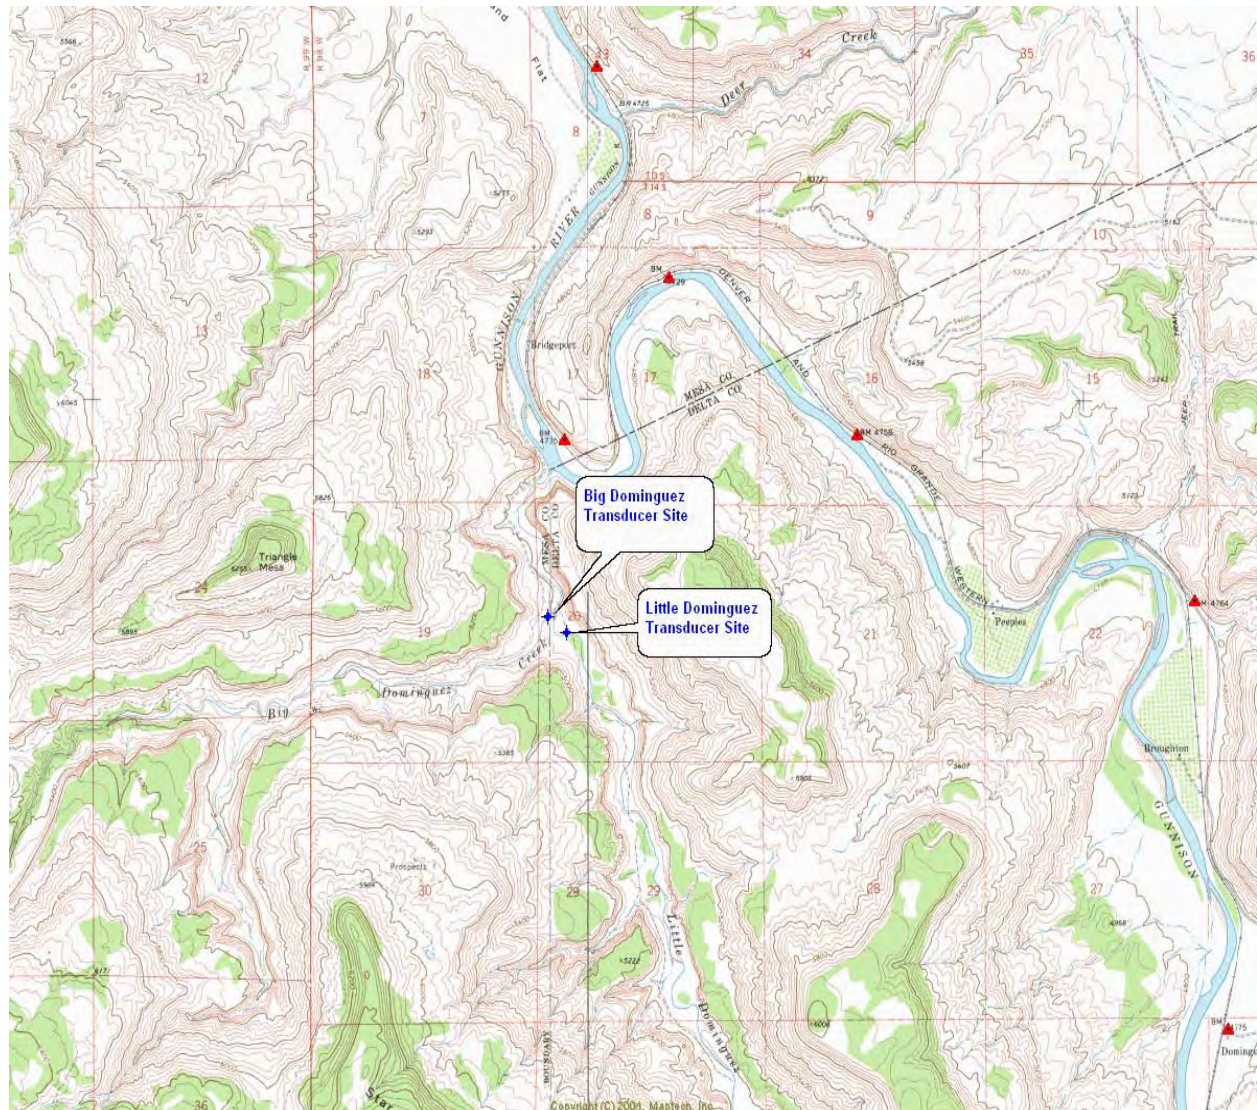
**Pressure Transducer Methodology.** To obtain stream stage data for developing a flow rating curve and ultimately a hydrograph, pressure transducers were installed in Big and Little Dominguez Creeks in September 2008. Each creek received two transducers. One transducer was installed on each creek near the confluence of Big Dominguez Creek and Little Dominguez Creek. An additional transducer was installed on each creek near the location where the creek enters BLM lands from US Forest Service lands. Refer to the following maps for the locations of the transducers. Refer to Figure 1 for a map of the lower Big and Little Dominguez sites,

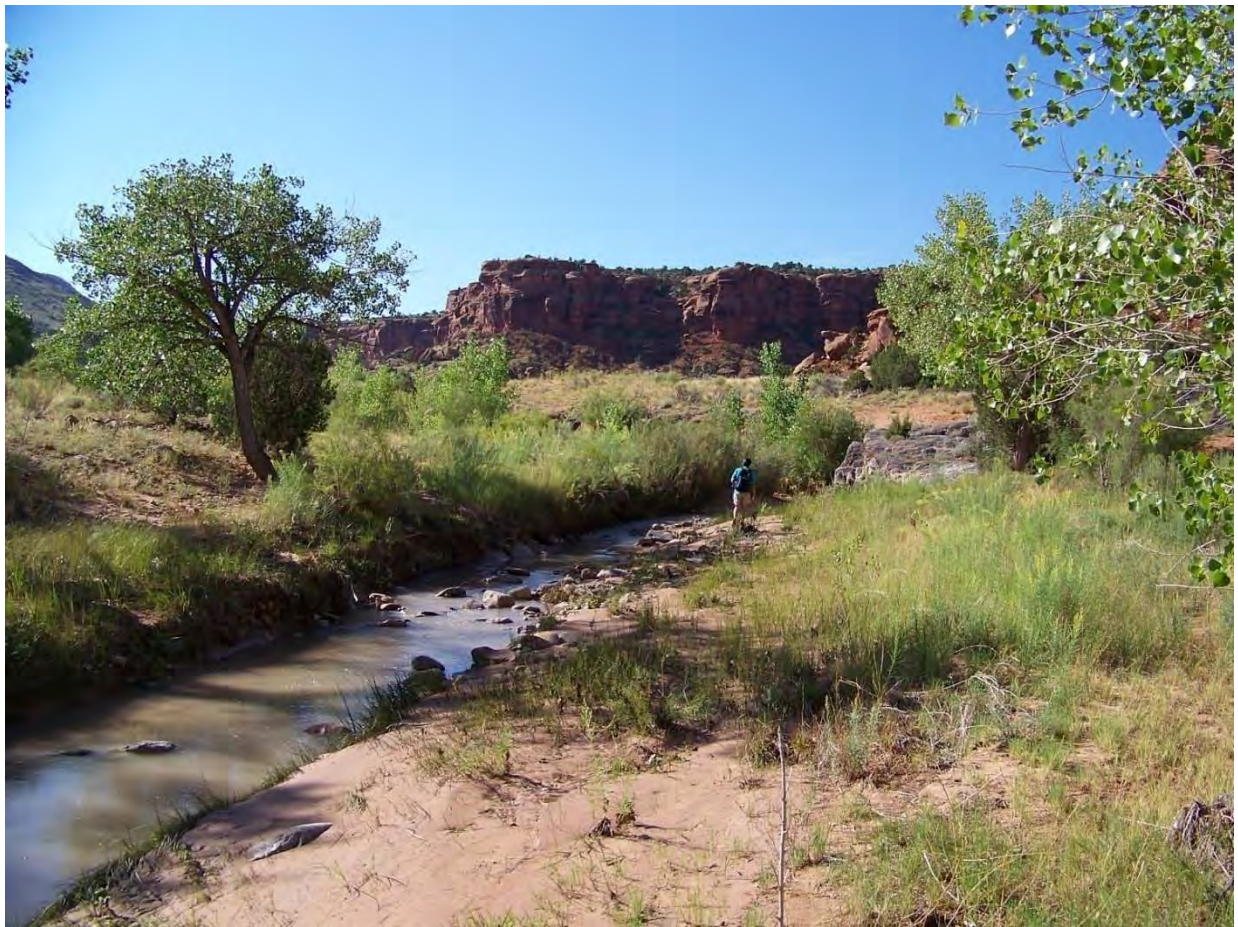
*Macroinvertebrate sampling location on lower Big Dominguez Creek.*

**Data Collection** – BLM staff collected invertebrate samples from two locations in each creek. One sample was taken at lower elevation near the confluence of the two creeks, at approximately 4,900 feet. Another sample was taken at higher elevation portions of each creek at approximately 6,900 feet. The samples were collected on July 15 and July 16, 2008. Riffle habitats were sampled with a 500 micron mesh net. Samples were sent for analysis to the National Aquatic Monitoring Center, which is located within the Department of Watershed and Sciences at Utah State University.

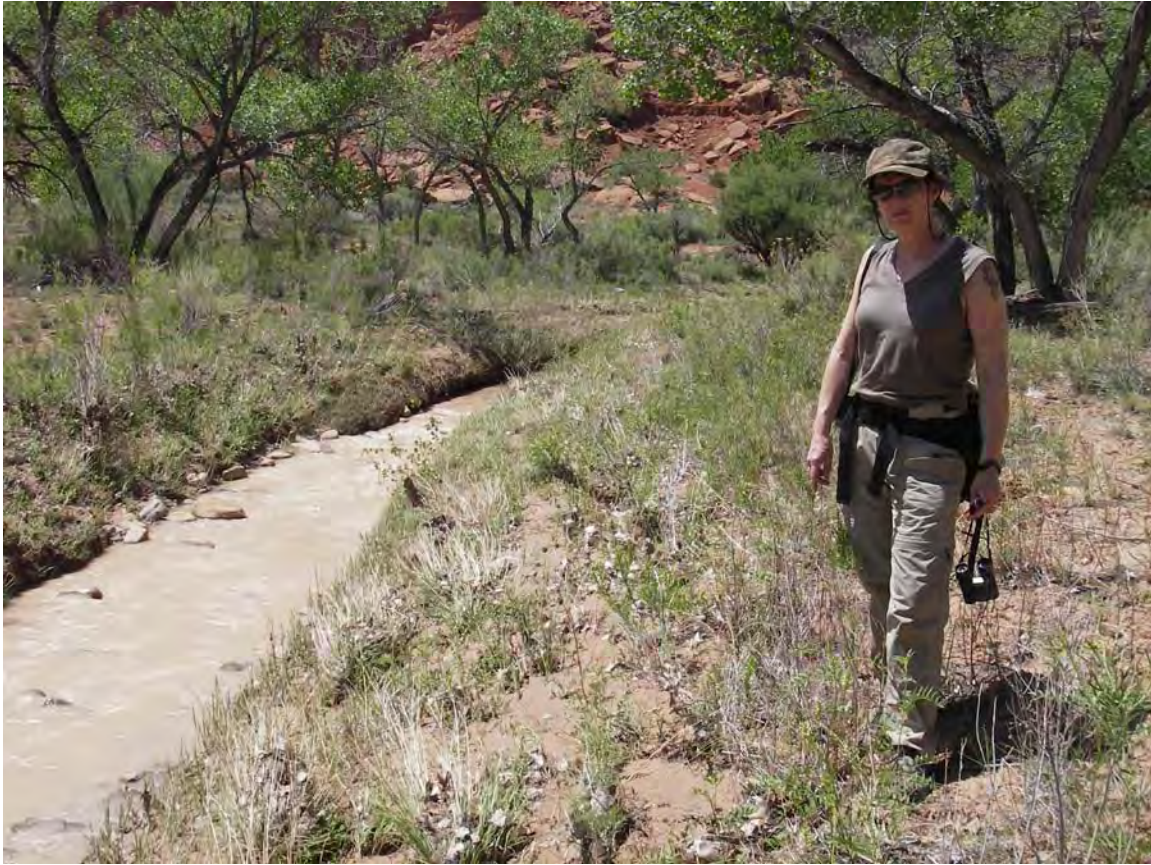
*Linda Bassi stands at the upper extent of sediment deposition from a spring 2009 flood event on Big Dominguez Creek.*

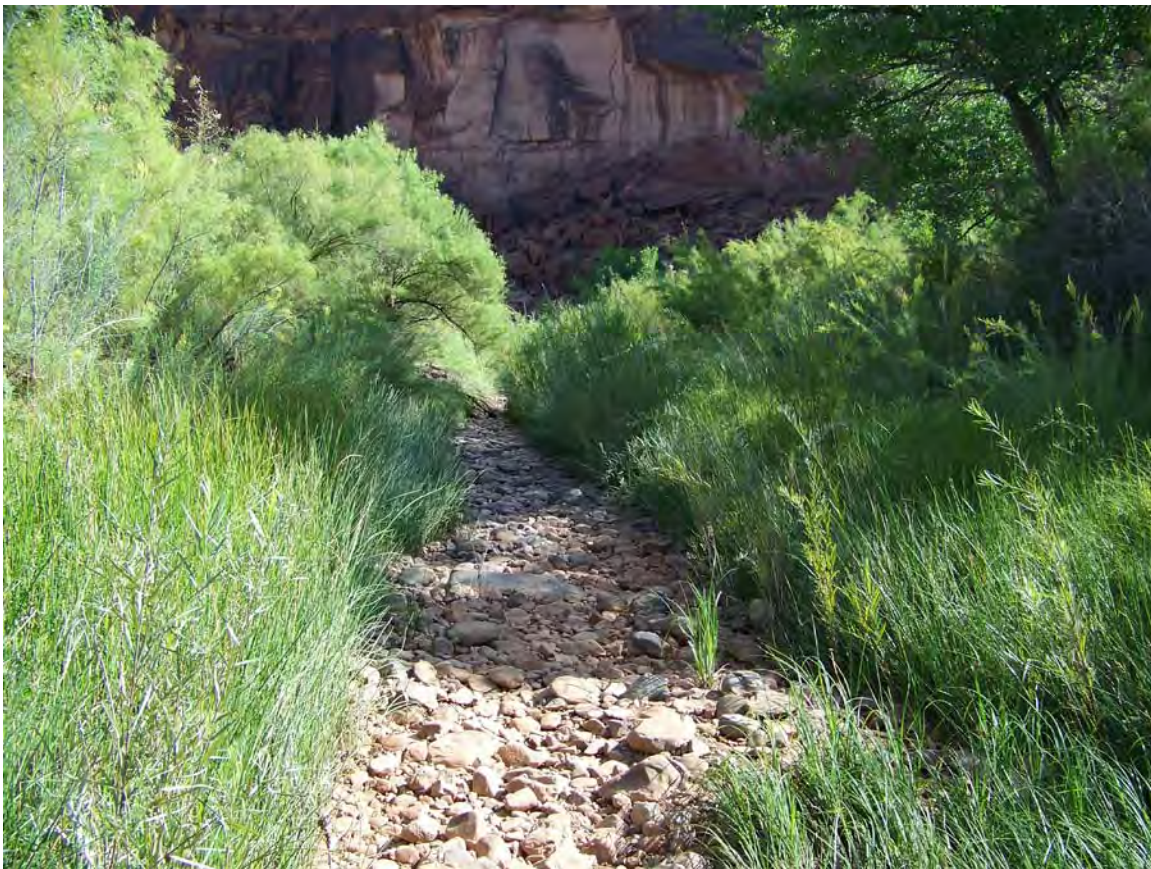
*The presence of lush and unstressed riparian vegetation along Big Dominguez Creek during a brief period of no surface flow demonstrates the importance of alluvial groundwater to the riparian community.*

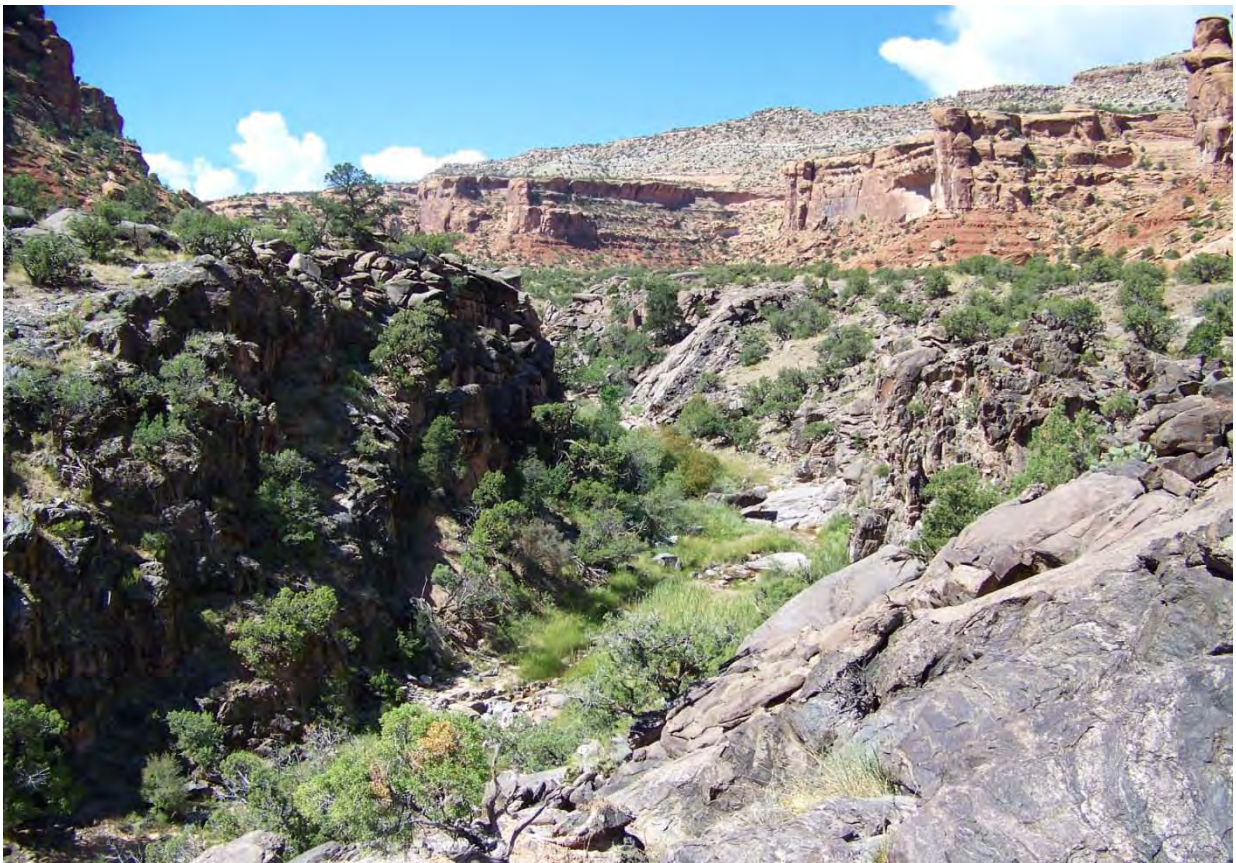
*The photo above illustrates the changing geology that forms the riparian zone. The black colored rocks below are granite geology, while the red colored layer above is sandstone geology.*

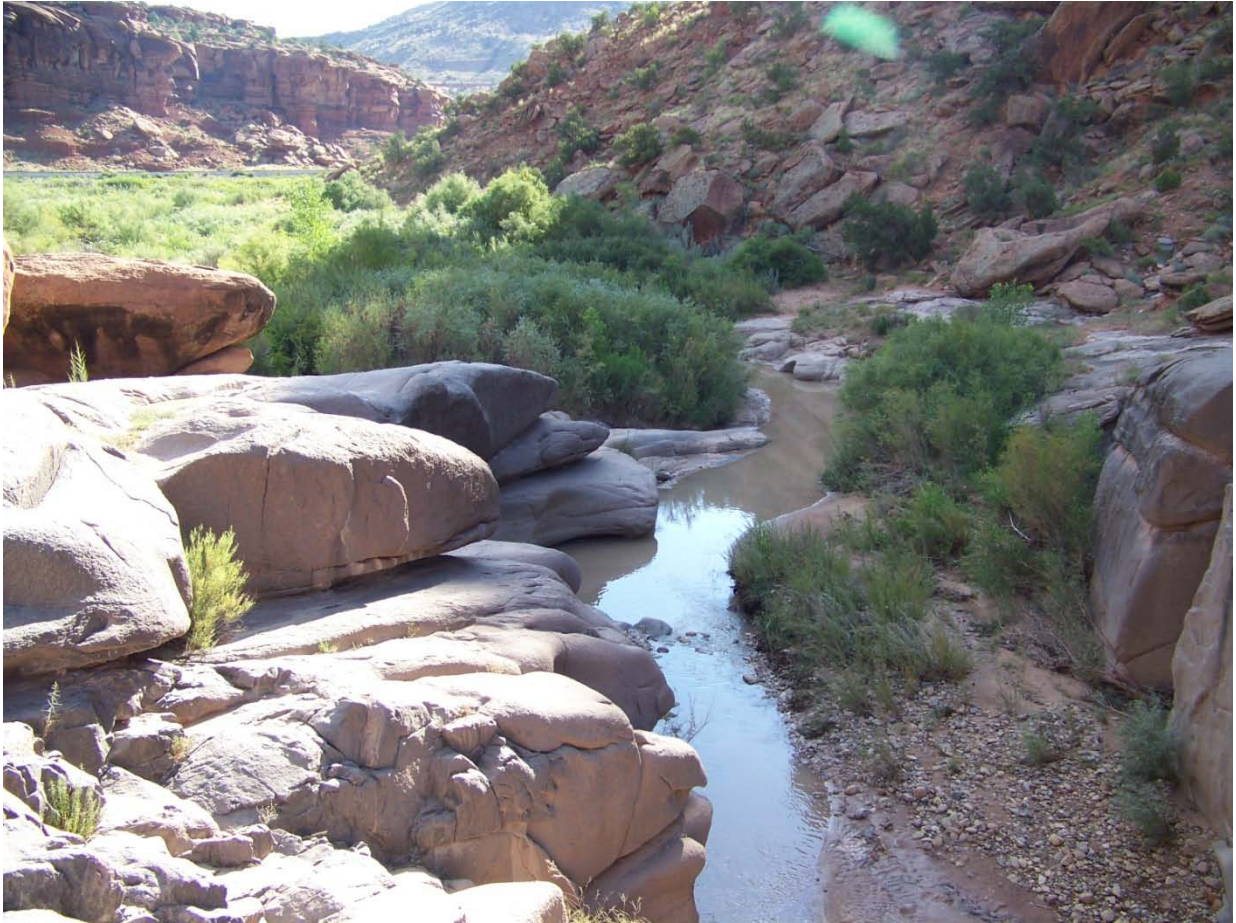
*The photo above illustrates the type of riparian zone that occurs in sandstone geology, where the channel is wider and the stream has greater sinuosity.*

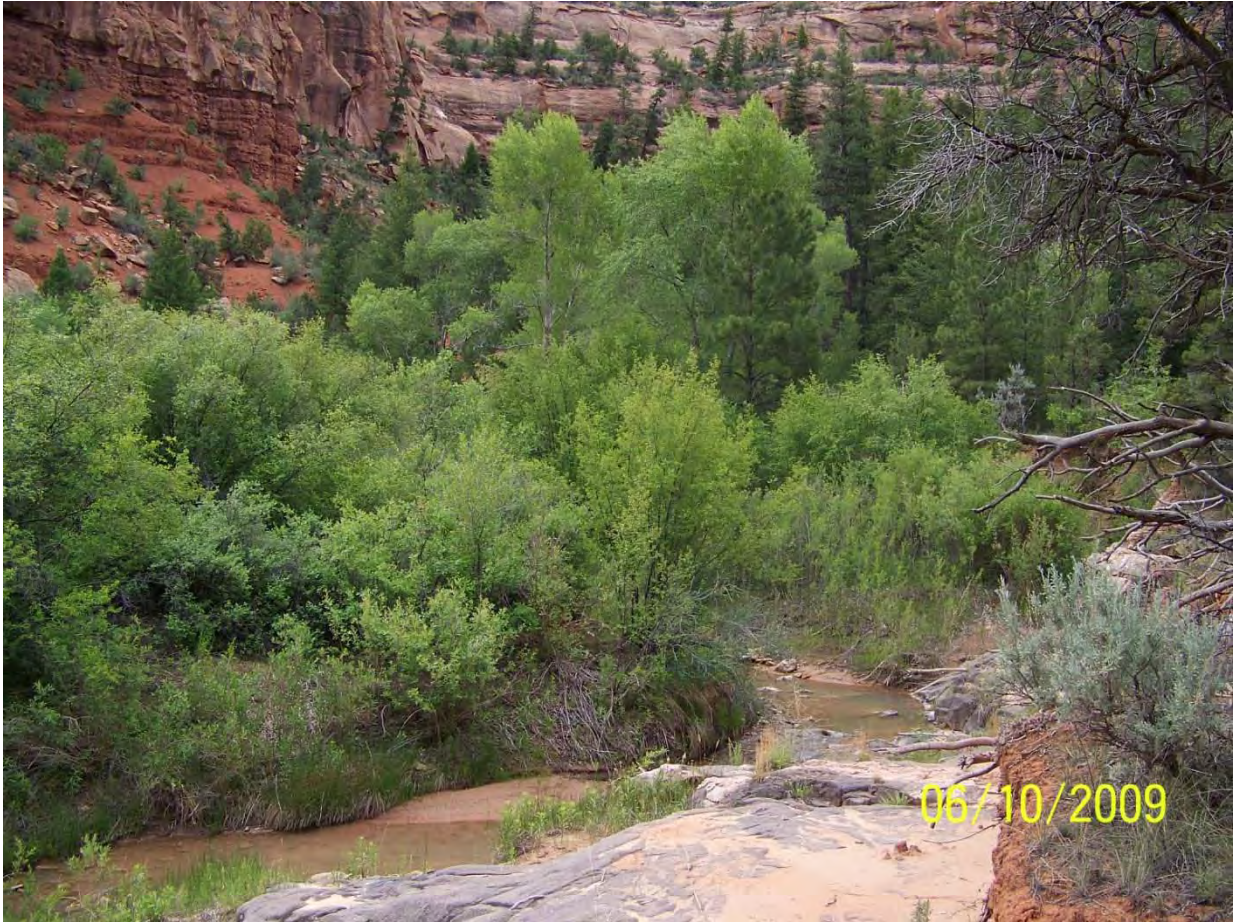
*The photo above illustrates a point in the riparian zone where the geology changes from granite geology (black rocks in foreground) to sandstone geology (red rock in background).*
