**Colorado Healthy Rivers Fund Grant (PO# 09-44)**

## **FINAL REPORT**

## **PROJECT DESCRIPTION AND BACKGROUND**

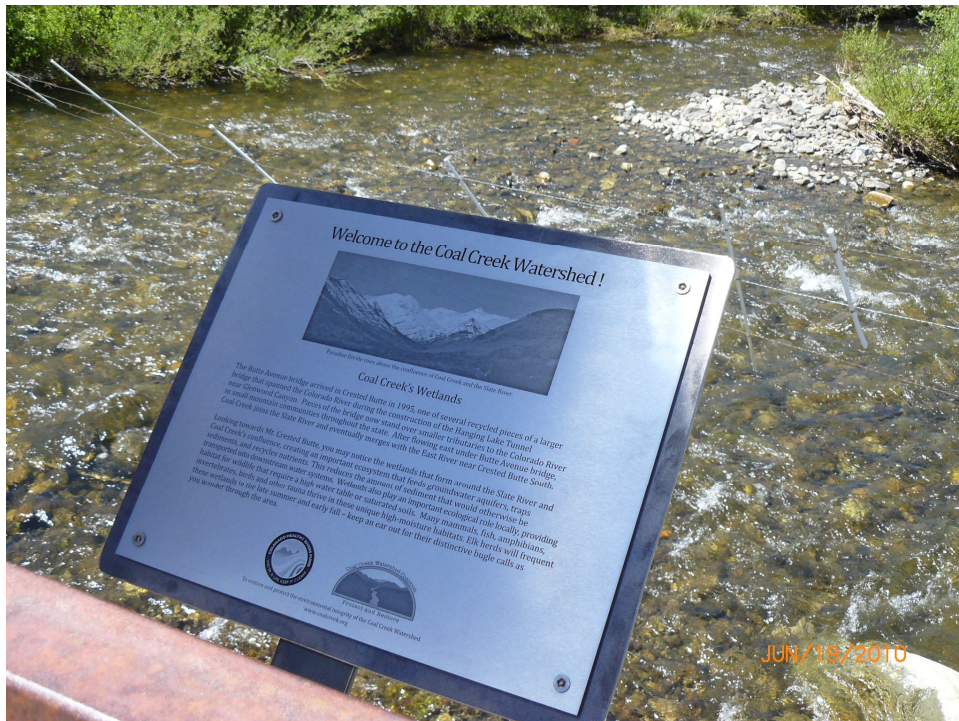
**Figure 5 - Signage near the Creekside Plaza featuring information about armoring and riparian corridors.**

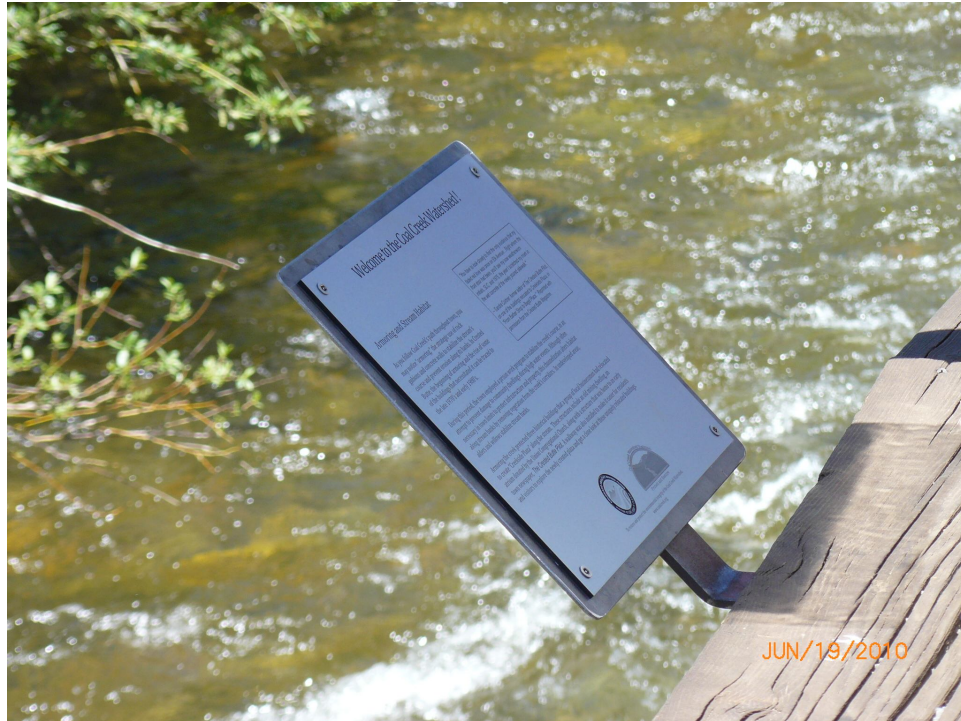
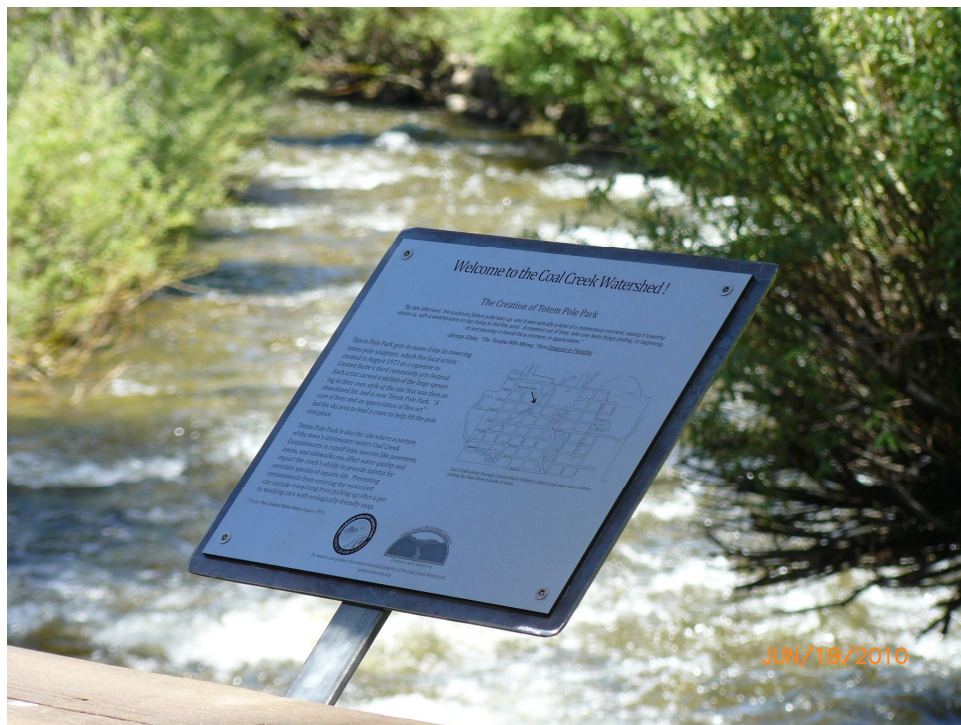
**Figure 6 - Signage at Totem Pole Park featuring information about non-point source pollutants.**

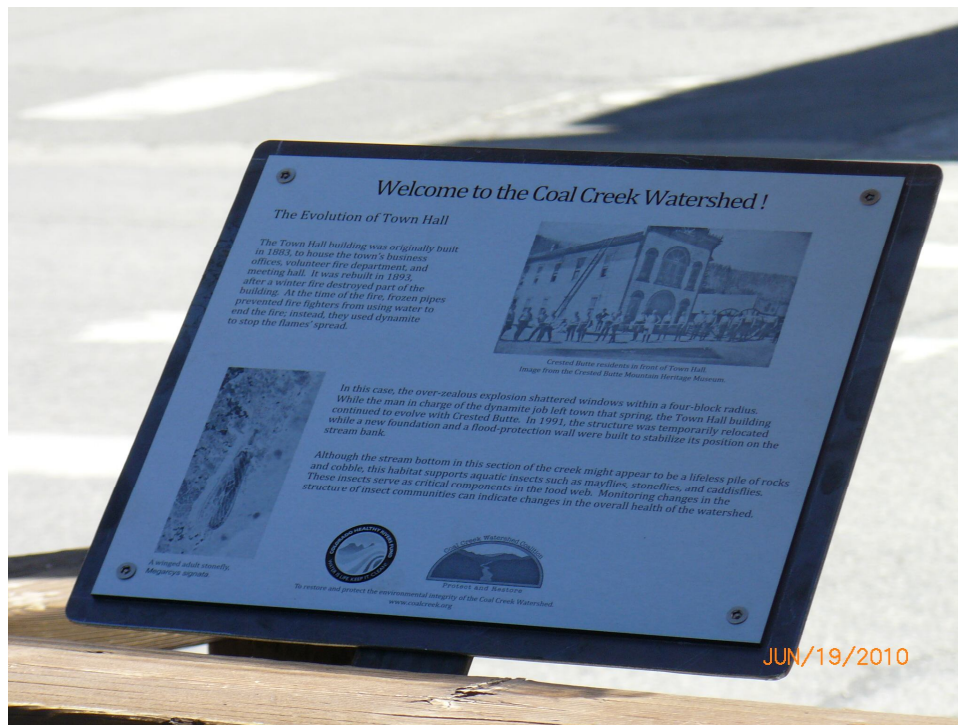
Figure 7 - Signage near Old Town Hall providing information on benthic habitats.

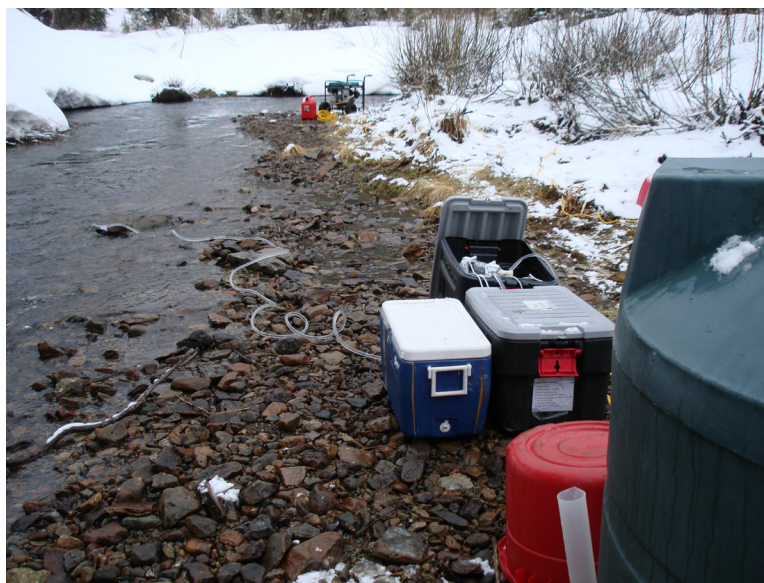
**Figure 4.** The injection setup at CC-3.085 for the metal loading tracer dilution test on April 8, 2007. From left to right, the tube delivering the injection solution to Coal Creek, the generator that powered the injection pump (in the background), the injection pump in the open container, and the 330 gallon injection tank (dark green, right foreground).

To prepare the tracer solution, 1,135 L (about 300 gallons) of stream water was pumped from Coal Creek into a polyethylene tank using a garden hose and gasoline-powered water pump on the day before the injection. Sodium bromide (234 kg; 520 pounds; Ameribrom, Inc., Fort Lee, NJ) was added to the stream water to create a bromide solution of 2.0 M concentration, stirred using a paddle, and left in the tank overnight to dissolve. On the day of the injection, April 8, 2007, the tracer solution was continuously injected into Coal Creek using a piston-driven metering pump (Fluid Metering, Inc.; QV pump; QCKC pump head with ceramic and polyvinylidene difluoride parts; V200 stroke rate controller) and Tygon<sup>®</sup> tubing (Fisherbrand, 12.7 mm inside diameter). The injection began at 8:00 and continued for 7.5 h. Injection flow rates were determined by measuring the amount of time needed to fill a 500 mL graduated cylinder with the injectate. The time-weighted average flow rate of the injection was 2.24 L min<sup>-1</sup> with a range of 2.20 L min<sup>-1</sup> to 2.30 L min<sup>-1</sup>. The tank was stirred with a paddle every 15-30 min. The injection setup is shown in Figure 4 and the injection details are recorded in Table 1. A rented snowmobile and sled were used to transport the injection equipment along County Road 12 over the snow-covered portions of the road.

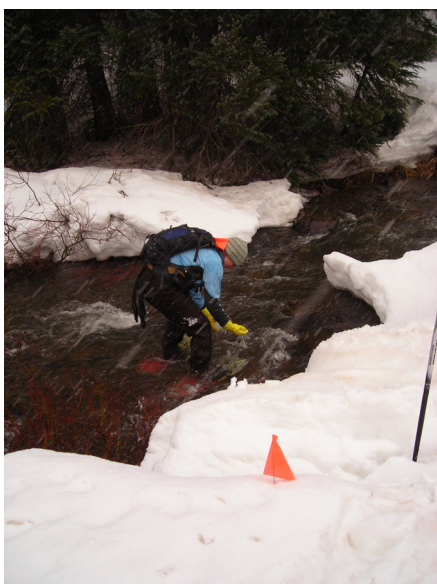
**Figure 5.** University of Colorado undergraduate research assistant Hallie Bevan samples Coal Creek from the downstream end during the April 8, 2007, synoptic sampling using snow shoes and chest waders.

When the bromide concentration reached a plateau at the downstream end of the injection reach, synoptic sampling of the reach was begun. Synoptic sampling lasted two hours. Two teams of two people carried out the sampling from the downstream and upstream ends of the reach. Two water samples were collected from each synoptic sample site in 250 mL high-density polyethylene Nalgene bottles. Accumulation of snow over the creek made sampling challenging. Samples were obtained by wading in the stream from the downstream end and by using a pole from the upstream end (Figures 5 and 6).

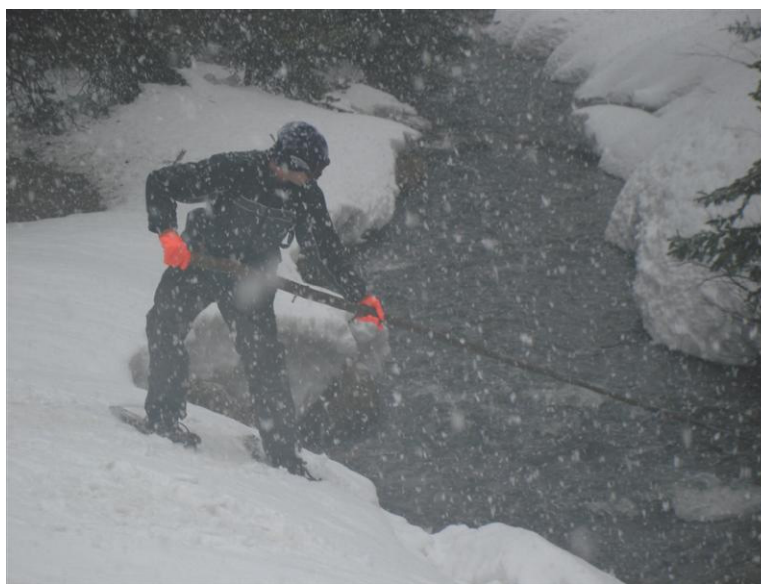
**Figure 6.** University of Colorado graduate research assistant Tim Dittrich samples Coal Creek from the upstream end during the April 8, 2007 synoptic sampling using snow shoes and a pole to extend the sample bottle into the stream without collapsing the snow accumulated on the north bank.

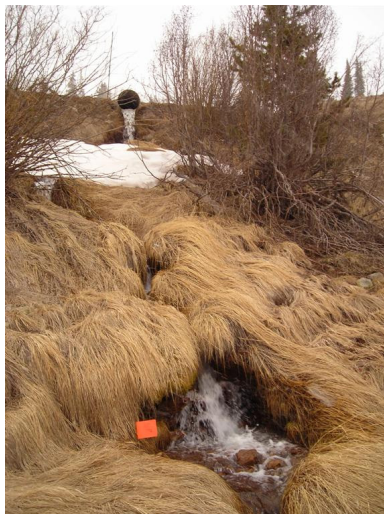
**Figure 7.** Unnamed tributary UT-3.212, the first and main iron fen tributary, followed a clear channel from the culvert under County Road 12 to Coal Creek; the sample was taken at the location of the orange flag within about 2 m of the creek’s north bank.

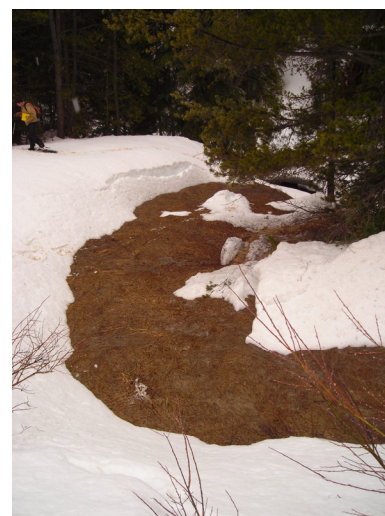
**Figure 9.** Unnamed tributary UT-3.895, which drains the iron fen and gossan, flows from a culvert as a thin sheet over saturated soil and peat down to Coal Creek. This tributary was sampled at the culvert under the road. Graduate research assistant Chase Gerbig collected samples while negotiating the terrain on snow shoes.

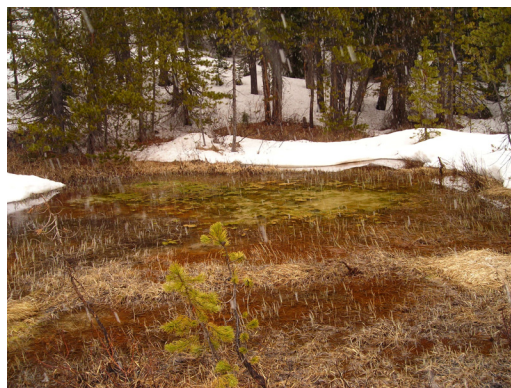
**Figure 10.** Marshy pool at the confluence of unnamed tributary UT-4.186, which drains the iron gossan, and Coal Creek. The tributary sample was taken at the culvert under County Road 12.

Sampling of the tributaries was often complicated by dispersal of flow from culverts under County Road 12 and snow cover. As observed during the previous metal loading tracer dilution tests, seepage from north bank slopes flows into road-side ditches and through culverts under the road. Water flowing out of the culverts flows to Coal Creek in clear channels in some cases (Figure 7), but in other cases, flows from the culverts is low and no clear channel to the creek is present (Figure 8). Where no clear tributary channel was present near Coal Creek, the tributary sample was collected from the culvert opening. In some cases, tributaries from culverts spread out as broad sheet flows over saturated soil and peat (Figure 9) or as marshy pools near the creek (Figure 10); these tributaries were also sampled at the culvert opening. The tributary

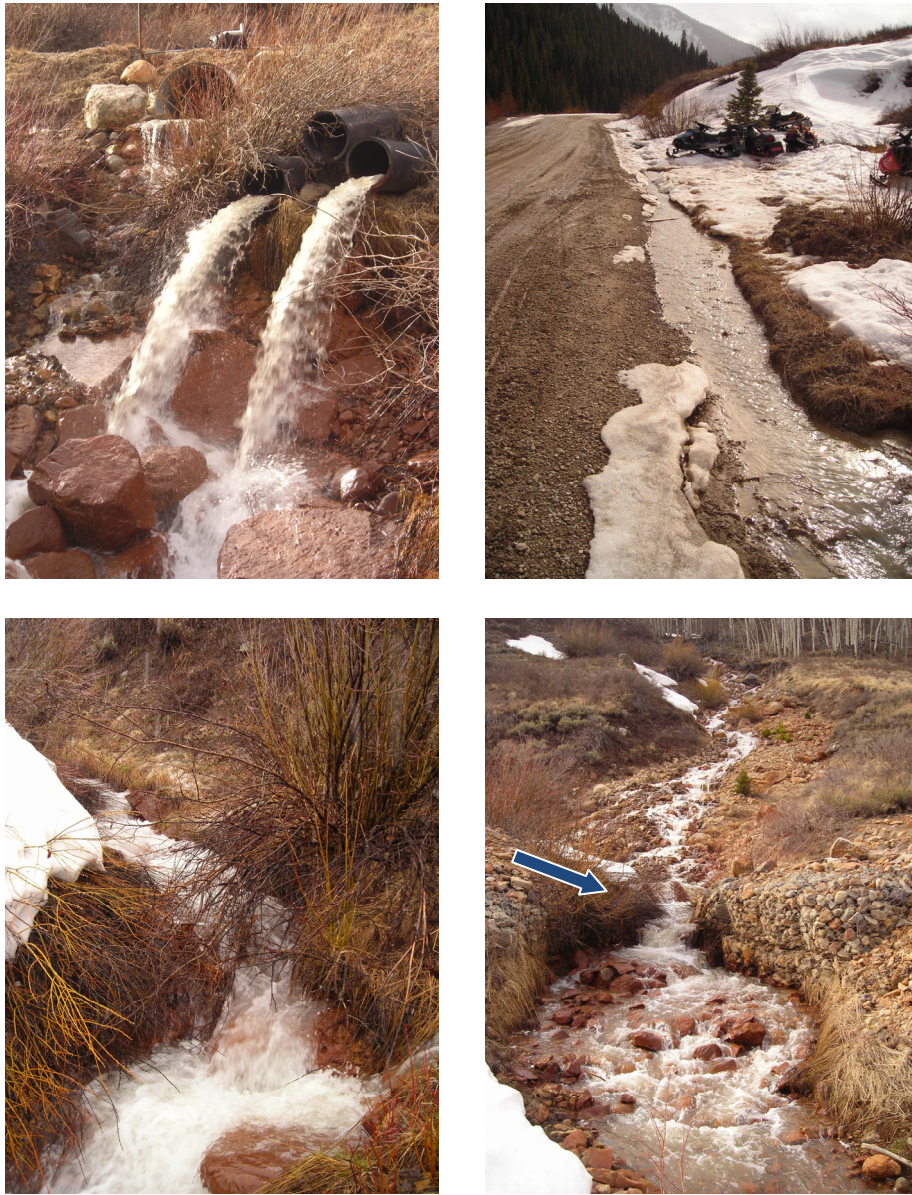
**Figure 30.** Photographs of the drainages combining to make up the tributary UT-5.368: (upper left) view from the south side of County Road 12 where the oval culvert in left background drains the road-side ditch and the cast-iron pipes drain the treatment plant effluent and the Keystone Mine drainage; (upper right) view of the road-side ditch on the north side of County Road 12 which drains through the oval culvert; (lower left) close-up view of the Mount Emmons treatment plant effluent; and (lower right) the Keystone Mine drainage which is joined by the treatment plant effluent at the blue arrow.

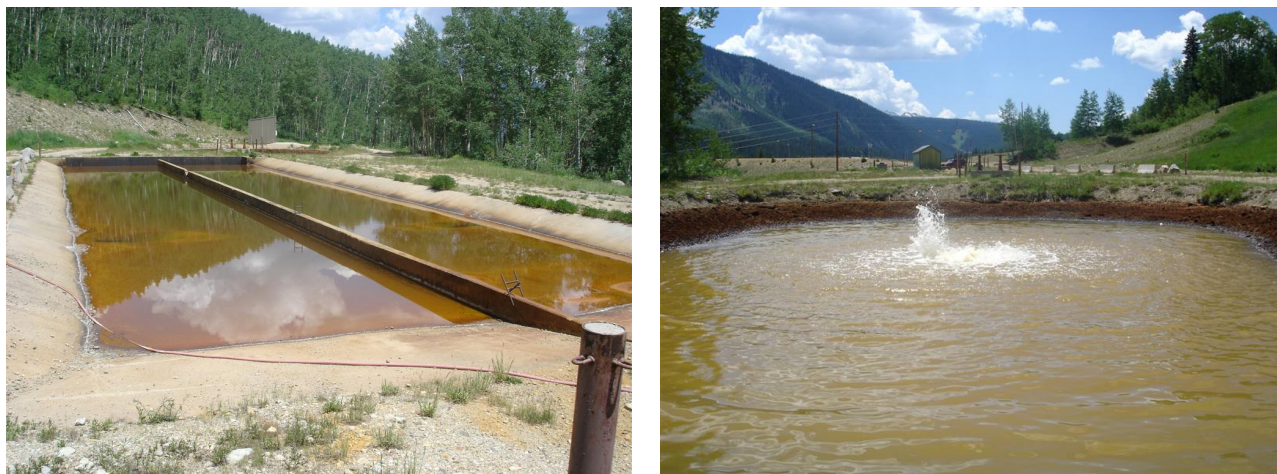
**Figure 32.** Photographs of the grit chamber (left) and equalization pond (right) used by the Mount Emmons treatment plant. The chamber and pond are located above the Keystone Mine drainage that forms part of unnamed tributary UT-5.368.

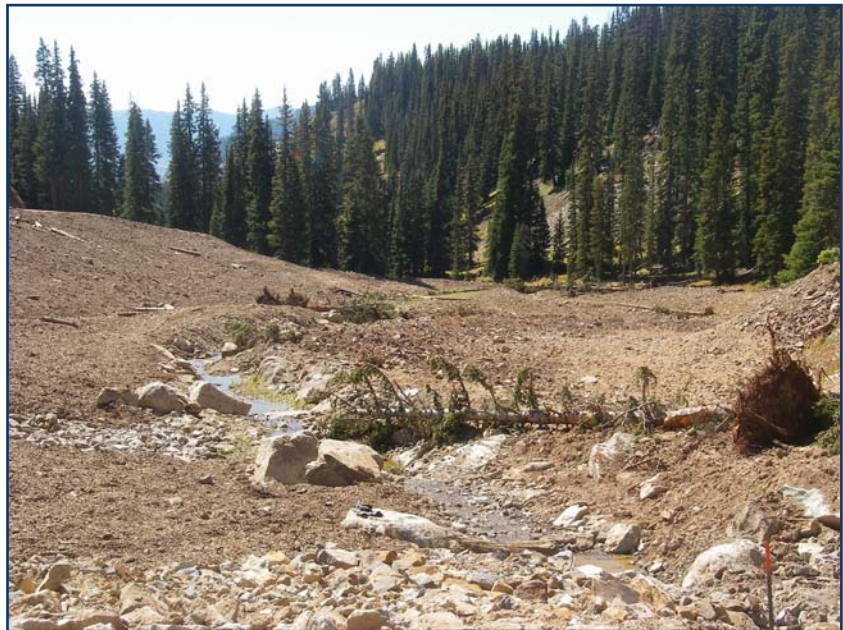
Figure 7. A view of the new Elk Creek with fallen trees, rock features, and vegetation incorporated into the design to mimic a natural creek.

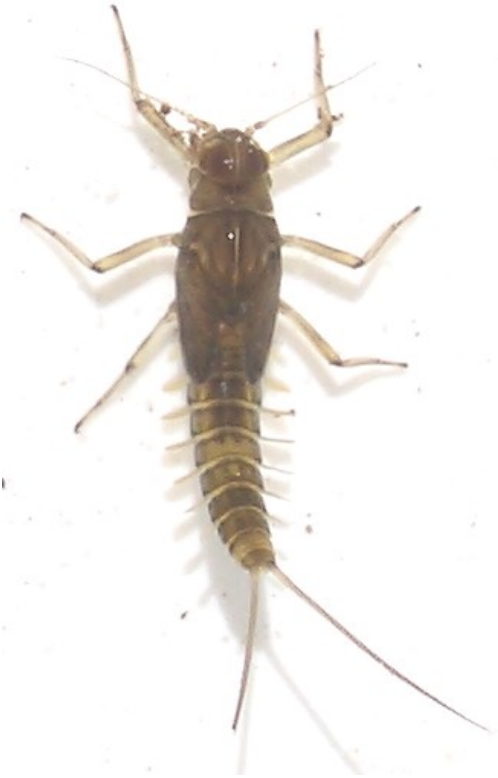
This mayfly (Baetis or Blue Winged Olive) is most tolerant of heavy metals of the animals on this slide.

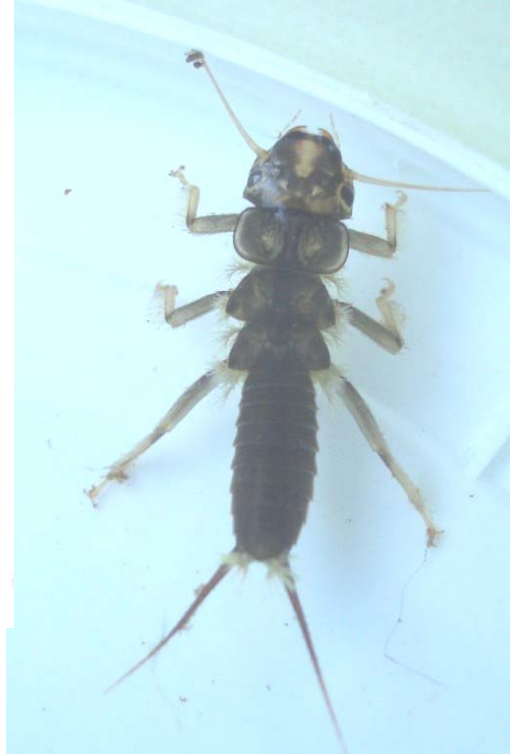
This is a stonefly (Hesperophylax or Golden Stone)

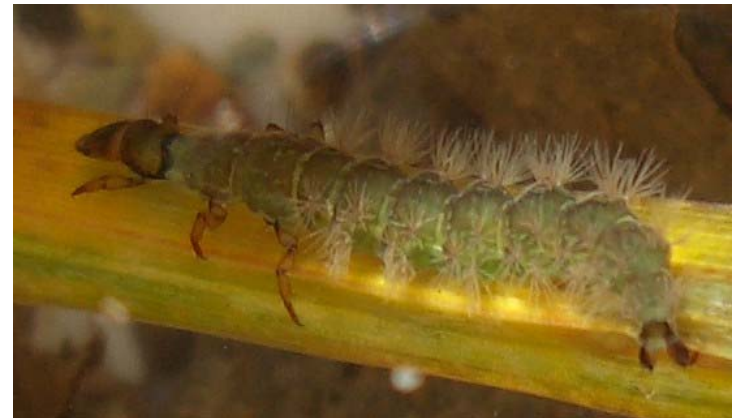
This caddis (Rhyacophila or Green Rock Worm) is very sensitive to heavy metals and is among the first to disappear below mines.

Figure 1: % Ephemeroptera, Plecoptera, and Trichoptera (% EPT) from 2006 – 2008.

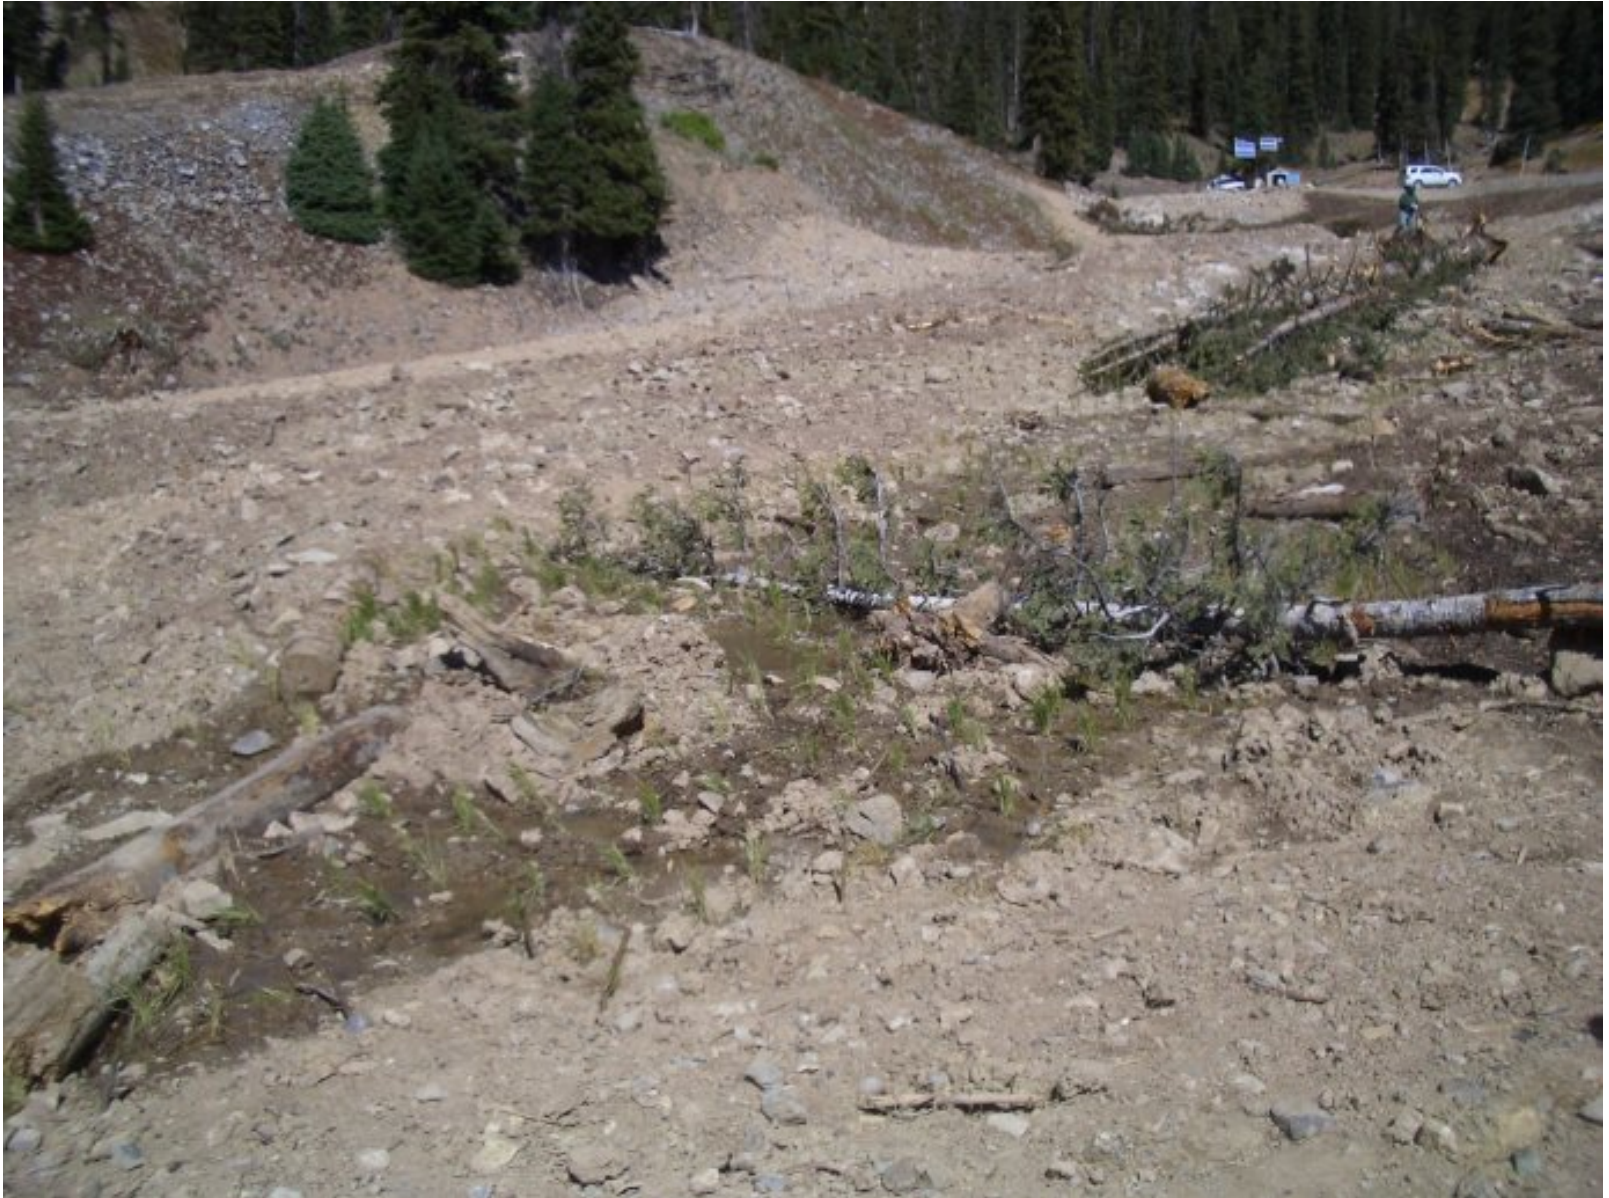
Figure X. Fore's Benthic Index of Biotic Integrity for the Coal Creek Watershed for 2006 – 2008.

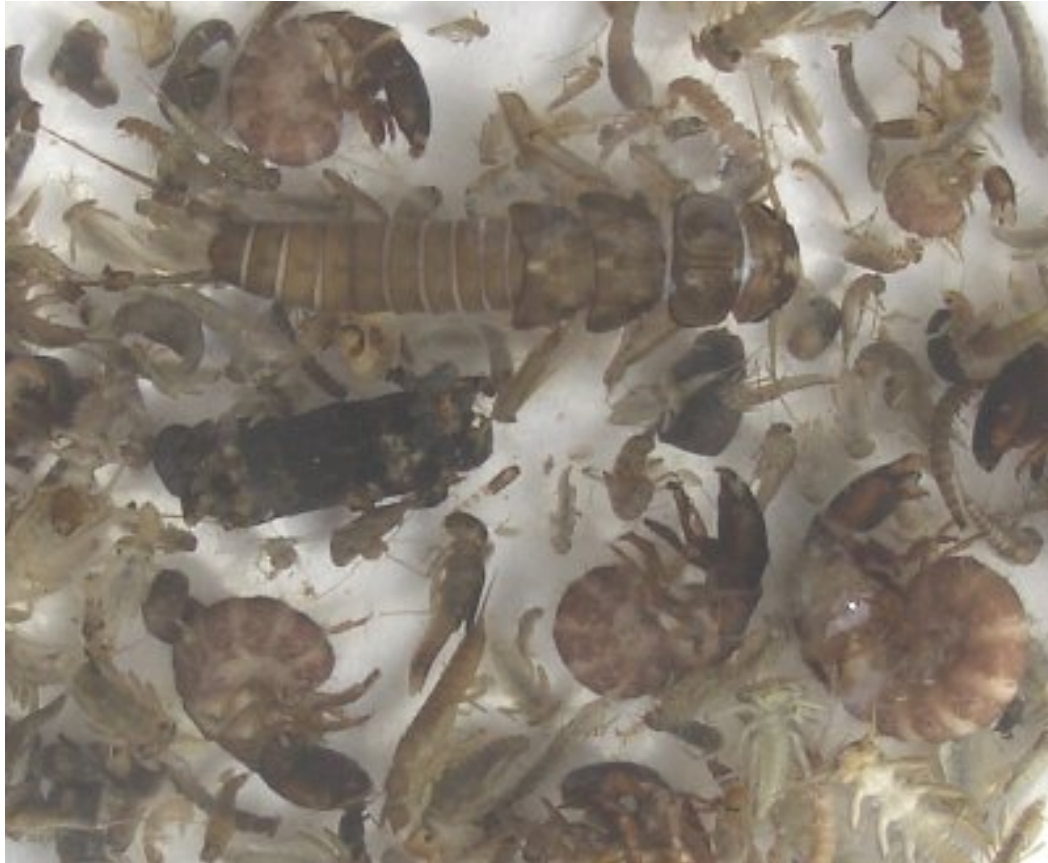
# Species Richness

is the number of different species in a sample

More is better.

Species change over the summer as they leave the water and emerge as adults entering the terrestrial habitat.

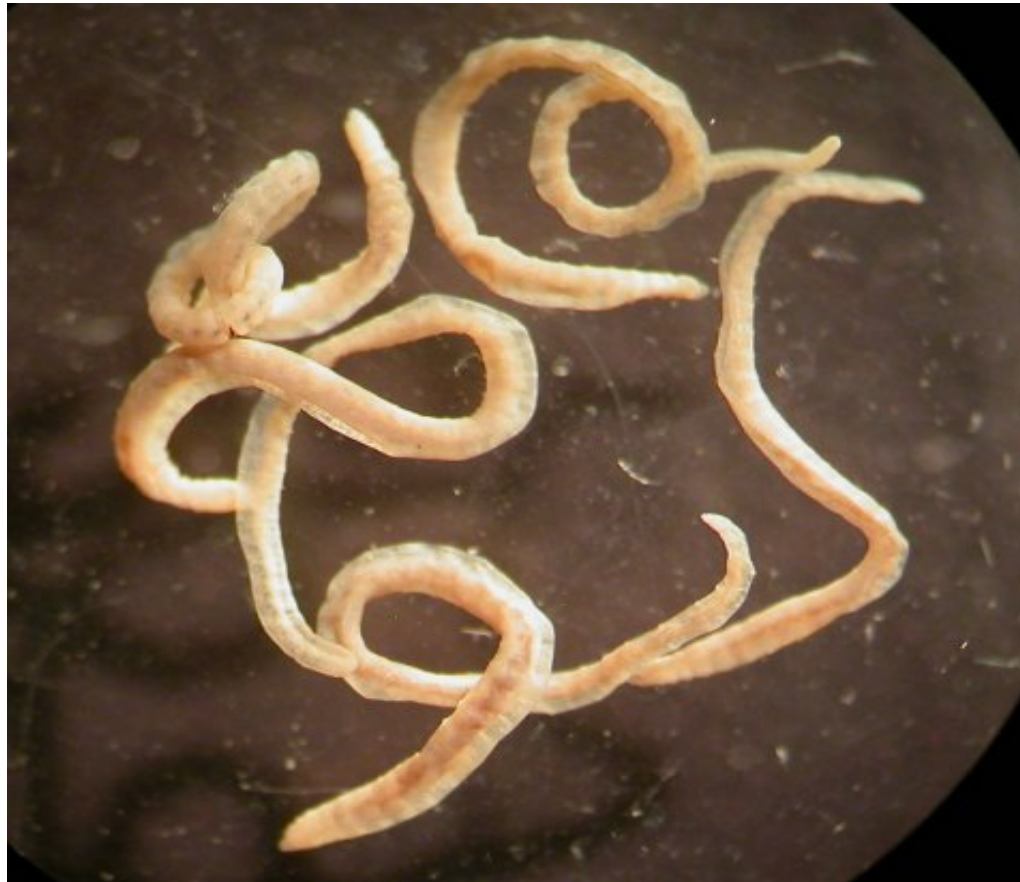
# % Oligochaetes (aquatic worms)

# Oligochaetes are aquatic worms.

Present in small numbers in all rivers,  
a large population indicates pollution from sewage, fertilizer or sediment.

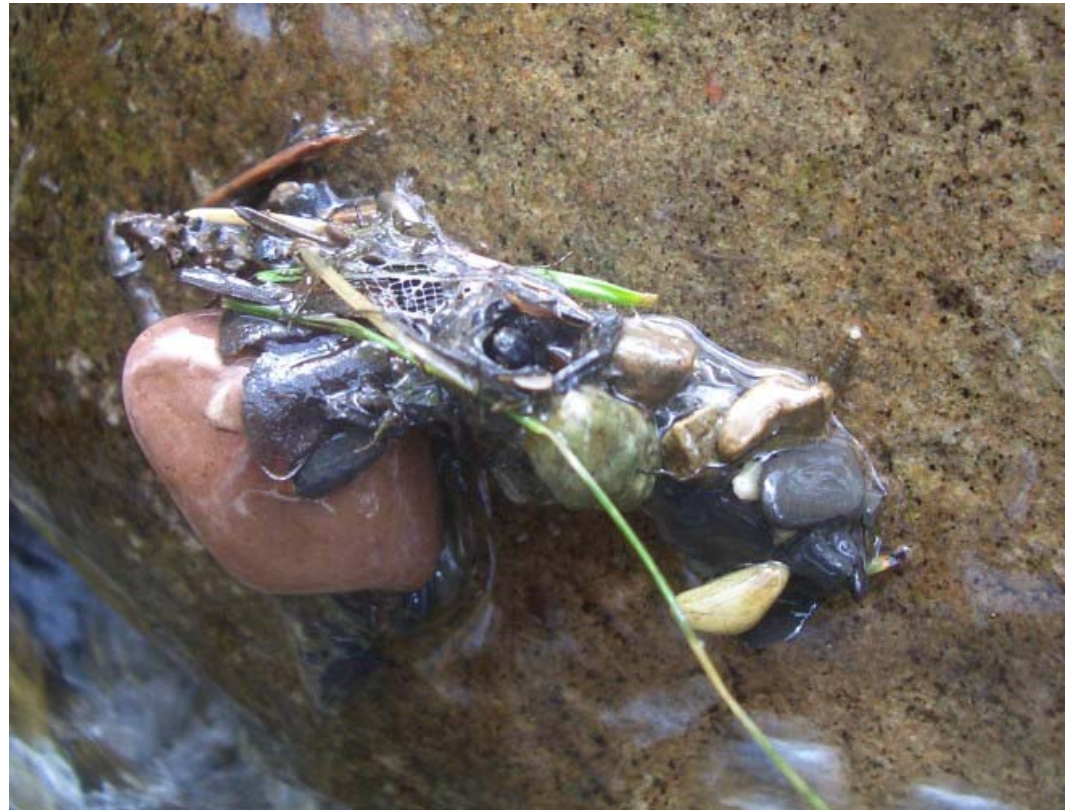
# % Hydropsychidae of all Caddis Net Spinning Caddisflies

They are tolerant of many types of pollution.

Notice the net on the retreat on the right. Living off the bottom and filtering food from the current may give these caddisflies less exposure to toxic sediments.
