# **Rock Creek/Boulder Creek Volunteer Restoration 2011 Final Report**

Wildlands Restoration Volunteers

November, 2010 - June, 2011

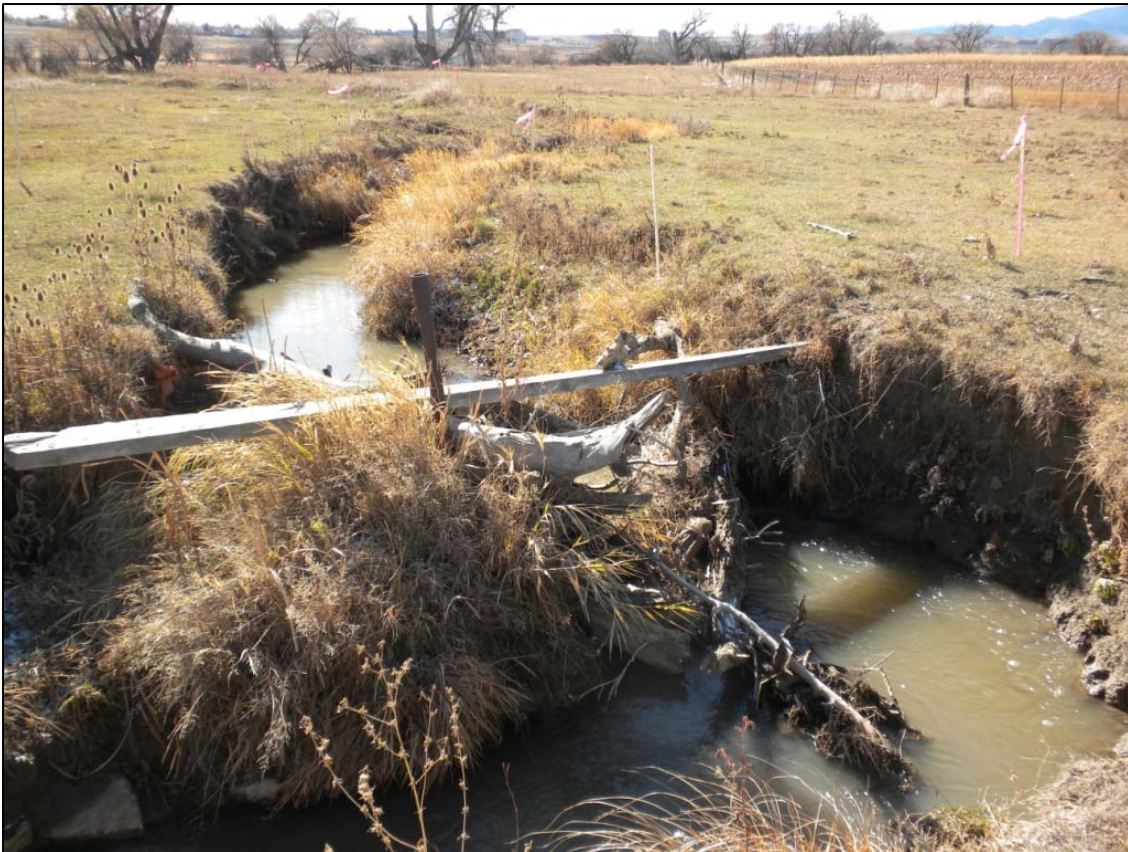
This photo shows the erosion of Rock Creek stream banks, prior to restoration work.

The down-cutting of the stream channel has caused the elevation of the water table along the stream to drop, thereby drying out the associated riparian area. If left alone, the down-cutting would have continued moving upstream until the channel hit an impenetrable area, e.g., bedrock or large cobbles. BCPOS, along with the UDFCD, has been working to restore this and other sections of Rock Creek to a stable, natural stream channel near the original stream channel.

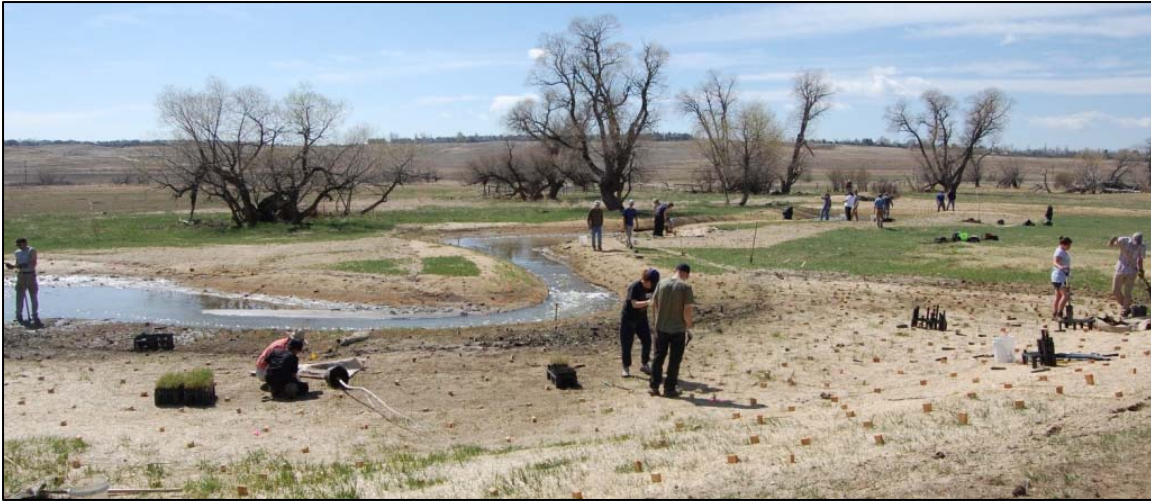
Volunteers plant according to flagging and staging of plants at Rock Creek on April 16, 2011.

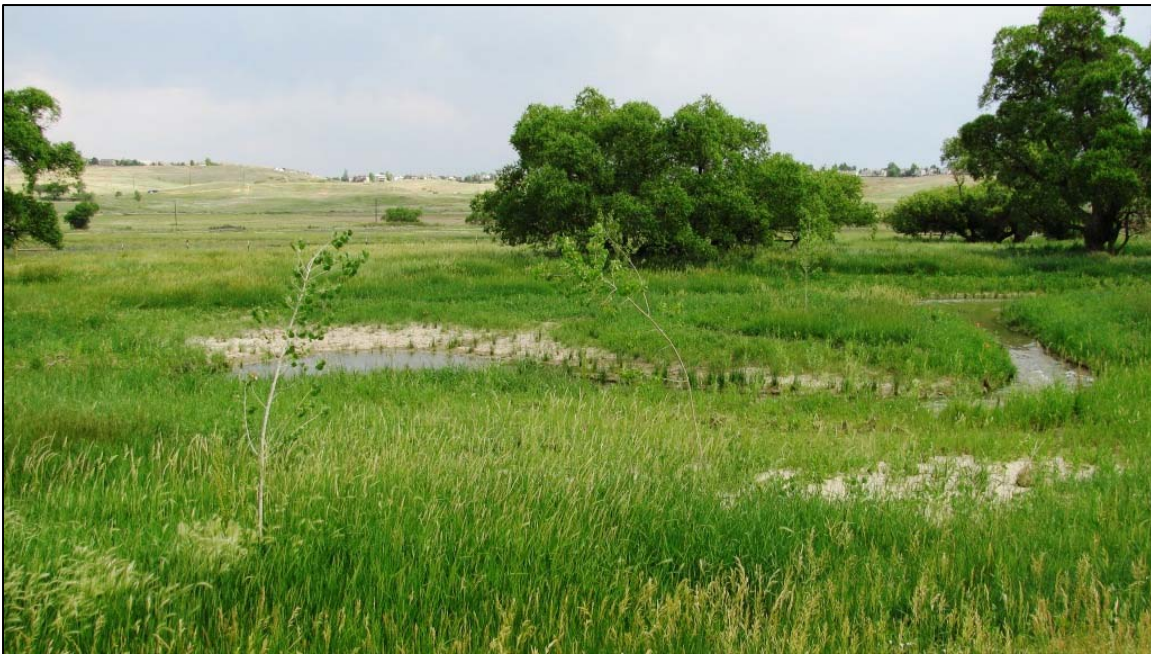
Follow-up photo at photo-point shows general seeding and planting success as of June 29, 2011 (reference photo on page 10).

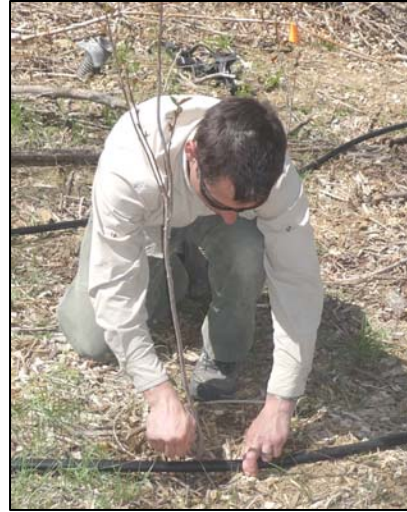
Specifically, a number of volunteers were asked to switch to a different project, and those who arrived were split into three groups. One group hand-watered 1,100 plants that had been planted on the southern edge of the site in 2010 and 2011, and installed a drip-line to water 300 plants until they mature. A second group planted approximately 350 native trees and shrubs next to the creek, including ~50 chokecherry, ~25 plains cottonwood, ~25 peach-leaf willows, ~50 golden currants, and ~200 coyote willow container plants provided by the City of Boulder. A third group dug Russian olive and crack willow branches out of a marsh to easy access for a chipper run by City staff. The branches had been cut by a volunteer leader, seasonal staff and an AmeriCorps crew before the project day.
