# **Rapid River Assessment of the Uncompahgre Watershed**

Ouray, Montrose, and Delta County  
Colorado

June 22, 2012

**Prepared by:**  
The Uncompahgre Watershed Partnership

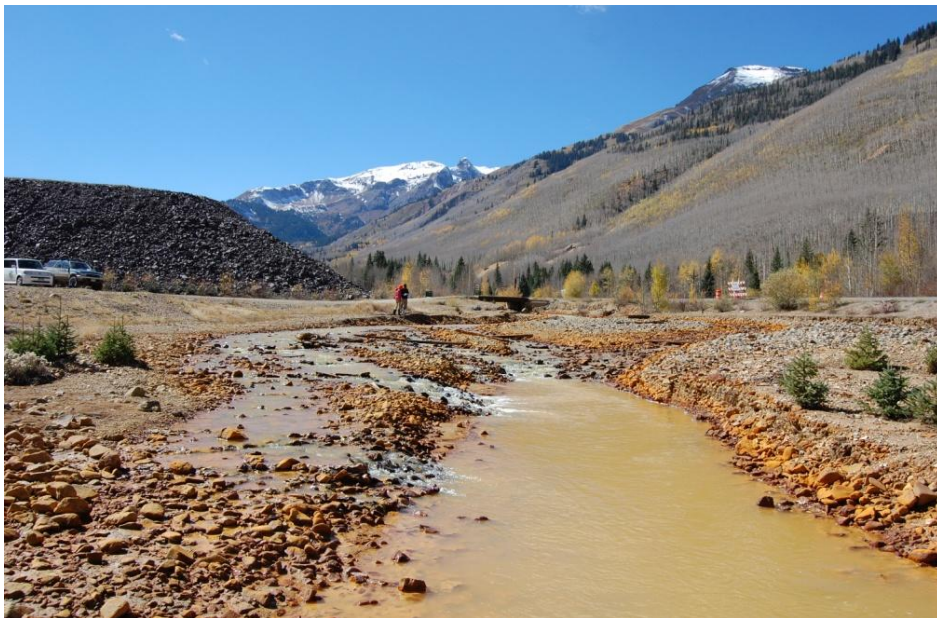
**Photo 1.** Red Mountain Creek at Ironton.

<b>Ironton</b>	<b>Score</b>	<b>Index</b>
Aquatic	32.4	Good
Terrestrial	13.9	Fair
Visual	0.5	Poor
Habitat Score	46.8	Fair

Based on the assessment data, recommendations for improvements in the Upper Watershed should include: 1) mitigation of acid mine drainage and mine reclamation to reduce anthropogenic heavy metal loading into streams, 2) channel restoration/engineering efforts that include pools and in-stream structures, 3) restoration of sediment transport dynamic above the hydrodam or removal of sediment trapped by the dam to improve natural geomorphic processes above the dam, 4) better understanding of downstream impacts from flushing potentially heavy metal-laden sediment from the dam.

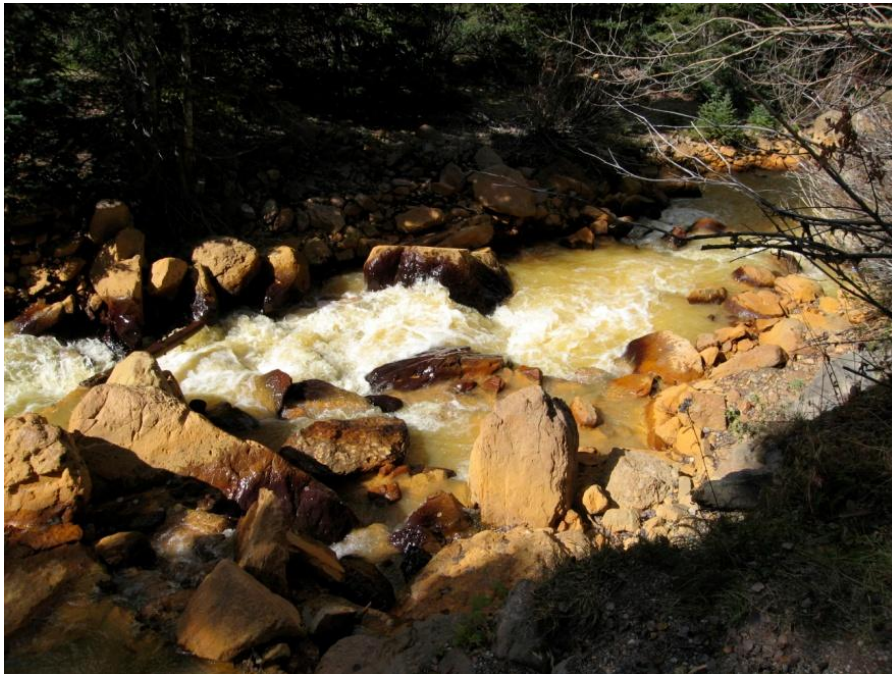
**Photo 2.** Red Mountain Creek at Memorial.

The Memorial site is also on Red Mountain Creek, just a few miles downstream from Ironton. There was an abandoned mine on river left and localized and road-caused erosion (Hwy-550) on the right bank. The riparian zone was 20 ft on each bank and was moderately vegetated with 40-80% being bare banks and trees providing partial shade. The channel was straight with sinuosity of 1.12. The morphology was step-pool and substrate was a mix of cobbles and boulders. The water appearance was red from iron oxidation (Photo 2),

<b>Memorial</b>	<b>Score</b>	<b>Index</b>
Aquatic	38.5	Excellent
Terrestrial	30.4	Good
Visual	1.0	Poor
Habitat Score	69.9	Good

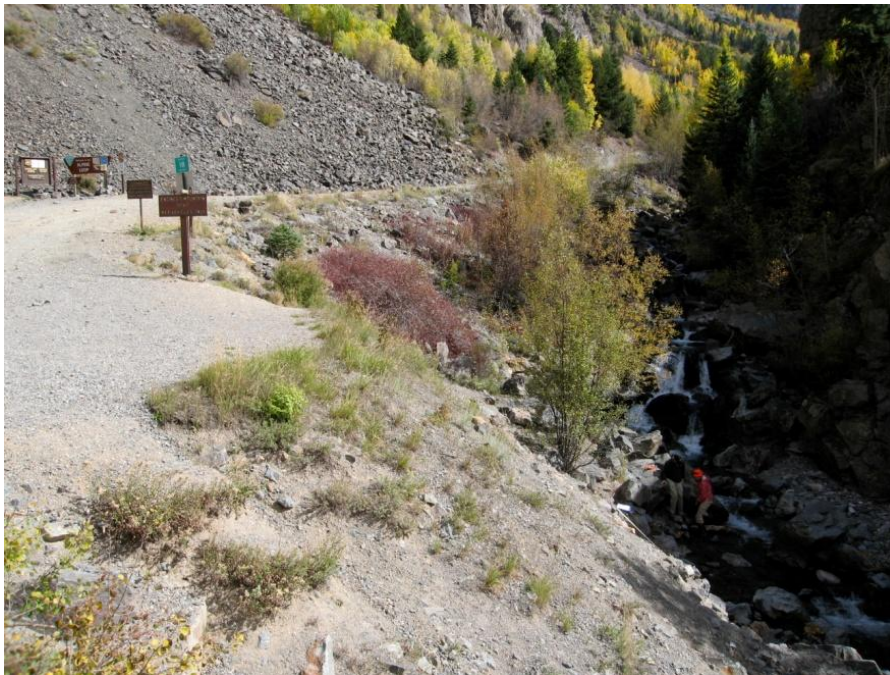
**Photo 3.** Engineer Pass site, Uncompahgre River before junction with Red Mountain Creek.

Engineer Pass	Score	Index
Aquatic	42.5	Excellent
Terrestrial	28.5	Good
Visual	10.0	Excellent
Habitat Score	81.0	Excellent

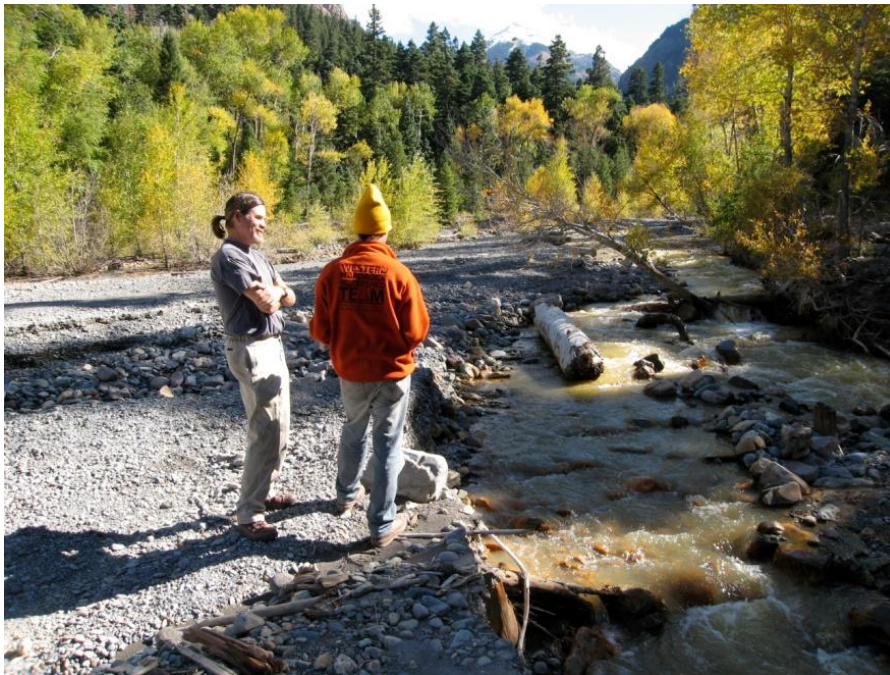
**Photo 4.** Above Hydrodam, Uncompahgre River.

As Red Mountain Creek joins the Uncompahgre River scores decline compared with those at the Engineer Pass site above the tributary junction. Below the junction, the river becomes highly incised into a bedrock canyon (sinuosity = 1.10). Above the Ouray Hydrodam there was channelization from sediment buildup caused by the grade change of the river bed and the subsequent change of water velocity (Photo 4). The substrate comprised of 75% cobble and 25% sand. There was extensive erosion from undercutting in the alluvium and bank failures were noted. The stream banks at bankfull flow line were 80% bare but hardwoods were predominant on the edges of the floodplain. Riparian zone width was 25 ft on left bank (LB) and 35 on right bank (RB). Iron oxide was present in the water.

<b>Above Hydrodam</b>	<b>Score</b>	<b>Index</b>
Aquatic	22.1	Fair
Terrestrial	24.0	Good
Visual	1.5	Poor
Habitat Score	47.6	Fair

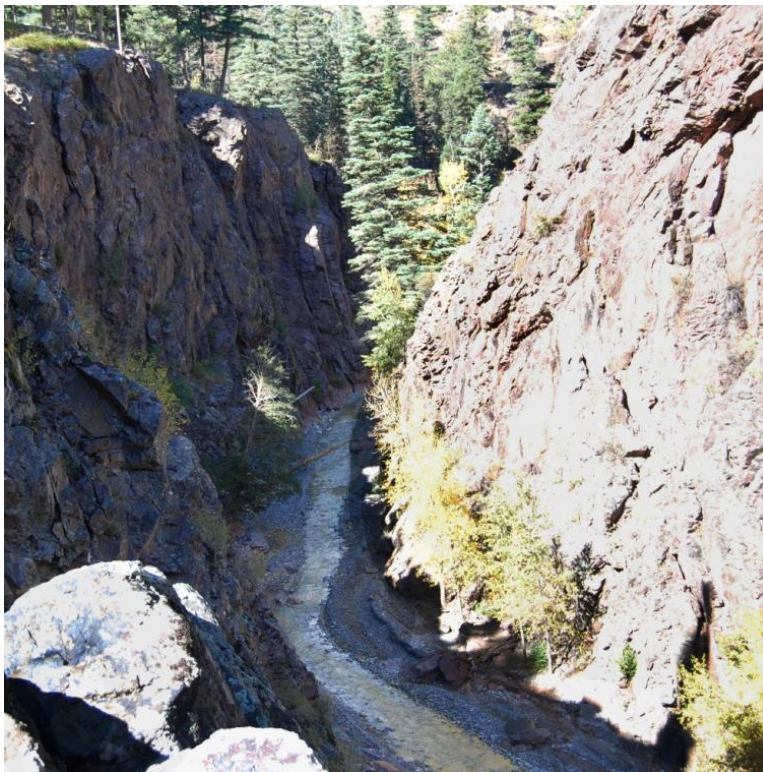
**Photo 5.** Uncompahgre River below the Ouray Hydrodam (Below Hydrodam site).

<b>Below Hydrodam</b>	<b>Score</b>	<b>Index</b>
Aquatic	34.7	Excellent
Terrestrial	14.3	Fair
Visual	2.0	Poor
Habitat Score	50.9	Good

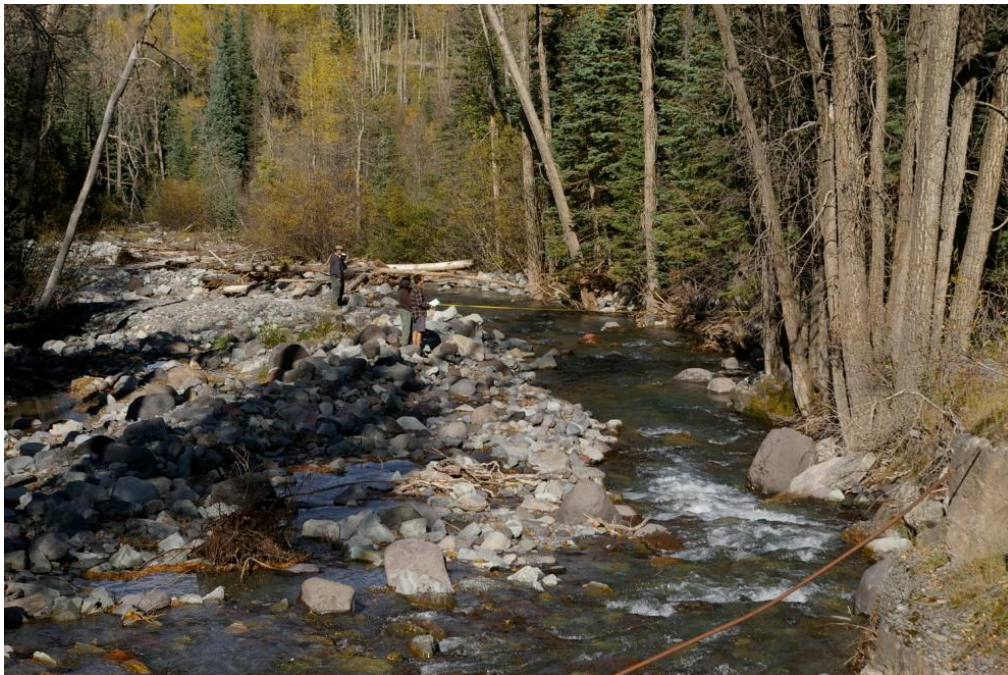
**Photo 6.** Canyon Creek site.

The riparian zone was well developed here, 30 ft width on LR and 15 ft on RB, and bare ground was 10%. Vegetation cover was mixed cottonwoods and conifers which provided partial shade over the active channel (Photo 6). There was some evidence of localized erosion with slight bank movements (Photo 6), sinuosity was 1.13. The channel was 25% riffle, 50% run, and 25% pools. The substrate was 75% boulders, 10% cobble and 15% sand. The morphology combined with substrate diversity and inputs of in-stream wood contributed to excellent habitat quality.

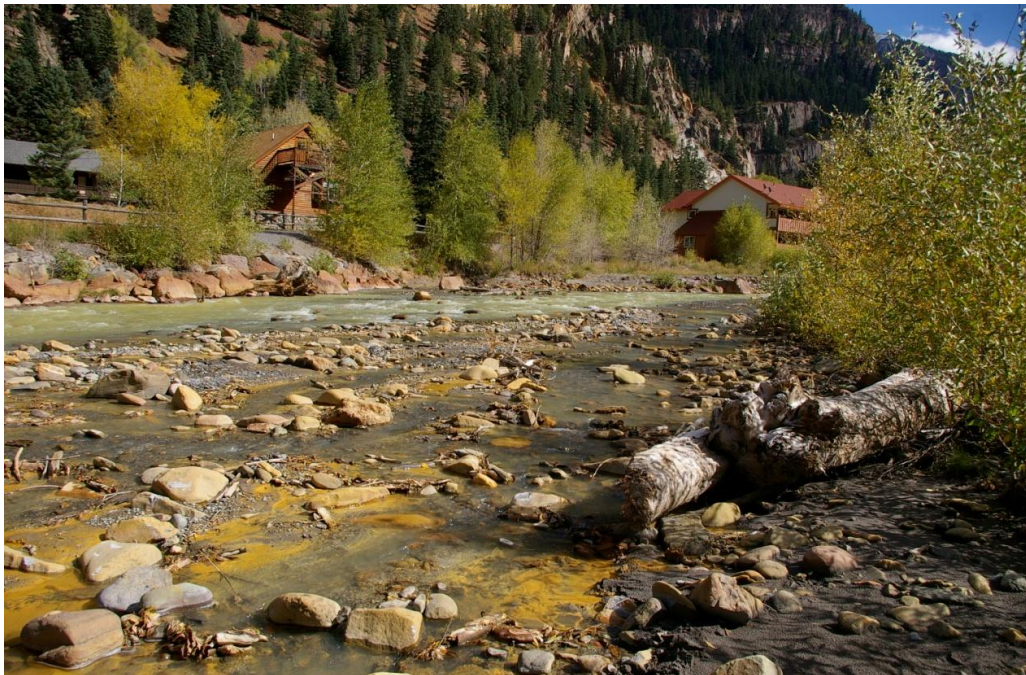
**Photo 7.** Ouray River Park, Uncompahgre River.

The Ouray River Park is located on the north end of the City of Ouray and it is an area of high sediment loading and lateral channel migration. As a result the potential for erosion is high and the city has stabilized large portions of the reach with boulders and rip-rap (Photo 7).

This was the lowest habitat scoring site in Region 2 (Table 11, Fig. 6). Assessment of this site suggests that even though a great deal of channel engineering and restoration has been done at this site, the efforts have not improved in-stream structures for habitat.

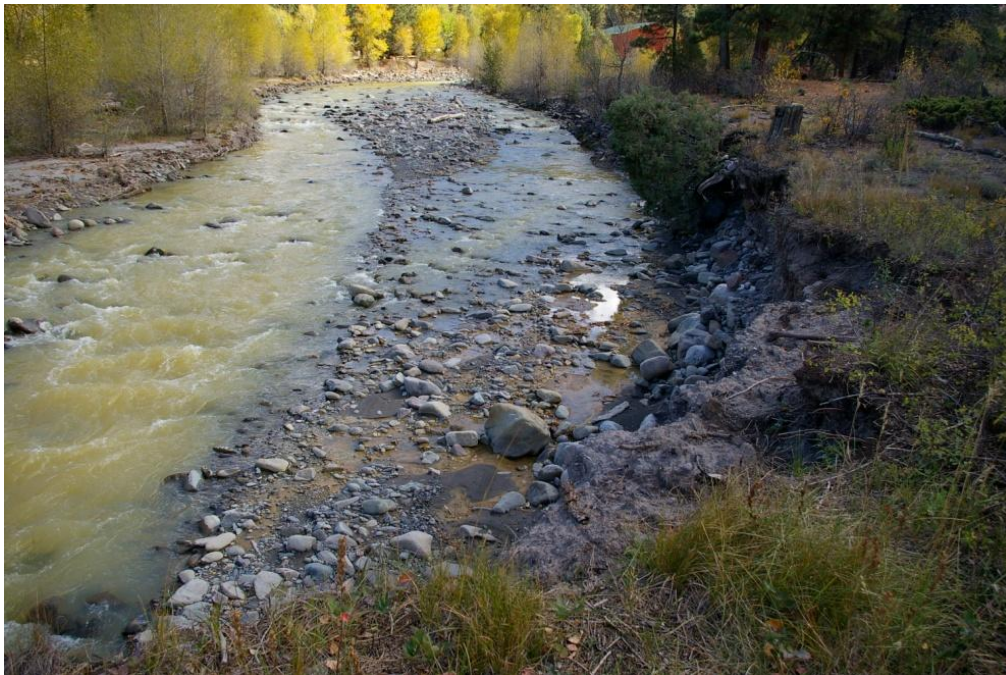
**Photo 8.** KOA site, Uncomahgre River.

There were no residential, commercial or agricultural land uses near the KOA site on the Uncomahgre River south of Ouray. This area was forested and the riparian zone was 80 ft on LB and 163 ft on RB. The vegetation on LB of the river was dominated by conifers and there were few riparian hardwoods and herbaceous vegetation on the bank to stabilize it (Photo 8). The reach exhibited extensive erosion and bank failures. The right river bank did not appear unstable and had high young cottonwood recruitment. Although the conifers provided about 10% stream shade, the young riparian hardwoods were set back from the active channel and likely contributed little to in-stream habitat. This reach was 95% riffle morphology (sinuosity = 1.05) and little in-stream stream structure to provide habitat. The bed surface was 70% boulders, 20% cobble and 10% sand. The water appeared discolored from sediment and iron oxide.

<b>KOA</b>	<b>Score</b>	<b>Index</b>
Aquatic	30.3	Good
Terrestrial	26.2	Good
Visual	3.8	Fair
Habitat Score	60.3	Good

The following recommendations are suggested for the Middle Watershed: 1) reduction of iron and other metals in the river (this might be mitigated by reductions of metal loading in the Upper Watershed), 2) planting of riparian hardwoods to stabilize river banks, provide stream canopy cover, terrestrial nutrient inputs, and large wood recruitment into streams, 3) improvements to in-stream habitat structure through creation of pools, backwaters or wetlands; this should be especially considered as part of other riparian active restoration projects, 4) engineering and stabilization of river banks to mitigate flooding where necessary to protect infrastructure and private property (these efforts should include in-stream structures for aquatic habitats). Monitoring efforts should include: 1) addition of at least one more sampling site between the

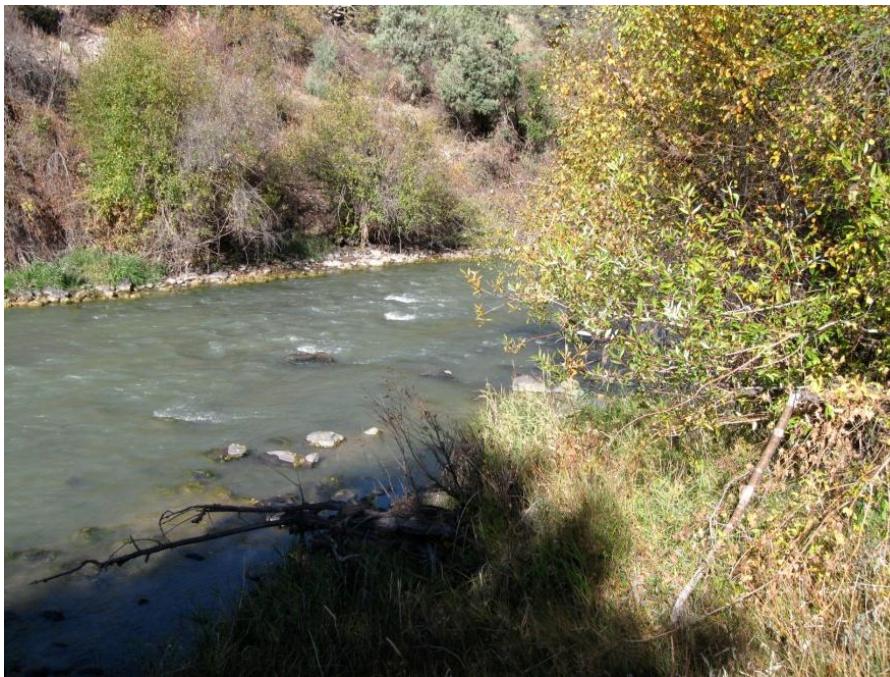
**Photo 10.** Spirek Property, Uncompahgre River.

The Spirek Property is located on the Uncompahgre River above Ridgway Reservoir, less than one mile south of County Road 24 in Ouray County. The dominant land use at the Spirek Property site is residential on the left and residential and agricultural on the right bank (RB). The width of the riparian zone ranged from 13 ft (LB) to 20 ft (RB) (Photo 10). The riparian vegetation consisted of trees (LB) and shrubs (LB, RB), but provided little in-stream cover. The riparian zone showed no signs of invasive or non-native species or disruption from grazing or development.

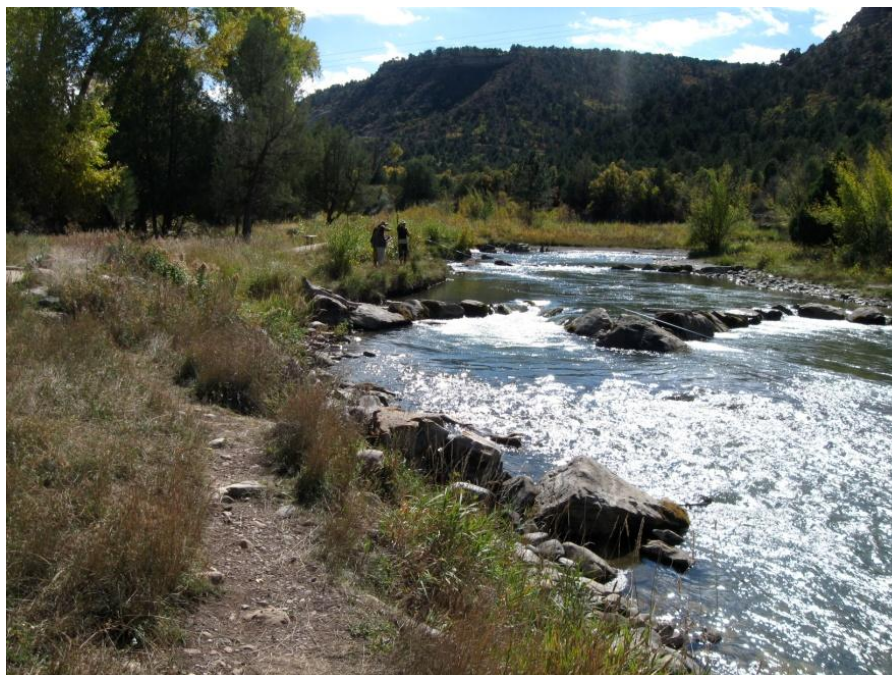
**Photo 11.** Pa-co-chu-puk site, Uncompahgre River.

The structural additions from the restoration projected provided this site with ample pool and riffle development, but limited in-stream cover for fish and macroinvertebrates. The substrate was 70% cobble with no signs of sediment deposition (sinuosity = 1.10). Our survey found few indications of localized erosion and some undercut banks. Approximately 30% of the stream substrate was covered in attached algae.

<b>Pa-co-chu-puk</b>	<b>Score</b>	<b>Index</b>
Aquatic	38.8	Excellent
Terrestrial	26.6	Good
Visual	6.7	Good
Habitat Score	72.0	Good

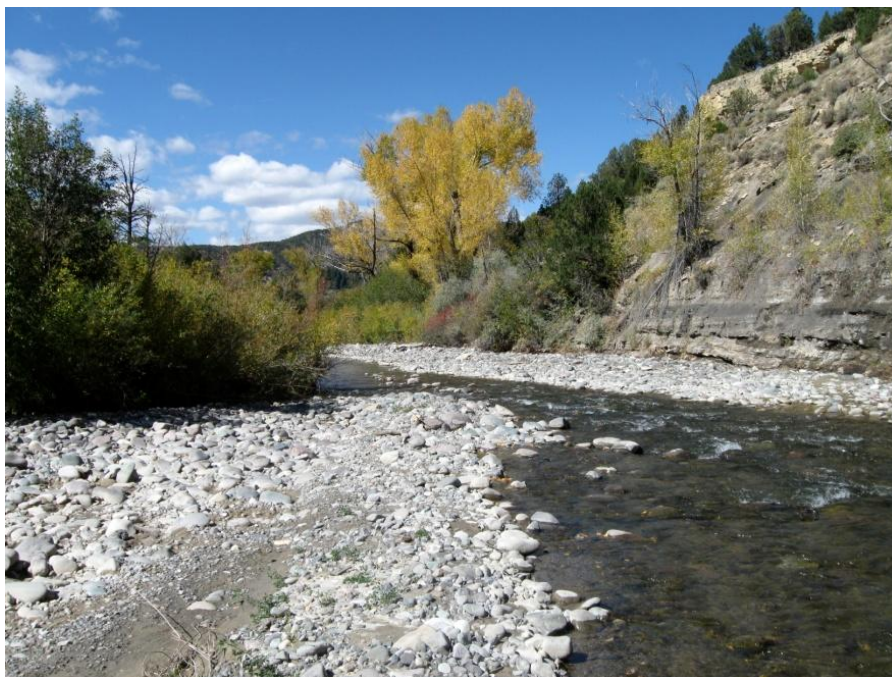
**Photo 12.** Cow Creek, tributary to Uncompahgre River.

The riparian vegetation at the Cow Creek site was similar to the Billy Creek SWA site, mostly willow with some interspersed cottonwood trees (Photo 12). The riparian zone ranged from 127 ft to 80 ft in width and showed no signs of human or livestock disturbance. Russian olive was present. River banks were 40% vegetated, but the riparian vegetation provided little in-stream canopy cover.

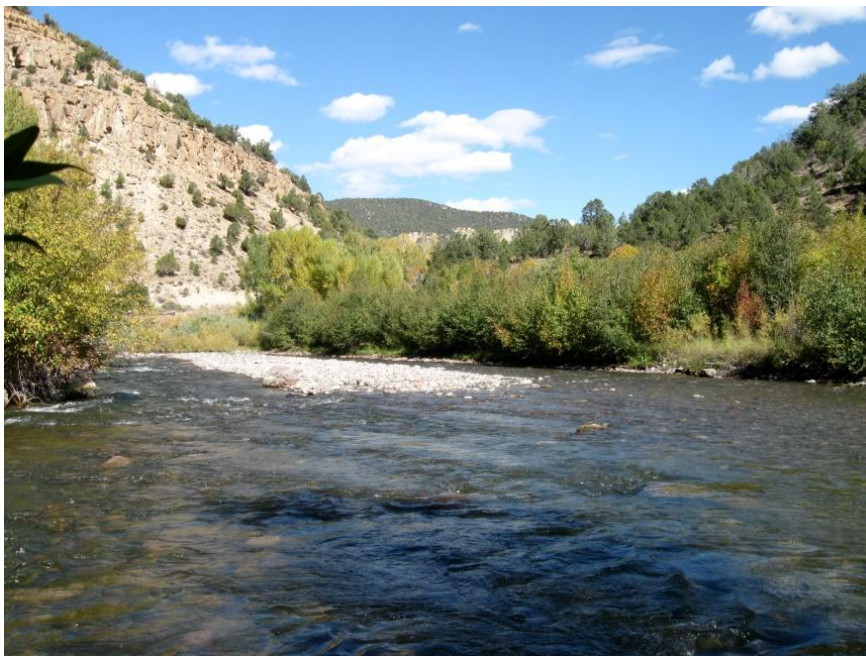
**Photo 13.** Billy Creek, tributary to Uncompahgre River.

The vegetation at the Billy Creek SWA site consists primarily of sagebrush, oakbrush and pinon-juniper. Some cottonwood habitat exists on the Uncompahgre and Billy Creek riparian zones. The riparian zone was approximately 100 ft wide on both banks, had optimal structural diversity and was dominated by willows (Photo 13). River banks were 40% vegetated and the canopy provided partial canopy cover. Russian olive and Canadian thistle were present at this site. The riparian zone showed signs of disruption, and may have been impacted by foot traffic from the adjacent parking lot or maintenance of an irrigation canal. The Billy Creek SWA site was characterized as half riffle and half run (sinuosity = 1.14), with no signs of pool development. There was marginal in-stream fish cover and over 50% cobble. Stream substrate was 50% cobble and exhibited few signs of sediment deposition. River banks at this site were stable with slight evidence of localized bank movement. Over 40% of the reach was covered with attached algae, indicating possible nutrient enrichment.

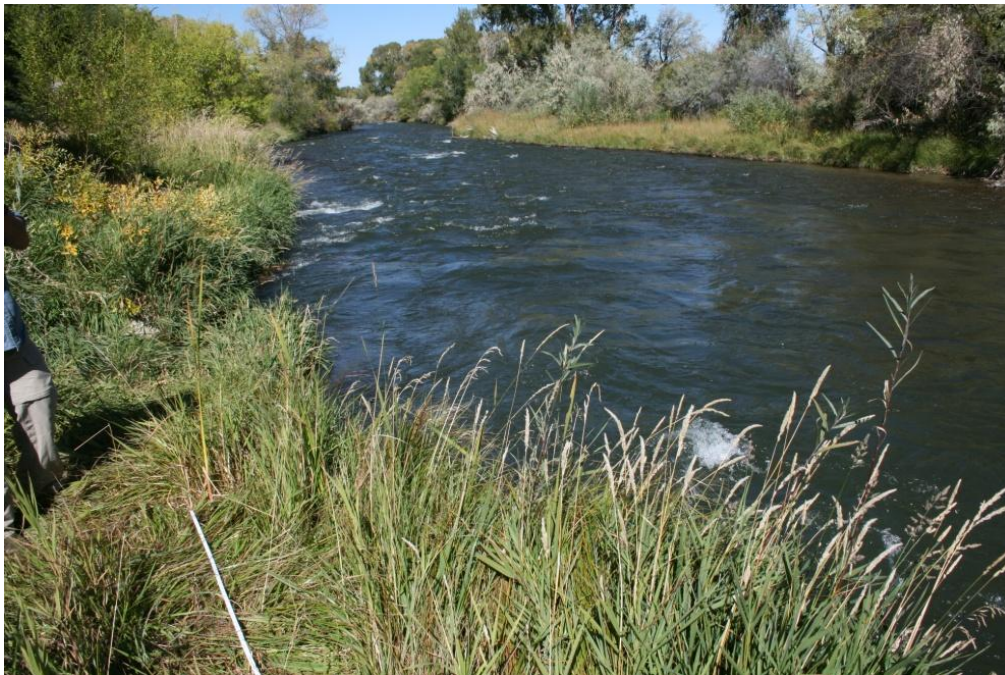
**Photo 14.** Ute Museum site, Uncompahgre River.

The dominant land use surrounding the Ute Museum site is commercial/park (LB) and field/pasture (RB). The riparian zone on the right bank was 60 ft wide and consisted of shrubs, grasses and herbaceous plants (Photo 14). The left bank had a thick and structurally diverse riparian zone (200 ft) with trees, shrubs, grasses and herbaceous plants. Russian olive was observed. River banks were 50% vegetated and the riparian zone provided marginal canopy cover.

<b>Ute Museum</b>	<b>Score</b>	<b>Index</b>
Aquatic	32.0	Good
Terrestrial	26.7	Good
Visual	7.2	Good
Habitat Score	65.9	Good

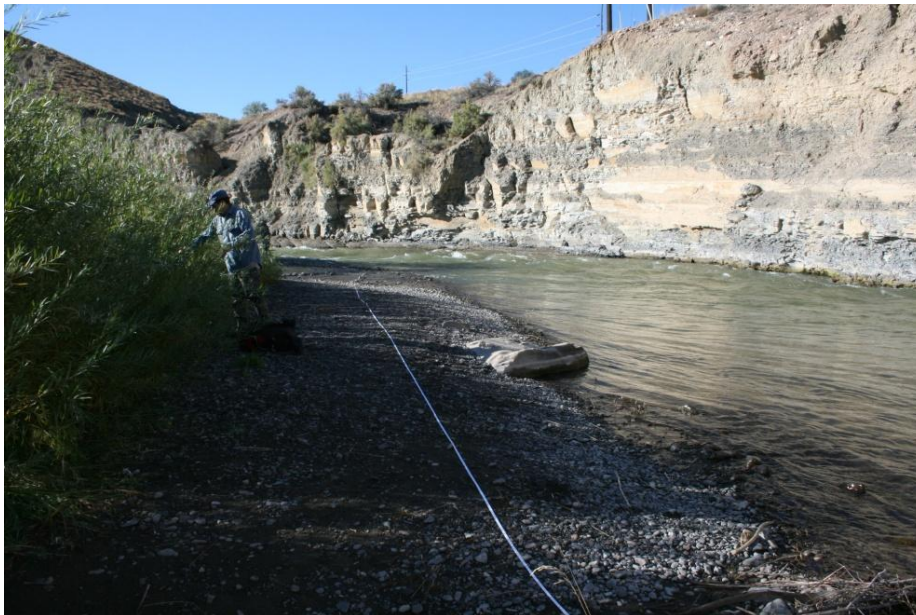
**Photo 15.** Baldridge Park site, Uncompahgre River.

The landscape at Baldridge Park was comprised of a grassy community park (RB) and steep cliff (LB) (Photo 15). There was limited development of the riparian zone at this site. The sparsely vegetated riparian zone was less than 20 feet wide on the cliff side. There was increased structural diversity in the 75 foot wide riparian zone on the park side, with trees, shrubs, non-native grasses and herbaceous plants present. There was an abundance of Russian olive, tamarisk and canary reed grass at this site. There was evidence of trash and disturbance of the riparian zone, most likely from park visitors. The Uncompahgre River at Baldridge Park is the site of a former restoration project designed to improve fish habitat and bank stability. Our survey found few indications of bank erosion. Habitat diversity at this site consisted of 60% riffle, 40% run, no pools (sinuosity = 1.20) and limited in-stream fish cover and insect habitat. There were signs of sediment formation including sand bars. The limited riparian vegetation did not provide stream canopy cover.

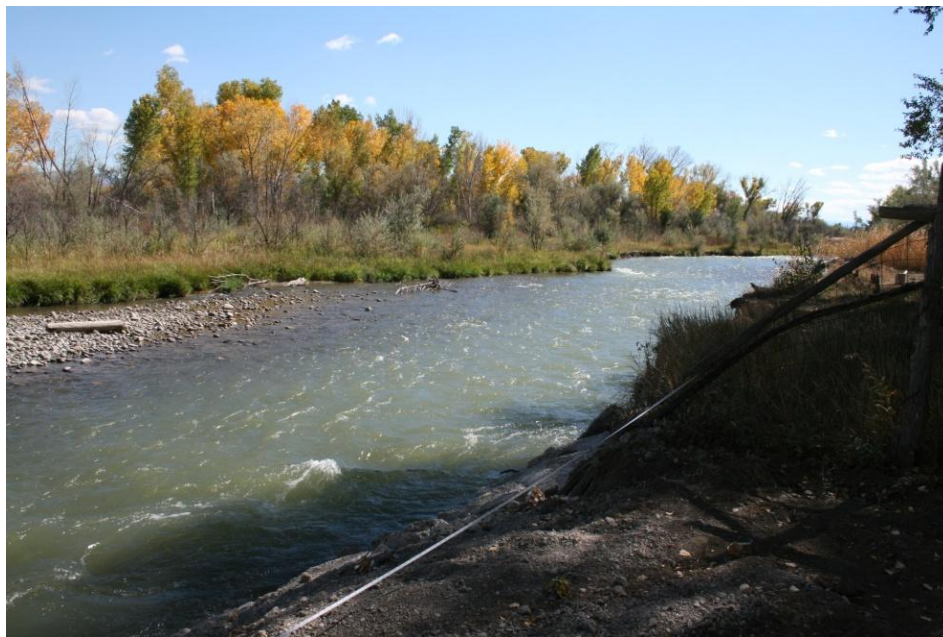
**Photo 16.** Waterway site, Uncompahgre River.

The Uncompahgre River at the Waterway View site had a sinuosity of 1.36 and the dominant in-stream feature was run (75%). There was minimal pool development and the existing pools were small and shallow. There was limited in-stream fish cover and the site showed signs of sediment deposition in the form of bar formation and accumulation of fine sediments in pools and riffles. The site also exhibited extensive signs of heavy erosion including bank failure on the left bank. The owner of the Waterway View property experienced excessive loss of land after the 2010 flood season.

<b>Waterfront</b>	<b>Score</b>	<b>Index</b>
Aquatic	22.3	Fair
Terrestrial	17.9	Fair
Visual	6.3	Good
Habitat Score	46.5	Fair

Based on river assessment data from Region 3 and 4, recommendations for the Lower Watershed include: 1) efforts to increase in-stream structure (planting of riparian willows and cottonwoods could be a surrogate for pools and in-stream structure because over-hanging vegetation and undercut banks and root crowns in these regions have been shown to provide fish habitat), 2) creation of pools and aquatic habitats (i.e. rock veins, backwater channels, wetlands) should be part of active restoration and stream engineering projects especially in public use areas, 3) bank stabilization in high use areas, 4) assessment of nutrient inputs from agricultural areas and sediment/salts/nutrients from residential and municipal areas, 5) removal of invasive species. Monitoring efforts should include: 1) addition of sampling sites where non-point nutrient loading

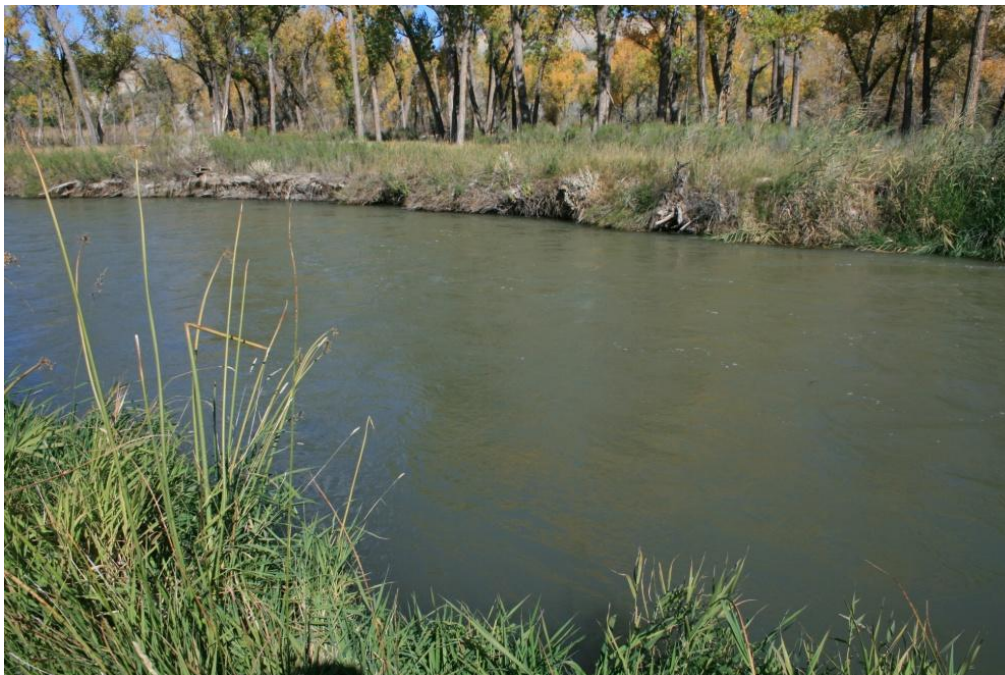
**Photo 17.** Sazama site, Uncompahgre River.

The Uncompahgre River at the Sazama Property was straight (sinuosity = 1.30), 90% run, and had no obvious signs of pools. There was little evidence of aquatic vegetation (less than 1%) and some evidence of erosion including slight bank movement. Undercut banks and vegetative root wads provided ample in-stream fish cover. The water appearance was cloudy and greenish. Although no irrigation diversions were directly present, this condition of the Uncompahgre River at the Sazama Property exhibited many signs of stress from local irrigation water management.

<b>Sazama</b>	<b>Score</b>	<b>Index</b>
Aquatic	34.5	Excellent
Terrestrial	29.0	Good
Visual	6.5	Good
Habitat Score	70.0	Good
