Chico Basin Riparian Restoration 2012 Final Report

Wildlands Restoration Volunteers

November, 2011 - April, 2012

Vega Revegetation Project on Chico Basin Ranch

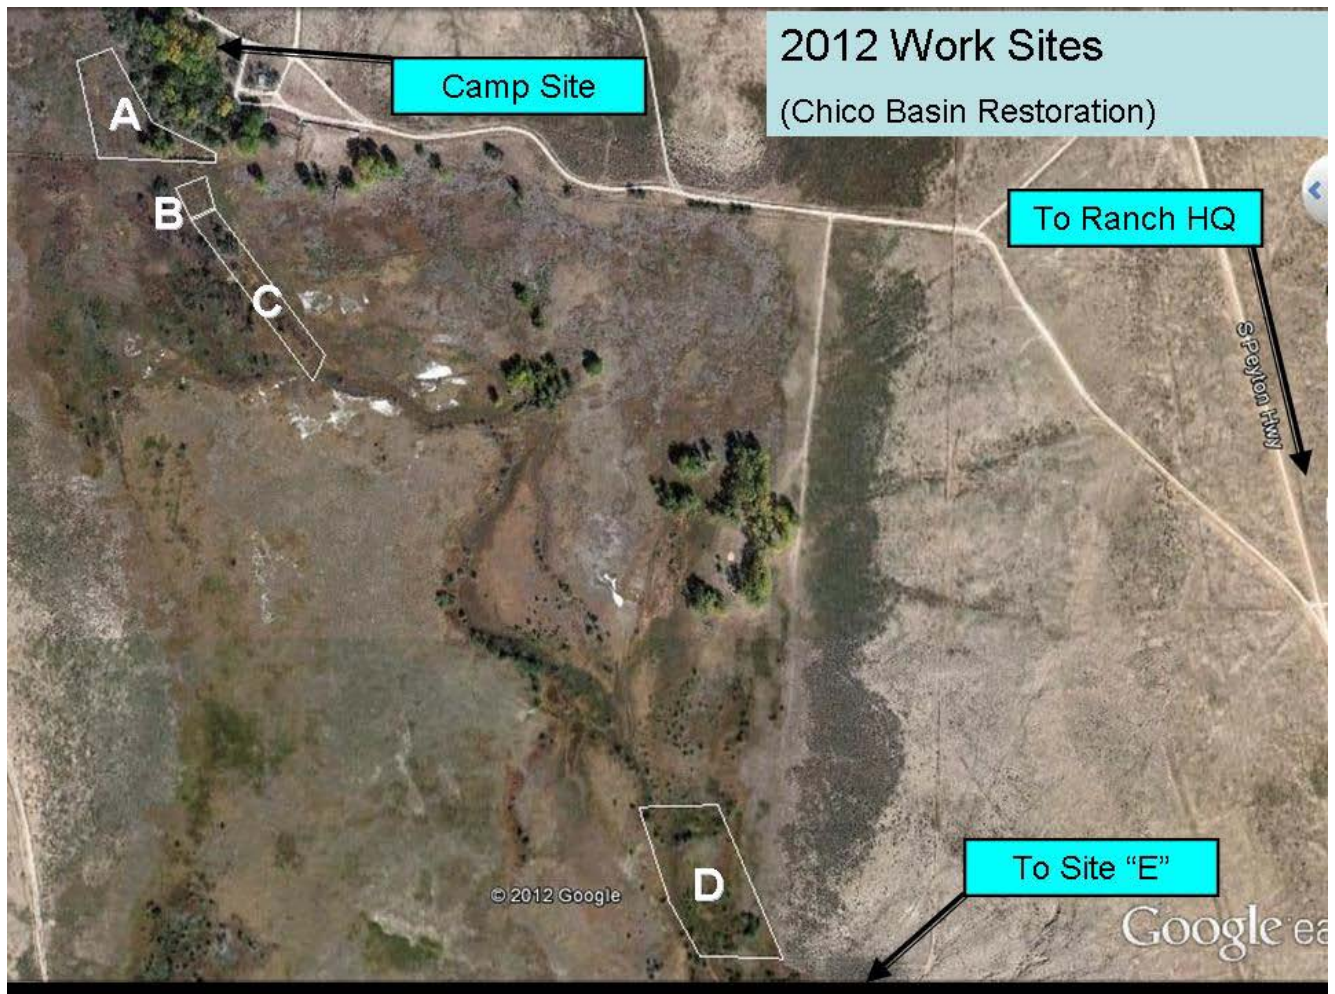
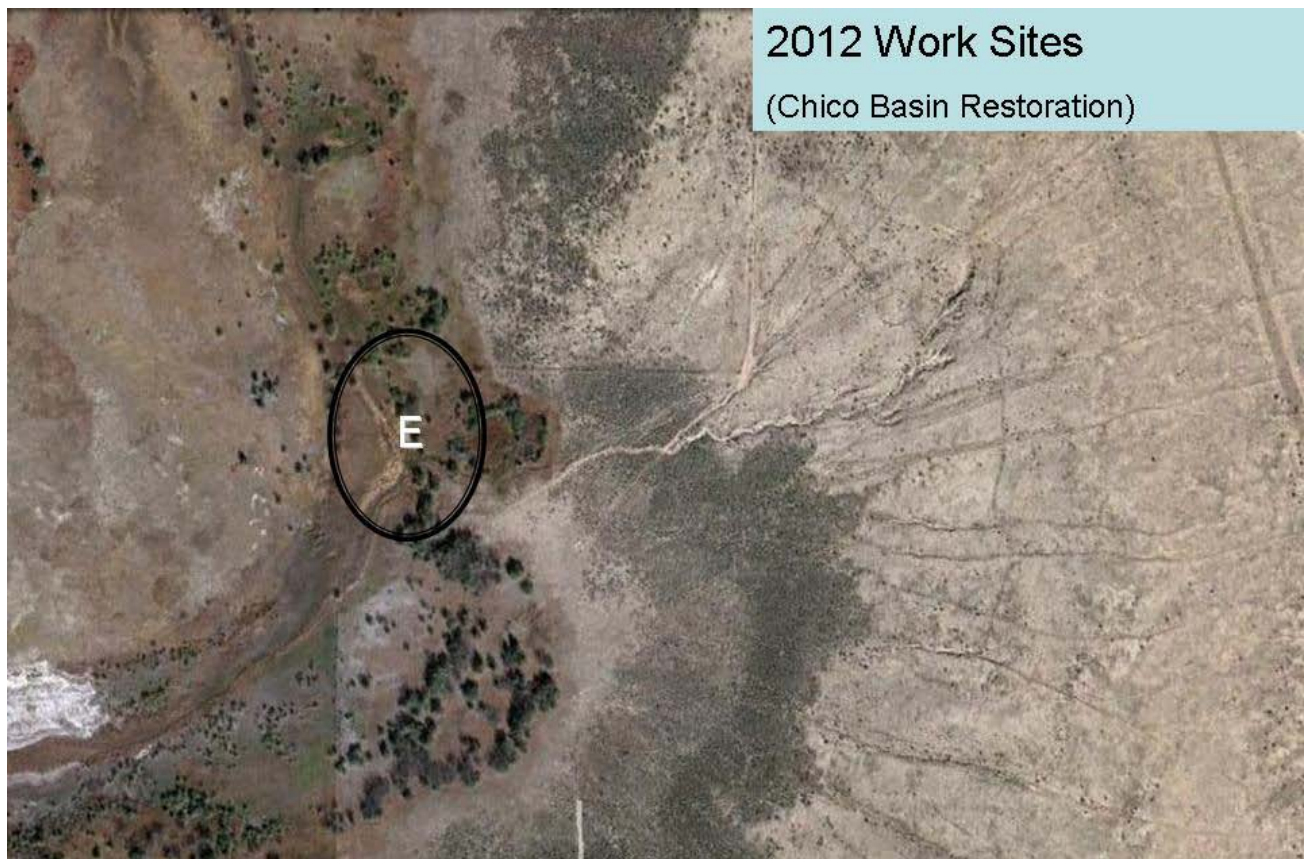
Chico Basin Riparian Restoration Project
2012 Sites (Vega and Holmes Springs)
Refer to Map for area locations, and section notes for GPS coordinates

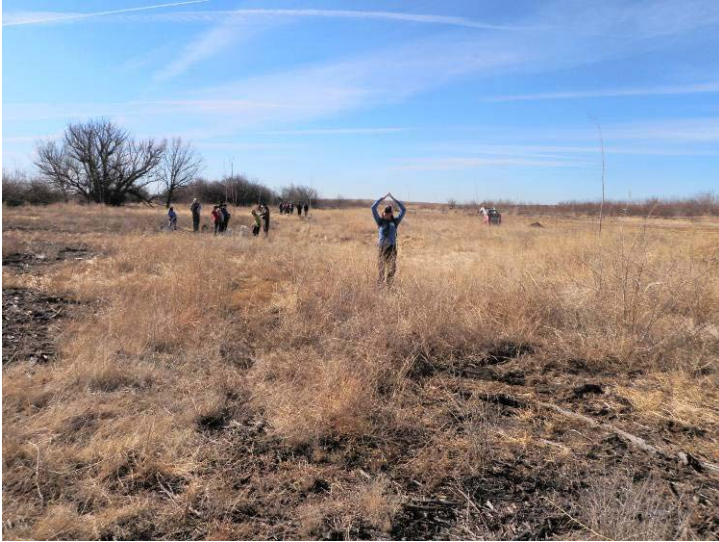
Area A – Chico Basin 2012 (from 0+00)

NOTE: Augered holes between stream and banding station contained significant sand, and showed adequate water at 4-6' down.

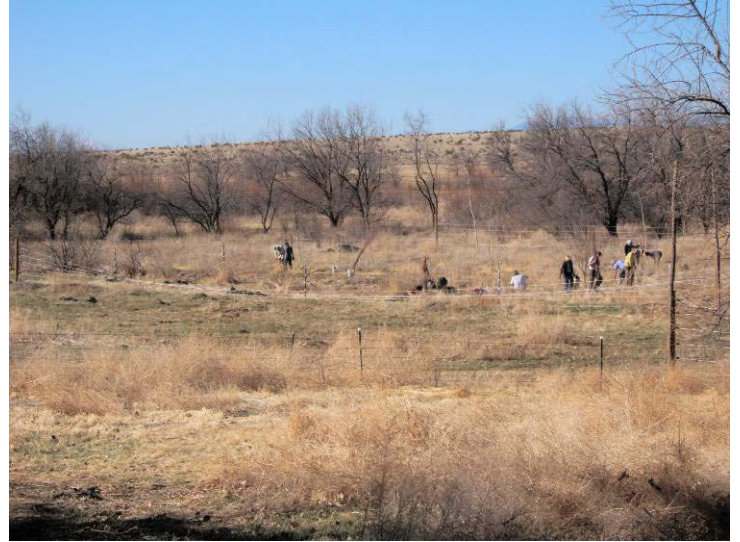
Area B – Chico Basin 2012 (from barn)

NOTE: This section includes significant wetland soils, and shallow distance to water table. Difficult for Cottonwood establishment.

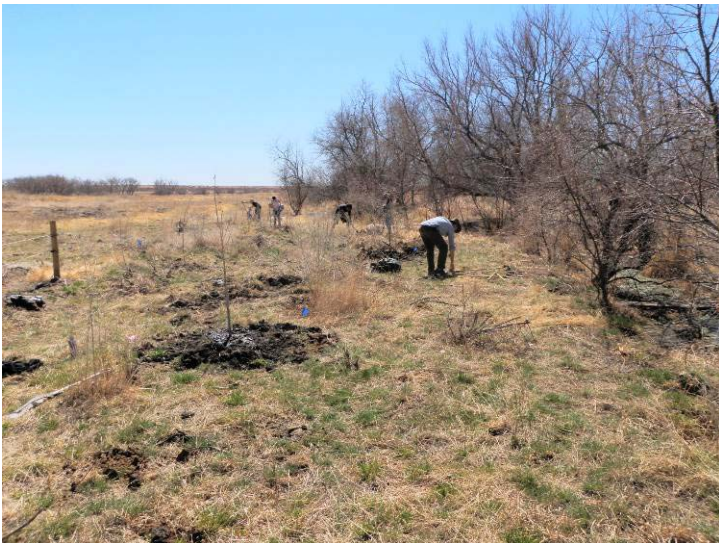
Area C – Chico Basin 2012 (from Area B)

NOTE: Area C is immediately down stream of Area B, and includes a long skinny fenced section of creek.

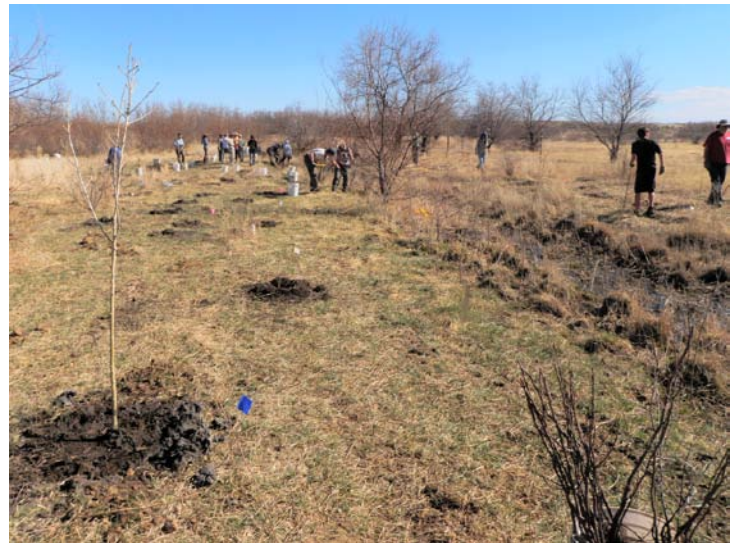
Area D – Chico Basin 2012 (from 0+00)

NOTE: This area is immediately upstream of Area E (see area map)

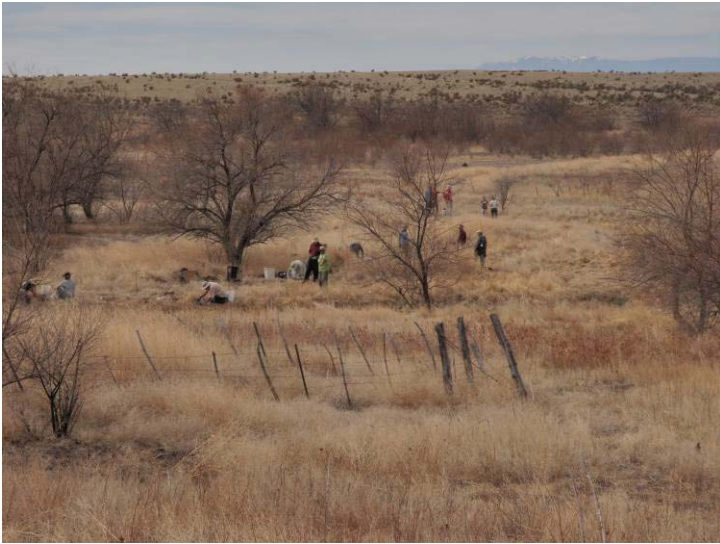
Area E – Chico Basin 2012 (from gate)

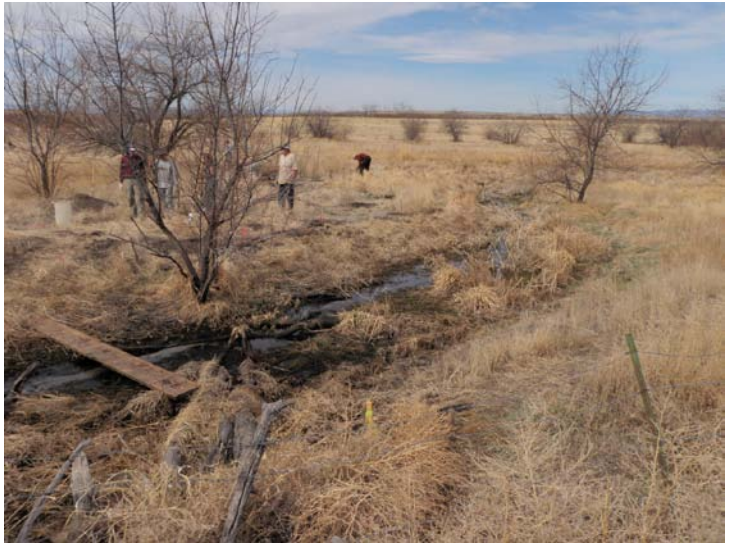
Area E – Chico Basin 2012 (from spring)

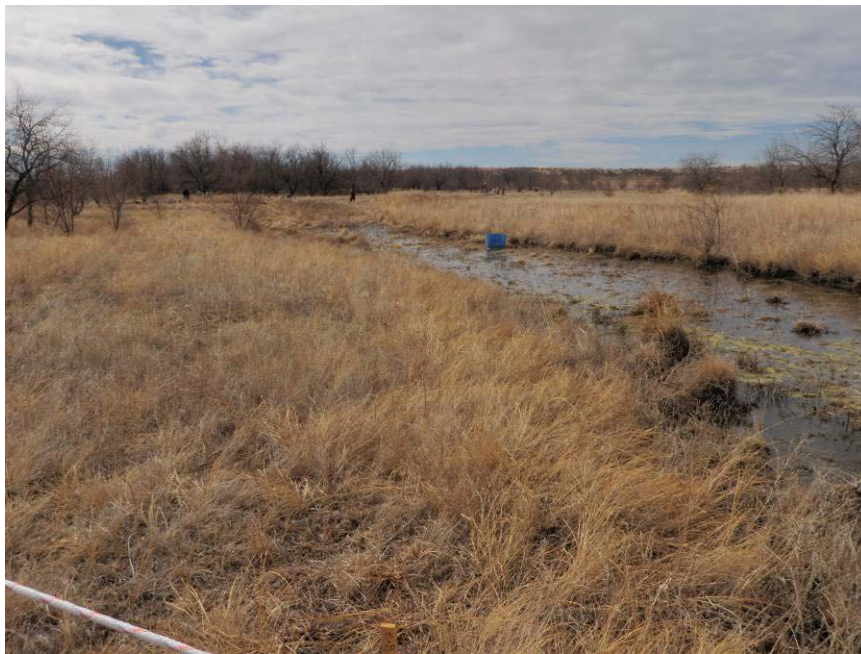
Area E – Chico Basin 2012
(from confluence of spring and creek)
