## Drainage Districts of the Lower Arkansas Valley

## FINAL REPORT

### Chapter I

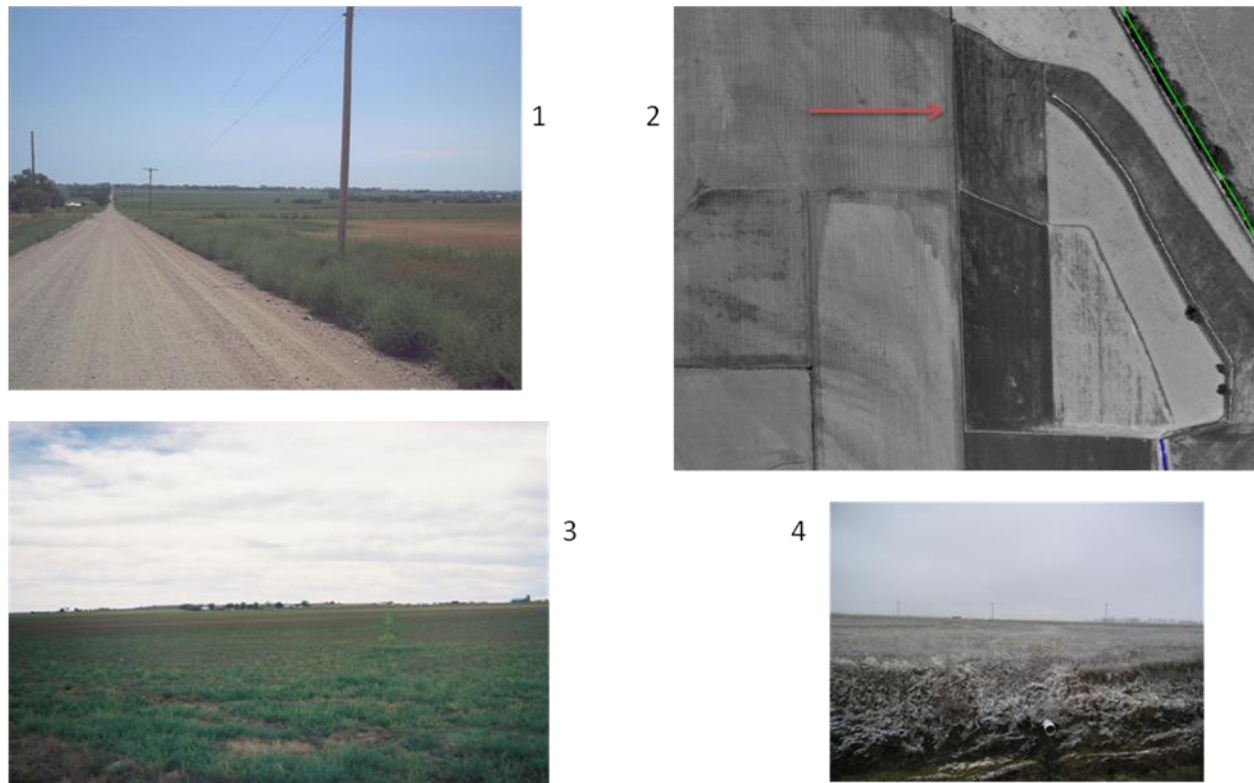
Orientation Photos – (1) Looking east across Wiley Drainage District; (2) Aerial photo showing crop marks indicating location of buried tile lines (open collector drain in blue); (3) Crop mark of tile line; (4) Tile line outlet into open collector drain.

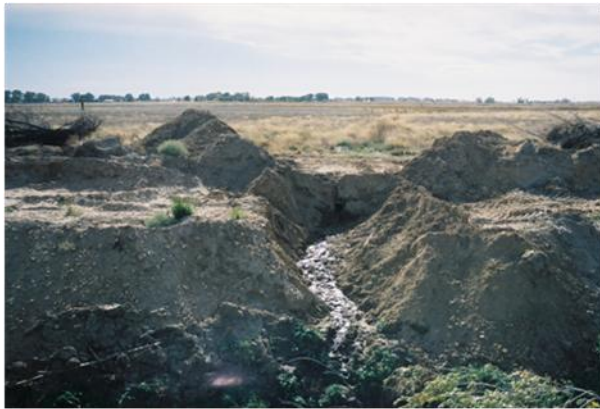
Typical Tile Line Outlet with Effluent  
Flowing into Open Drain (forefront)

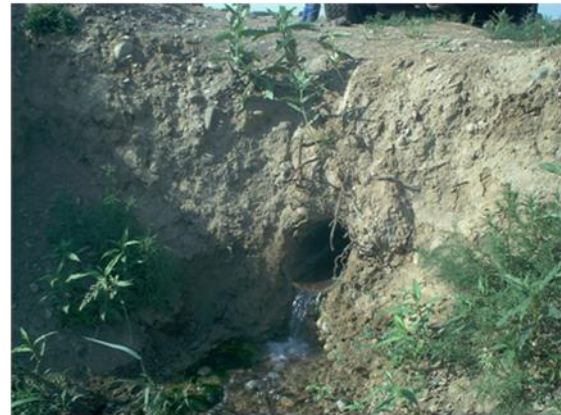
Close View of Outlet

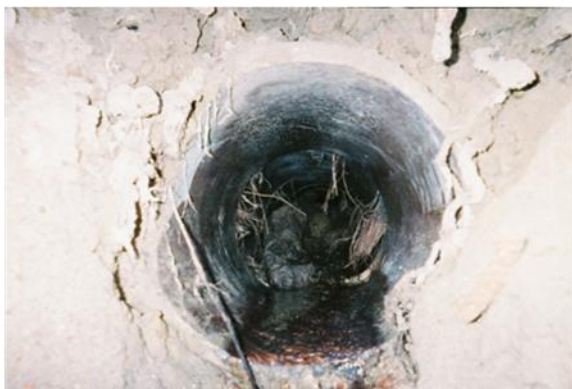
Obstructions in Tile Line Before Cleaning

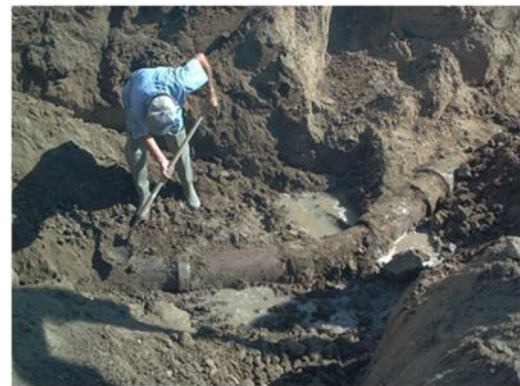
Exposing a Tile Line Before Installing a Manhole

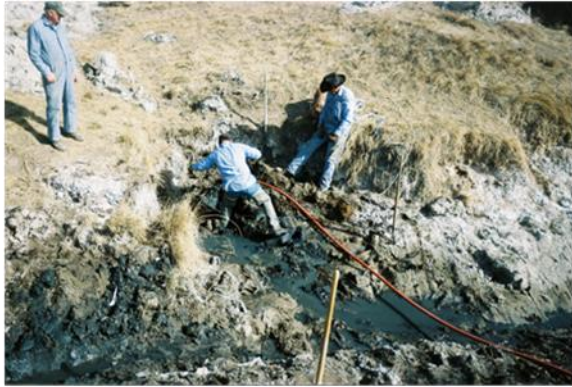
1

Miscellaneous Photos – (1) Cleaning out a tile line in the Wiley Drainage District; (2) Map showing the alignment of a damaged drain in the Arbor Drainage District; (3) Typical tile line repair procedure in field.

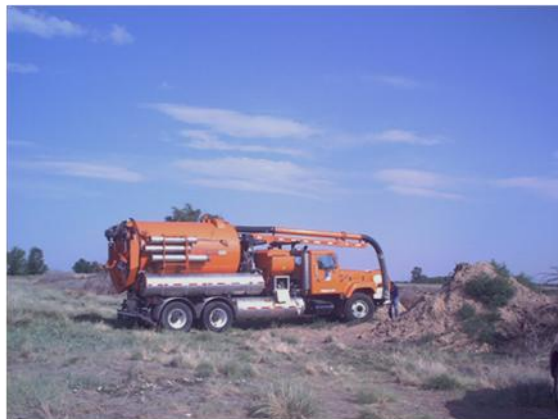
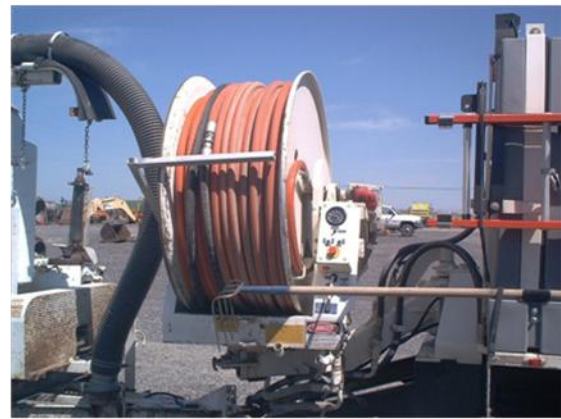
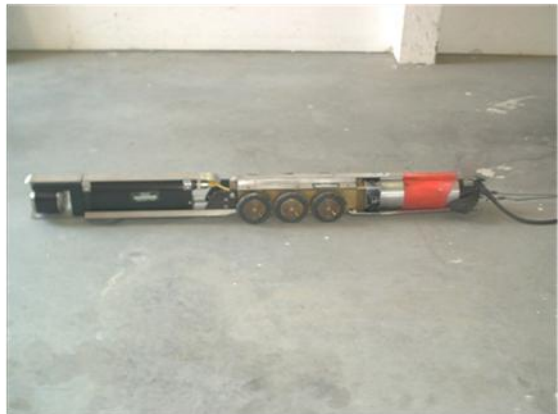
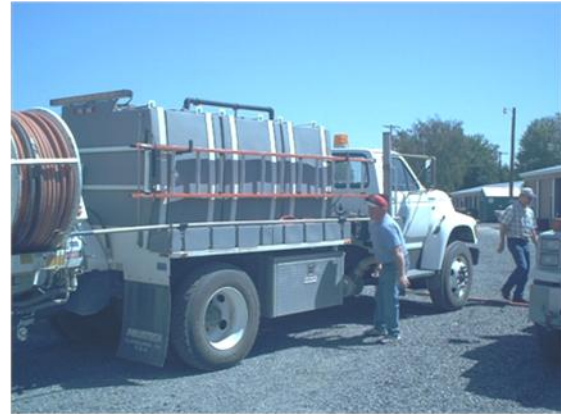
Drainage maintenance equipment – (1) Combo jet-vac rig; (2) Pressure hose on trailer; (3) Mobile camera for drain investigation; (4) Water truck with trailer hose.

In the Washington district, drainage line maintenance is conducted utilizing standard sewer cleaning equipment typically found in large municipalities today. These include a jet cleaning and vacuum combine truck, a water tanker truck used to accompany the jet cleaner anywhere in the district, a mobile camera attached to a cable that is used to enter and travel up drain lines and display and/or videotape problems before cleaning or maintenance begins in the lines, and a variety of water nozzles and other equipment to cut into heavy silt and root problems in the drains and manholes (see photos, page 11). The vacuum is used to clean out manholes and to facilitate other activities when flowing water or heavy silt obstruct cleaning activities. Once purchased, this equipment is not expensive to operate, and can generally be managed by two people. That is the case in the Washington district, where two field staff employees perform most work under the supervision of one experienced drainage technician hired by the district to oversee their entire drainage maintenance program.

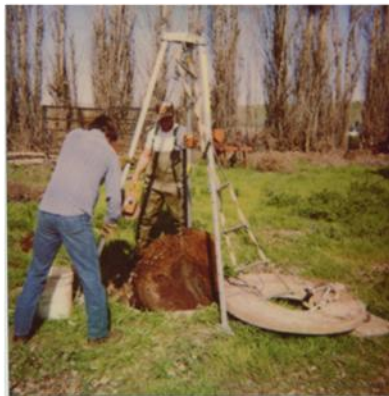
3

South Columbia Basin Irrigation District (three man drainage crew) – (1) Dan Morasch, Technician (retired); (2) total field crew for 1200 miles of tile lines and 3000 manholes; (3) Cleaning a root ball out of a manhole; (4) Cleaning out a manhole. Their maintenance program is discussed later in the report.

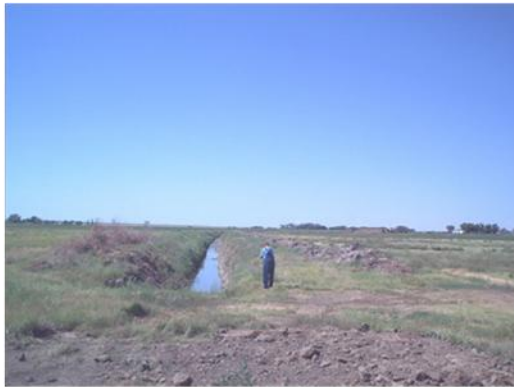
1

Open collector drains – (1) Los Animas Consolidated (extension) DD (previously a buried tile line); (2) Kornman DD; (3) Pleasant Valley DD; (4) Wiley DD open collector drain where it meets the Amity Canal. These open drains collect effluent from the tile lines.

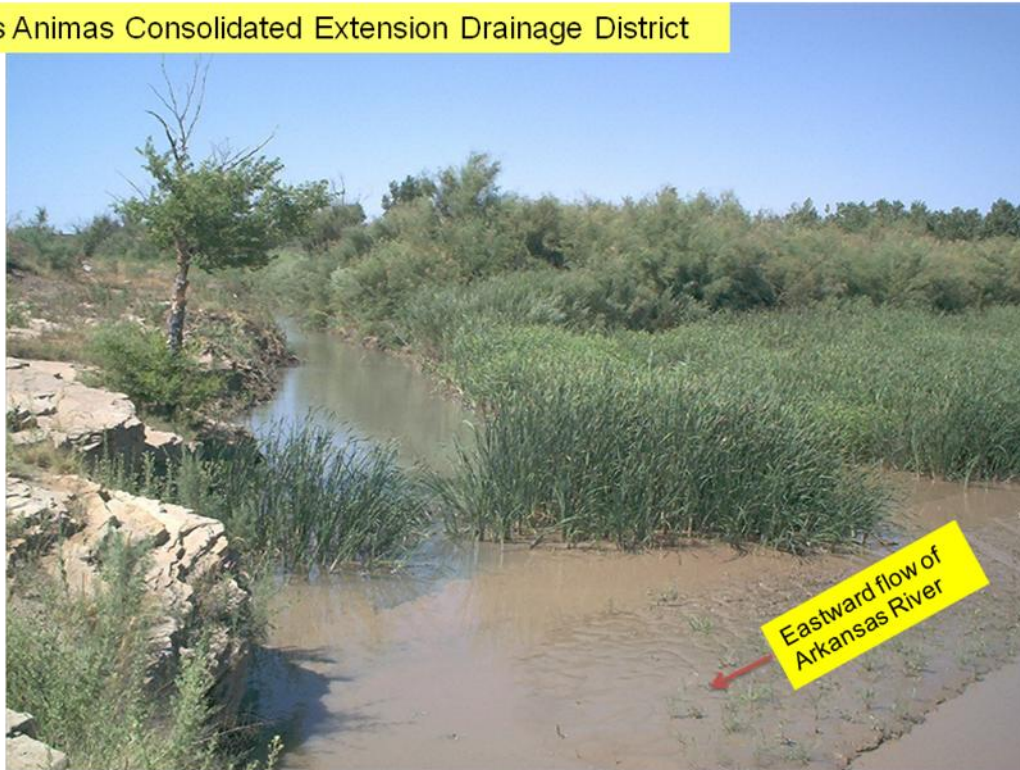
This photo shows the main open collector drain of the drainage district entering the Arkansas River. Due to the silting up of the river (and the drain), the drain has lost all elevation relative to the river. The drain thus backs up, further damaging the tile line system in the district; the large majority of which has been dug up because the tile lines no longer function adequately.

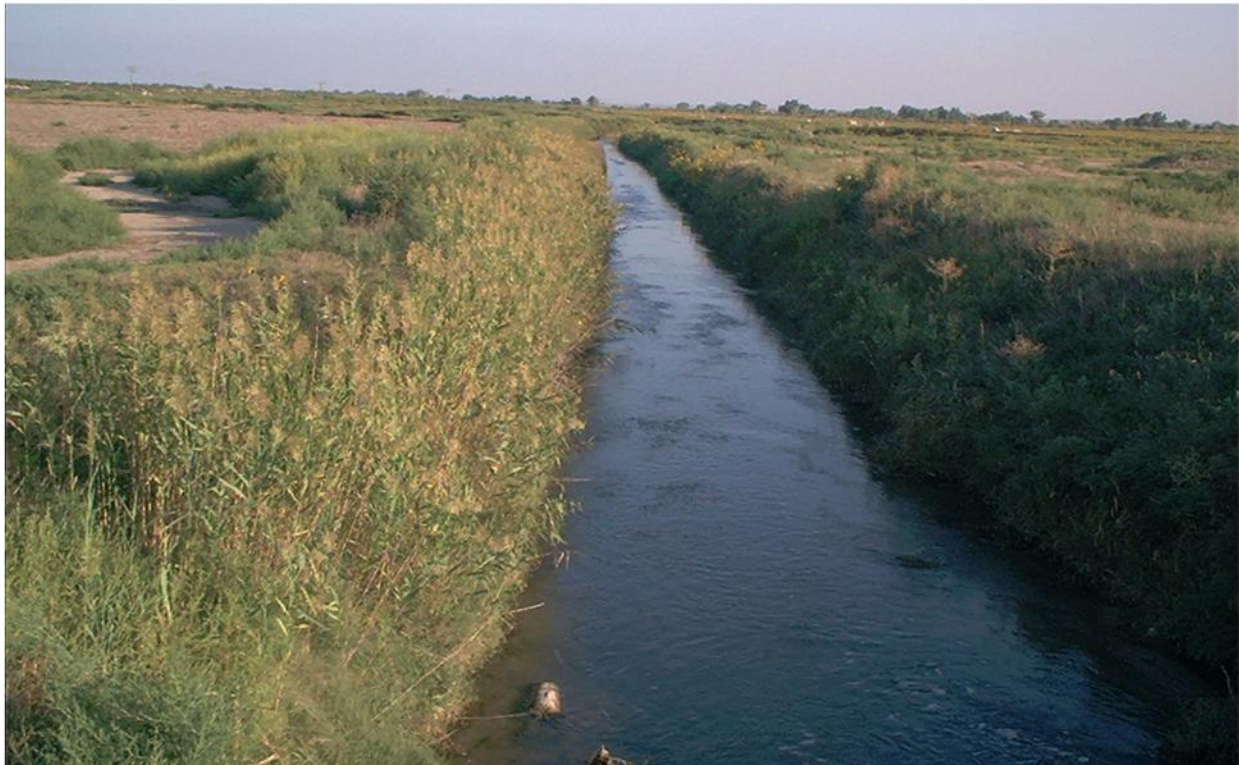
This drainage district is located near the Kansas state line. The photo is of a branch of the main open drain just west of the Town of Holly, looking south, right on Highway 50. The drain shows substantial flow during a drought. The photo was taken on August 5, 2003.

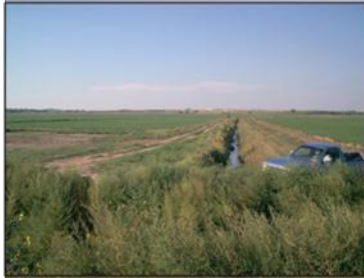
Yellow arrow shows the alignment of the upper reaches of the main collector drain shown in the inset photo. Notice the headgate diversion point on the upper reaches of the drain that takes water into a field for irrigation. Water rights are filed on these diversions.

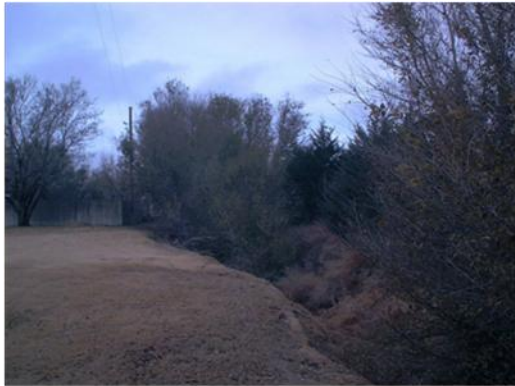
1

(1) Rural subdivision encroachment onto open drain; (2) Bell tile joint; (3) Cleaning alfalfa roots out of a tile line; (4) Typical sink hole in middle of field.

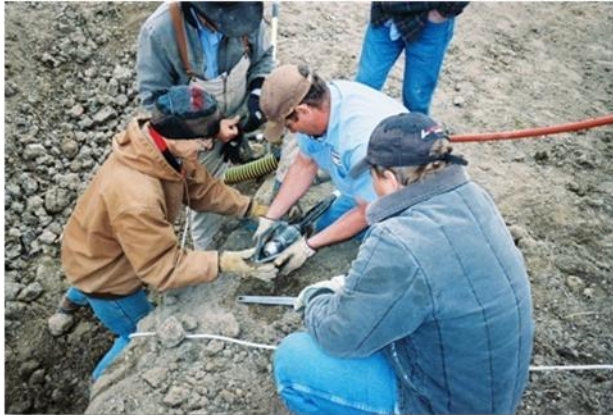
Attaching high pressure nozzle to 1" water hose.

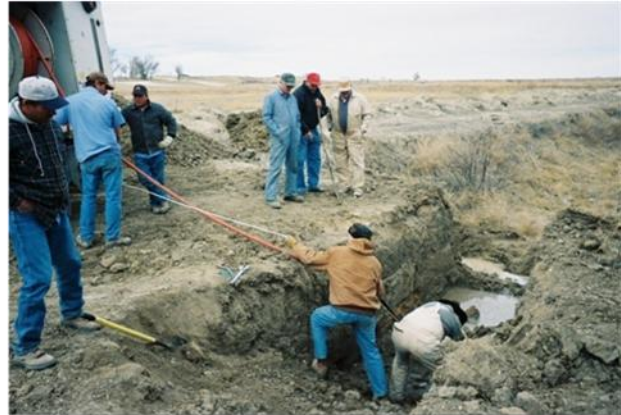
Running nozzle and hose into tile line

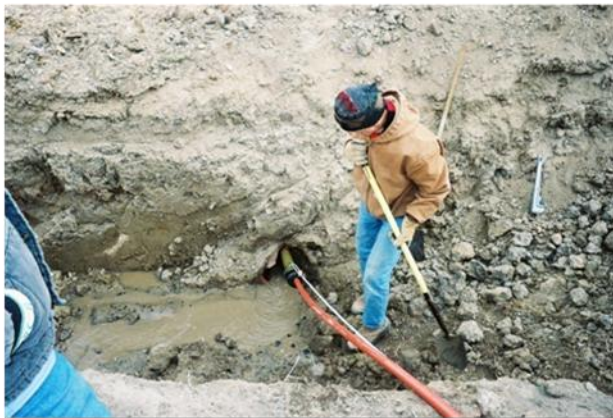
Working (moving in and out of) tile line

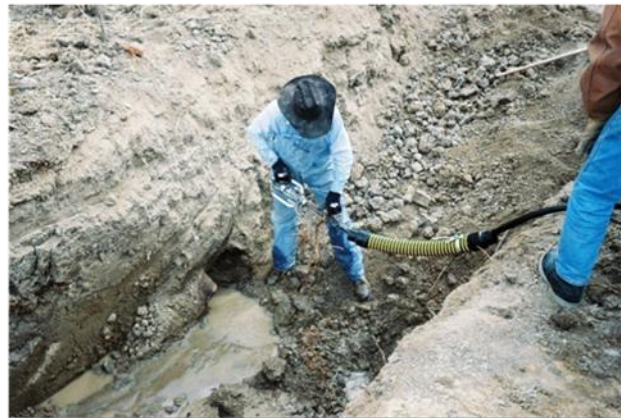
Cleaning roots off nozzle

The study was successful in organizing several demonstrations for landowners in the more current methods of tile line maintenance (above). These demonstrations have provided an opportunity to show the usefulness of a routine drainage maintenance program. This in no way suggests that previous efforts at tile line maintenance have been inappropriate. Given the condition of the drainage system and the limited funds available in the past, landowners have simply done the best they could. In addition, several Arkansas Valley contractors have contributed their considerable experience to helping districts and landowners with such efforts.

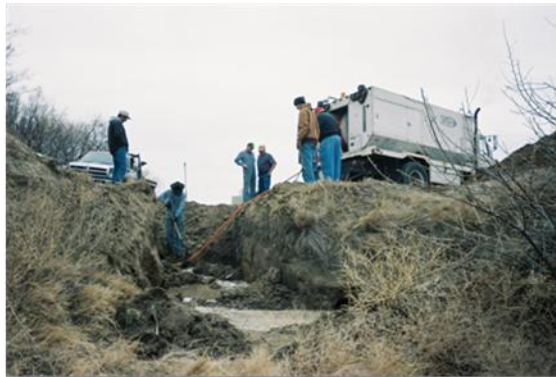
1

Demonstration tile line cleaning on George Reyher farm – (1) Inserting nozzle and hose into tile line; (2) Waiting for the “wart hog” (high pressure nozzle) to pass through the plugged 800 foot long 8” diameter line; (3) Jet nozzle exiting tile line where a new 6’ diameter galvanized pipe manhole (above left) is planned; (4) Aerial view of the cleaned tile line on Reyher farm.

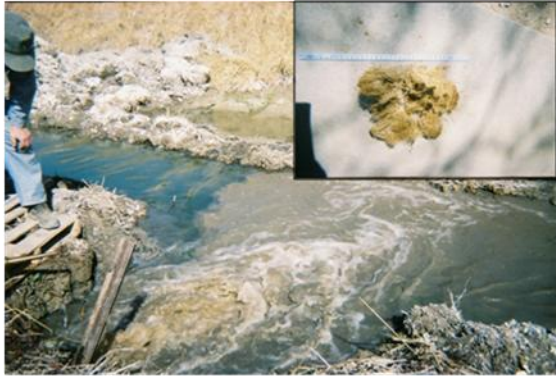
1

Common debris in tile lines – (1) Alfalfa roots, whose root system can extend down enough to enter 12' deep tile lines ; (2) Clay concretions (a major culprit); (3) Tree roots, often from windbreaks planted across tile lines); (4) Traps pulled into tile lines by animals.

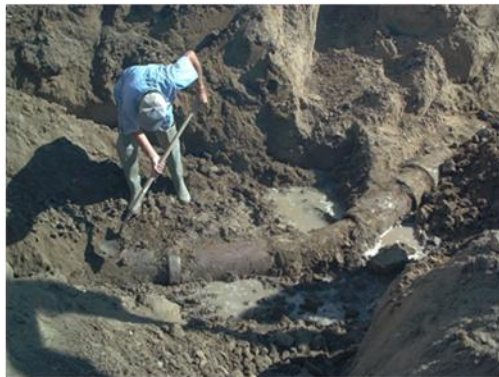
1

Tile Line Penetration - Installing and then cleaning out a manhole in order to clean an otherwise inaccessible plugged tile line – (1) Carefully excavating tile line to install manhole at bend; (2) Installing manhole, connecting pipe, and use of vacuum to assist installation; (3) Completing installation; (4) vacuuming silt out of manhole after the plugged tile line has been cleaned.

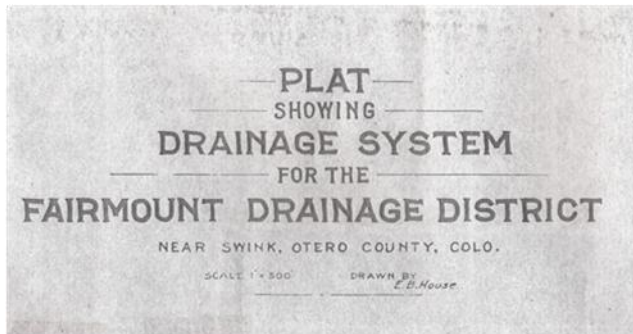
In the plat below, the black dots refer to the location of manholes designed to access the drainage system, while the dashed lines show the location of tile lines. It is estimated that the Fairmont DD has upwards of 20 miles of tiles lines of different diameter dimensions. In recent years, many of the manholes in the Fairmont DD have been buried in order to avoid damage during land preparation and harvesting.

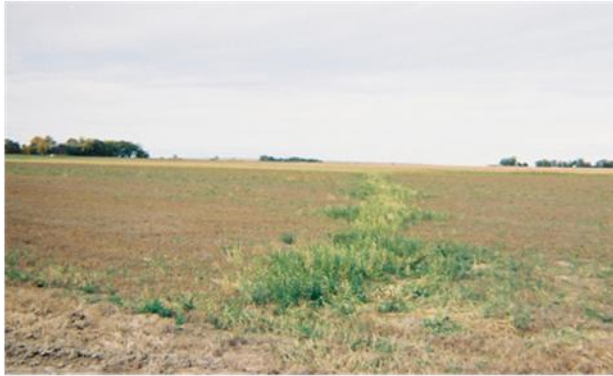
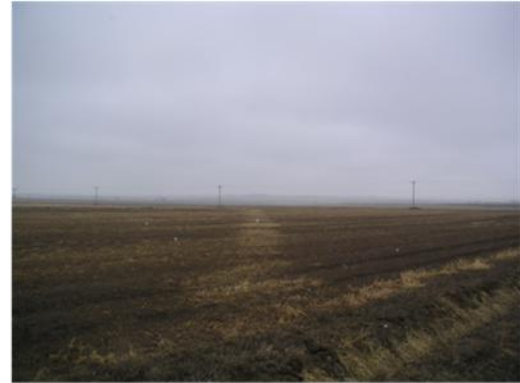
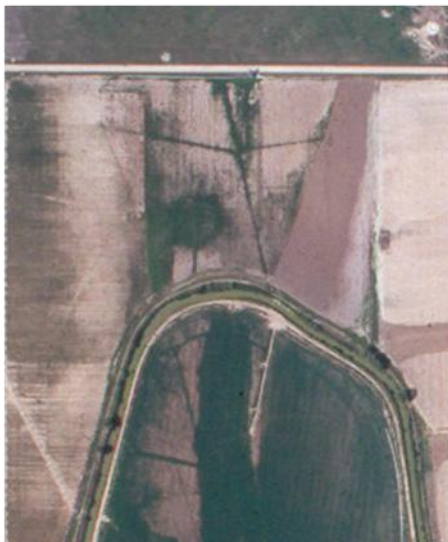
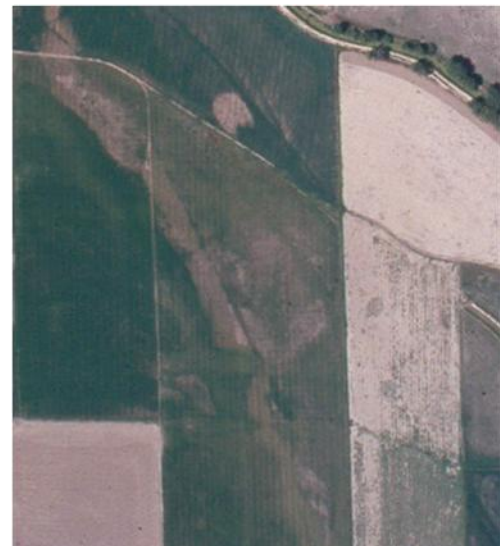
Various images showing the more visual locations of tile lines.

As might be expected, there were many of these very suggestive crop marks that could not be verified on the ground. Clearly they could have been created by a soil disturbance over the years, such as from oil and gas pipeline and utility installations, or simply being the old alignment of a now abandoned irrigation ditch or farm road. The possibility that they were attributable to geology was generally viewed as remote, due to their rather straight alignment and running at odd angles across a field.

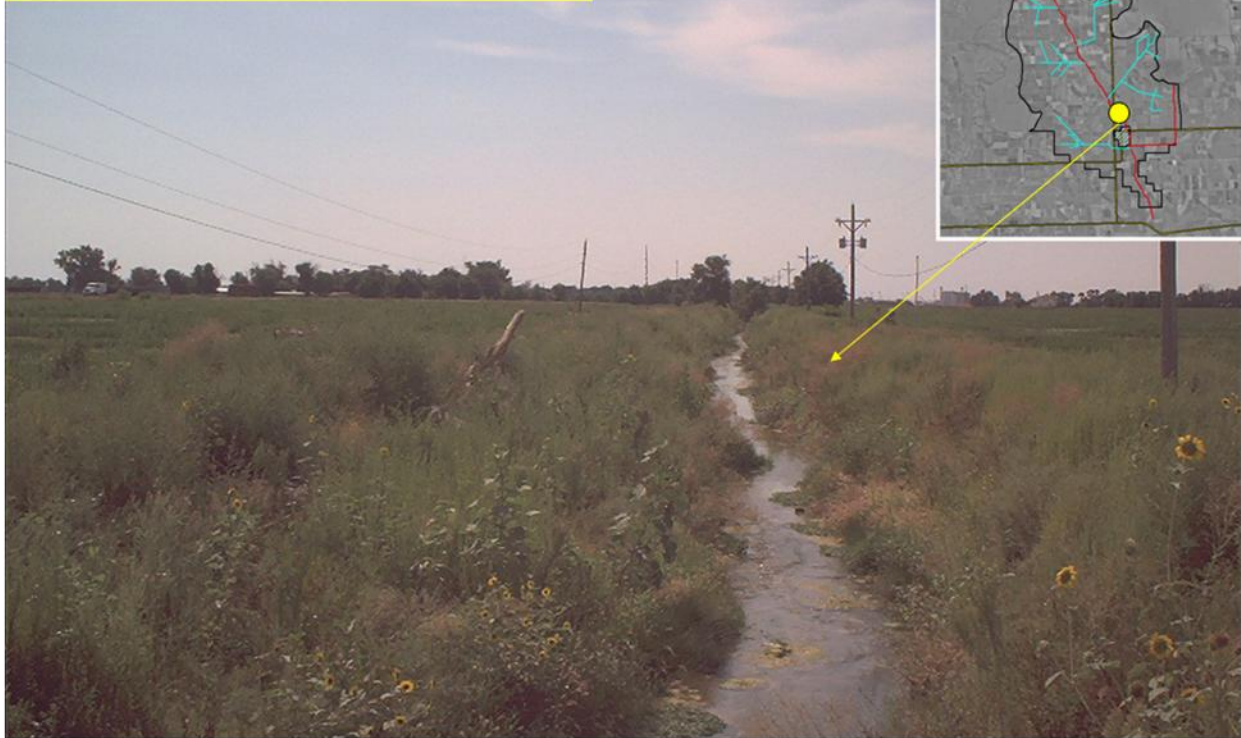
Looking due south down the main collector drain before it crosses Highway 287 (Town of Wiley in distance).

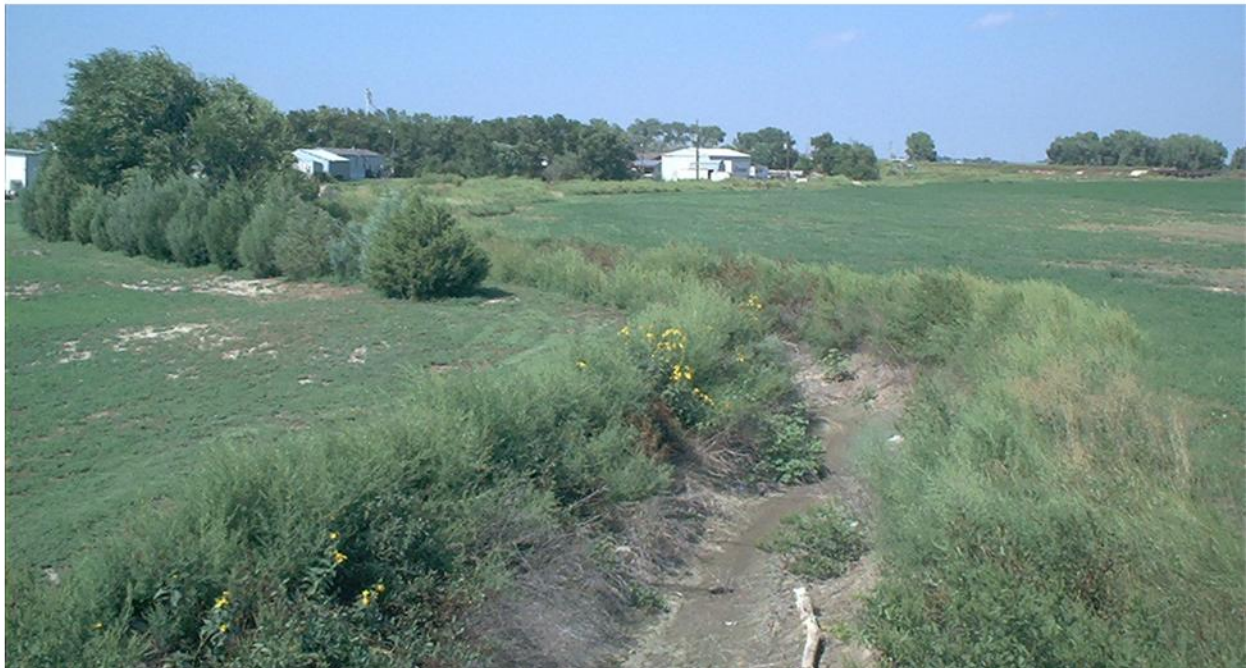
Here we encounter another unique problem with drainage in the valley. This has to do with the encroachment of housing subdivisions onto drainage easements. There is generally no bylaw or rule of thumb pertaining to drainage easements in these districts. Subdivision encroachment does not happen frequently, but when it does, it can cause problems for maintenance. Channel dredging activities are hindered by back yard fences and other obstructions. In addition, due to the fact that these open drains can carry storm flows and irrigation return flows as well as drainage effluent, there is the possibility that damage from flooding can occur to homes located near these drains. Flooding can result from household and landscaping debris being inadvertently thrown into these drainage channels as well. In the future, it will be important that drainage easements are honored, much in the same way that irrigation canal easements should be honored, to ensure that routine maintenance can be conducted on these facilities.

As with the two other Prowers County drainage districts mentioned above, the Kornman Drainage District could be improved with additional tile lines, as well as through the cleaning and/or replacement of older lines. A demonstration of jet cleaning of one of the tile lines in the district, conducted for the study by the City of Lamar, showed some of the benefits of cleaning existing lines. Additional manholes may need to be installed to continue the cleaning process up the line.

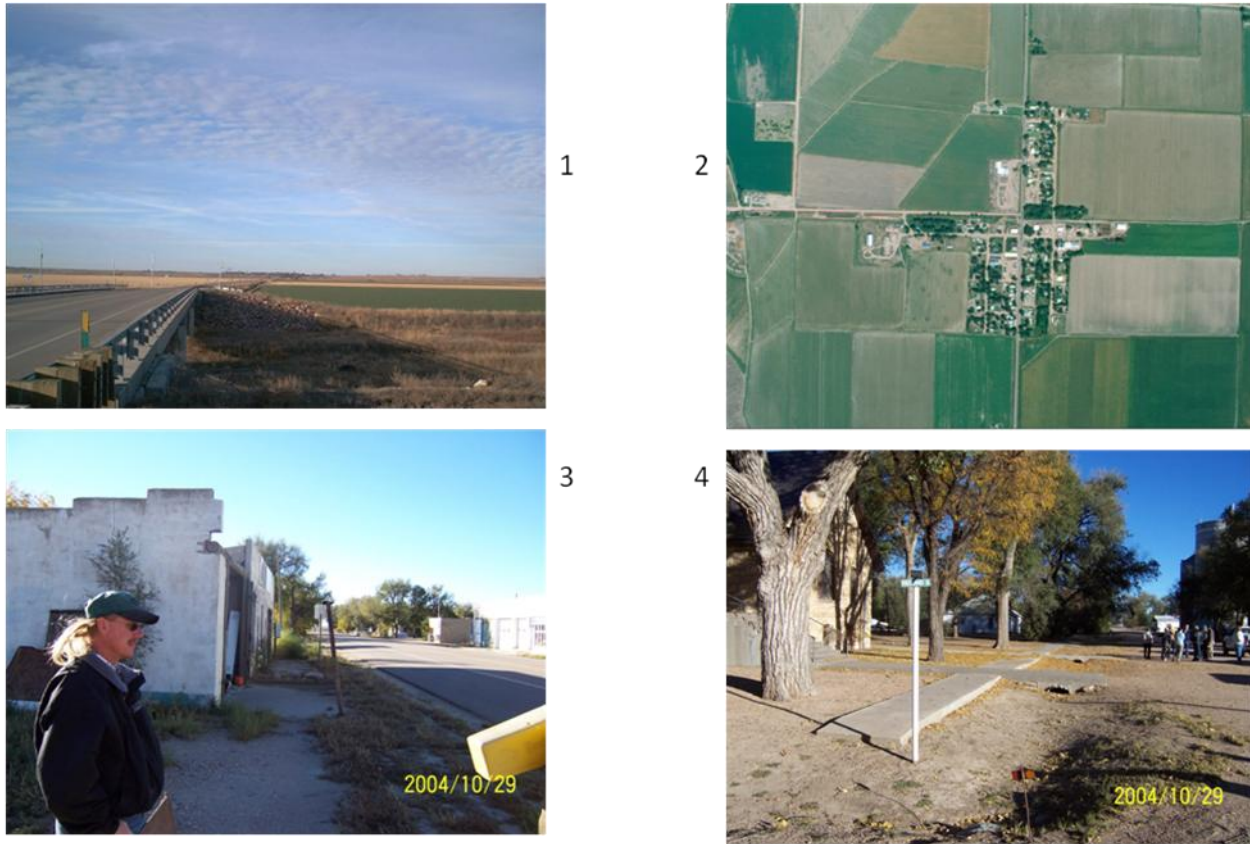
Bristol, Colorado – (1) View (north) of Bristol from Highway 50; (2) Bird’s eye view of Bristol on irrigated bench lands; (3) Previous flooding in Bristol destroyed downtown; (4) Silted up drainage system in Bristol.
