Platoro's Crest of the Dam Project Summation

October 30, 2012

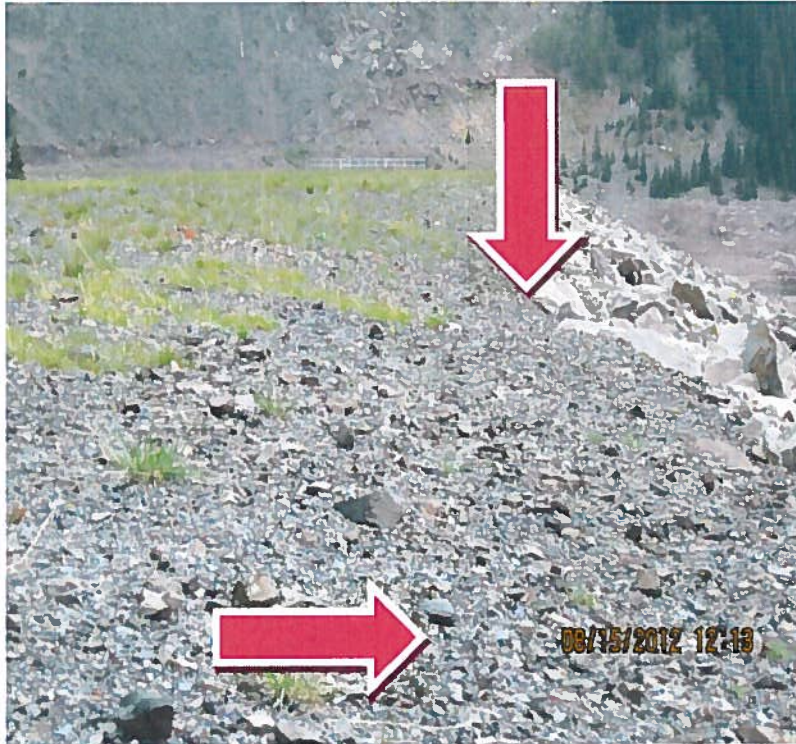
This picture shows the “sloughing” of the edges and the rounding effect of the rock settling, this exposes the small rock to wind erosion that could ultimately expose the core.

In order to maintain the integrity of the Platoro dam during high water and flooding events, the Crest of the dam was re-rocked and graded. The rock, gravel, and grading are what protects the impermeable center "core" of the dam during high water and possible flooding events. It is necessary to maintain this area of the dam so as not to incur operational restrictions to either capacity or day to day operations because of safety concerns.

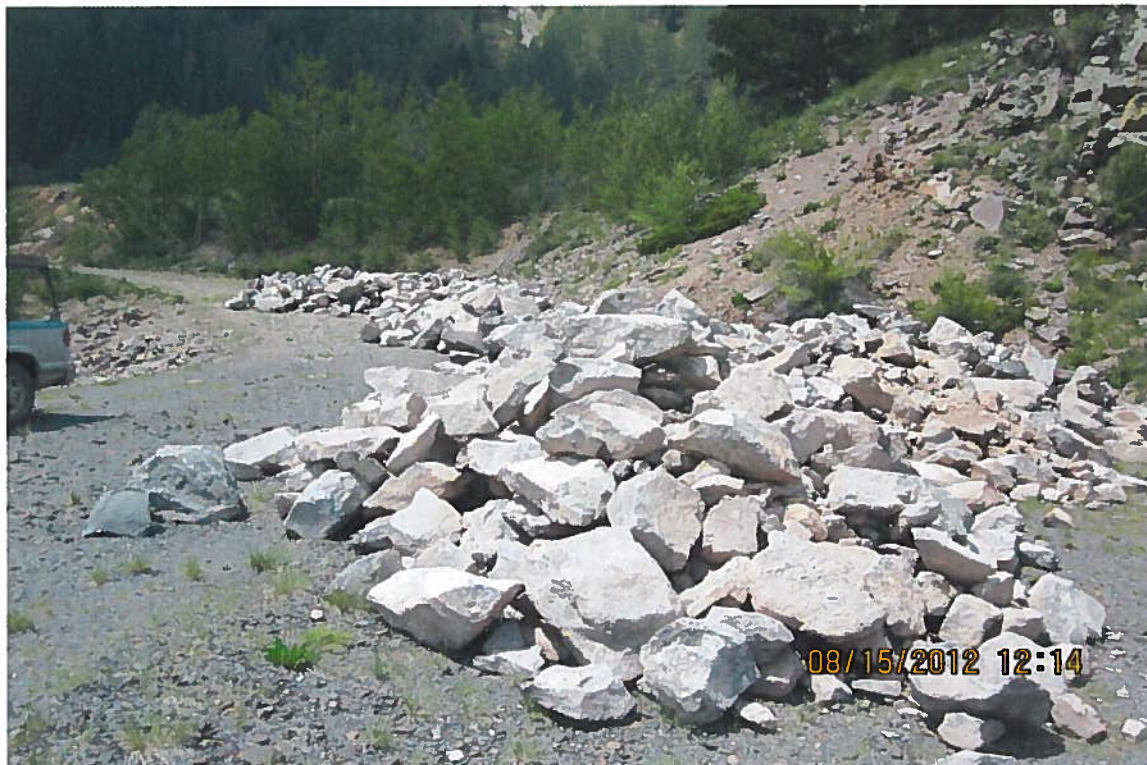
The rock was stockpiled for as needed use along the crest of the dam

Each Rock was placed individually by the excavator. It was a very time intensive job.

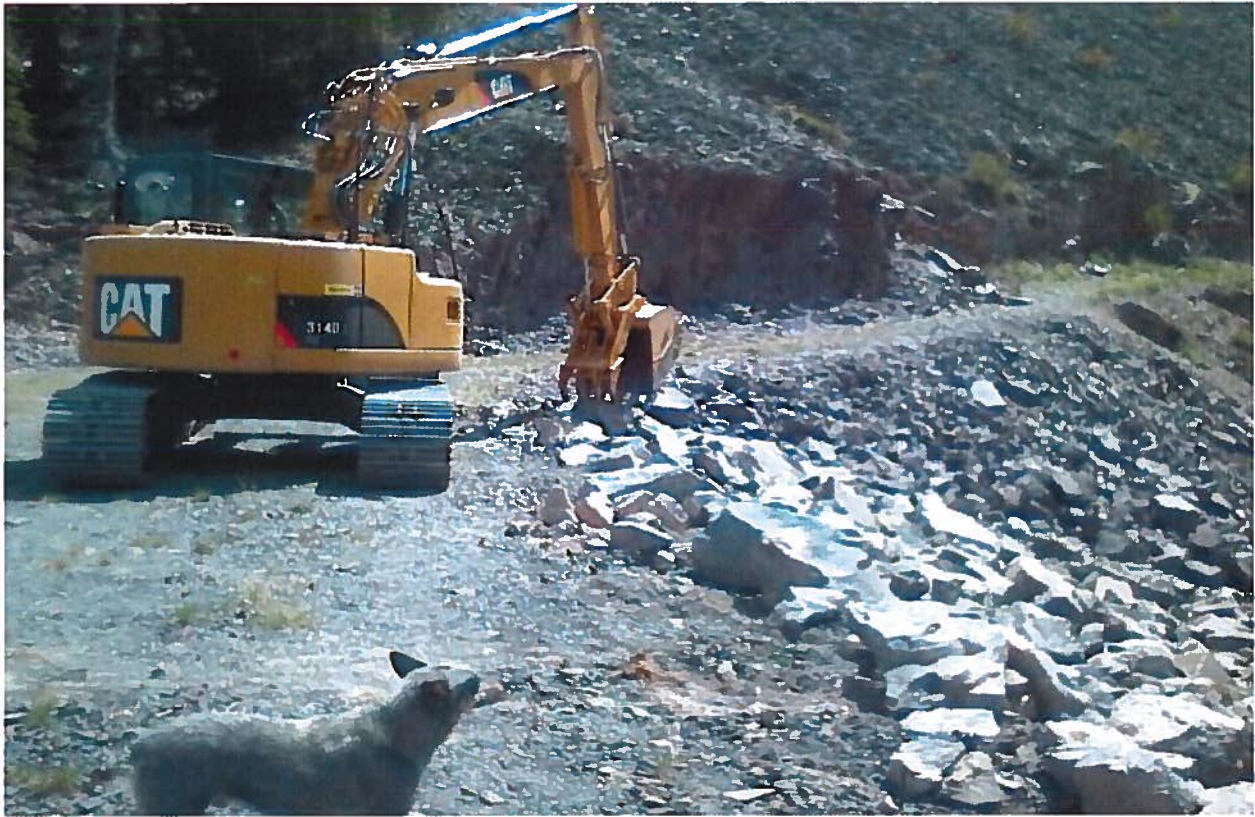
This picture shows the rock placement before the final gravel and grading.

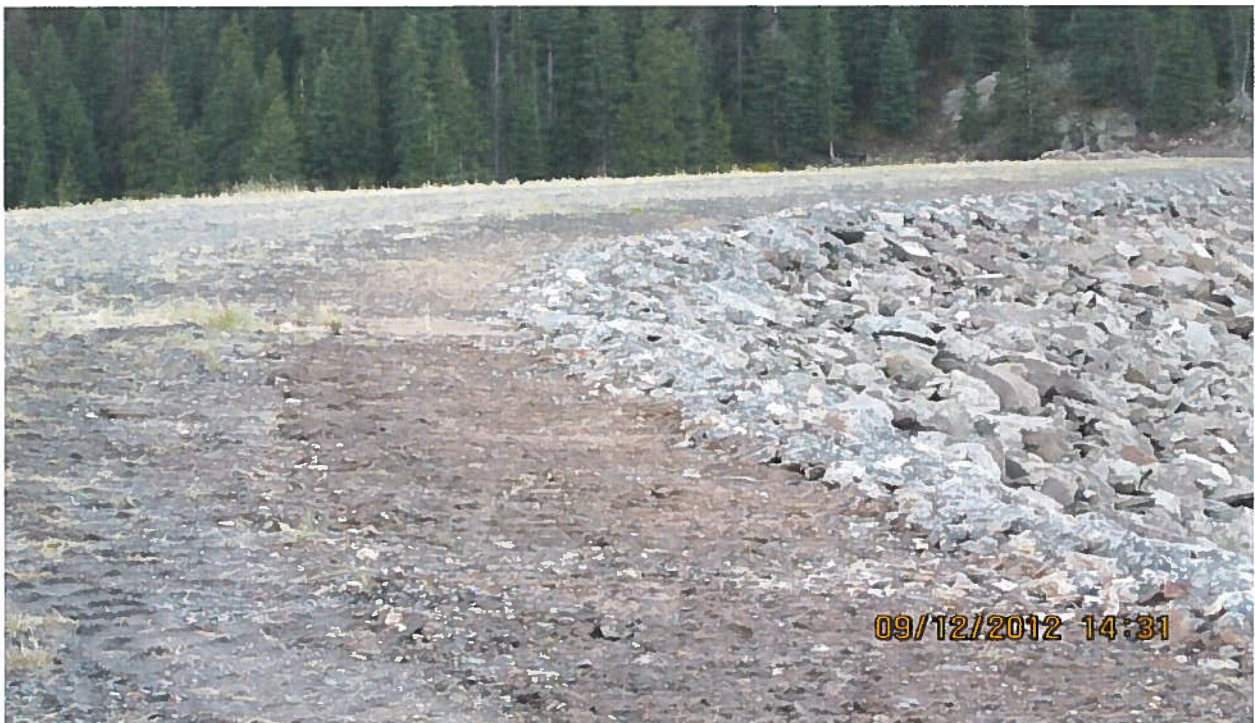
This is after the final gravel and grading. Notice the orange outline, this is a survey settlement point for the dam.

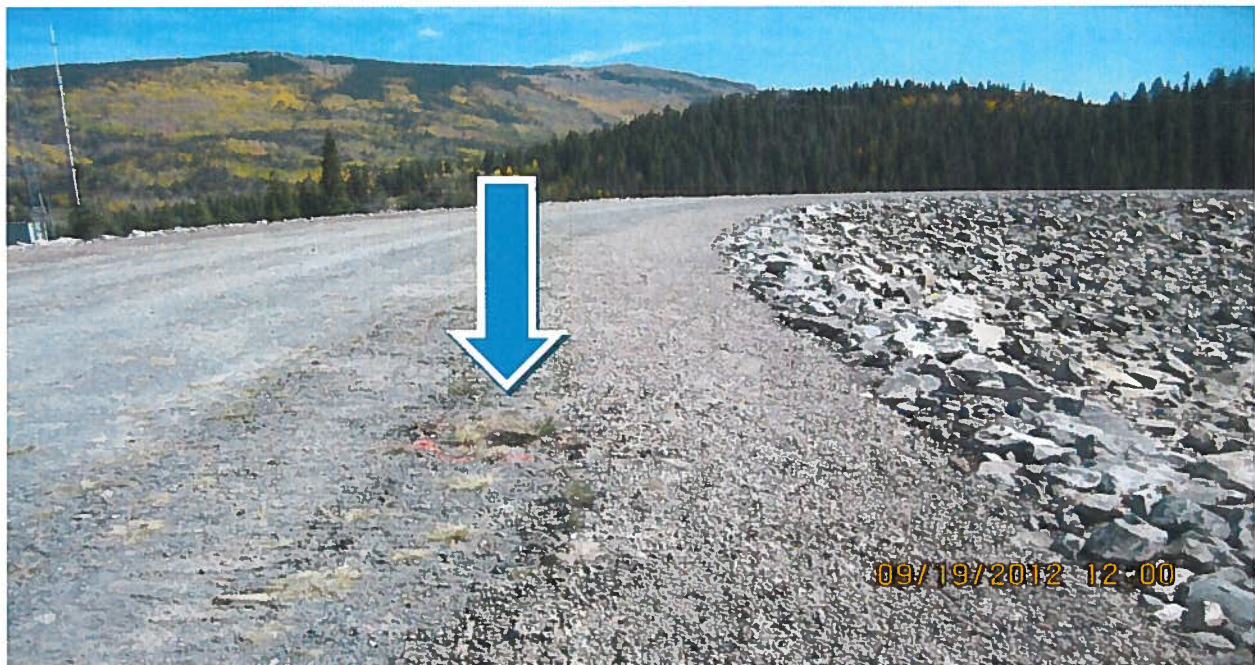
The arrow in the final picture demonstrates the "square" edges of the crest.

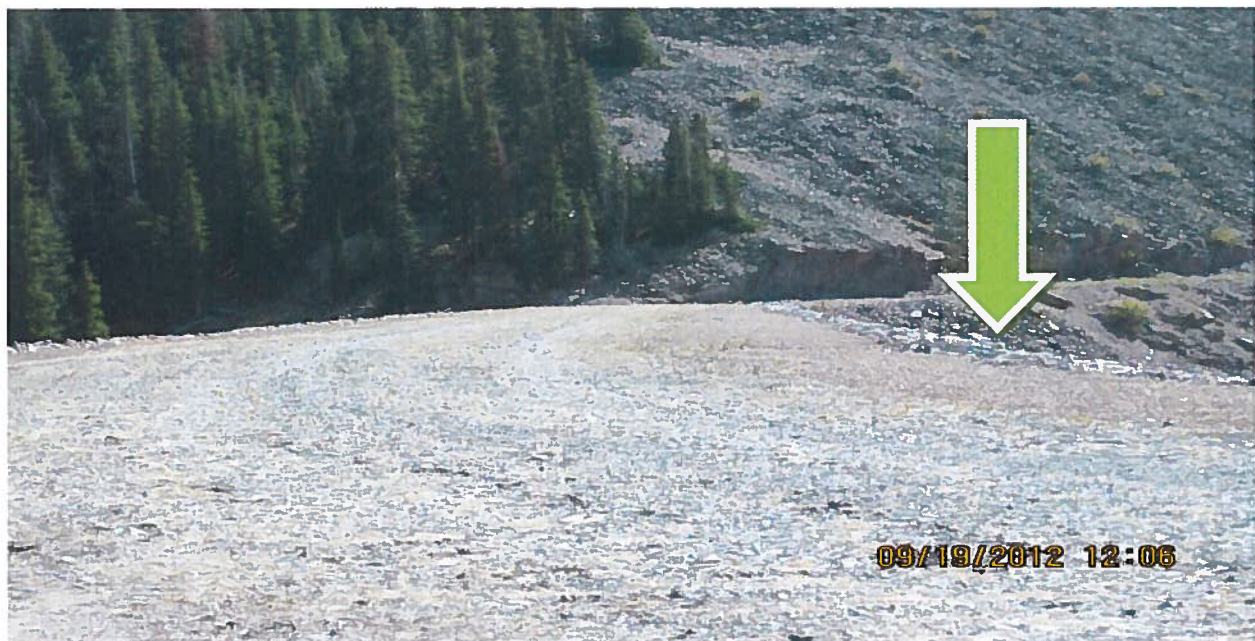
This is what the final project looks like. It is very clean, precise, and exactly what we were expecting.
