2008 Rio Grande Riparian Stabilization Project – Phase 3

Final Report, December 2012

Colorado Rio Grande
Restoration Foundation

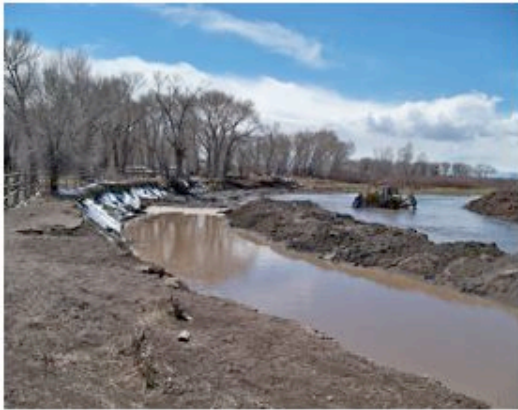
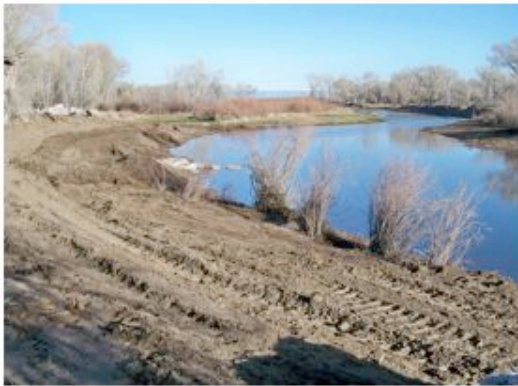
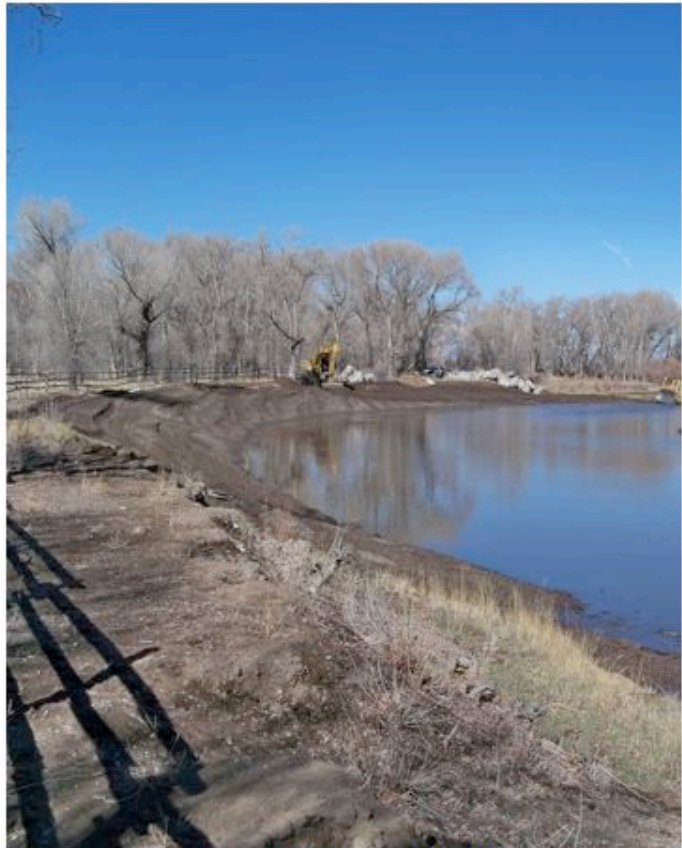
Figure 4. Streambank Stabilization Techniques, Utilized on Woodard Site.

Channel and Streambank Shaping.

Rock Barb Installation and Clump Willow Plantings.

Streambank Shaping and Topsoiling.

Task 1 – Streambank Stabilization: The RGHRP hired third party engineering firm, Riverbend Engineering, and restoration contractors, SLV Earthmovers, to design and implement streambank stabilization methods on 1.8 miles of riparian area. The methods utilized included sloping and shaping banks, building floodplain benches, reconfiguring the channel to move the thalweg away from the bank, and installing rock barbs to move water away from and stabilize the streambanks. Based on erosion rates calculated in the 2001 Study, the estimated reduction in sediment loading from these efforts is 16,750 cubic feet per year. These efforts resulted in improved water quality, reduced erosion, increased sediment transport capacity, increased quality of riparian areas and habitat, and proper functioning floodplains.

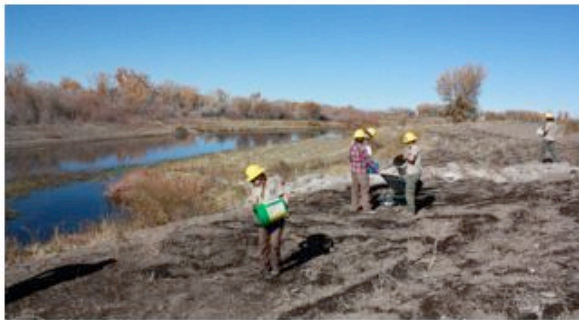
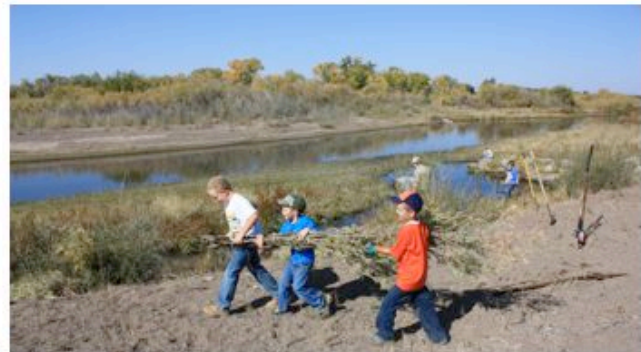
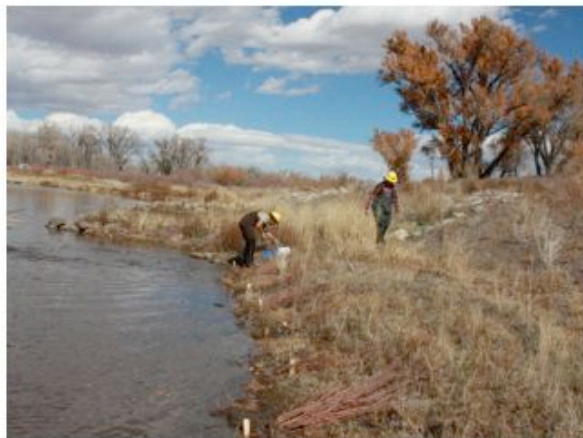
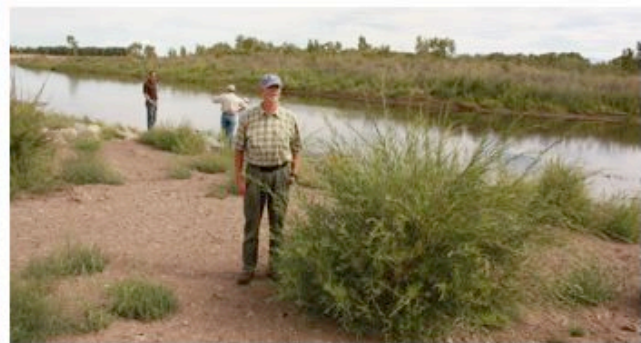
Figure 5. Bioengineering Methods.

Boy Scouts Planting Willow Bundles During Volunteer Day.

Southwest Conservation Corps Spreading Compost (top) on Sites with Low Organic Matter and Planting Willow Bundles (bottom).

Successful Willow Clump Planting at Russell Site.

Task 2 – Bioengineering: The RGHRP hired Riverbend Engineering and SLV Earthmovers to design and implement bioengineering techniques in order to further stabilize the streambanks following construction in Task 1. Techniques used in the riparian areas included, willow clump plantings, and grass and forb seeding. Upland areas disturbed during onsite activities were reseeded with appropriate species. The RGHRP organized 3 volunteer revegetation events: in October 2010, 21 volunteers from the community and Sargent High School planted 60 willow bundles and 30 sedge clump transplants. In April 2011, 8 volunteers planted 360 bareroot shrubs and trees purchased from the Colorado State Forest Service. In September 2012, 51 volunteers from the Alamosa Boy Scouts planted 50 willow bundles. In 2012, it was noted that revegetation was low in sandy areas with low organic matter near the streambanks. As such, a crew of 9 from the Southwest Conservation Corps was hired for two weeks in October 2012 to spread 38 tons of compost and reseed 7 acres of streambanks. The crew also planted 290 willow bundles in the Phase 3 Project Area.

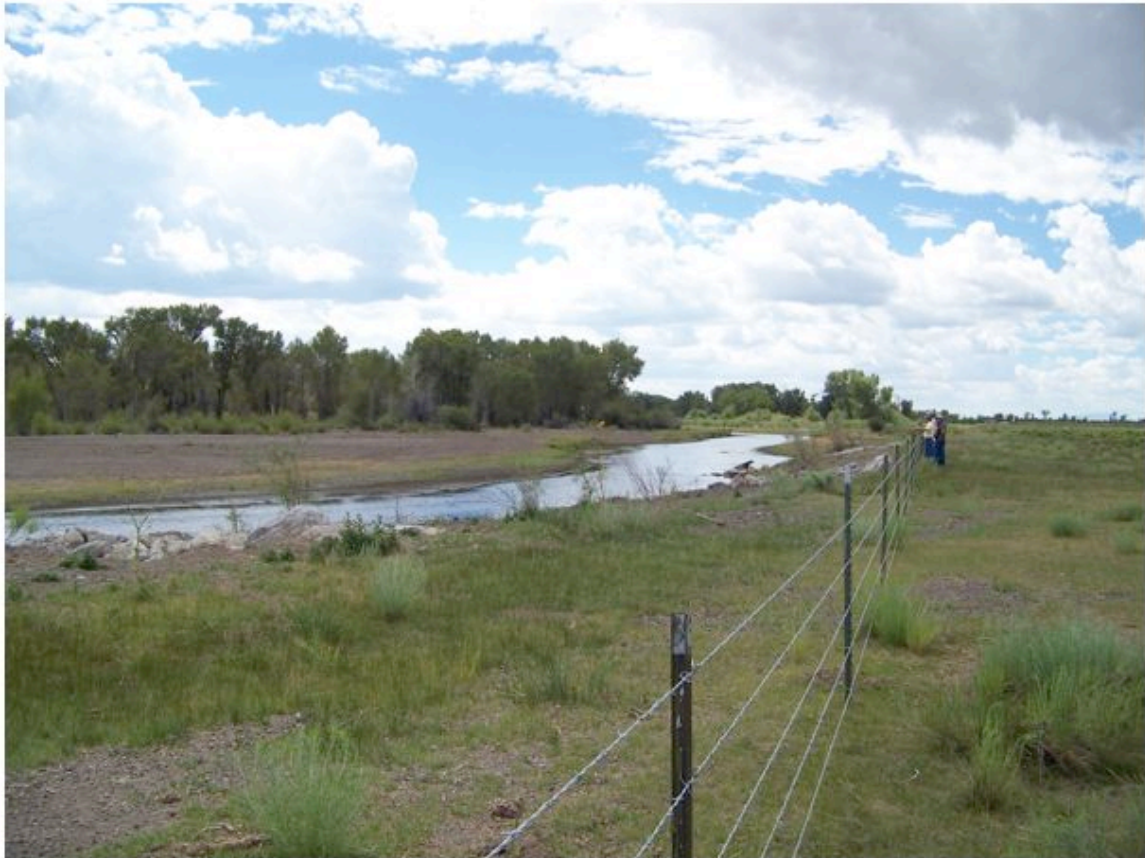
Figure 6. Grazing Best Management Practice, Fencing, Implemented at Gilmore Site.

Task 3 – Grazing Management: The landowners on three of the five restoration sites graze livestock on their property. These landowners protected the riparian area from overuse and implemented grazing BMPs, including fencing and short duration grazing rotations. The other two sites are never grazed.

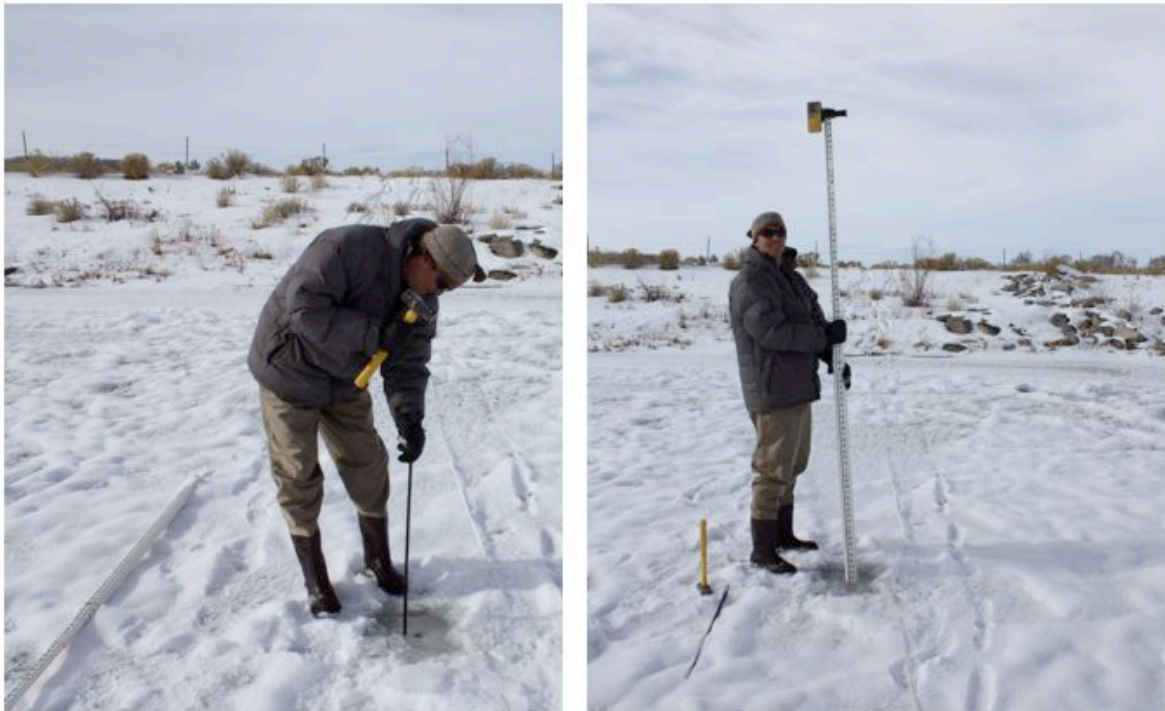
Figure 7. Monitoring Cross Section at Gilmore Site.

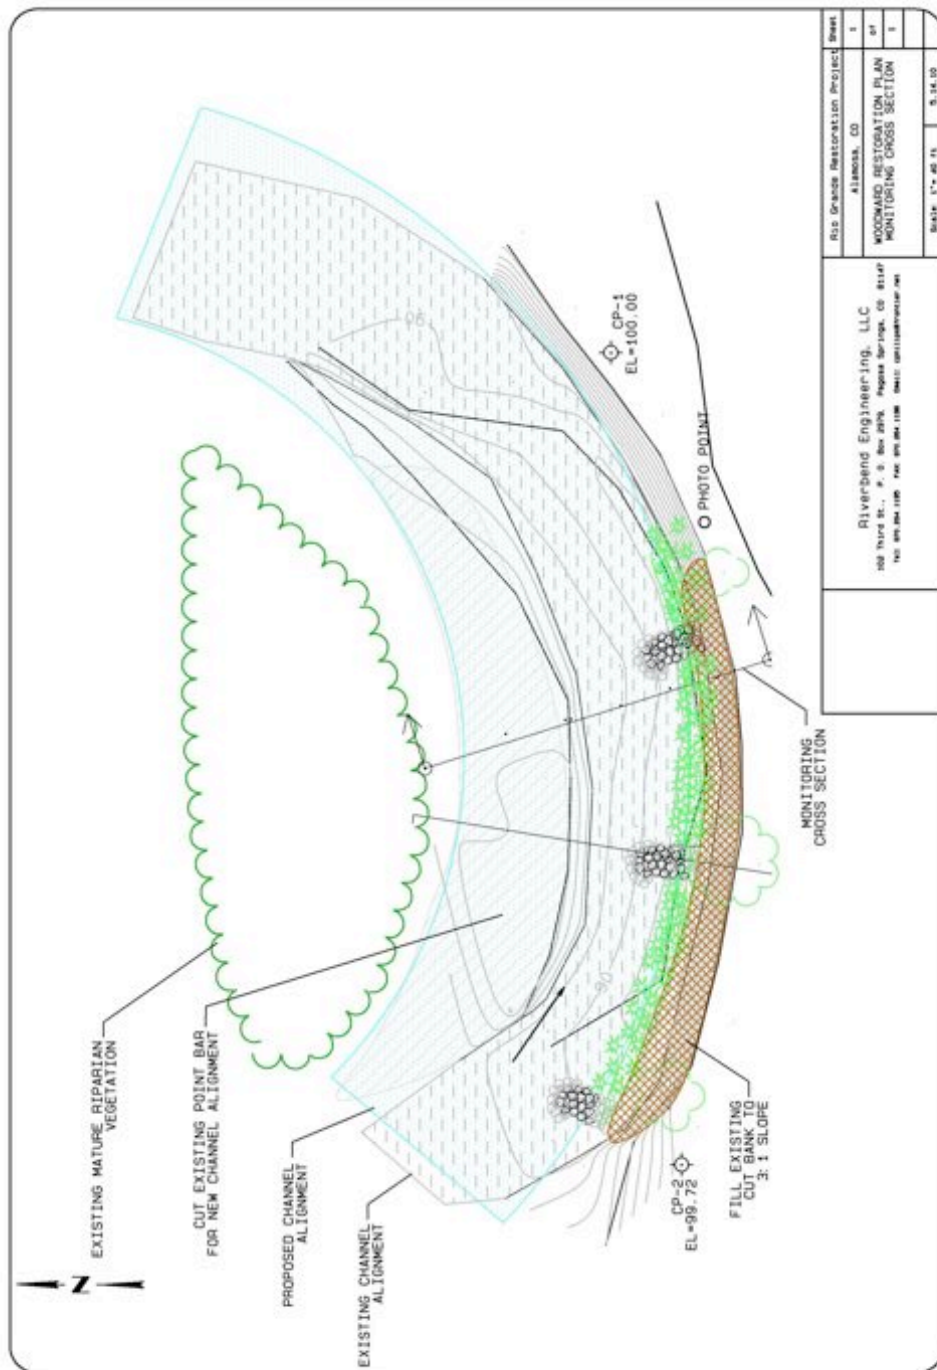
Figure 10. Woodard Site Design, Cross Section Location, and Photopoint Location.

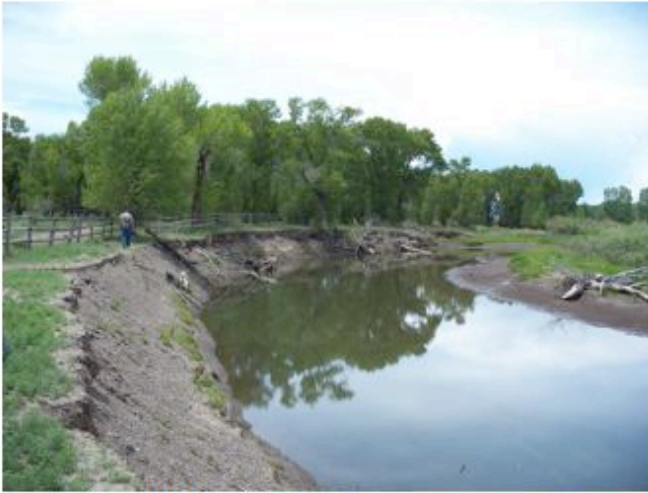
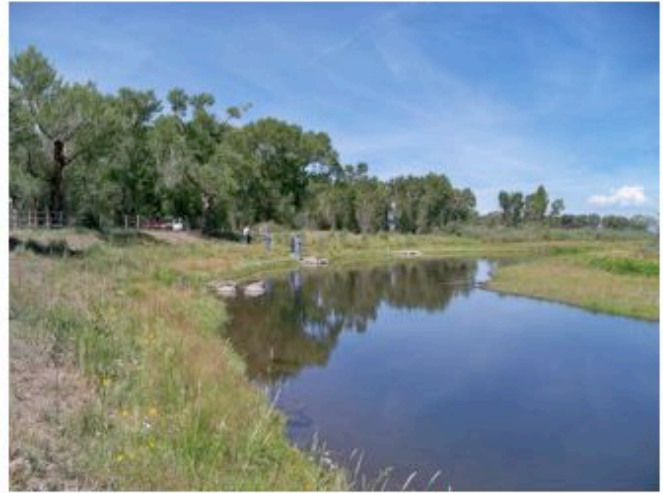
Figure 11. Woodard Site Photos Before and After Construction.

Before - June 2009

After - August 2012

Table 3. Woodard Stream Visual Assessment Scores		
Assessment Category	Preconstruction May-11	2012 Monitoring August-12
Channel Condition	1	10
Hydrologic Alteration	1	7
Riparian Zone	3	10
Bank Stability	1	9
Water Appearance	6	10
Nutrient Enrichment	7	7
Barriers to Fish Movement	10	10
Instream Fish Cover	3	5
Pools	6	3
Invertebrate Habitat	3	4
Canopy Cover	1	1
Manure Presence	5	5
Salinity	N/A	N/A
Riffle Embeddedness	3	5
Macroinvertebrates Observed	N/A	N/A
Overall Score	3.85	6.62

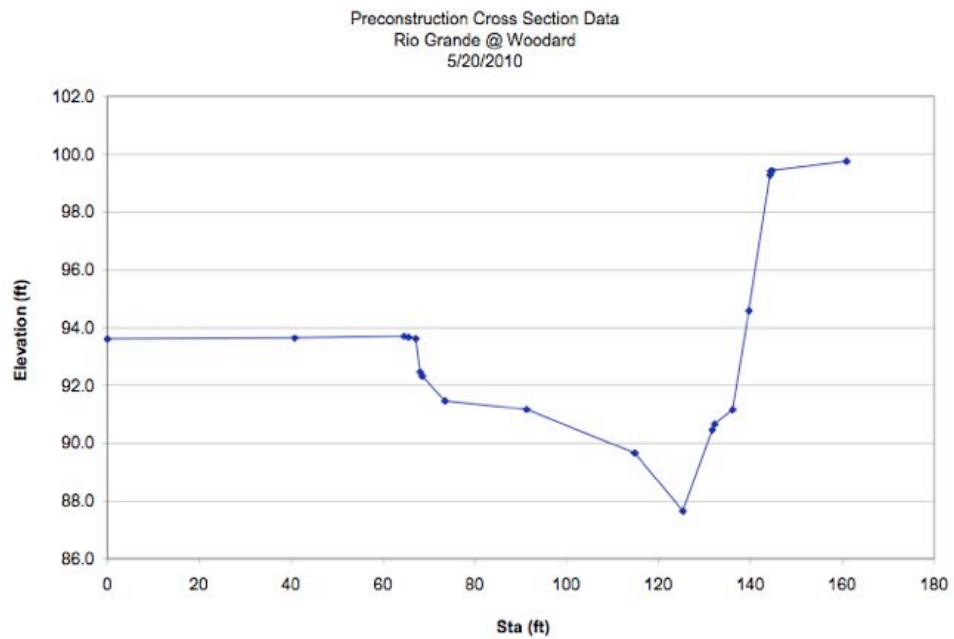
Figure 12. Woodard Site Cross Section Data Before Construction.

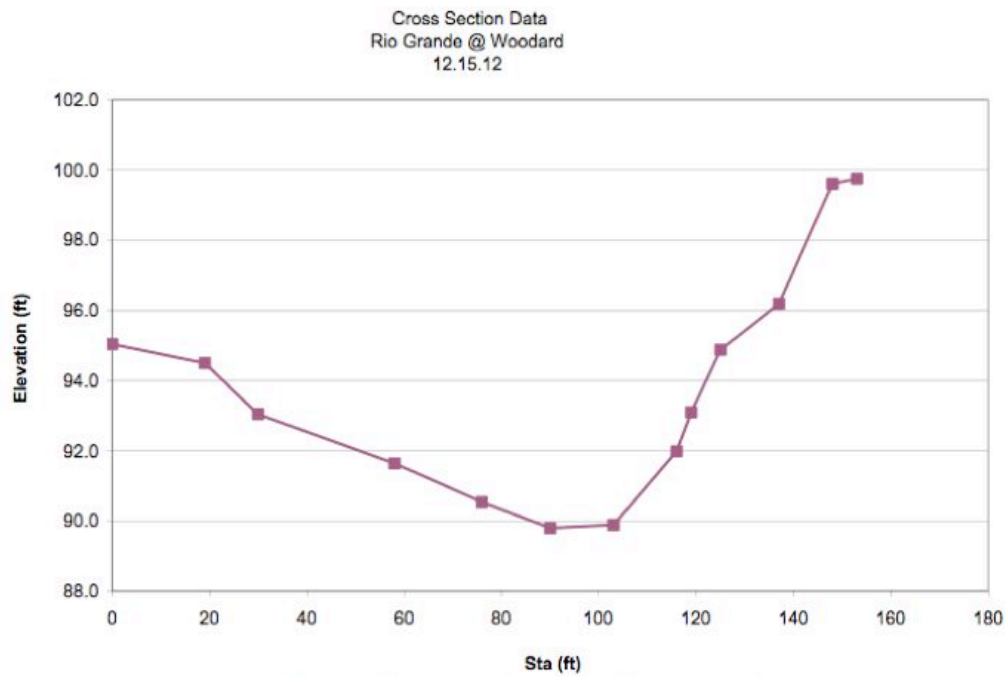
Figure 13. Woodard Site Cross Section Data After Construction.

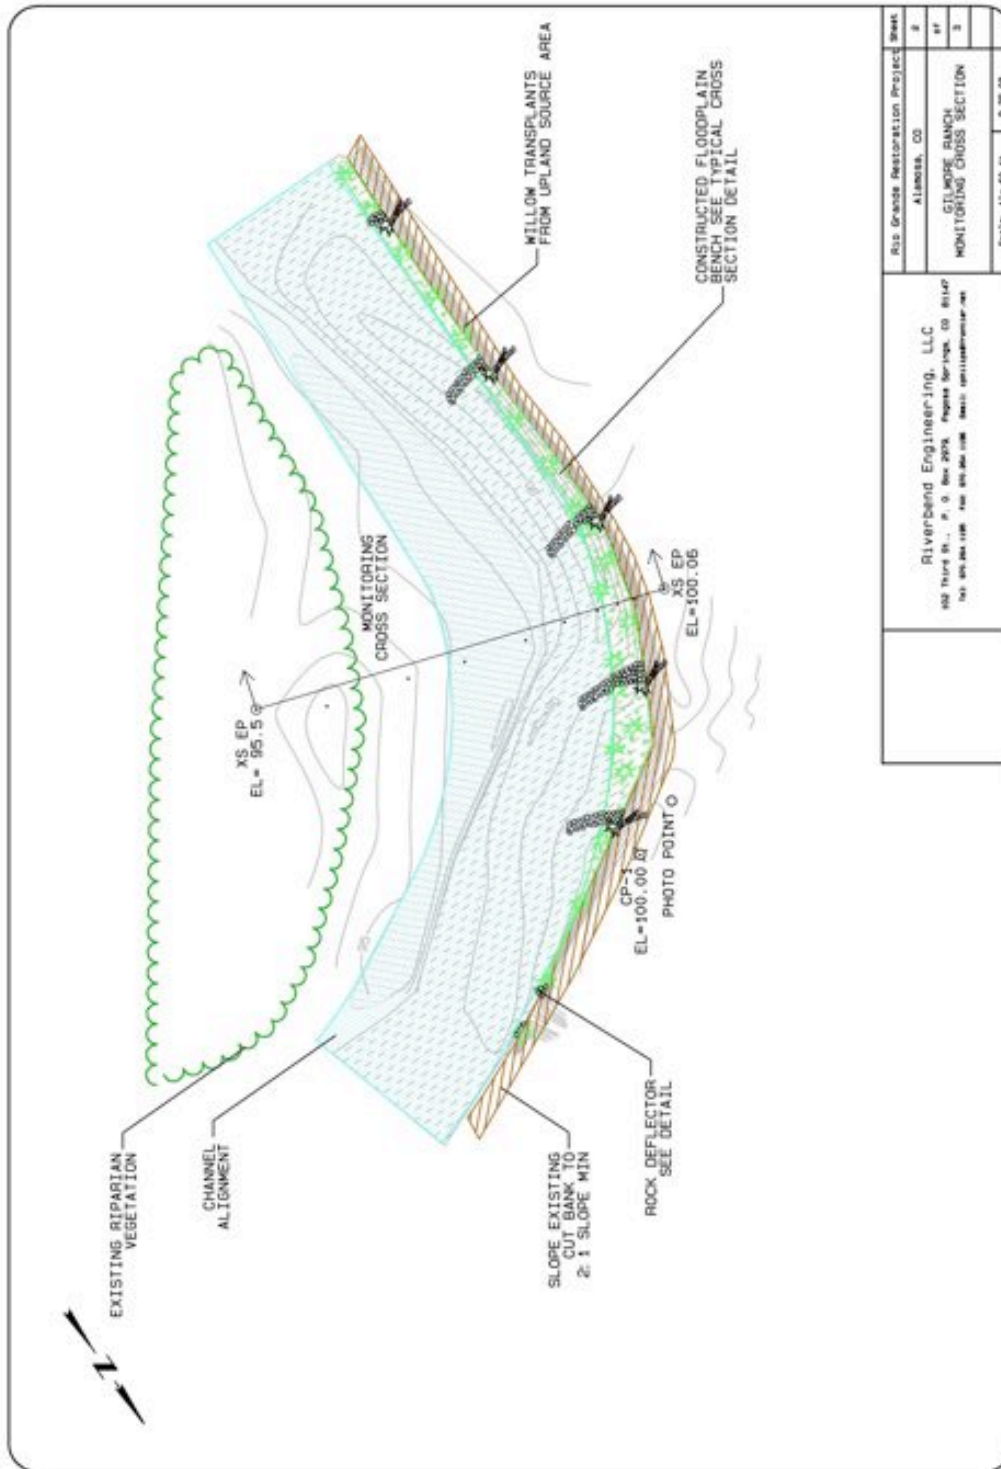
Figure 14. Gilmore Site Design, Cross Section Location, and Photopoint Location.

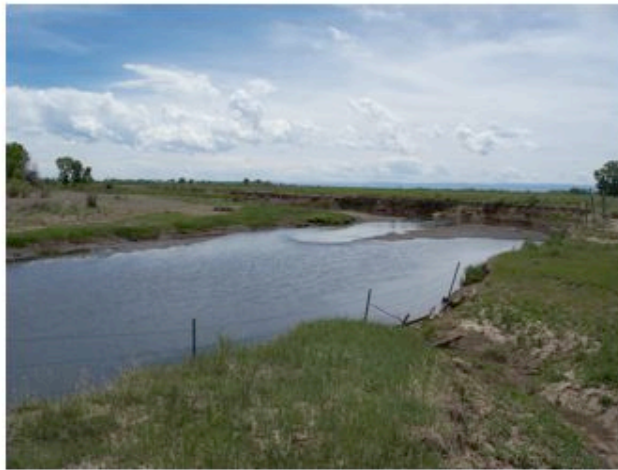
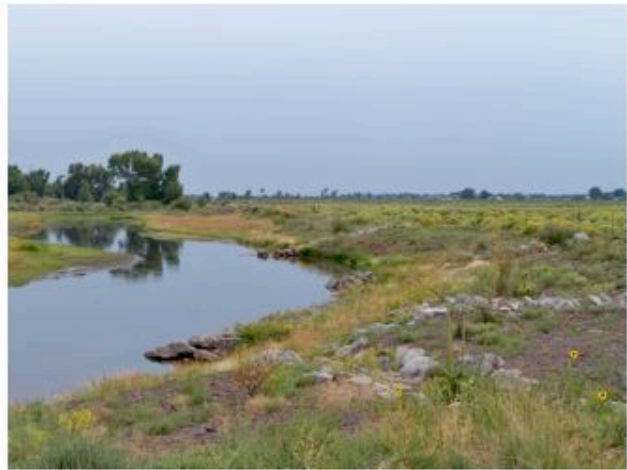
Figure 15. Gilmore Site Photos Before and After Construction.

Before - June 2009

After - August 2012

Table 4. Glimore Stream Visual Assessment Scores		
Assessment Category	Preconstruction March-10	2012 Monitoring August-12
Channel Condition	2	10
Hydrologic Alteration	2	7
Riparian Zone	4	8
Bank Stability	1	9
Water Appearance	7	10
Nutrient Enrichment	7	7
Barriers to Fish Movement	10	10
Instream Fish Cover	3	5
Pools	6	2
Invertebrate Habitat	3	4
Canopy Cover	1	1
Manure Presence	5	5
Salinity	N/A	N/A
Riffle Embedddness	3	5
Macroinvertebrates Observed	N/A	N/A
Overall Score	4.15	6.38

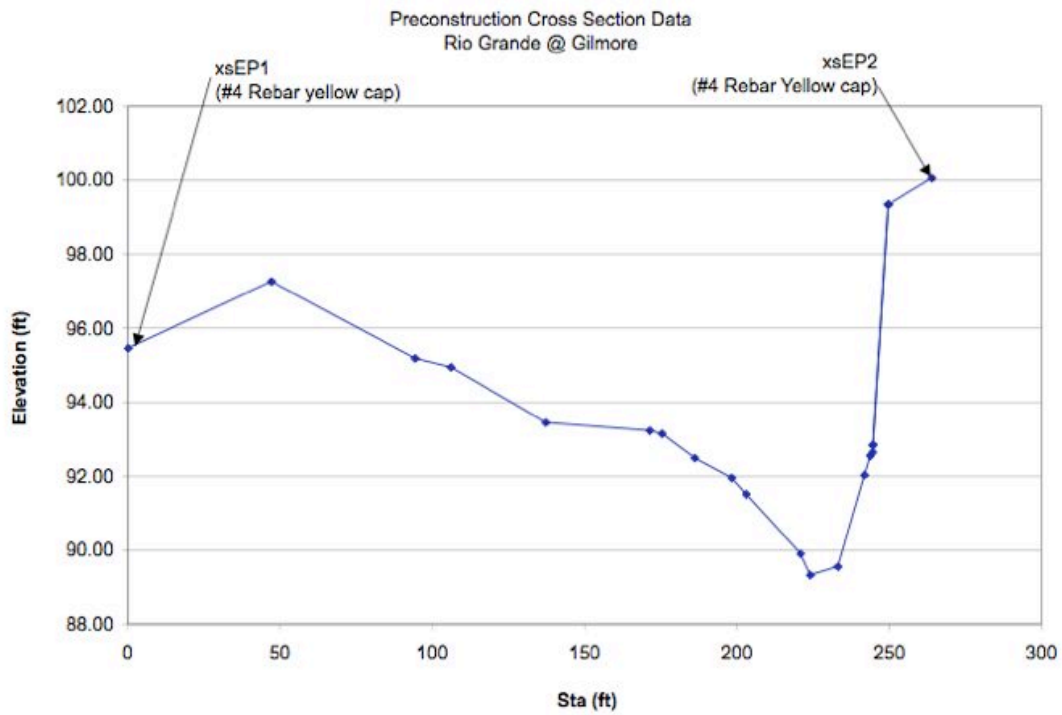
Figure 16. Gilmore Site Cross Section Data Before Construction.

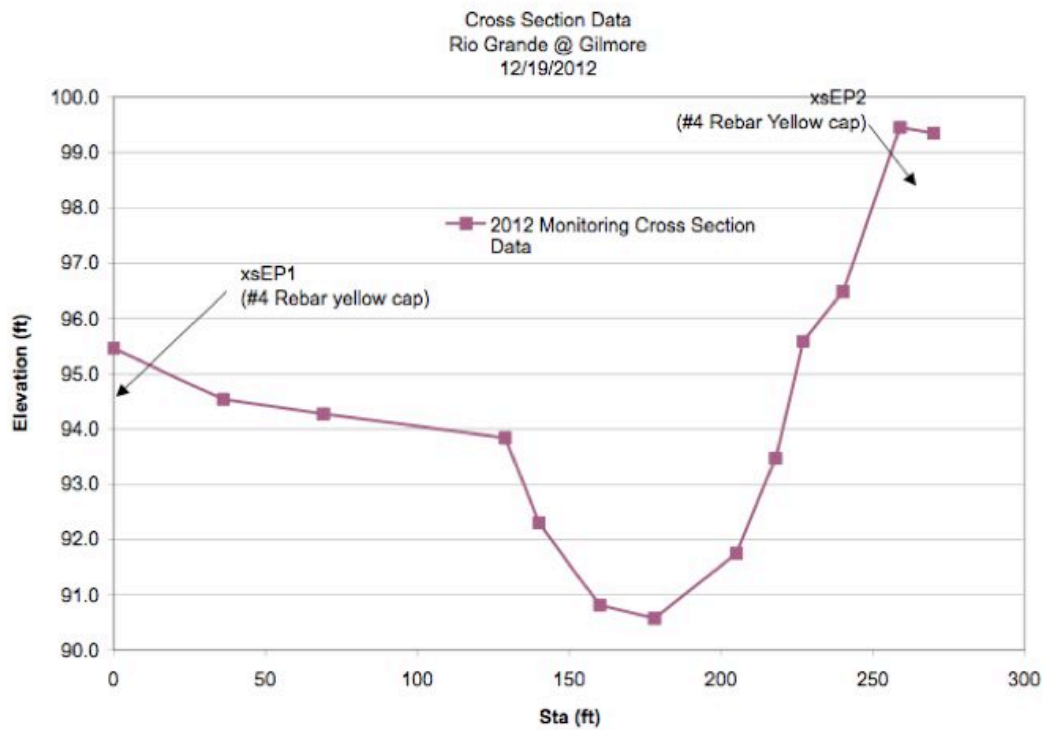
Figure 17. Gilmore Site Cross Section Data After Construction.

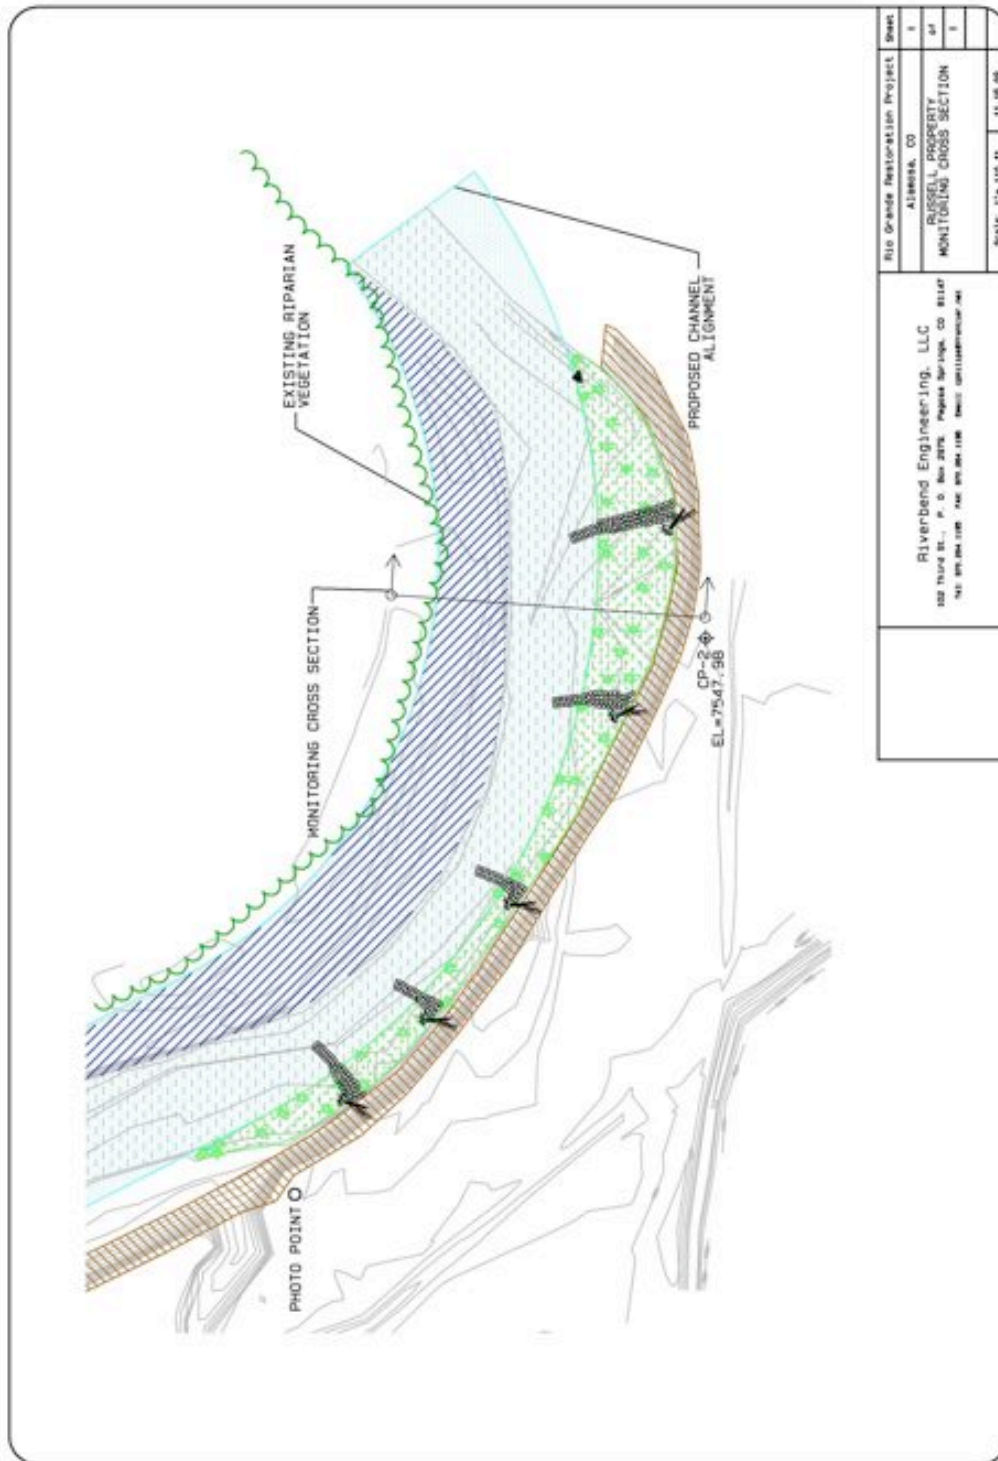
Figure 18. Russell Site Design, Cross Section Location, and Photopoint Location.

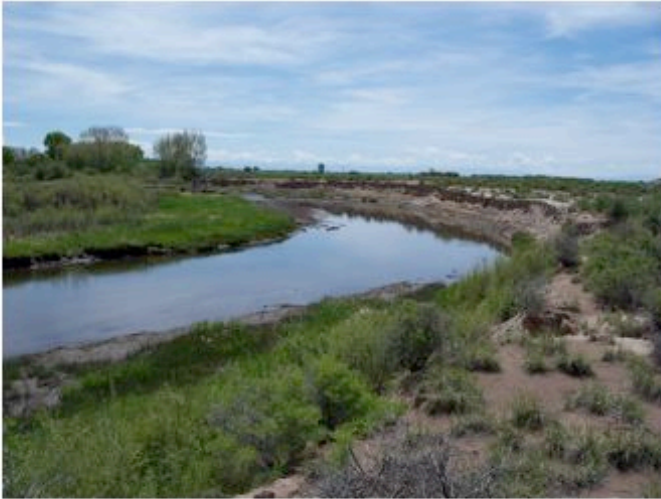
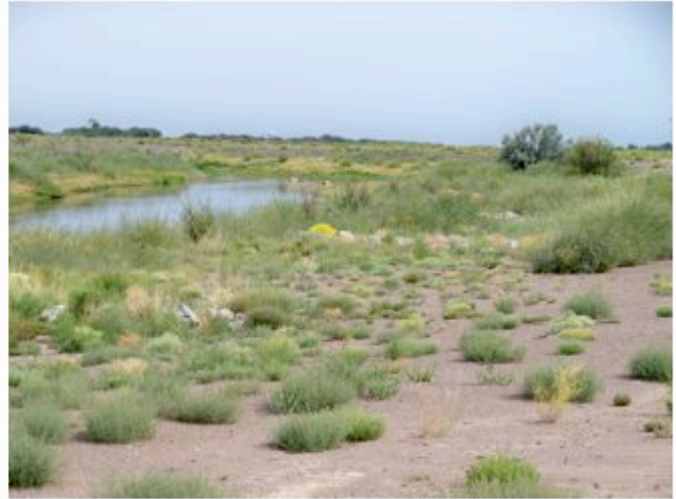
Figure 19. Russell Site Photos Before and After Construction.

Before - June 2009

After - August 2012

Table 5. Russell Stream Visual Assessment Scores		
Assessment Category	Preconstruction March-10	2012 Monitoring August-12
Channel Condition	2	10
Hydrologic Alteration	1	7
Riparian Zone	4	10
Bank Stability	1	9
Water Appearance	7	10
Nutrient Enrichment	8	7
Barriers to Fish Movement	10	10
Instream Fish Cover	3	5
Pools	6	3
Invertebrate Habitat	3	4
Canopy Cover	1	1
Manure Presence	N/A	N/A
Salinity	N/A	N/A
Riffle Embeddness	3	5
Macroinvertebrates Observed	N/A	N/A
Overall Score	4.08	6.75

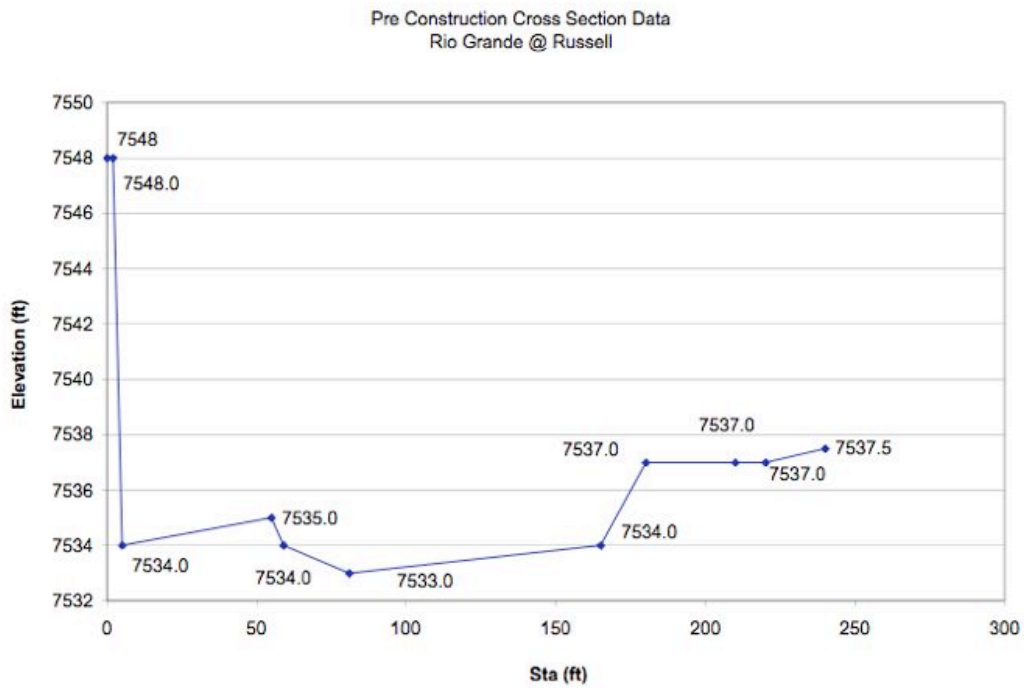
Figure 20. Russell Site Cross Section Data Before Construction.

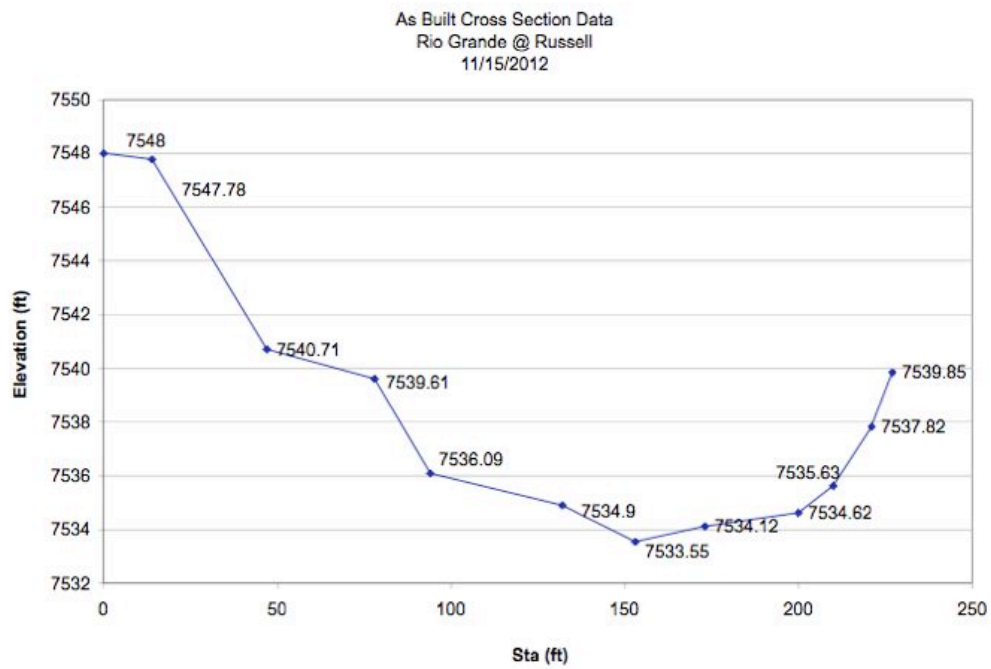
Figure 21. Russell Site Cross Section Data After Construction.

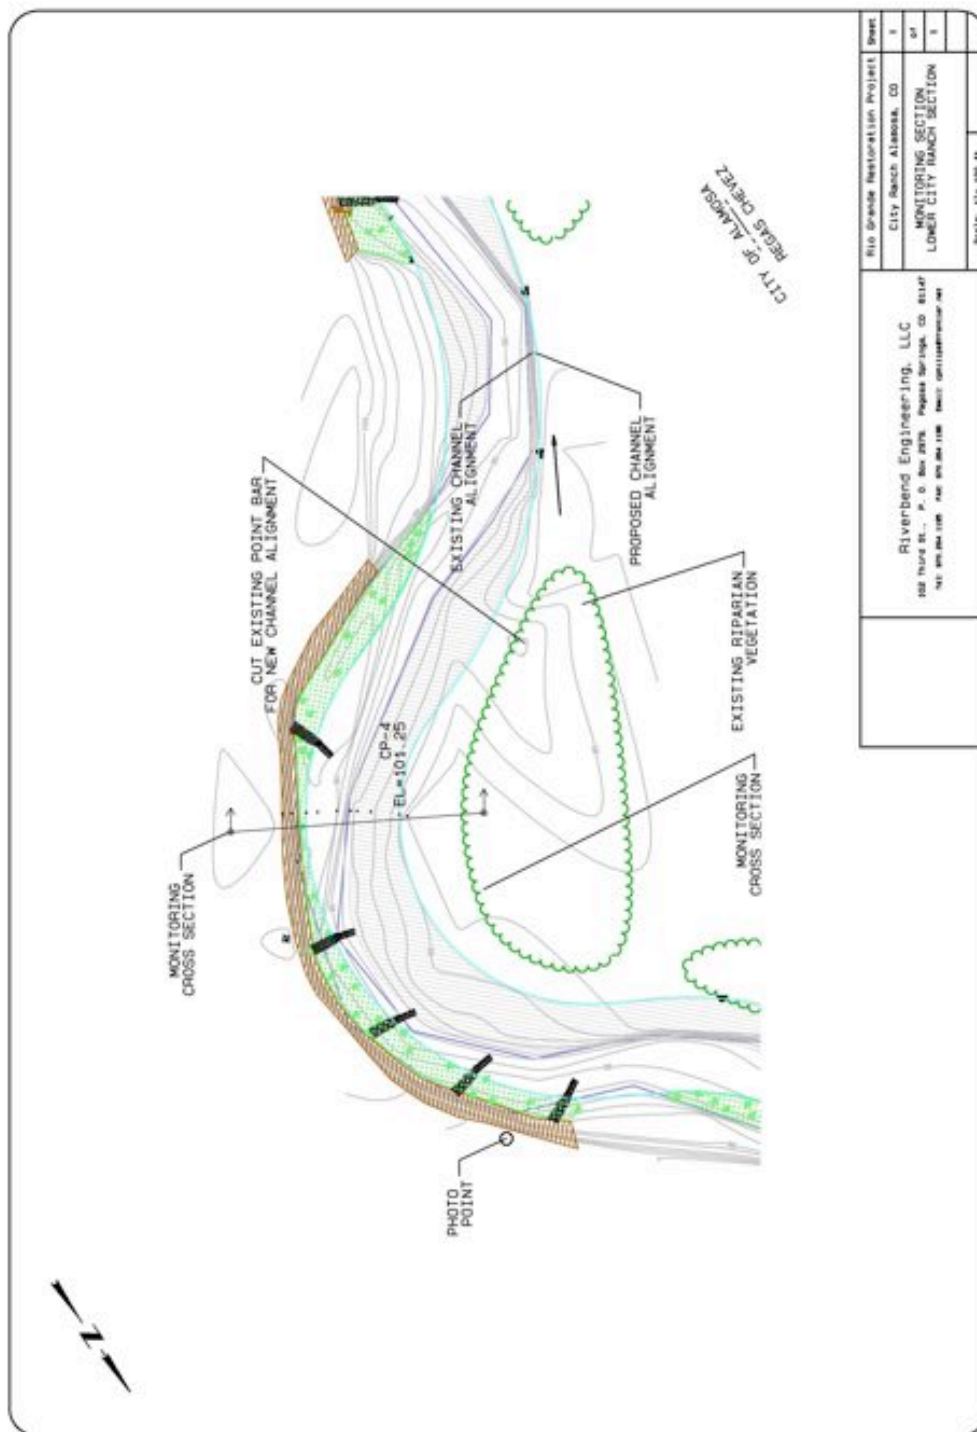
Figure 22. Alamosa City Ranch Site Design, Cross Section Location, and Photopoint Location.

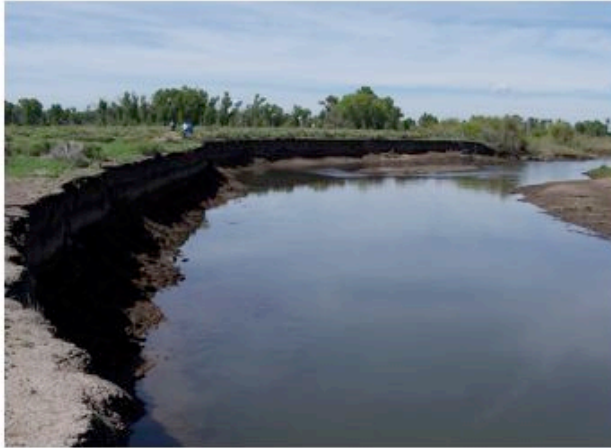
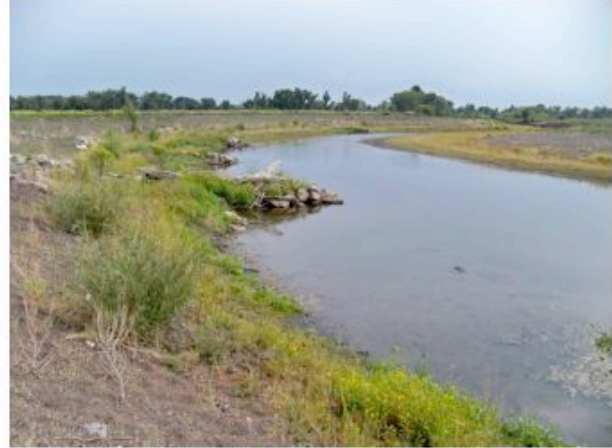
Figure 23. Alamosa City Ranch Site Photos Before and After Construction.

Before - June 2009

After - August 2012

Table 6. Alamosa Ranch Stream Visual Assessment Scores		
Assessment Category	Preconstruction July-10	2012 Monitoring August-12
Channel Condition	1	10
Hydrologic Alteration	1	7
Riparian Zone	3	7
Bank Stability	1	8
Water Appearance	7	10
Nutrient Enrichment	7	8
Barriers to Fish Movement	10	10
Instream Fish Cover	3	5
Pools	5	3
Invertebrate Habitat	3	3
Canopy Cover	1	1
Manure Presence	5	5
Salinity	N/A	N/A
Riffle Embeddedness	3	5
Macroinvertebrates Observed	N/A	N/A
Overall Score	3.85	6.31

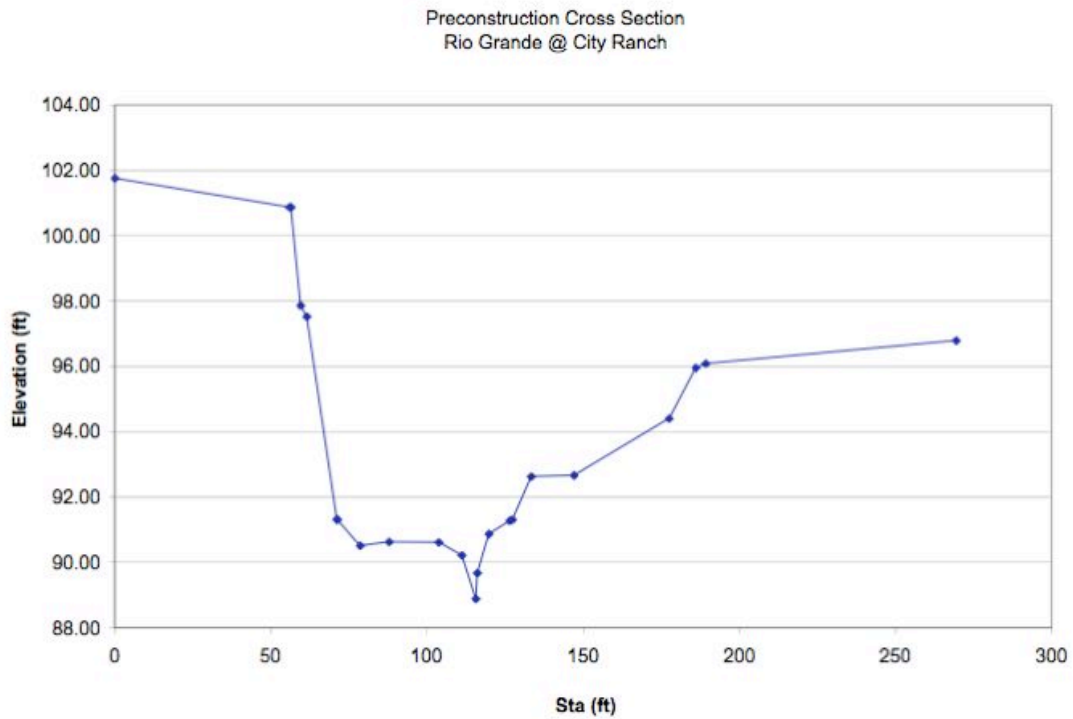
Figure 24. Alamosa City Ranch Site Cross Section Data Before Construction.

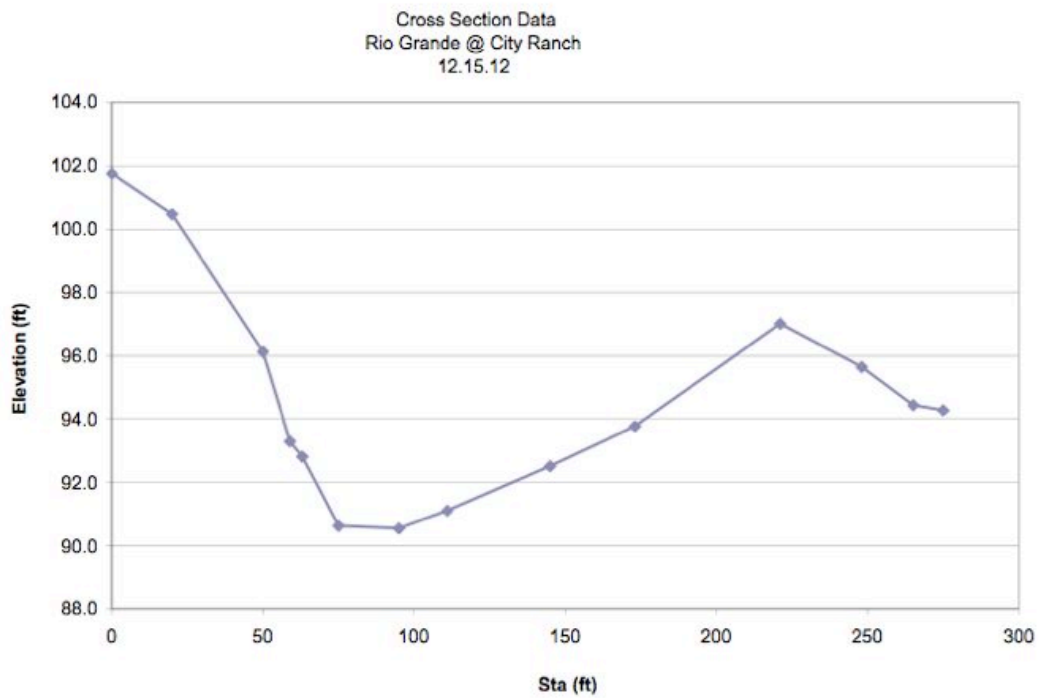
Figure 25. Alamosa City Ranch Site Cross Section Data After Construction.

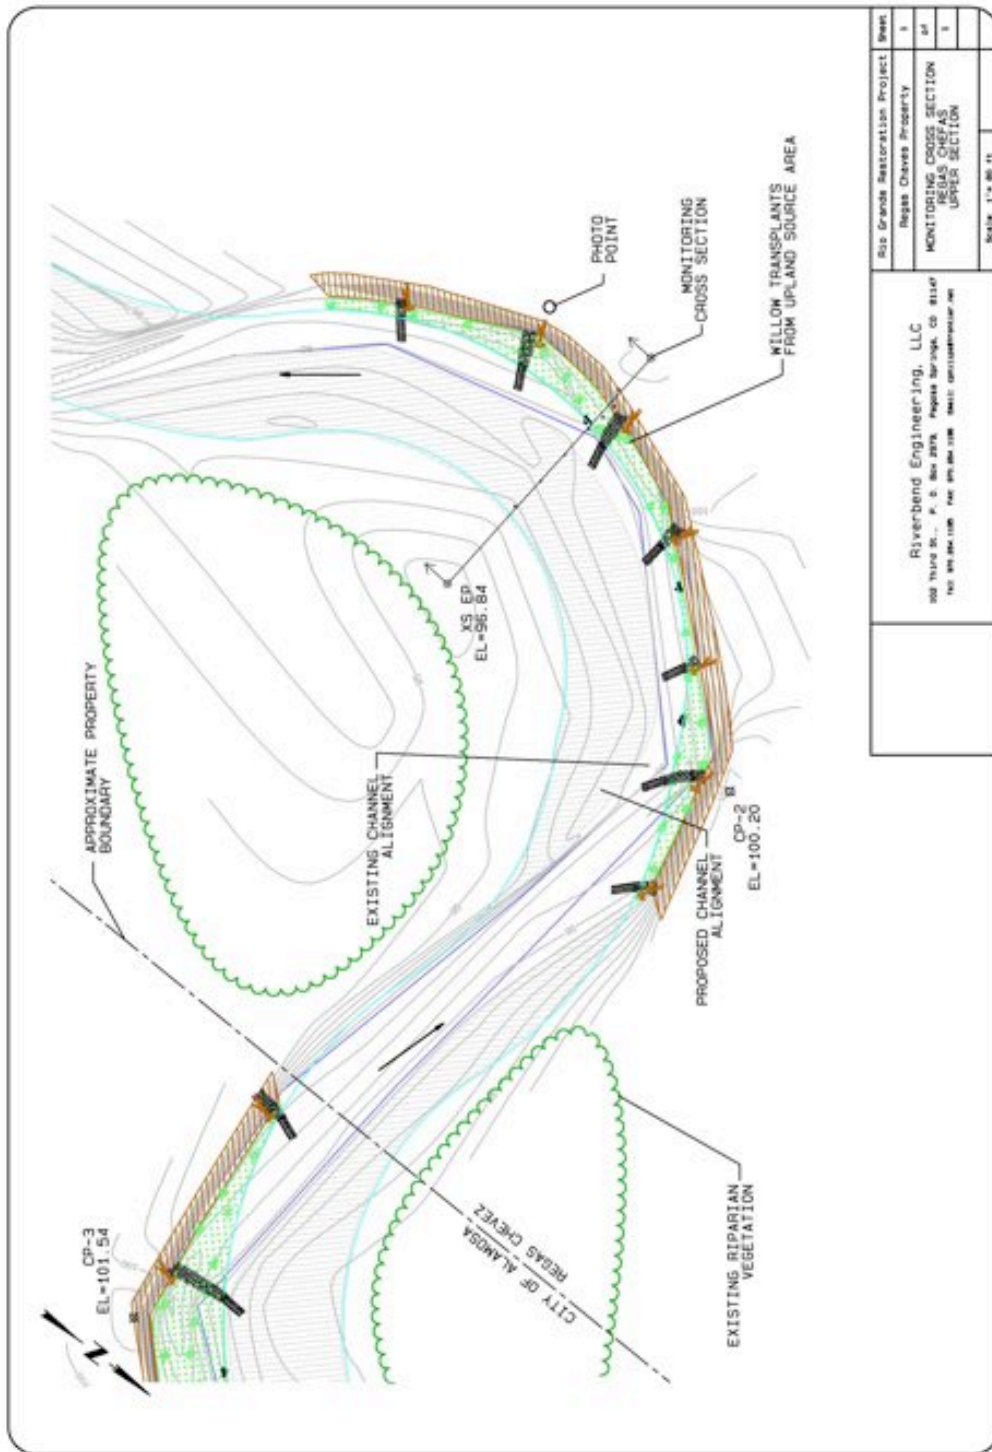
Figure 26. Chefas Site Design, Cross Section Location, and Photopoint Location.

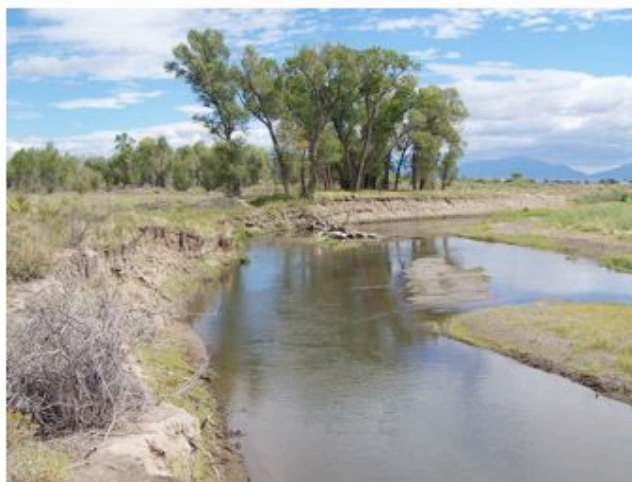
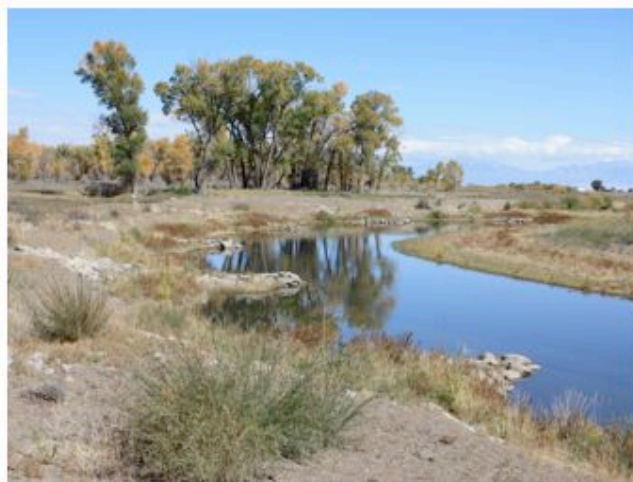
Figure 27. Chefas Site Photos Before and After Construction.

Before - June 2010

After - September 2012

Table 7. Chefas Stream Visual Assessment Scores		
Assessment Category	Preconstruction July-10	2012 Monitoring September-12
Channel Condition	1	10
Hydrologic Alteration	1	7
Riparian Zone	3	8
Bank Stability	1	8
Water Appearance	7	10
Nutrient Enrichment	7	8
Barriers to Fish Movement	10	10
Instream Fish Cover	3	5
Pools	5	3
Invertebrate Habitat	3	3
Canopy Cover	1	1
Manure Presence	N/A	N/A
Salinity	N/A	N/A
Riffle Embeddedness	3	5
Macroinvertebrates Observed	N/A	N/A
Overall Score	3.75	6.50

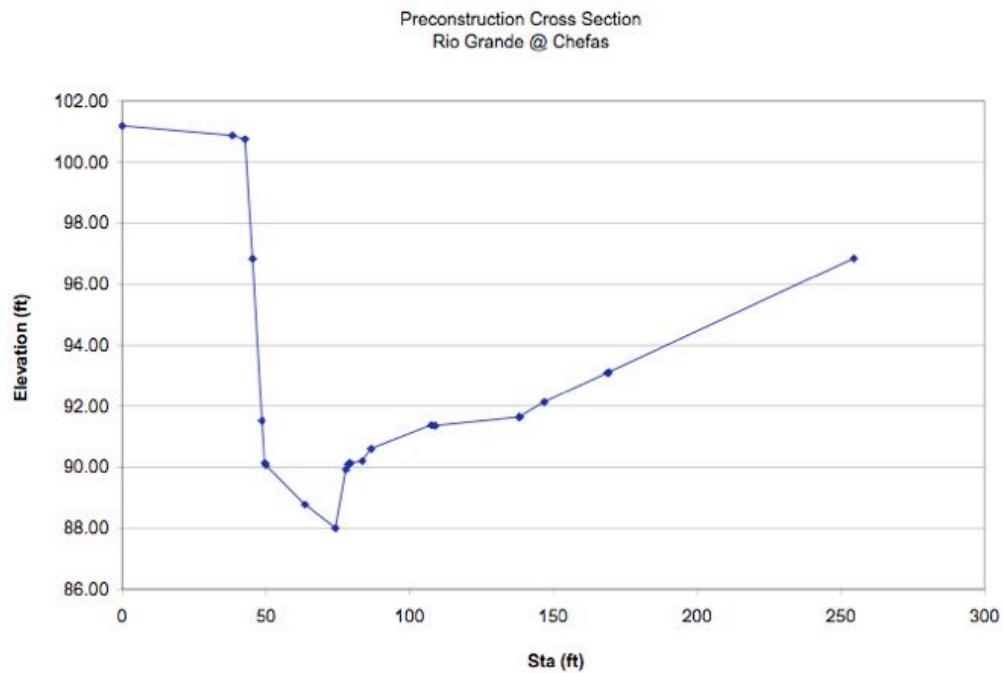
Figure 28. Chéfas Site Cross Section Data Before Construction.

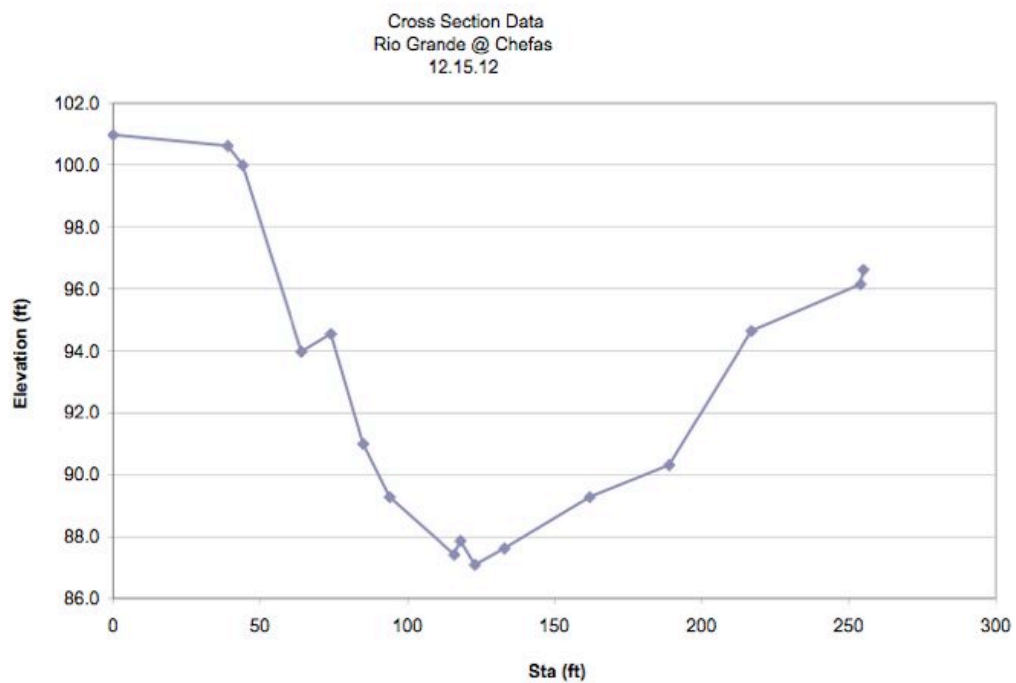
Figure 29. Chéfas Site Cross Section Data After Construction.
