Animas Consolidated Ditch Company and Partners

RE: Final Report for the Animas River Diversion Headgate Monitoring Study

Animas River Diversion Headgate Monitoring Study

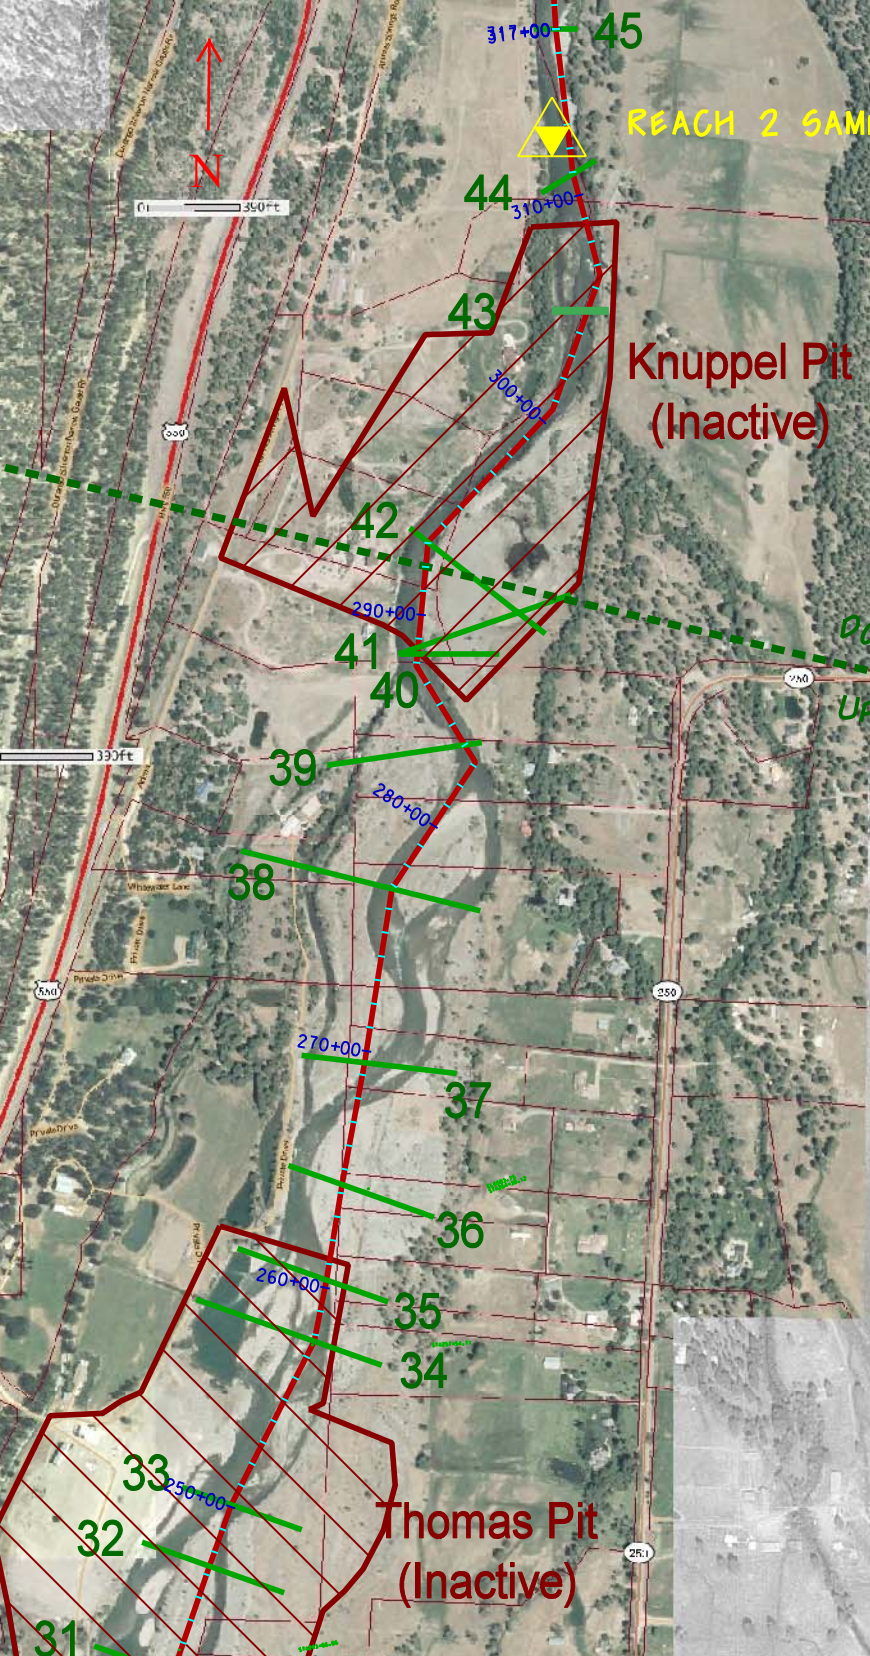
Appendix 1: Basemap (Taken from Stonestreet, 2006)

Following the data collection above, RWE researched the sediment transport and fluvial geomorphological situation in the vicinity of the Thomas Pit (near Station 240+00 on the basemap shown in Appendix 1). USACOE scientists suggest

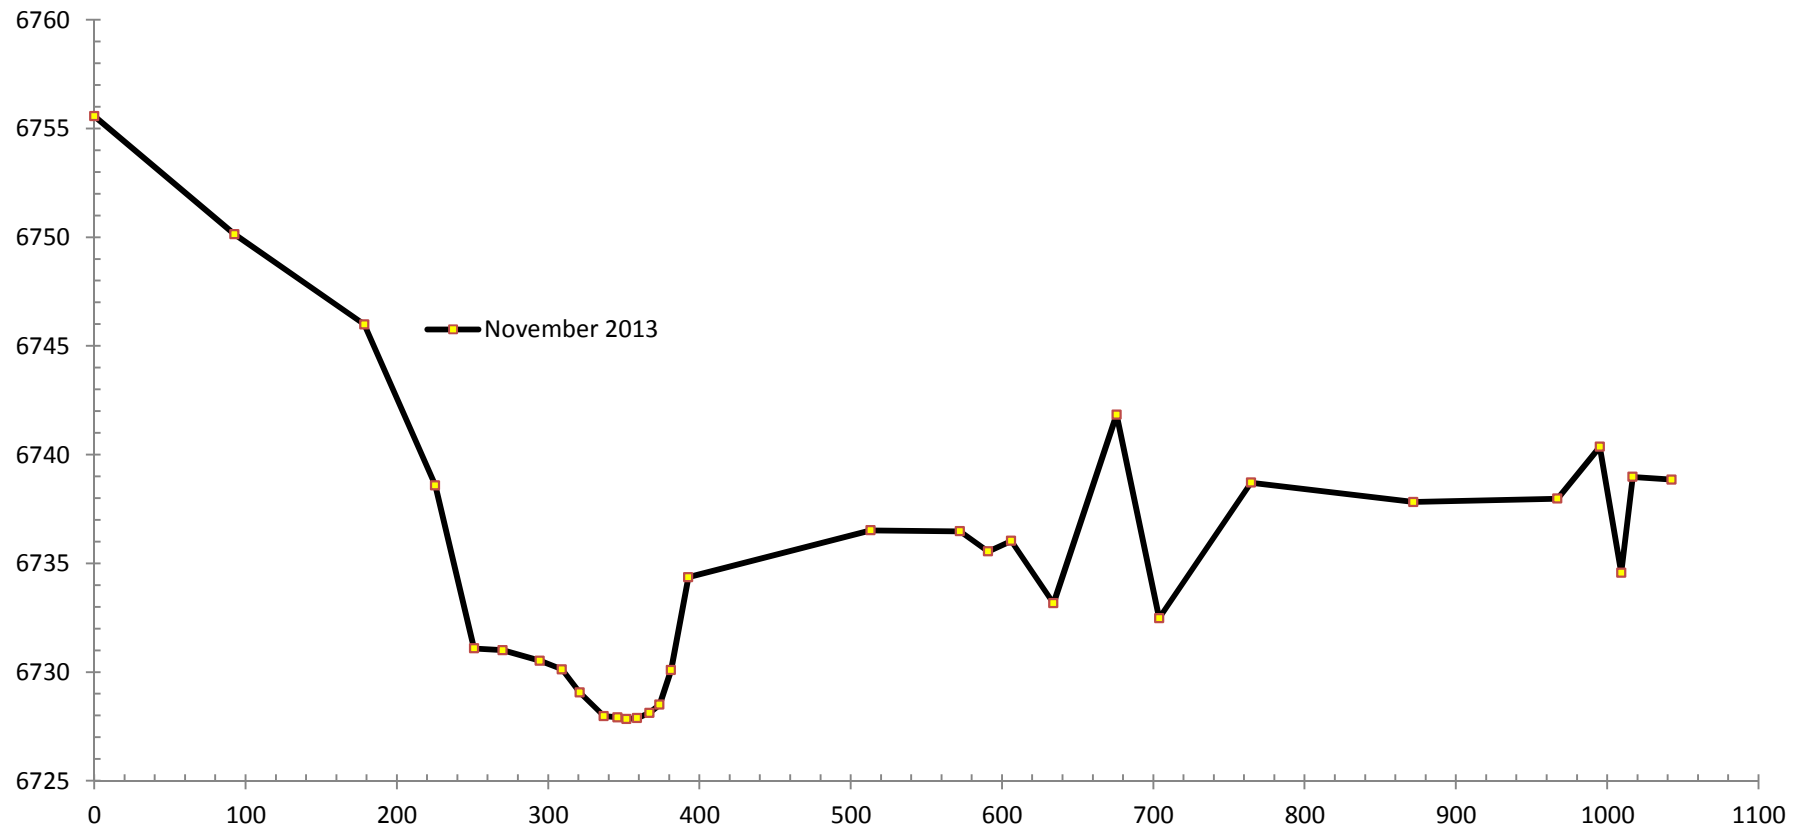
Cross Section 45: Cross Section 45 data was collected by RWE, but no historic data was found during the data search. The cross section may be useful for future analysis.

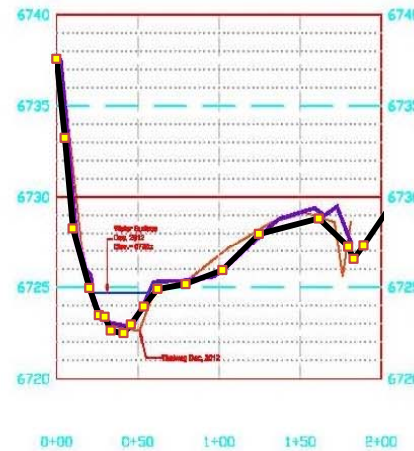
SECTION 44

Cross Section 44: Cross Section 44 is located just upstream of the Knuppel Pit. Review of the cross section temporal plot suggests the cross section collected by RWE is similar to the previously collected cross section and no geomorphological changes are evident.

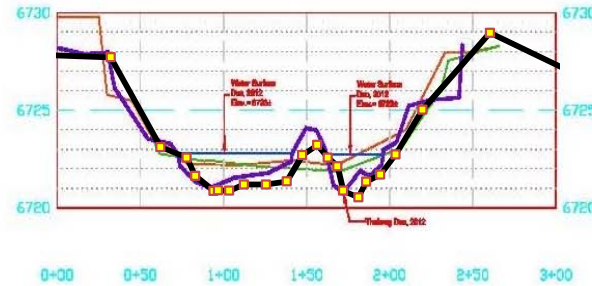
SECTION 43

Cross Section 43: Cross Section 43 is located within the area of the Knuppel Pit. Review of the cross section temporal plot suggests the cross section collected by RWE is similar to the previously collected cross section and no geomorphological changes are evident.

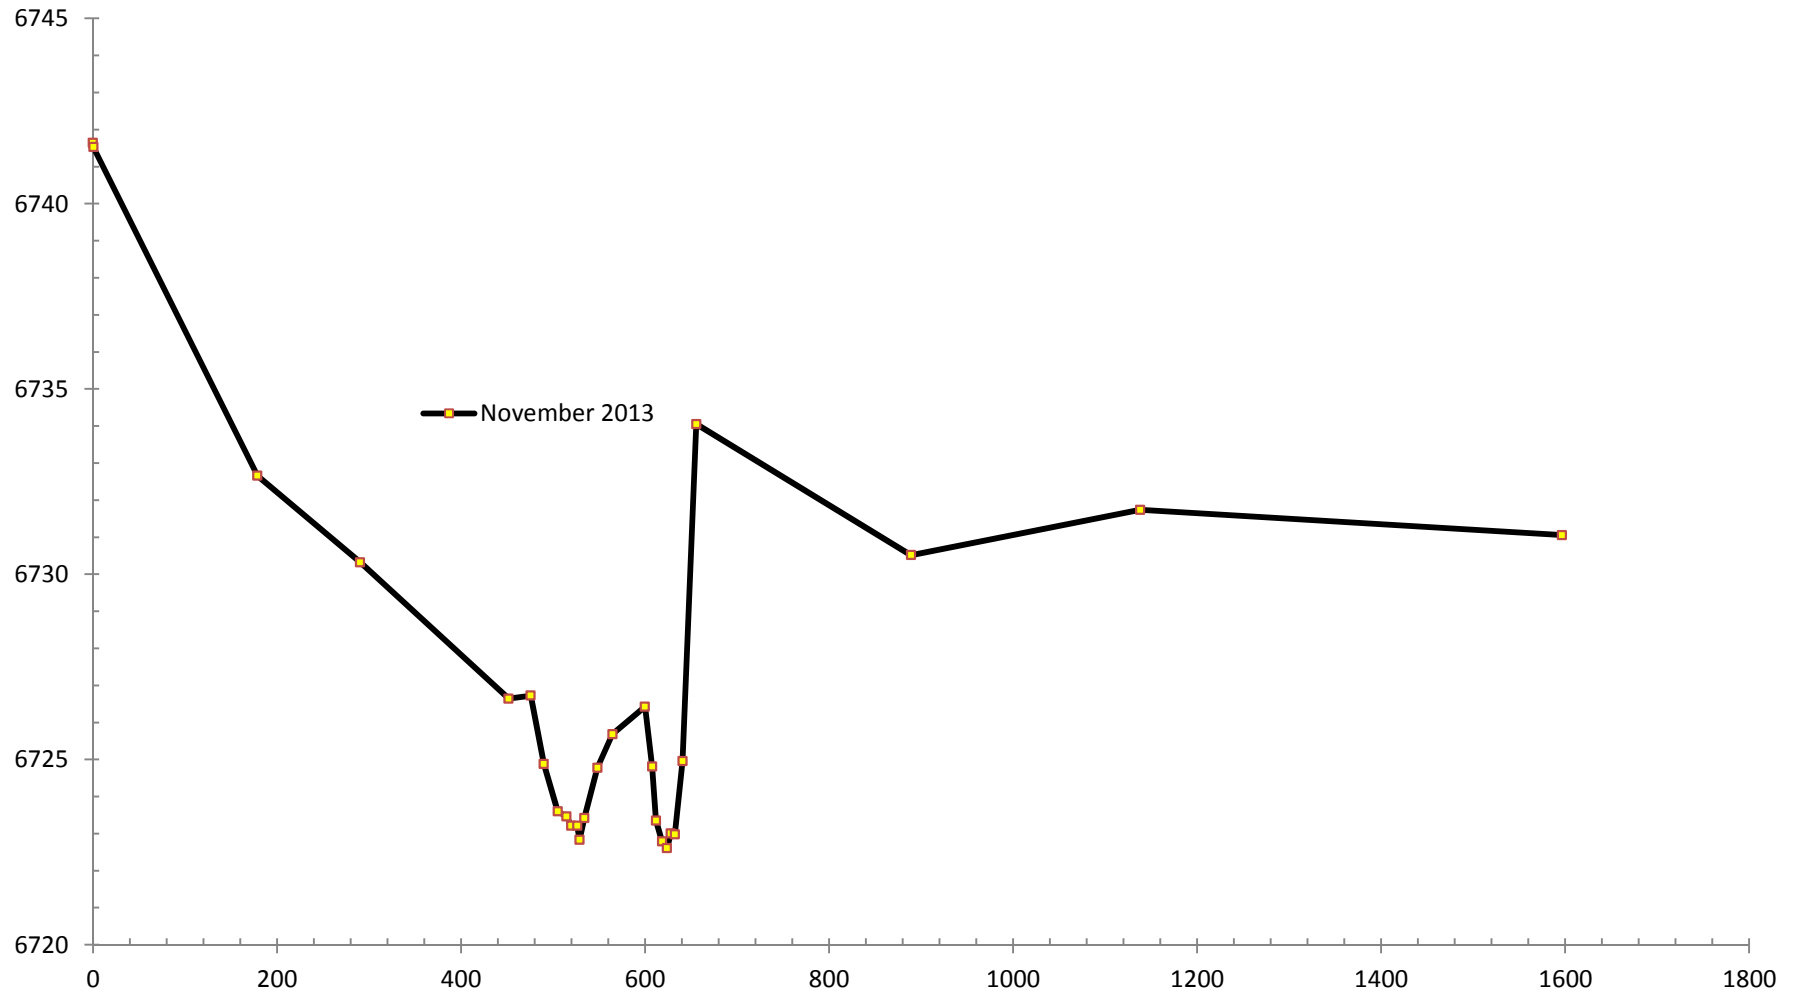
Cross Section 42.7: Cross Section 42.7 is a supplemental cross section located upstream of the Reid Ditch diversion that may be used for future comparisons.

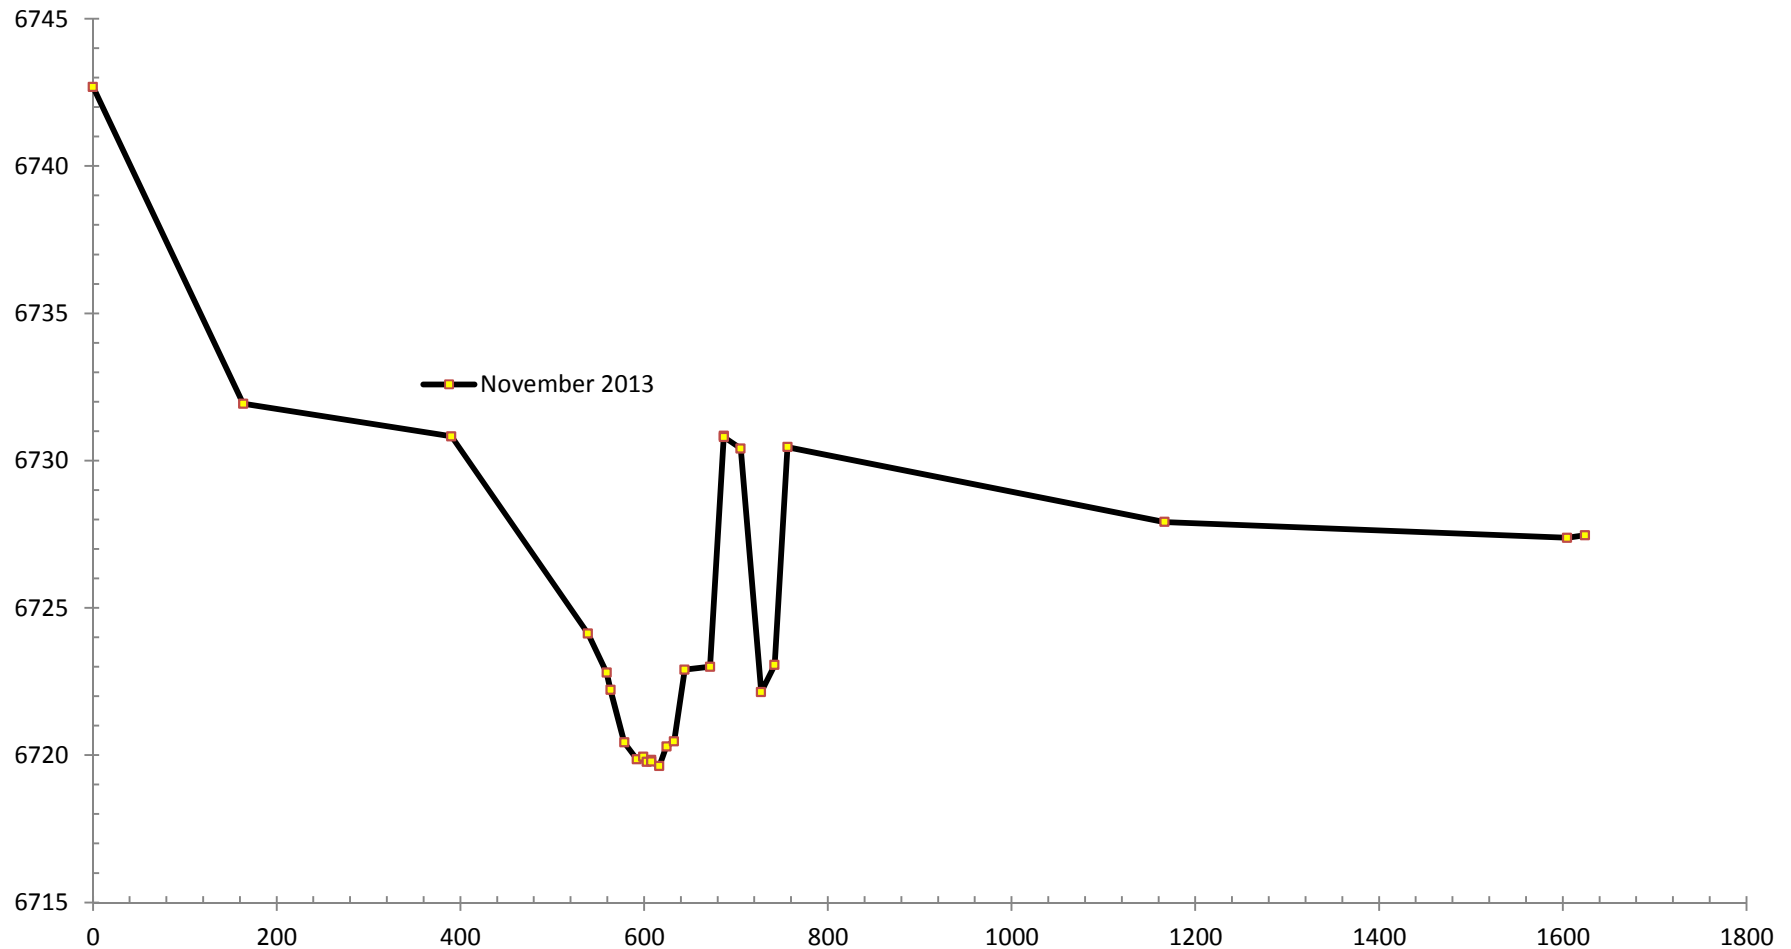
Cross Section 42.3: Cross Section 42.3 is a supplemental cross section located downstream of the Reid Ditch diversion that may be used for future comparisons.

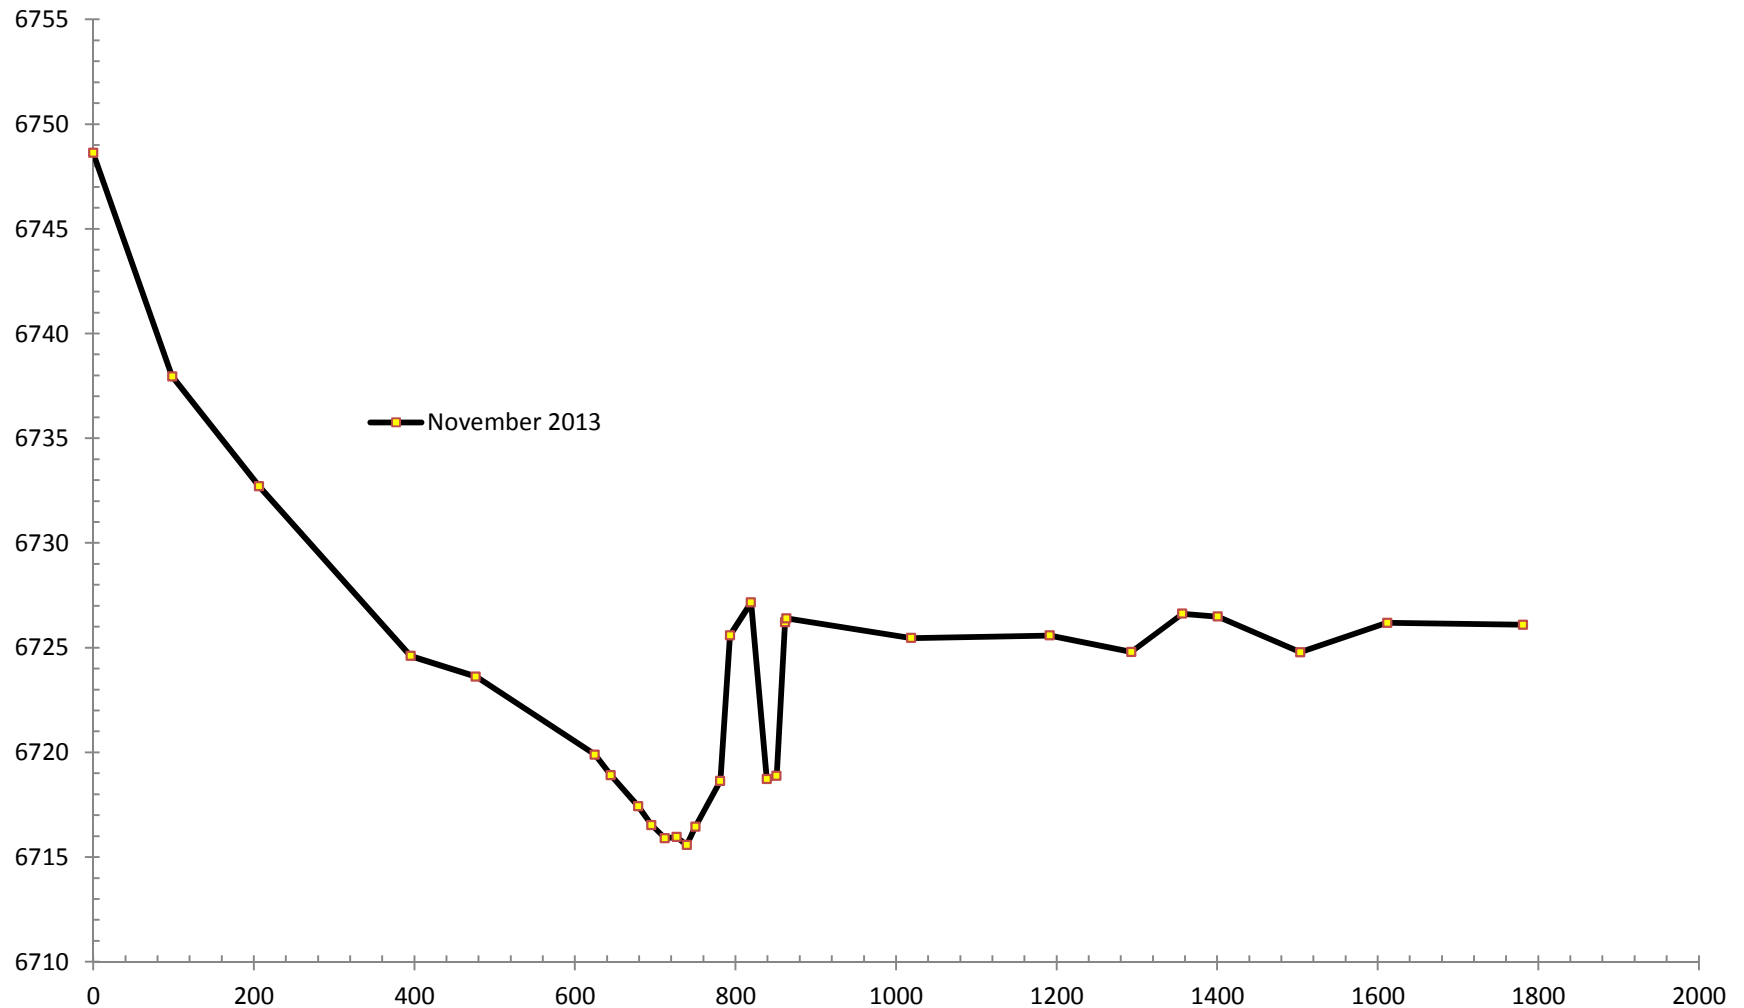
Cross Section 42.1: Cross Section 42.1 is a supplemental cross section collected to acquire additional data between cross sections 42 and 43.

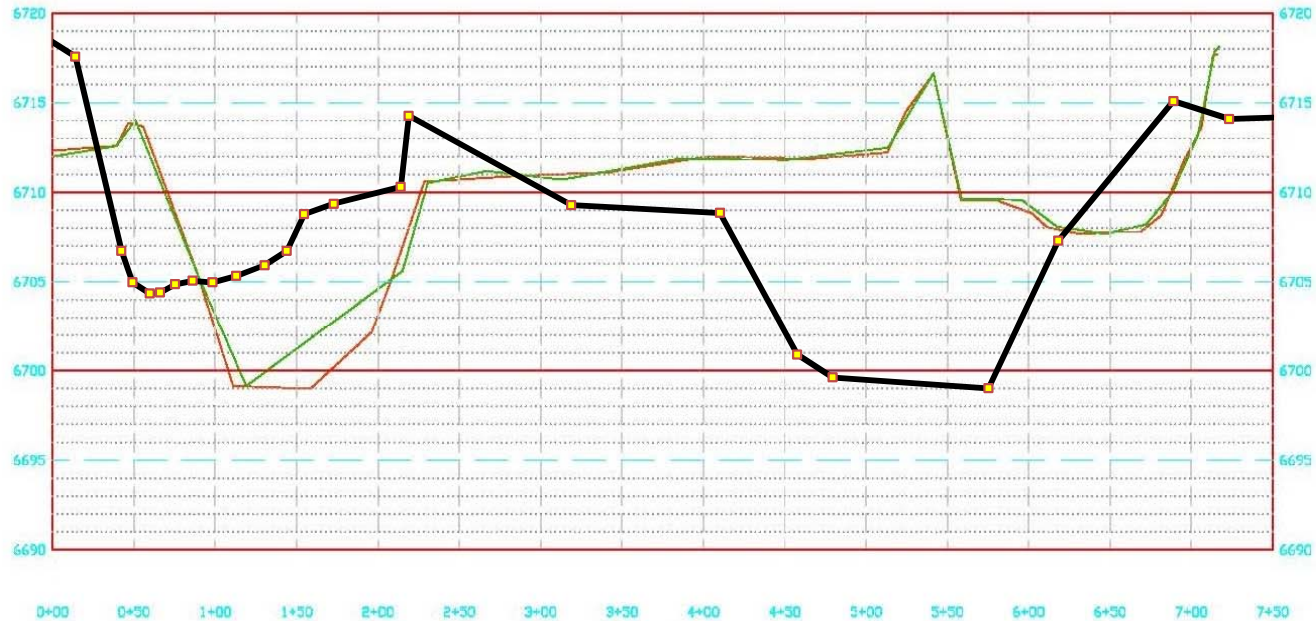
SECTION 42 293+08.29

Cross Section 42: Cross Section 42 is located within the area of the Knuppel Pit. Review of the cross section temporal plot suggests the cross section collected by RWE and the 2003/2004 data do not line up well and the 2003/2004 data may be transposed. RWE suspects this is due to the skewed nature of the cross section as shown on the basemap and mistakes made during data compilation and graphing. Because of this, the cross sections can be roughly compared with the understanding that the cross sections are shown transposed to each other. Because of this, RWE does not have comments related to the geomorphological changes in this area.

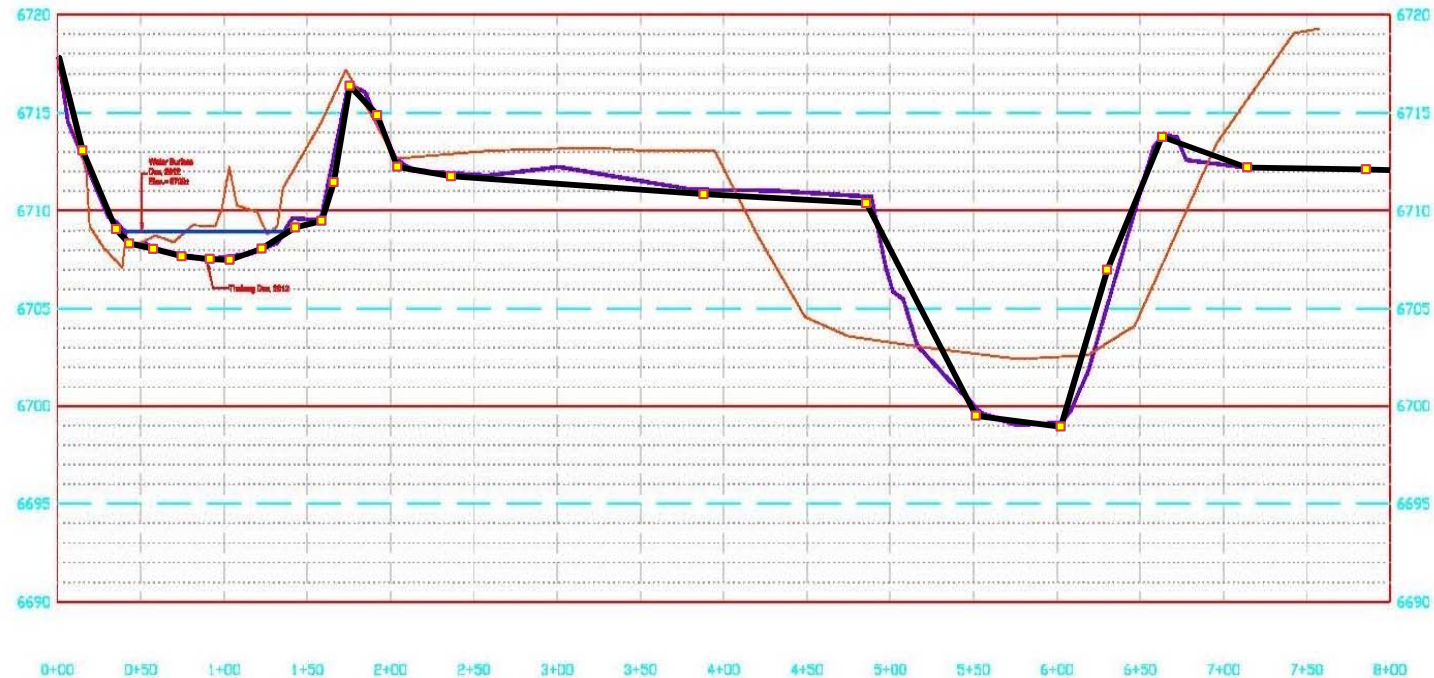
SECTION 41 288+68.79

Cross Section 41: Cross Section 41 is located just upstream of the ACD Ditch diversion and near the downstream extents of the Knuppel Pit. Review of the cross section temporal plot shows two channels are located at this location. The channel on the left shows some minor changes in both cross sectional area and thalweg elevation between 2003 and 2012/2013, but neither is indicative of channel morphology related to a Headcut. The channel on the right appears to be the downstream end of the historic Knuppel Pit and suggests there has been cross section and thalweg changes between 2003 and 2012/2013. RWE does not have any explanation for these changes and recommend further review of the Knuppel Pit, the material taken from the pit, and the remediation associated with that pit. These findings are consistent with the hypothesis that a Headcut is located downstream of this location.

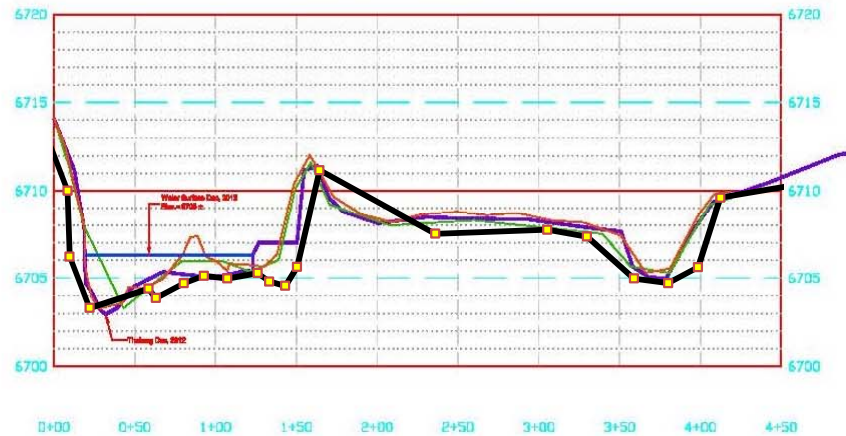
SECTION 40 288+40.89

Cross Section 40: Cross Section 40 is located just upstream of the ACD diversion. Review of the cross section temporal plot shows indefinite changes to both cross sectional area and thalweg elevation. These findings are consistent with the hypothesis that a Headcut is located downstream of this location.

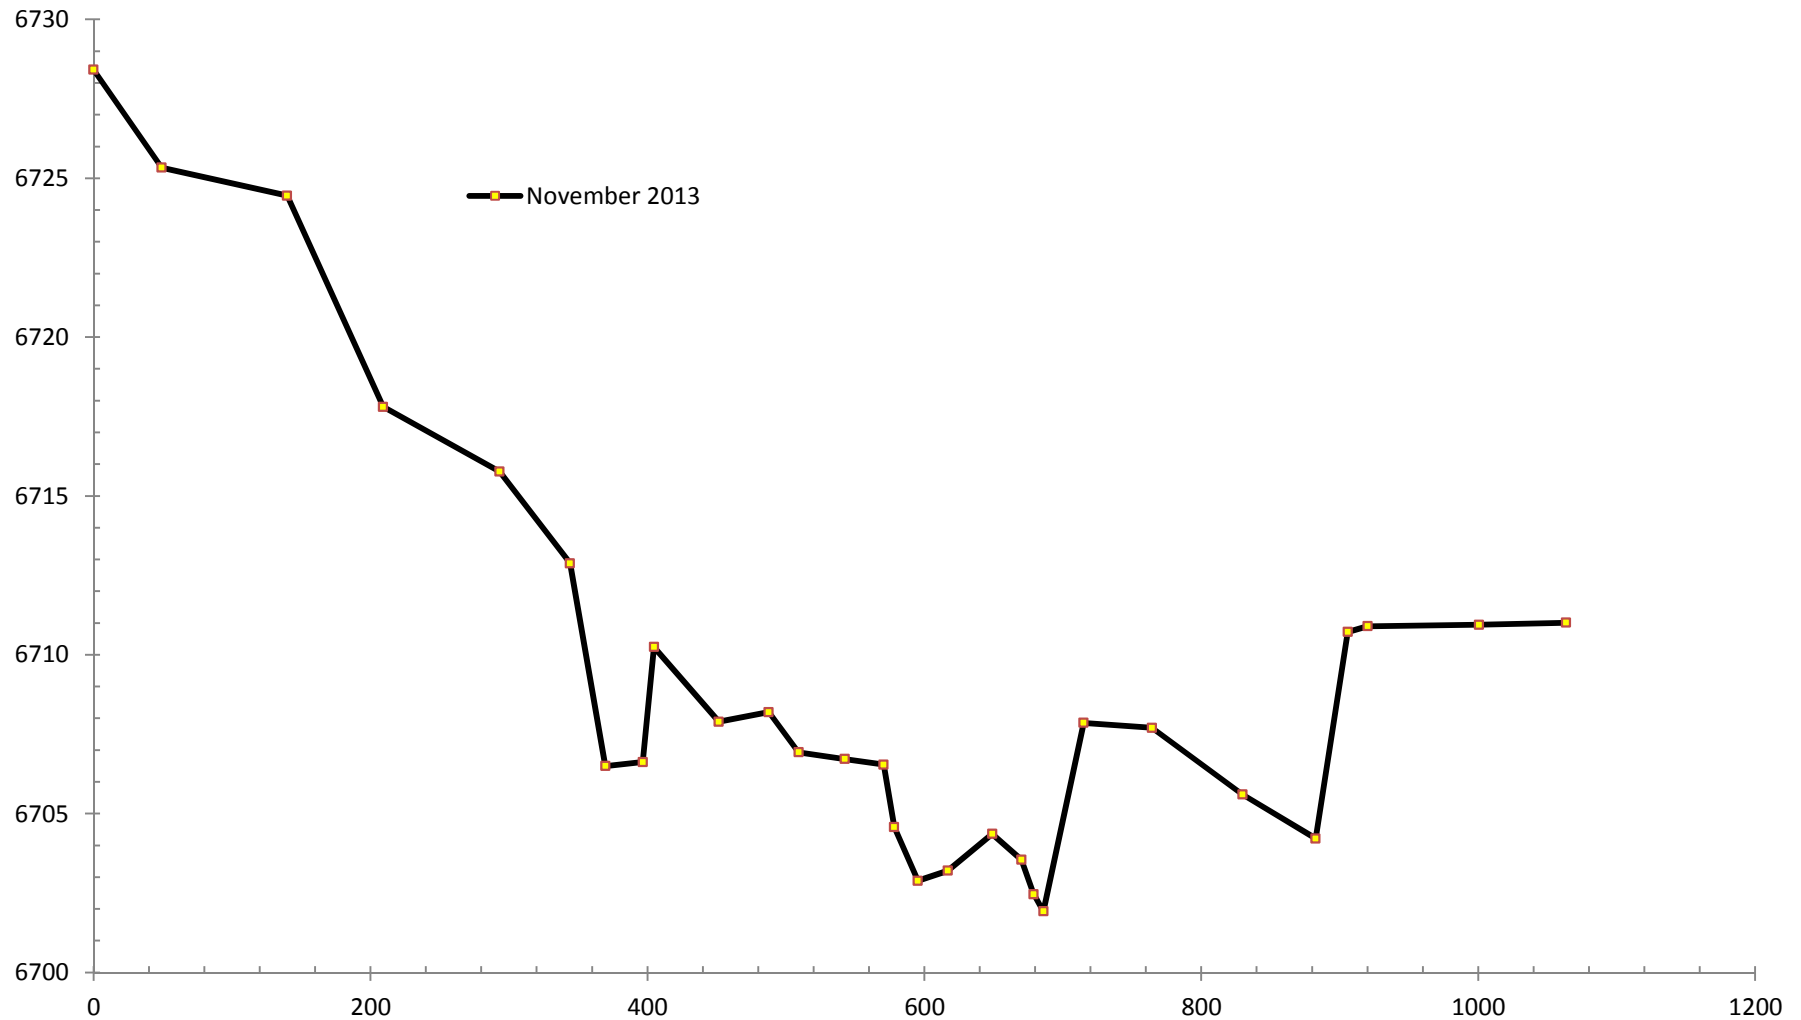
Cross Section 39.5: Cross Section 39.5 is a supplemental cross section collected just upstream of Cross Section 39. The location is important because it is located just downstream of the ACD diversion. Future fluvial geomorphological impacts to this cross section would be indicators of impacts to the ACD diversion.

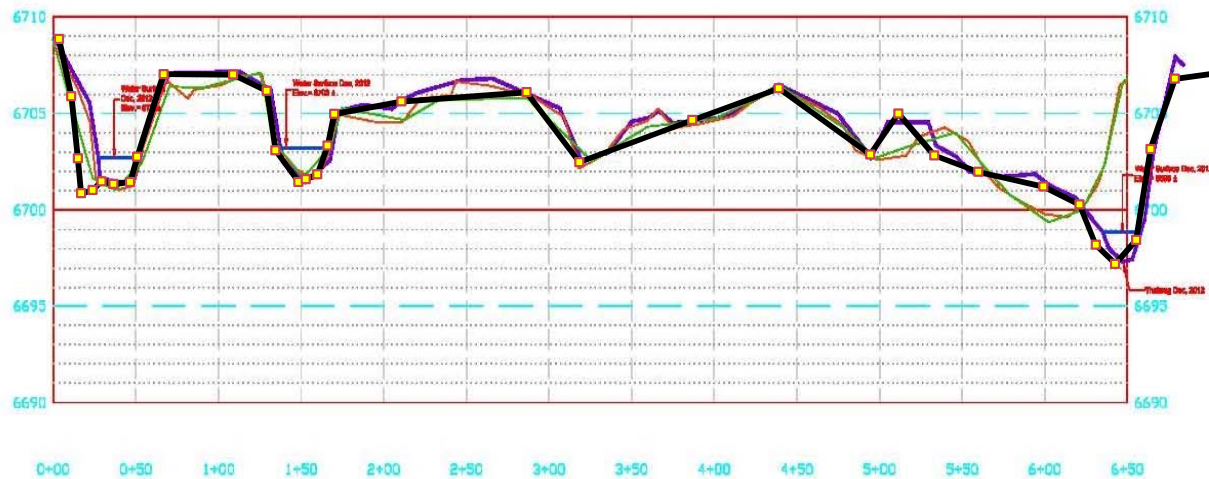
SECTION 39

Cross Section 39: Cross Section 39 is located downstream of the ACD diversion. Review of the cross section temporal plot suggests the channel thalweg and area have changed little between December 2012 and November 2013 but the channel has incised approximately 2.5 feet since 2003-2004. In addition, the channel is notably more incised with a lower cross sectional area suggesting the Headcut is located near this cross section. RWE's visual observations found the terminus of the Headcut 100-200 feet downstream of this cross section.

RWE observations during site visits suggest there is a Headcut located at approximately station 282+00 (just downstream of cross section 39). The Headcut appears to have an approximately 3-4 foot drop over a longitudinal distance of approximately 20 feet. Based on the field data collected in November 2013, it is not possible to estimate the rate the Headcut is propagating upstream, but analysis of Appendix 3 (the longitudinal profile) suggests that between the Bechtolt 2012 survey and the November 2013 survey, the thalweg elevation at Cross Section 38 dropped by 2.7 feet. Cross Section 38 is located just downstream of the Headcut noted by RWE. This value should be taken with caution because earlier surveys (2003-2010) showed comparable thalweg elevations to the November 2013 survey.

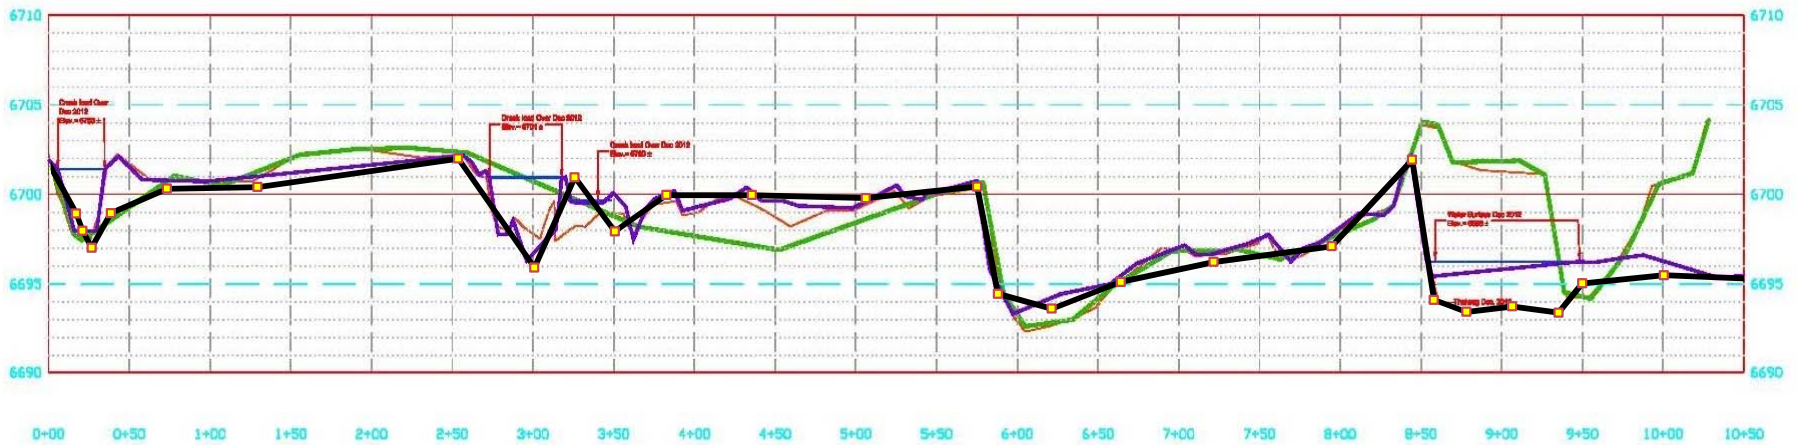
SECTION 38 276+90.04

Cross Section 38: Cross Section 38 is located within a braided section of the Animas River downstream of the ACD diversion. Review of the cross section temporal plots in Appendix 3 suggests the thalweg of the channel is located on the right side of the figure. Comparing the December 2012 survey with the November 2013 survey suggests the channel thalweg is approximately two feet lower and erosion is occurring at this cross section. Comparing the cross sectional area from 2003-2004 to 2012 to 2013 suggests the channel has progressively increased in cross sectional area and the thalweg is lowering. Both these observations support the hypothesis of a Headcut near this location.

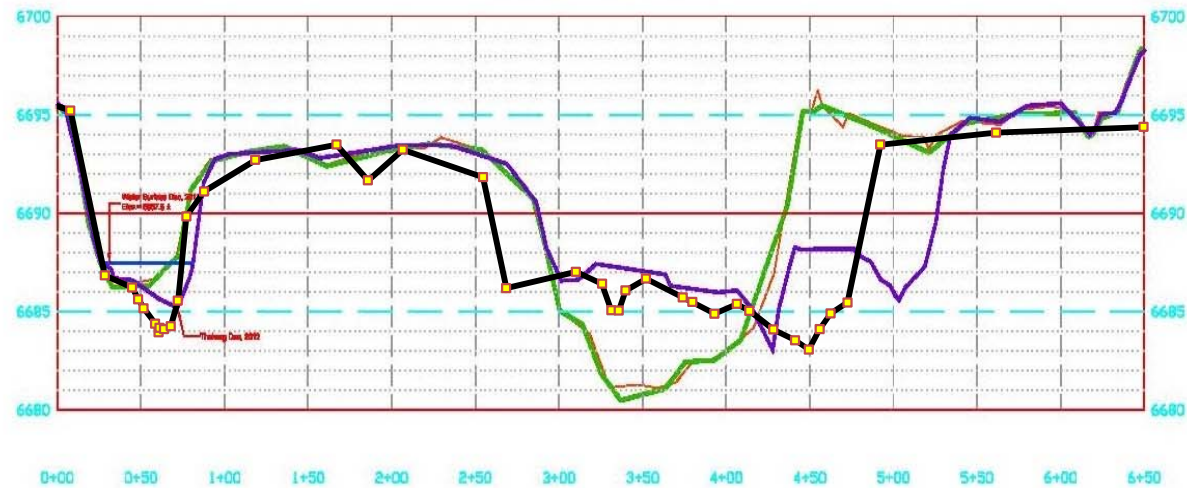
SECTION 37 269+56.15

Cross Section 37: Cross Section 37 is located in a braided section of the Animas River. Review of the Figure suggests the extreme left channel (looking upstream) is likely the return flow from the ACD (and other) diversion. We feel the Thalweg December 2012 label is inappropriate and the mainstem of the Animas River was running on the right side of the Figure. Review of the thalweg and the cross sectional area in the mainstem channel suggests there was little-to-no change in the thalweg elevation from December 2012 to November 2013 and little-to-no change in the cross sectional area. The two cross sections are slightly skewed to each other, which could be explained by slightly different paths taken by the two survey crews.

Comparing the 2003-2004 data with the 2012-2013 data suggests the channel thalweg in this area has risen 2.0-2.5 feet and the channel has transformed from a deeper, thinner channel to a wider and shallower channel. One possible explanation for this change is that the Headcut moved through this area closer to the 2003-2004 period, has since moved upstream, and the area is beginning to aggrade and return to a dynamic equilibrium.

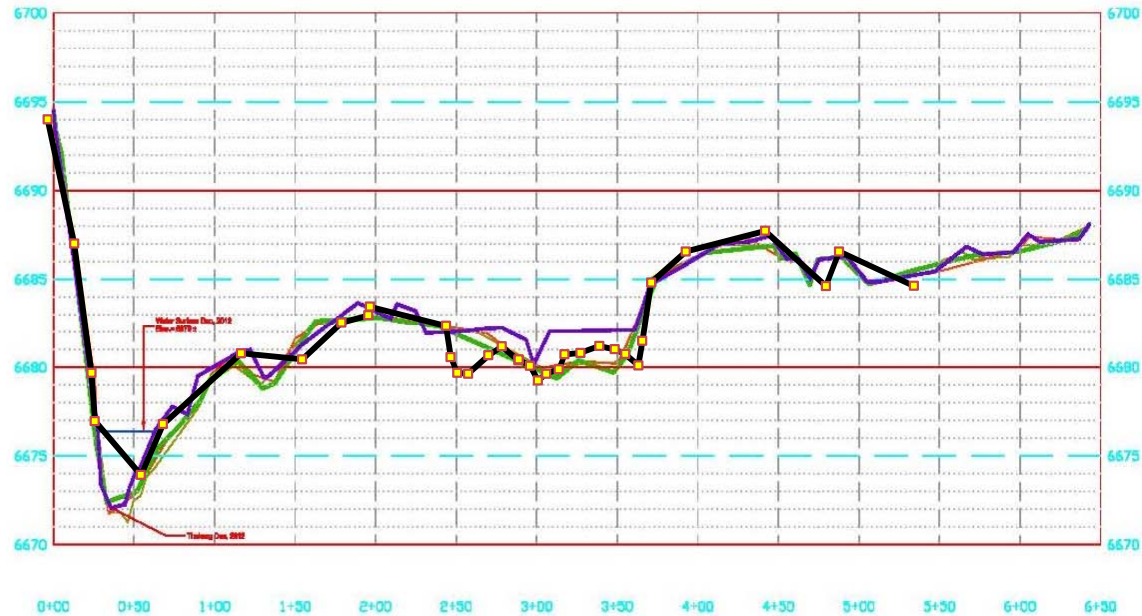
SECTION 36 264+40.26

Cross Section 36: Cross Section 36 is located just upstream of the Thomas Pit. Review of the data in Appendix 3 suggests the channel has aggraded from December 2012 to November 2013 approximately 2-feet. The data supports the hypothesis that material is being deposited (aggrading) to fill the void left following gravel extraction.

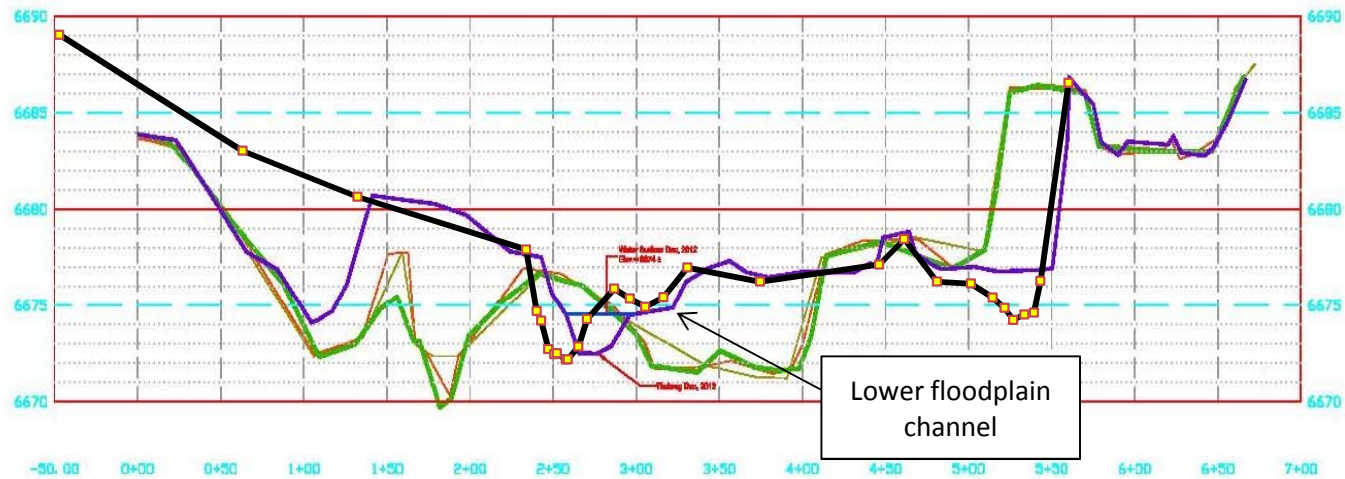
SECTION 35 260+37.43

Cross Section 35: Cross Section 35 is located near the upstream terminus of the Thomas Pit. Field observations and data collected in November 2013 suggest the channel is located near the extreme left side of the channel (west). The thalweg appears to be approximately 0.3 feet lower than the survey in December 2012, but up to 1-foot higher than the thalweg in 2003-2004. In addition, the lower floodplain channel area (labeled on the Figure) appears to be approximately equal to December 2012 but much higher and lower in cross sectional area than 2003-2004, suggesting the channel is aggrading in this area. This is consistent with the geomorphological conclusions of Stonestreet 2006, which suggest the channel in the vicinity of the Thomas Pit should be aggrading.

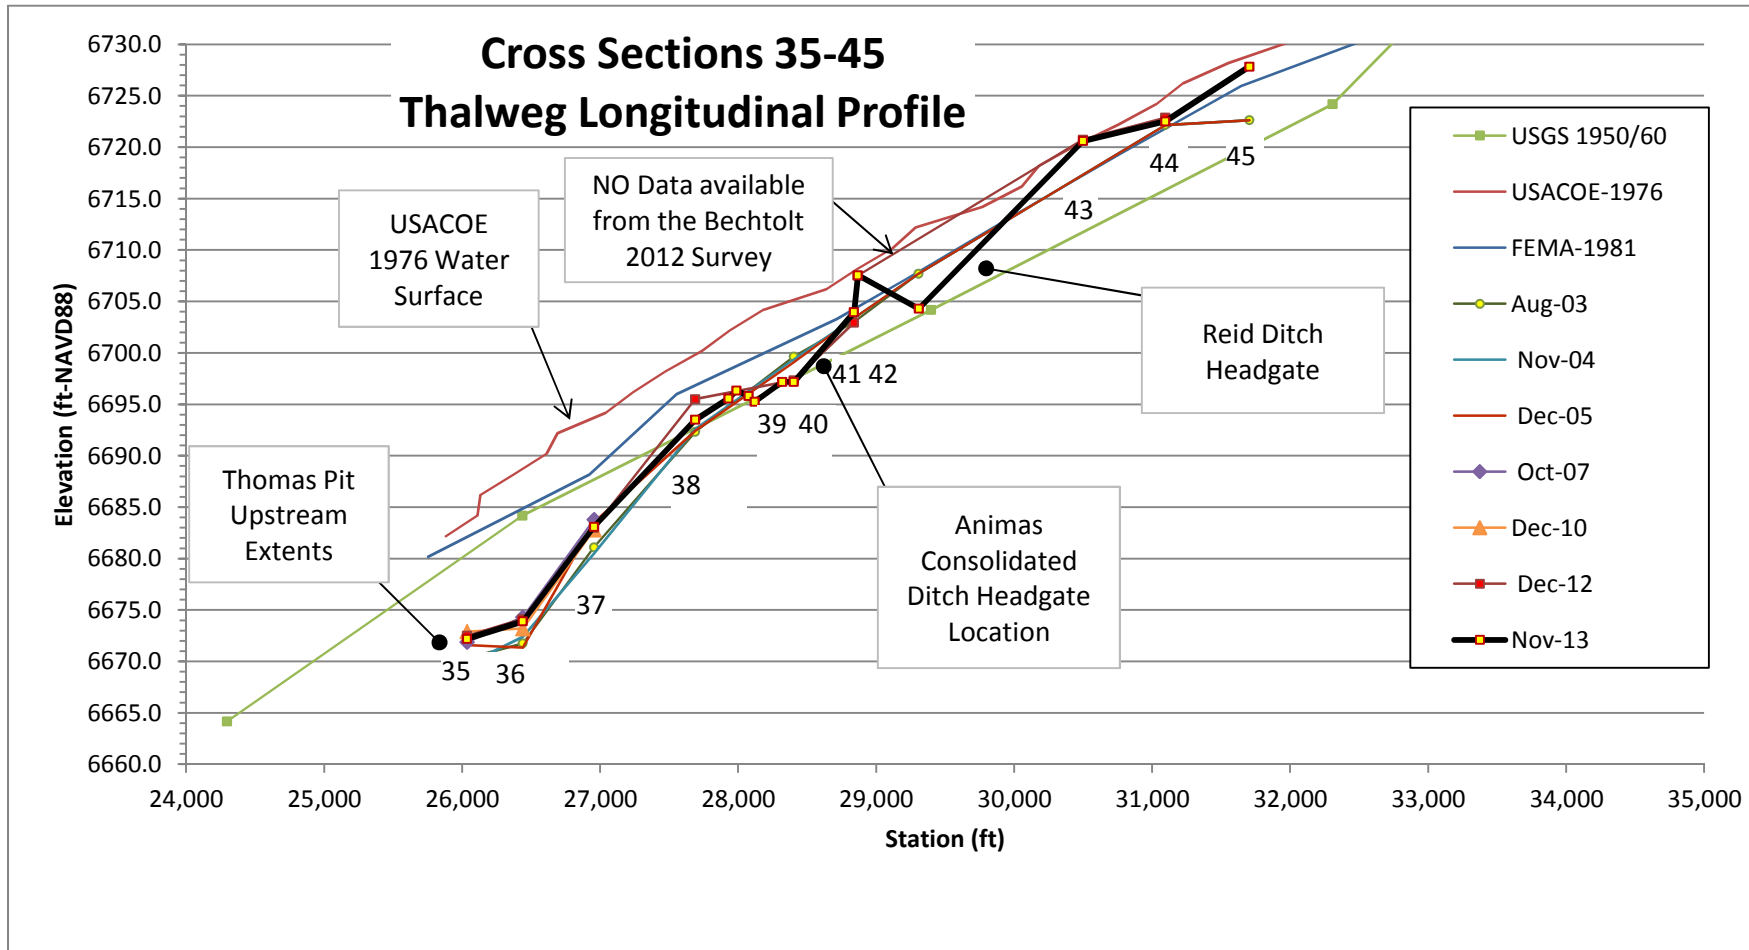
Longitudinal Profile

In addition, RWE compiled and analyzed a thalweg longitudinal profile (See Appendix 3) through the project reach and offer the following preliminary assessments:

- The profile contains multiple data sources, some of which do not contain data over the entire reach and some of which RWE is not able to review for accuracy, but the plot has multiple locations that contain valuable information.

- In the vicinity of Sections 35 and 36, it appears the data collected by the USGS 1950/1960, the USACOE-1976 water surface, and the FEMA1981 data are significantly higher and suggest a relatively constant slope through the area during this period. The data from Aug-03 to present suggest the slope has greatly decreased near these two cross sections and aggradation is occurring. This finding is consistent with comparisons made in the cross section temporal plots.

- Between Section 36 and Section 38, the channel slope increases which is consistent with higher rates of transport and the Headcutting situation discussed in the cross section temporal plots. It is within this area that the most drastic changes in channel form are evident. It is also important to note the thalweg elevation at Cross Section 38 is approximately two feet lower than measurements shown by the Dec-12 plot. This two foot decrease in elevation in less than a year suggests significant Headcutting in this area.

- Above Section 38, the channel generally follows a trend of progressive aggradation moving upstream. This is consistent with prior sediment transport studies suggesting the area of the Animas River downstream of Baker's Bridge is a gaining reach with aggradation resulting from material transport from the higher gradient Upper Animas River. Detailed analysis is beyond the Scope of this study.

- 1) United States Army Corps of Engineers (USACOE) 1976 data is the water surface elevation from topographical mapping. The data is valuable to show the approximate slope of the channel during that time. Absolute elevations should not be directly compared to other data within the plot.
- 2) The metadata associated with the data sets is included in the memo written to the Animas Consolidated Ditch Company and Partners dated December 20, 2013.
