**FINAL REPORT**

**WSRA Grant  
Fountain Creek Bank Restoration  
at the Frost Ranch**

**May 30, 2014**

Final Report – May 2014  
Matrix Project No.: 13.526.003.000

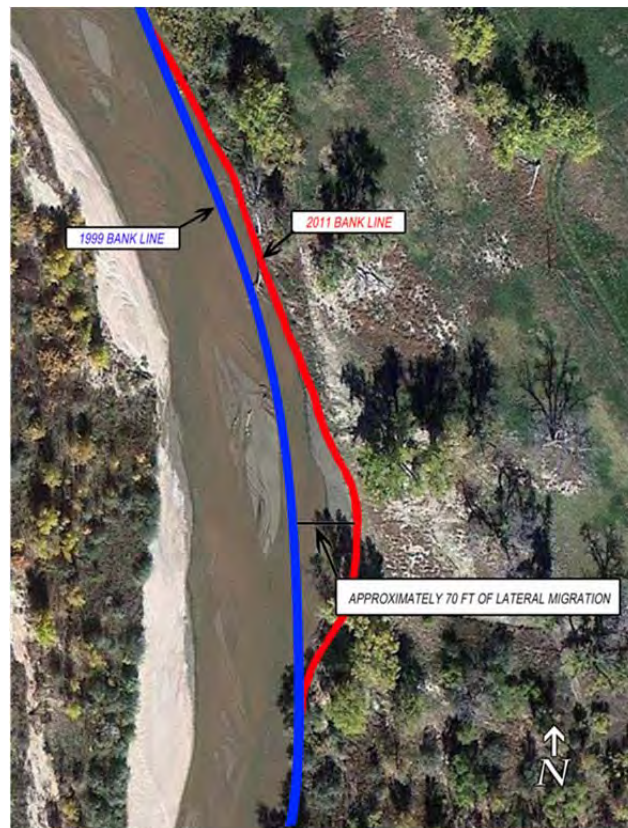
**Figure 2. Bank Erosion**

The Project lies along an eroding bendway where Fountain Creek migrated into a bank with little riparian vegetation, which led to accelerated soil erosion. Over the years, the bank erosion caused property loss and increased sediment supply. Eliminating erosion along the bank will protect viable agricultural land, reduce sediment supply downstream, and improve both terrestrial and aquatic habitat. Figure 2 shows the progression of bank erosion in recent years.

The lack of vegetation along about 400 feet of the left bank (looking downstream) allowed the soil to be readily removed during high flow events. Consequently, the landowner experienced flood damage and bank erosion that caused loss of property, damage to fences, loss of productivity, and loss of habitat and vegetation. Since 1999, the bank has migrated as much as 70 feet at one point.

As a result of the bank erosion, the creek became over widened from the stable Fountain Creek reference width of about 160 feet to more than 200 feet. Near the lower end of the Project, the bank “scaloped” out and created severe secondary currents (eddy) that would have aggravated future erosion. Using an estimate of erosion based on a bank erosion hazard index and near bank stress, it was predicted that routine (non-flood) erosion increased from about 0.1 tons/foot/year to nearly 1 tons/foot/year. Along the 400-foot Project reach that equates to an increase from 40 tons/year to 400 tons/year, or a ten-fold increase. The over widening and increased sediment supply caused downstream deposition which, if allowed to continue, would in-turn aggravate bank erosion.

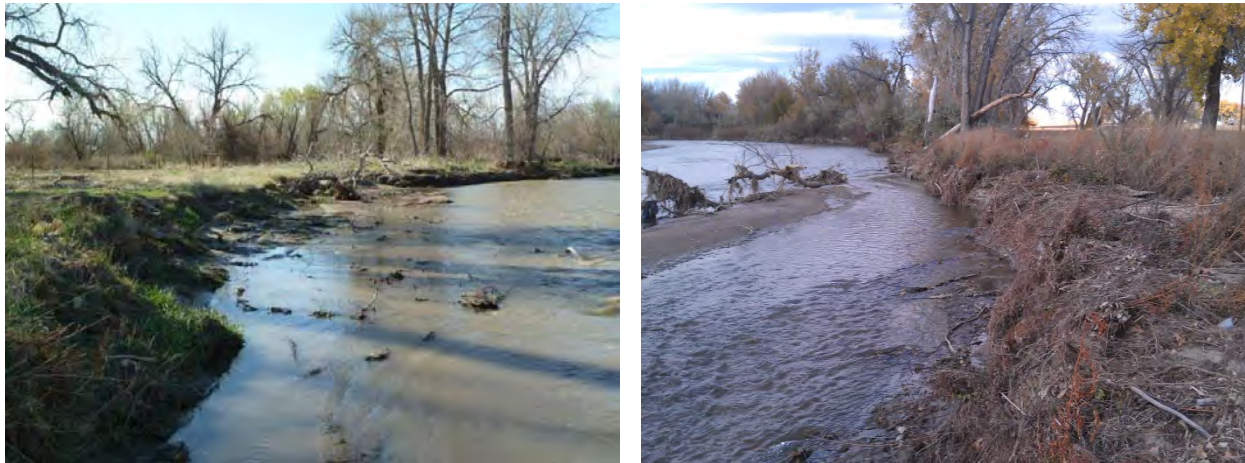
### Photos 1 & 2. Pre-Project Conditions

The Project bank had a relatively low height compared to other severely eroding banks on Fountain Creek. That allowed the Project to proceed with available WSRA funds to demonstrate effective habitat-sensitive restoration techniques at a reasonable cost by comparison. The Project bank is readily accessible and will be an excellent location to demonstrate techniques that can be used to systematically address larger erosion and sedimentation issues along Fountain Creek. Addressing these issues will begin to reduce the sediment supply that is contributing to irrigation, flooding, and stream stability problems downstream on Fountain Creek and the Arkansas River.

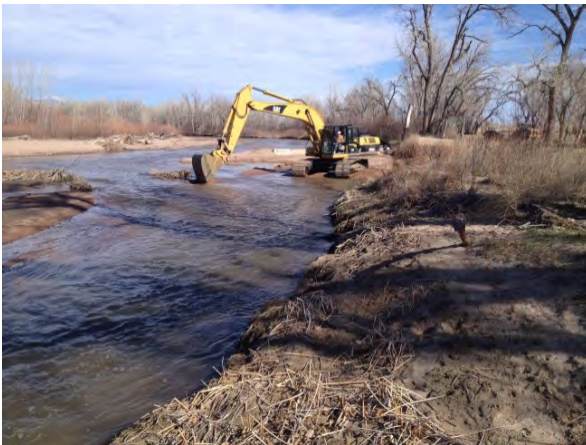
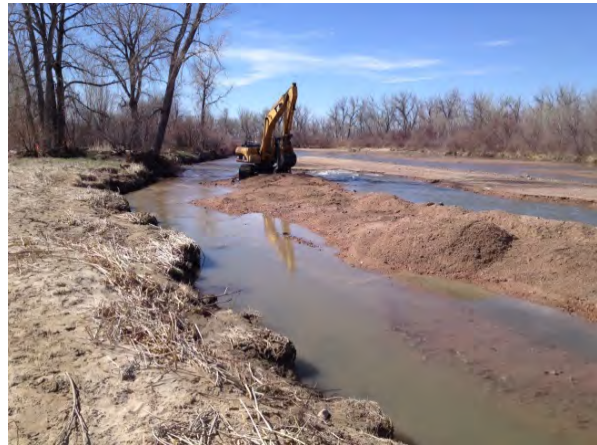
**Photos 3 & 4. Cofferdam Excavation 4/9/14**

Numerous site visits were conducted by Matrix and THK Associates, Inc. staff. Excavations were observed, as well as the installation of the soil-filled KoirWrap 1000®, willow stakes, seed and transplanted bulrush plants. The following photos provide an overview of construction and the finished project. All project photos are included on a CD attached in Appendix F.

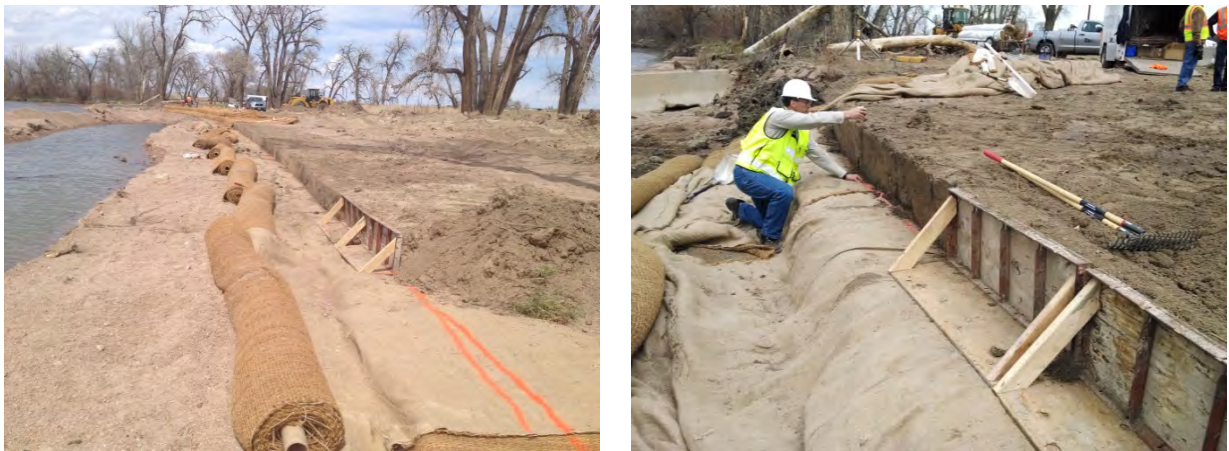
**Photo 21. Batter Board and Final Installation of KoirWrap Blanket 5/2/14**

Soil-filled blankets have a variety of methods of installation. The blankets were installed and backfilled with moist top soil in the front (creek side) of the lifts. By forming the leading edge with topsoil and a batter board, the overall appearance of the Project area was improved. It was critical to select a woven 2-layer coir/jute blanket in order to provide the strength of a woven product and the second layer of jute to hold soil particles in place. Single layer woven products have an open weave and prone to having soil wash out from underneath. Meanwhile, other mattress-style, non-woven products cannot provide the shear resistance and strength to withstand impact and abrasion.

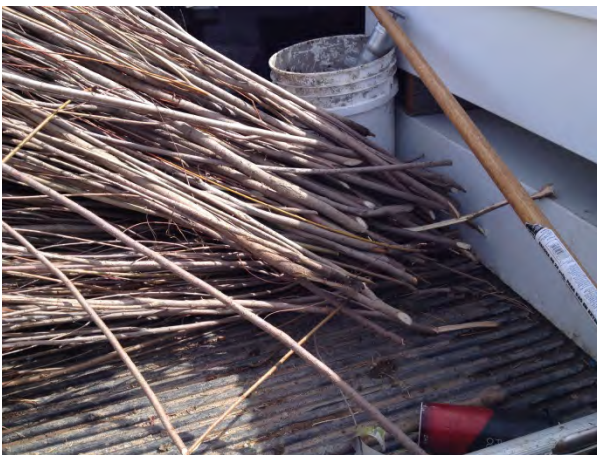
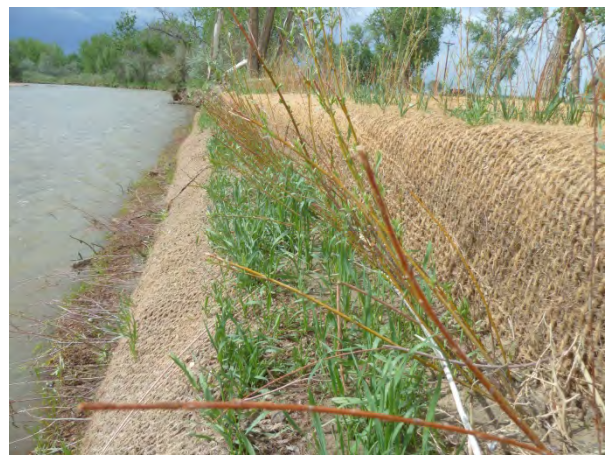
**Photo 22. Harvested Willow Stakes and Willows Stakes Leafing Out**

Extensive field observation and direction were required for the contractor and the instructions and methods of harvesting and storing willows. It was essential to keep these willows cool and dormant, with no leaf growth prior to planting.

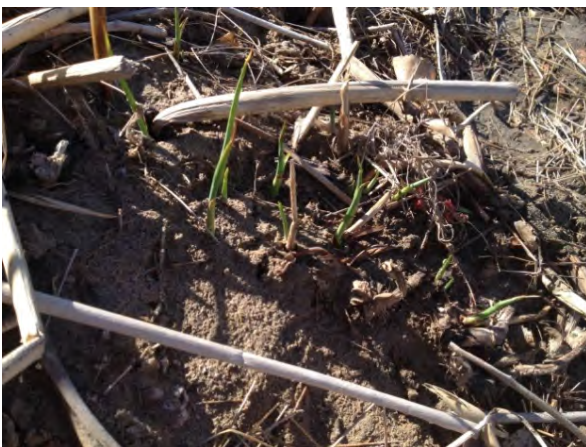
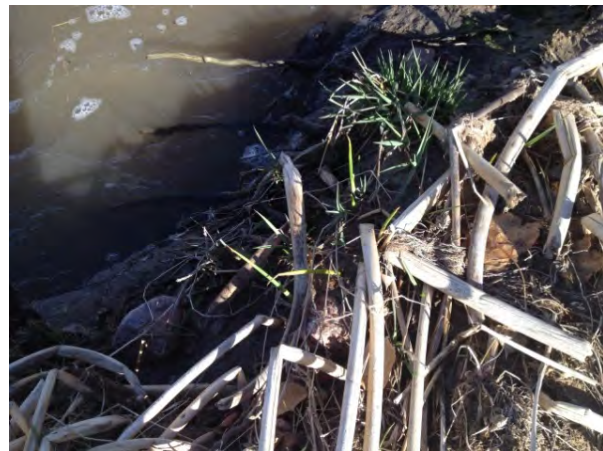
**Photos 23 & 24. Salvaged Bulrush Plants**

Stockpiling and preserving existing on-site vegetation, in this case a large stand of bulrush, helped to increase the plant diversity of this project. Bulrushes were reinstalled along the leading edge of the soil-filled blankets.

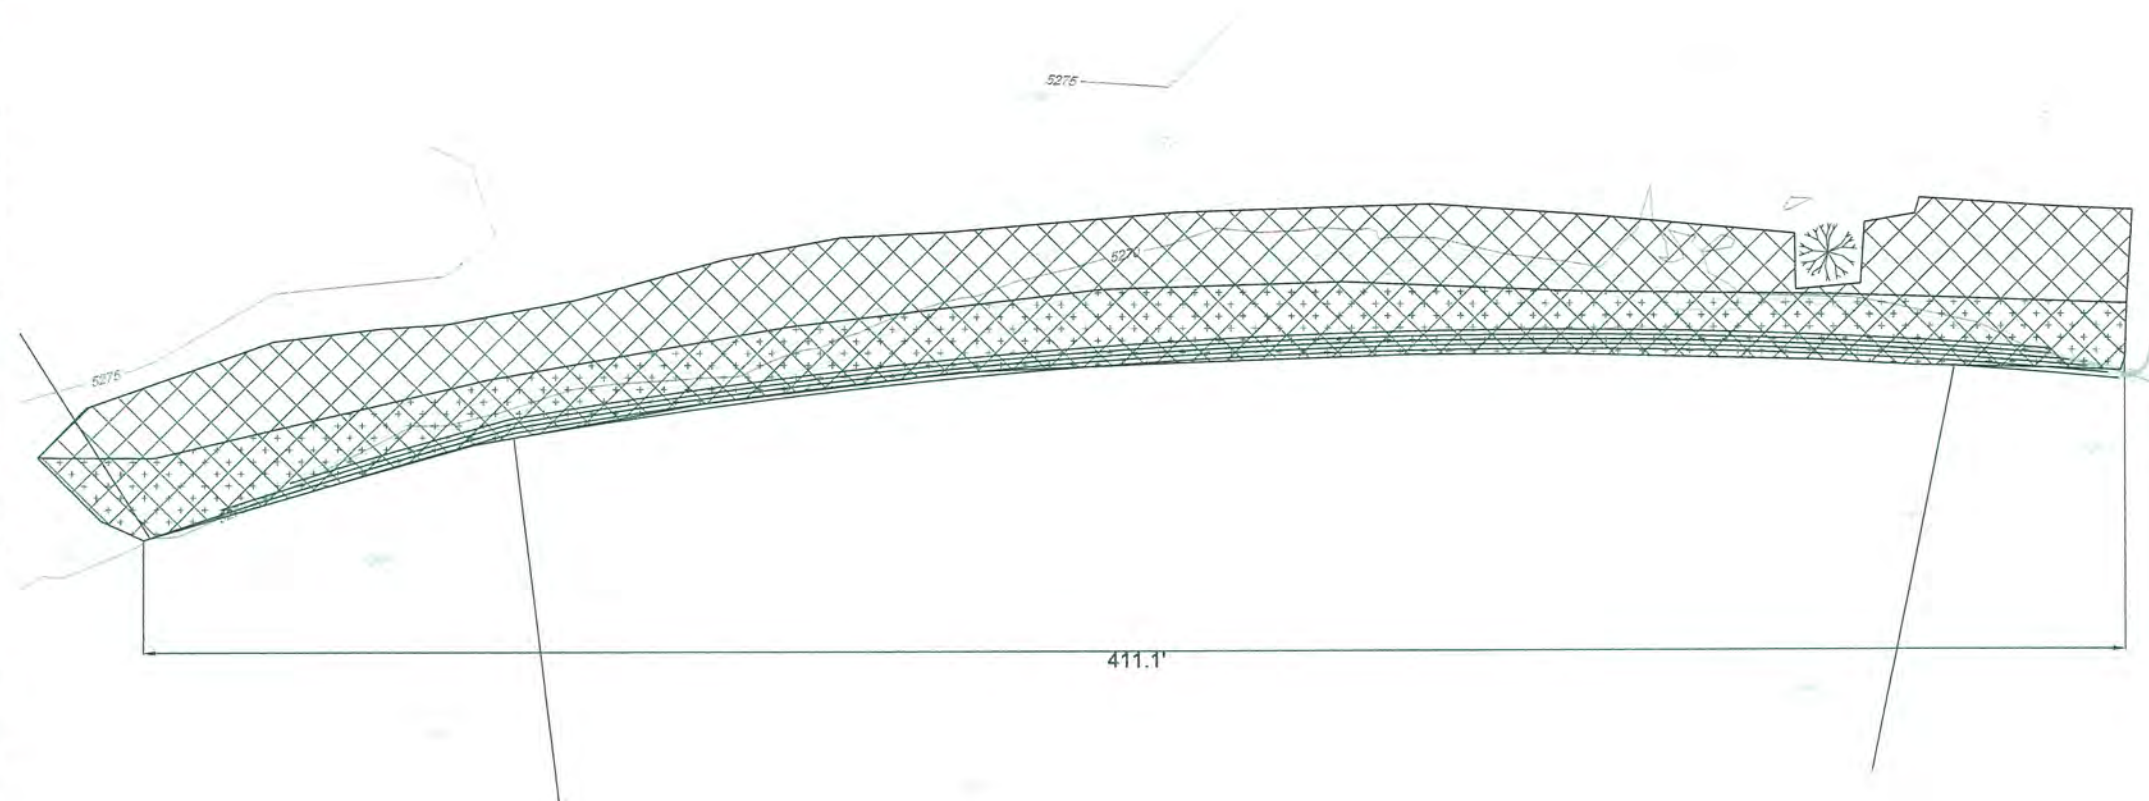
GRADING & EROSION CONTROL PLAN

AS-BUILT LIMITS OF KOIRWRAP  
1000 SEEDED WITH RIPARIAN MIX

AS-BUILT LIMITS OF LIVE WILLOW  
STAKING SPACED @ 2' O.C.

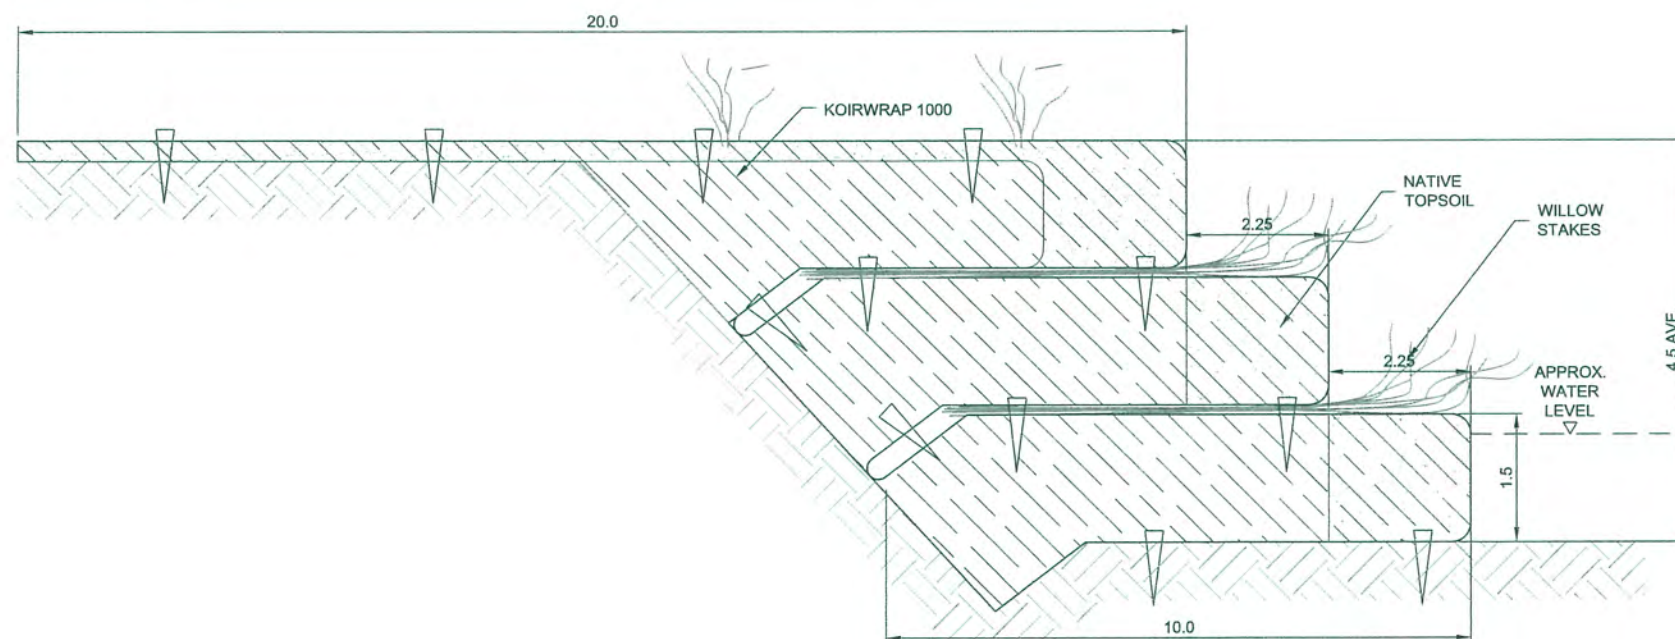
BRUSH LAYERING DETAIL  
N.T.S.

CLEAN AND GRADE THE BASE OF THE SLOPE OR STREAM BANK TO CREATE A LEVEL AND COMPACT SOIL SURFACE. PLACE A STABILIZER BOARD (3/4" PLYWOOD CUT TO THE LIFT HEIGHT) VERTICALLY ON THE OUTSIDE FACE OF THE BASE LIFT. SECURE THE STABILIZER BOARD USING 2" x 2" WOOD STAKES OR #4 REBAR PINS OR OTHER METHOD.

UNROLL KOIRWRAP PERPENDICULAR TO THE STREAM BANK OR FACE OF THE SLOPE AS THE CASE MAY BE. ENSURE THAT THE SECONDARY LAYER (JUTE FABRIC) IS ON TOP. DRAPE KOIRWRAP OVER THE STABILIZER BOARD SO THAT IT FORMS A 90° ANGLE WHERE THE INNER FACE OF THE STABILIZER BOARD MEETS THE SOIL SURFACE. KEEP A MINIMUM EMBEDMENT LENGTH OF 10'. ANCHOR KOIRWRAP USING 12" ECOSTAKES AT 3' SPACING ALONG THE STABILIZER BOARD AND ALONG THE EDGE OF KOIRWRAP. BACKFILL WITH A WELL GRADED MIXTURE OF ALLUVIAL MATERIAL AND SOIL.

COMPACT SOIL LIGHTLY. SPREAD RIPARIAN SEED MIX ON THE PORTION OF THE LIFT THAT WILL BE EXPOSED TO SUNLIGHT. STRETCH KOIRWRAP OVER THE COMPACTED SOIL AND EXTEND TOWARDS THE BANK. ANCHOR KOIRWRAP USING STAKES AT 3' SPACING. THIS BASE LIFT FORMS THE FOUNDATION FOR THE UPPER LIFTS AND PROVIDES ADEQUATE STABILITY TO THE SLOPE. PLACE LIVE SELF-ROOTING CUTTINGS.

REPEAT THE SAME PROCEDURE FOR THE UPPER LIFTS. NATIVE SOIL WITHOUT ROCK SHALL BE USED AS BACKFILL FOR UPPER LIFTS. OFFSET EACH LIFT 27" FROM THE PREVIOUS LIFT AS SPECIFIED.

ON THE TOP LIFT, SPREAD TOPSOIL AND RIPARIAN SEED MIX PRIOR TO PLACEMENT OF KOIRWRAP.

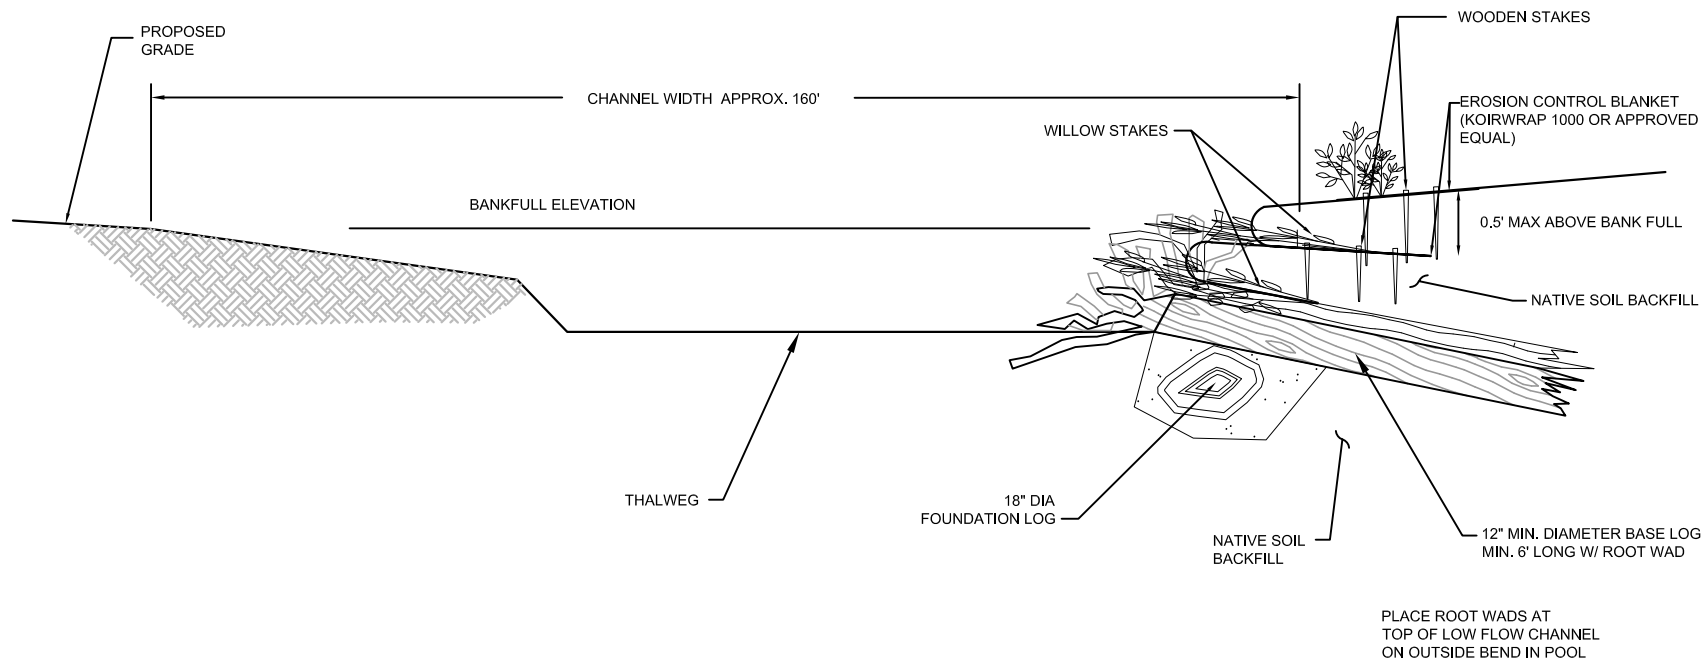
TOE WOOD DETAIL  
N.T.S.

During site visits with potential contractors, the availability of green trees in the vicinity of the Project was discussed. Green trees that are full of water and correspondingly heavy are best for constructing the toe wood alternative because they don't float during construction, are less susceptible to uplift during high flows, and they have greater longevity in the bank. Although, numerous dead or downed cottonwoods were available near the Project, few green or recently downed trees were available. After considering the number of trees required for the Project, the impact to the landowner, and the impact to avian nesting habitat, the Project team opted to abandon the idea of using toe wood.
