The Lower Willow Creek Restoration Project Final Report

Prepared by the Lower Willow Creek Restoration Company

Project Title: The Lower Willow Creek Restoration Project-Phase 1
Contract Number: C150467

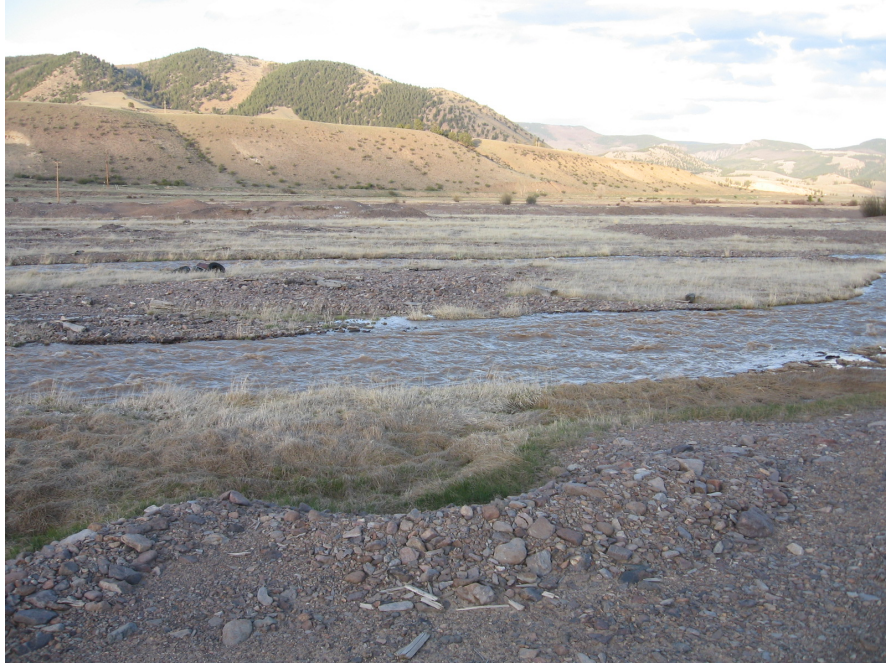
Figure 5: Previous state of the Lower Willow Creek Floodplain.

Beginning in the early 1900's and ending in 1965, the project site was used to store waste rock in settling ponds from two mills. On two occasions, the berms that contained the ponds were breached and produced fish kills as far downstream as the town of South Fork. In the late 1980's the majority of the pond sediments were consolidated, relocated, and capped just northeast of the project site. This pile is known as the Emperius Tailings Pile. Water samples collected by the WCRC and a tracer study performed in 2003 indicated that despite the cleanup effort, Willow Creek was receiving an additional load of heavy metals as it ran through the floodplain. To address this issue the WCRC, in conjunction with the NRCS, created a planning document to identify known site conditions and provide recommended reclamation activities. The recommendations included the construction of a new channel to avoid 'hot spots' that were potential pollutant sources and re-vegetation of the site. The Company used this document to guide engineered drawings and construction activities to accomplish the Lower Willow Creek Restoration Project.

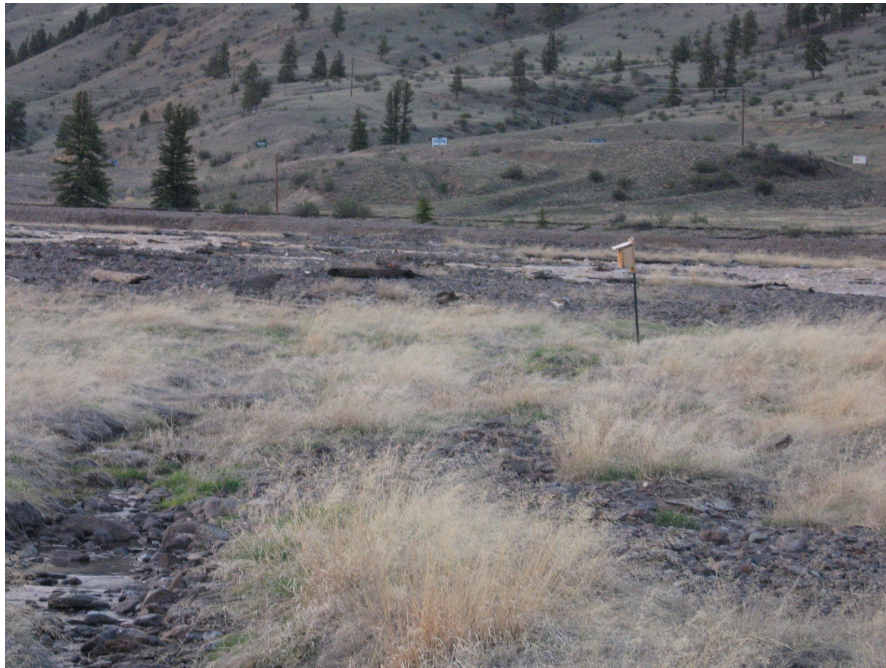
Figure 6: Previous state of the Lower Willow Creek Floodplain.

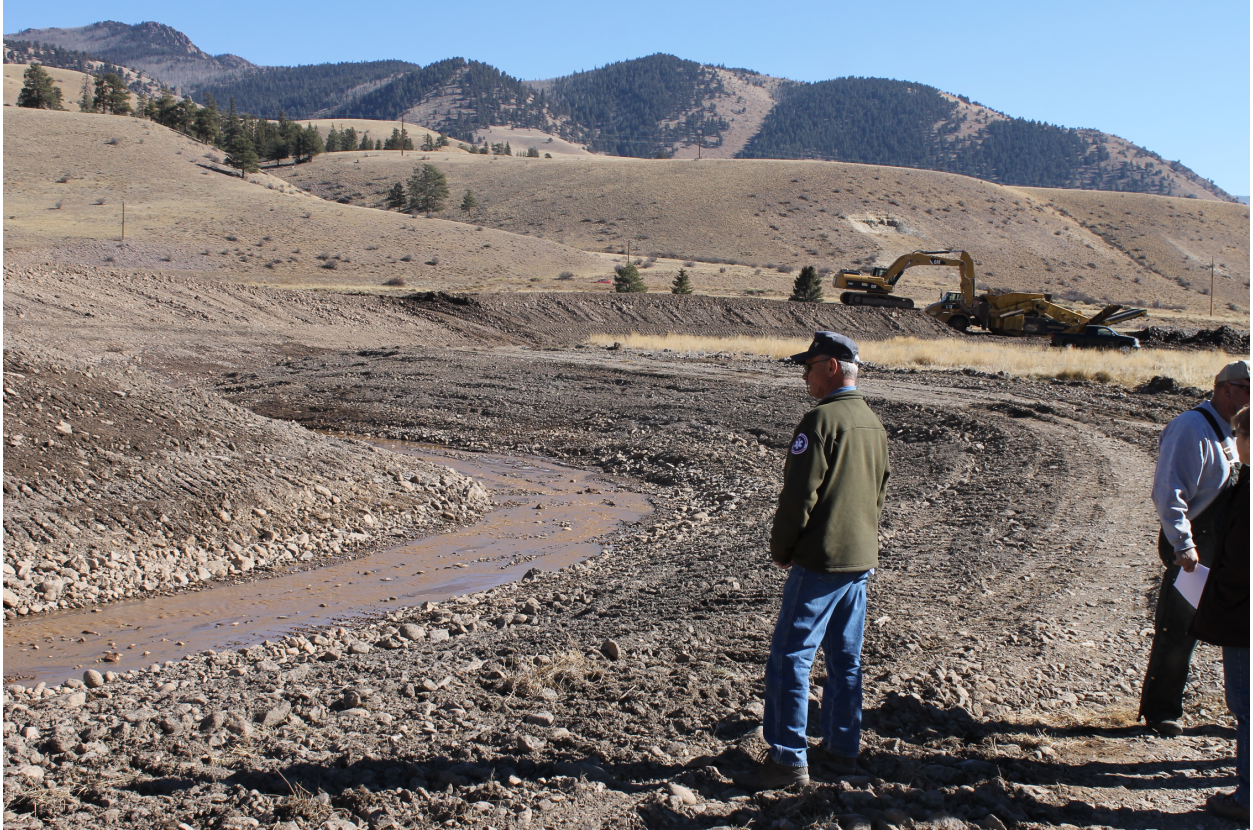
Figure 7: Willow Creek Reclamation Committee visits the site during channel construction, November 2012.
