Hecla Junction Flood Mitigation and Stream Restoration Concept Plan

Arkansas Headwaters Recreation Area

Hecla Junction Alluvial Fan, August 2006

Prepared for:
Colorado Division of Parks and Outdoor Recreation
In Cooperation With
Colorado Water Conservation Board, Flood Protection Section

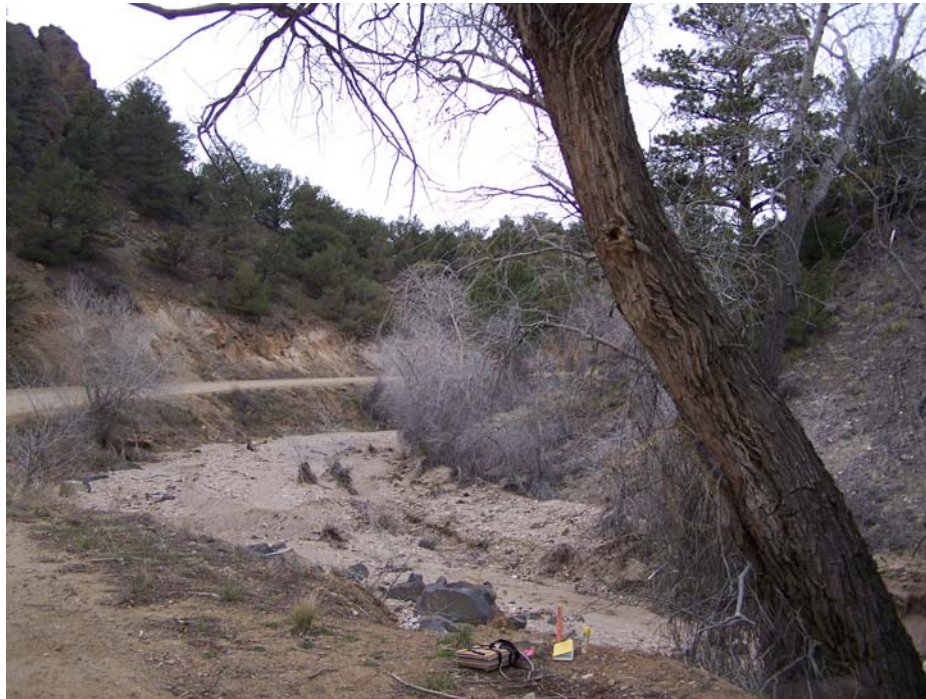
Figure 1– Pinyon Juniper Woodland and Hecla Wash

Pinyon Juniper Woodlands Surrounded by Hecla Wash (Plot 1)

Vegetation is dominated by pinyon pine (*Pinus edulis*) and Rocky Mountain juniper (*Juniperus scopulorum*) with ponderosa pine (*Pinus ponderosa*) and douglas fir (*Pseudotsuga menzessii*) sparsely dispersed throughout the woodland. The understory consists of species including silver sage (*Artemisia frigida*), yucca (*Yucca sp*) and native grasses such as blue gamma (*Chondrosium gracile*) and Fescue (*Festuca spp*) as well as other grasses and forbs. The Hecla Wash intermittent stream bed has a narrow riparian fringe, >30% vegetated, and is comprised mainly of narrow leaf cottonwood (*Populus angustifolia*) and rush (*Juncus spp.*). Herbaceous weeds documented include yellow sweet clover (*Melilotus officinalis*) and toadflax (*Comandra umbellata*). Soils are mainly sand, gravel, cobble and boulder, and the intermittent stream bed has clay rich mottled soils in the gully areas.

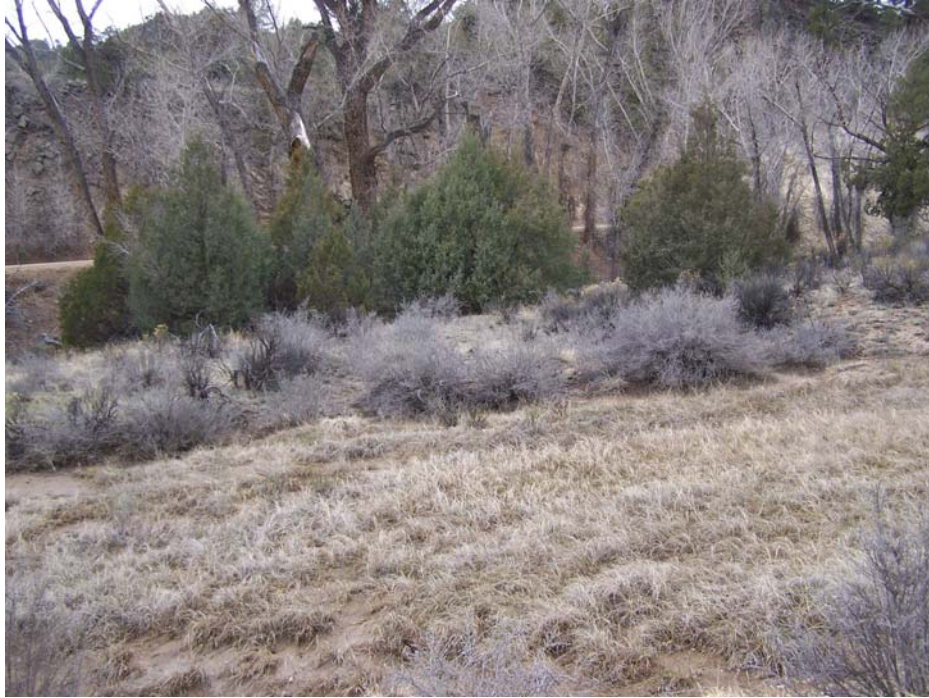
Figure 2 – Cottonwood Gallery Forest with Sage Scrub and Grassland

Cottonwood Gallery Forest Surrounded by Sage Scrub, and Grassland (Plot 2)

Mature cottonwood gallery forest dominates this section of the Hecla Wash with an intermittent stream bed similar to the section described above. The habitat is surrounded by pinyon juniper, sage scrub and herbaceous grassland. A mixture of cool and warm season grasses occur including blue grama, fescue, mountain muhly (*Muhlenbergia montana*) needle and thread (*Hesperostipa comata*), junegrass (*Rostraria cristata*), and various other grasses, which were not identified due to early season growing conditions.

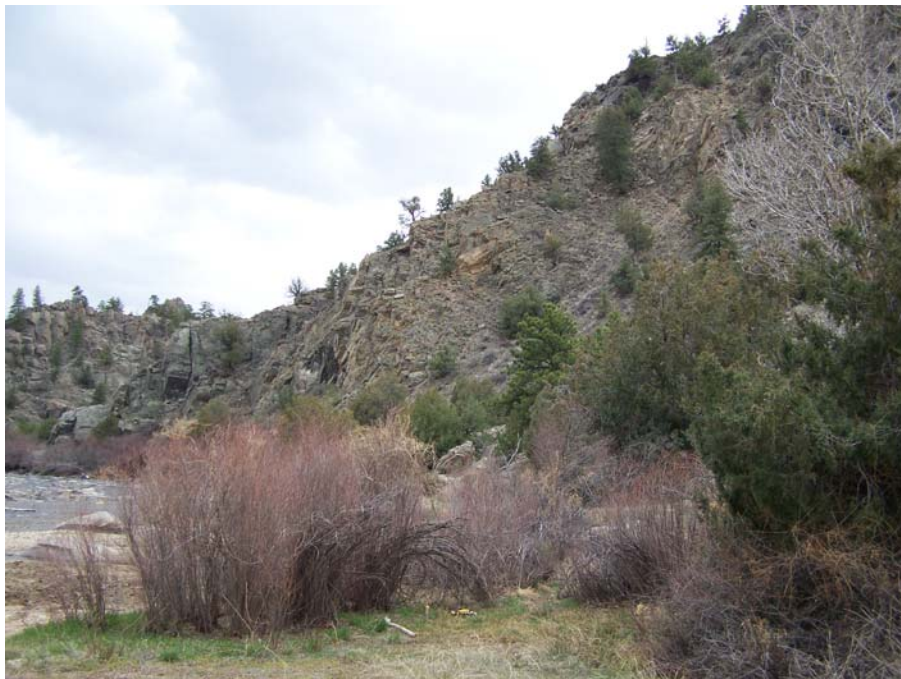
Figure 3 – Narrow Riparian Fringe of the Arkansas River

Floodplain and Riparian Wetland on the Arkansas River (Plot 3)

The riparian community along the Arkansas River at Hecla Junction is composed of willow (*Salix spp*), alder (*Alnus spp*), birch (*Betula spp*) and cottonwood with an understory composed of grasses, sedges, rushes. There are limited amounts of emergent or submergent shoreline vegetation. A narrow fringe of sandbar willow (*Salix Exigua*) and Alder (*Alnus spp.*) occurs with various grasses including fescue, and foxtail (*Phleum spp*) including forbs, which were not identified due to early season growing conditions. Weeds such as thistle (*Cirsium spp*) and dandelion (*Taraxacum officinale*) also occur to some extent.

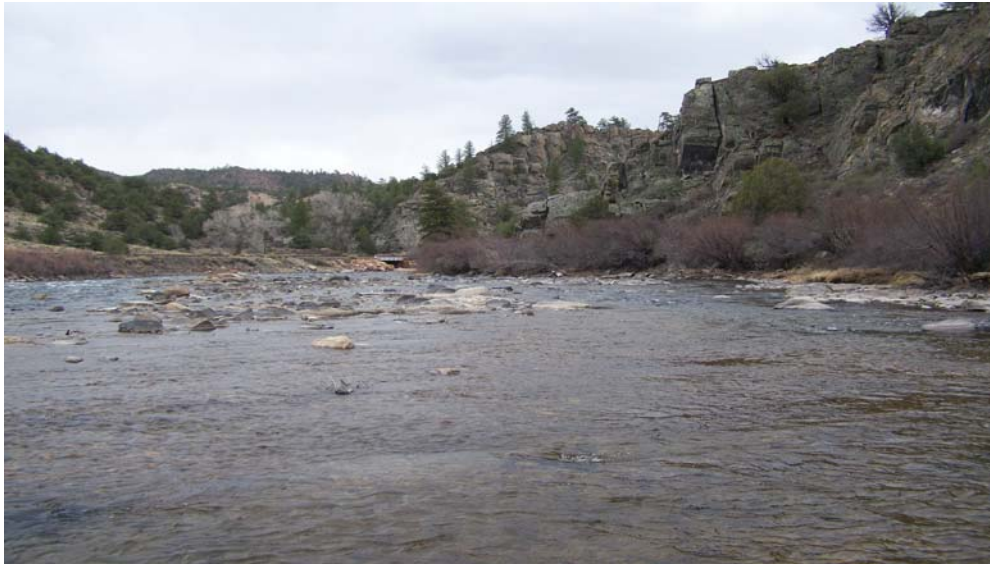
Figure 4 – Riffle-Pool Complex of the Arkansas River

Riffelpool Stream Complex of the Arkansas River (Plot 4)

The section of the Arkansas River at Hecla Junction includes a rifflepool complex. There is a low sinuous channel with riffles, large pools and long runs, and alternating bars. There are many large boulders from ancient glacial outwashes and bedrock constrictions that form excellent pocket water. The most heavily fished and popular sections of the Arkansas River are downstream of Browns Canyon. The river averages from 70-100 feet wide in most areas with boulders, bends and deep seams creating superb habitat for the trout that reside here (Fly Fishing Connection, 2007).

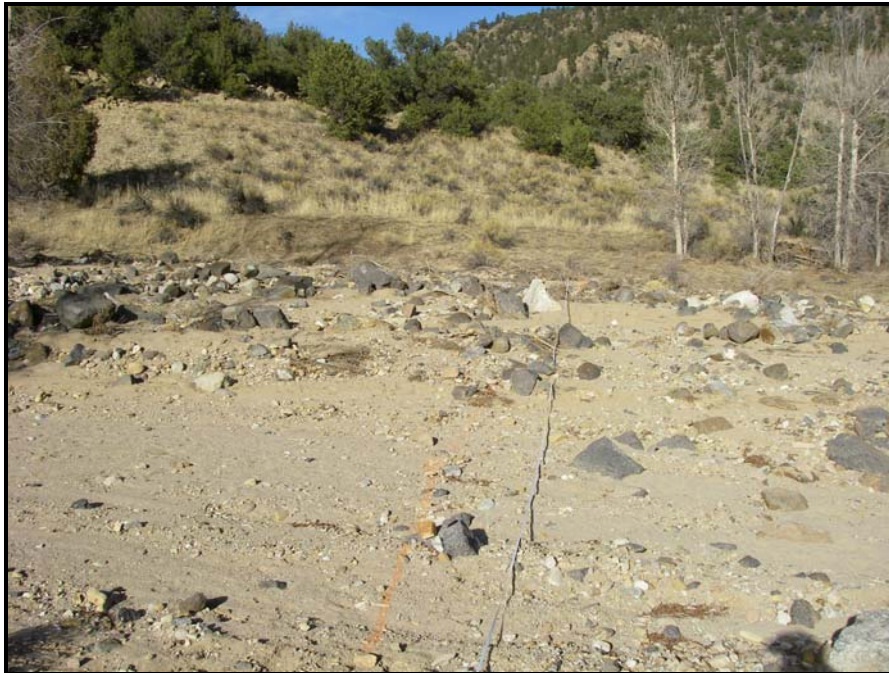
Photograph 5 shows the Wolman pebble count cross section on Reach 4.

Table 1 shows an example of the size variation of sediments deposited during these events. On April 20th, 2007, data was collected at one transect in Reach 4, upstream of

the dip x-ing (RiverRestoration.org, 2007). Size classes ranged from 0.22-24in; data shows a threshold at 3in, 83% of the material is finer. Most of the volume of sediments transported are sand and gravel size classes; although, large angular rock was present indicating colluvial erosion of bedrock slopes. The large rock in adjacent terrace gravels is very rounded. The terrace gravels are likely a different deposit, an ancient terrace of the Arkansas River, and not from the existing alluvial fan.

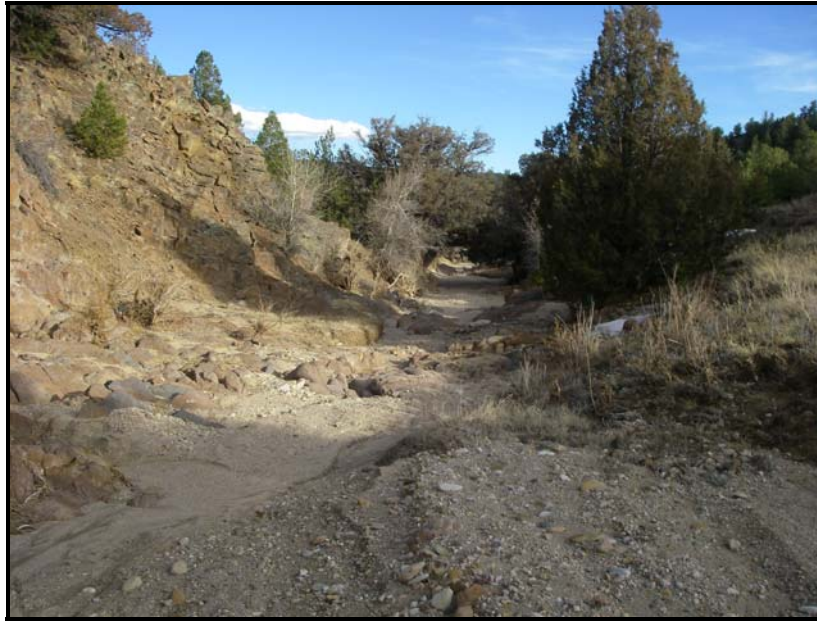
Photograph 10 shows the exposed bedrock after the debris flow event 10/11-12/06.

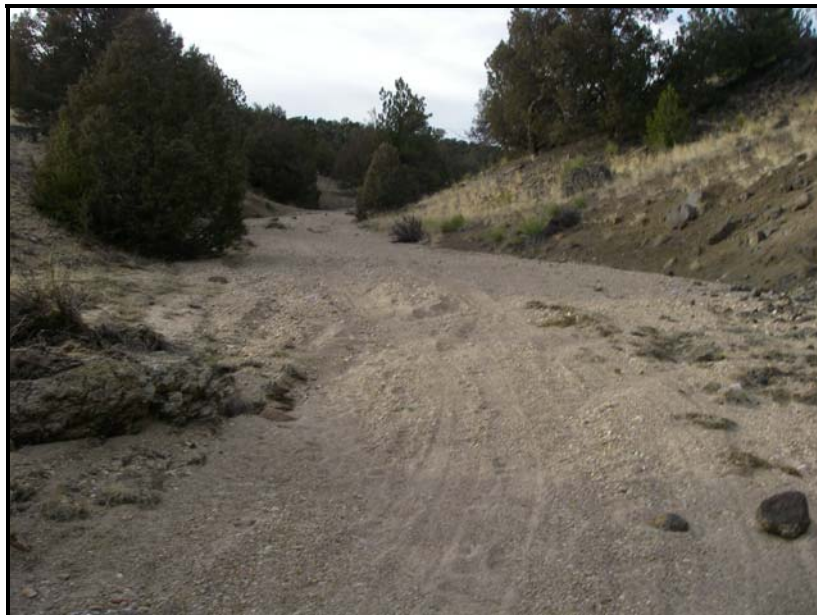
Photograph 11 shows sediments stored in the north tributary
