# **Final Report**

## **Slate River Wetlands Preserve Erosion Control Crested Butte, Colorado**

**Submitted to: Colorado Water Conservation Board  
December 19, 2012**

**Submitted by: Crested Butte Land Trust**

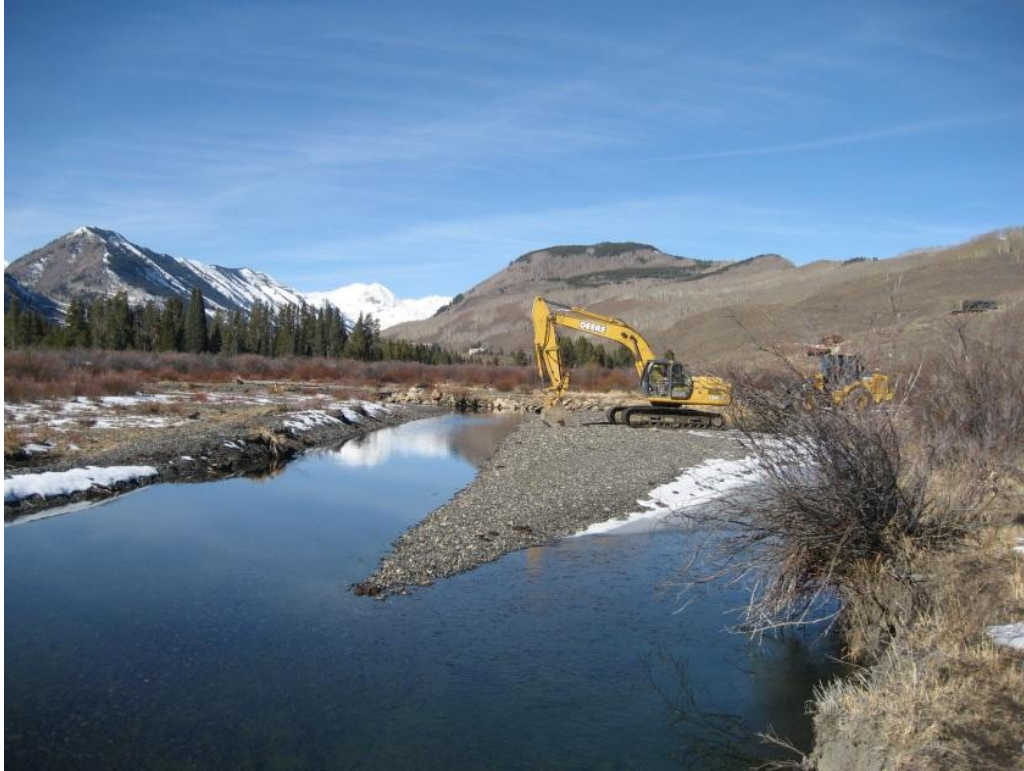
Pre-work gravel bar obstructing natural bend

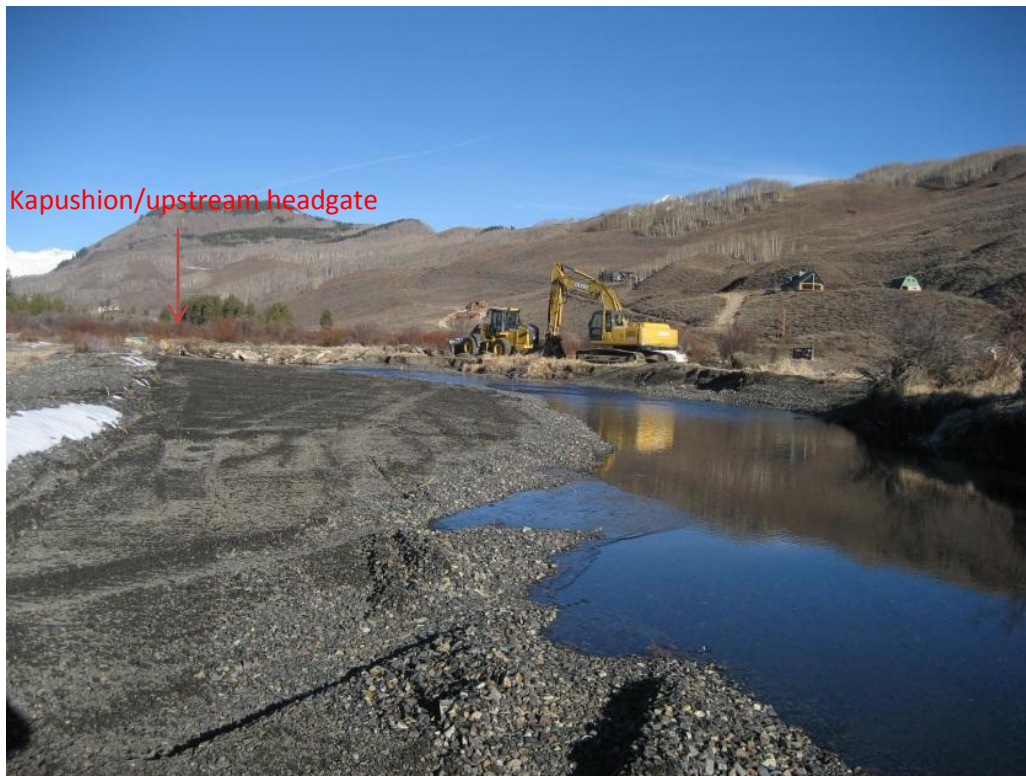
Post work gravel bar blended into west bank

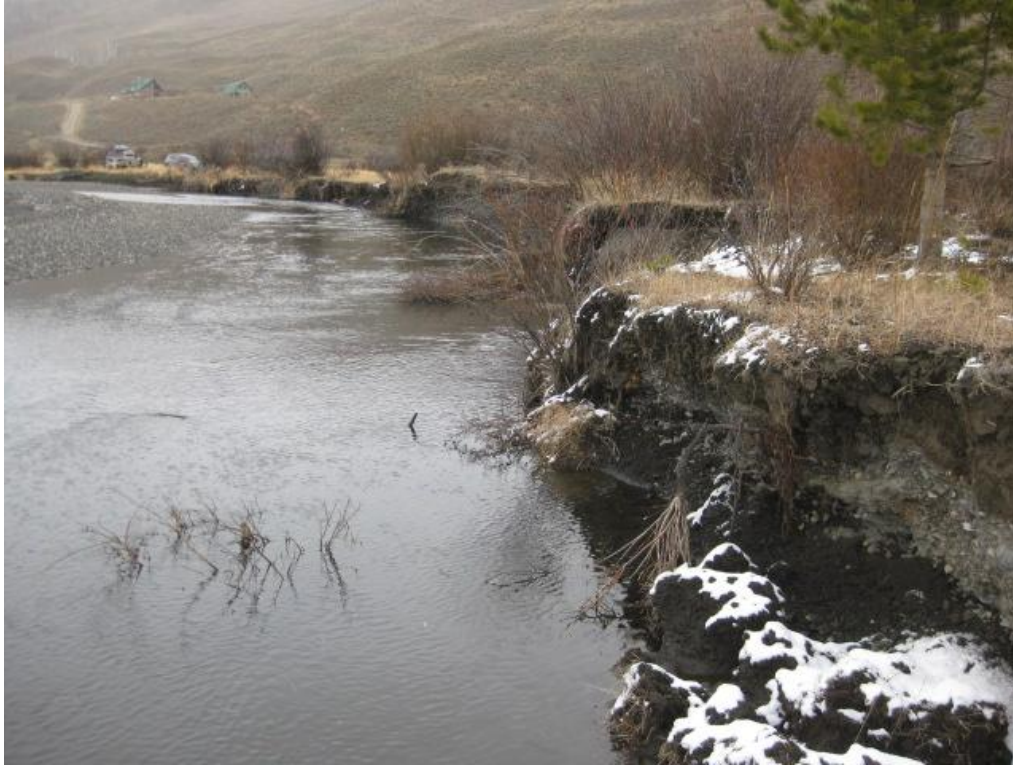
Pre-work view of river stretch (This photo was taken in 2010. The east bank has since eroded to the extent that the pine tree in the forefront was washed downstream)

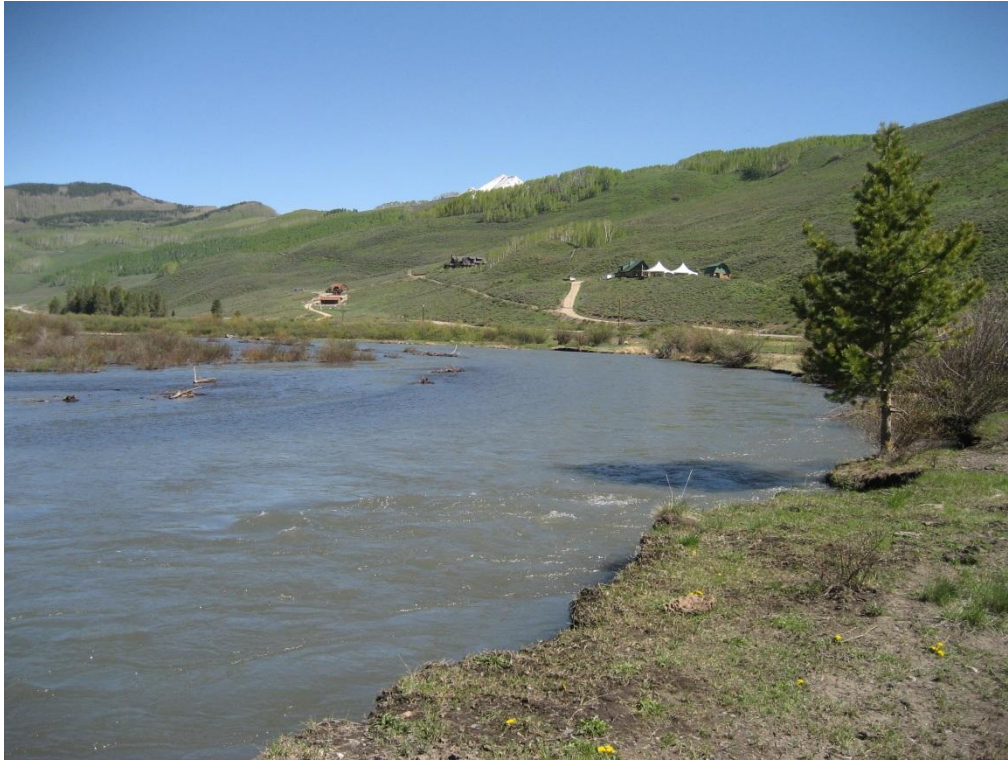
Pre-work view of river stretch at high water

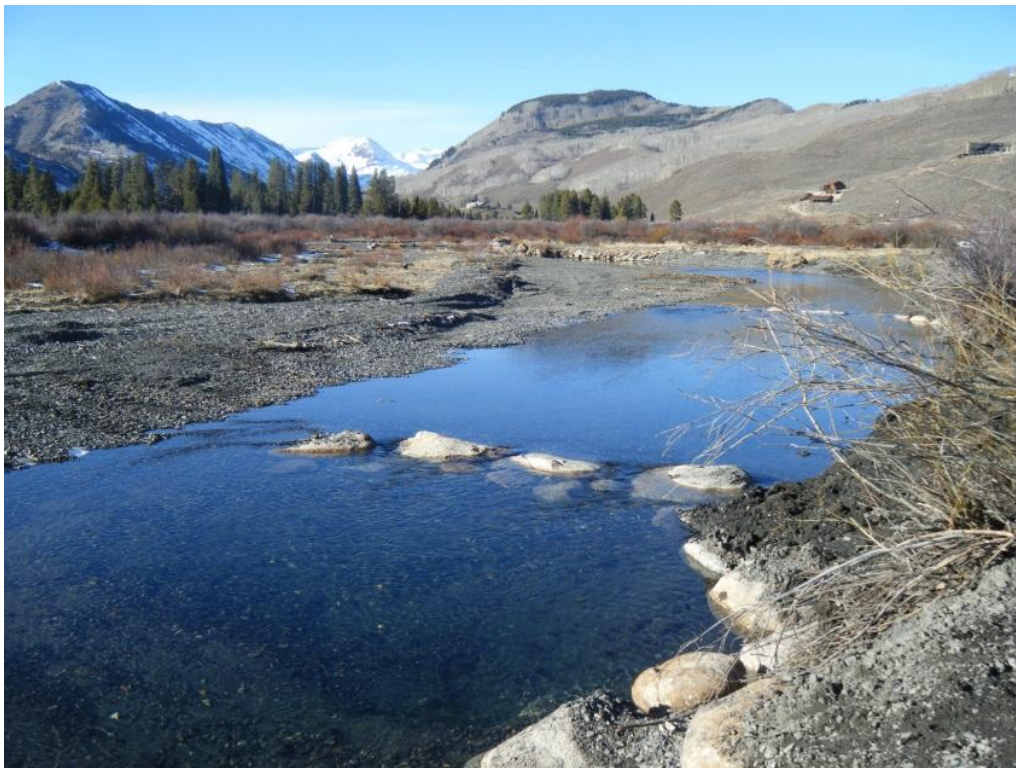
Post work view of middle and upstream j-hooks

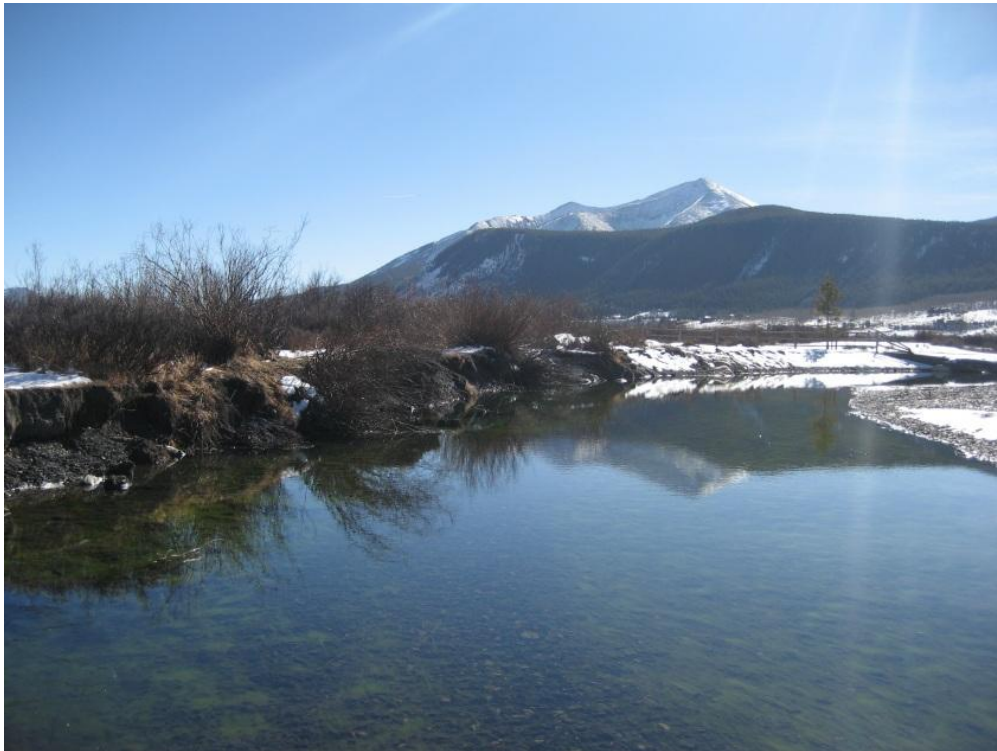
Pre-work view of river stretch and east bank

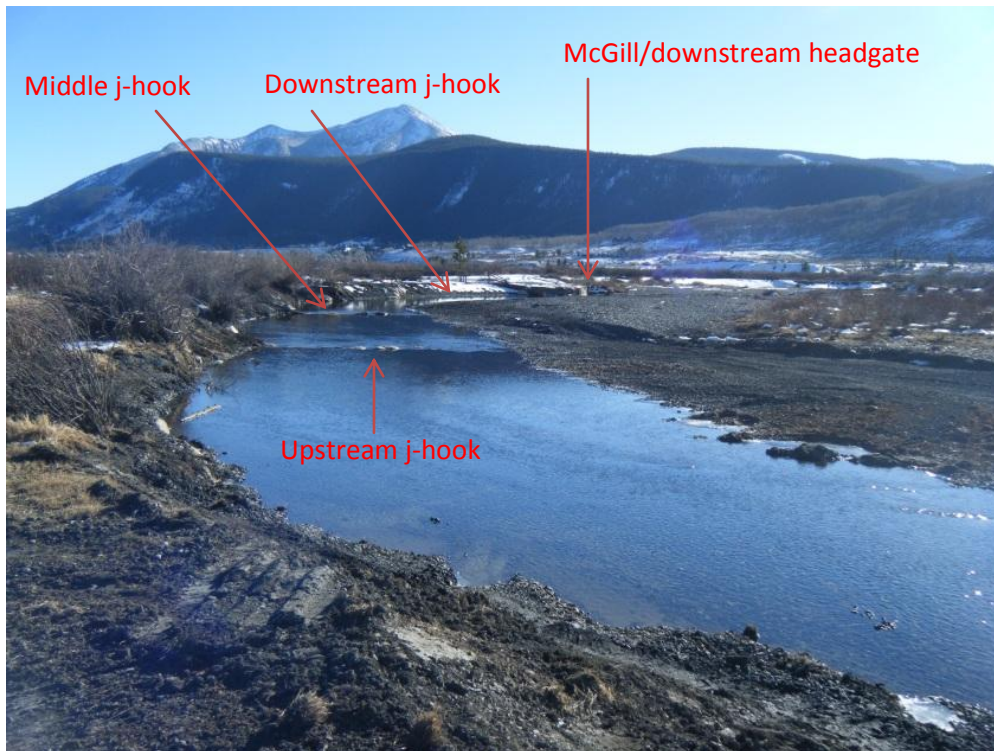
Post work view of restored bend and j-hooks

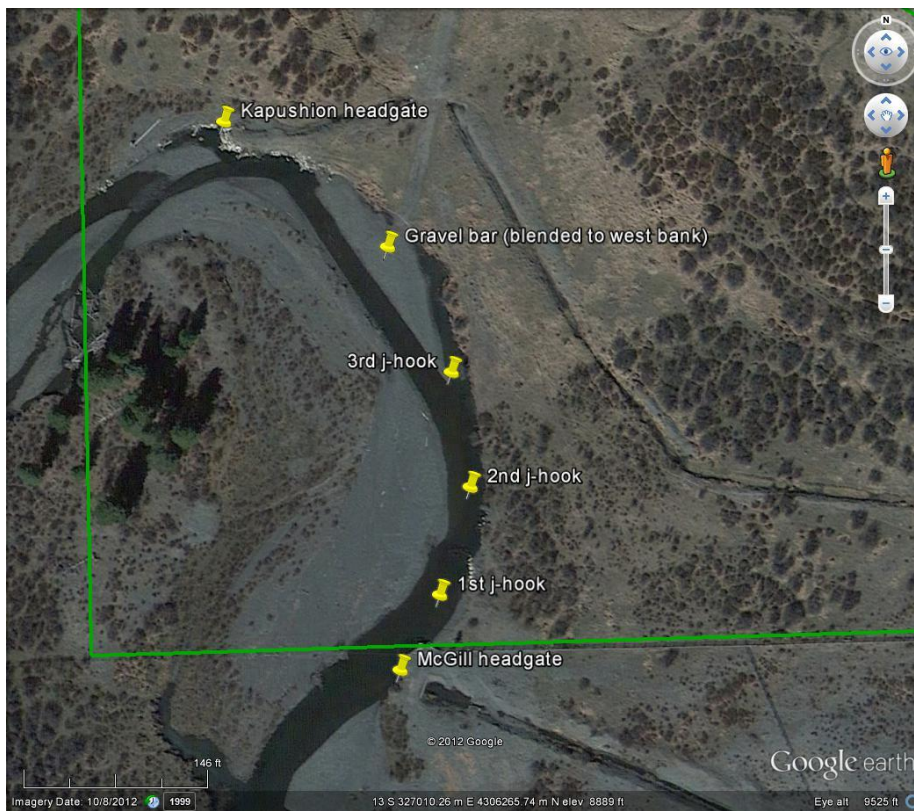
Structure placement map

The following is from a field visit with Danielle Beamer, Stewardship Coordinator to look at the site. We staked J-hooks #1 and #2, and then took a GPS point at #4.

The J-hooks will be about 30 CY's per structure with about 100 CY's of cut from the gravel bar and fill associated with #1 and #2 J-hooks to provide for bank sloping and opening up the channel to keep the channel out from the bank.

#4 J-hook would be completed only if the Land Trust had money in their budget to remove the mid-channel gravel bar. This gravel bar (#3) could be blended in with the point bar on the west side of the Slate River and would amount to about 280 CY's of material moved and repositioned to keep the River against the bank.

#5 is some repair work that could be completed on the Kapushion Ditch Diversion. This would need to be coordinated with the Kapushion's. I have talked with their land manager, Barb East, and she is aware of the need to do some work at this location.

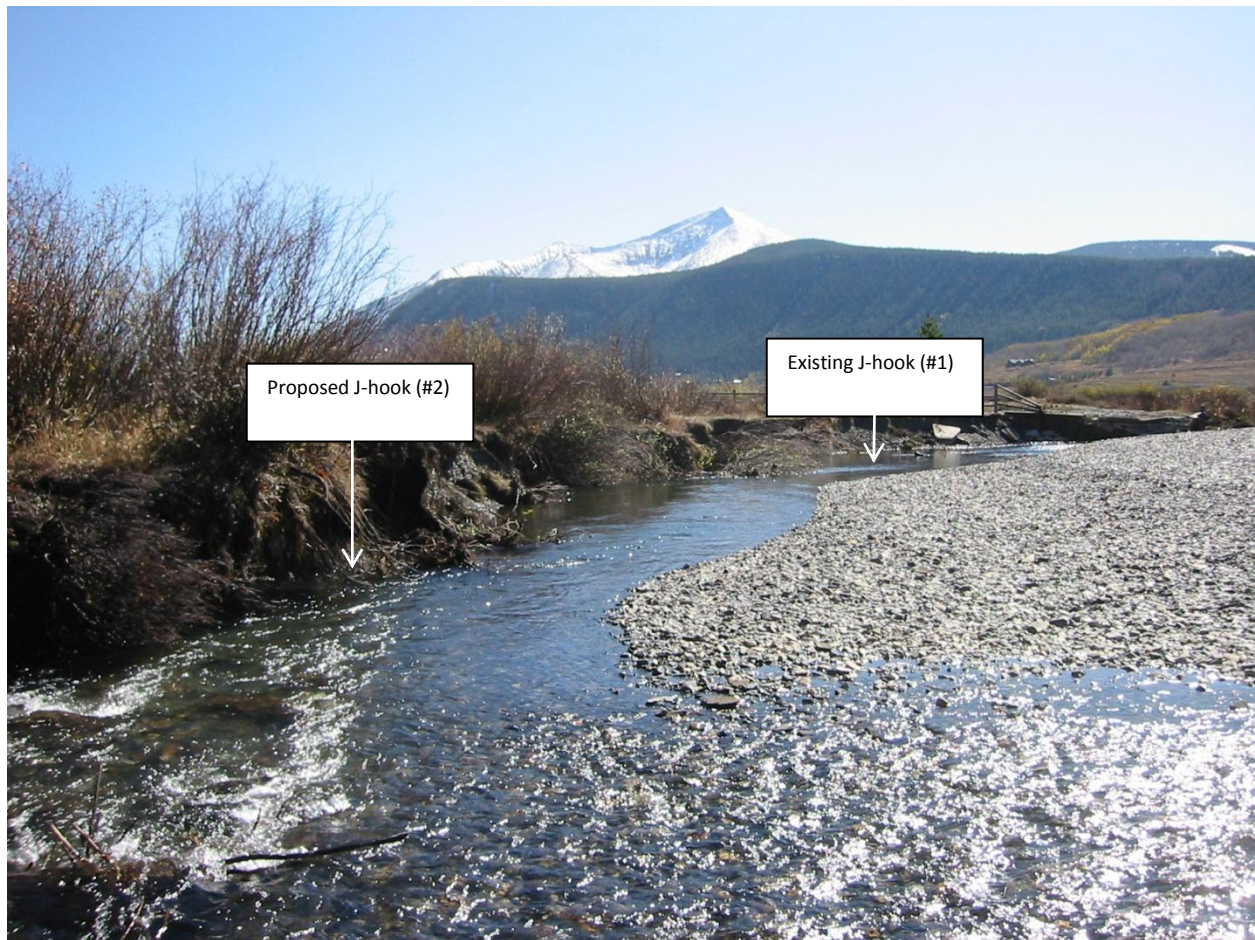
Location for J-hooks #1 and #2- looking downstream (south)
