## **Colorado Healthy Rivers Fund 2012 Final Report**

**GRANTEE and FISCAL AGENT (if different)**  
**Southwest Conservation Corps**

**PROJECT NAME**  
**Rio Grande Restoration Project (RGRP)**

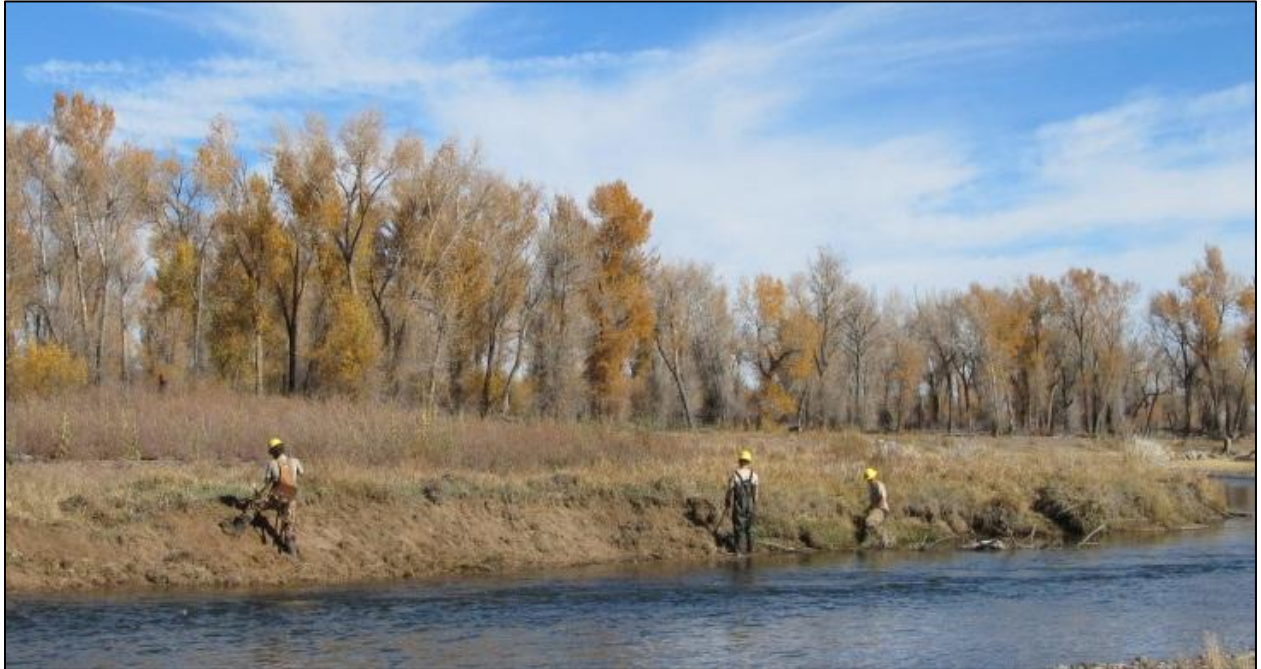
Above: Bank sloping to create 2:1 slope and reduce erosion. Right side of photo shows vertical banks before, left side shows progress by SCC crew.

- Bank sloping: Corpsmembers utilized hand tools (pick-mattocks, shovels and McLeods) to grade vertical banks and create a gentle, 2:1 slope. This reduces the bank's propensity to erode, creates a more suitable surface for re-vegetation of native species, and allows the river to flood cottonwood galleries when it tops its banks.

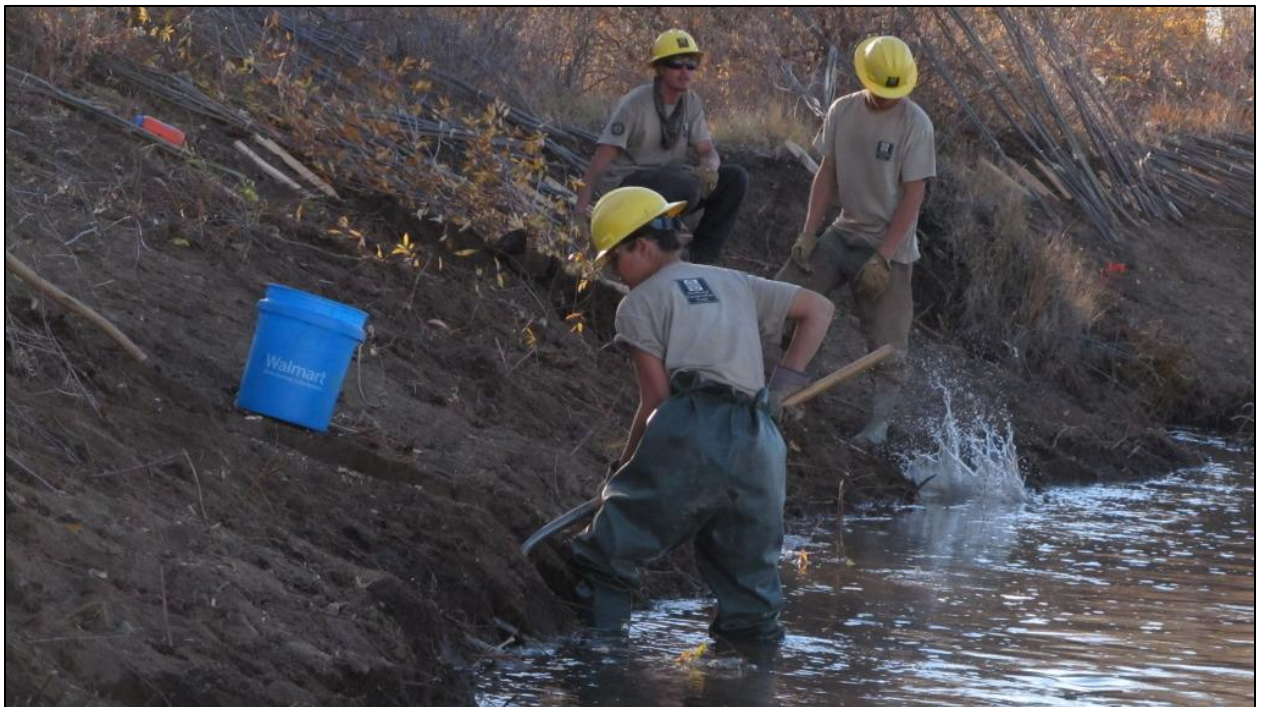
Below: Preparing trenches for willow transplants on re-sloped bank

- Vertical willow bundles: Corpsmembers harvested groups of dormant willow sticks, bundled them in groups of 6-8 sticks, and tied them together with twine. The willows selected were young, with smooth bark, which allows them to sprout roots from the stems when planted. The Corpsmembers then dug a small trench (6-8" deep) in the streambank, perpendicular to the river, and anchored the bundles into the trenches using wooden stakes, ensuring the bottom of the willow bundles were submerged as deep as possible in water. Because the Project was completed in the fall, during low flow, the trenches were dug below bankfull elevation. Bundles were placed along the river's edge every 1-2 feet. The bundles were then covered loosely with soil and then drenched gently with water to wash soil into the bundles and ensure good soil to stem contact. The stems will grow roots and shoots, taking hold in and revegetating the banks. Vertical bundles are designed to lay vertically up the bank which typically gives them an advantage on stream systems that have rapidly fluctuating water levels because no matter where the water level of the stream is, some part of the vertical bundle will be in the water.

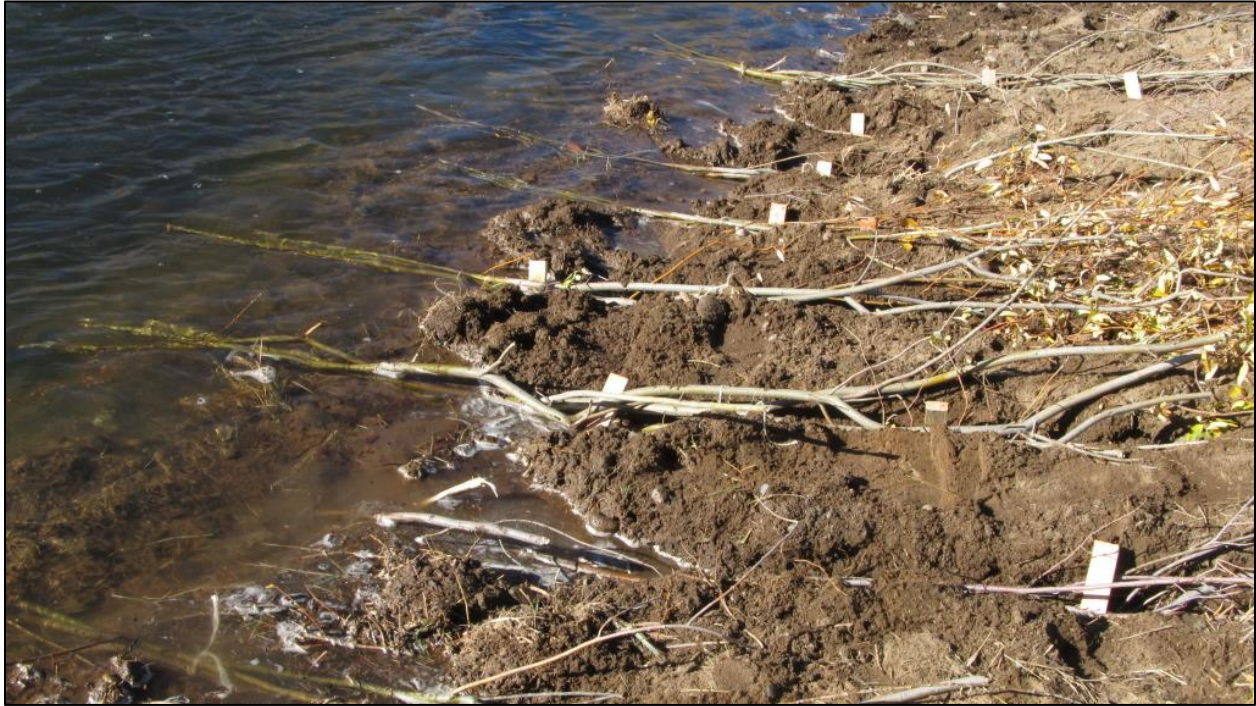
Above: Willow bundles transplanted (harvested, tied and staked) along stream bank to improve vegetation and prevent future erosion.

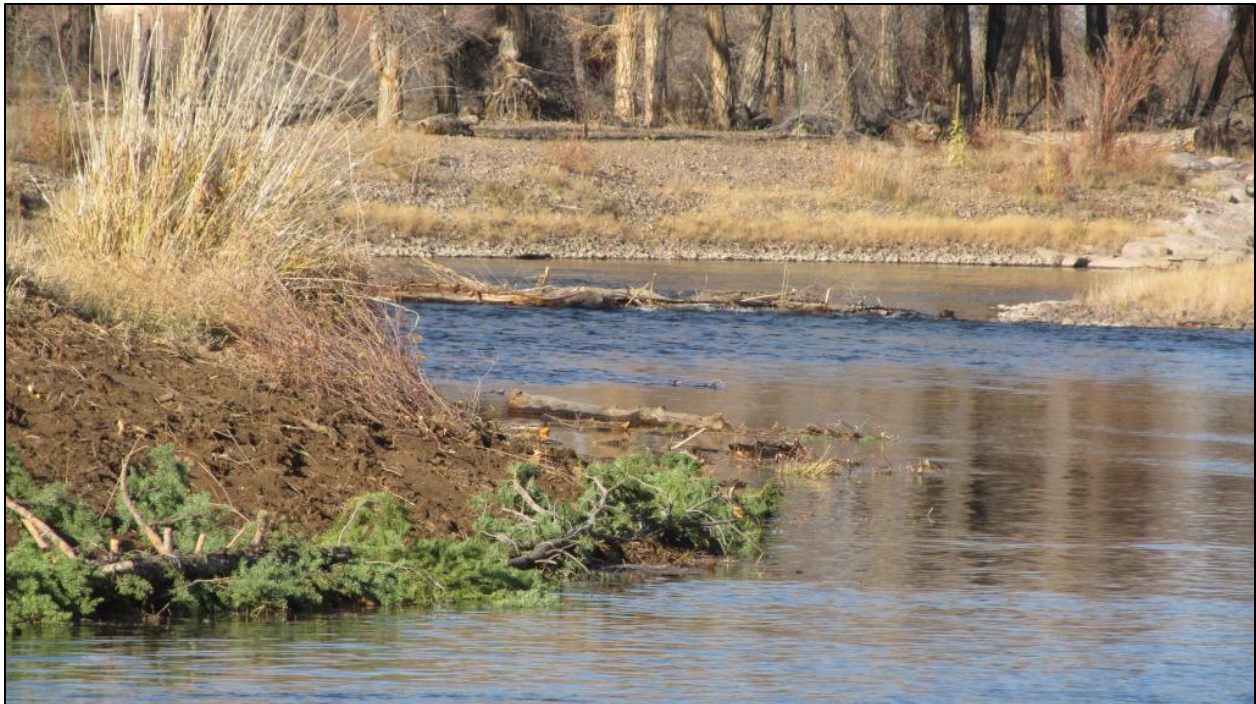
Below: Tree revetments installed along streambank

- Tree revetments: Corpsmembers collected small (6-10' tall) Engelmann spruce, subalpine fir, lodgepole pine, and ponderosa pine trees that had been thinned and left as slash on a local Forest Service timber project. The trees were used to create tree revetments. Construction of the revetment includes placing a tree at the toe of the streambank, on top of the willow bundles. The butt end of the tree is pointed upstream and anchored by driving a duckbill into the bank and securing the tree to the duckbill with attached cable. The next tree is then moved into place with its top overlapping the butt of the first tree. The trees keep the flow off of the willow bundles, protect the banks from erosion, and allow silt and sand to deposit along the bank and within the tree branches. The deposited material forms a good seedbed and parent material for riparian vegetation. By the time the revetment trees have decayed, the bank should be stabilized by the roots of the riparian shrubs and vegetation. As an added benefit, tree revetments provide excellent fish and wildlife cover
