2013 Slate River Water Sampling: Macroinvertebrate & E. coli Final Report

Prepared For:
Colorado Healthy Rivers Fund Grants
Attn: Chris Sturm
Colorado Water Conservation Board

Prepared and Co-Authored by:
The Coal Creek Watershed Coalition - Crested Butte, CO
Zach Vaughter, Executive Director
&
Alpine Environmental Consultants LLC
Ashley Bembenek, Water and Soil Specialist

Colorado Healthy Rivers Fund: Task B. Slate River Water Quality Monitoring

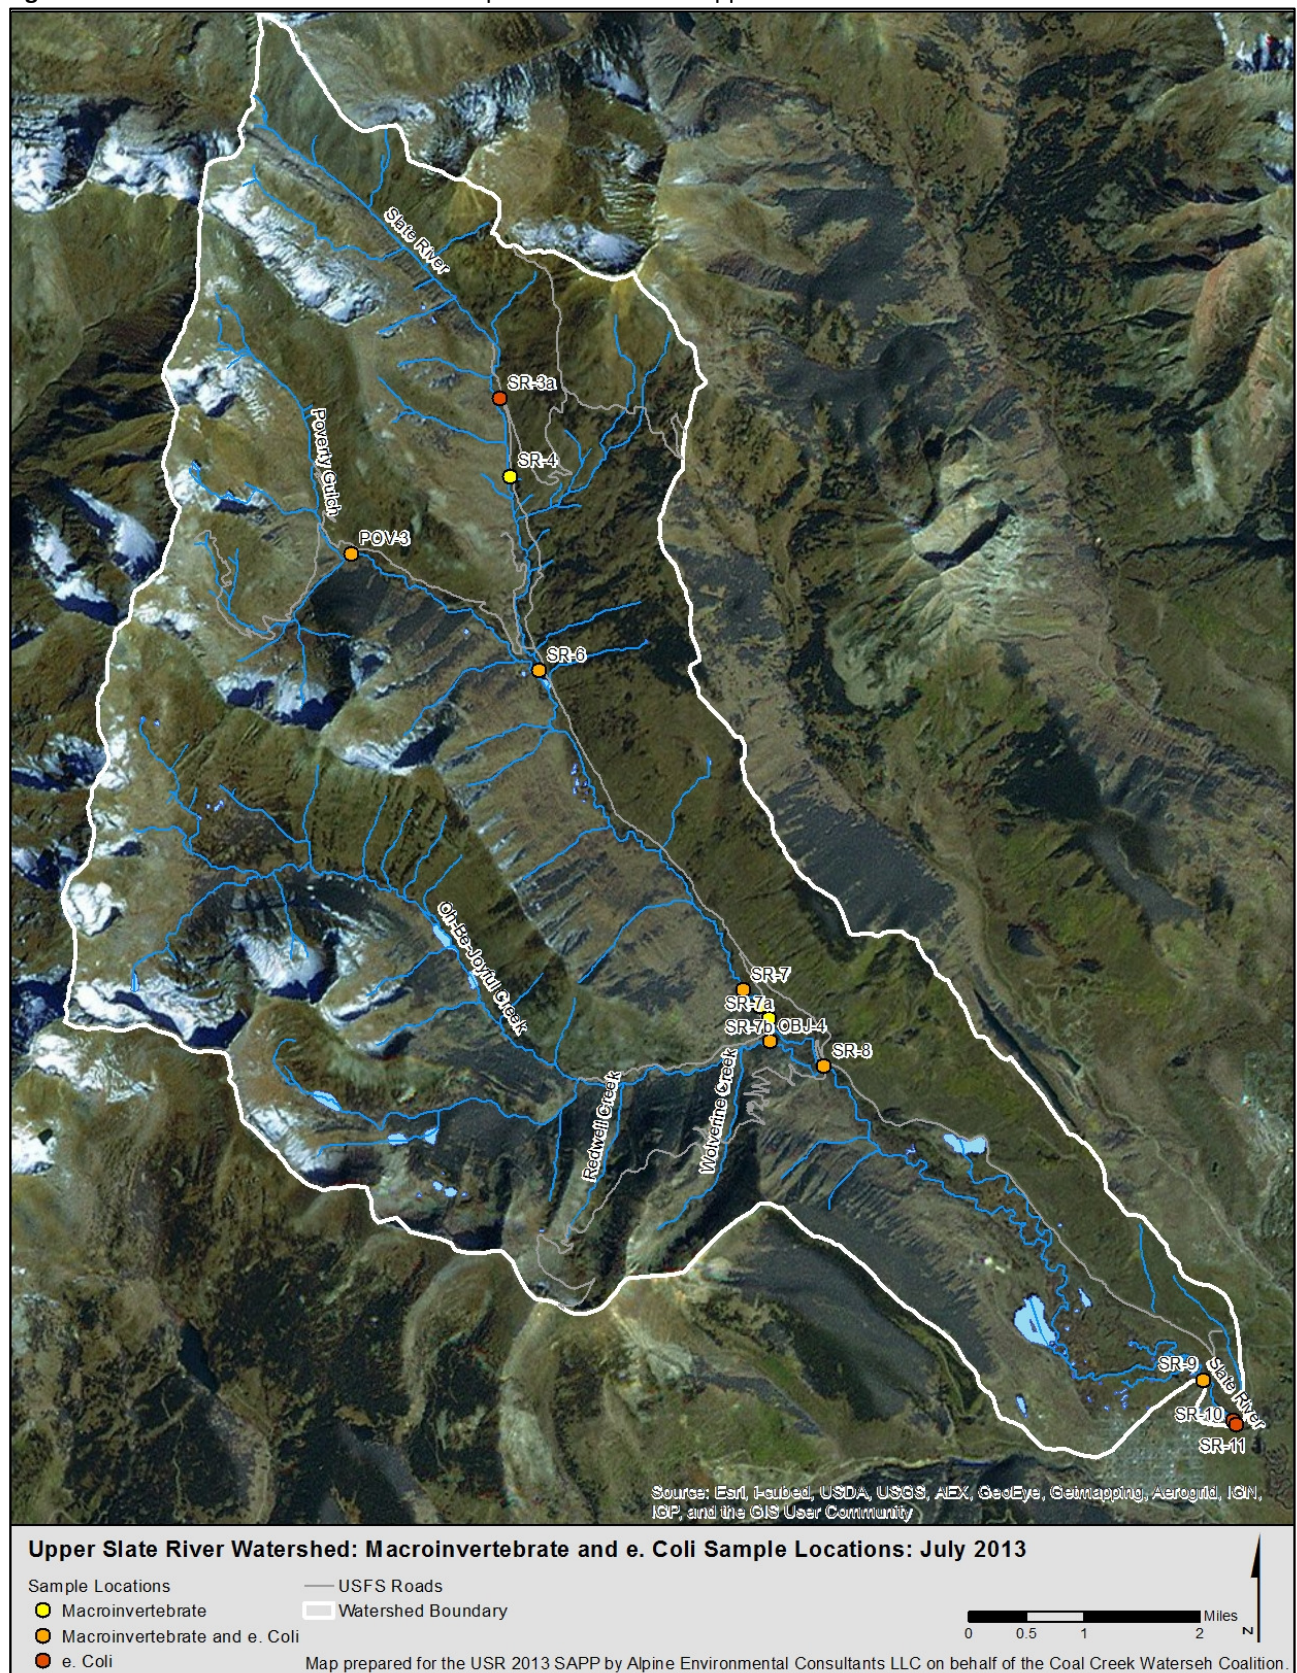
Figure 1. Macroinvertebrate and *E. coli* sample locations in the Upper Slate River Watershed

The Upper Slate River (USR) Watershed is located near Crested Butte in southwestern, Colorado. The watershed drains approximately 34 square miles on the east side of the Ruby Mountain Range, in Gunnison County. The USR Watershed contains roughly 71 miles of rivers and streams (perennial, intermittent and ephemeral; Figure 1).

On July 29, 2013 MI samples were collected from 9 locations according to the protocol established by the National Aquatic Monitoring Center (NAMC; Figure 1). The NAMC protocol is suitable for calculating Multi-Metric Index (MMI) scores. MMI scores are the criteria used by CDPHE to assess attainment of aquatic life use standards. The NAMC protocol was followed by trained field technicians. The MI samples were collected from eight randomly selected subsample locations on a 500 foot transect. Macroinvertebrates were sampled from a 0.74 square meter area. Transects were sampled from downstream to upstream to prevent disturbance to potential subsample locations. Following collection and preservation, with ethanol, the samples were sent to the Utah State University Bug Lab. The lab analyzed the MI samples to genus level according to the methods outlined by NAMC. A duplicate sample was collected from SR-7. The relative percent difference (RPD) between the duplicate and original sample was less than 10 percent. The RPD is suitable and suggests that both field and lab methods were consistently applied.

On August 12, 2013 *E. coli* samples were collected from 12 locations in the USR Watershed (Figure 1). Field technicians followed standard collection protocols for *E. coli* sample collection. The National Park Service provided in-kind laboratory space and supplies to complete sample analysis using EPA Method 1603 (EPA, 2009). Sample collection and analysis was completed within the holding times outlined in Method 1603. The control samples, a small volume of deionized water used to determine whether contamination occurs in the lab, did not support *E. coli* growth and the *E. coli* concentrations were 0 colonies per 100 milliliters (col/100 mL). The *E. coli* concentration measured in the duplicate sample collected from SR-6 exceeded the concentration of the original sample SR-6 with concentrations of 32 and 126 col/100 mL, respectively (Table 2). The *E. coli* concentration of the duplicate sample was the highest concentration measured during the sample event (Table 2). The *E. coli* concentration of the duplicate suggests that some form of contamination was introduced to the duplicate sample collected from SR-6. The control results indicate this contamination did not occur in laboratory. The *E. coli* concentrations of the other samples do not suggest that ambient conditions in the Slate River are a likely source; all other reported values were less than half of the duplicate concentration (Table 2). It appears that the duplicate was contaminated immediately following sample collection or during transit to the lab. The sample collected from SR-4 leaked during transit and could not be analyzed at the laboratory.

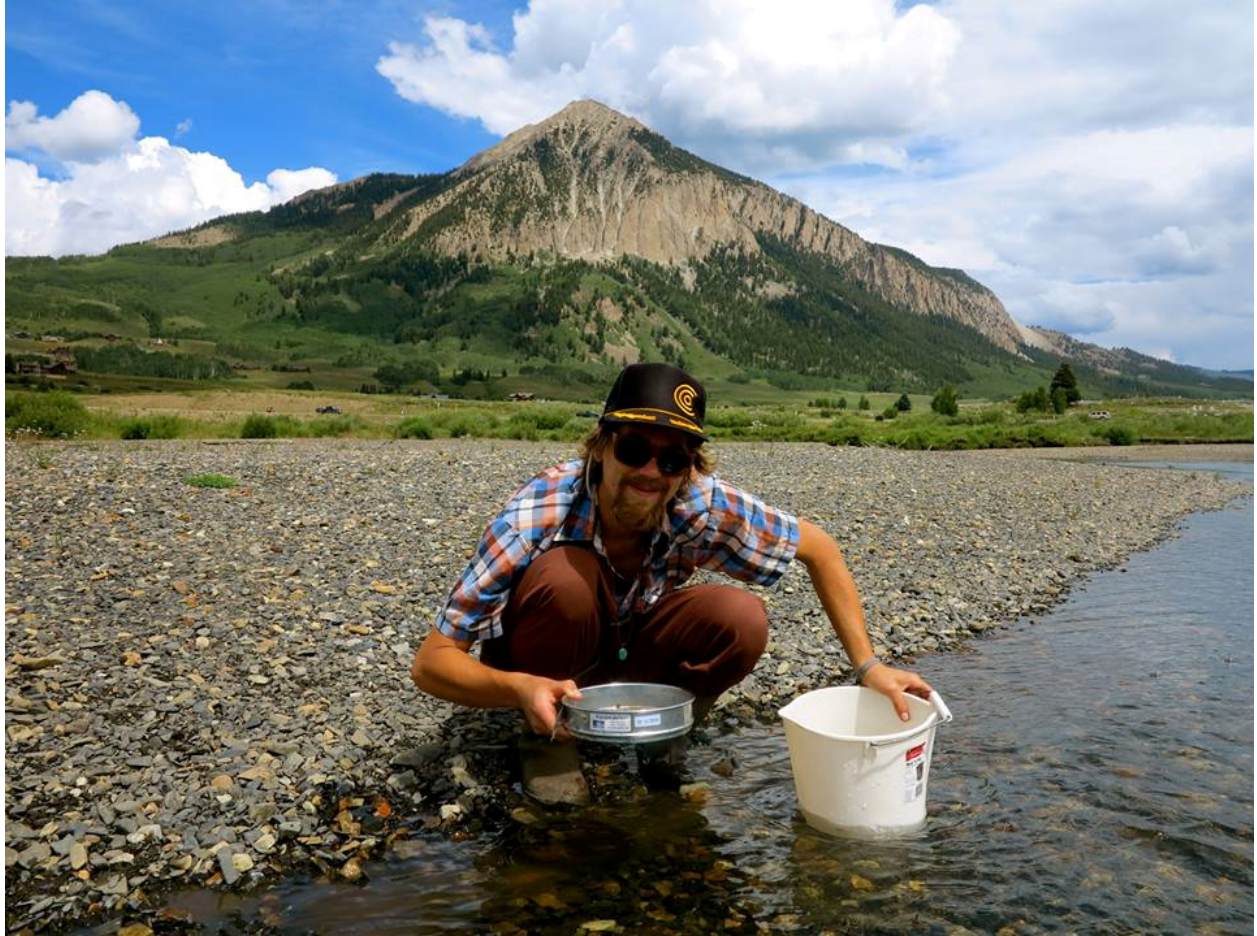
CCWC Field Technician, Zach Vaughter collects Macros on August 12th 2013 on the lower reach of the Slate River before it's confluence with Coal Creek. Mt. Crested Butte in the background.
