Commercial Water Conservation Audit Program Final Report

Grant Number OE PDA # 13000000065

The Center for ReSource Conservation
2639 Spruce Street
Boulder, CO 80302

July 31, 2014

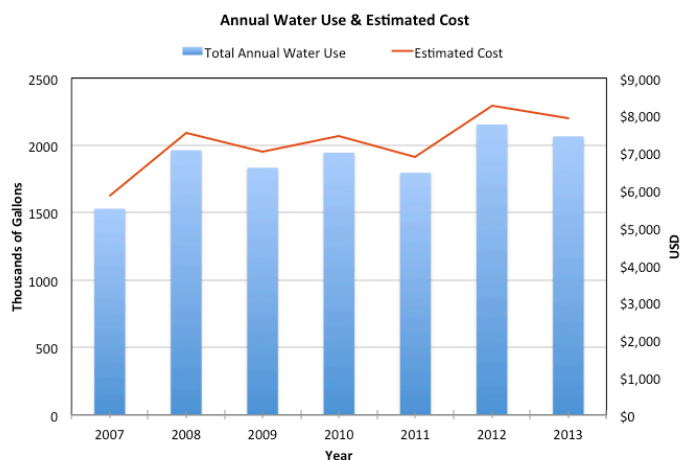
Figure 2. Annual water use (blue bars) (thousands of gallons) and estimated cost (red line) (\$) from 2007-2013 for a Thornton restaurant.

Total annual use was also provided to each business. Figure 2 shows the total annual use and estimated annual cost for a Thornton restaurant. Graphs such as this were used to provide businesses with some sense of how much water they were using and how much it cost them annually. The cost estimate was not always included with the annual usage information due to challenges with calculating the estimated cost, however in the future this may become a standard part of the report if we find it useful for encouraging businesses to implement the water conservation recommendations.
