OPHIR PASS FEN RESTORATION PROJECT

FINAL REPORT *Project Number OE PDA 12000000090*

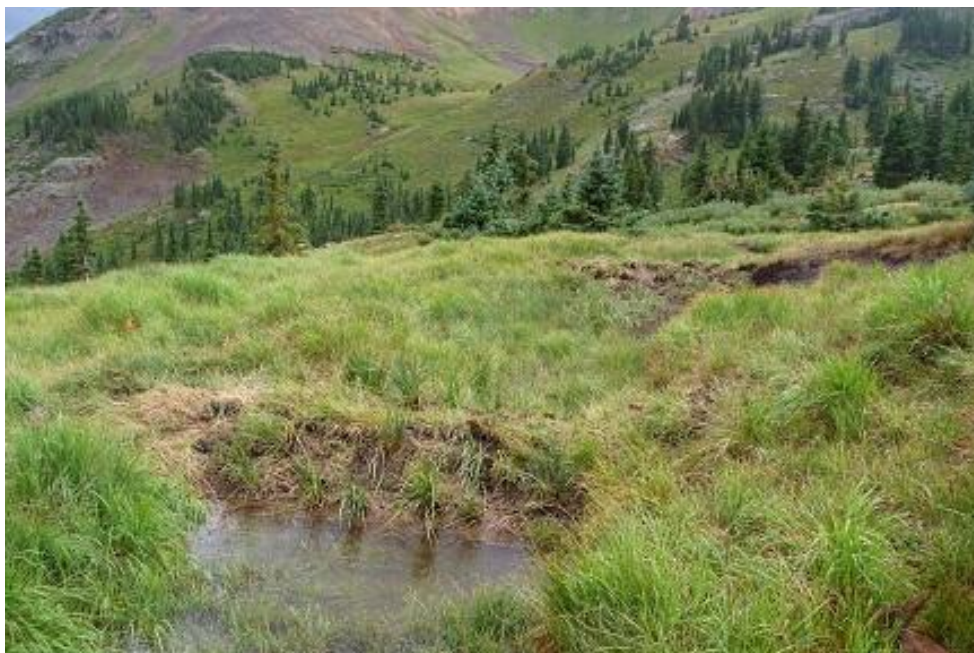
Figure B-9: Ditch 3 Excelsior bale hams holding water (August 2012)

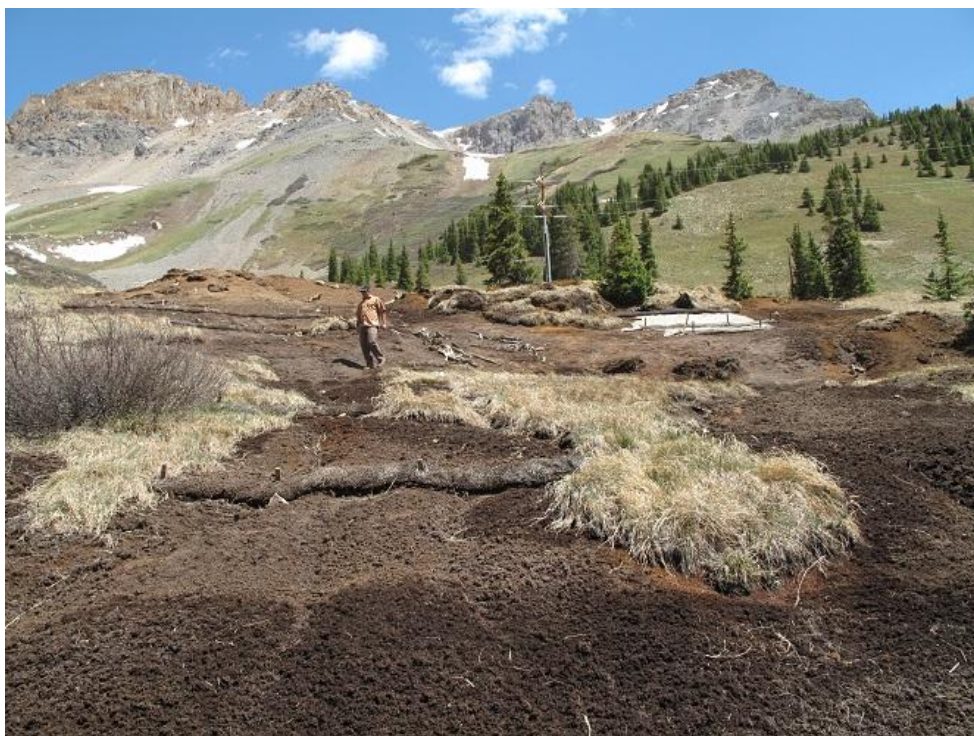
Figure B-10: looking north and upslope at the erosion of the steep bare area (May 2012)

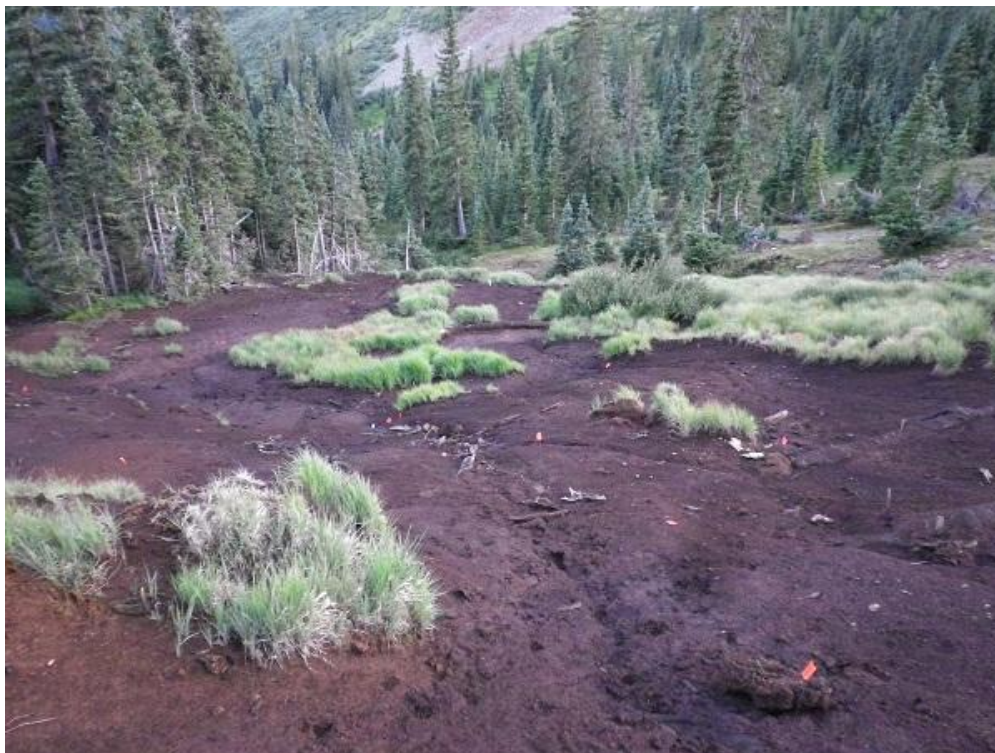
Figure B-11: looking south and downslope at the erosion of the steep bare area (July 2012)

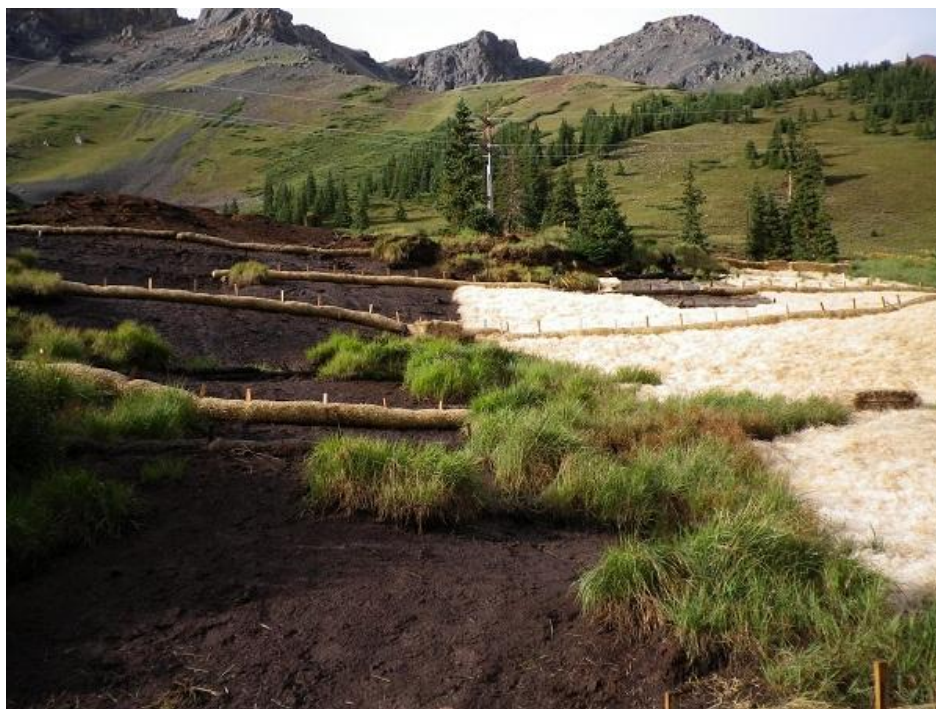
Figure B-12: looking north and upslope at the steep bare area after grading occurred and wattles and partial mulch were laid (August 9, 2012)

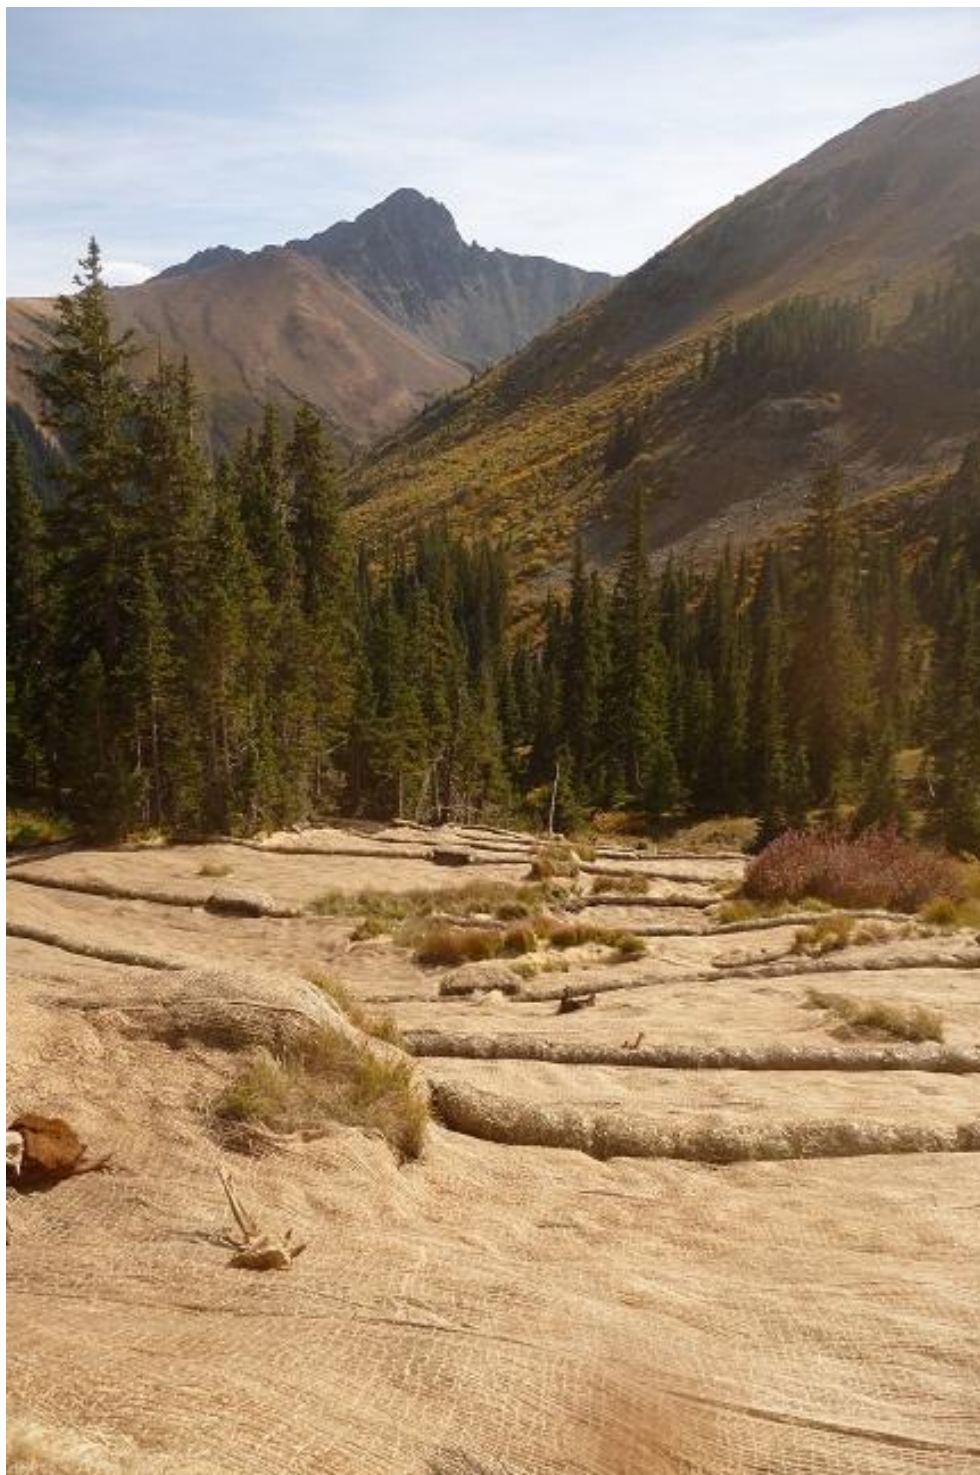
Figure B-13: looking south and downslope after all the steep bare area mitigation was completed (August 9, 2012)

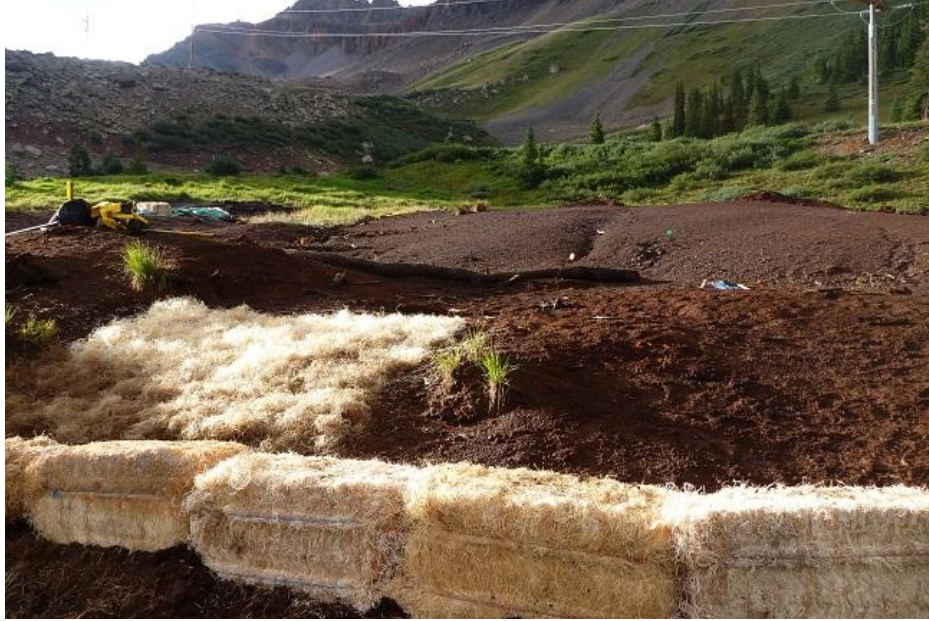
Figure B-14: looking north and upslope at the western mineralized mound on the large bare area (background). The bales in foreground are the erosion control installed to catch sediment from heavy equipment construction (August 1, 2012)

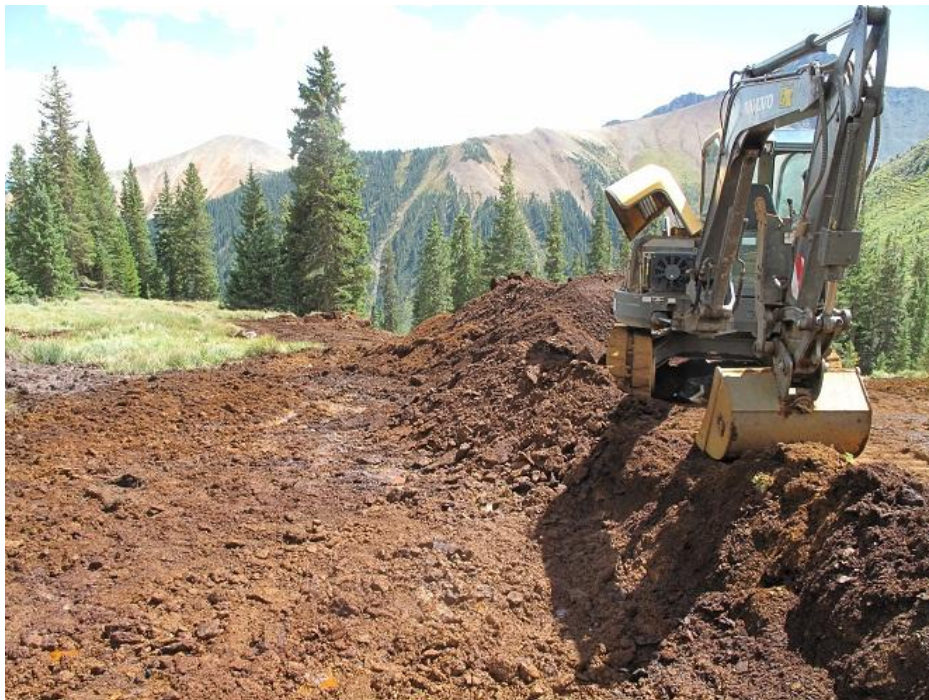
Figure B-15: looking south and downslope at the western mineralized mound being excavated by AJ Construction (September 4, 2012)

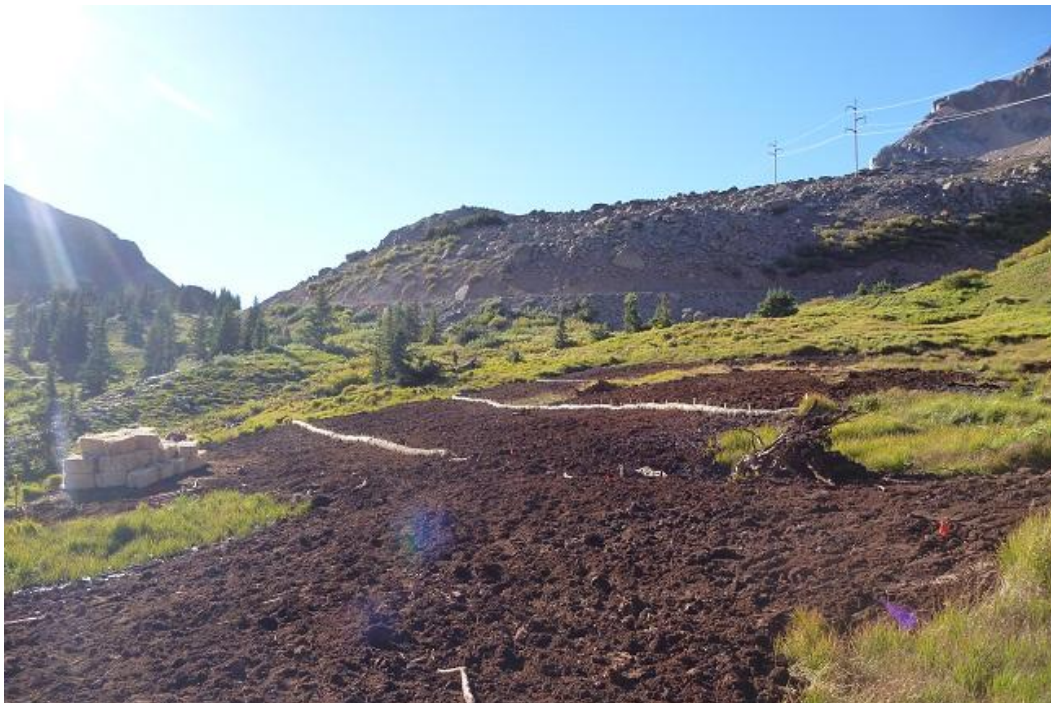
Figure B-16: looking west across the newly graded large bare area after construction (September 5, 2012)

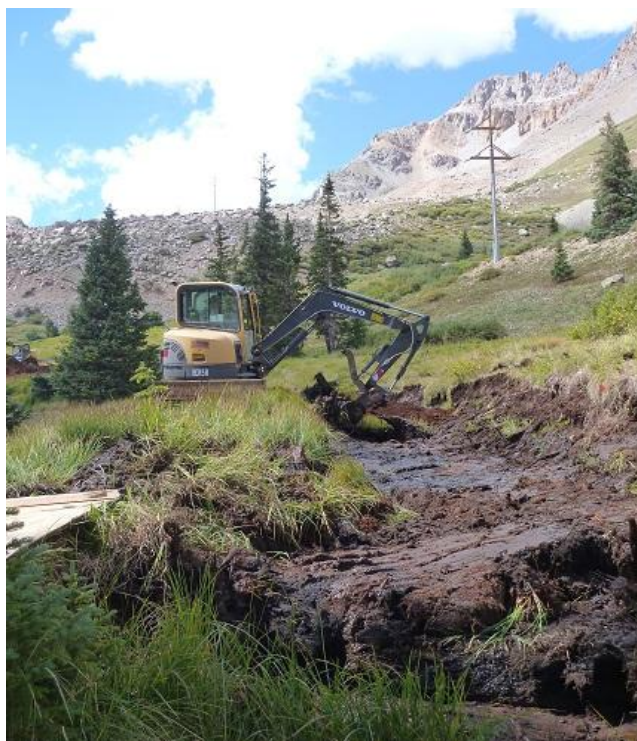
Figure B-18: AJ Construction removing vegetation as construction on Ditch 6 begins (September 4, 2012)

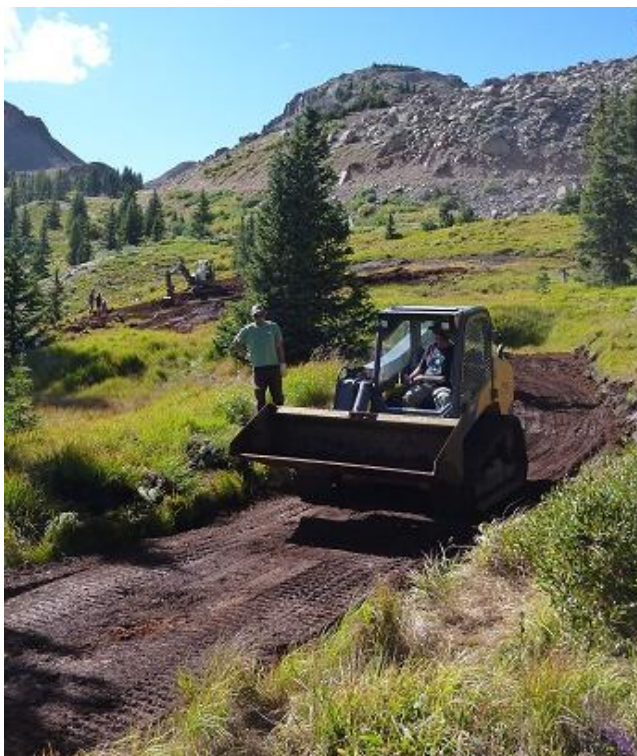
Figure B-19: AJ Construction filling Ditch 6 with material from the large bare area (September 4, 2012)

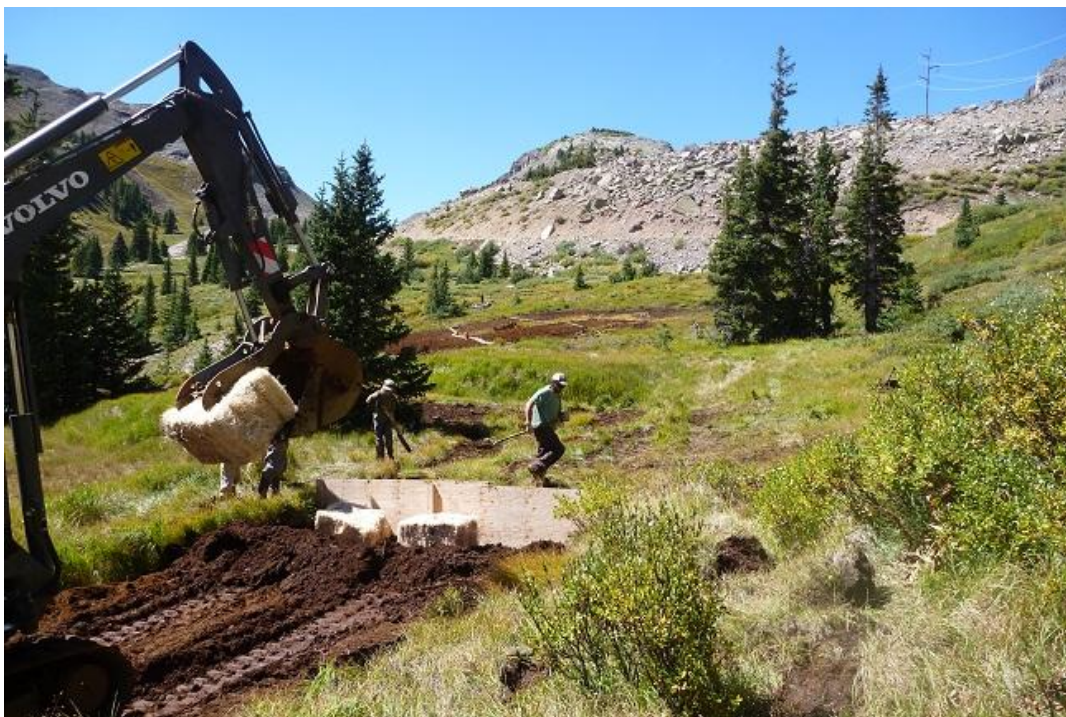
Figure B-20: AJ Construction installing a plywood dam and excelsior bales in Ditch 6 (September 5, 2012)

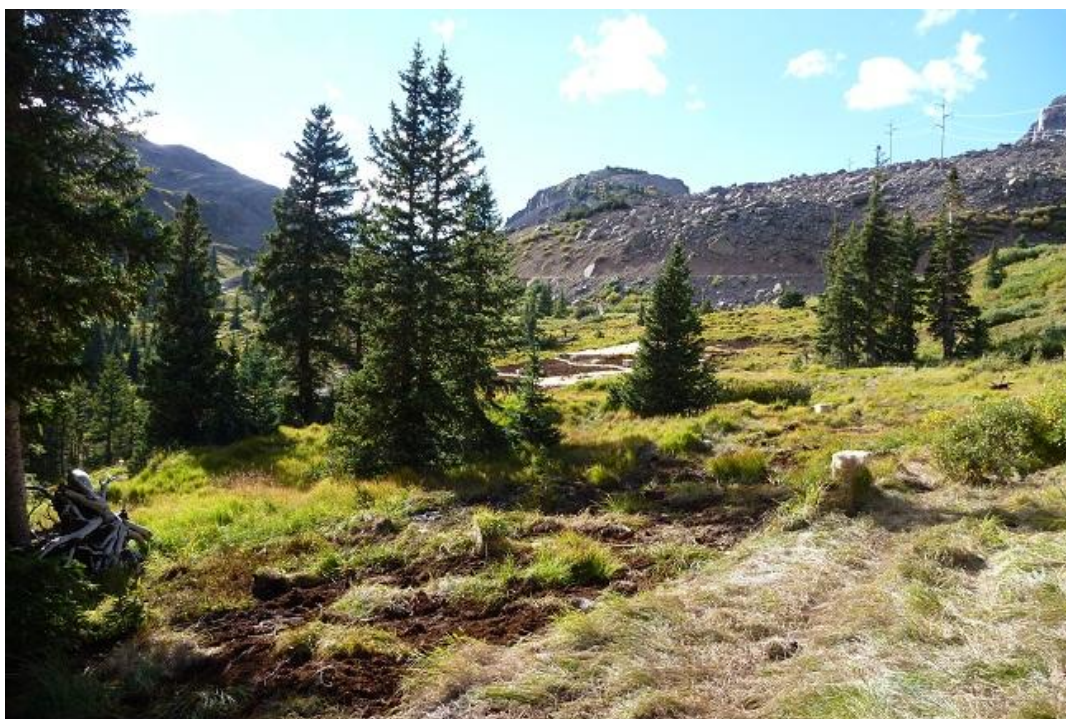
Figure B-21: Ditch 6 after infilling, installing plywood dams, and revegetating (September 5, 2012)

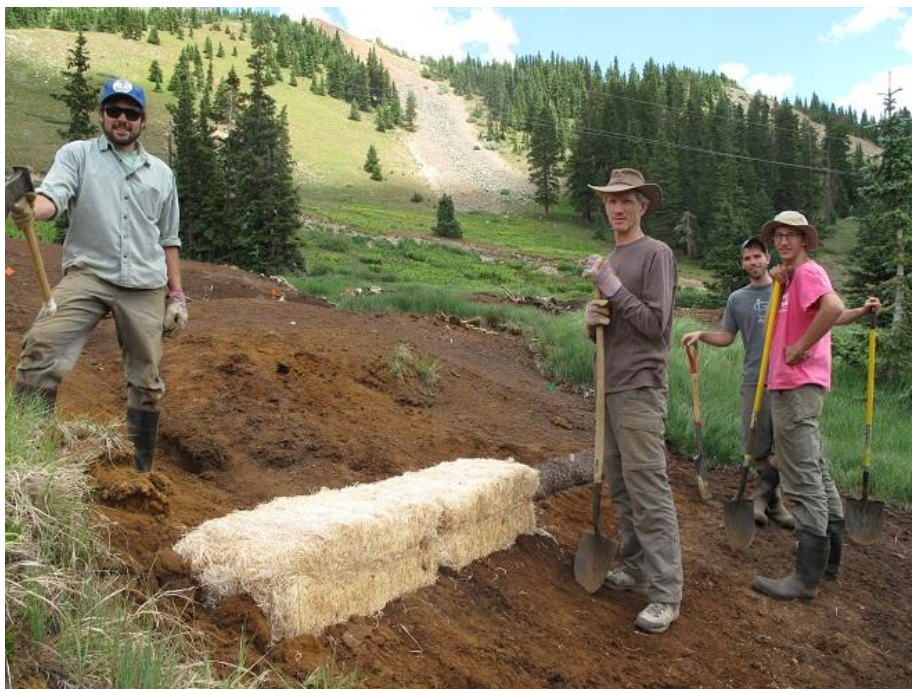
Figure B-22: installing Excelsior bale erosion controls with MSI staff, interns and a visually impaired student volunteer from University of Colorado (July 11, 2012)

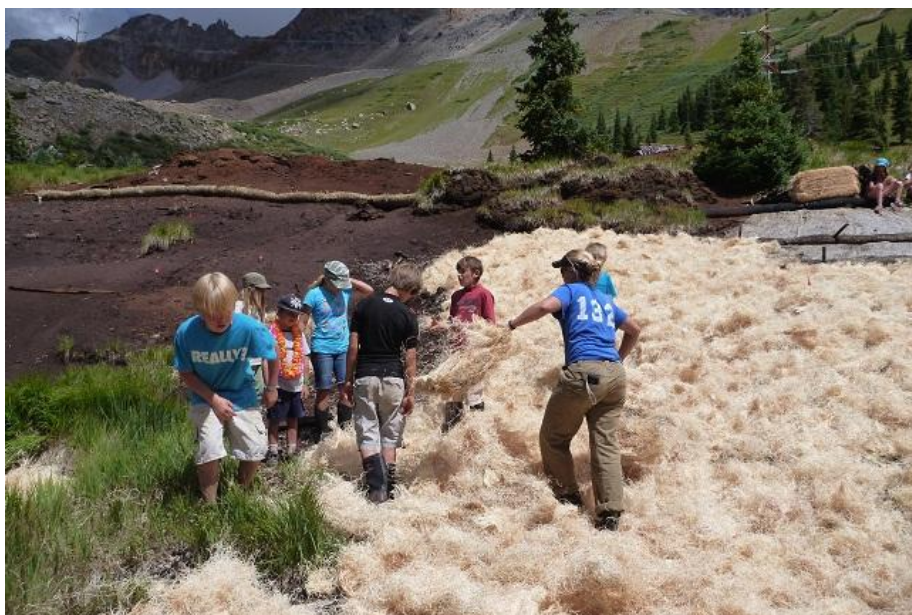
Figure B-23: Gretchen Fitzgerald's and Silverton Ecology Camp mulching the steep bare area (August 7, 2012)

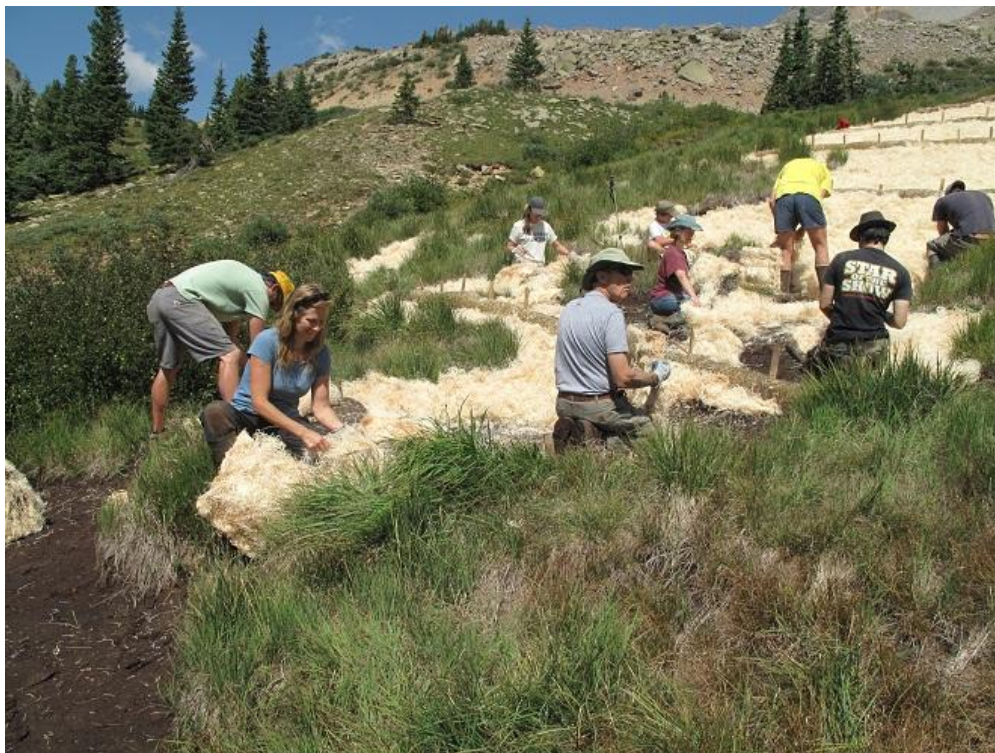
Figure B-24: MSI staff and Colorado Mountain Club volunteers mulching the steep bare area (August 18, 2012)

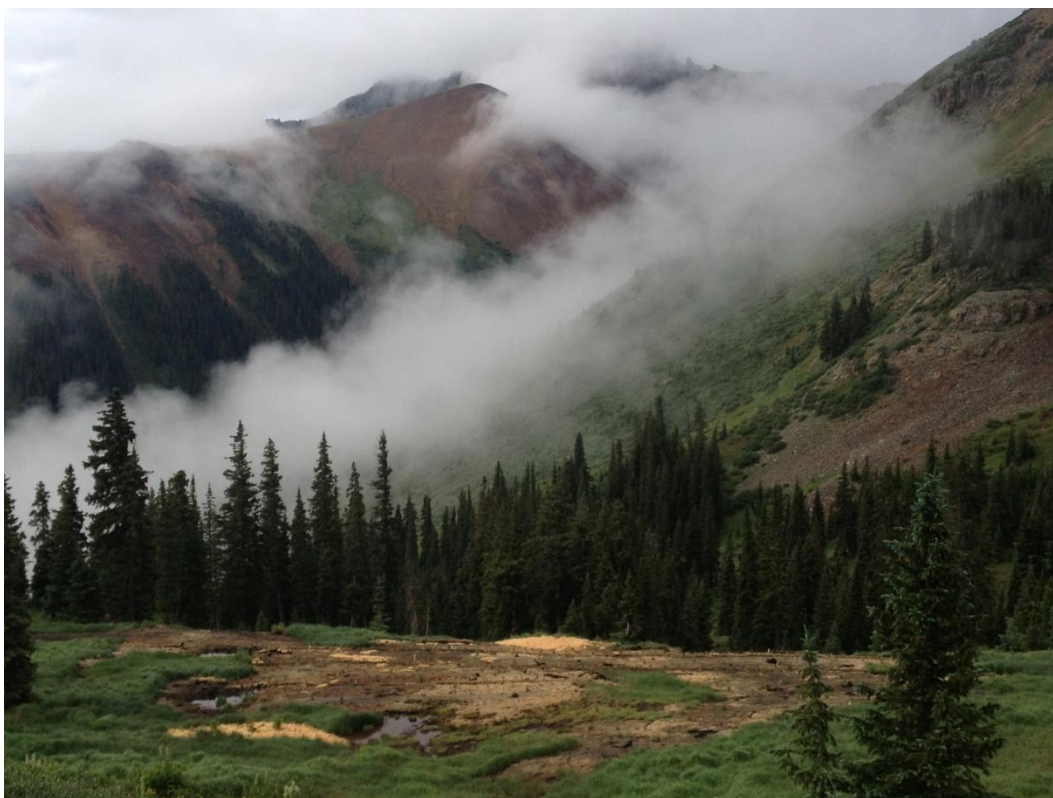
Figure B-27: Ophir Pass Fen after spring melt (June 14, 2013)
