Boulder Creek Volunteer Restoration 2011 Final Report

Wildlands Restoration Volunteers

July 20 – December 31, 2011

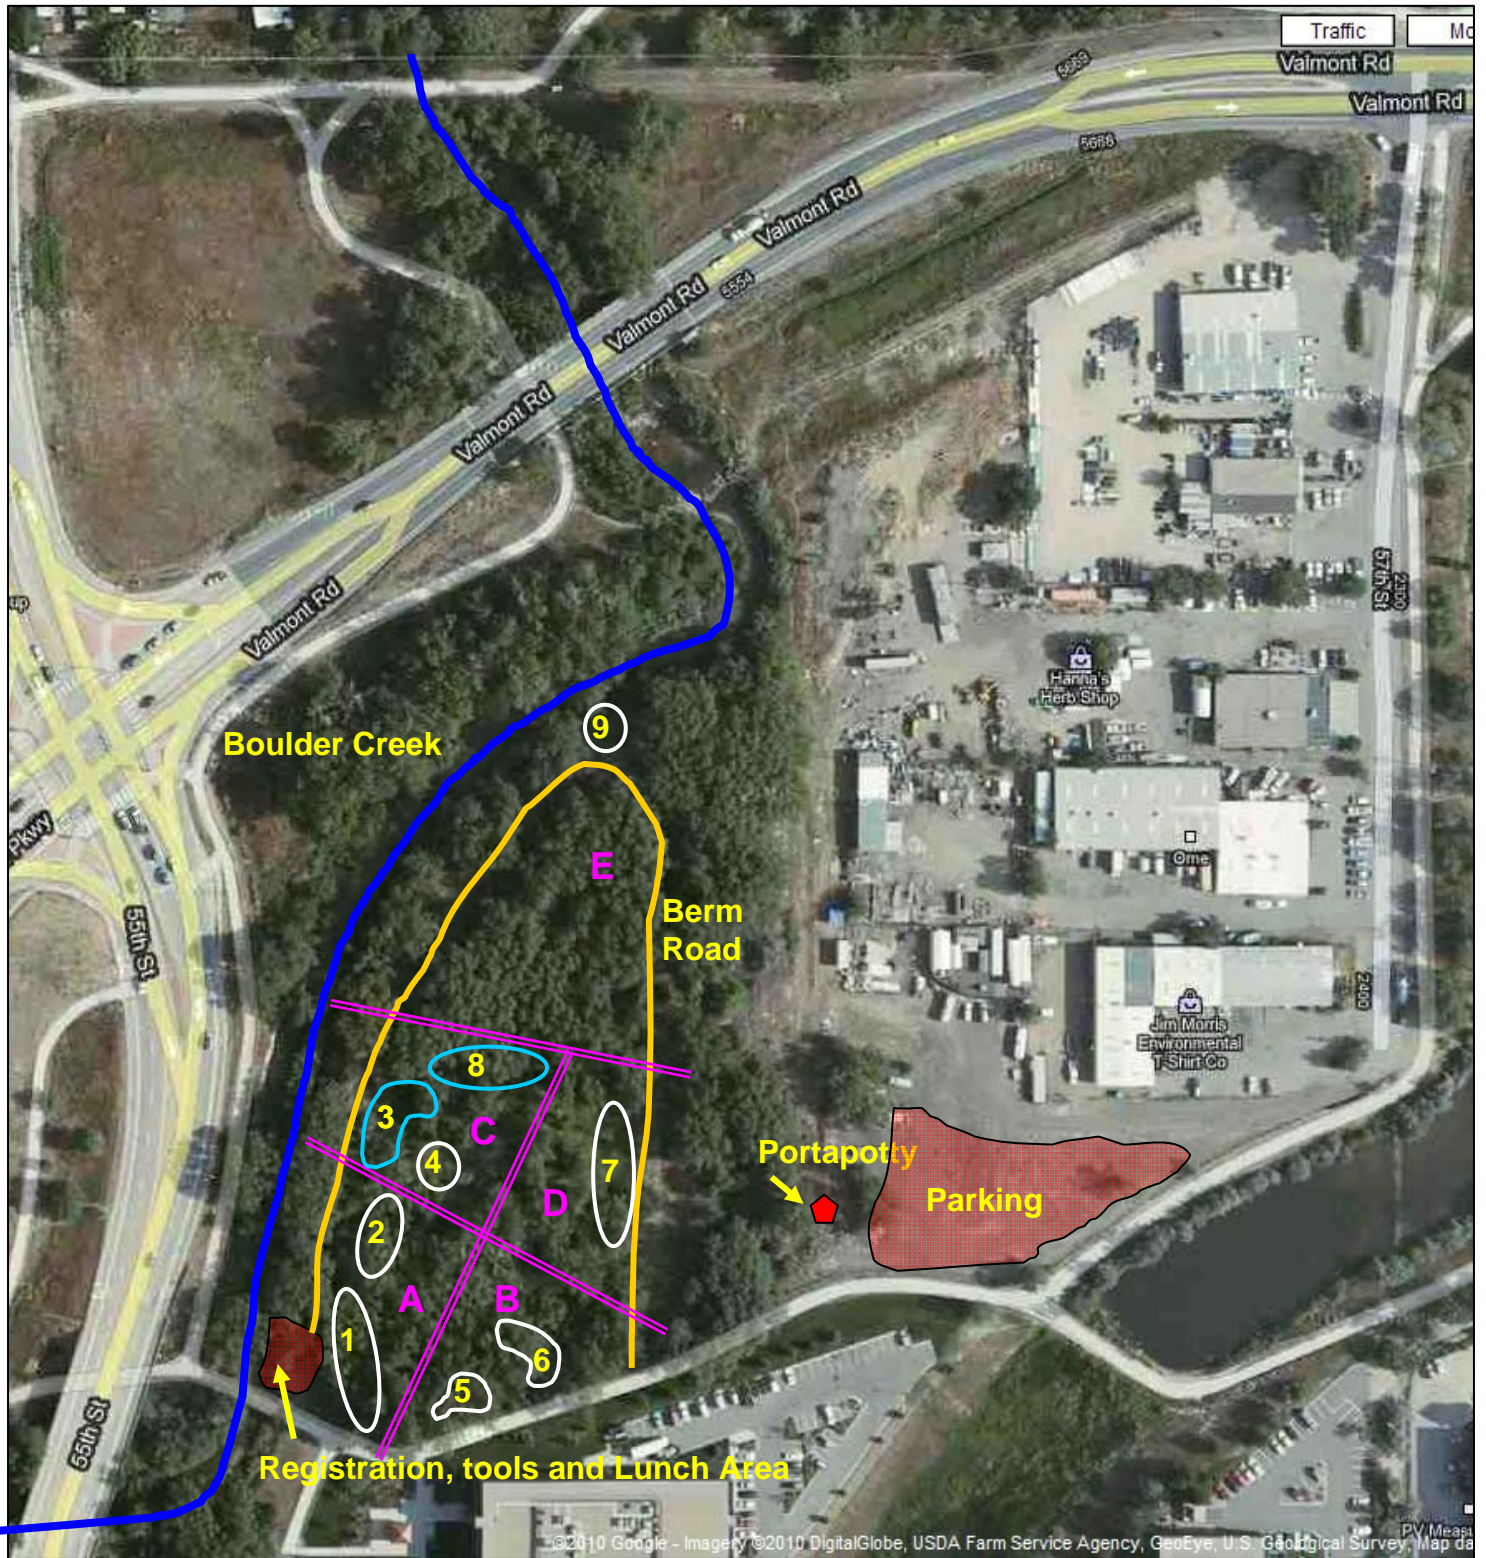
Boulder Creek #2 & #3 Map

Volunteers cut and bagged flowering heads of teasel, houndstongue, musk thistle, Scotch thistle, and perennial pepperweed, and chopped down plants at base, cutting all basal leaves, and leaving non-flowering material on the ground. Volunteers hand pulled young green ash and box elder using weed wrenches in order to minimize herbicide use. They used loppers and hand saws to limb larger branches and drag them to chippers from recent felling of tree species. Volunteers also planted 20 willows and 125 container plants previously laid out by City staff.

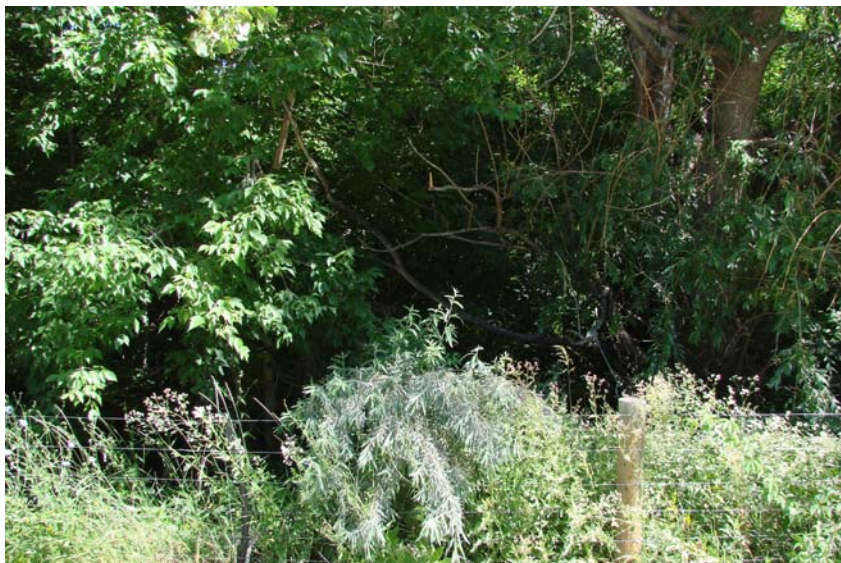
Photopoint 1 looking north at the dense box elder community, 2010.

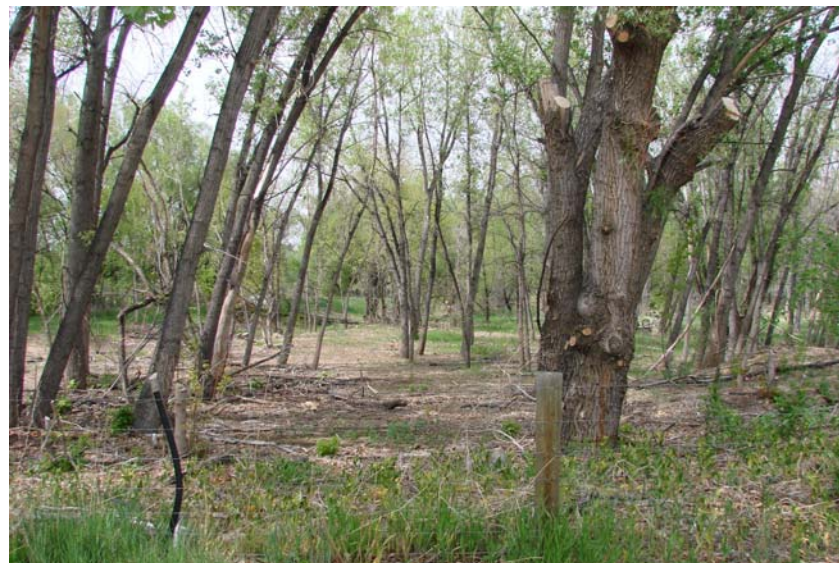
Photopoint 1 looking north following clearing, June 2011.

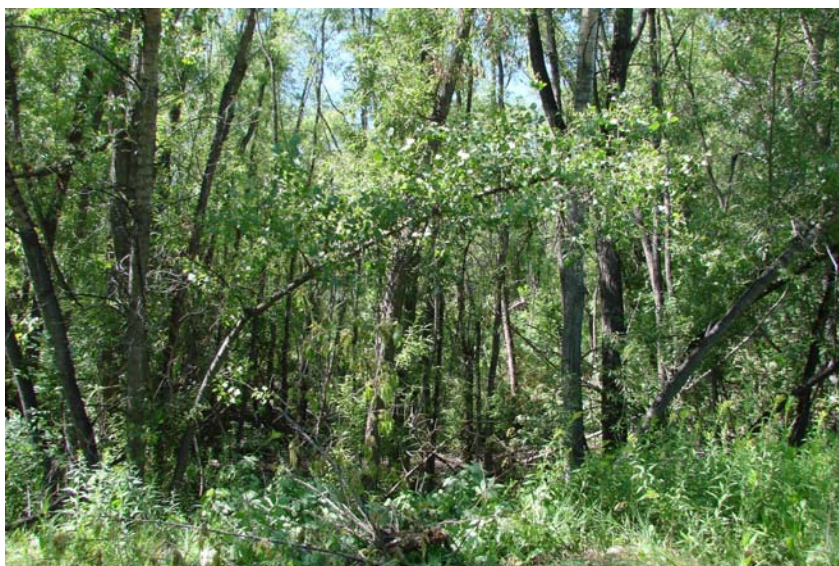
Photopoint 2 looking SW into a dense crack willow grove, June 2010.

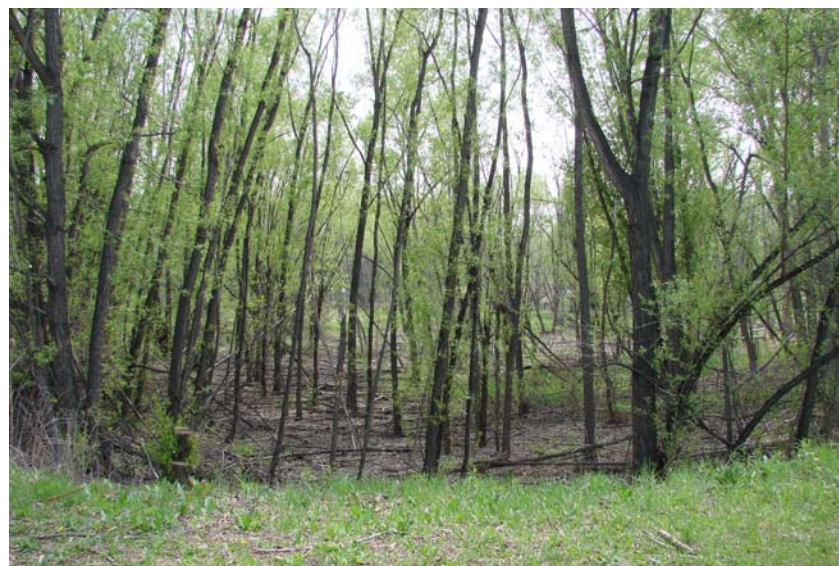
Photopoint 2 looking SW prior to completion of clearing, June 2011. Area completed in 2011.

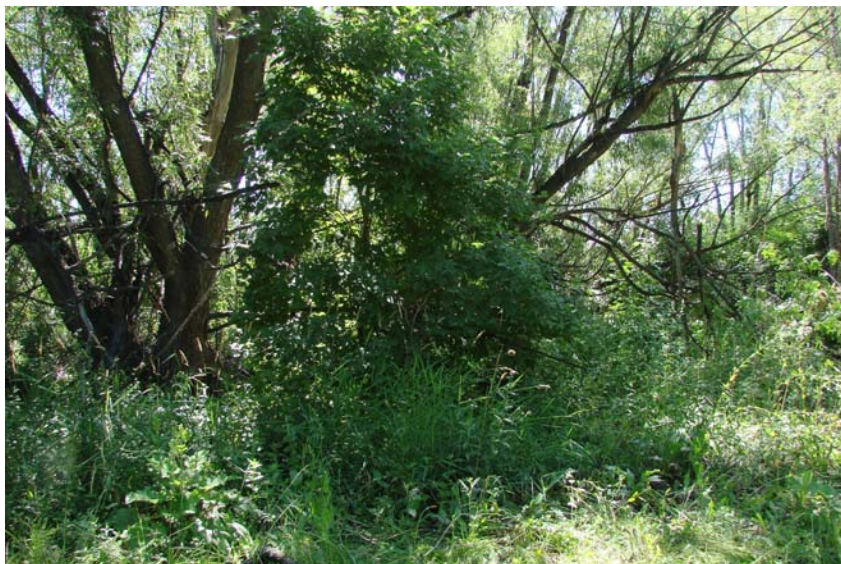
Photopoint 2 looking SE, into a dense crack willow grove, June 2010.

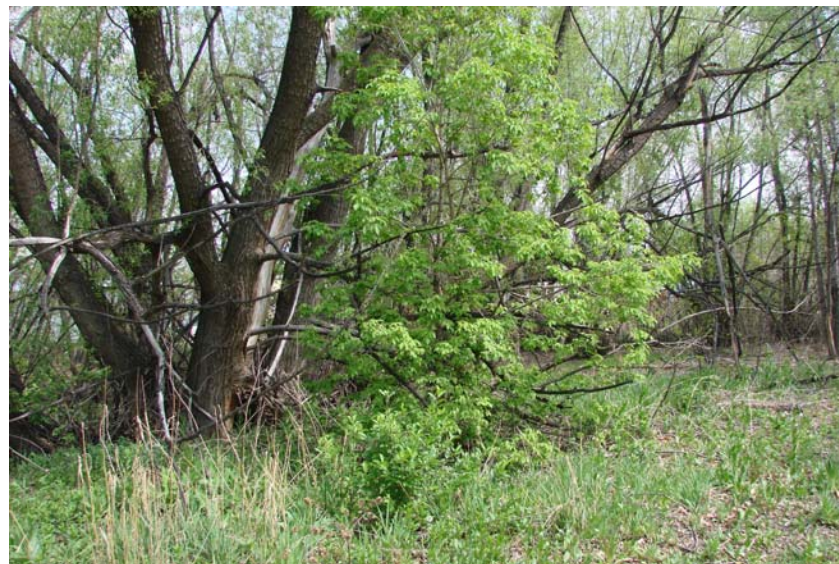
Photopoint 2 looking SE, clearing was completed in December 2011, June 2011. Several crack willow were left dead standing.

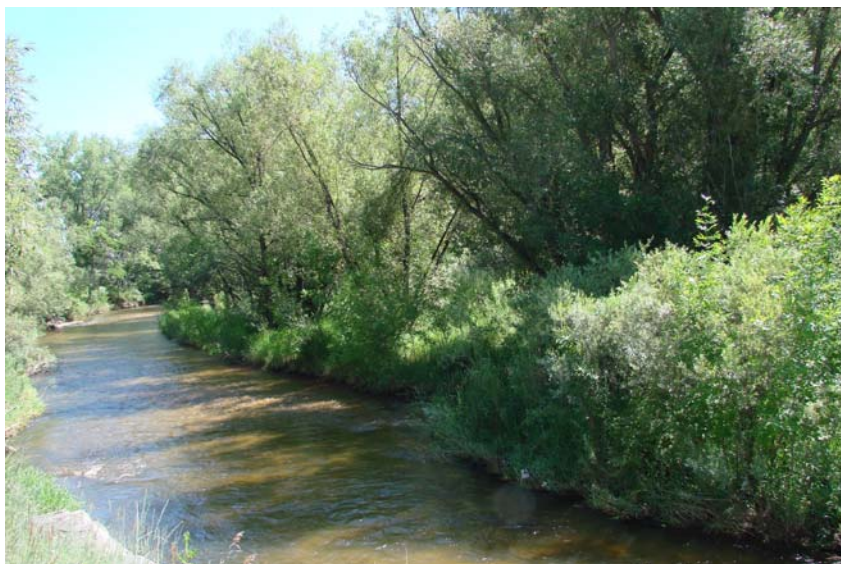
Photopoint 3 looking NE along Boulder Creek at a cottonwood-crack willow community, June 2010.

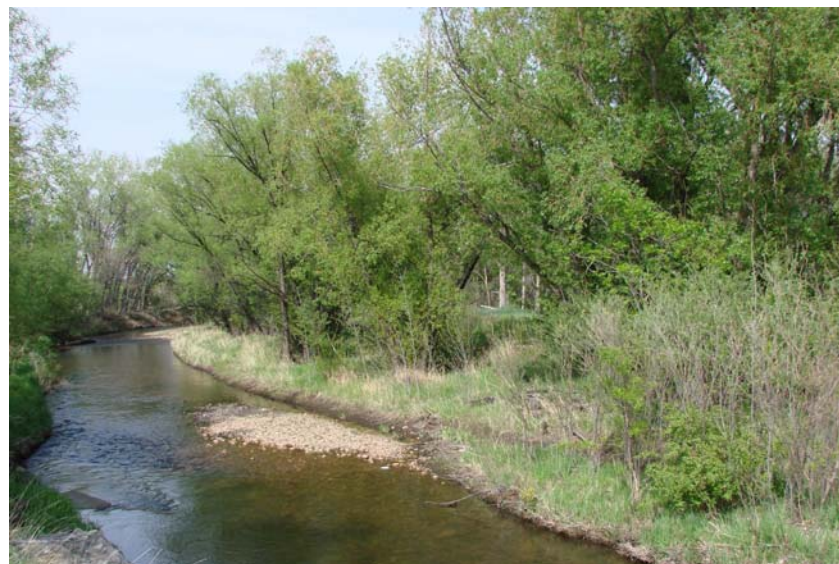
Photopoint 3 looking NE prior to clearing, June, 2011. clearing was completed in December, 2011.

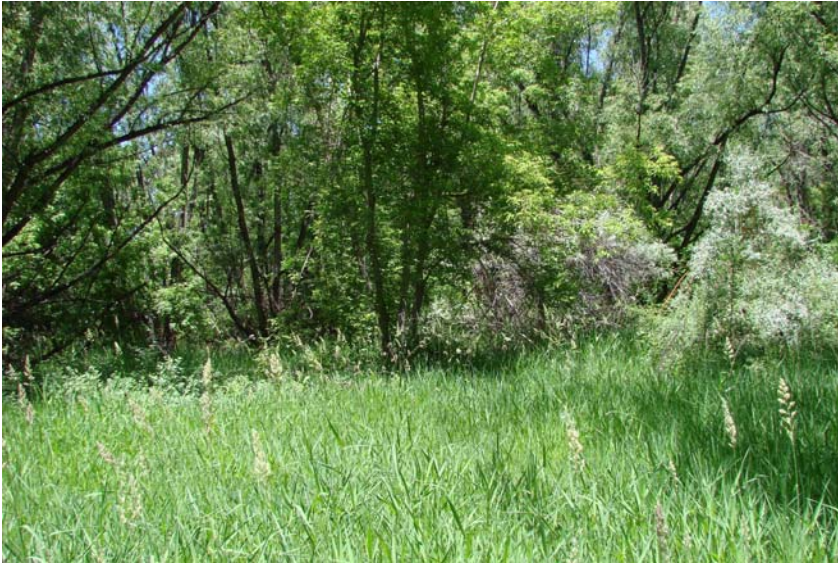
Photopoint 4 looking NW into a dense crack willow grove, June 2010.

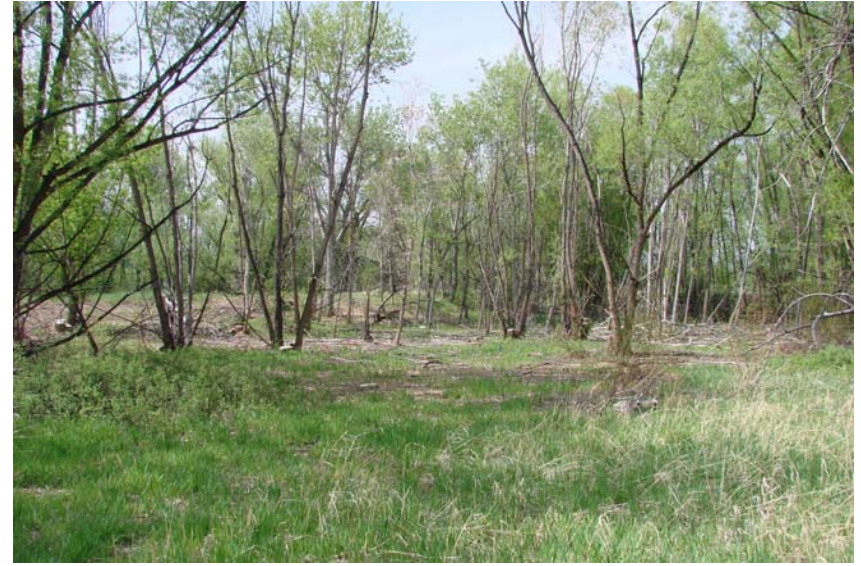
Photopoint 4 looking NW following clearing, June, 2011
Note several crack willow left dead standing.

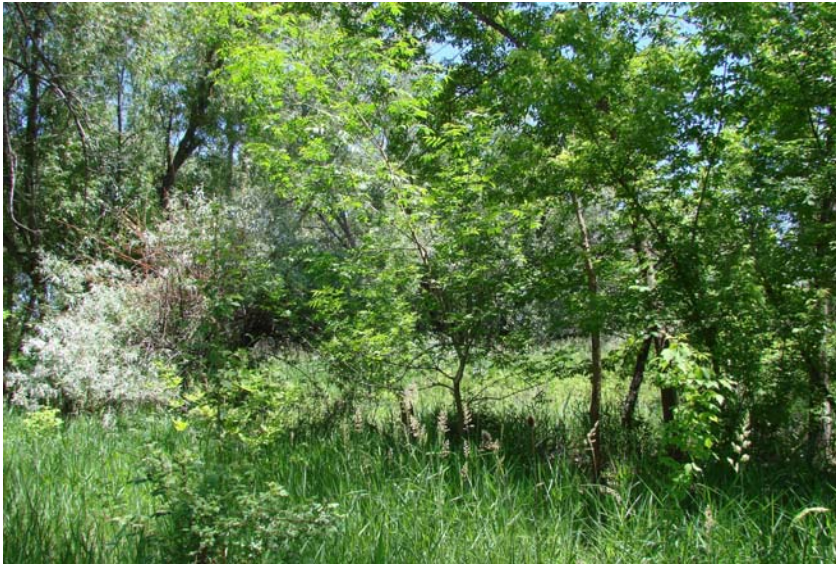
Photopoint 5 looking east at a clump of box elder under a canopy of cottonwood trees, June 2010.

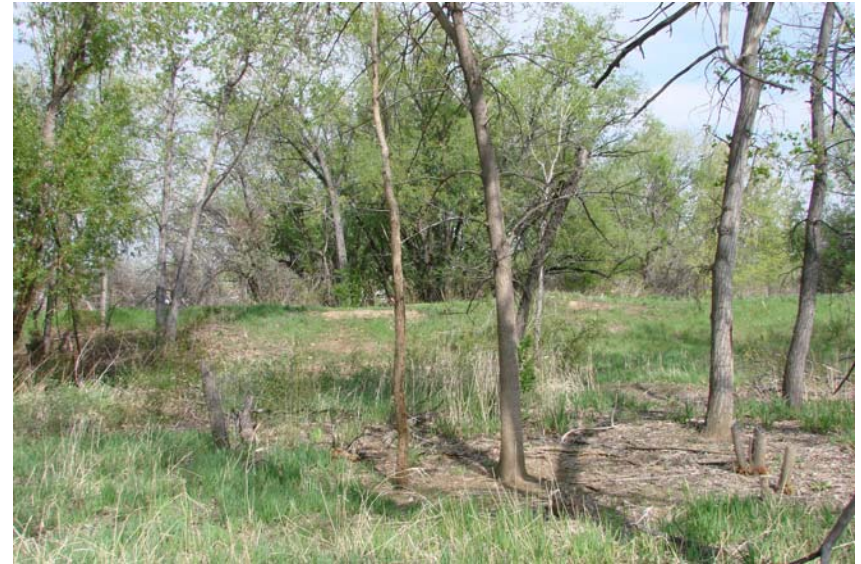
Photopoint 5 looking east following clearing, June, 2011.

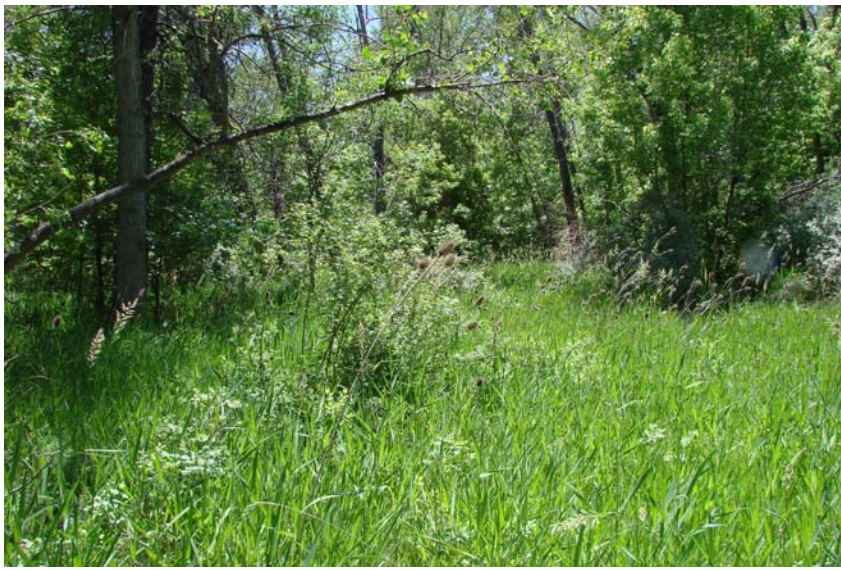
Photopoint 5 looking south at the dense box elder community, June, 2010.

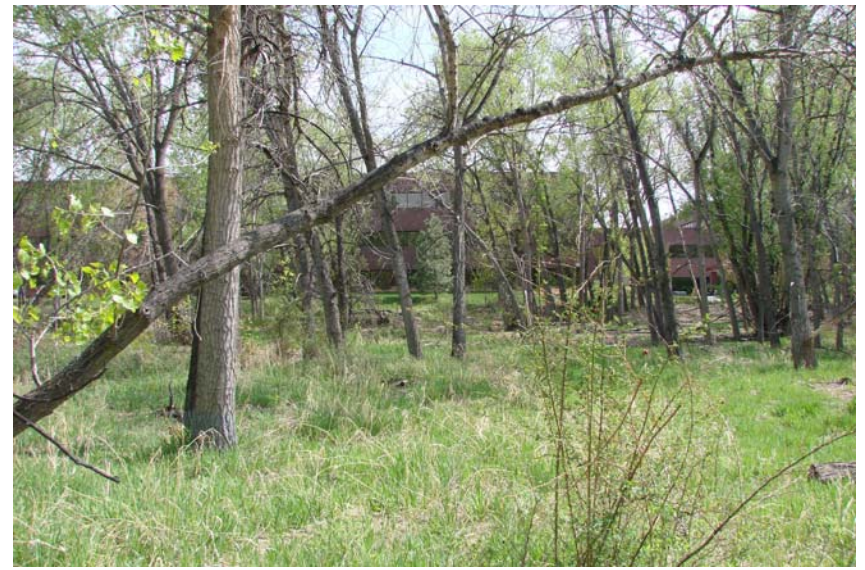
Photostation 5 looking south following clearing, June, 2011.

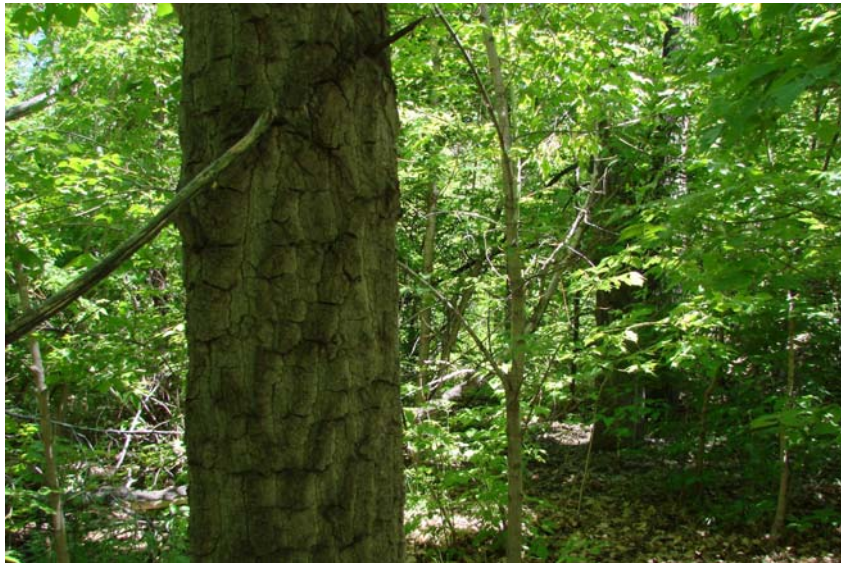
Photopoint 6 looking NE in the dense box elder community, June 2010.

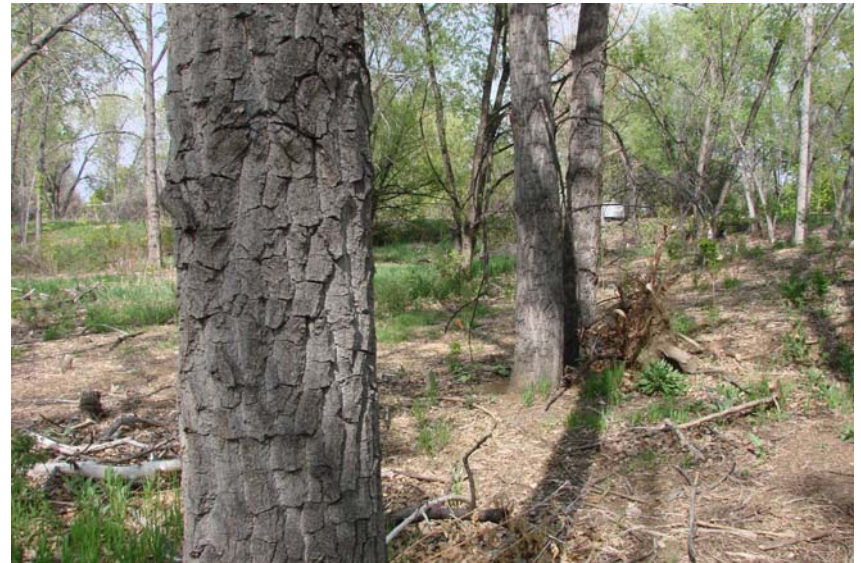
Photopoint 6 looking NE following clearing, June, 2011.
