Hydrologic Evaluation of the Big Thompson Watershed

Post September 2013 Flood Event

Colorado Department of Transportation
Region 4 Flood Recovery Office

August 2014

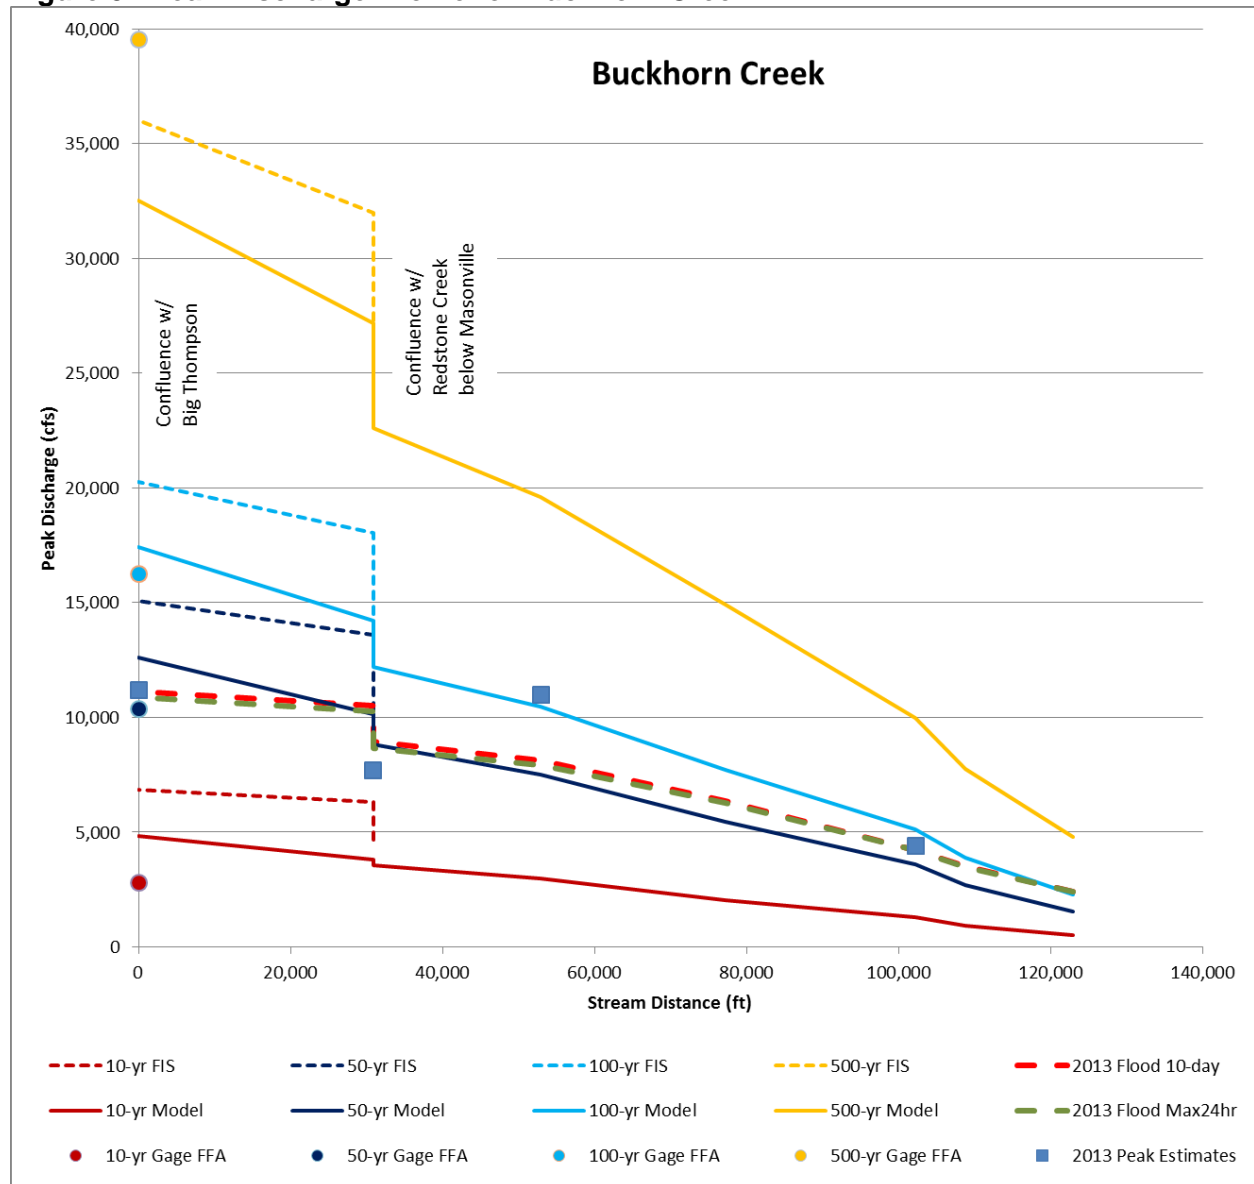
Figure 5. Peak Discharge Profile for Buckhorn Creek

Further downstream on Buckhorn Creek at County Road 24H, near the CDWR stream gage, the calibrated model discharge (11,100 cfs) was within 1% of the estimated peak discharge of 11,200 cfs by Bob Jarrett. The CDWR stream gage recorded stage data during the 2013 flood event with a peak stage of 14.82 feet occurring on September 13, 2013 at 3:15AM. Bob Jarrett noted that the high water marks he measured in the field were within a few tenths of a foot of this elevation. The hydrologic model was also calibrated to match the timing of the peak discharge with the peak stage recorded at the CDWR stream gage, to ensure that the peak discharge at the confluence of Buckhorn Creek and the Big Thompson aligned correctly.

At the confluence of the Big Thompson River and Buckhorn Creek, the calibrated model discharge (24,000 cfs) was approximately 26% higher than the estimated peak discharge of 19,000 cfs determined by Ayres Associates (at the upper limit of the 15% to 25% range of hydrologic uncertainty associated with the estimates). Upstream of the confluence on the Big

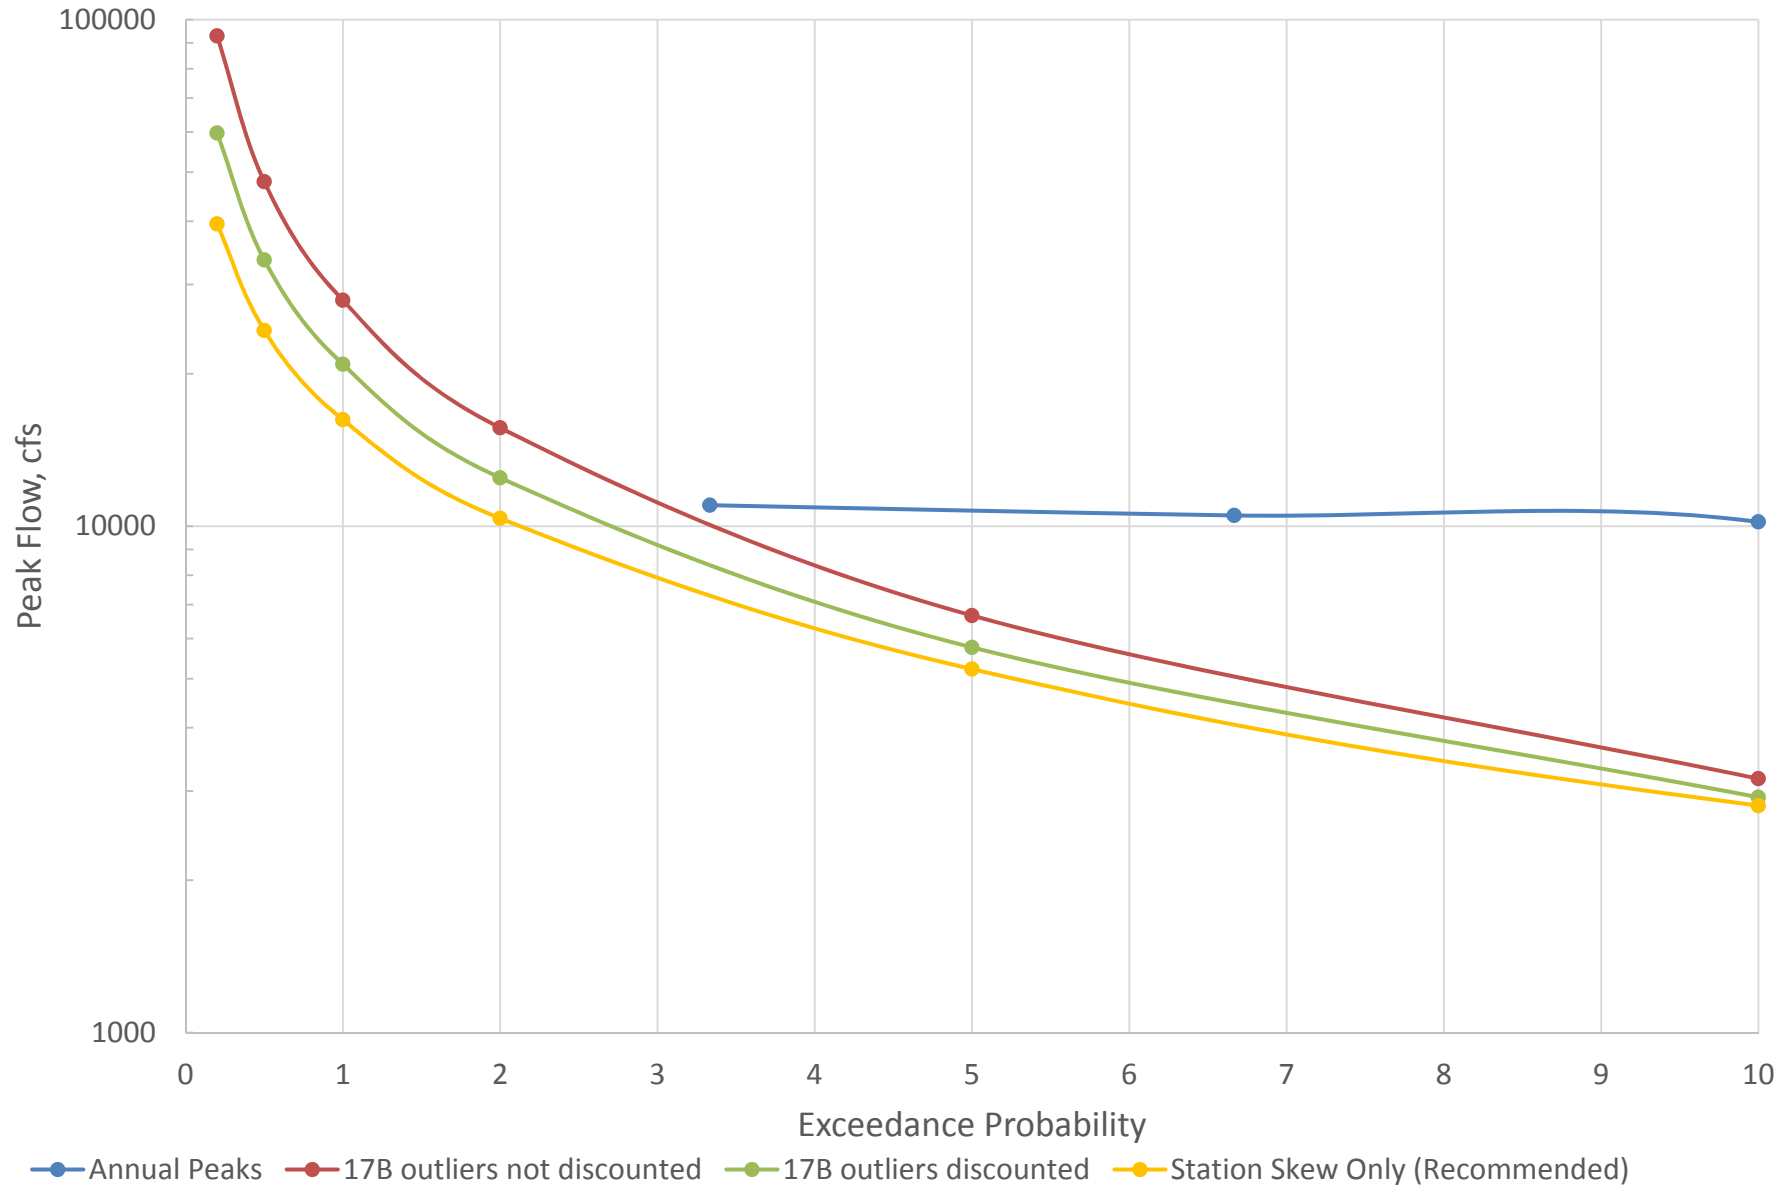
Buckhorn Creek- Ordered Distribution of Annual Peaks for > 10-Year Events (Log)

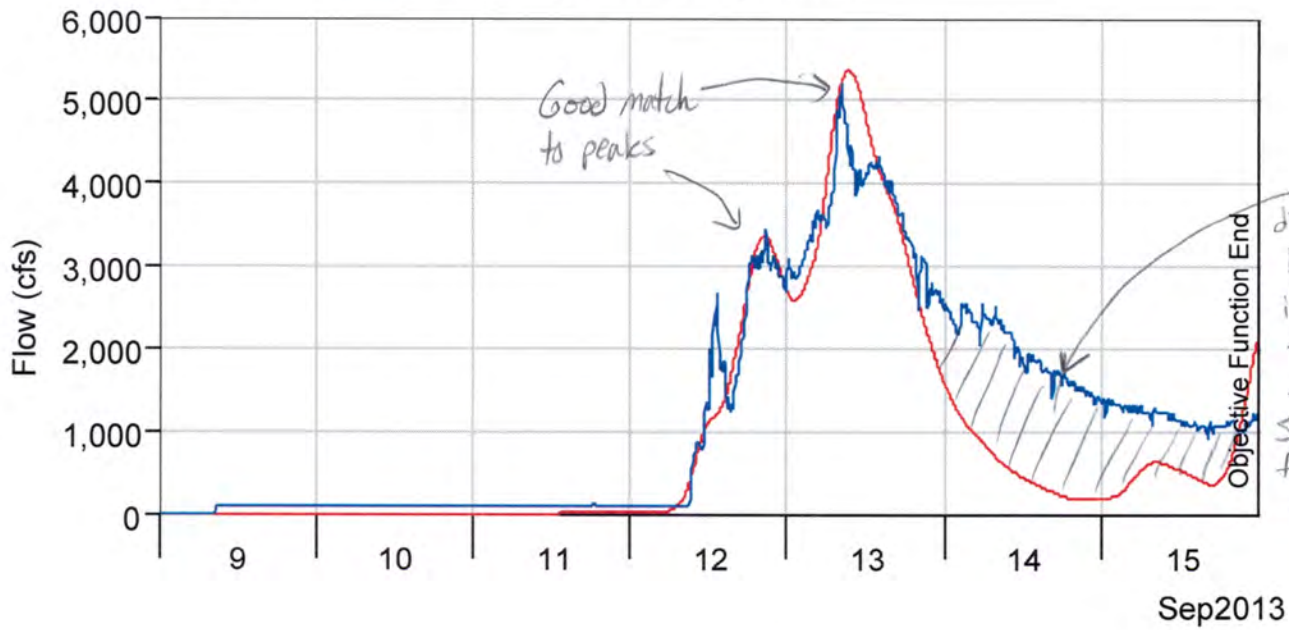
Lake Estes Inflow Hydrograph Comparison

— Opt:BT CN Optimization Element:J4055 Result:Outflow

— Opt:BT CN OPTIMIZATION Element:J4055 Result:Observed Flow

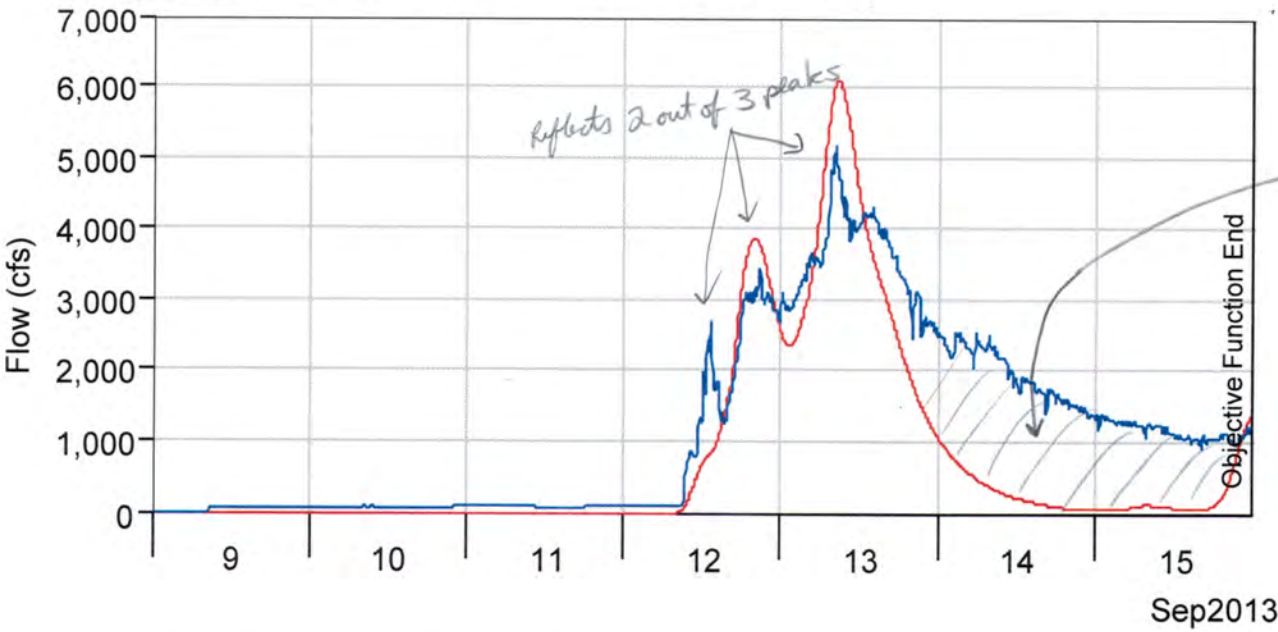
Lake Estes Inflow Hydrograph Comparison

- Opt:BT Constant Optimization Element:J4055 Result:Outflow
- Opt:BT CONSTANT OPTIMIZATION Element:J4055 Result:Observed Flow

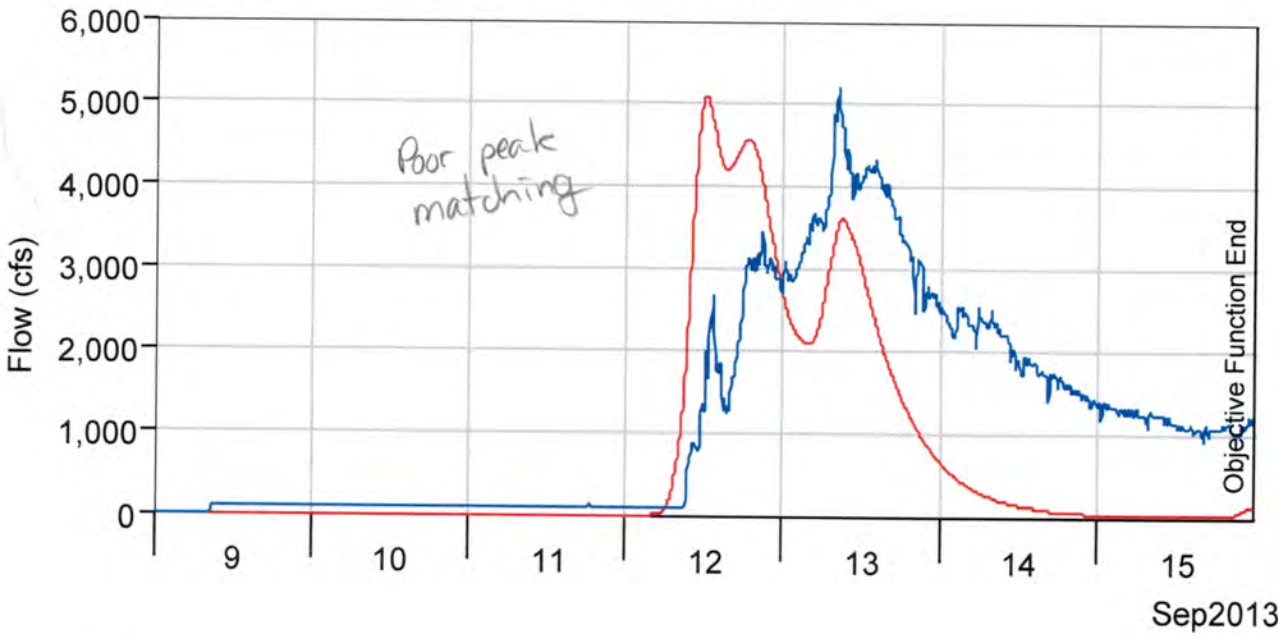
Lake Estes Inflow Hydrograph Comparison

- Opt:Green Ampt Optimization Element:J4055 Result:Outflow
- Opt:GREEN AMPT OPTIMIZATION Element:J4055 Result:Observed Flow

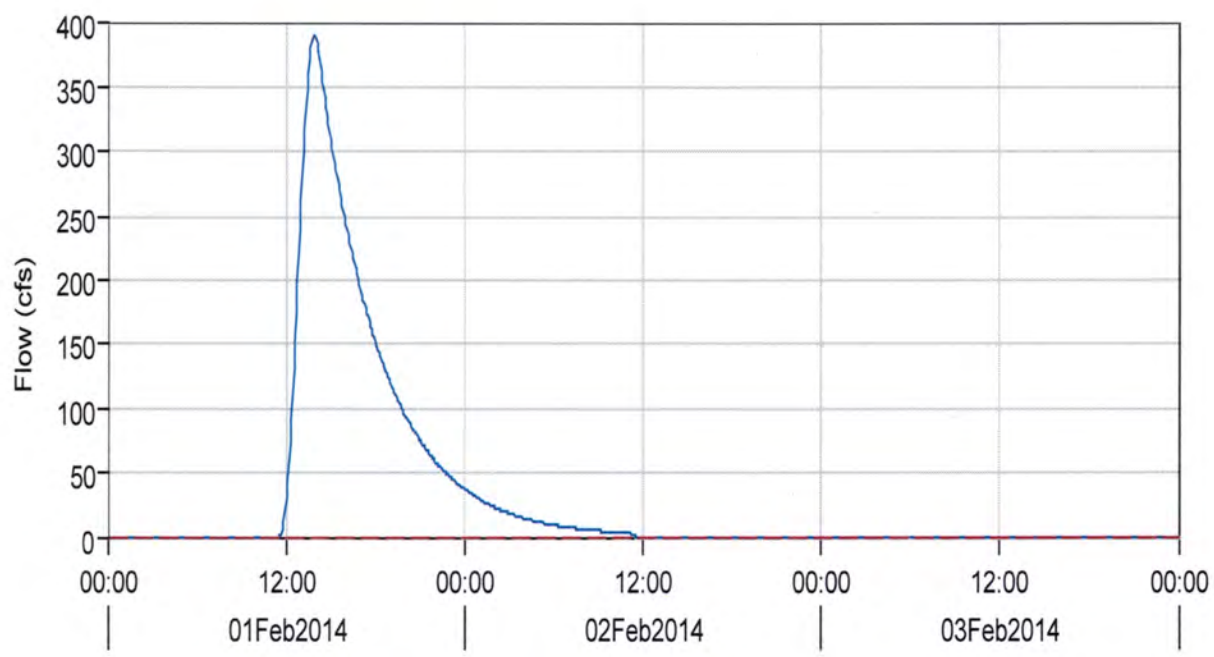
Subbasin "BT09" Results for Run "BT 100yr Exponential"

- Run:BT 100yr Exponential Element:BT09 Result:Precipitation
- Run:BT 100YR EXPONENTIAL Element:BT09 Result:Precipitation Loss
- Run:BT 100yr Exponential Element:BT09 Result:Outflow
- Run:BT 100YR EXPONENTIAL Element:BT09 Result:Baseflow

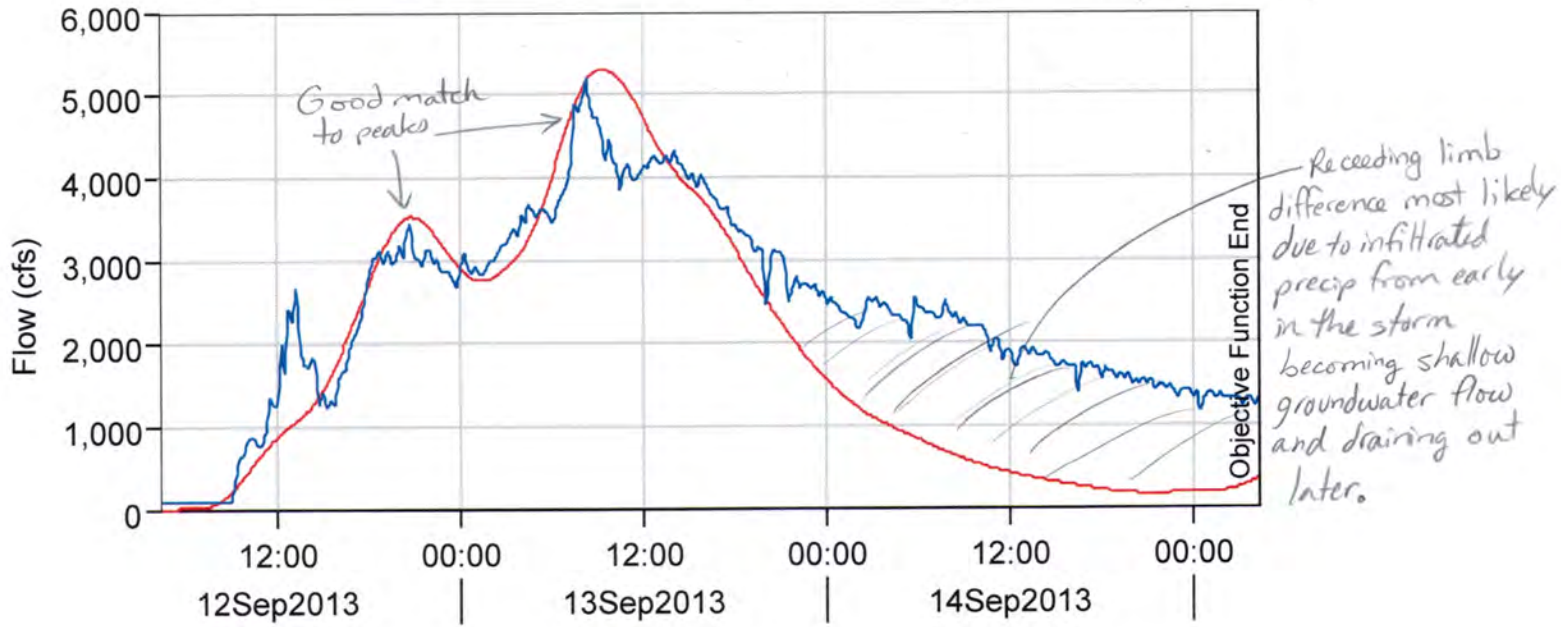
Lake Estes Inflow Hydrograph Comparison (24-hr Period)

— Opt:BT CN Optimization Max24hr Element:J4055 Result:Outflow

— Opt:BT CN OPTIMIZATION MAX24HR Element:J4055 Result:Observed Flow

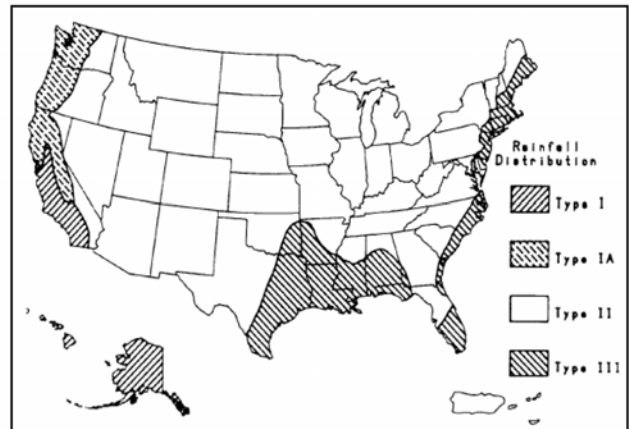
Figure 1: Geographic boundaries for the NRCS rainfall distributions
