**Final Report to the Colorado Watershed Restoration Program**  
**Regarding**  
**North Massey Draw**  
**Stream Restoration Improvements at the**  
**Ken-Caryl Ranch Equestrian Center**

**PROJECT NAME - North Massey Draw Stream Restoration Improvements at the Ken-Caryl Ranch Equestrian Center**

**INTRODUCTION AND BACKGROUND**

## **KEY PROJECT INFORMATION**

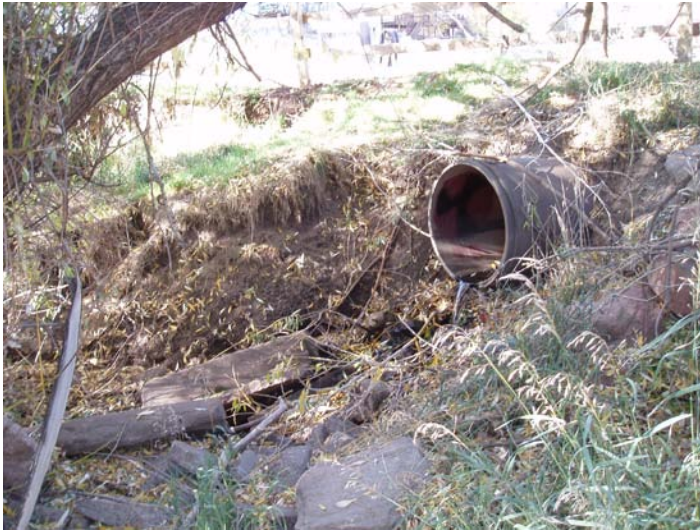
**1. Pre-construction photo of downstream end of culvert.**

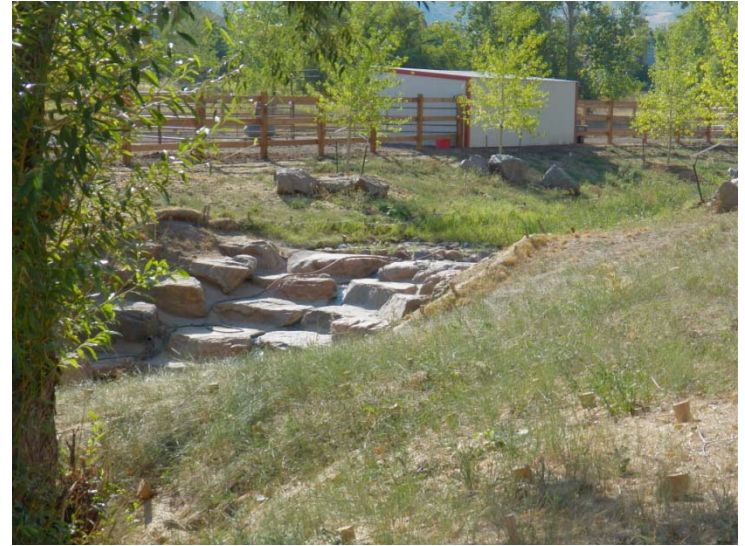
**2. Post-construction photo of same location. Culvert was Replaced with open channel.**

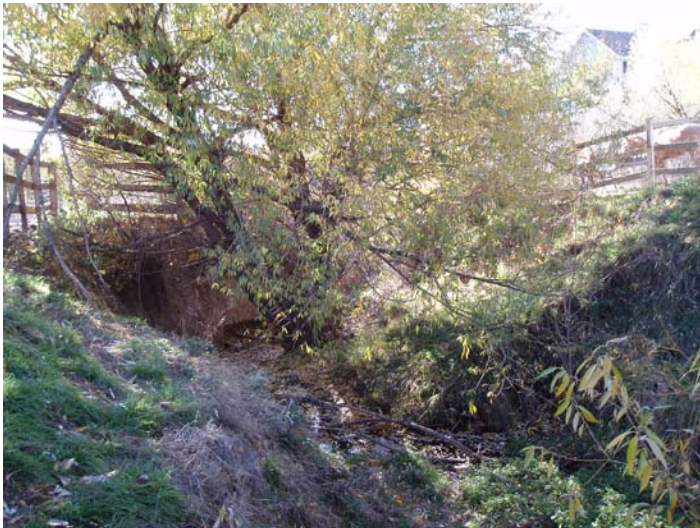
**3. Pre-construction photo of area downstream of culvert Outlet.**

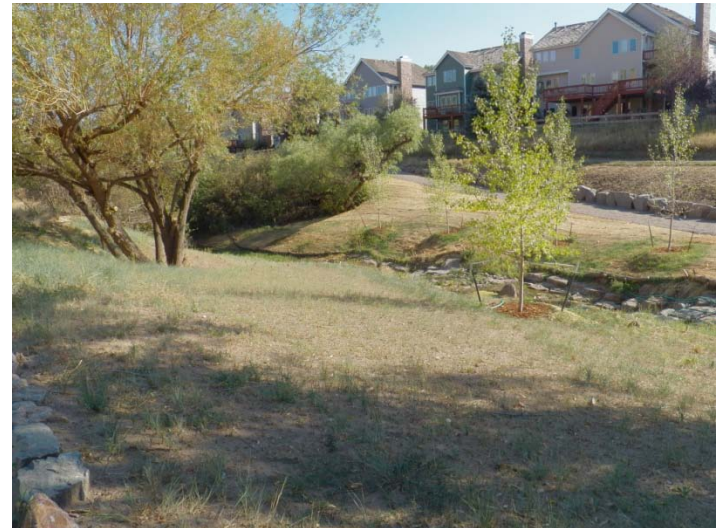
**4. Post-construction photo of same general area. Tree in Upper left corner is same tree in pre-const. photo. New Stream channel is south of old channel with extensive bank grading**

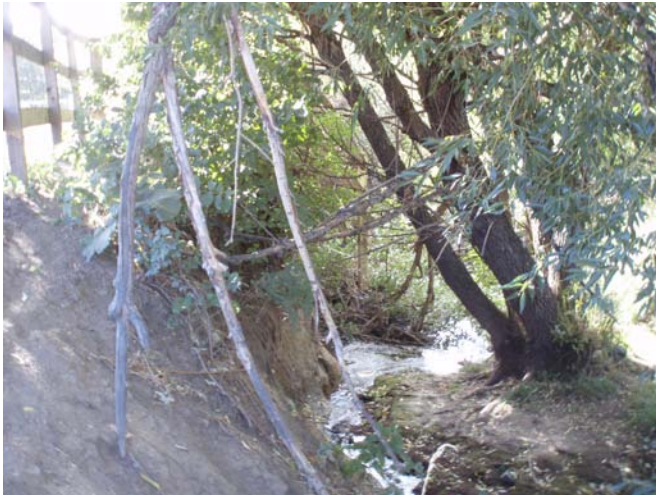
**5. Pre-construction photo of area downstream of culvert.  
Tree in photo same as photos #3 and #4.**

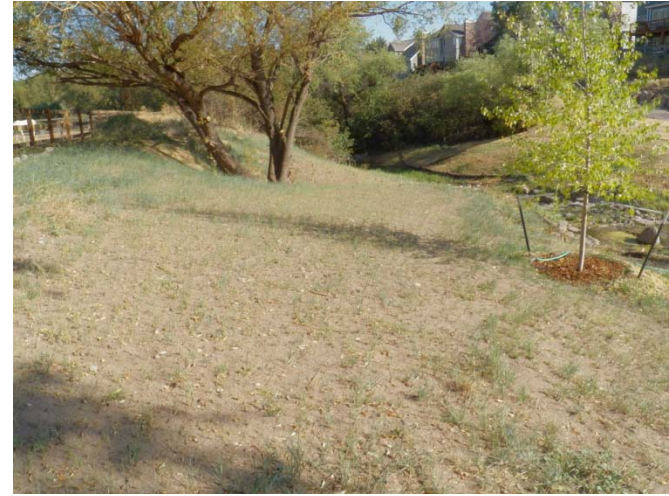
**6. Post-construction photo of area downstream of culvert.  
Tree in photo same as in photo #5. Fence at top of bank  
Stayed in original location.**

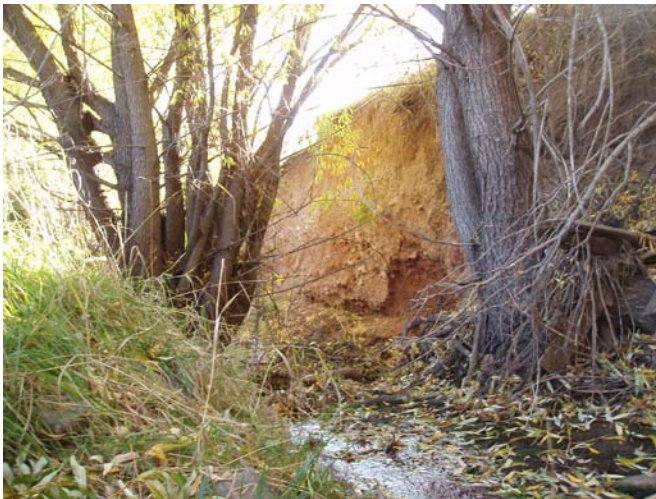
**7. Pre-construction photo of area downstream of large tree  
above.**

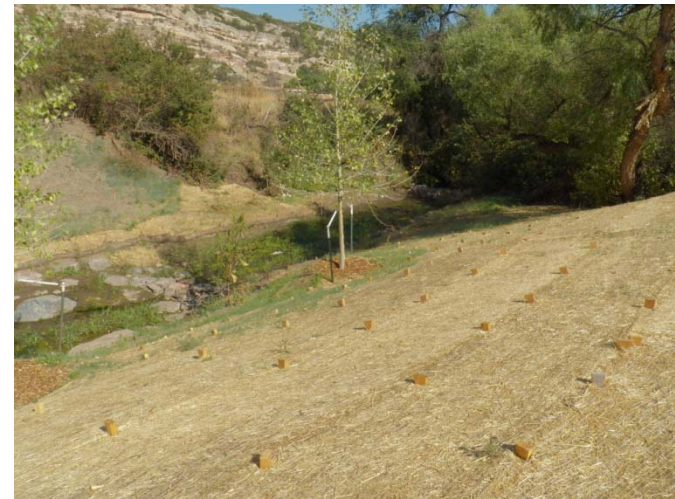
**8. Post-construction photo of area in photo #7 taken from  
Opposite bank.**

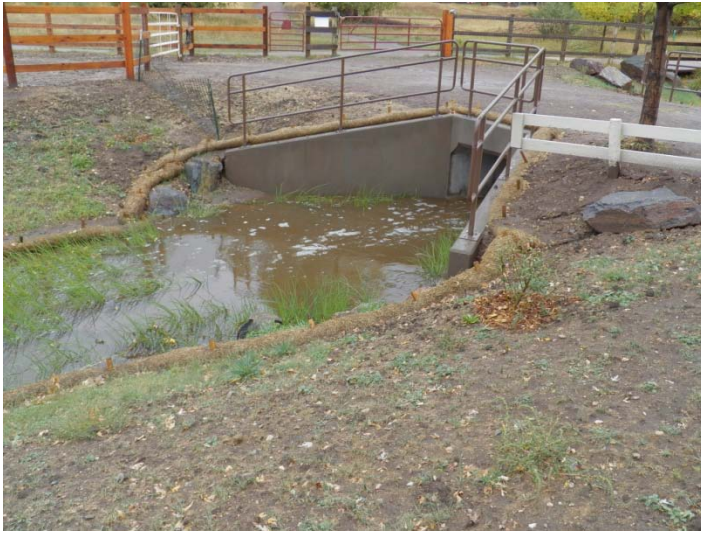
**9. Post-construction photo of downstream end of box culvert.**

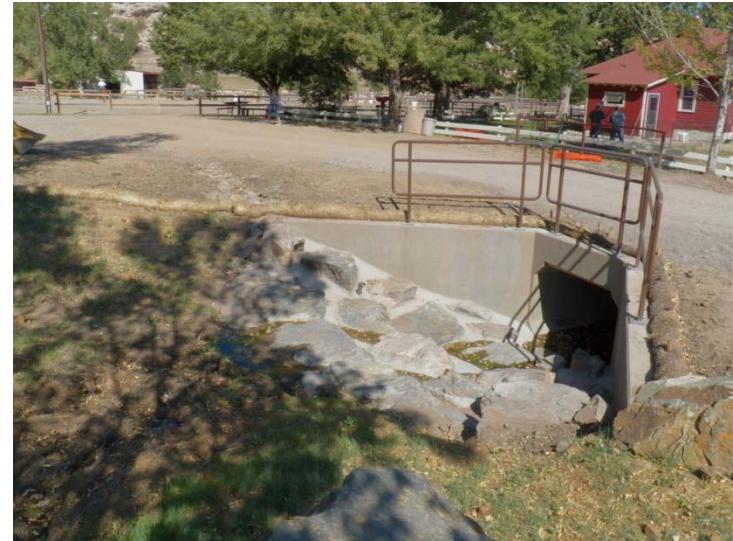
**10. Post-construction photo of upstream end of box culvert.**

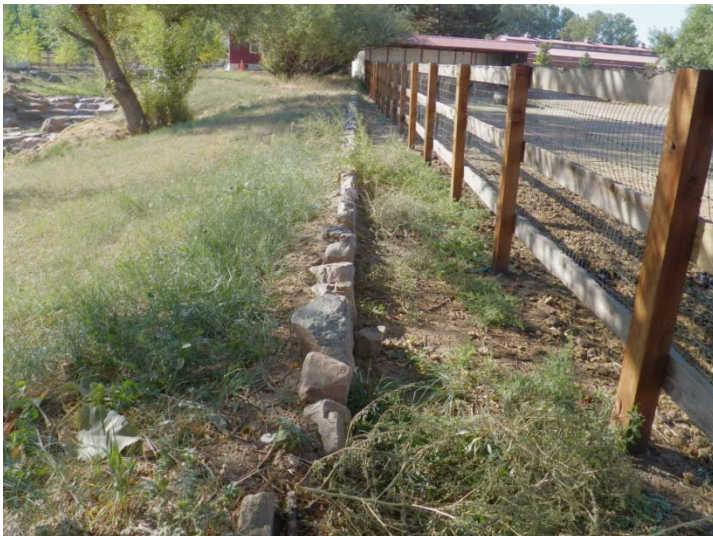
**11. Post-construction photo of rock lined berm designed to prevent manure from entering drainage.**

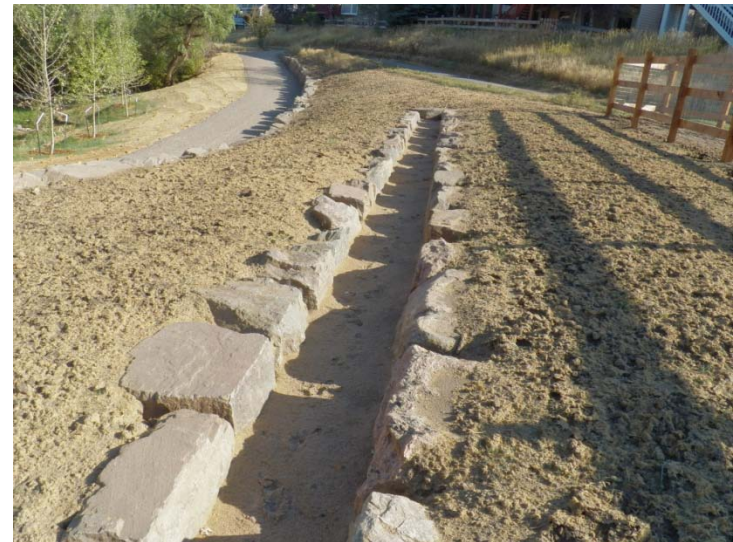
**11. Post-construction photo of water quality trench. Run-off from Adjacent pasture is intercepted by the trench and treated Before entering the stream channel.**

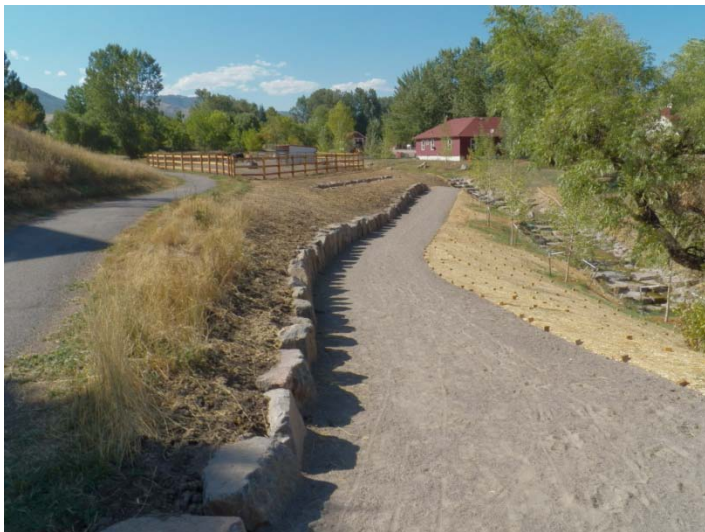
13. Post-construction photo of recreation trail/maintenance access

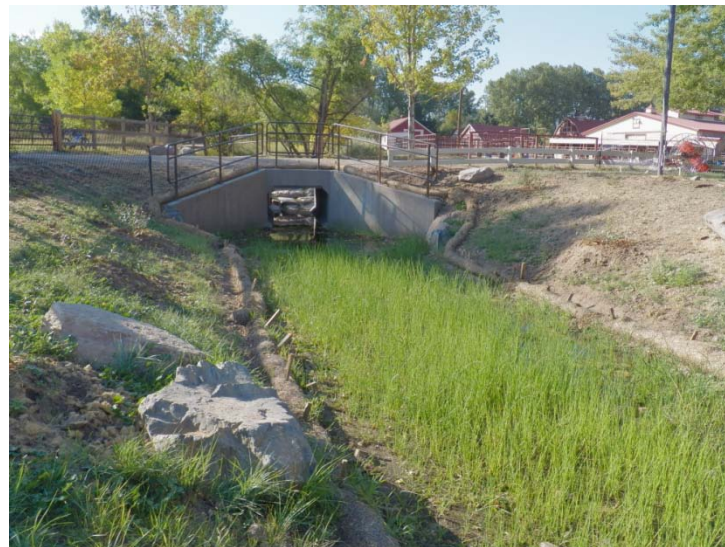
14. post-construction photo of upper channel. Wetland vegetation Establishing quickly.

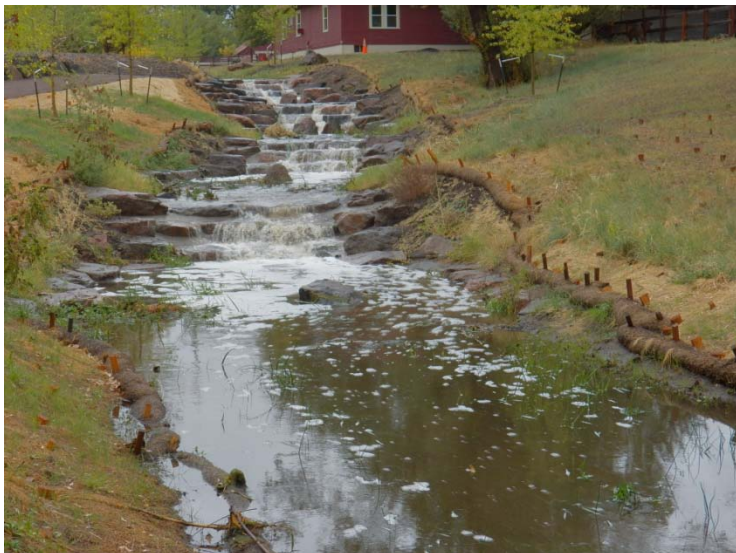
15. Post-construction photo of grouted boulder drop structures During storm event.

November 2011-Summer 2012: Construction completed over 9 months including installation of the lower channel, grouted boulder drop structures (completed between February 2012 through April 2012) of which **80 square yards of grouted boulder drop structure is directly attributable to money received from the CWCBC**. No major problems were encountered during construction of this project.
