## **CWCB Watershed Restoration and Protection Project**

### **Glen Cove 'Tin Barn' Wetland Restoration Project Final Report June 28, 2013**

1. Project Title: Upper Glen Cove Creek Watershed Erosion Control and Restoration Project
2. Project Location: Pikes Peak, CO Lat. 38°53'01" N, Long. 105°04'24" W
3. Grant Requested Amount: \$29,500
4. Cash Match Funding: \$35,666
5. In-Kind Match Funding: \$6,188
6. Project Sponsor: Rocky Mountain Field Institute
7. Contact Person/Title: Amber Shanklin, Program Director
8. Address: 815 South 25<sup>th</sup> Street, Suite 101 Colorado Springs, CO 80904
9. Telephone/ E-mail: (719) 471-7736, [rmfi@rmfi.org](mailto:rmfi@rmfi.org)
10. Project Type: Watershed Restoration and Protection

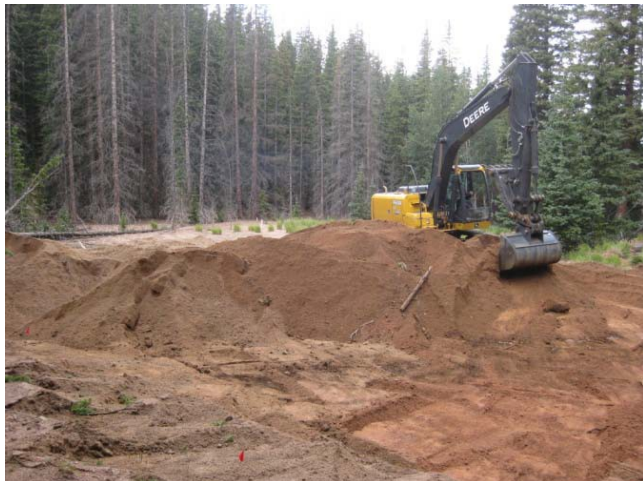
Figure 1. Heavy equipment used to remove alluvium deposition in Tin Barn Wetland during 2012 work.

Phase 1 work consisted of removal of the deposited alluvium and initial revegetation within the wetland. Chaparral Construction began removing sediment from the wetland on July 30, 2012. Sediment removal was overseen by RMFI staff and Fin-Up Habitat Consultants. A total of 46,035 cubic feet (1,705 cubic yards) of material was excavated and moved to an approved disposal site (Figure 1). Chaparral Construction also installed 4 log ‘rock and roll’ structures (Figure 2) and 6 waterbars along the newly created access road to catch sediment prior to wetland deposition. RMFI engaged volunteers to complete initial revegetation work within the wetland. Native seed was spread over a third of an acre which was then covered with an aspen matting to prevent erosion. Volunteers also stabilized 300 feet of an old conveyance channel.

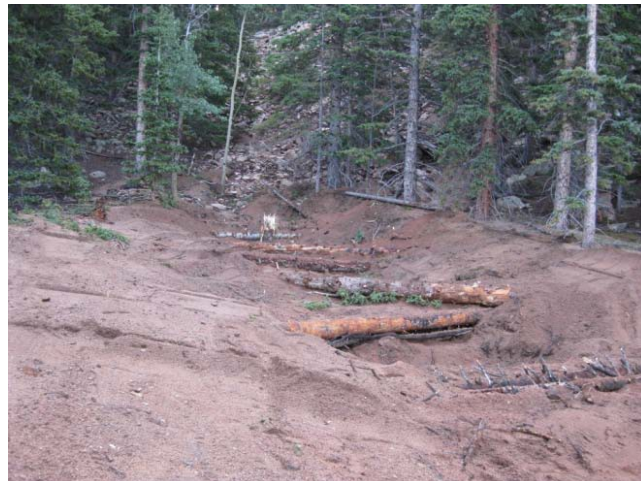
Figure 2. Log 'rock and roll' structures installed during 2012 work.

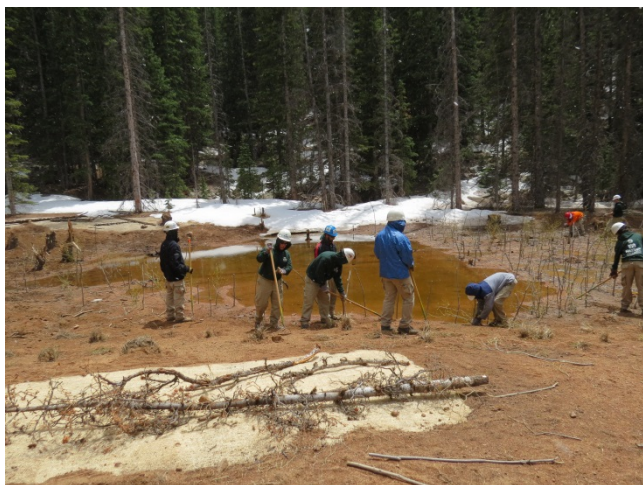
Figure 3. Tin Barn Wetland during restoration during 2013. Notice visible water within the wetland.

Phase 2 work consisted of final revegetation of the wetland (Figures 3 and 4) and decommissioning the access road used by the heavy equipment. Work was completed by RMFI staff and a Mile High Youth Corps crew during the week of May 27, 2013. The access road created the previous year for heavy equipment removal was hand decompacted and seeded with a native seed mix (Table 1) (Figure 5). Biosol® fertilizer was spread over the road to increase germination rates of the seeds. Trees were felled along the upper part of the road to create 24 contour logs to minimize future disturbance and to provide microhabitats to improve seedling germination rates. 5 log erosion barriers were installed near the end of the road (nearest the wetland) to ensure minimization of future sediment deposition into the wetland. Though a small portion of the wetland was seeded the year before, additional revegetation was required. Local sedges (*Carex aquatilis*) and willows (*Salix sp.*) were collected from a wetland near South Catamount Reservoir for transplant into the Tin Barn Wetland. Using locally collected species ensures native species are used and ensures a high establishment rate since plants are well adapted to the environment. Native seed species purchased from a local company were also spread within the wetland area to establish a greater diversity of species (Table 2) (Figure 7). Approximately 1,000 square feet of erosion control matting was placed along the banks of the wetland and in key areas along the road to prevent erosion (Figure 6).

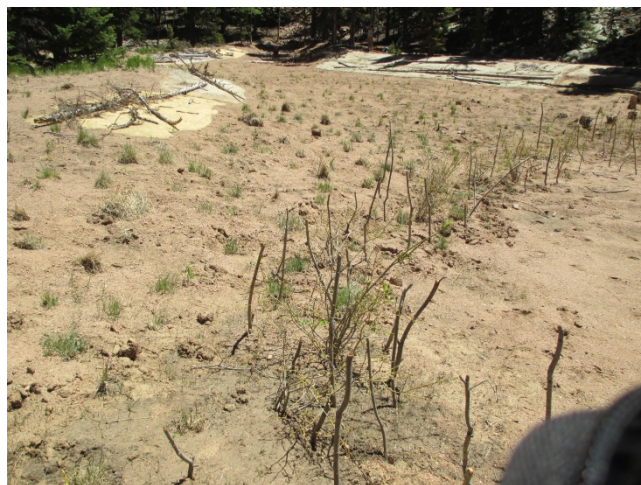
Figure 4. Tin Barn Wetland 1 month post-restoration during 2013.

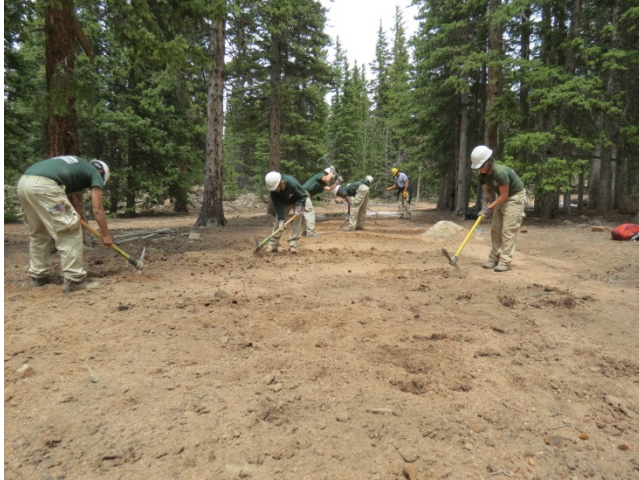
Figure 5. MHYC members hand decompacting wetland access road during 2013.

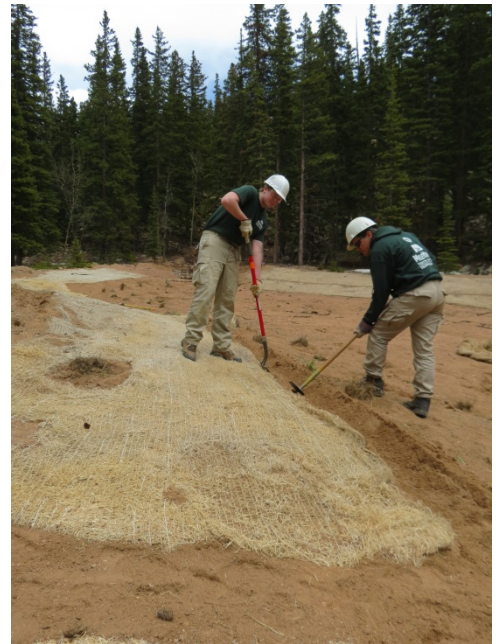
Figure 6. Installation of erosion control matting near Tin Barn Wetland during 2013.

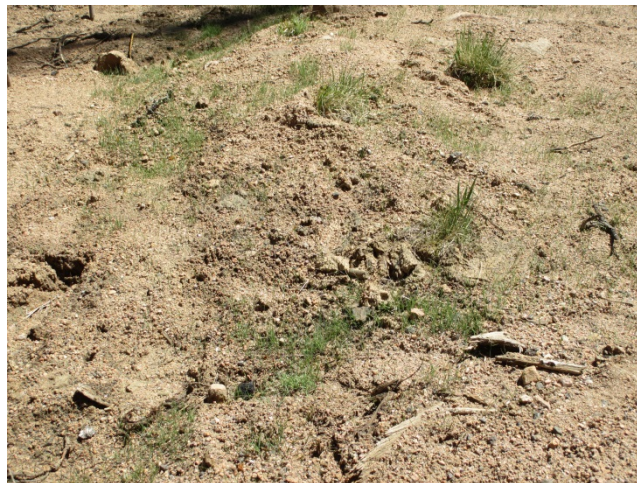
Figure 7. Newly seeded native grasses emerging 1 month post-restoration at the Tin Barn Wetland during 2013.
