**Boulder County 2012 Fourmile Fire Flood Mitigation Project**  
**Final Project Report 6/26/2013**  
**\$24,500 CWCB grant**

## 2012 Fourmile Canyon Fire Rehabilitation Report

Fourmile Fire  
Treatment Implementation & Evaluation Report

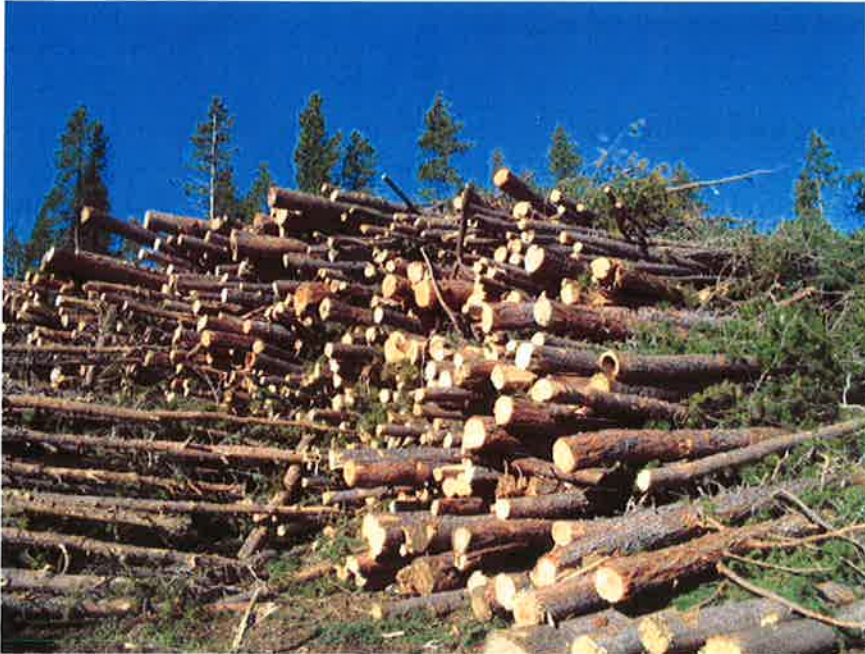
Figure 2: Raw material for wood shred production from USFS Forest Stewardship Project.

The County project managers visited the Forest Concepts Stewardship Project site and inspected the production of the wood shreds. Several combinations of screens from 2 inch combined with 4 and 6 inch screens were tested. The best product came from using only the 4 inch screens. The raw tree material did include some limbs with pine needles still attached.

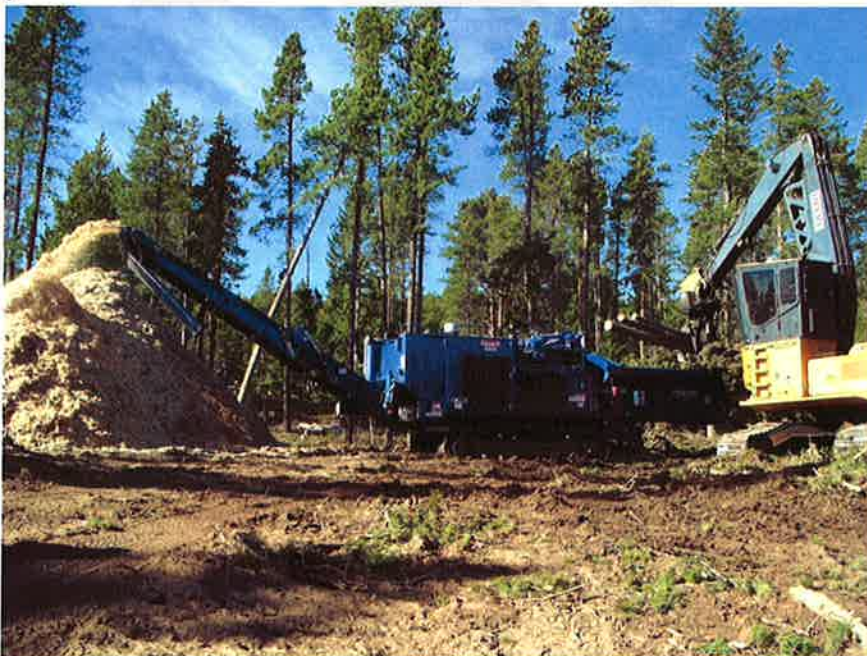
Figure 3: Peterson horizontal grinder

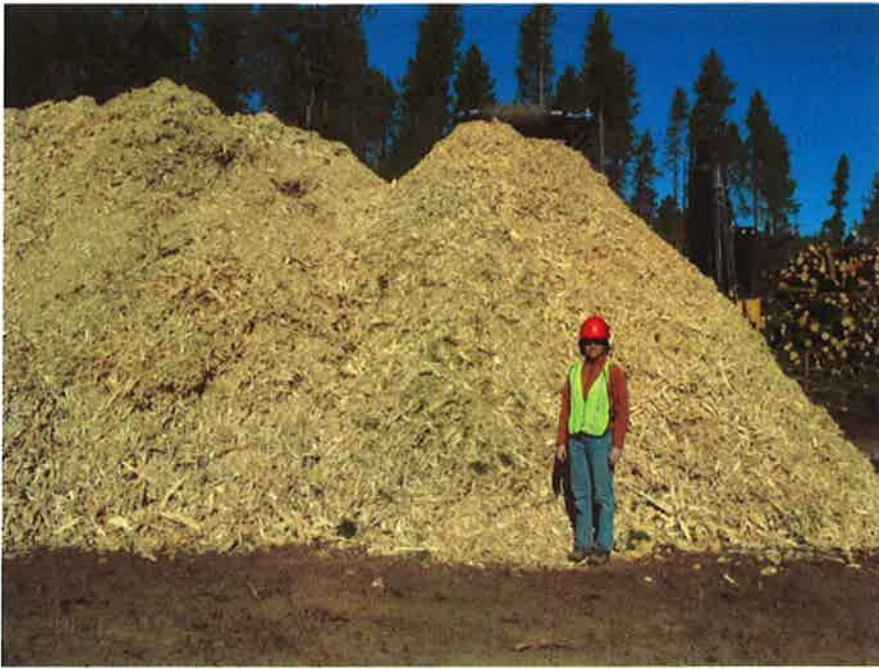
Figure 4: Final approved wood shreds (Claire DeLeo in photo).

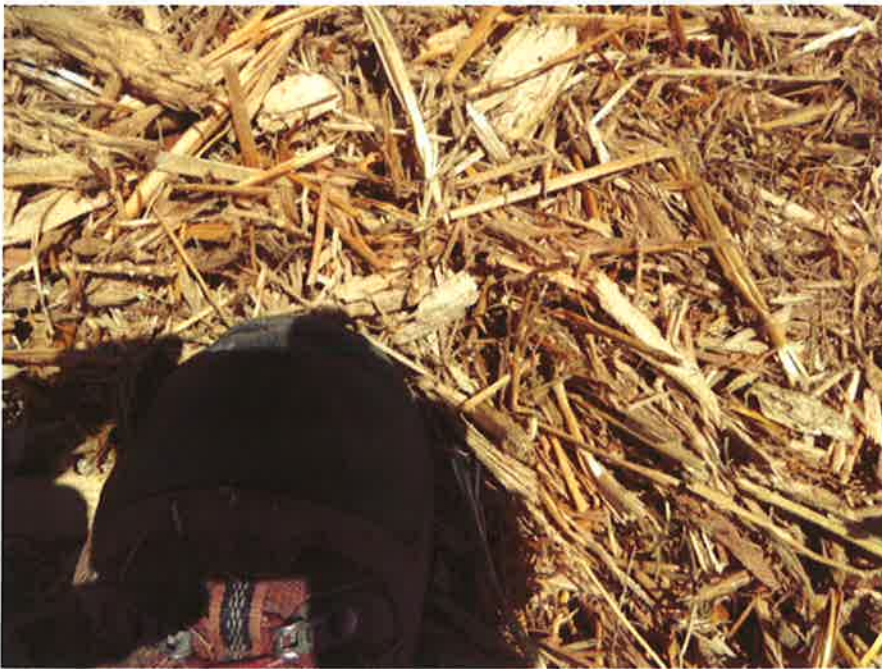
Figure 5: Wood shreds and agricultural straw mixed on staging area.

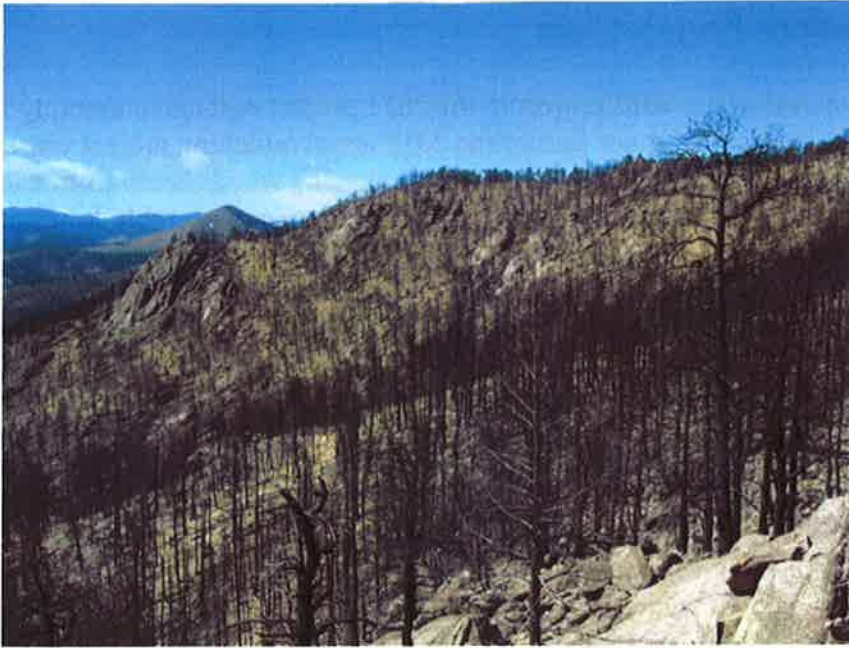
Figure 6: Ingram Gulch post treatment 2012

The Ingram drainage basin was the largest of the 2012 treatment areas, with 249 acres treated in 2012. This drainage had treatment in 2011 of agricultural straw in the upper 30 acres and Wood Straw (Forest Concepts) treatment in the rest of the 208 acres. This drainage was also the drainage that received check dams and catchment ponds at the base of the hill.

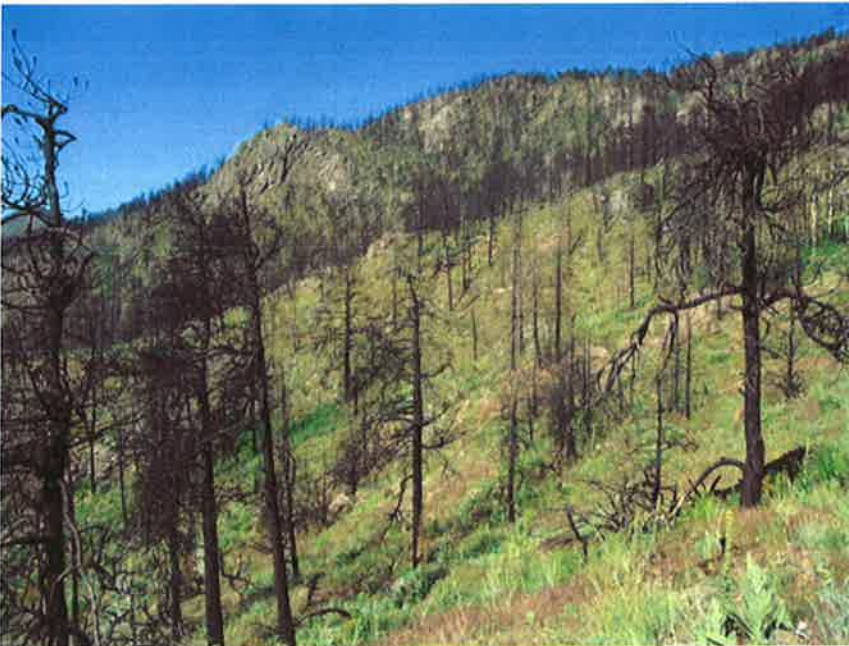
Figure 7: Ingram Gulch post treatment spring 2012

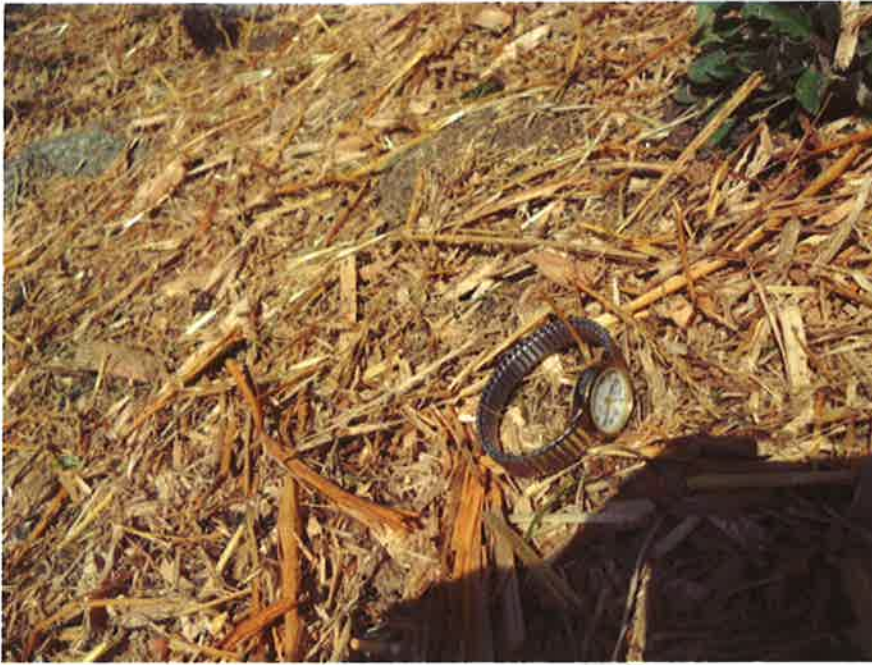
The mulch application inspections included the percentage of ground covered by mulch, depth of mulch, proportional coverage by the wood shreds and agricultural straw and any clumping of the agricultural straw. There was minimal clumping of either mulch product. Despite consistent mixing of the agricultural straw and the wood shreds on the ground prior to loading the nets, we found that in some areas the two mulch types separated while falling to the ground.

Figure 8: 2012 Applied mixed mulch

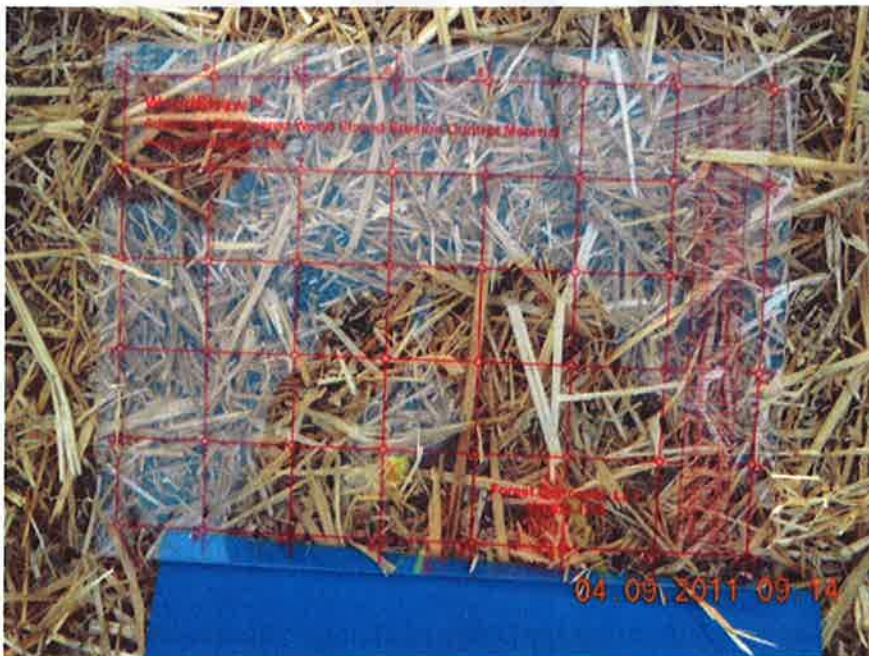
Monitoring of the applied mulch was completed by randomly locating transects with a random bearing inside the treatment polygons. Monitoring of ten transects in both Ingram Gulch and Melvina Basin (Hoosier Hill) was completed by staff. The monitoring of the transects was completed by the observer taking ten paces and placing the monitoring grid (figure # 10) on the ground surface at approximately every 30 feet.

Figure 9: Treatment inspection transect monitoring grid

The number of intersections on the grid that intercepted mulch was counted and the designated percentage was recorded. The percentages for the ten plots for each transect were then averaged and then the ten averages for each plot were averaged for all ten transects.

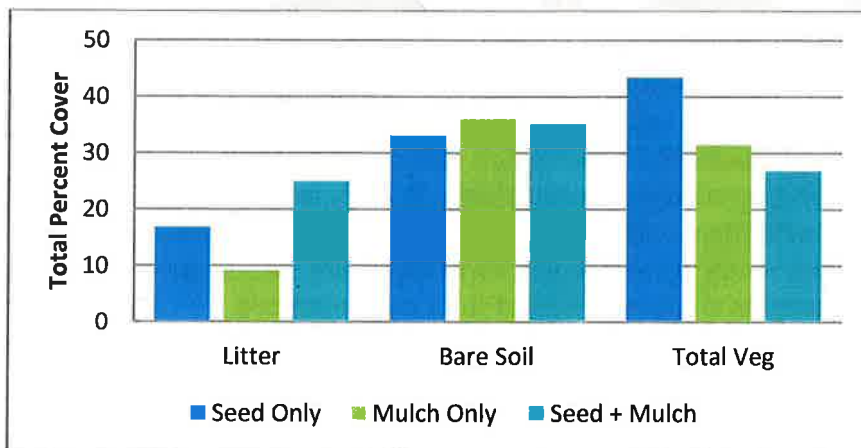
Figure 10: Total cover by treatment, 2012

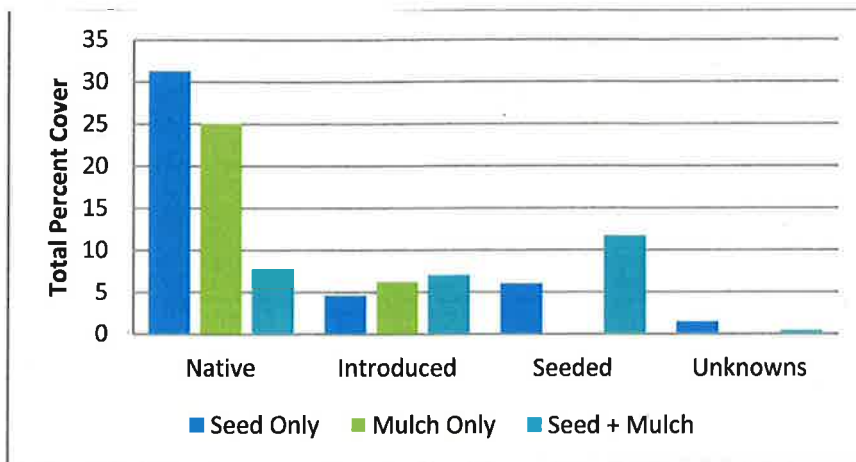
Figure 11: Vegetative cover by treatment, 2012

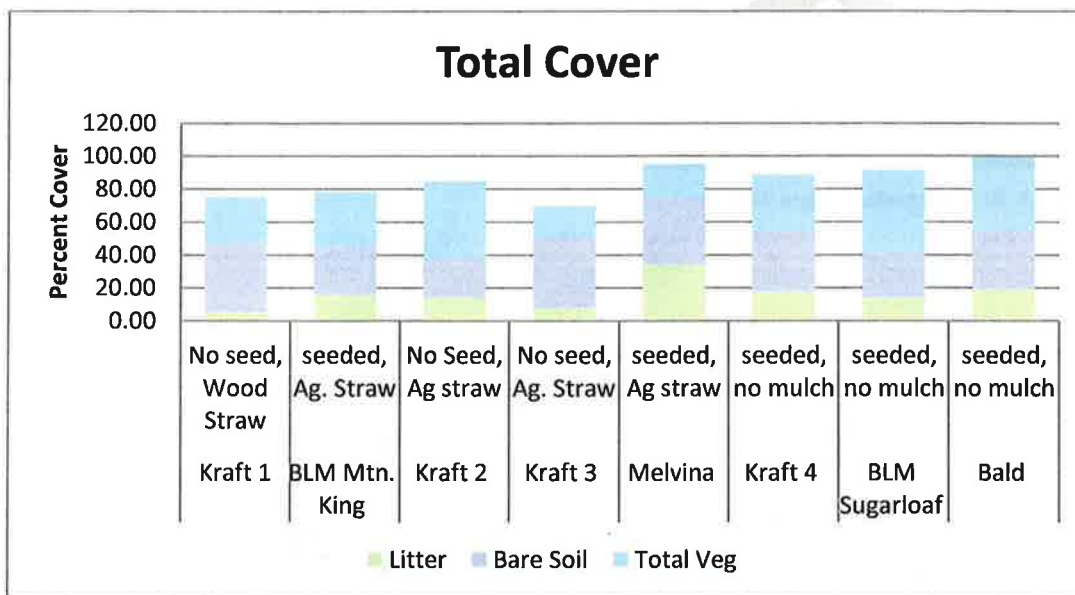
Figure 12: Total cover at all sites.

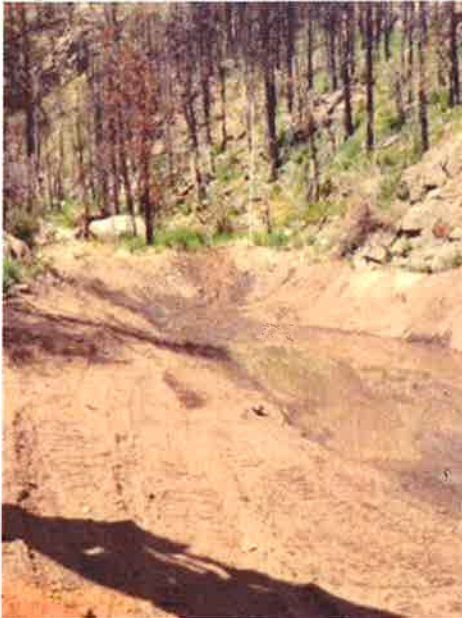
Upper Pond, As Built

- Excavated material was placed at a two and a half foot to one-foot slope at an onsite repository, and compacted with an 80,000 lb. excavator.
- A 6-foot high low flow boulder spillway was constructed on the eastern end of the pond. A tracked hydraulic excavator drove foundation boulders into the earth until refusal. Subsequent boulder layers were seated into each other by strategic positioning and driving them with the excavator bucket. The approximate dimensions of the boulder spill way are; six feet in height, 15 feet in width, and 15 feet thick.

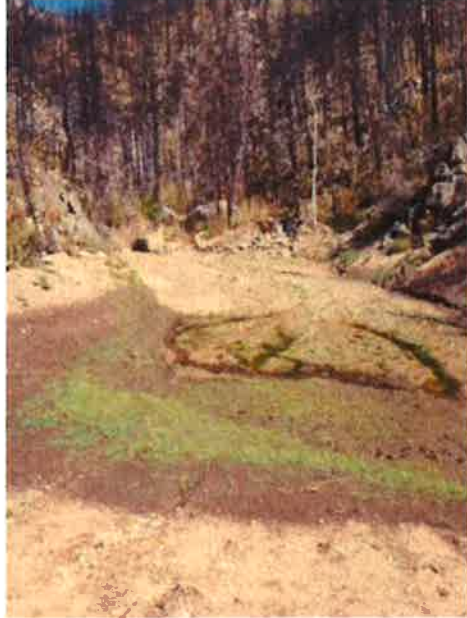
Upper Pond, Post Event

Operations and Maintenance (O&M) will be needed on both ponds to ensure their viability for the 2013 monsoon season. Excavation of captured sediments will increase the effectiveness of both structures. Some erosion has occurred around the spillway in the upper pond, this should be filled in to prevent any further decay of the structure. Anders Environmental recommends semi-annual inspections to stay ahead of any maintenance issues.

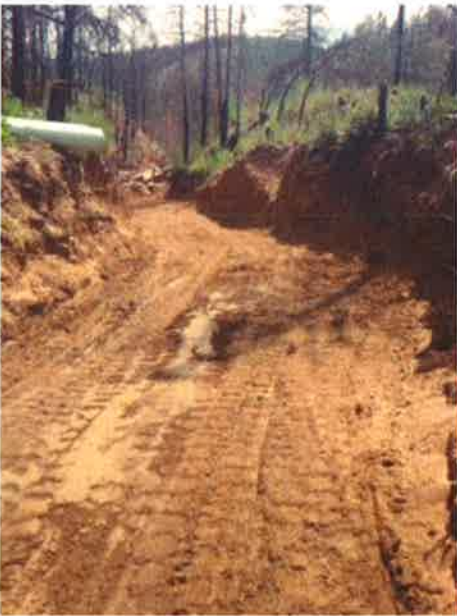
Lower Pond, As Built

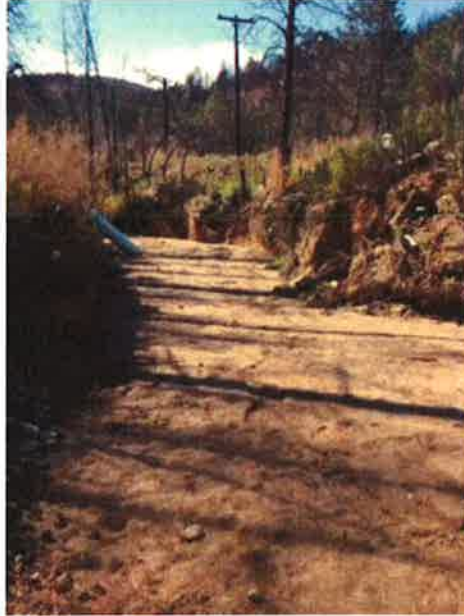
Lower Pond, Post Event

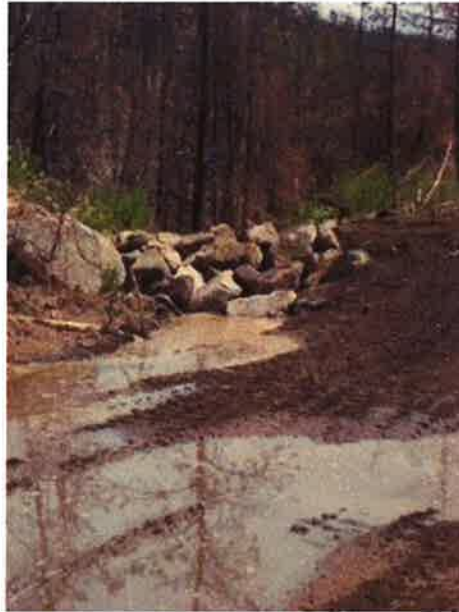
Upper Pond, Spillway

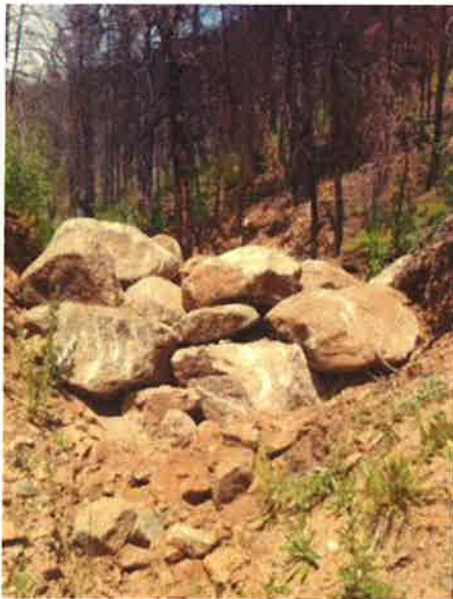
Lower Pond, Check Dam

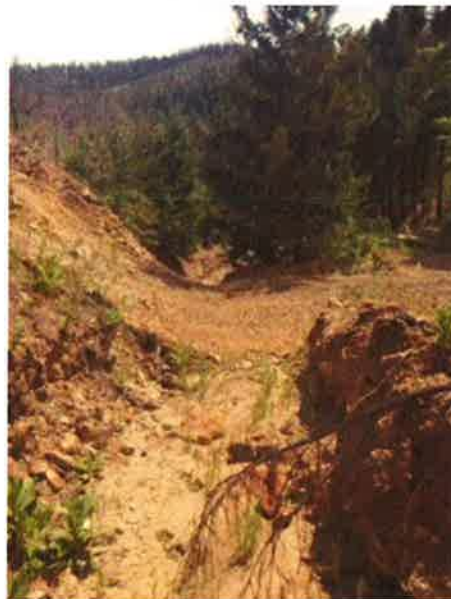
Lower Pond, Culvert Removal

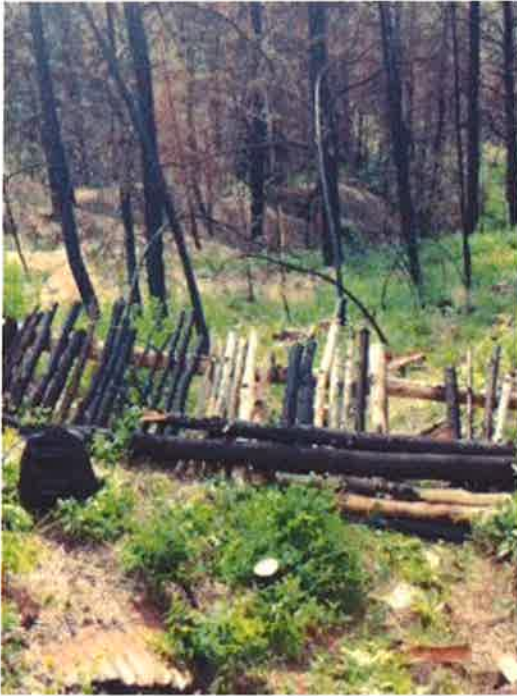
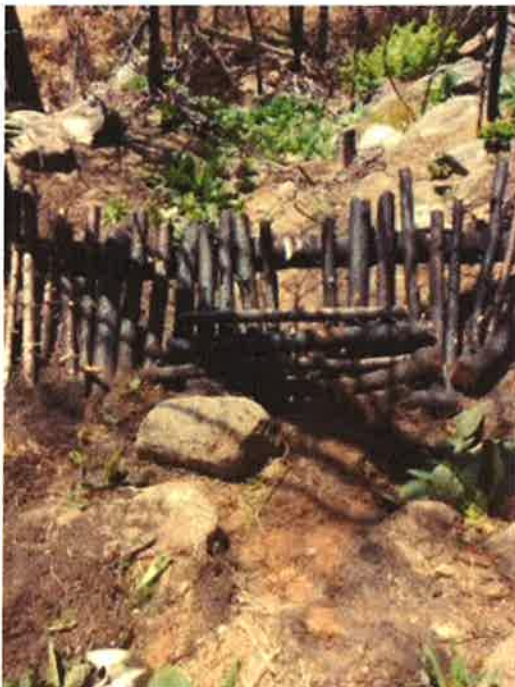
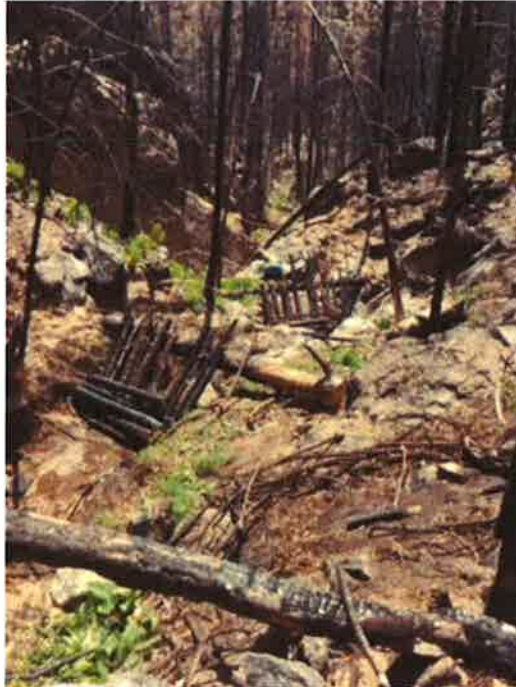
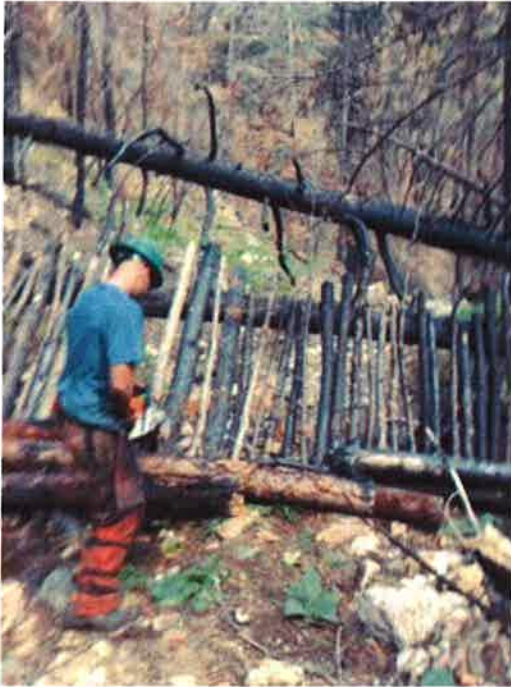
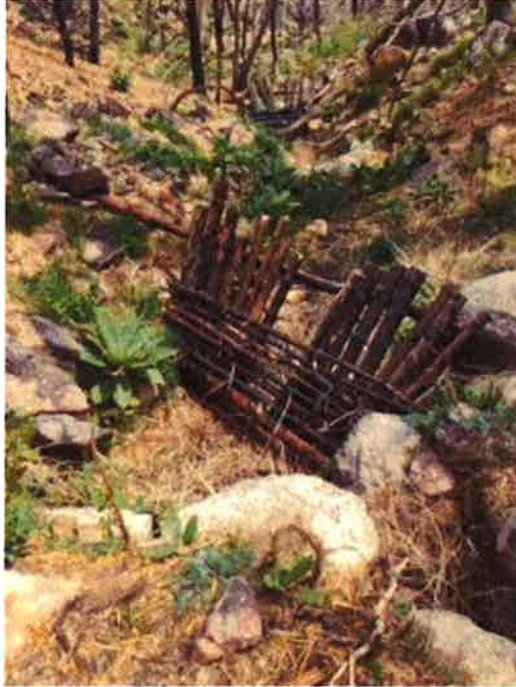
Check Structure, As Built

Check Structures, As Built

A total of fifty-three (53) check structures were placed in Ingram Gulch as specified by the WWE *Fourmile Canyon Debris Flow and Review and Mitigation Analysis, December 2011* report. Check structures were placed in the general locations outlined by the 2012 Proposed Watershed Protection & Noxious Weed Treatments map (See Figure 2). GPS coordinates for the exact locations of each check structure can be found in Table 1. Check structures were constructed in areas that provided the greatest sediment capture rates, and where suitable anchor points for the horizontal beam could be found (See Appendix A for pictures).

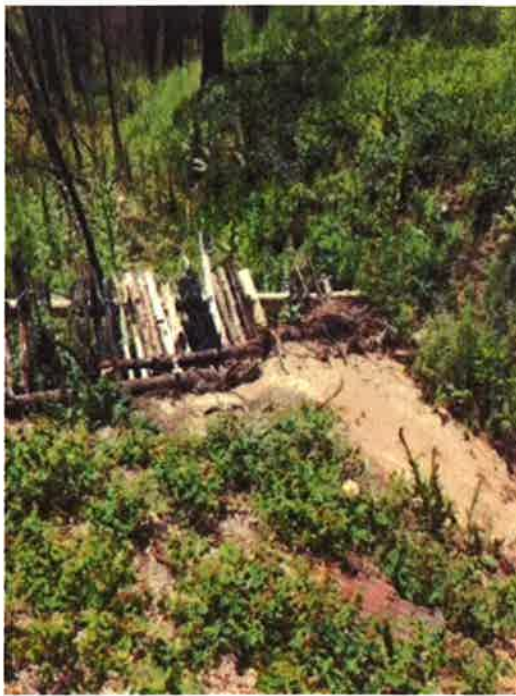
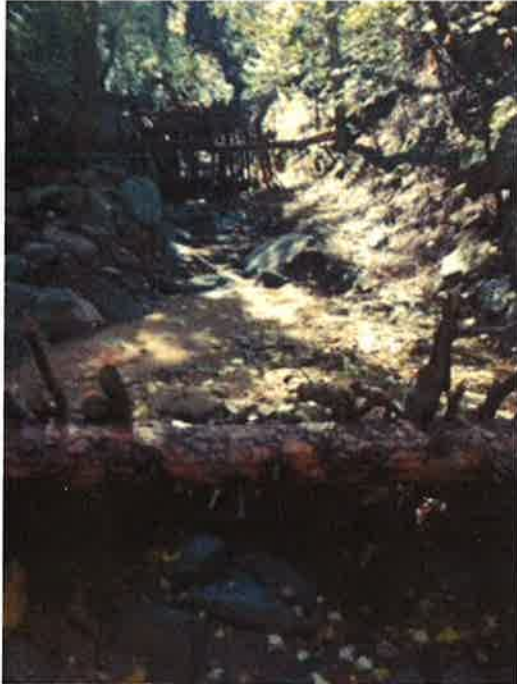
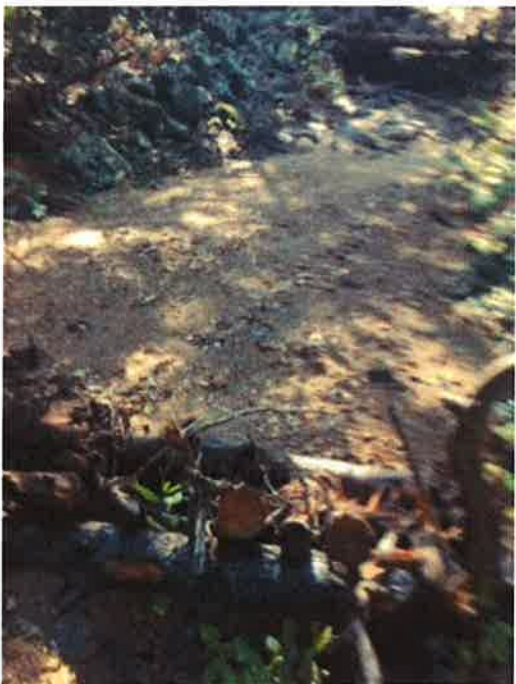
The lower check structures in the basin functioned in the same manner, but were breached much more often during the large rainfall events that the area experienced during the monsoon rains in July. Structural failure of the check structures generally occurred in the upper horizontal crossbeam due to overloading during large precipitation events. Some failures were a result of high velocity flood events sweeping or floating the vertical poles and lower horizontal logs.

Check Structure, Post Event

Check Structures, Post Event

To mitigate the upper crossbeam failures, living trees should be utilized when available as opposed to the fallen timber outlined in *Table 1, Section 3.2, Technical Memorandum 5*, of the *WWE December 2011* report. The increased flexibility and structural integrity of living trees will enhance the durability of most check structures.

Decreasing the failure rate of check structures due to high velocity water can be mitigated by increasing the number of structures in the lower reaches of the basin. This is evident by the high survival rate of the lower Monument Hill structures.

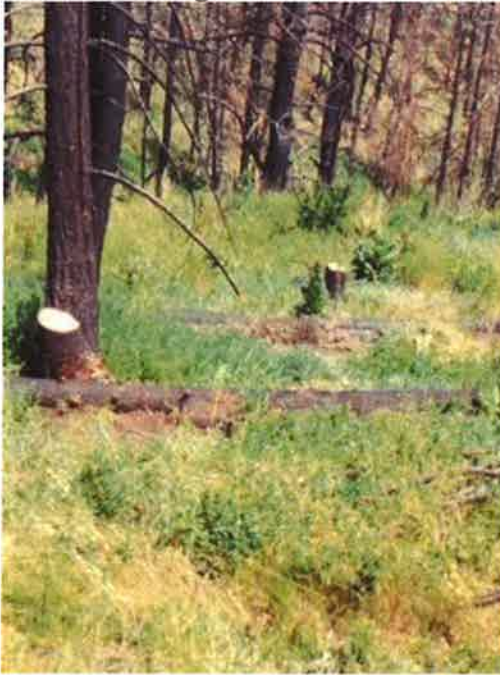
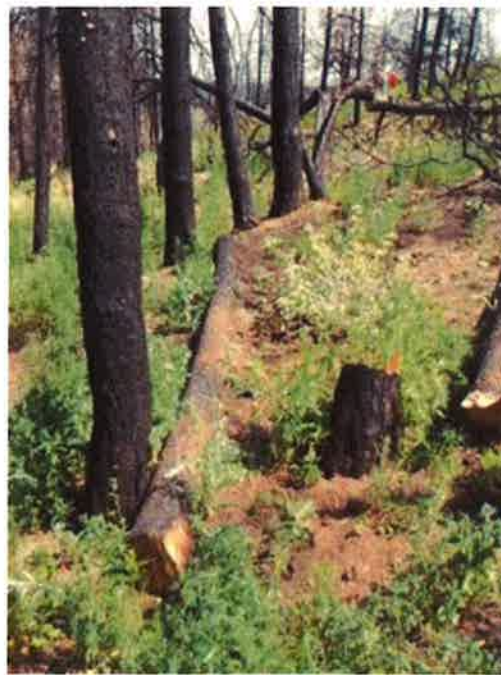
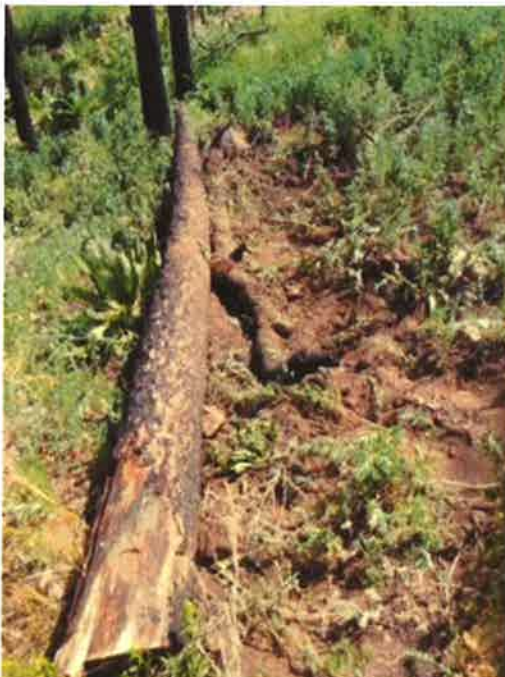
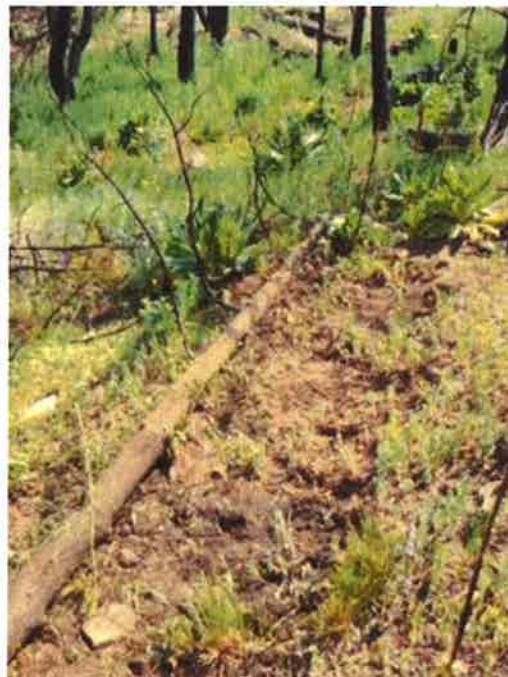
27.6 acres of contour felling was completed at 458 & 382 Whispering Pines. Anders Environmental installed LEBs in accordance with the methods for contour felling laid out in Chapter 2 of the *USFS BAER Treatments Catalog*. Due to the undulating rocky terrain found in this area, LEBs were concentrated on the eastern portion of this basin due to the steep slopes that had the highest probability of erosion (See Appendix A for pictures).

Contour Felling, As Built

A small segment on the eastern side of this area was surveyed after the heavy monsoonal rains in July. The LEBs appeared to be functioning as intended at that time. Due to the small volume of sediment each log can capture the logs in the steep bare areas had already been covered. During a subsequent site visit on September 27<sup>th</sup>, 2012, Anders Environmental observed increased vegetative cover, which stabilized the slopes on the western side of the treatment area.

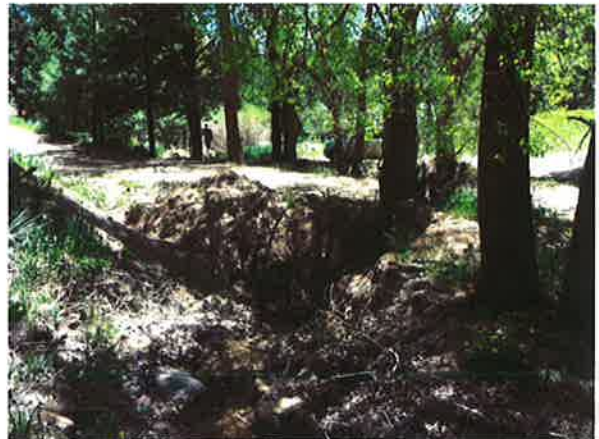
Whispering pines above upper culvert  
preconstruction

*Task Completed:* This task was completed in June 2013. The site was reviewed, and designs were completed to replace existing culverts crossing the road, add erosion control and regrade downstream area to provide better flow containment. Work completed included grading, channel rehabilitation, and culvert replacement and armoring (200 linear feet). Three pine trees were removed and all cottonwoods were retained. Two 36” culverts (58 feet long) were installed with boulders and cobble for riprap protection at both ends of the culvert, and 9 tons of road base was added to the project area. All disturbed areas were revegetated with onsite stockpiled topsoil and seeded and mulched .16 acres with Boulder County approved native seed mix. Please refer to the attached before and after pictures of this area included in Attachment D.

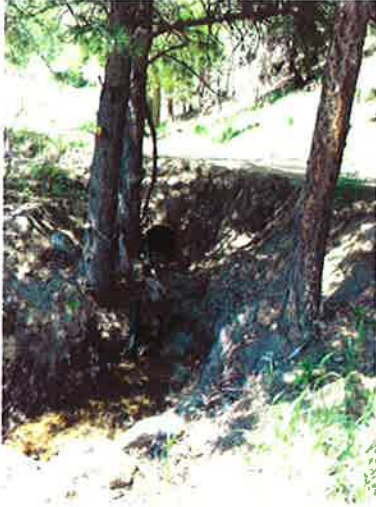
Whispering pines below upper culvert  
preconstruction
