CWRP Final Report
Prepared by: Emily Galanto
June 2013

Grantee: Uncompahgre Watershed Partnership

PROJECT NAME – Uncompahgre River Riparian Health Improvement Project

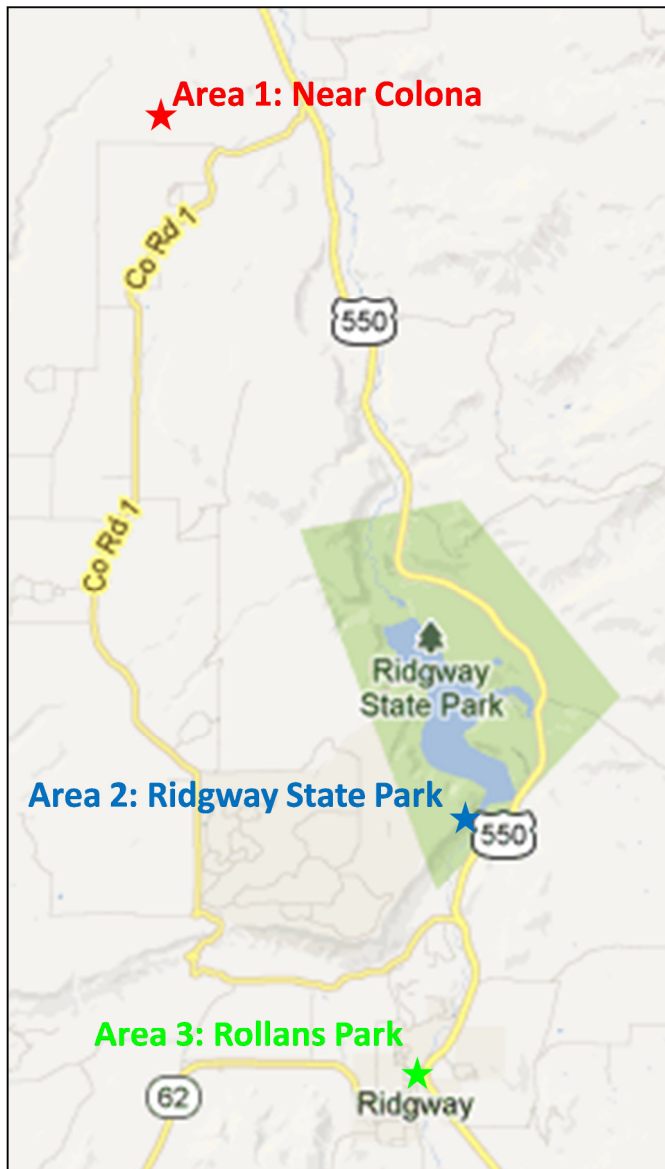
Figure 1. Locations of 3 areas treated for tamarisk in Ouray County.

Figure 1 shows locations of treated tamarisk populations. The following table shows % completion of tamarisk removal in each area, and the approximate date the rest of the tamarisk will be removed:

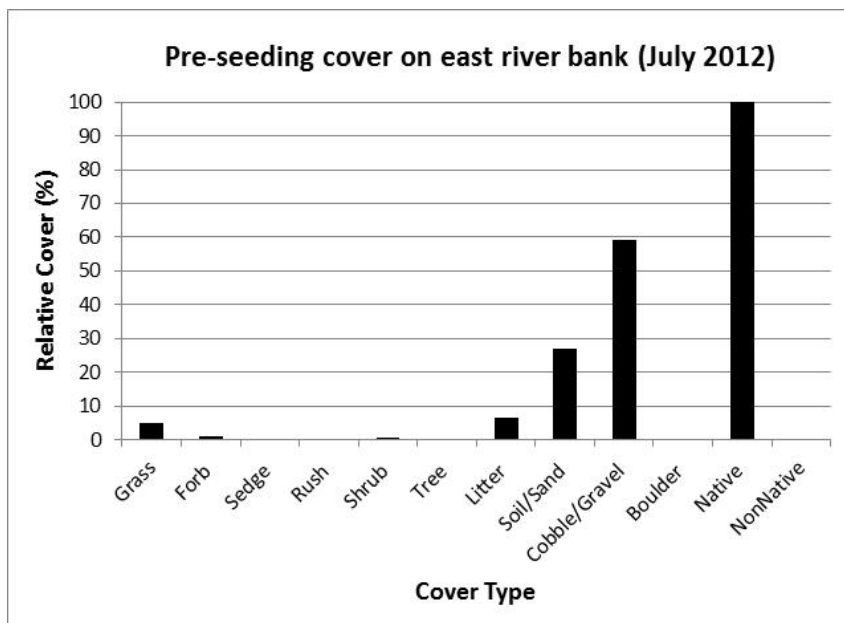
Figure 2. Average relative cover by cover type collected at 10 plots on the east river bank before seeding in October 2012.

Deliverable 1: Figure 2 and 3 show average ground cover estimates collected before October 2012 seeding events. Figures 2a and 3a show the post-seeding percent cover data as of May 2013. These results are preliminary as the fiber has not degraded yet (normally takes between 12-24 months) and the native grass seeds have not fully grown in yet.

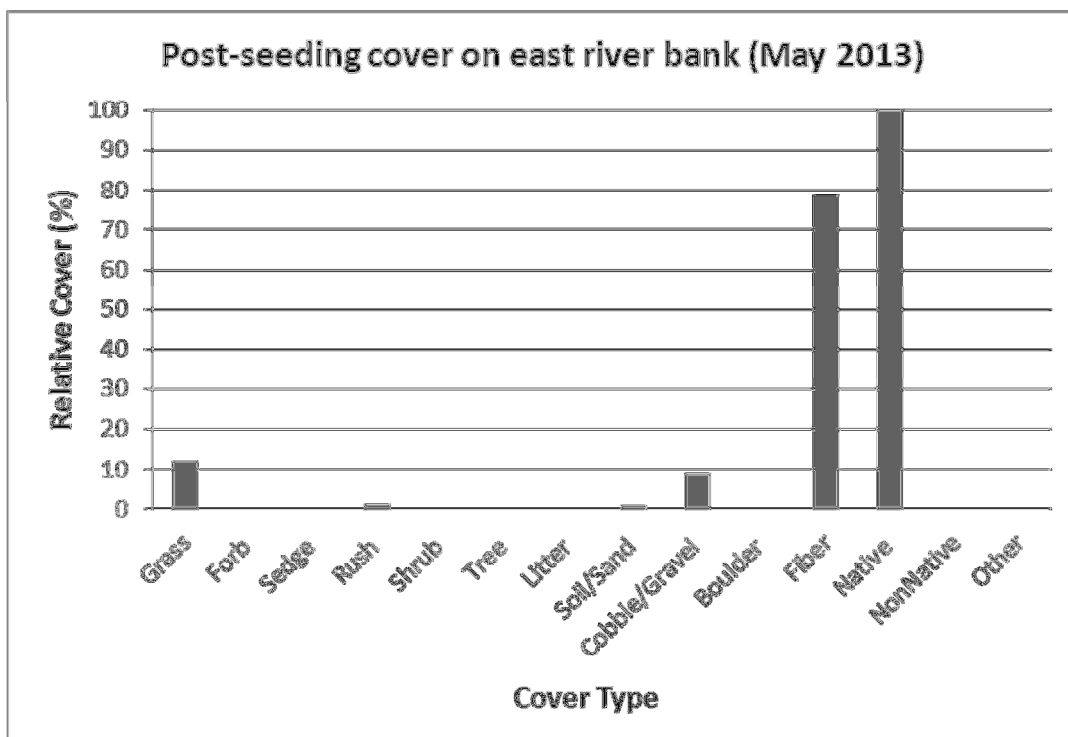
Figure 2a. Average relative cover by cover type collected at 11 plots on the east river bank after seeding. Data collected in May 2013.

As of May 2013, there has been a 6.1% increase in grasses on the east bank, and an 11.2% increase on the east spit. All of the vegetation is still 100% native. Over time, the ground cover is expected to increase as the fiber degrades and the seeds have longer to germinate and establish. The UWP will continue to monitor these plots until 2014.

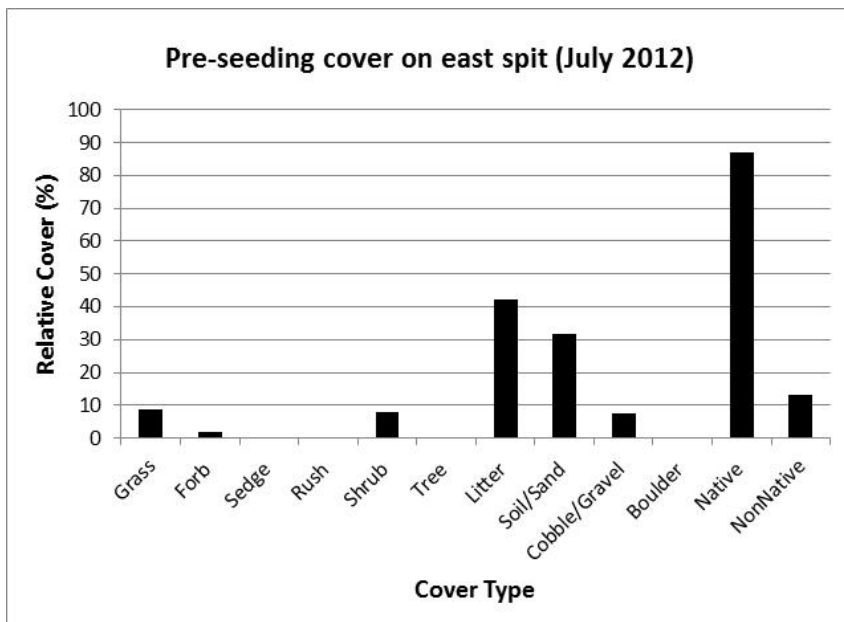
Figure 3. Average relative cover by cover type collected at 5 plots on the east spit before seeding in October 2012.

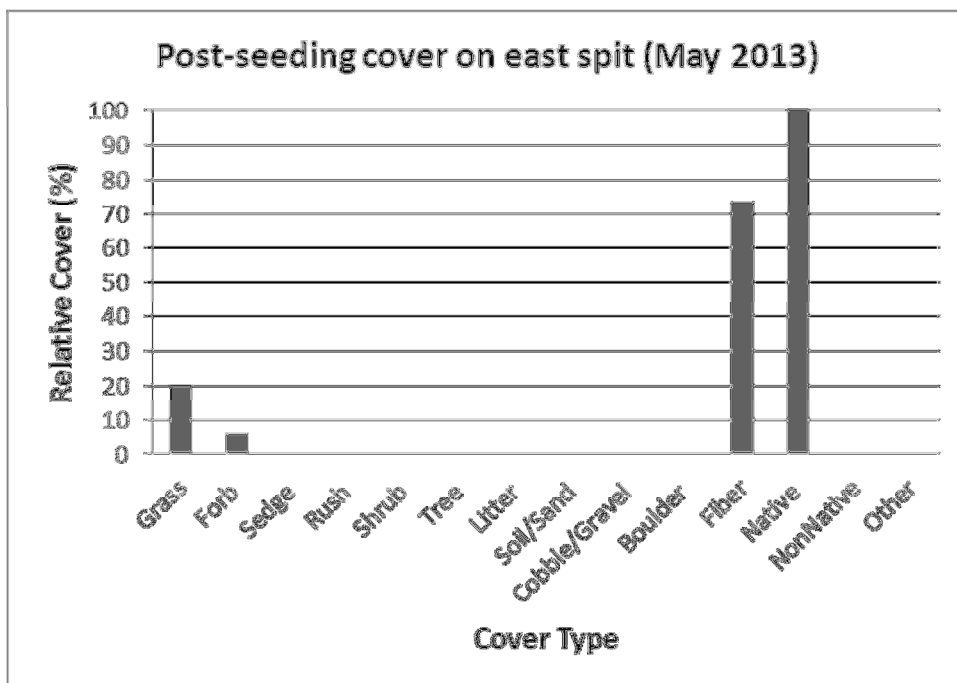
Figure 3a. Average relative cover by cover type collected at 5 plots on the east spit after seeding. Data was collected in May 2013.

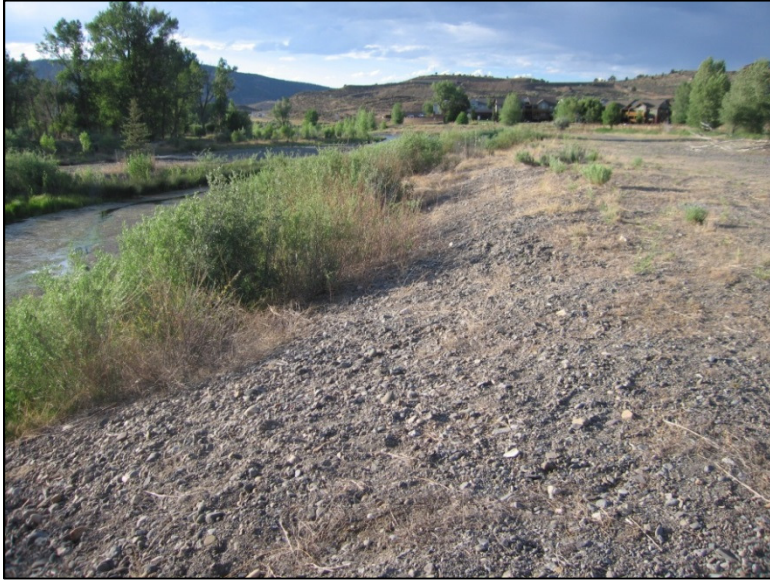
Photo 1. Eastern streambank before seeding.

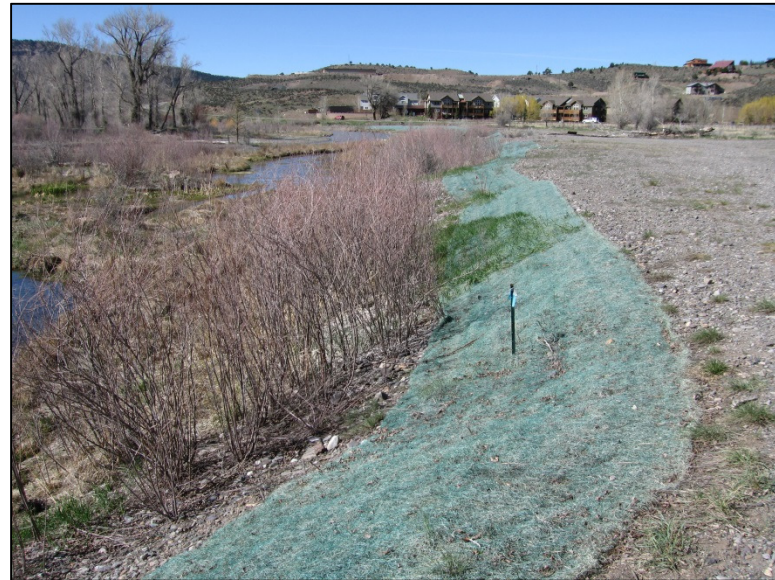
Photo 1. Eastern streambank after seeding in Fall 2012.

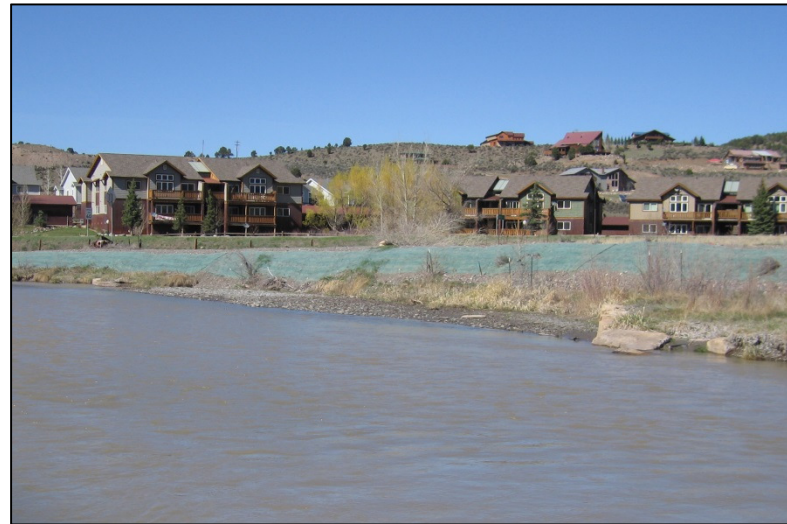
Photo 2. Barren eastern streambank from west side before seeding.

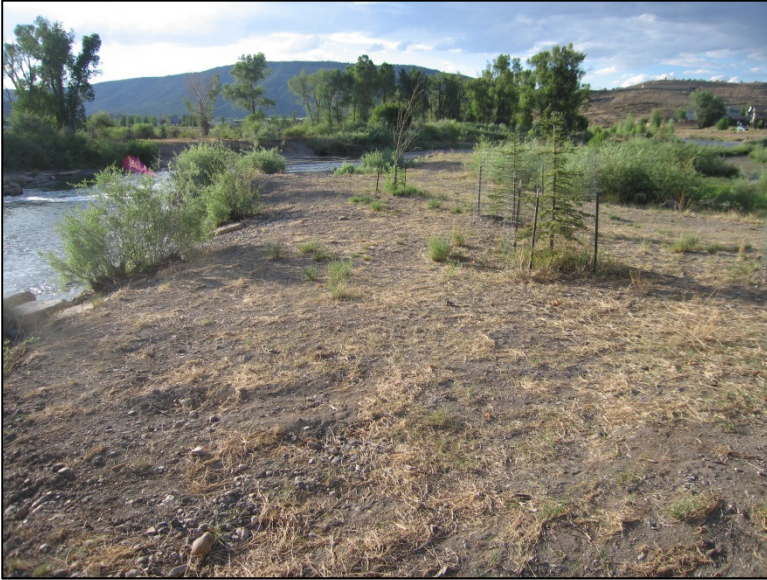
Photo 3. Eastern spit before seeding.

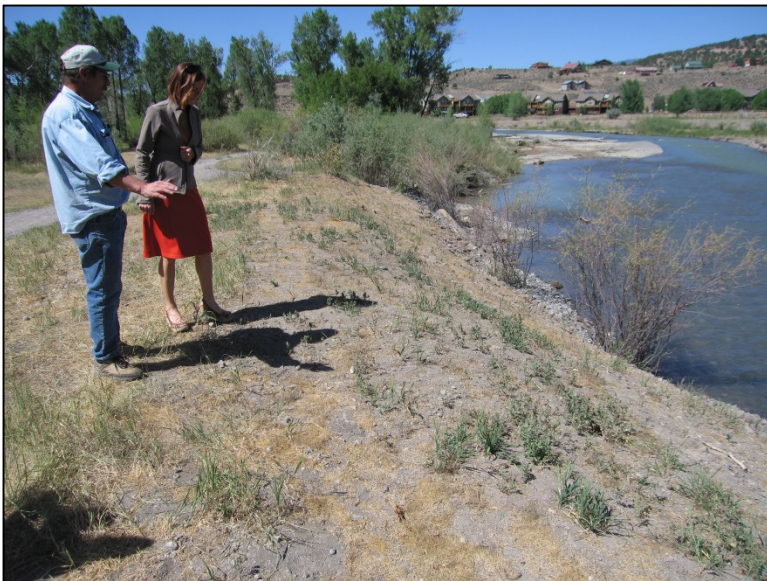
Photo 2. Eastern streambank from west side after seeding in Fall 2013.

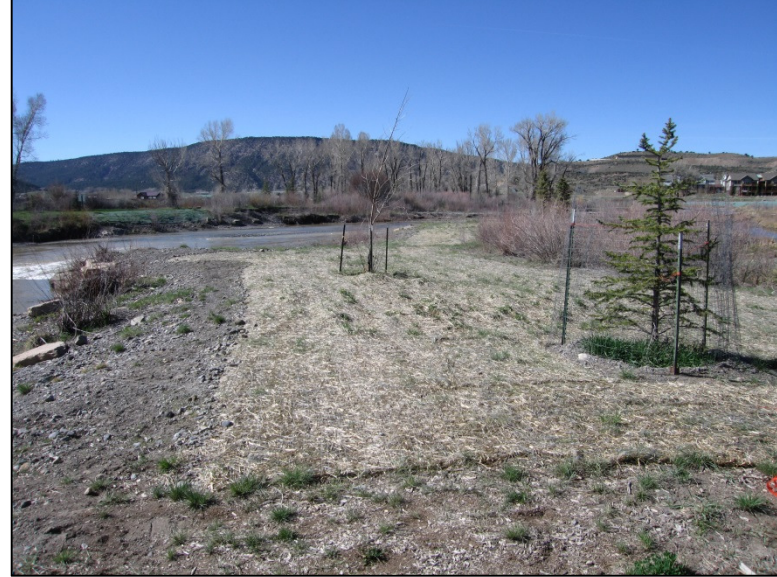
Photo 3. Eastern spit after seeding in Fall 2012.

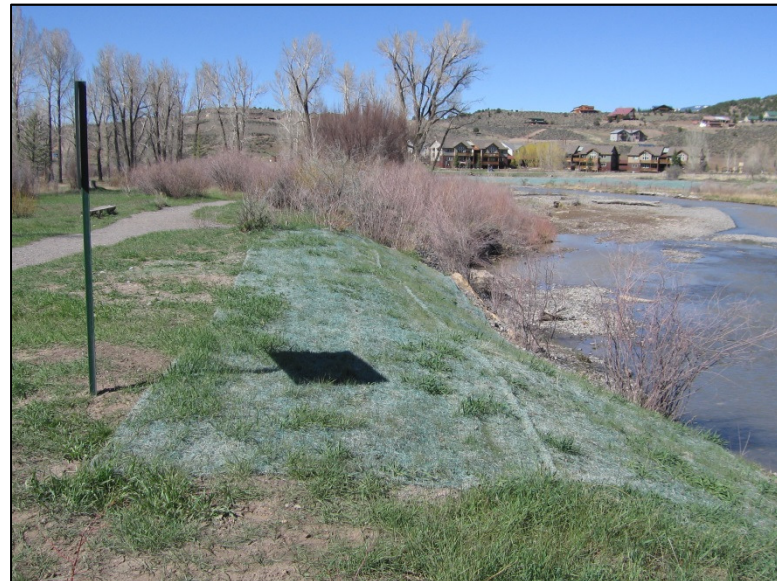
Photo 4. 200 ft west side bank before seeding.

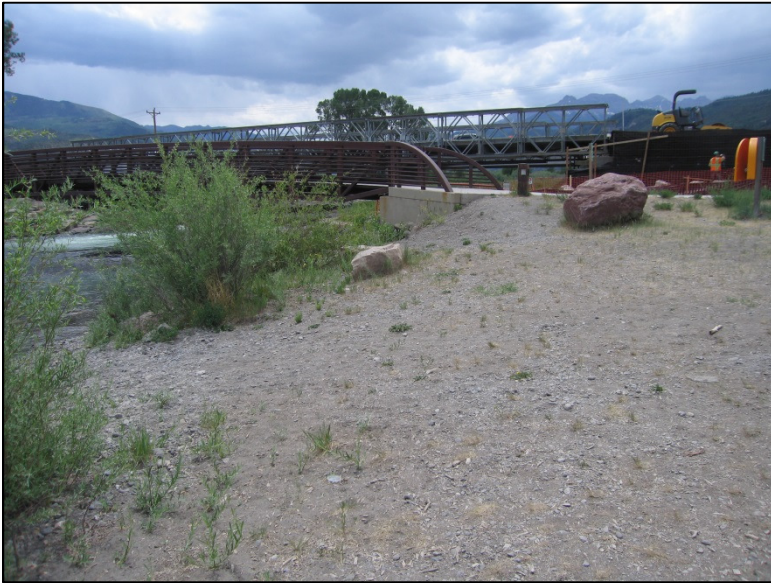
Photo 5. Area on west side of footbridge before seeding.

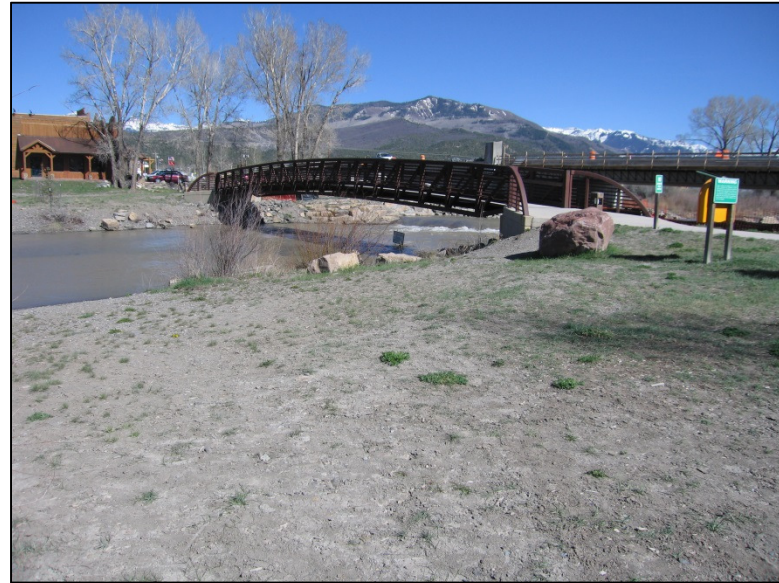
Photo 5. This area will be re-seeded in Fall 2013.

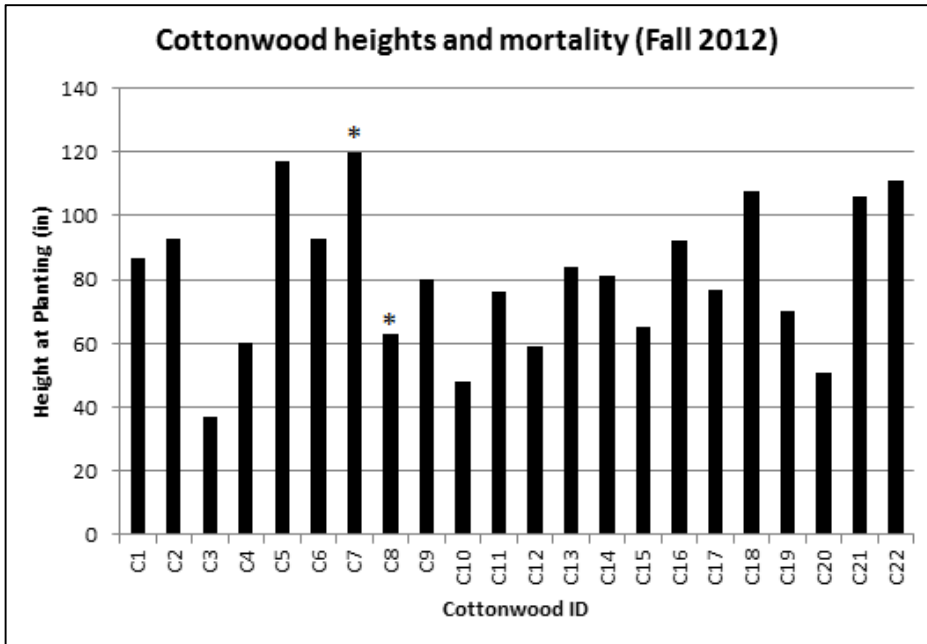
Figure 3. Heights and mortality of transplanted cottonwoods in Fall 2012.

* indicates trees which did not put on new leaves by end of growing season 2012 and possibly did not survive.

Figure 3 shows initial tree heights and indicates which trees appeared not to survive transplantation by Fall 2012. Figure 4 shows the conditions of each tree, as well as other specifics, as of May 2013. Based on these data mortality was 9%, survival 59% and survival of 32% of the trees was uncertain: they had basal sprouting but no new growth on limbs which might or might not result in long term survival. We will re-assess the trees in Fall 2013 and consider pruning the surviving basal sprouters to single stem in the future to promote long-term survival.

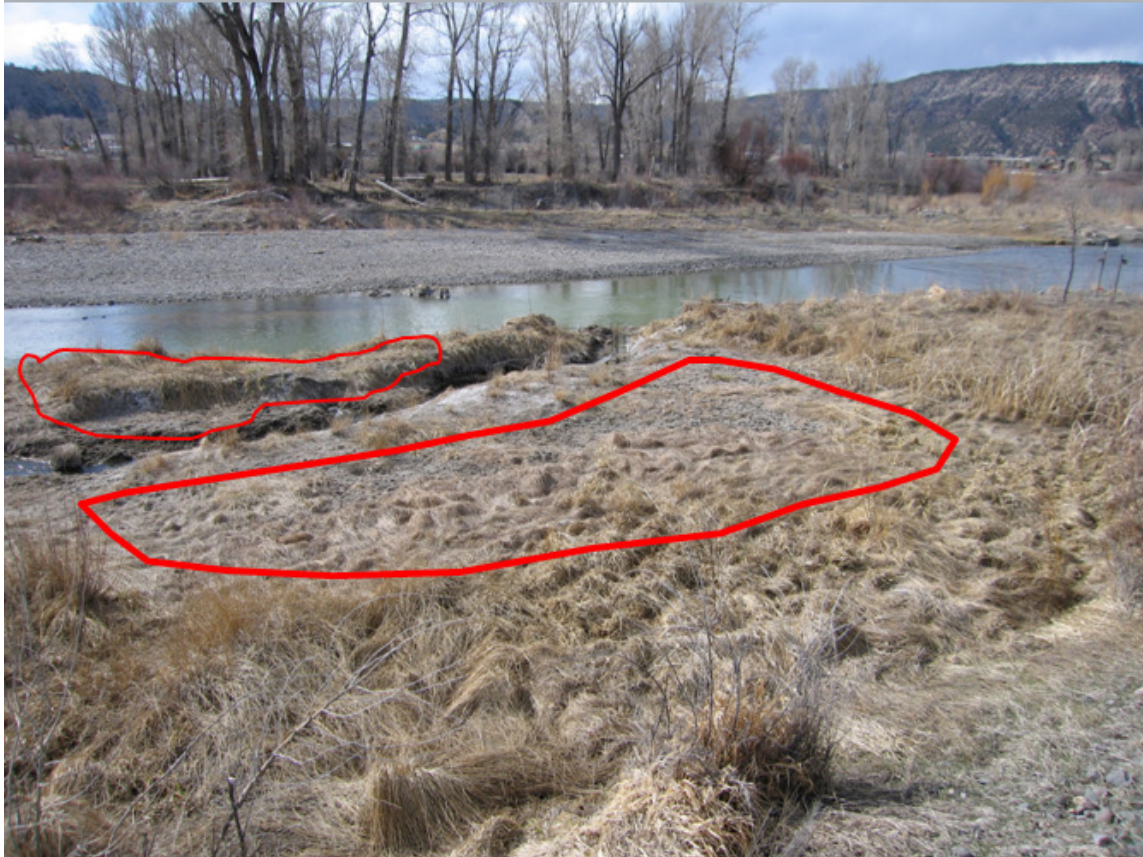
3. The willows were then transported and immediately planted. We used rebar, sledges, and post-pounders, donated by the Town of Ridgway, to make slim, 2-4 feet deep holes for the willows. The willows were inserted into 28 holes in a wetland area on the east side of the Uncompahgre River. 22 willows were planted with one pole, 3 were planted with the terminal buds snipped, and 3 were planted with 3-pole bundles. The removal of the terminal buds and the bundles were experimental sites. The photo below shows the site where the willows were planted:

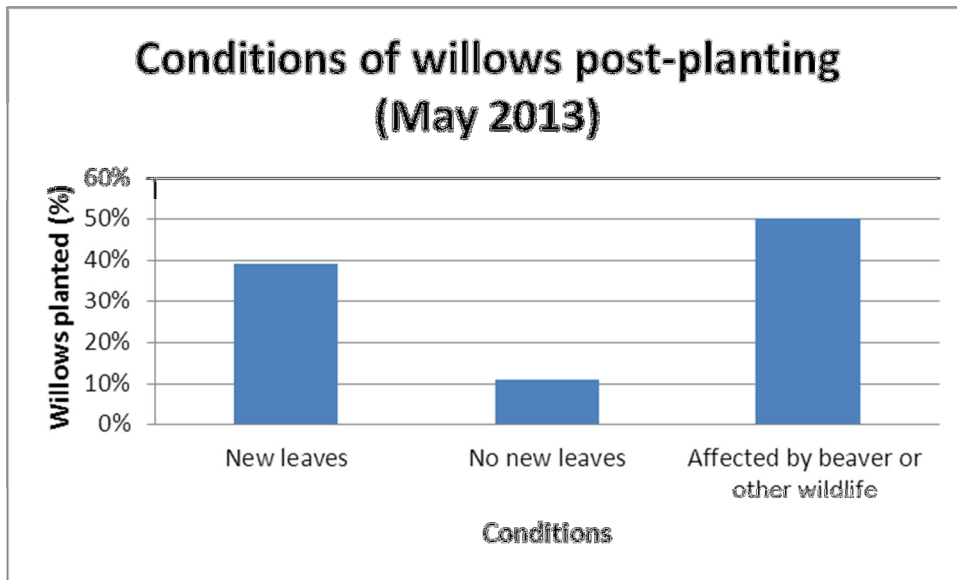
Figure 5. Percent of willows in each observed condition.

The willows were monitored shortly after planting in late-May 2013. Table 1 shows these observations, and Figure 5 shows percent of willows in each post-planting condition. As of May 2013, the planted population of willows exhibited a 40% survival rate. The willows will continue to be monitored into 2014.
