# **Chico Basin Riparian Restoration 2013 Final Report**

Wildlands Restoration Volunteers

## 2013 Site (Long Branch Draw)

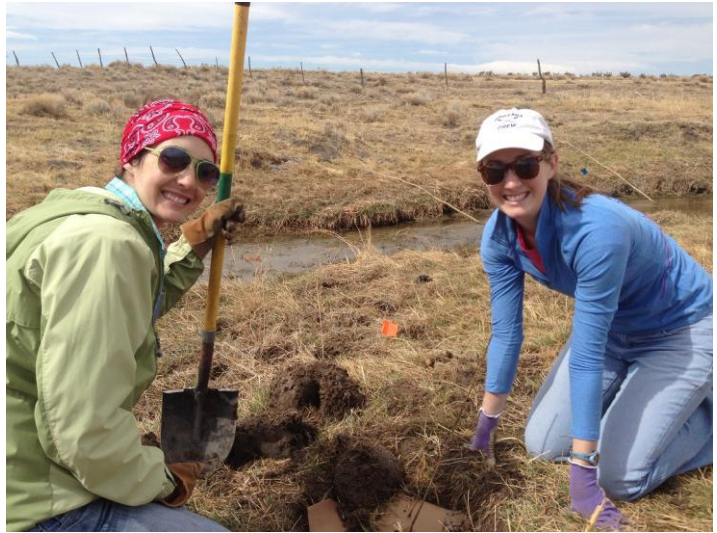
Long Branch Draw – Implementation  
Chico Basin 2013
