FINAL REPORT

LOWER SWAN RIVER AND WETLANDS RESTORATION PROJECT

BRECKENRIDGE, COLORADO

Submitted to:
Colorado Water Conservation Board
January 31, 2013

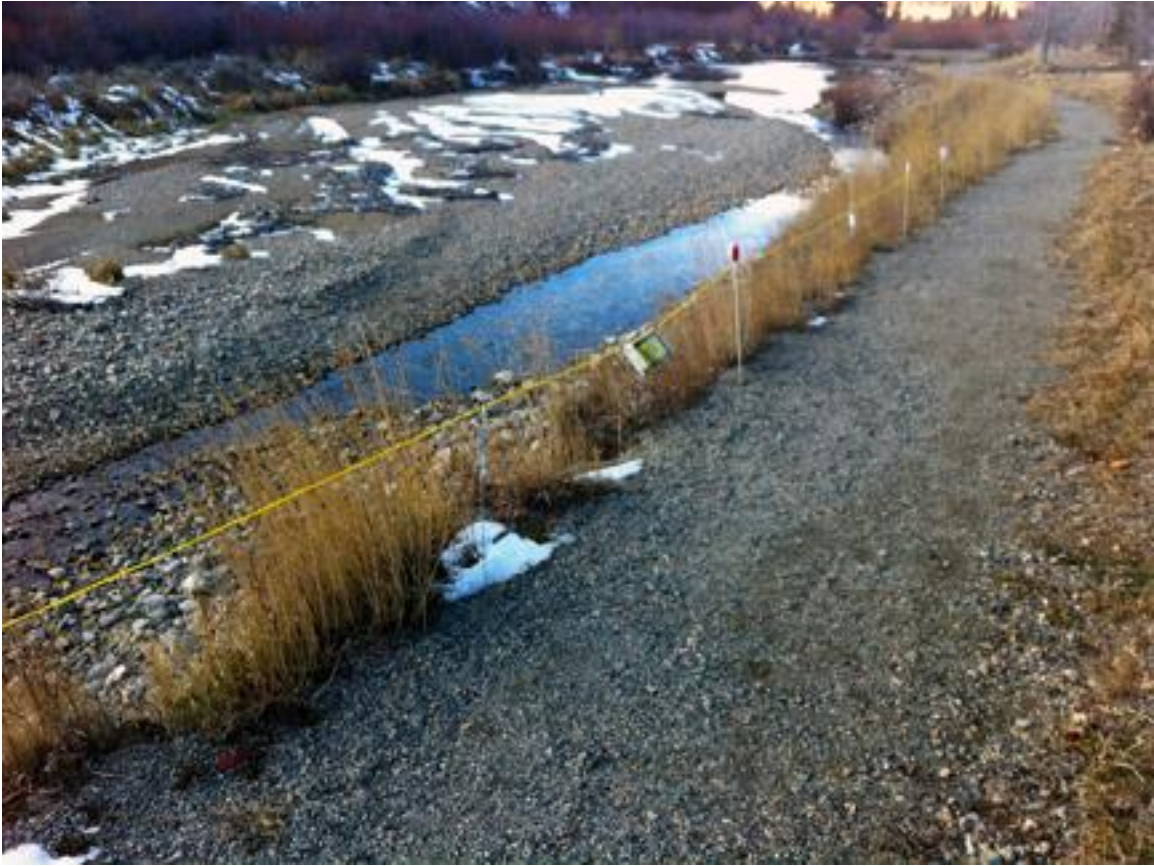
Prior to the damage caused by the run-off from the winter of 2010/11 the riverbank extended out fully eight feet past the roped-off area shown in this photo. Rubble from the bank collapse and also washed in by the run-off event is visible in the background.

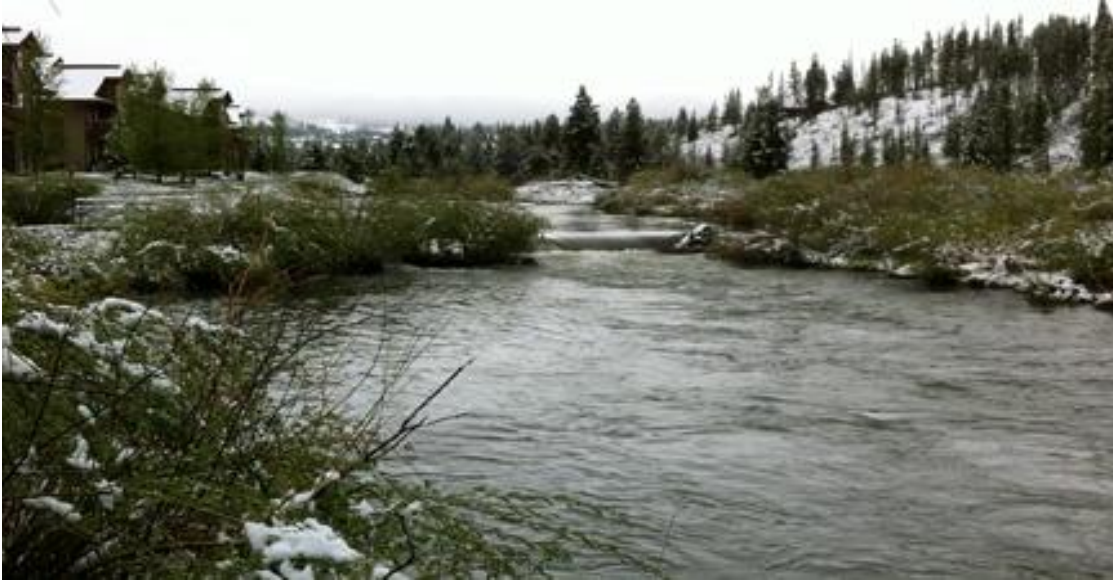
This photo shows the near peak runoff following the winter of 2010/11

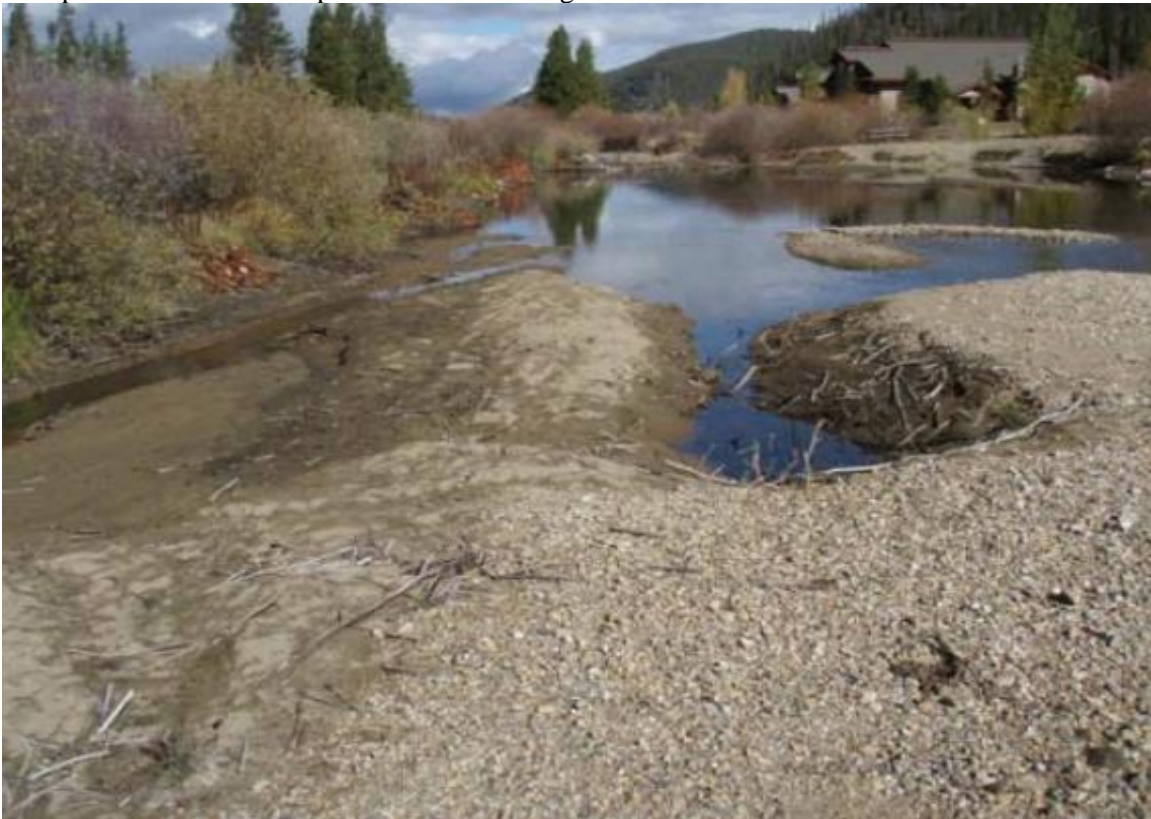
This photo shows the rubble brought in by the 2010/11 runoff as well as what remains of the upper pond.

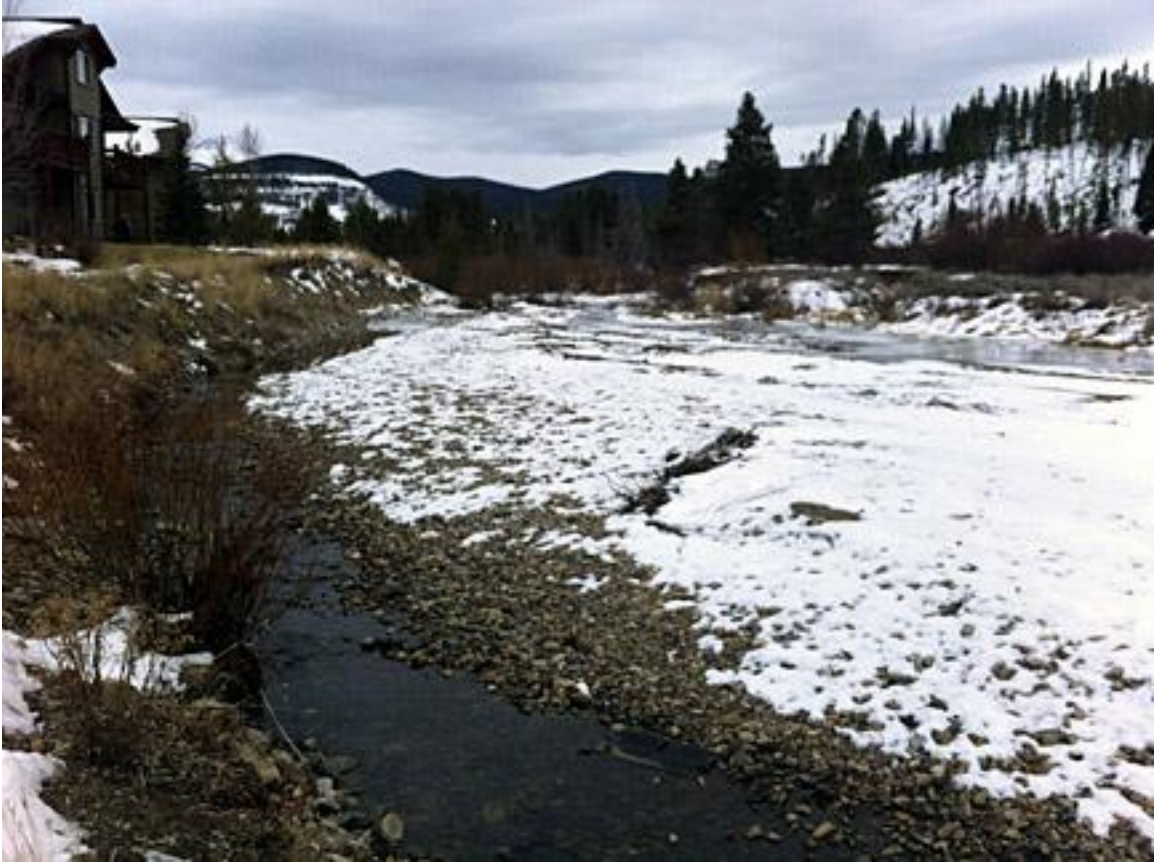
Virtually all of the rubble evident in this photo came from the collapsed bank shown in the background.
