Re: Colorado Watershed Restoration Grant Annual Report -- Coal Basin and Crystal River Confluence Area Restoration Project

South Fork of Dutch Creek Pilot Project Report

***Prepared by:* Sharon Clarke, Roaring Fork Conservancy;
Justin Anderson, Mark Lacy, Brian McMullen, and John Proctor,
White River National Forest
March 26, 2014**

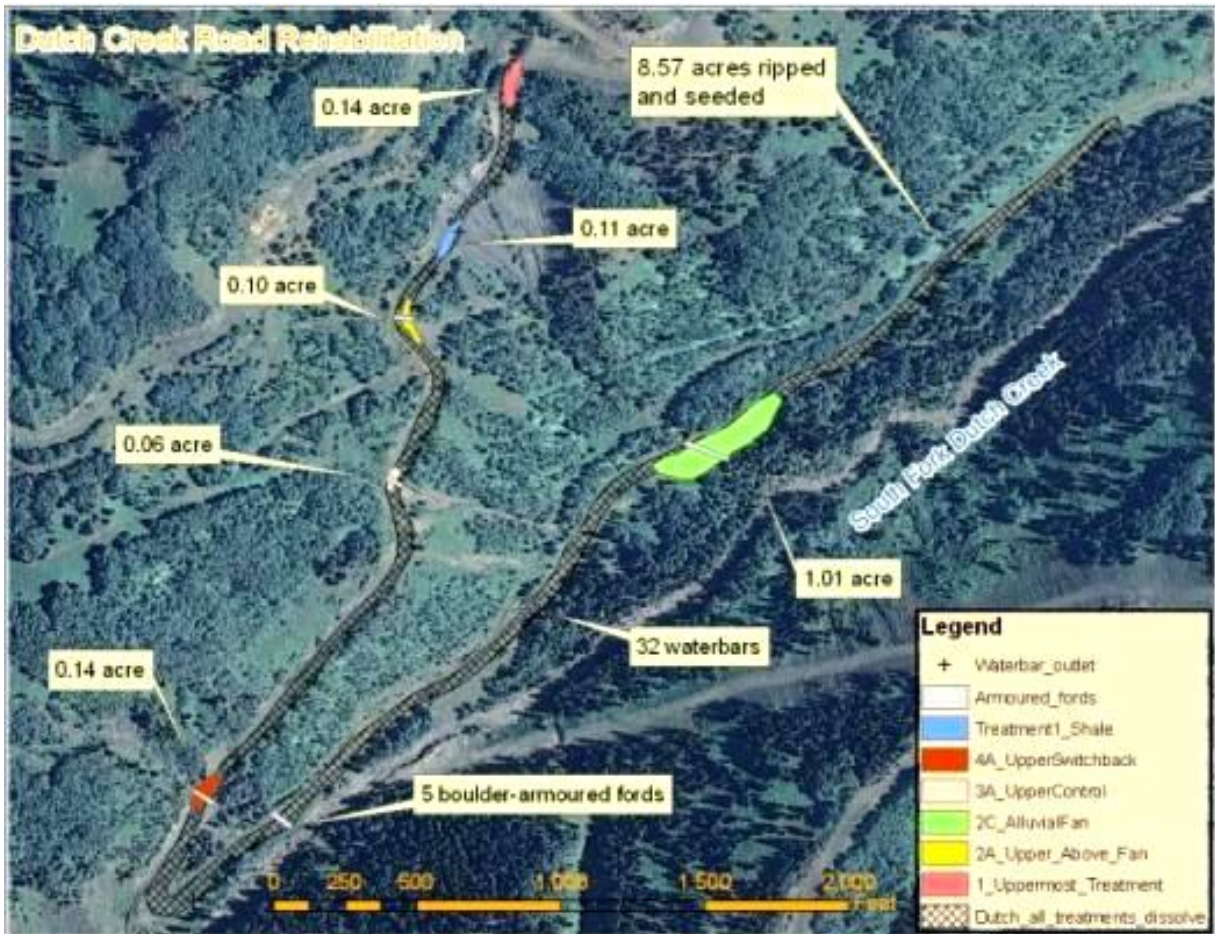
Figure 4. Pilot project area with treatment areas outlined.

Name of Treatment Area	Acres
1 Uppermost Treatment	0.14
Treatment 1 Shale	0.11
2a Upper Above Fan	0.1
3a Upper Control	0.06
4a Upper Switchback	0.14
2c Alluvial Fan	1.01
Road seeded and ripped	8.57
Total:	10.13

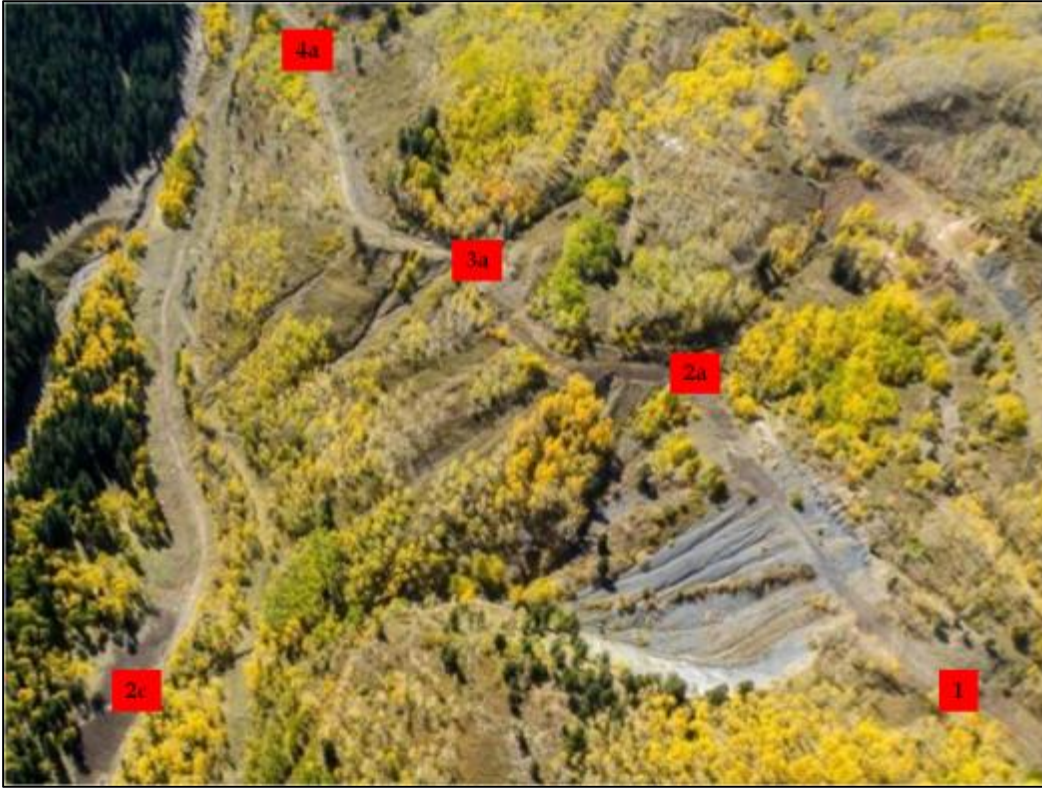
Figure 5. Pilot project area with work ongoing, September, 2012 (source: EcoFlight). Note the darkened surface at area 2c (“alluvial fan”) area, where the largest volume of compost/biochar was applied.

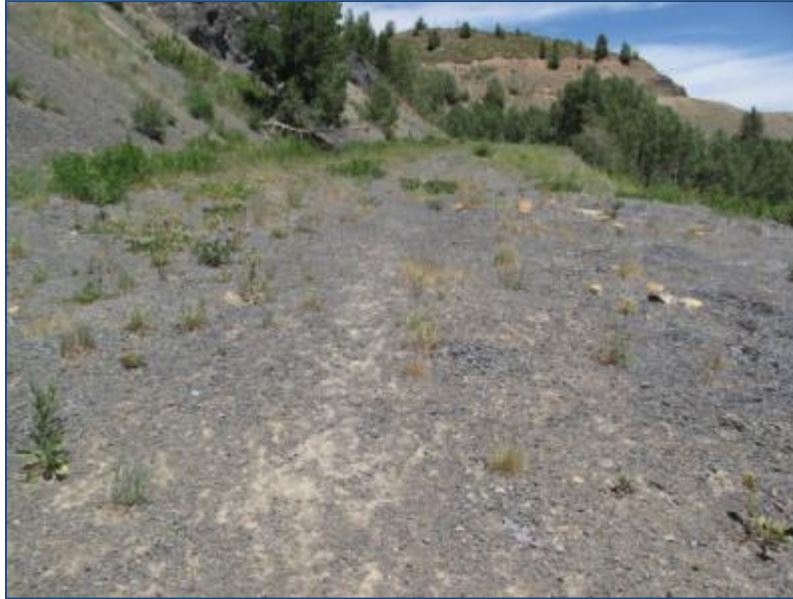
Figures 8 and 9 show the road prism before and after reclamation. In Coal Basin there are approximately 17 miles of legacy mining roads that were built using the cut-and-fill method; these were in-sloped to convey water, which was subsequently routed through culverts under the road. The culverts contributed to channel degradation by increasing flows in channels not naturally designed to carry these flows. Part of the reclamation work done by CDRMS was to out-slope the road prism and remove the culverts. Additional work still needed to be done on the road prism to improve water routing, increase water

Figure 8. Road prism before treatment; road had minimal infiltration and excessive overland flow.

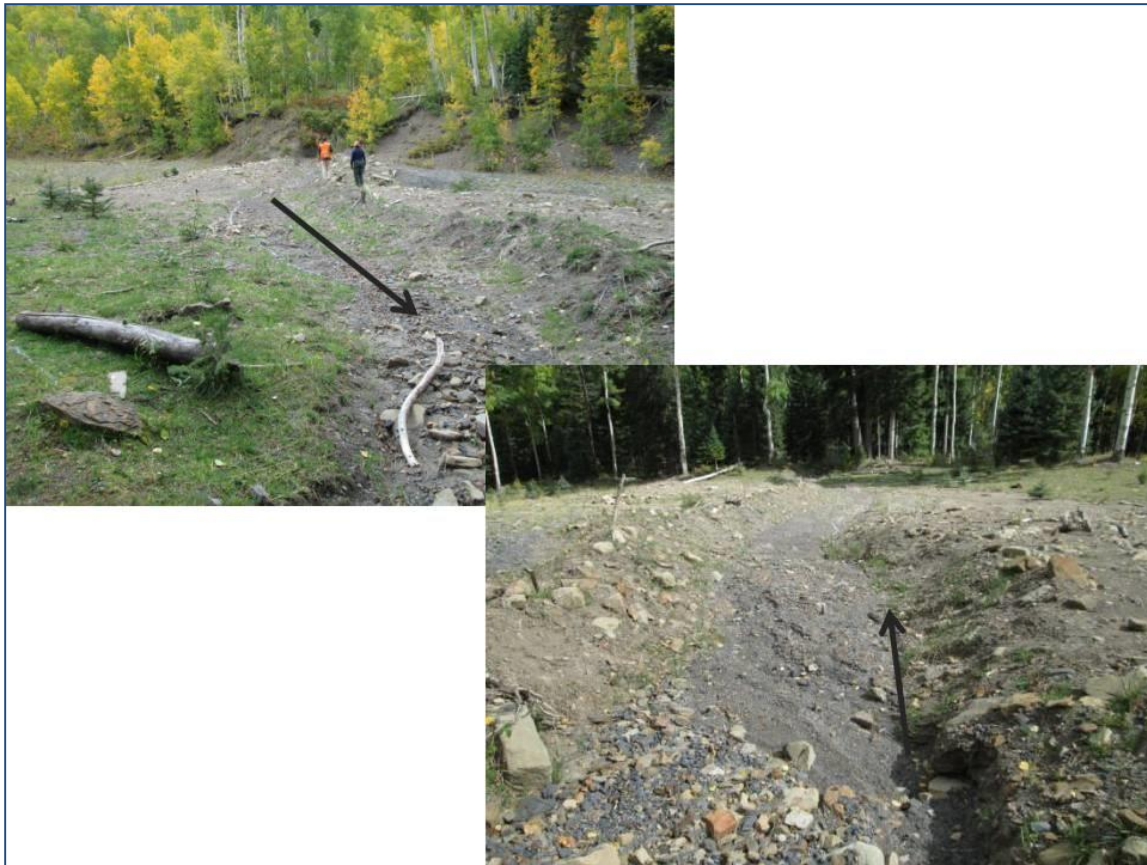
Figures 10-13 show the extensive work done on the intermittent stream channel (area 2c), road prism, and floodplain. The primary objective of this effort was to reduce overland flow and sediment delivery to the streams and to provide opportunities for water infiltration and sediment storage in the upland areas, all while increasing vegetative cover. Figure 10 shows the intermittent channel as it drops to the valley floor near the confluence with the South Fork of Dutch Creek. Low gradient areas and associated wide floodplains, such as this area, are where sediment is naturally stored. To attempt to mimic this natural function, restoration began upslope at site 2a and continued to the confluence area at site 2c. A natural alluvial fan located near the confluence of Braderich and Coal Creeks was used for reference during construction of the alluvial fan shown in Figures 12 and 13. Several things were done as part of this site reclamation: the stream road crossing was stabilized (as discussed above); the road prism was cross-ripped and soil amendments were added; a 1-acre alluvial fan was constructed; grade controls were installed at the downstream end of the fan/intermittent stream channel using logs; and the area was revegetated with a grass seed mix, spruce seedlings, and willow cuttings.

Figure 10. Area 2c alluvial fan before restoration (arrows show direction of flow).

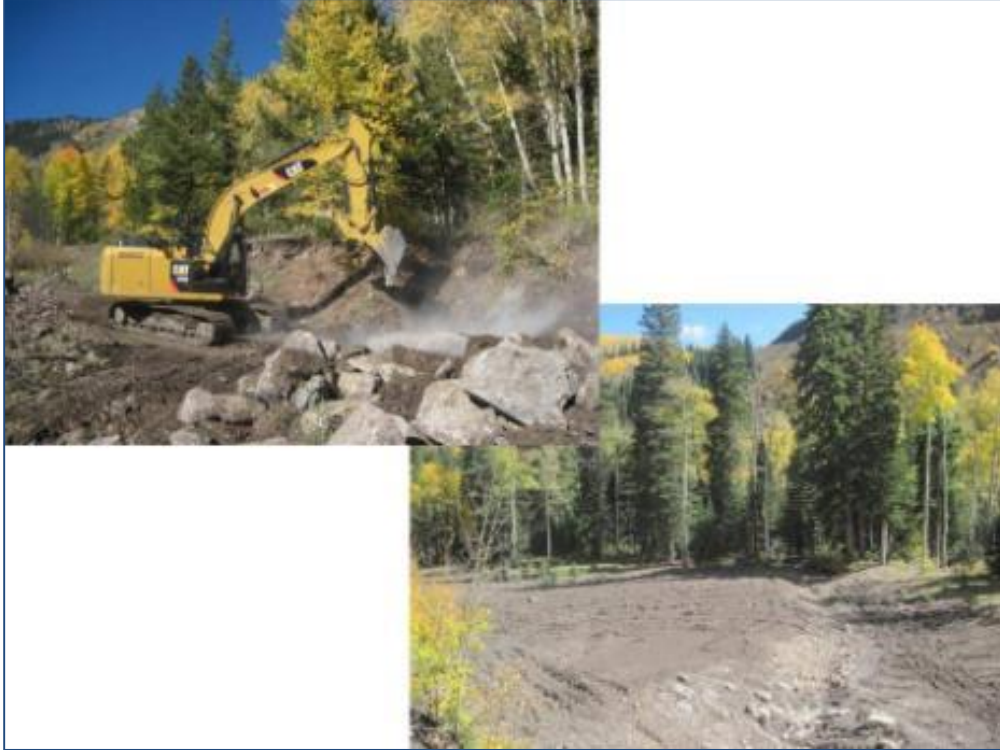
Figure 11. Area 2c alluvial fan during restoration.

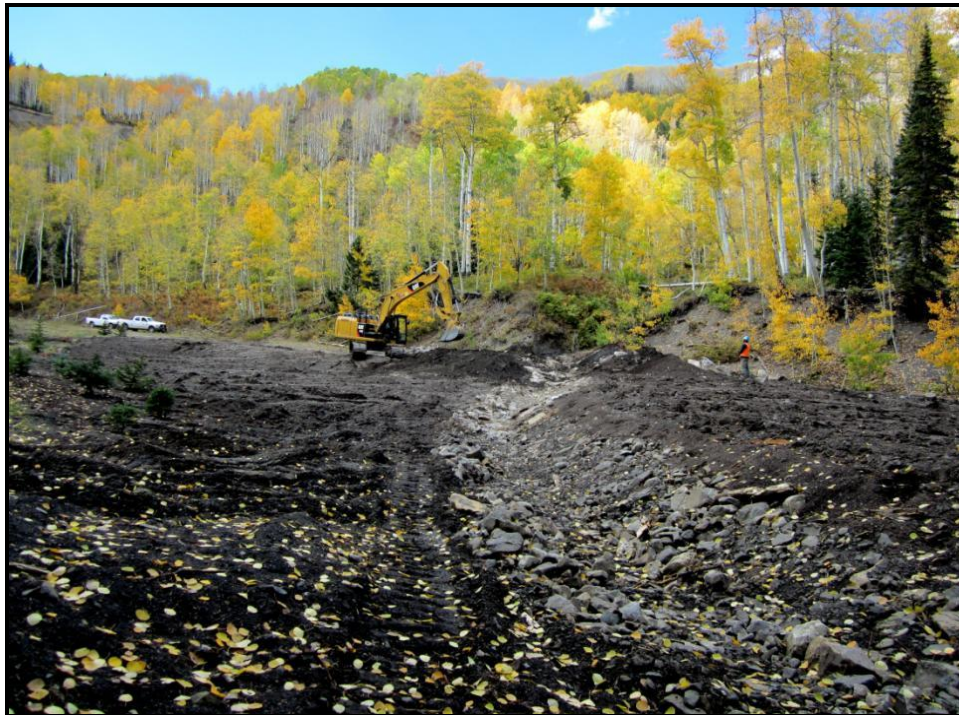
Figure 12. Area 2c alluvial fan during restoration.

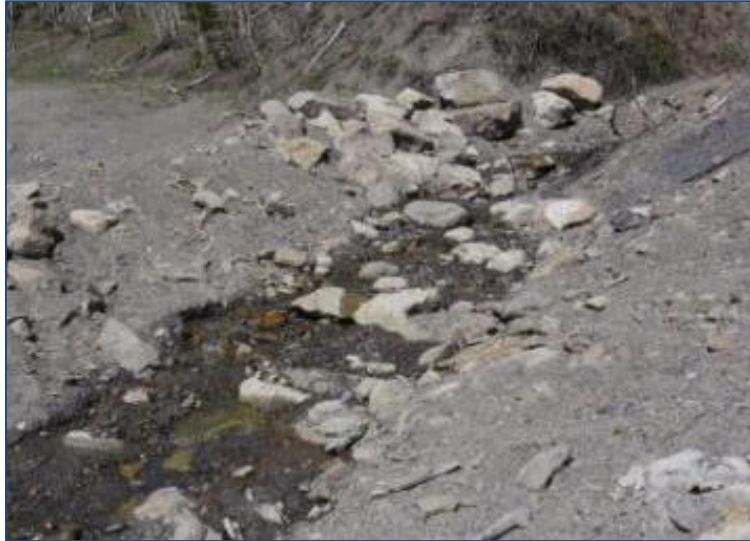
Figure 13. Area 2c alluvial fan transporting water and dissipating sediment following restoration. May 13, 2013.

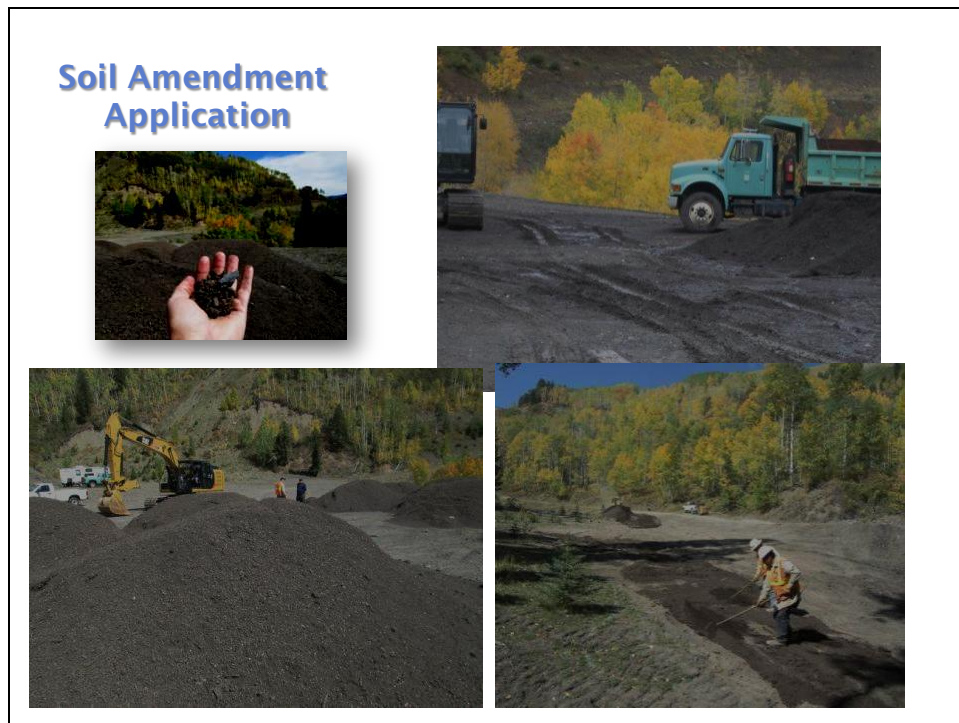
Figure 14 shows the application of soil amendments. The purpose of soil amendments is to reduce soil compaction/bulk density, increase soil moisture content, and provide nutrients for plants. Three treatment types were used: a control (no amendments); compost only; and compost with biochar. Compost was obtained from the South Canyon Landfill/Heartland Environmental Services and biochar from Biochar Reclamation, LLC. Table 2 lists the location of the different treatment options.

Figure 14. Application of biochar/compost and compost only soil amendments in treatment areas. Top left photo is a close up of biochar. Piles in photos are compost/biochar blend.

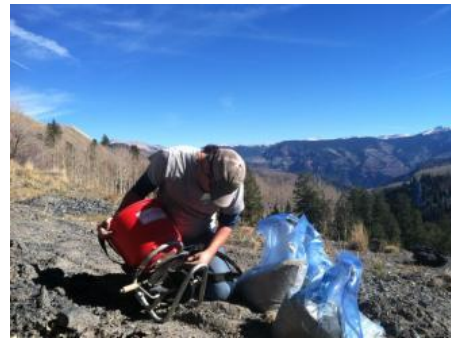
Seeding with Native Vegetation October 31, 2012

Figure 15. Seeding with native (ecotypic) WRNF grass seed mix.

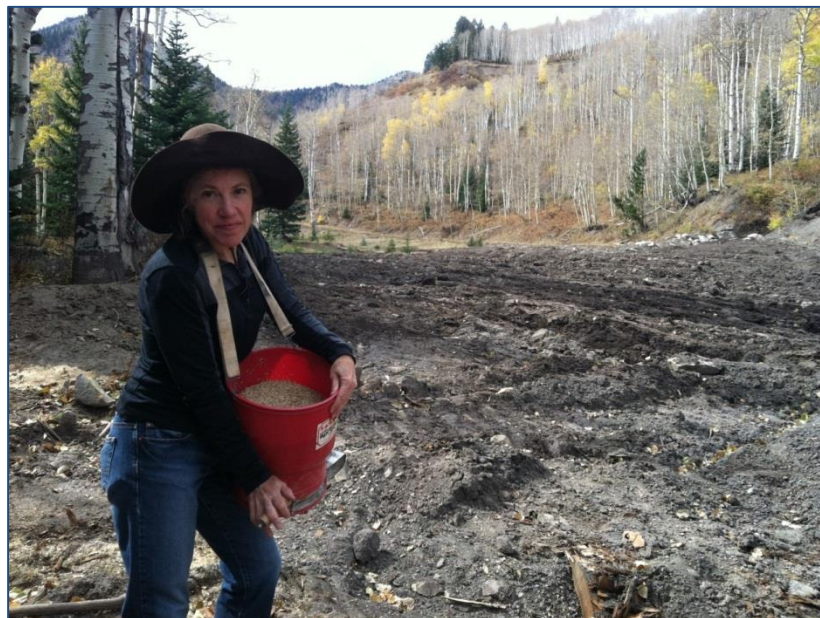
Figure 16. Reconstructed alluvial fan seeded with WRNF mountain brome, slender wheatgrass and blue wildrye.

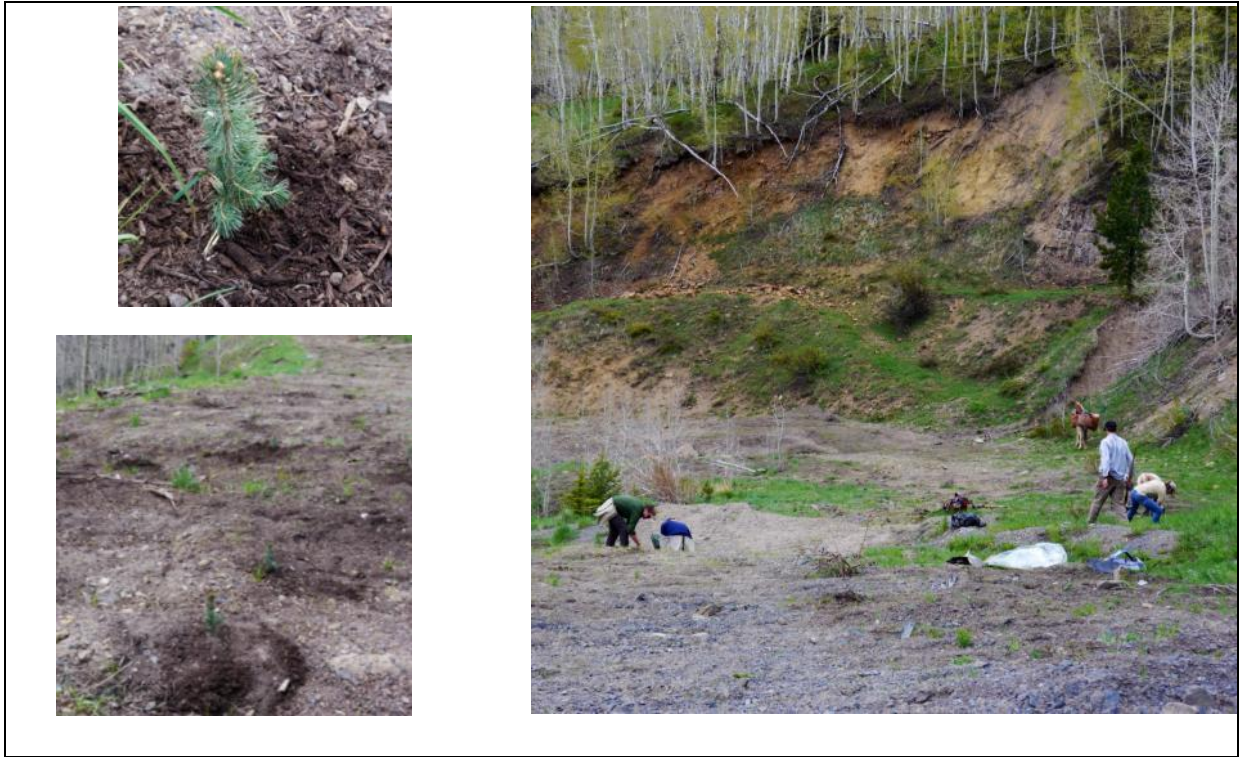
On June 3rd and 4th, 2013, 750 Engelmann spruce trees (provided by the USFS) were planted by USFS staff with the help of Colorado Parks and Wildlife and the brute strength of “Aspen”, a USFS mule(see [Figure 17](#)). Each tree was planted in a hole where the soil was amended to improve conditions at the micro-site level. Planting took place over approximately 4 acres within a 9,000’- long decommissioned road prism. Wet draws from the top to the alluvial fan and then down to the gate at the Lamphouse (an abandoned mining facility) were planted, in addition to all amended soil locations and other water bars that had visible water. The idea was to plant timber stringers up draws and mimic naturally-occurring features on such aspects. (Cottonwood sprouting out of cottonwood logs half buried on the upslope end of the fan was noted.)

**Figure 17. Engelmann spruce tree planting, June 2013.
Note the improvement of conditions at the micro-site level.**

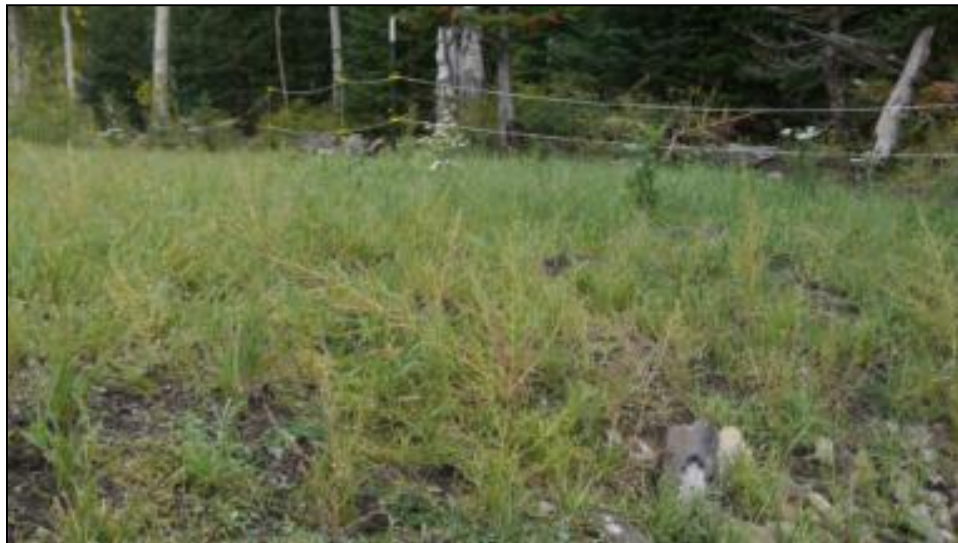
To protect the vegetation in the project area from cattle grazing, an electrical fence was installed by USFS personnel before cattle were turned out in the USFS grazing allotments (see [Figure 18](#)). Mules and horses were used to haul fencing material to the project site. This fence was taken down after the cattle were removed and stored for the winter. It will be put back up in the spring of 2014.

Figure 18. Electric fence in alluvial fan area.

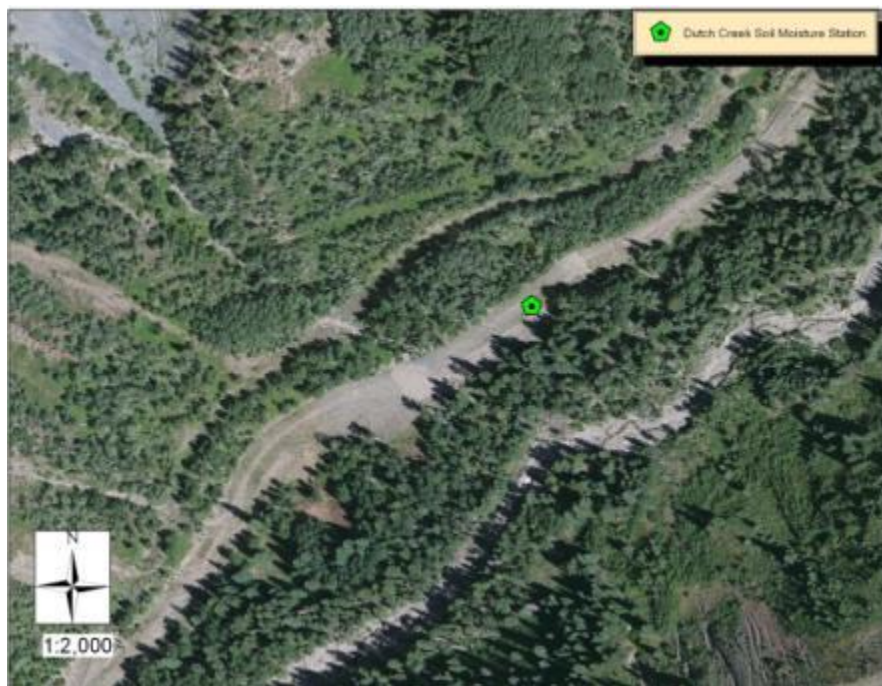
Figure 21. Location of the soil moisture monitoring station in the pilot project area.

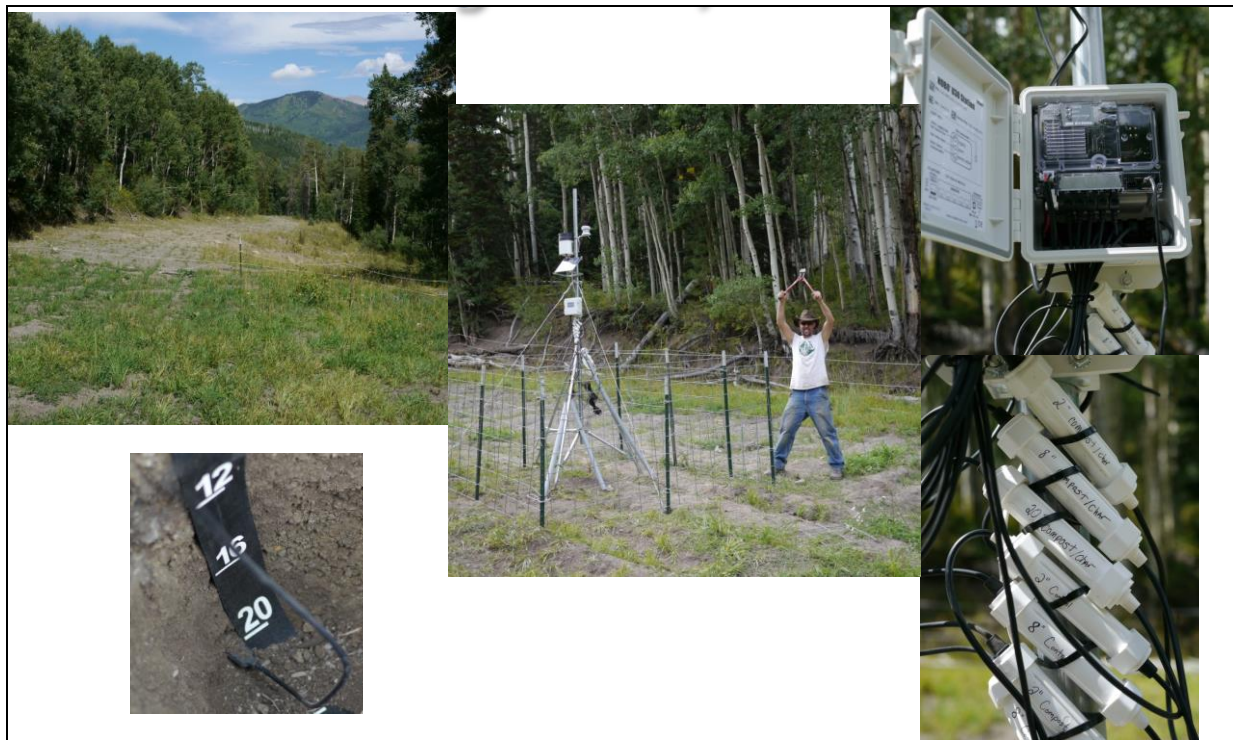
Figure 22. Soil moisture monitoring station. August 2013.

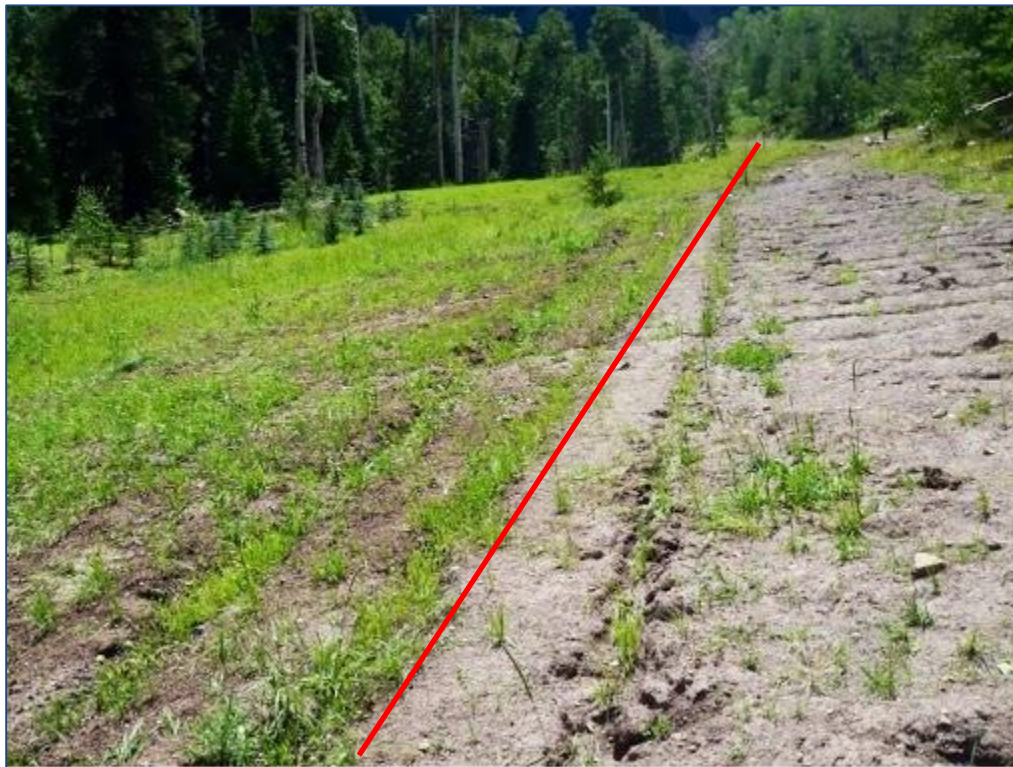
Figure 33. Contrast between alluvial fan area amended with compost-biochar (left of red line) and without (control-right of red line). September 24, 2013.

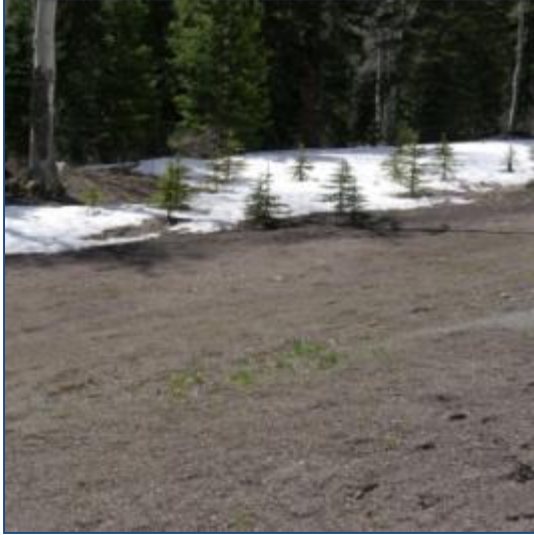
Figure 34. Alluvial fan. May 13, 2013.

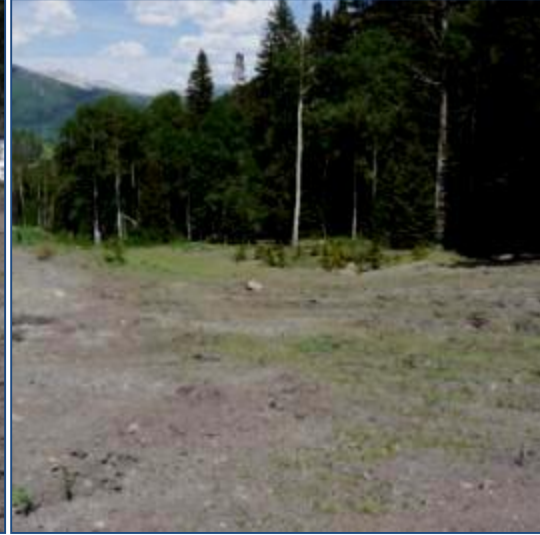
Figure 35. Alluvial fan. June 10, 2013.
