SUBJECT: Vallejos Ditch Diversion Structure

VALLEJOS DITCH HEADGATE REPLACEMENT PROJECT

Final Report

Rio Grande River Basin, Culebra Watershed, - Vallejos Ditch Head-gate Replacement Project

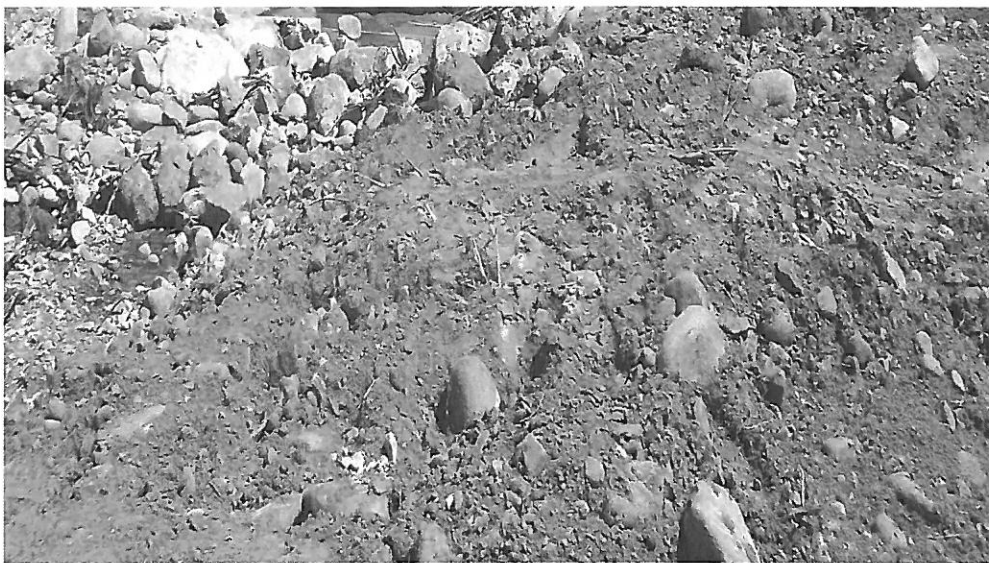
Deliverables: The work area was sufficiently dry prior to work commencing, as displayed in the picture below.

Method/Procedure: Isolated work area and removed all water from work area. Vallejos Creek was diverted as requested in Task 2.

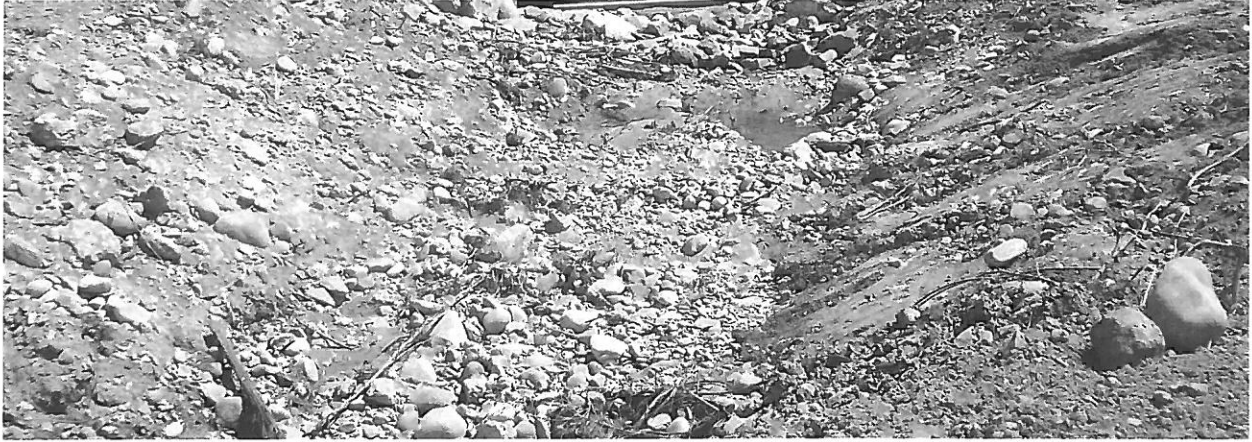
Deliverables: The natural shape of Vallejos creek restored to ensure stability of new structure, seeded with native vegetation, meeting specifications of NRCS engineers and regulatory authorities. Picture below shows the creek bed.

Method/Procedures: Kept the natural shape of the creek and restored to ensure stability of new structure, rip rap needed to protect inlet/outlet of the new structure, additional structure access, and catwalk, cleared & grubbed to access weir.

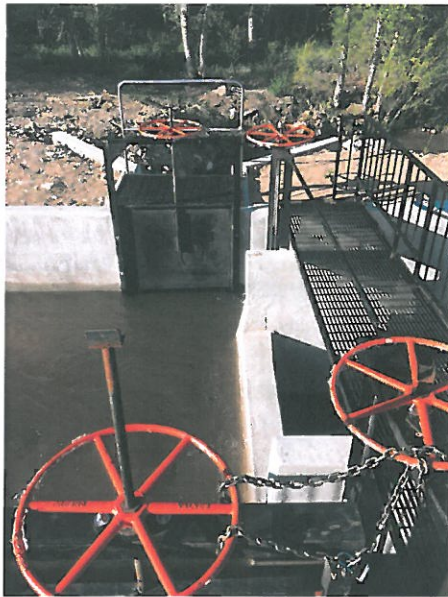
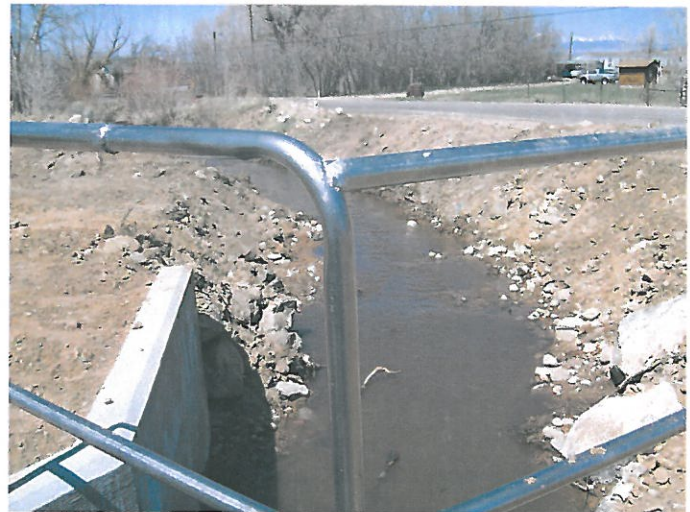
Deliverables: The installation of the gates & rails greatly improved control of irrigation releases; protective rails on catwalk significantly reduced the risk of accident or injury.

Method/Procedure: Purchased and installed hardware into the concrete structure according to all manufacturer's guidelines and were in compliance with all NRCS and regulatory requirements.

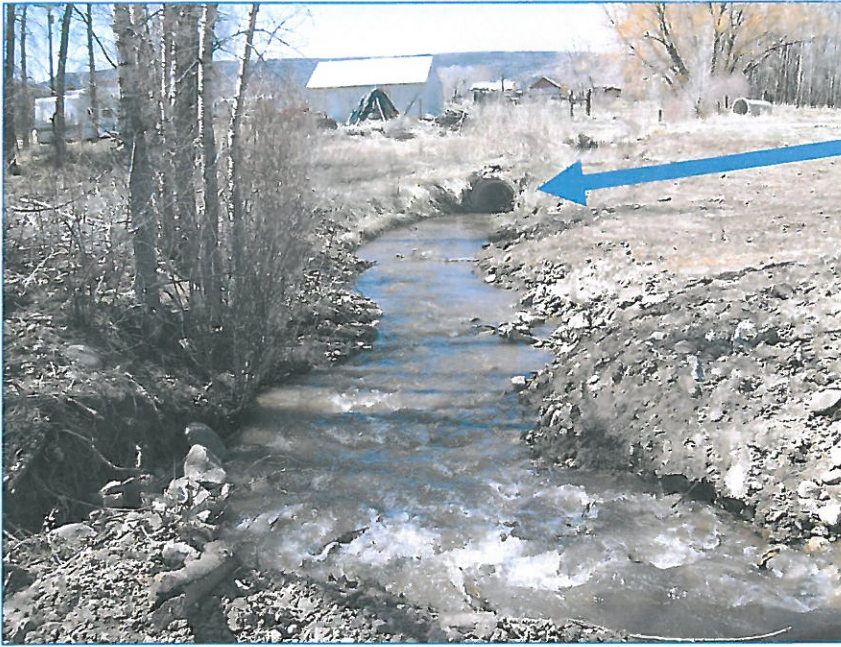
Concrete Culvert
Structure before Picture—
was impeding the water
flow downstream from
the newly built structure.

Deliverables: The project team removed concrete culvert and reinstalled to allow adequate flow through the pipe. The picture on the next page displays work that was completed.

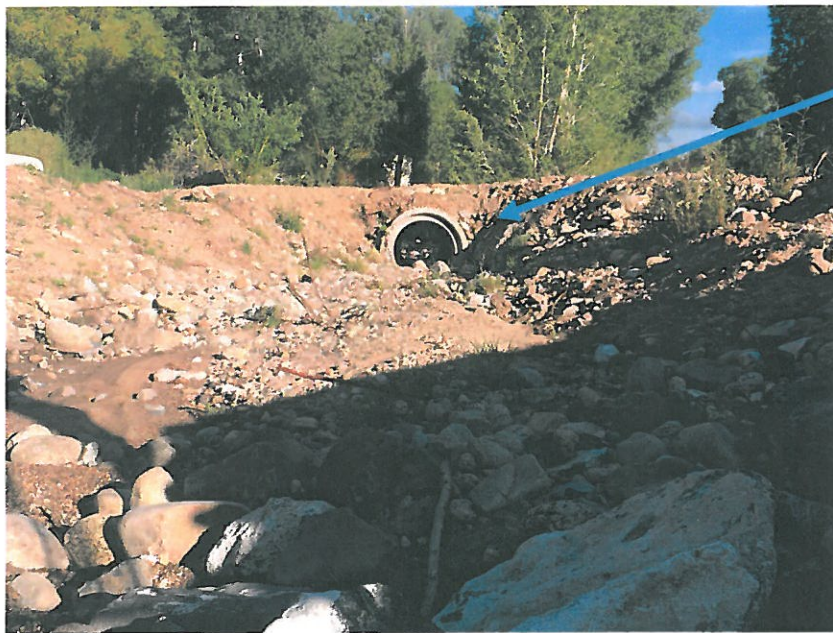
***THE NEWLY INSTALLED
CONCRETE STRUCTURE***

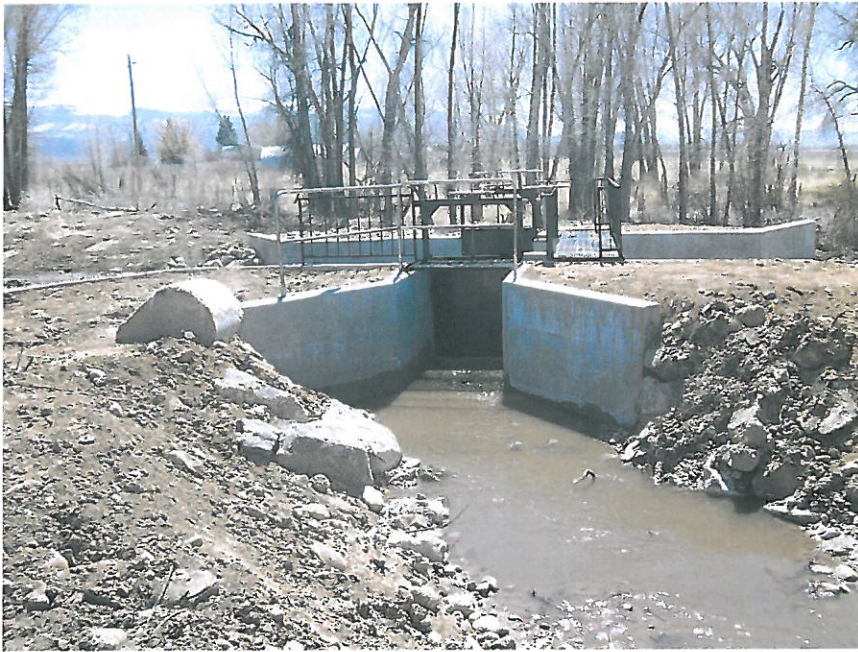
Top Picture shows the North Lateral Sluice Gate that will supply water to the Upper Vallejos Ditch Irrigators.

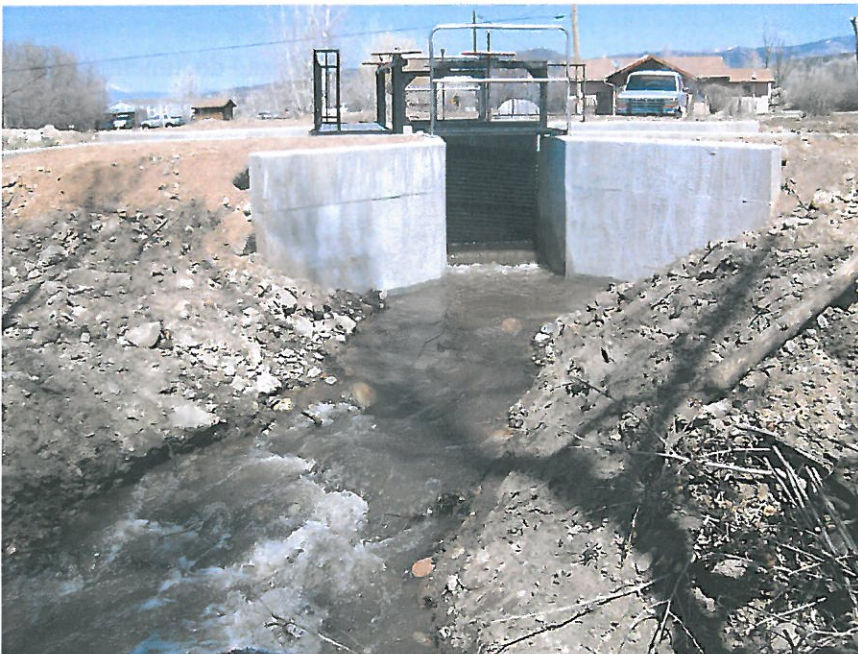
Bottom Picture shows the South Lateral Sluice Gate that will provide the Lower Vallejos Ditch Irrigators.

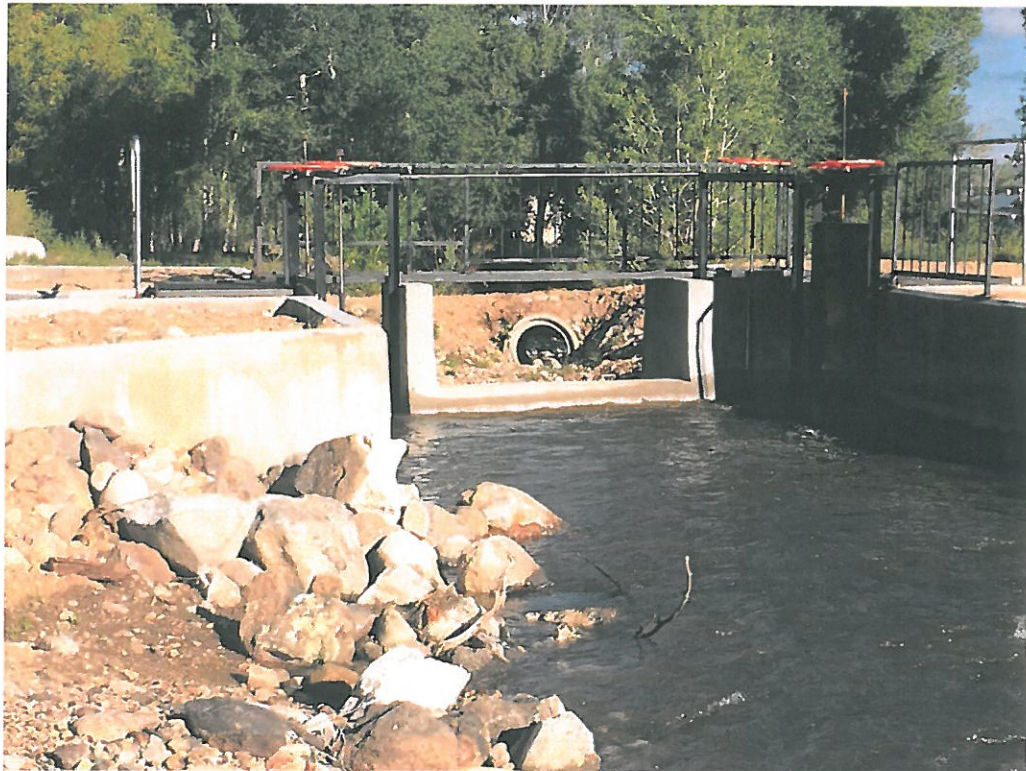
Picture on Next Page shows the completed head-gate identifying various components of the Head-gate.
