St. Vrain Creek Watershed Master Plan

PREPARED BY

Baker

The St. Vrain Creek Coalition

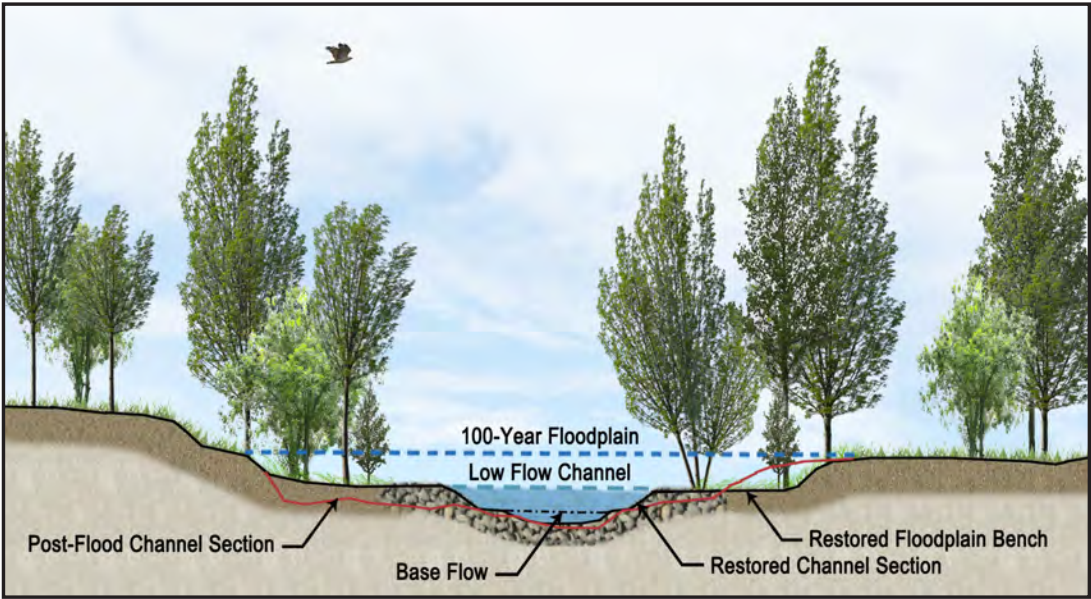
Figure 7.1 Typical Channel Restoration Section*

Incorporate/Stabilize a Low Flow/Bankfull Channel Section and Floodplain Bench: The low flow/bankfull channel (Figure 7.1) is an essential element to a healthy and stable stream channel. The bankfull discharge, or discharge that fills the low flow/bankfull channel, is the flow at which natural channel maintenance is most effective. Bankfull discharges correspond to a discharge with a recurrence interval between 1 and 2 years. The low flow/bankfull channel would be designed to carry this event. To further reduce energies and shear stress placed on stream banks, the channel cross-section will be modified to incorporate a floodplain bench (Figure 7.2). This approach decreases the stress placed on banks by decreasing flow velocities and depth for a given discharge. Beyond helping to stabilize the channel, this approach also increases the cross-sectional area of the overall flood channel, potentially decreasing the flood stage during storm events as compared to the current condition. At a minimum, the proposed excavation of floodplain benches would provide increased storage capacity during storm events, aiding in the attenuation of storm flows. The floodplain benches can be vegetated with native seeding, willow staking, cottonwood poles, and other native transplants.

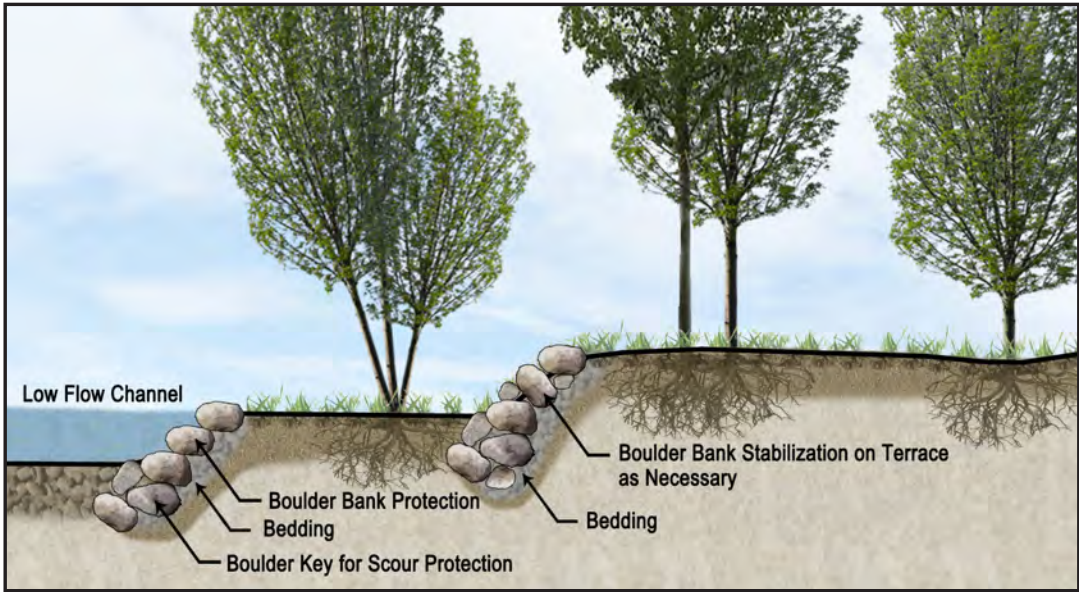
Figure 7.3 Boulder Bank Protection Detail*

Bank Protection: The type of bank protection recommended by this plan varies depending on the location of the protection and what is being protected. Boulder bank protection (Figure 7.3) is the recommended bank protection in high risk areas such as banks in the vicinity of bridge abutments, culvert inlets and outlets, roads, and existing structures. Boulder bank protection provides reliable and immediate channel bank protection. The bank protection should include a boulder key to prevent the toe of the protection from scouring, and a filter layer that prevents fine grained native materials from piping through the boulders while still allowing seepage. To improve revegetation and wildlife habitat, covering rip rap with soil and planting appropriate species in the voids is recommended.

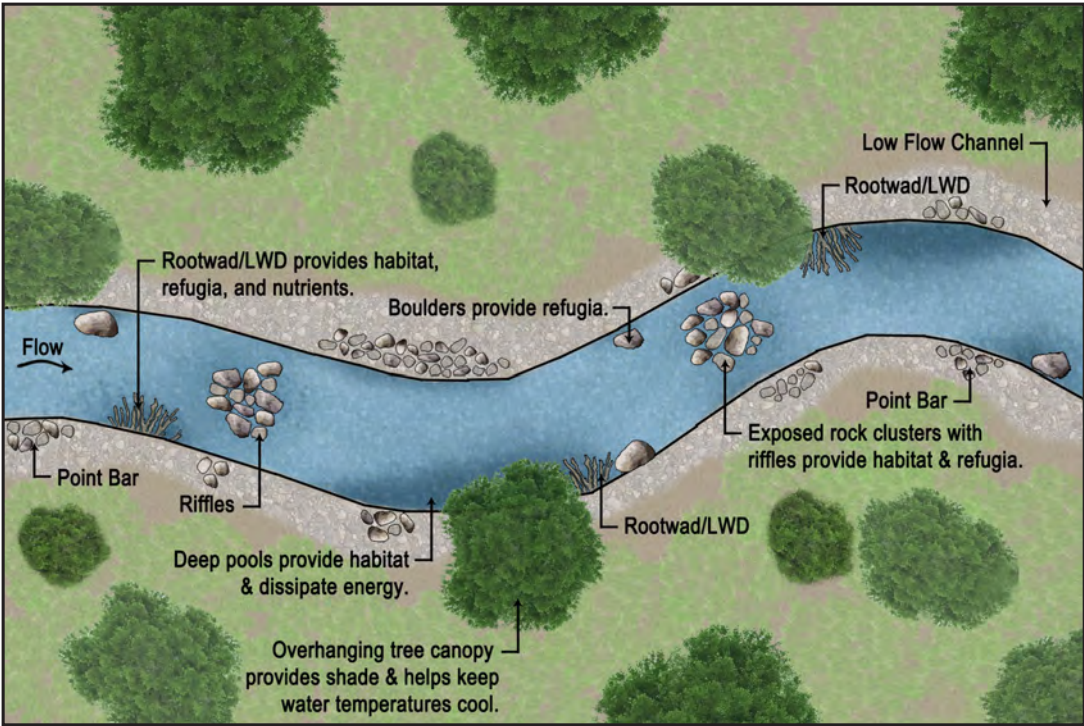
Figure 7.6 In-Stream Stability and Habitat Examples*

- » Constructed Riffles - A constructed riffle is created by placing well-graded material (gravel, cobble, and small boulders) in the stream at specific riffle locations along the profile. The purpose of this structure is to provide initial and/or permanent

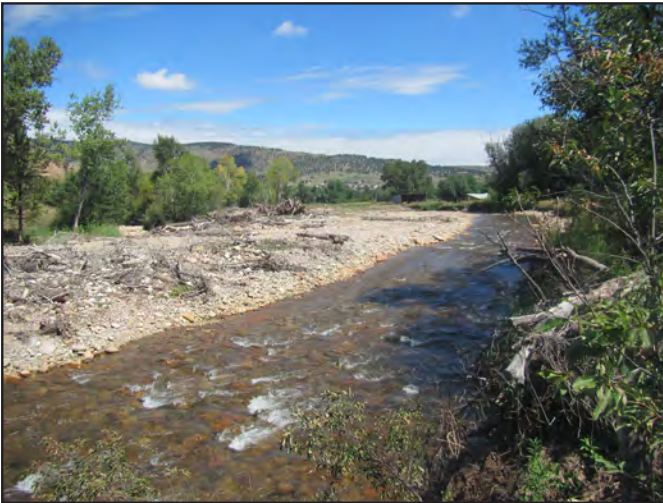
The recommended plan for Reach 4b is shown on the following Figures. The purpose of this alternative is to implement a channel alignment that will optimize the interaction with completed, ongoing, and funded projects while being sensitive to the constraints presented by the presence of numerous private residences throughout this river corridor. The implementation of this alternative will expedite the maturation of this reach by re-establishing a natural channel, repairing erosion scars, re-establishing floodplain benches, building point-bars and excavating pools, re-vegetating denuded areas, and stabilizing channel banks. The Baker Team conducted a feasibility analysis during the planning process to evaluate the potential for detention in the vicinity of Andesite Quarry as outlined in PDG 10. The analysis showed a lack of significant reduction in downstream flood risk and concluded that such a facility would not be cost beneficial as a result of the large cost of designing, building, maintaining, and operating such a facility with limited public benefit. Thus, the study did not recommend this flood control measure. If desired by the Town of Lyons and others, additional analysis could be undertaken to further evaluate the feasibility of detention at this location and whether it could be made more cost beneficial. Any further analysis would require additional engineering studies, cost-benefit analysis, and environmental investigations including an evaluation of the potential impacts to in-stream and riparian habitats that such a facility would create both upstream and downstream. See Appendix D and G for more information.

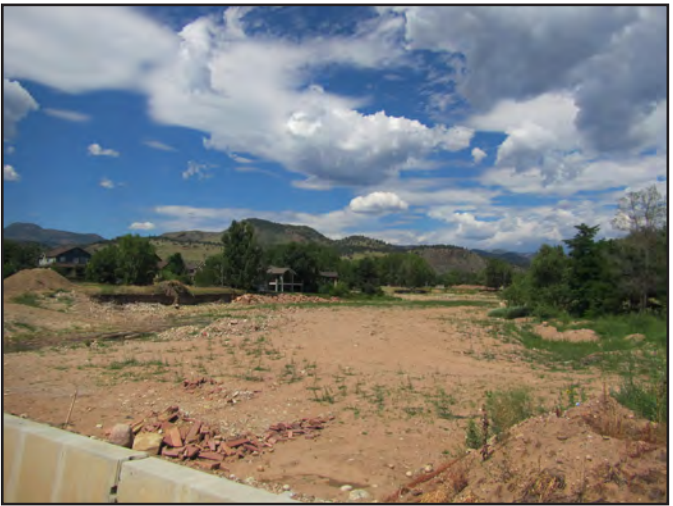
The focus of the improvements for this reach is at the site of the McConnell ponds. The reconstruction of these ponds is important to the community because of the social, recreational, and aesthetic benefit that they provided to the community. There has been ongoing discussion within the Lyons community about where the McConnell Ponds should be reconstructed in their pre-flood location on the south side of St. Vrain Creek or a new location on the north side. The qualitative analysis for the two alternative locations yielded very close results. The recommendation is to perform a more in-depth analysis as additional information (survey and hydraulic modeling) become available to further inform the pros and cons of the location of the McConnell Ponds. Note that the qualitative scoring in Appendix D has been redacted so as not to influence this future analysis.

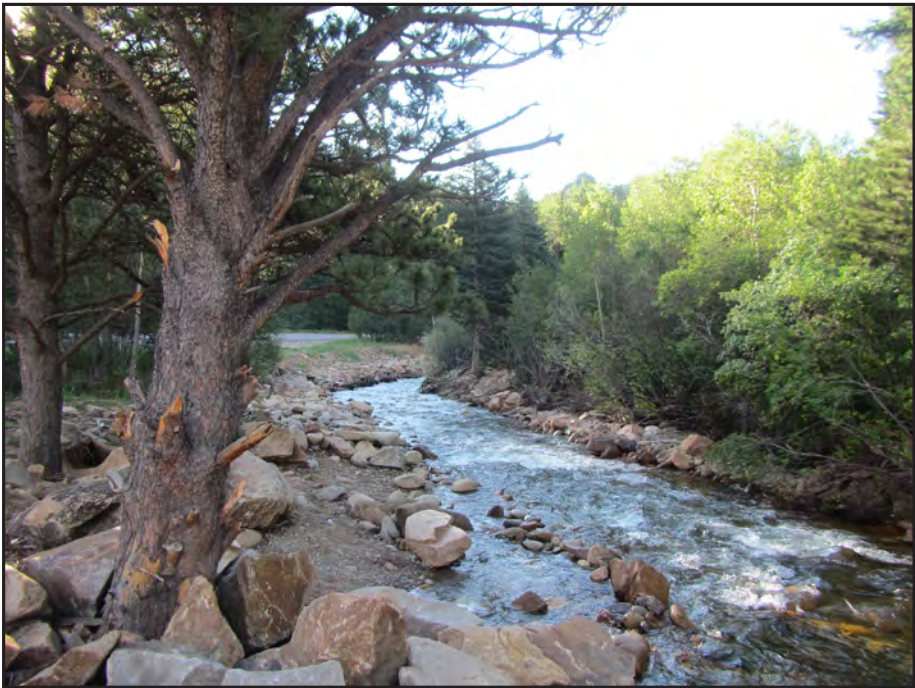
Damage to Riverside Drive was caused by embankment failures triggered by lateral channel migration. However, Riverside Drive encroaches upon the river corridor, which has reduced the floodplain and riparian zone width and altered the natural channel function. The lateral channel migration that occurred during the September 2013 flood was likely a result of the river attempting to reestablish a stable planform. Therefore, it is recommended that opportunities to increase the floodplain width be evaluated during upcoming roadway improvements instead of only re-armoring the channel banks.

Flood-related damages occurred throughout this reach and consisted mostly of damage to private residences and the privately-owned roadway crossings leading to the residences. Several of the residences adjacent to the South St. Vrain were damaged by flooding. Many of these homes are still at risk for future flooding that could be triggered by modifications in channel configuration or debris jams.
