# Tarryall Meadows Ranch Landscape Reclamation and Habitat Enhancement Project

## *2014 Update Report*

**Prepared for Colorado Open Lands  
By Jessica Doran and Mark Beardsley of EcoMetrics  
December 2014**

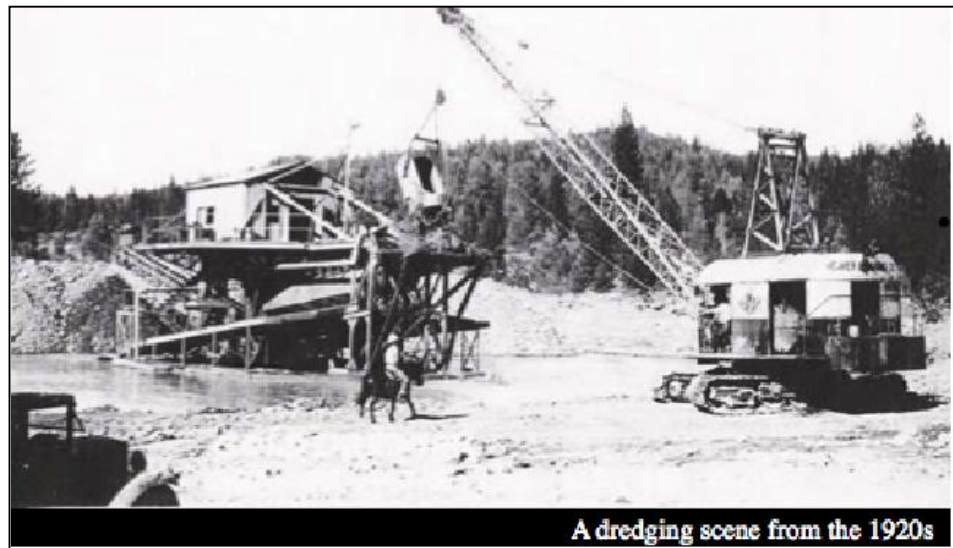
**Figure 1: Dredge mining was popular in the 1920s. It was an extremely intensive process where entire streams and riparian areas were often excavated and worked.**

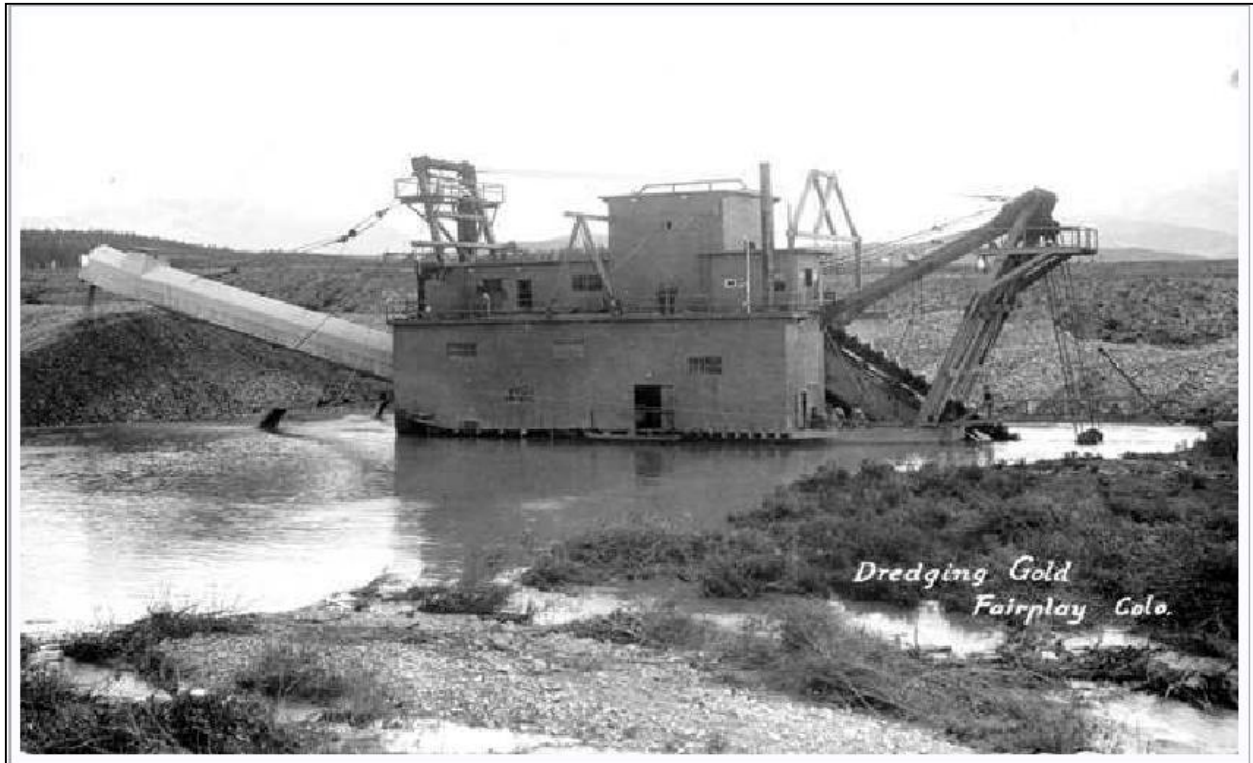
**Figure 2: The dredge that operated near Fairplay until the early 1950s was a huge machine. The ones used on Tarryall were probably slightly smaller versions. Dredging in riparian areas required the removal of all soil and inundation of the area behind large dams so that the dredge boats could float along, excavating, working, and then re-depositing deep alluvial material.**

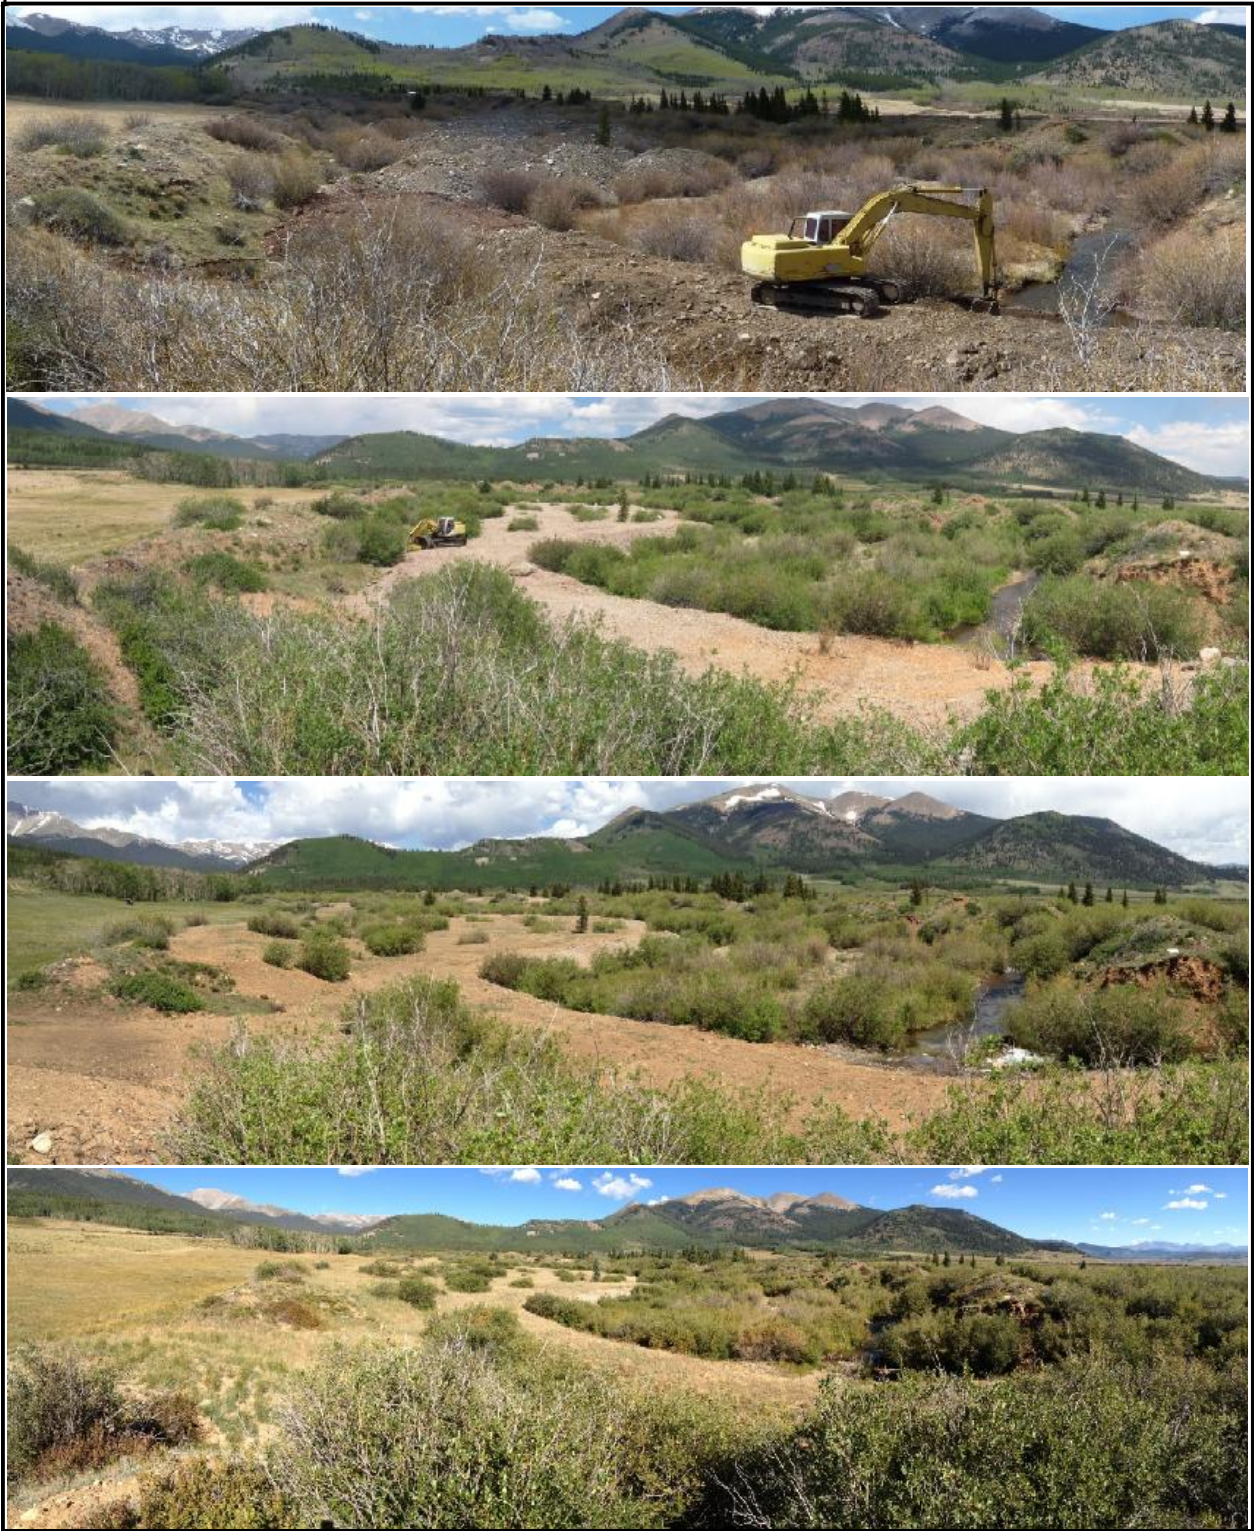
**Figure 5: This time series starts in 2012 before treatment (top) and concludes with a photo from 2014 (bottom). This series illustrates the landscape level changes that were made on the property and the successful re-vegetation of the treated area.**

Figures 5, 6, and 7 illustrate examples of the extensive transformation that occurred on the landscape.

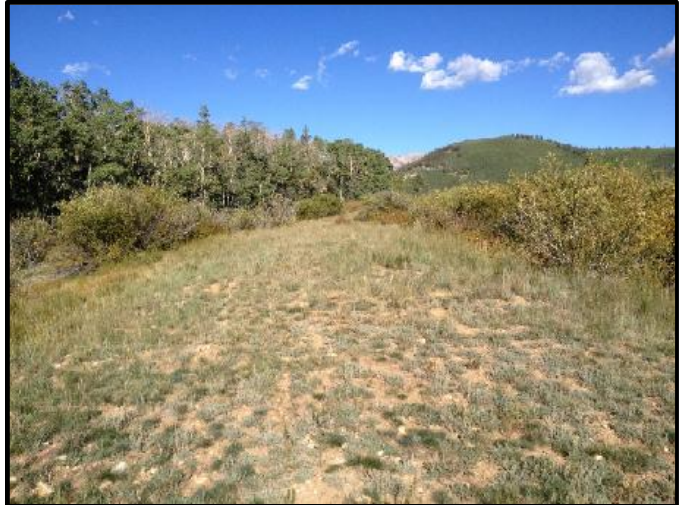
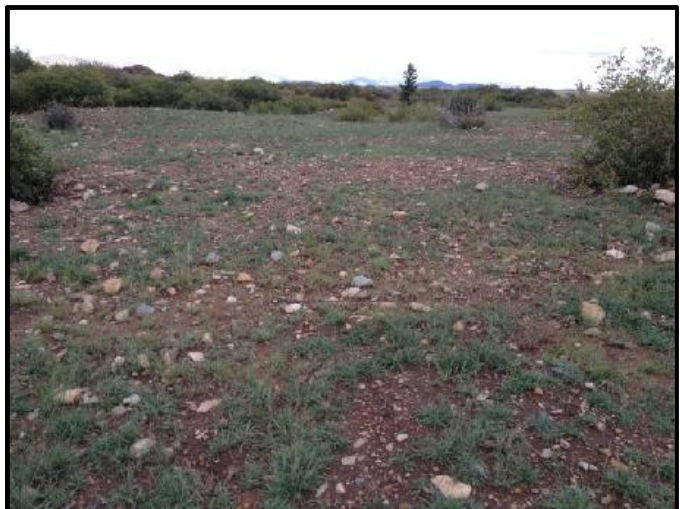
**Figure 6: Two examples of re-vegetation in progress. The top photo is a shaped overburden pile that was seeded. The bottom photo is of a remediated tailings area that was capped with soil, seeded, and hydro-mulched.**

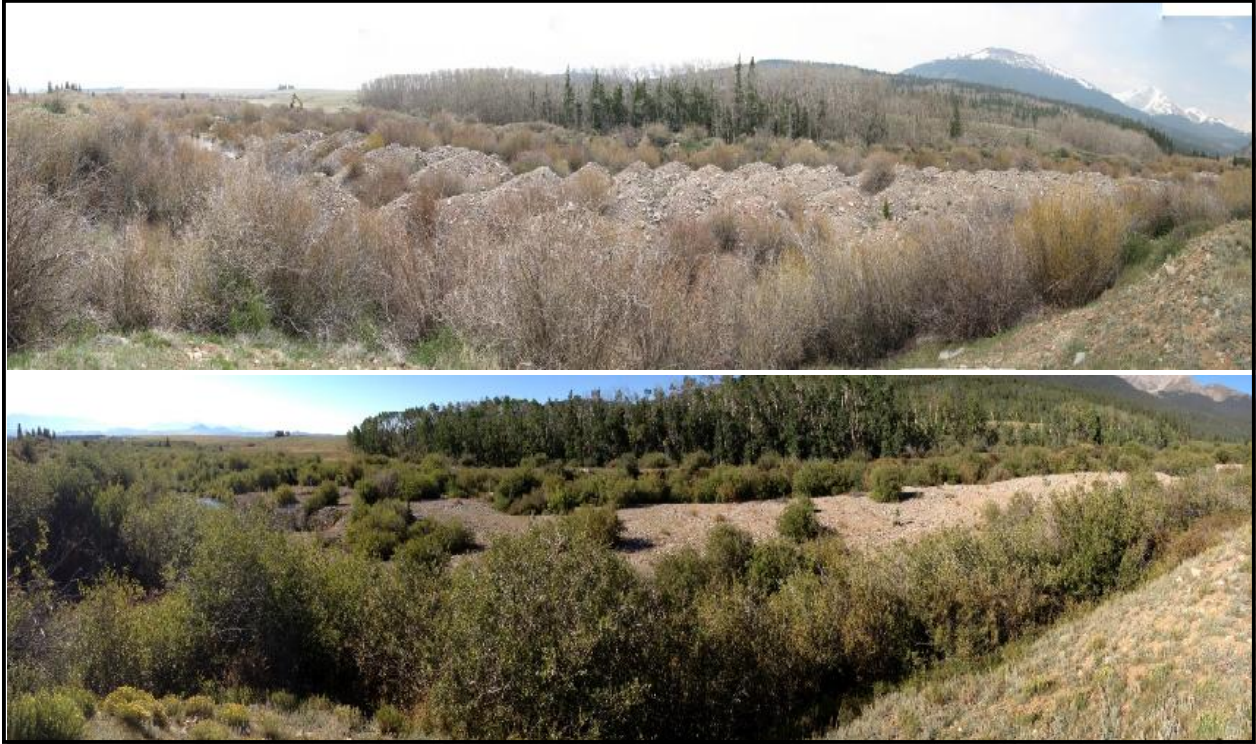
**Figure 7:** This before-after comparison is of the 2011 treatment area. While still not a fully-functional riparian area by a long shot, the landscape has been remediated from a post-industrial mine site to a much more natural, aesthetic, and functional condition.

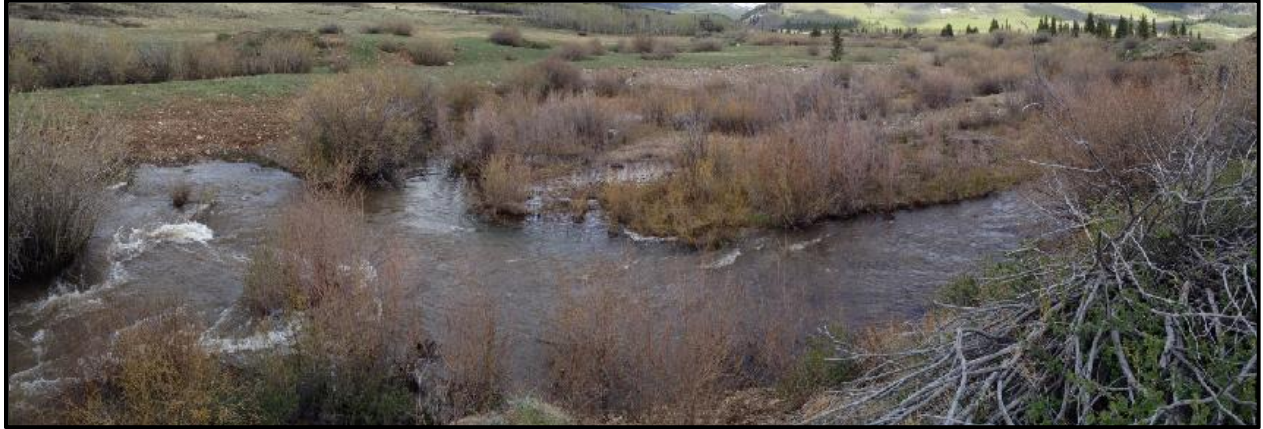
**Figure 8:** This photo shows the reach during runoff in 2014. The streamside bankfull benches are obviously inundated at 160 cfs, but the reclaimed tailings area in the background is still inaccessible to high flows, being about two feet higher than the benches.

During the high flows in 2013 and 2014, all of the newly constructed riparian bench features were inundated (Figure 8), and pre-existing high flow connections were active (Figure 9). As expected, even the record high flows in 2014 did not approach an elevation anywhere near high enough to escape the entrenched area. The treated tailings areas were still 1.0 to 2.5 feet above the water surface even during the highest discharge rates.

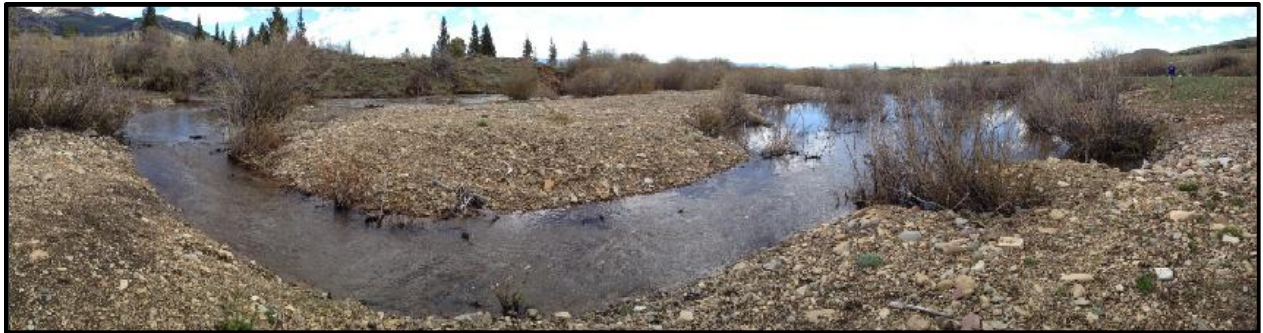
**Figure 9:** This photo shows a side channel with water flowing in 2014. Again, most of the surrounding tailings remediation areas are still much higher than flood water levels.

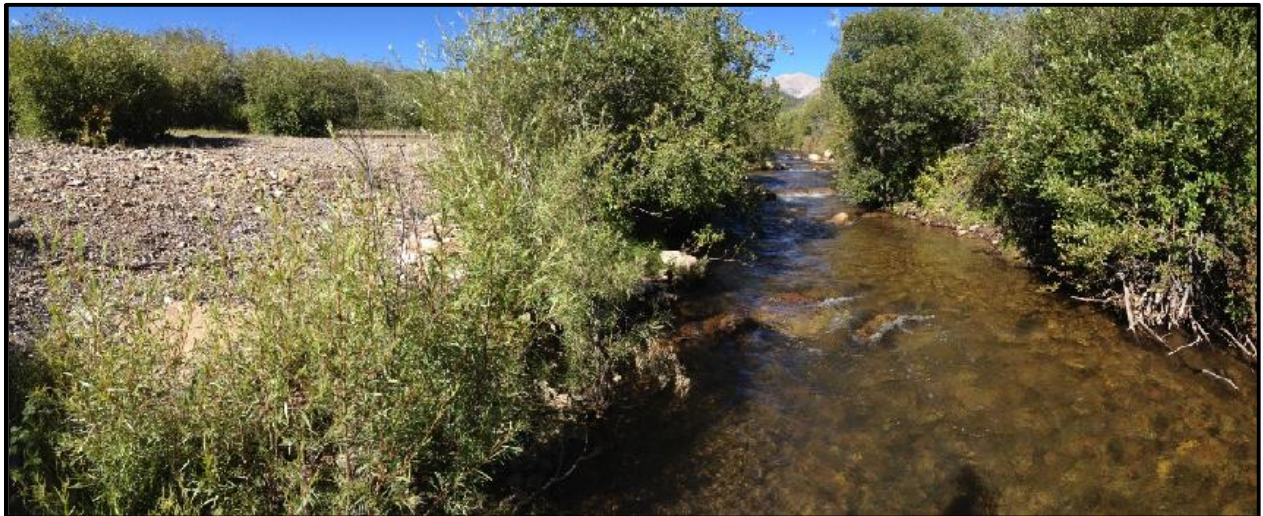
**Figure 10:** An example of a stream reach with a newly created riparian flood plain bench. The area closest to the stream has well developed vegetation that is expected to expand over time.

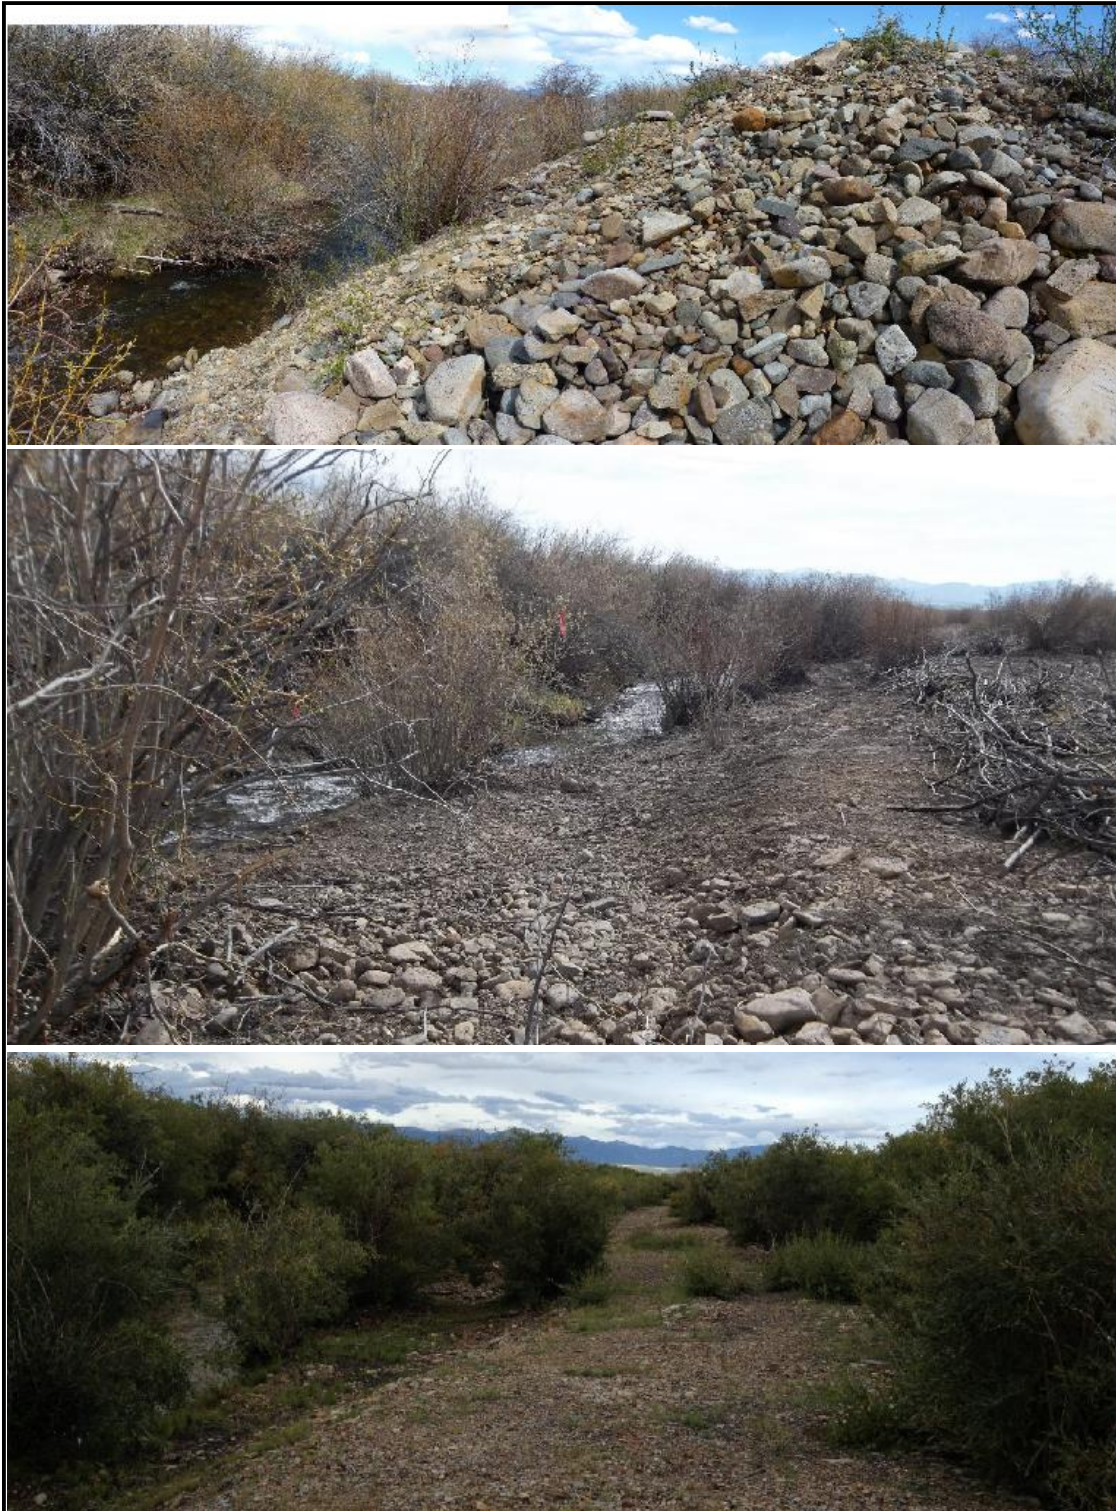
**Figure 11: This time series shows the dramatic change in streamside condition. Large tailings piles were removed from the stream edge to construct a riparian bench. The root systems of existing willows were undisturbed. These plants survived and are beginning to spread.**

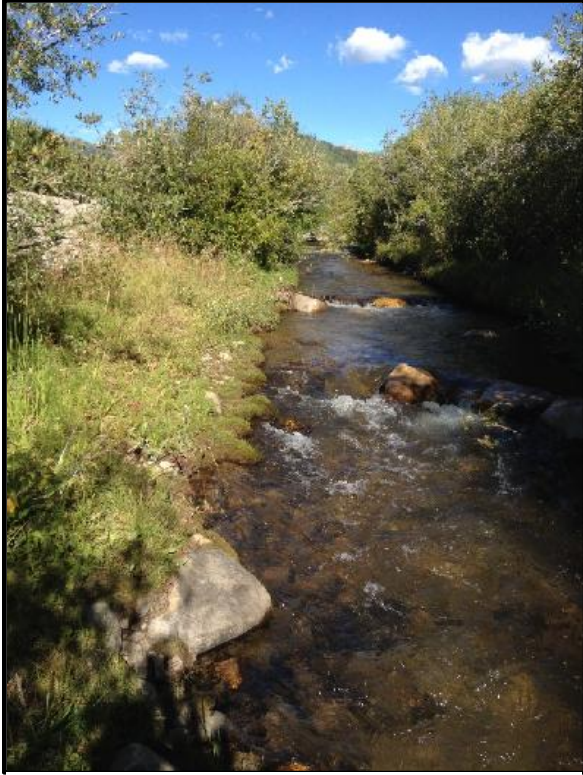
**Figure 12:** View of a well vegetated riparian bench in section G of the project. The width of vegetated area is expected to expand over time creating a larger and larger riparian area next to the creek.

Bankfull benches are recovering with predominately hydrophytic vegetation (Figure 12). In some areas we observed deposition of fines, suggesting that the added floodplain area is functioning to create slower water velocities near the edges where suspended sediment can be deposited. These deposited fines will promote continued vegetation establishment by adding much needed

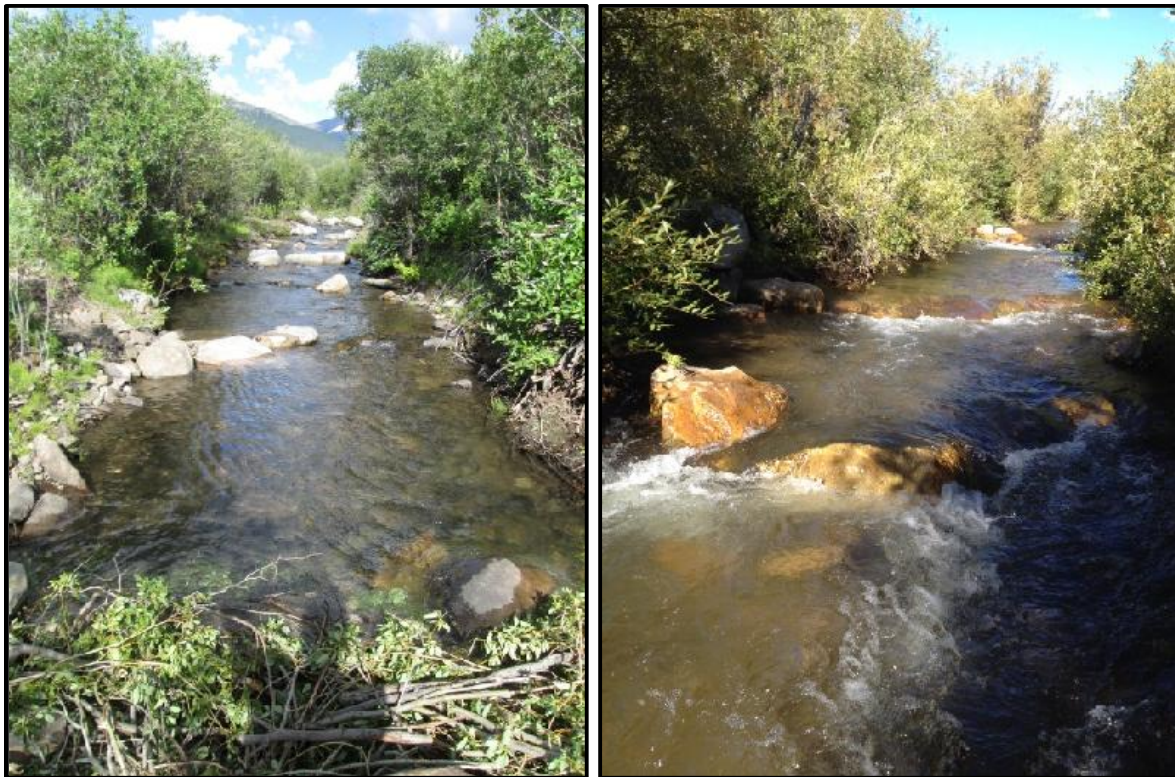
**Figure 13: Examples of the creek after structures were built. The purpose of these structures is to create pocket water, a meandering thalweg, and areas of slow water.**

Aquatic habitat diversity was significantly increased. The number and size of holding areas (pockets) are significantly increased during low flows, and during high flows there is now at least some velocity refuge (Figures 13, 14, and 15). Inducing lateral instability via increased bank scour and erosion is proving to be a more difficult objective. The extreme high flows of the 2014 runoff were an excellent test of this function. When the waters receded, we observed very minimal mobility of the structures (they were stable) and were surprised to find very little lateral erosion. By and large, this channel is proving to be even more resistant than we had expected.

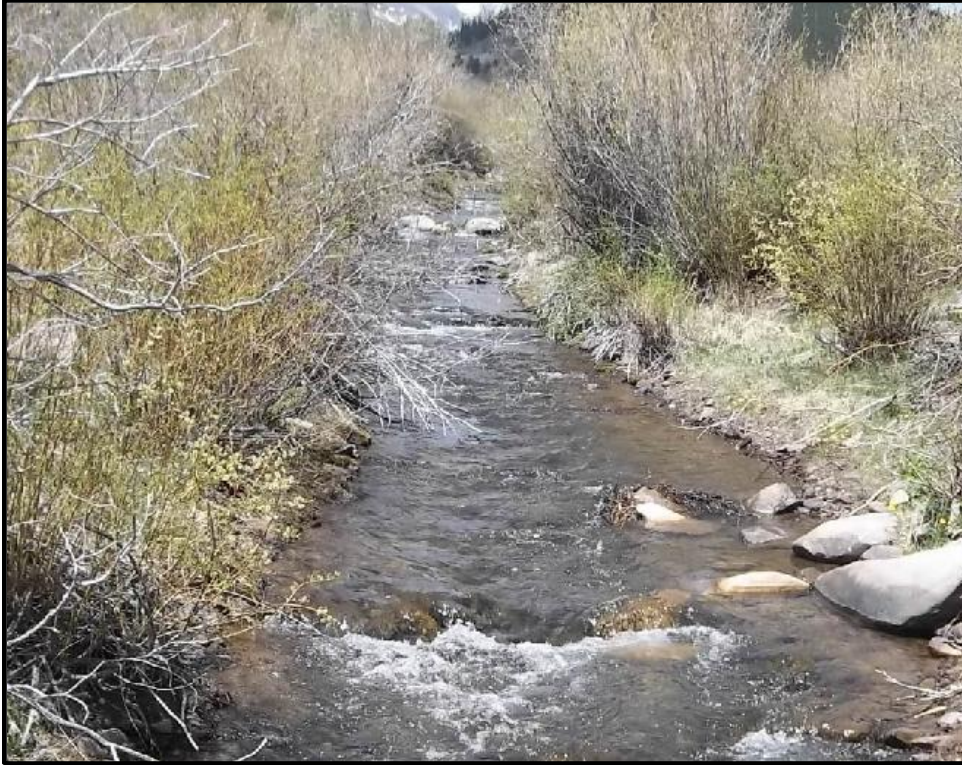
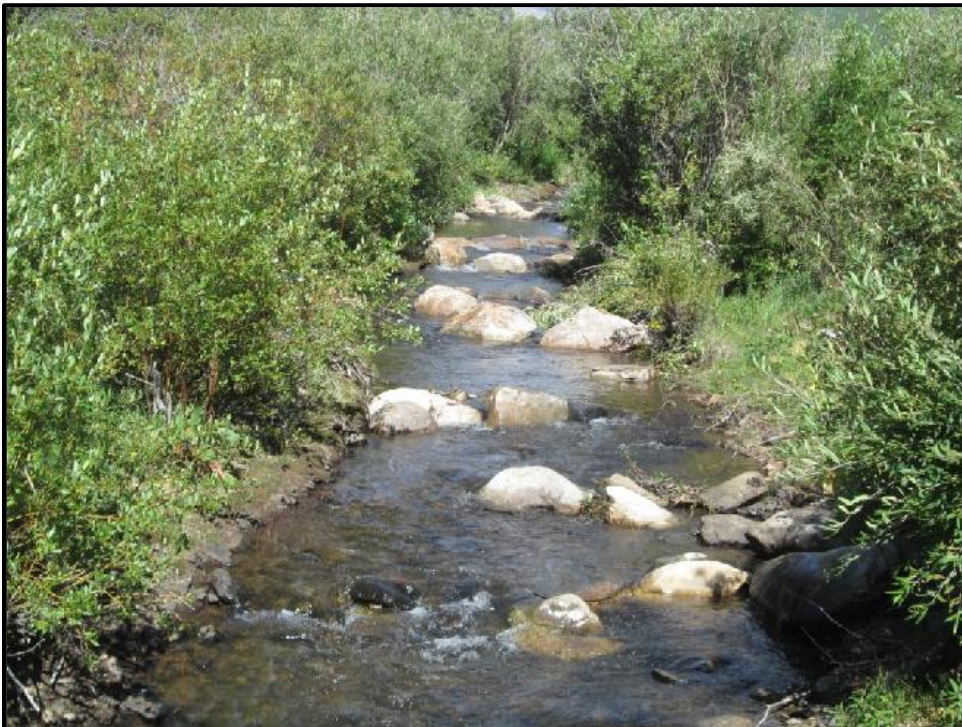
**Figure 14: Before-after photos showing a typical rock structure treatment. The rock structures break up the homogenous riffle gradient creating pockets of slow water and a sinuous.**

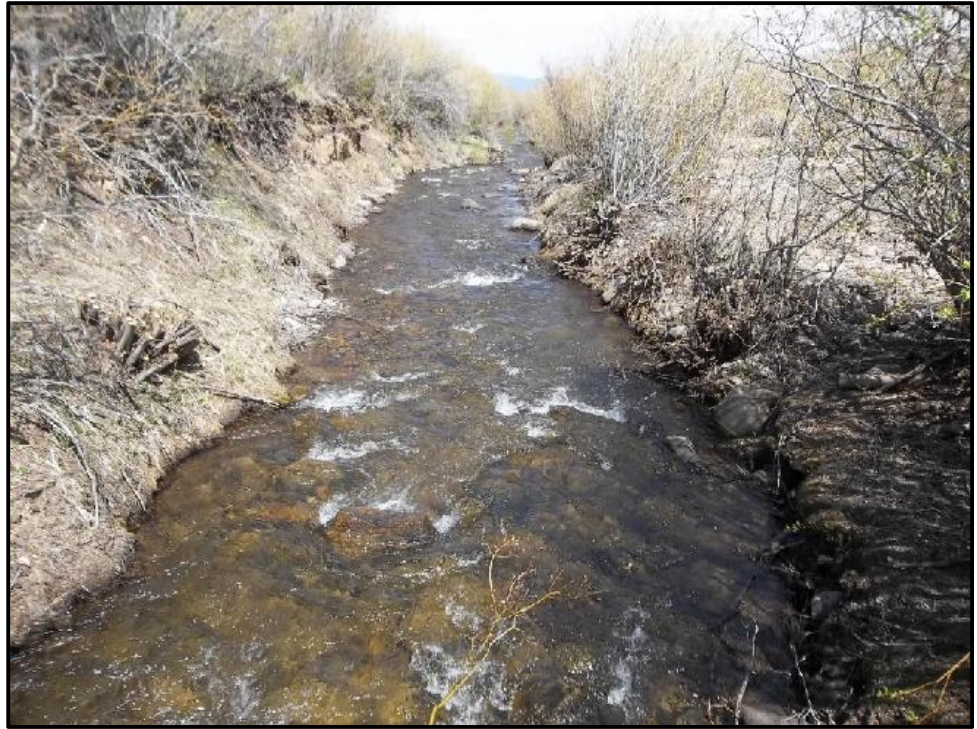
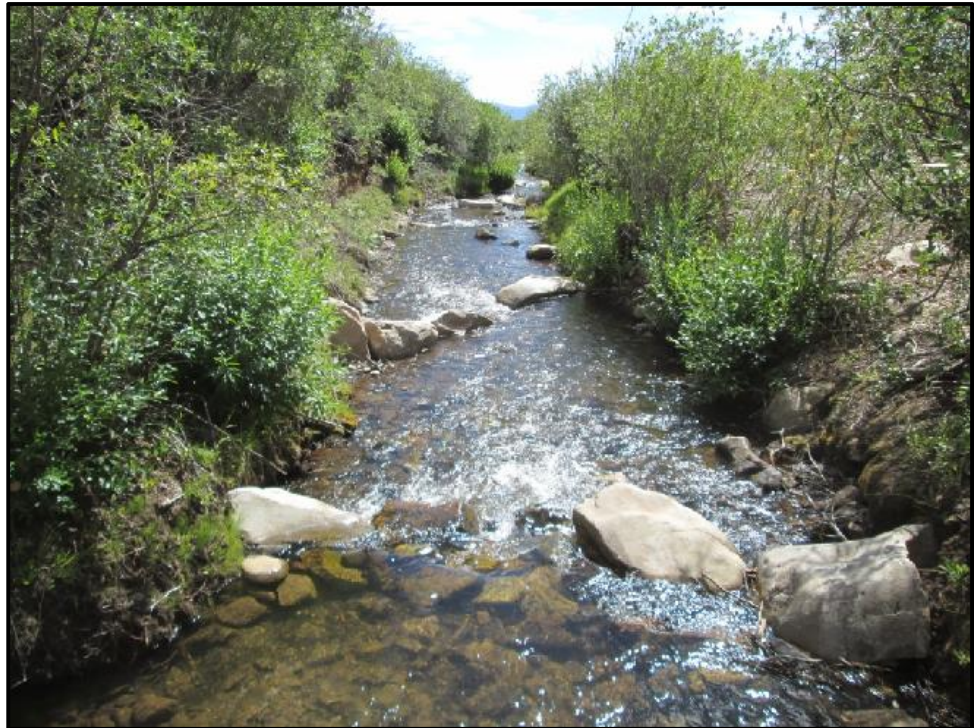
**Figure 15: Before-after photos showing a typical rock structure treatment.**

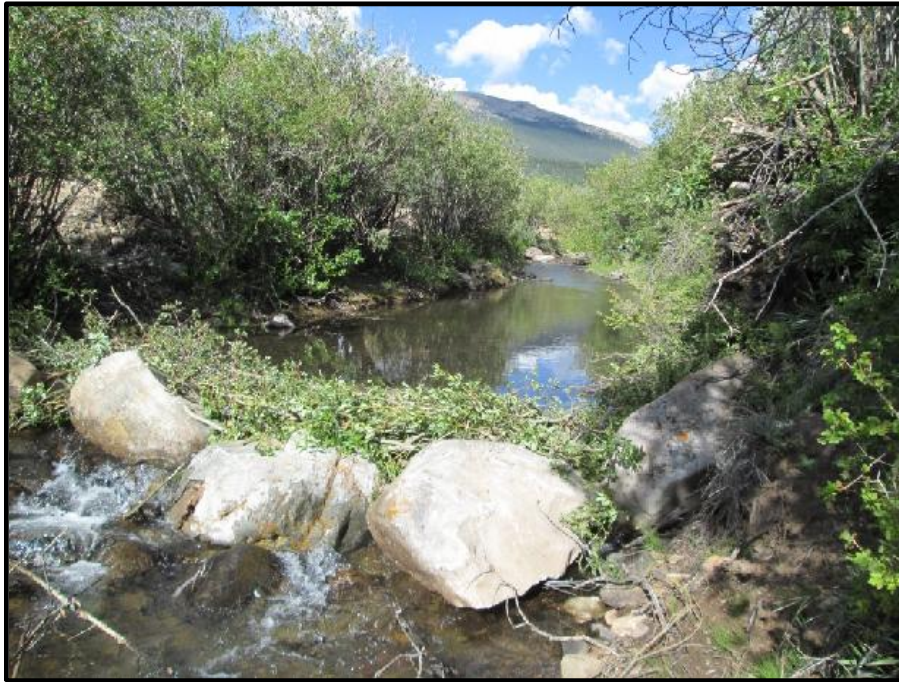
**Figure 16:**  
Examples of  
beaver start kits  
which were  
constructed at  
several locations  
within the project  
area. The  
structures were  
successful in  
impounding water  
and mimicking  
small beaver  
dams, but beavers  
tended to build  
their own dams in  
other locations.  
None of the large  
persistent dams  
that they built on  
the project site  
were on start  
structures.

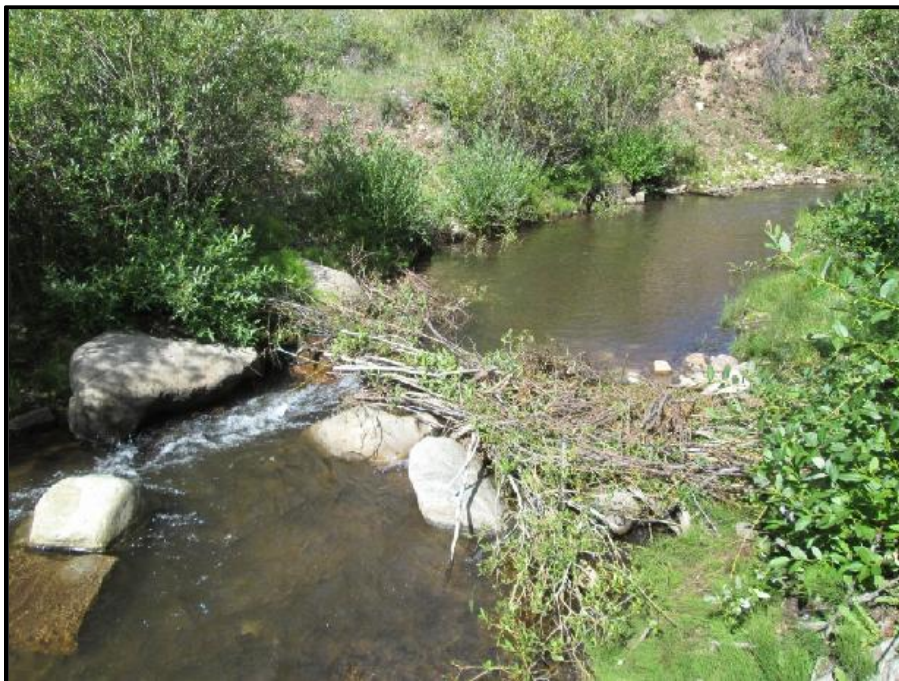
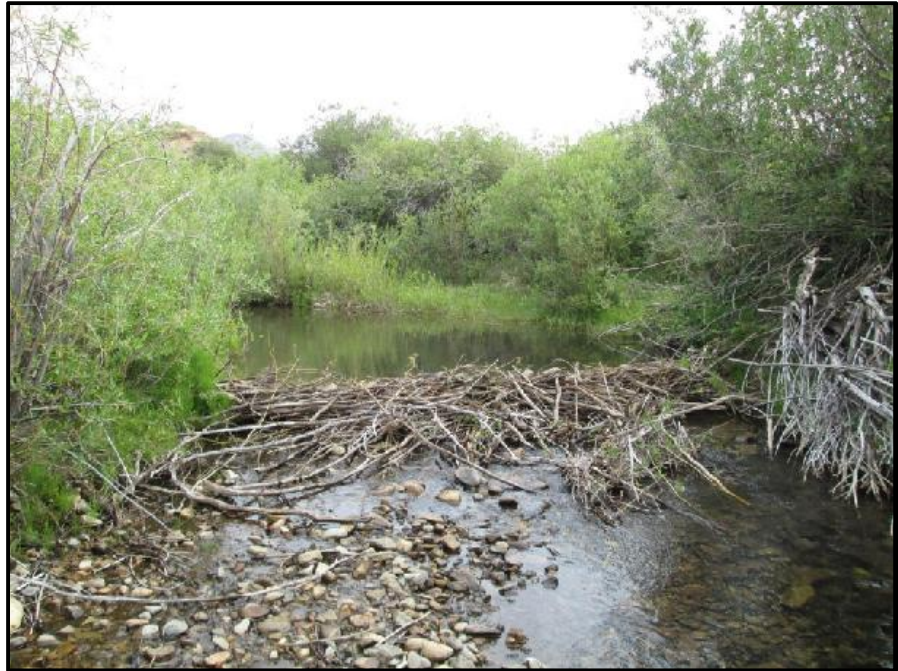
**Figure 17:  
Examples of  
two locations  
where beavers  
built dams on  
the ranch in  
2013.**

After implementation, we observed beaver activity at several locations in the project area (Figure 17). In fall of 2012, there were two active beaver families on the reach, and in 2013 there were 4-5 active groups. The increase in beaver activity was very promising, but the locations that beavers selected to build their dams was a bit of a surprise. While we did see some beaver activity on a few of our beaver starts, the majority of activity was at locations of the beavers' own choice, which was generally not where we had been prepared for them. Of six full-scale dams on the reach in 2013, none were located on beaver start structures.

The 2014 runoff apparently proved to be too much for all the beavers on the reach since all of the dams were wholly or partially destroyed. In summer of 2014, we saw very little beaver sign, indicating that the displaced beavers had likely emigrated. By fall, the start of several dams was again observed on the reach, so we are hopeful that beavers will continue to use the reach.

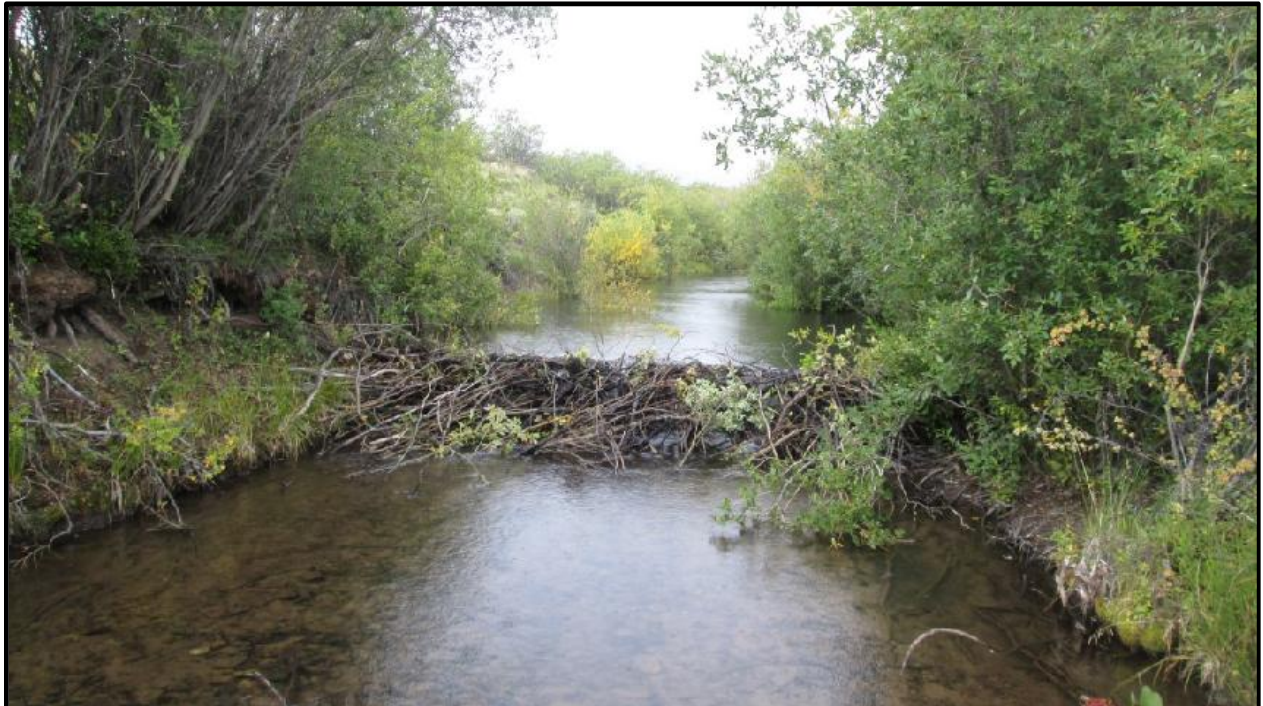
**Figure 18: This series of photos are of the main beaver pond that was present from 2011-2014. In the "before" picture (top) the creek/pond is barely visible behind the tailings at the edge. After the tailings were moved from the edge of the pond, the beavers raised the dam about one foot, increasing the size of the pond and bringing water near the elevation of the reclaimed tailings.**

removal of adjacent tailings by building the height of the dam ever higher until water was effectively flooding onto the remediated tailings area (Figure 18). The dam became so high, in fact, that the beavers had diverted most of the channel flow through a side channel and pond area, mimicking the behavior of reference systems. Unfortunately, the system did not persist very long as the dam was overwhelmed by high flows in 2014 (Figure 19).

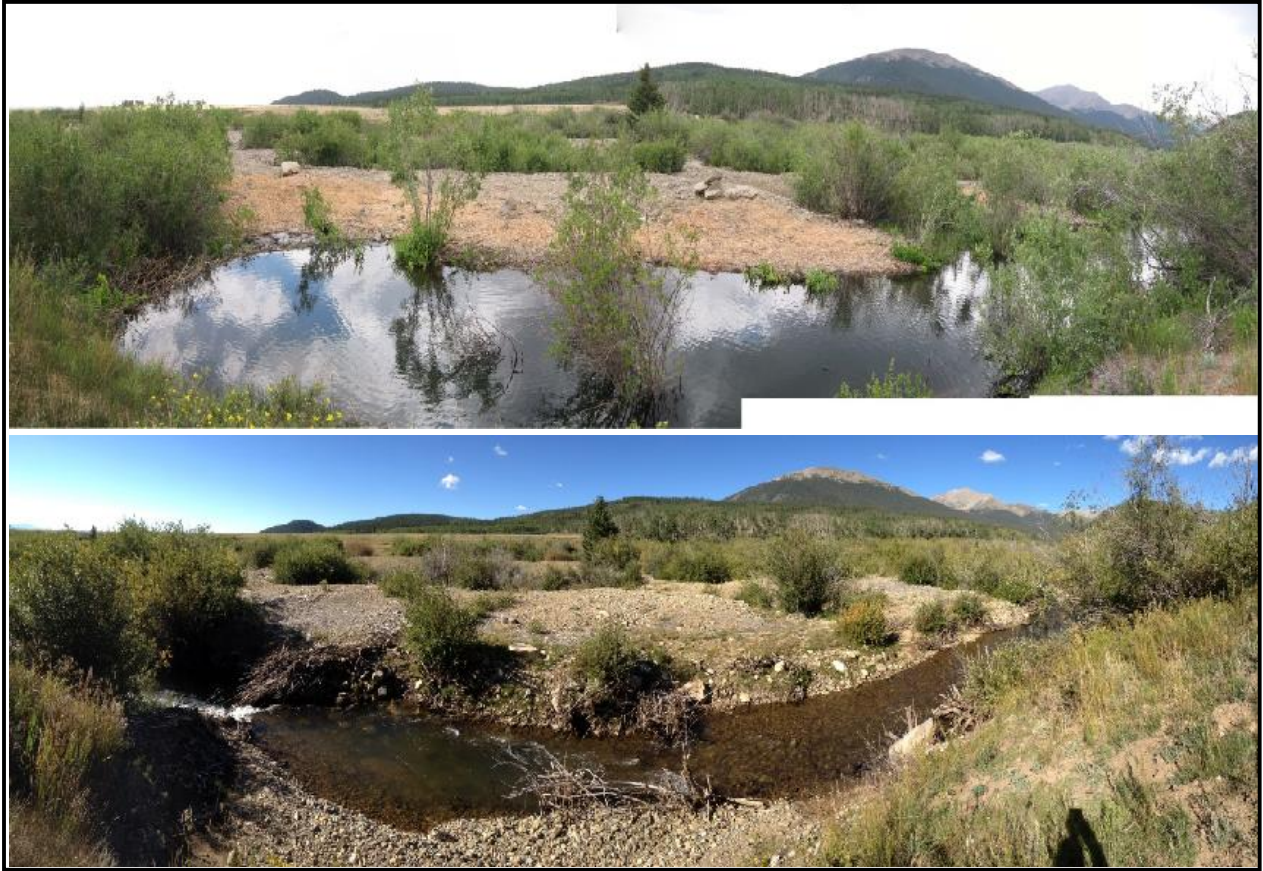
Figure 19: This view shows the main beaver dam when the dam was at full height in 2012 (top) and in 2014 (bottom) after the dam failed. Even with this major disturbance, there was very little erosion or change in channel morphology, giving us little hope for any major natural recovery of the reference riparian condition.

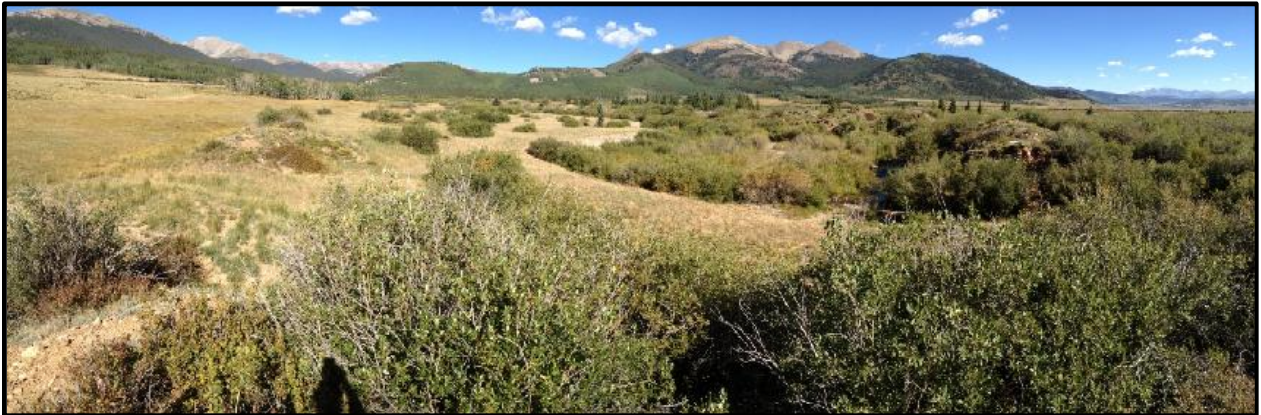
**Figure 20: View of open, trail area that was created from tailings piles.**

Establishing human and wildlife access was an intended byproduct of tailings remediation (Figure 20) that we capitalized upon further by creating sections of interconnecting trails. The long term expectation is that there will be relatively easy walking access in the upland for many years to come. The plant communities in these areas are coming in as upland grasses with patches of willow shrubs that makes for easy walking. Access points to the stream were created by opening up gaps in the dense strips of willows and by clearing areas of the over-topping decadent willow canopy. The trimmed willows are responding with exceptionally fast re-growth rates, which means that the access points are closing in quickly. Stream access will become problematic again soon unless these points are constantly maintained.

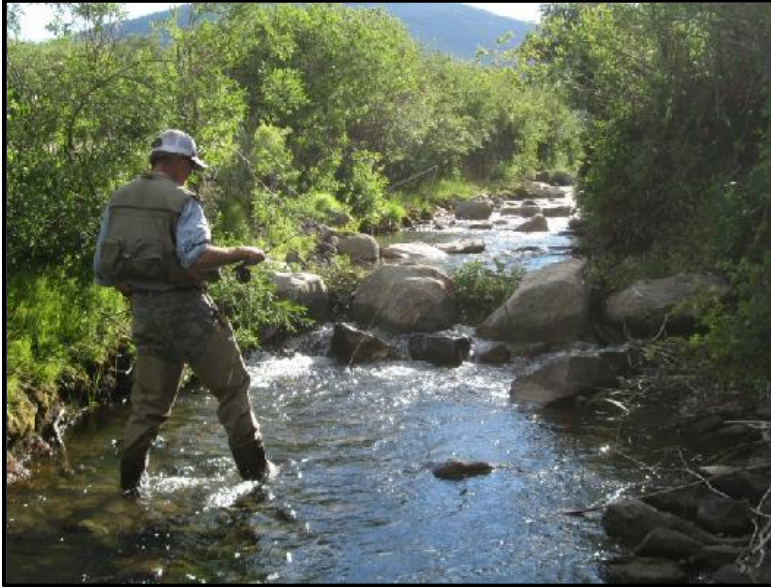
**Figure 24:** Access points have been appreciated by anglers and other recreationists.

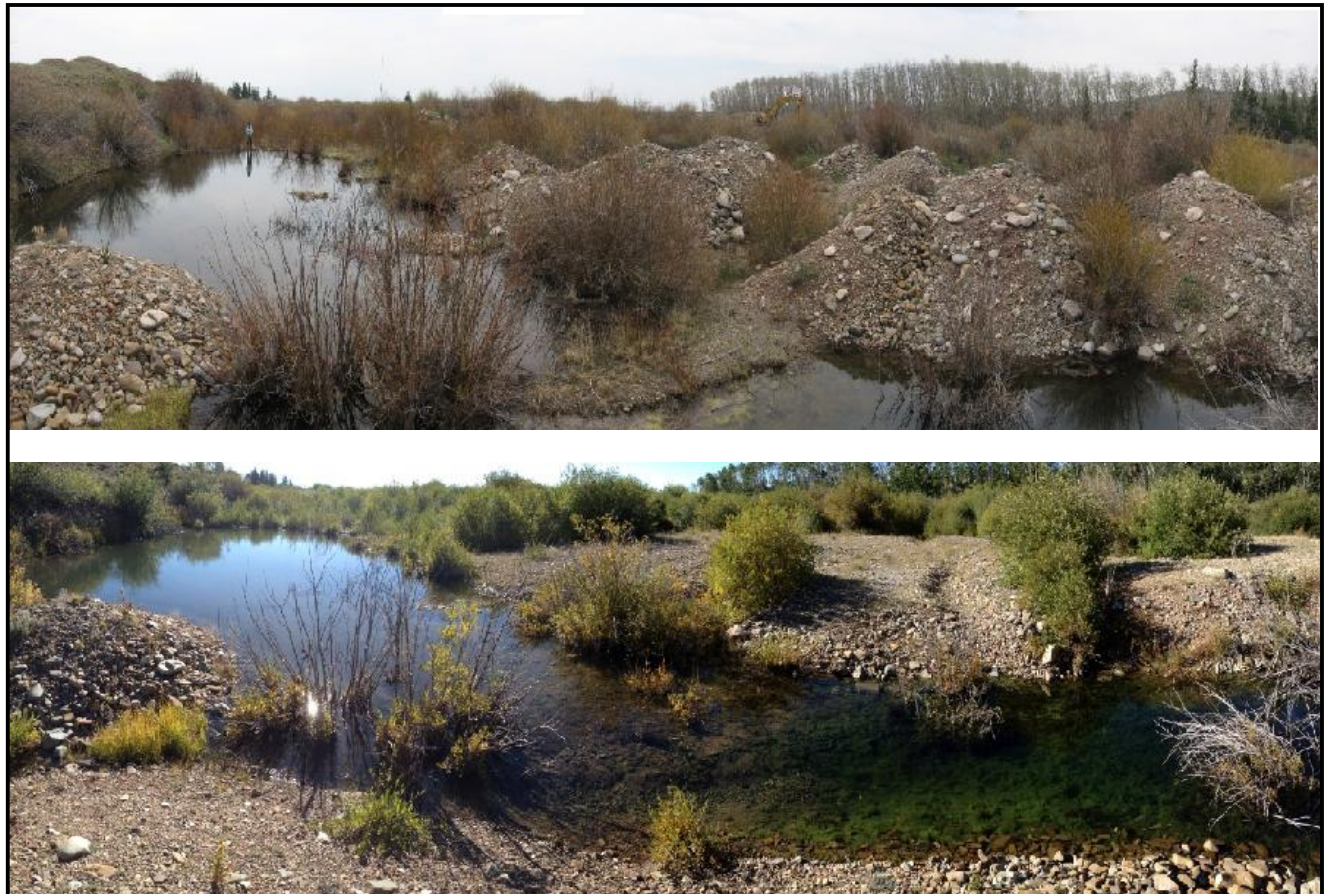
**Figure 25:** Before treatment (above) the tailings made access to this beaver pond difficult. The goal of these treatments was to make the area more suitable for vegetation establishment and more accessible for both people and wildlife.

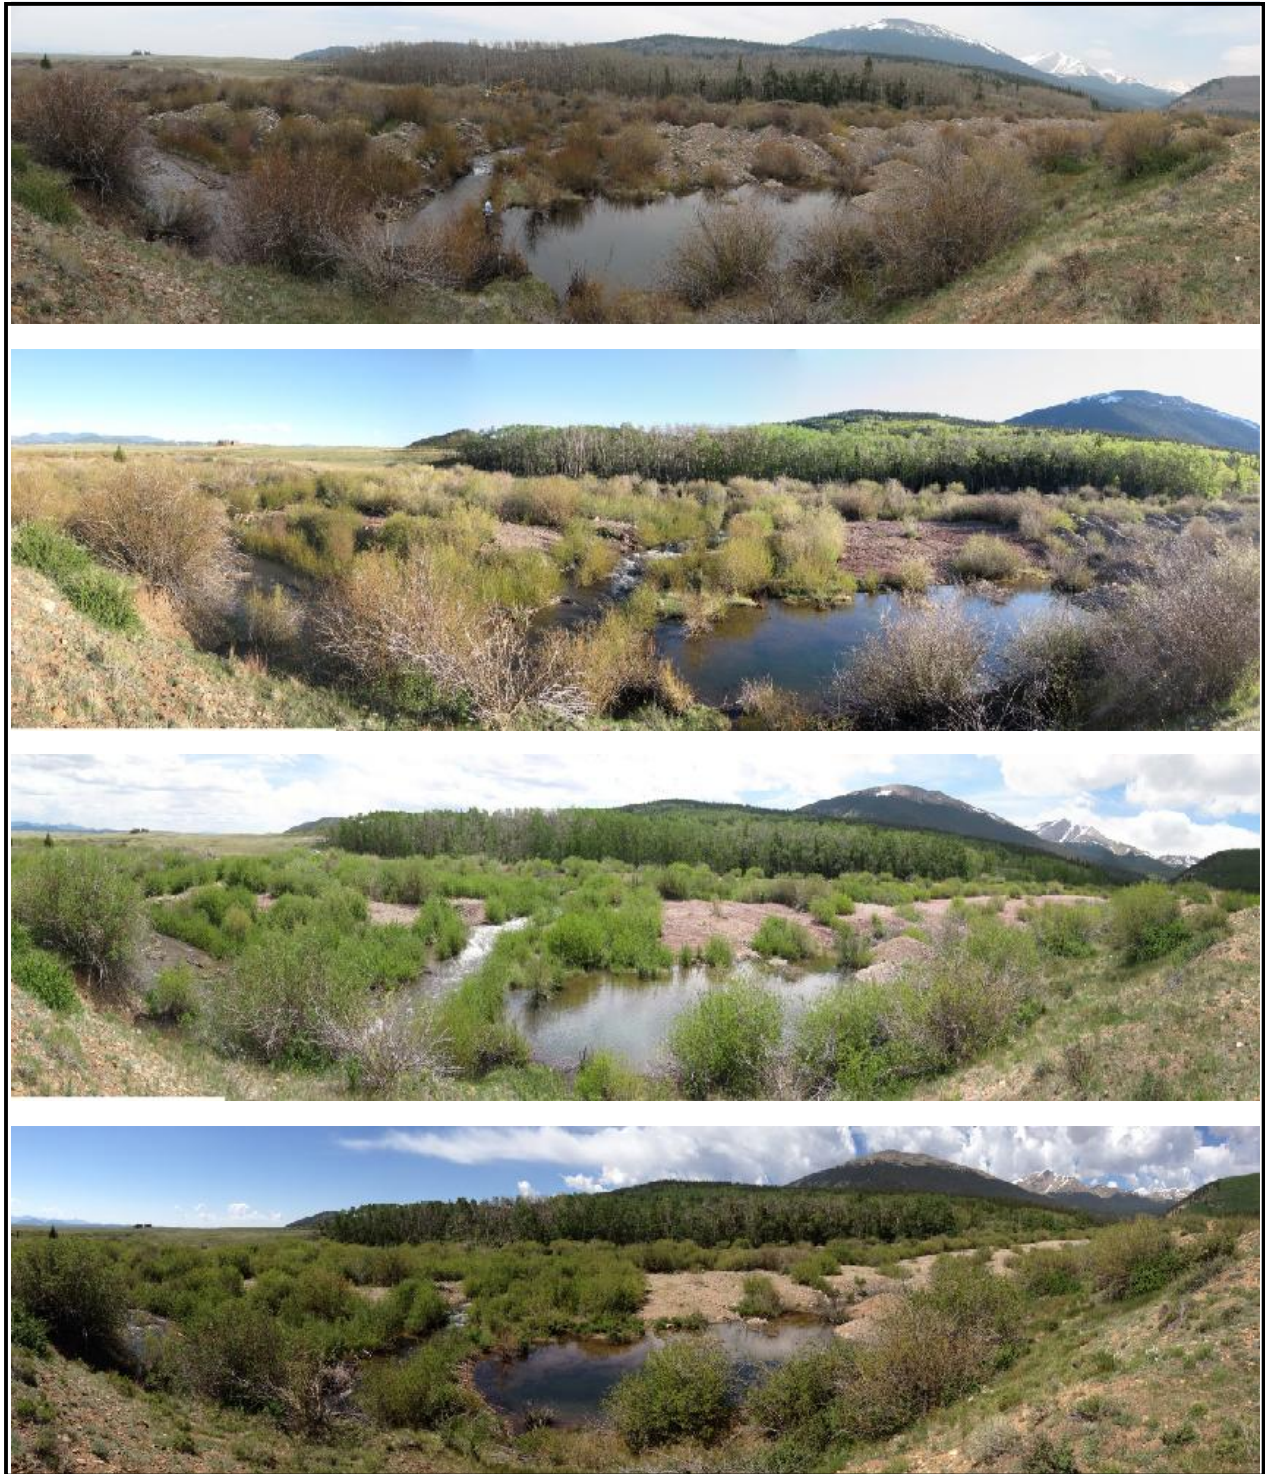
**Figure 26: This time series starts in 2011 (top) showing pre-project conditions and follows the progression of the tailings, beaver pond, and creek to 2014.**

Looking to the future, the most influential factor in the system's continued recovery will be beaver activity. The increase in beaver activity on the property through 2013 was encouraging, as was the return of beavers following the destruction of all their dams during runoff in 2014. The stream is remarkably stable and resistant to change, however, so one must be cautiously optimistic about any large-scale systemic recovery. Any major change will be slow in coming. In the meantime, the property is much improved over its past condition and appearance (Figure 26).
