# Tarryall Meadows Ranch Landscape Reclamation and Habitat Enhancement Project

## *2014 Update Report*

**Prepared for Colorado Open Lands  
By Jessica Doran and Mark Beardsley of EcoMetrics  
December 2014**

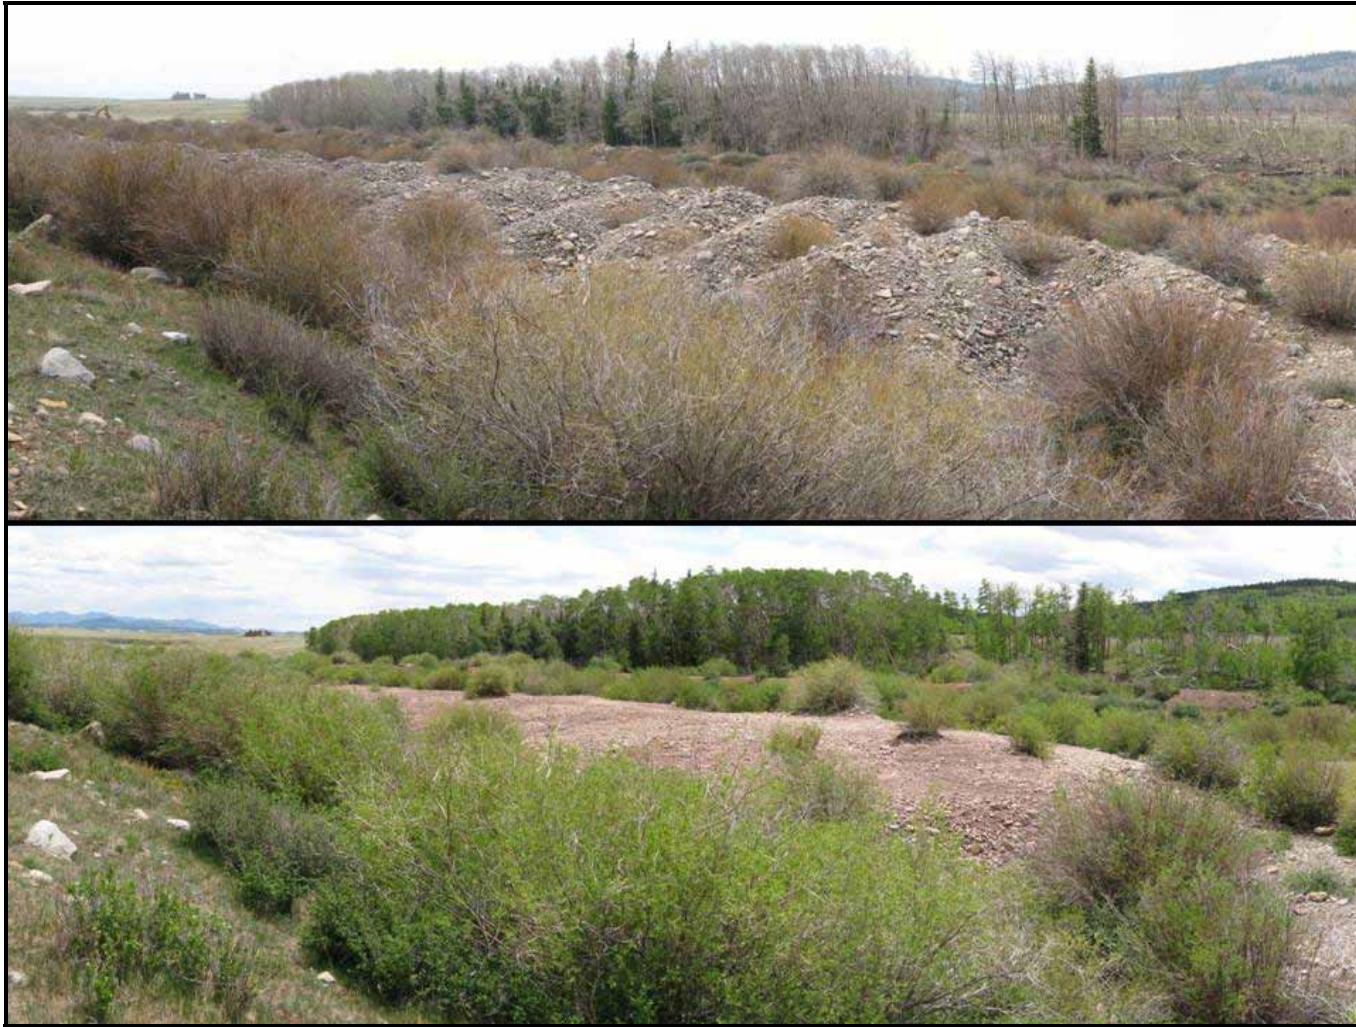
**Figure A-2: Southeast view of reclaimed tailings area**

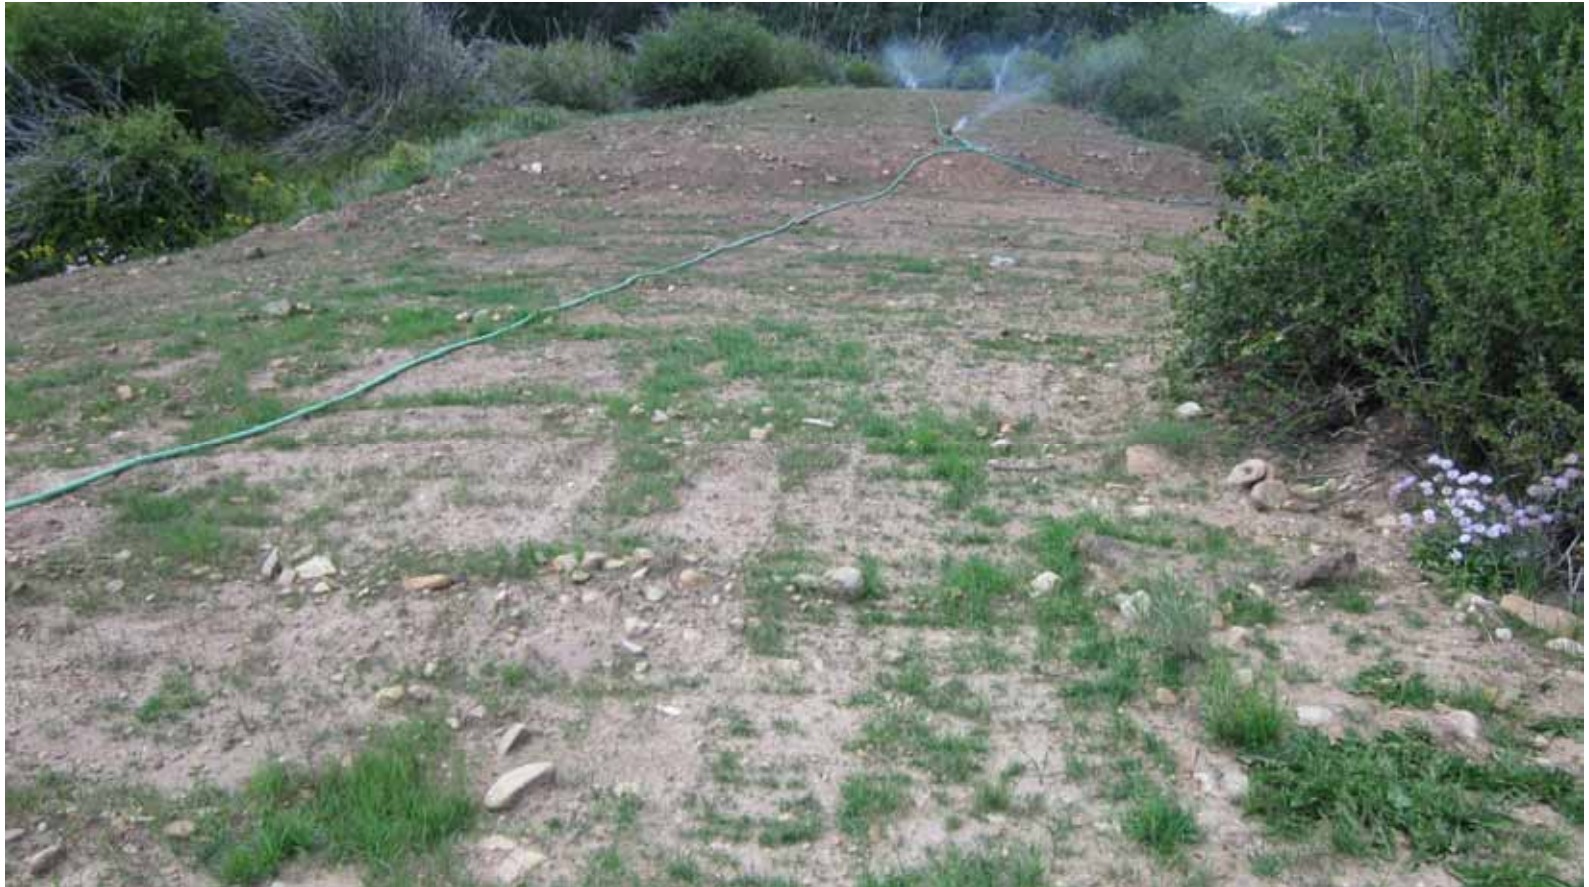
**Figure A-3: Native grass seed and irrigation were used to re-vegetate graded overburden (edge) piles**

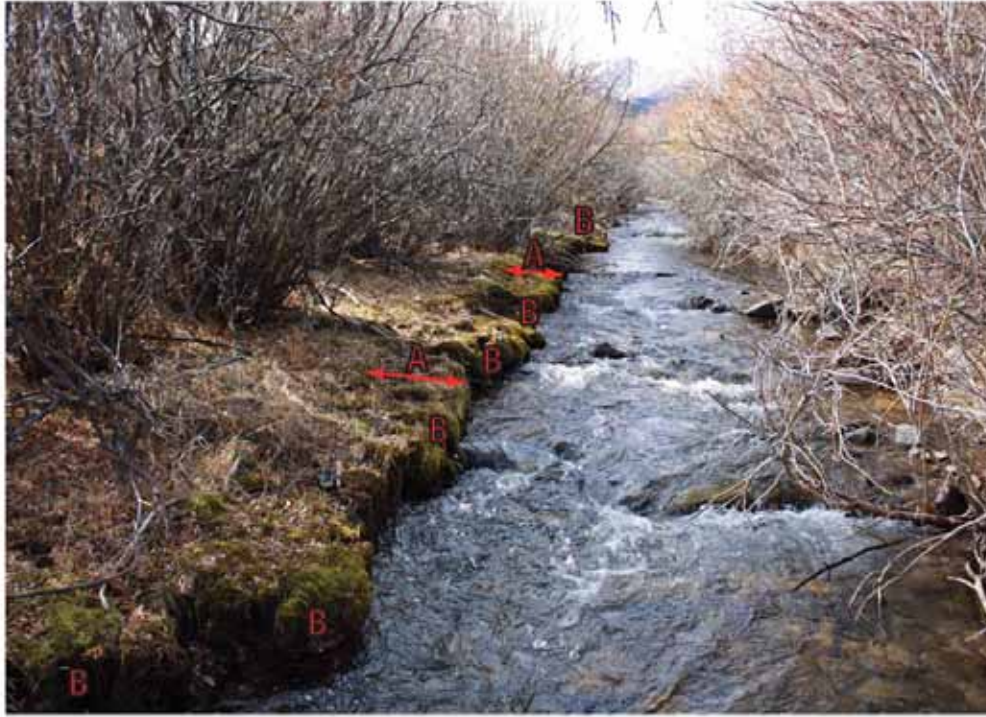
**Figure C-1: Floodplain Benches**

Narrow but stable riparian benches ("A") have become established along much of this straight, confined reach of channel. In contrast to most of this drainage, erosion resistant bryophytes line the south bank ("B") in these shady, moist sections of stream.

This work will be accomplished in a judicious manner so that stable riparian soil and plants (i.e. bryophytes) remain undisturbed. Within a matter of years, width of the riparian (flood plain) community is expected to increase from its current extent (0-5 feet) to 10-20 feet in treated areas. As a result, habitat diversity will be greatly enhanced by creating a non-linear floodplain over long distances of the channel.

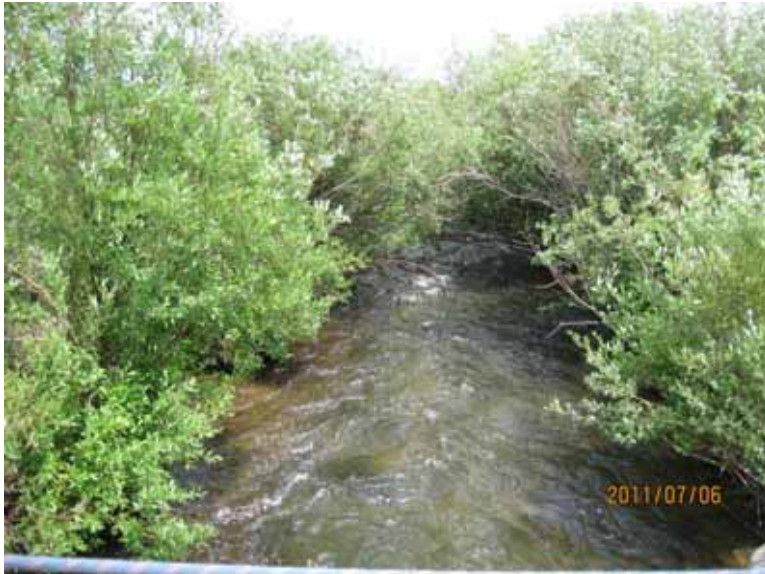
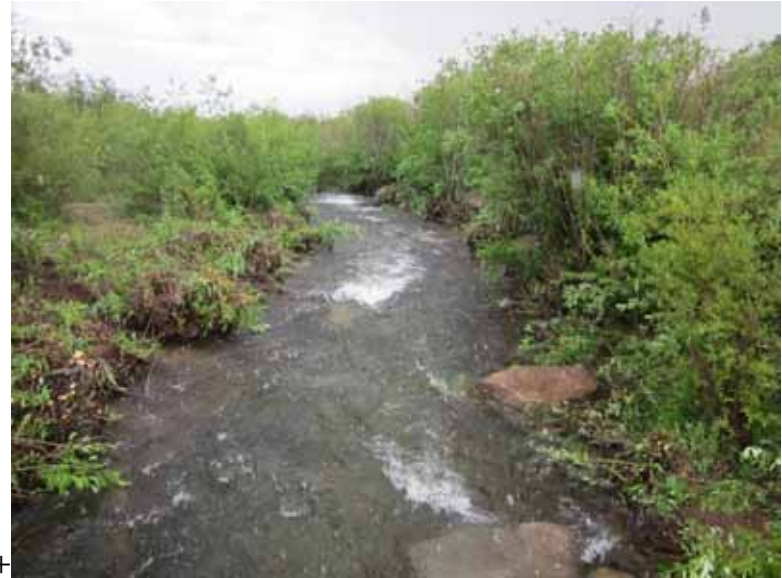
**Figure C-2: Selective Vegetation Cutting in the 2011 Project Area**

This before and after sequence shows a test reach on the Tarryall Meadows ranch where willows were selectively cut along the stream channel in 2011. The “after” photo (right) shows how willows were generally cleared from the north bank and selectively trimmed along the south bank. Our 2012 plan is to leave root material and smaller shoots intact, and to maintain a willow canopy on one bank for cover and shade (typically along the south bank).

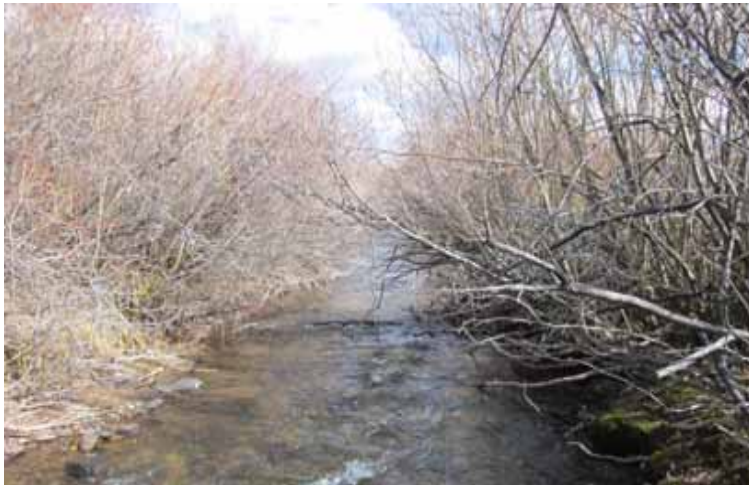
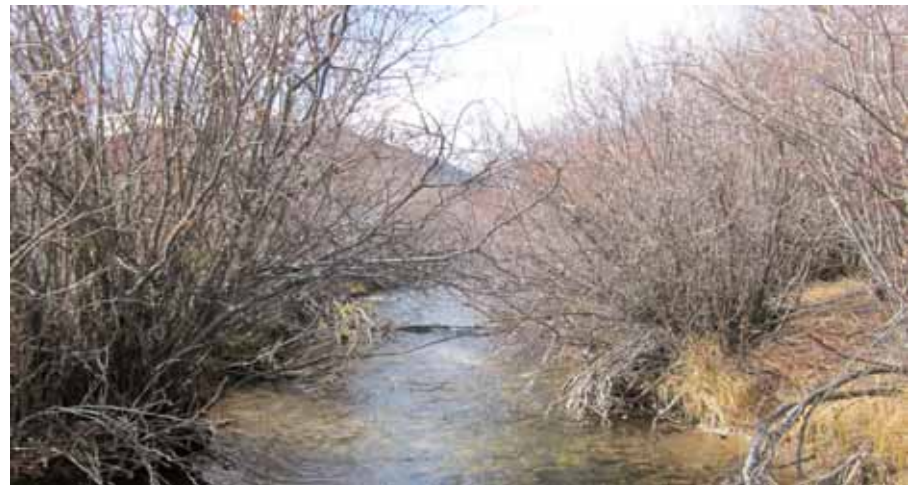
**Figure C-3: Vegetation Cutting Areas in the Central Reach**

These photos are representative of the central (“tube”) section of channel. Channel stability in this artificially straightened, confined reach is not generally dependent on vegetation. However, shrub cover is very important from an aquatic habitat perspective. This reach would benefit from selective clearing and pruning of senesced willows. Consequently, our 2012 clearing efforts will necessarily be selective and judicious to maintain stream cover and shade.

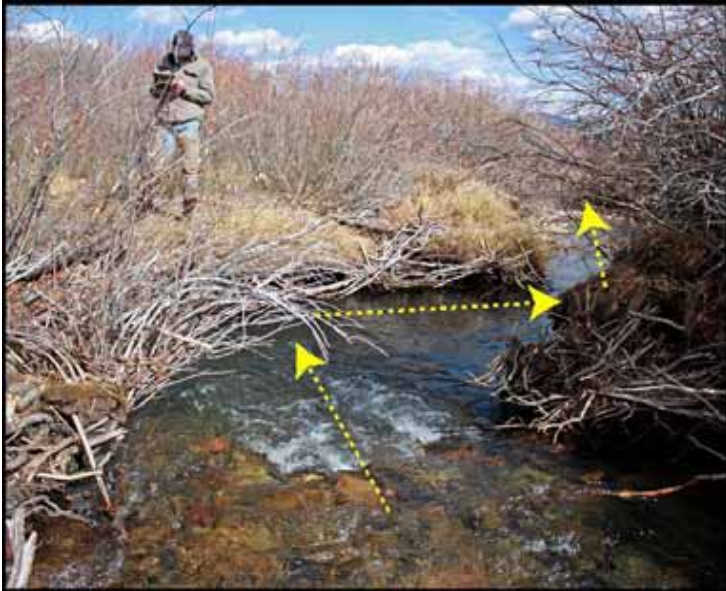
Located toward the bottom of the property on “Reach 9,” this bend pool is the deepest pool on the property (except beaver ponds). Pool depth is self-maintained by scour against a strong vegetated bank created by a very tight bend ( $R_c \sim 1.0$ ). Here the channel turns more than 90 degrees to the right and 90 degrees back to the left within 40 feet (yellow arrows). Turbulent cover, overhanging banks, and deep slack water areas provide excellent fish habitat under a variety of conditions. This type of feature may be replicated in a few reaches of the project area.

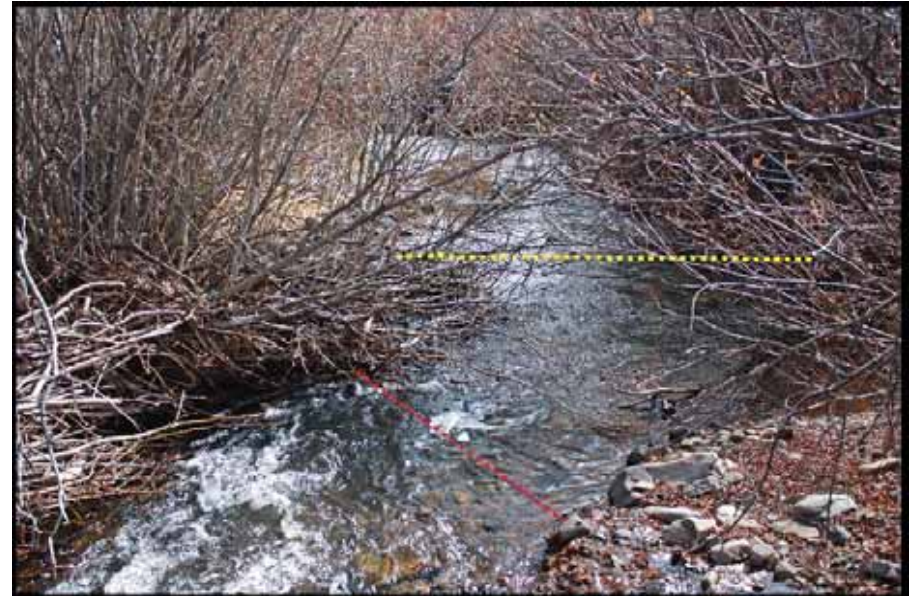
Small, incipient bend pools are present within the project area. In this example, a nice pool has formed below a slight “dog leg” meander. The channel is about five feet wide where the stream turns abruptly to the right (red line). As it’s directed back to the left, it widens into a pool that’s about 15 feet wide and 24 inches deep (yellow line). This reference demonstrates that bend pools can be maintained even on very slight bends or “dog legs” as long as bank materials are strong. Opportunities exist to create similar “dog-leg” bend pools at a few other locations within both the floodplain and confined reaches of channel.

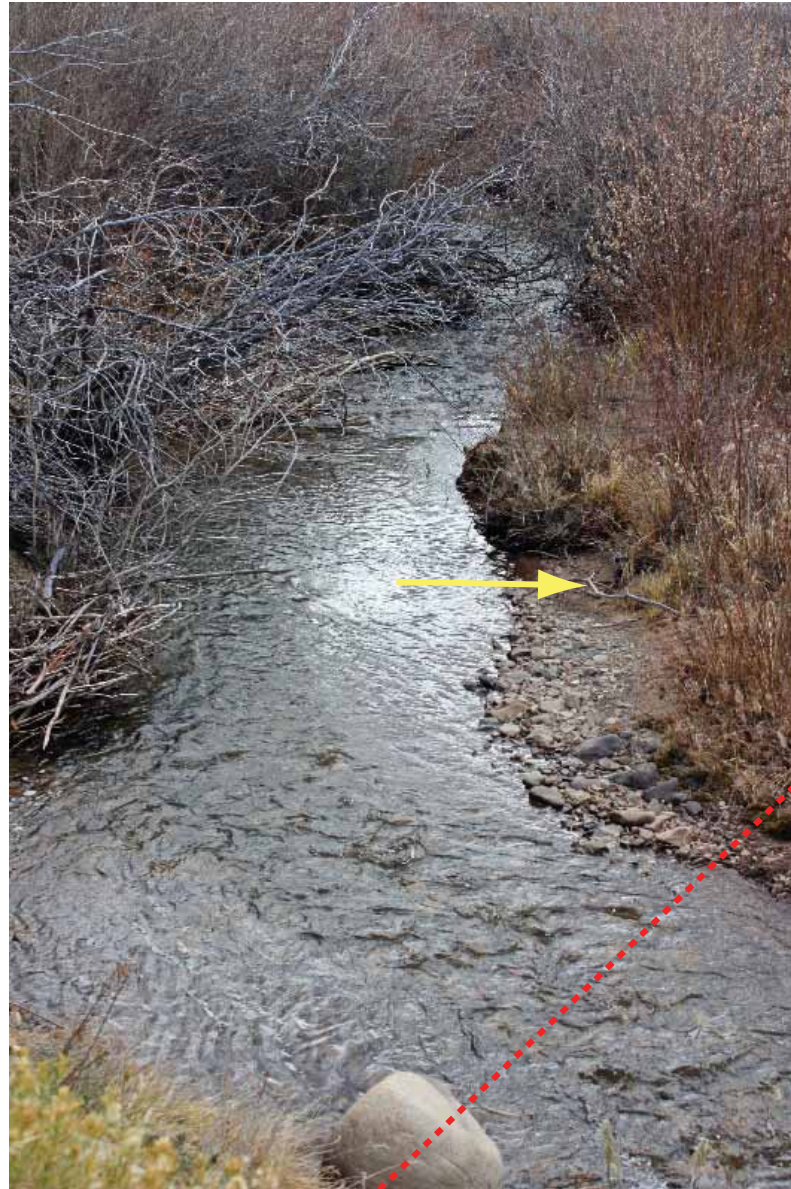
**Figure D-2: Proposed Bend Pool Enhancement in the Central Reach**

A low profile grade control structure comprised of embedded boulders and cobbles would be constructed at the red line to provide greater depth and fish cover at low flows, without excavating the bed to make it deeper.

Willow branches would be selectively pruned at this location to increase upstream access while maintaining summer shade and overhead stream cover along the south bank.

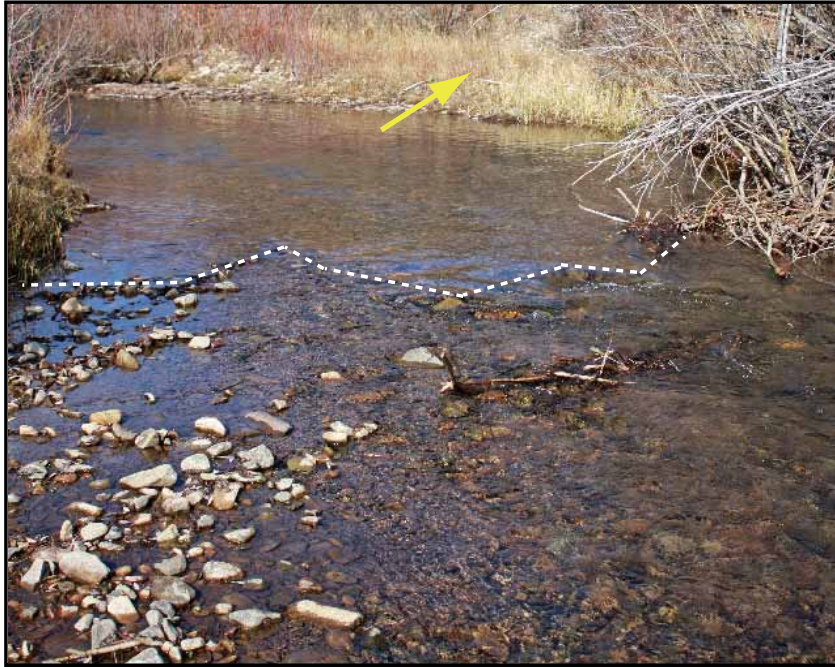
A hard riffle crest at the tail of this pool (white line) maintains the upstream pool elevation at low flows. A wide bench along the north bank (yellow arrow) dissipates stream energy and provides quiescent aquatic habitat during high flows. This pool tails out gradually from its deepest point (photo at right), providing both feeding and spawning habitat at different stream stages.

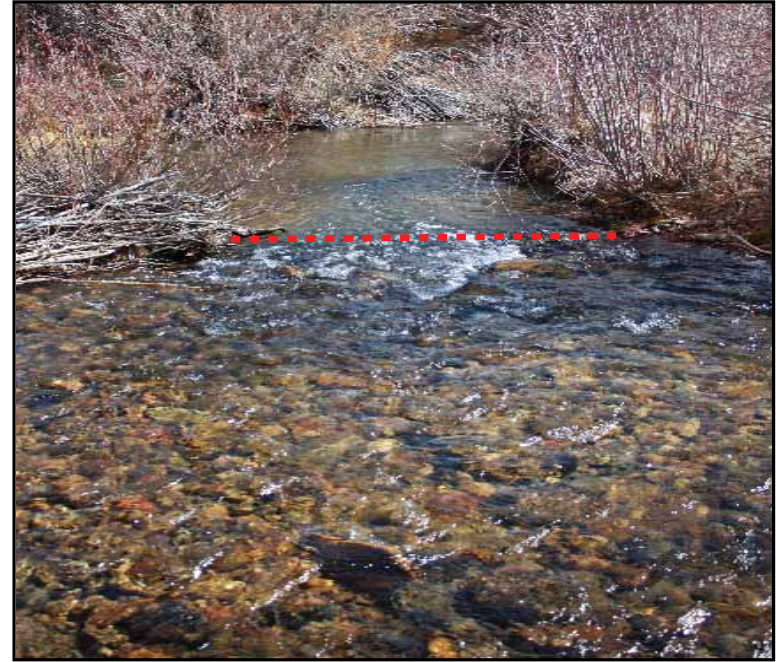
At the head of this pool, channel width contracts to about 8 feet (red line) where it plunges into deeper water. Good depth (18"-24") and turbulent cover provide pool habitat for fish under base flow conditions. This constriction and downstream plunge pool are maintained by a cemented cobble bed with willow "hard points" on either bank.

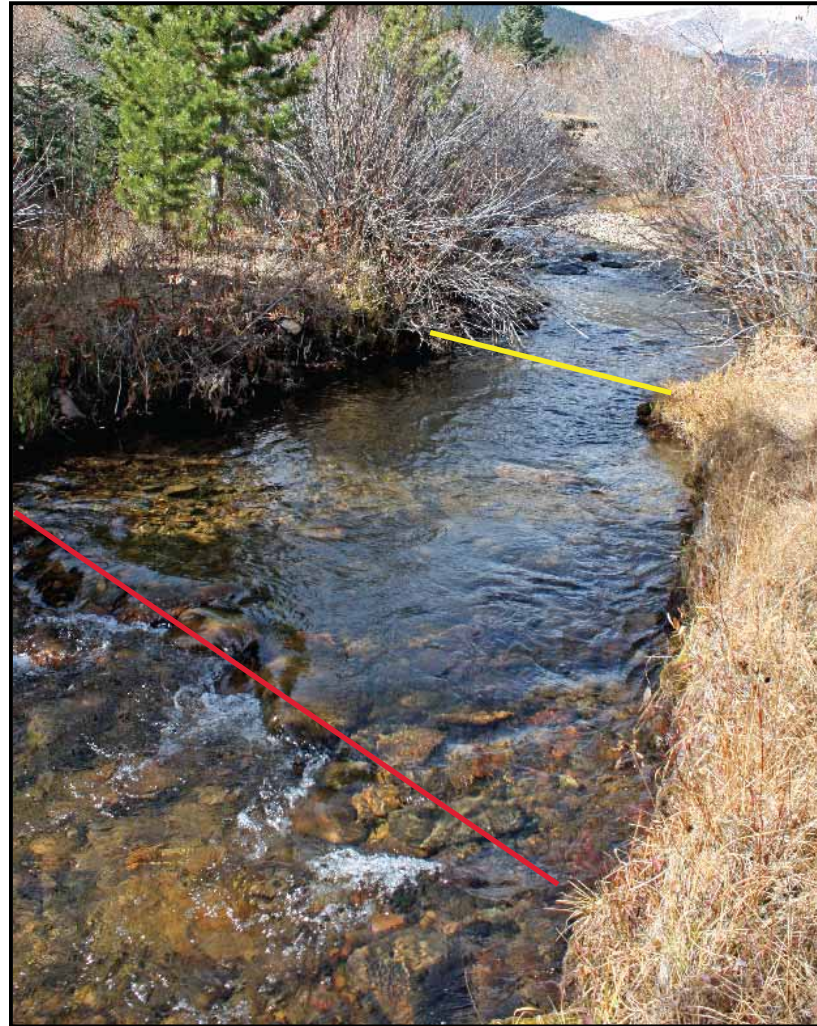
**Figure D-4: Reference Constriction Pool**

This reference pool is maintained by contraction scour through the constriction (yellow line) which maintains greater pool depth and turbulent fish cover at low flows. The hard riffle crest (red line) is comprised of larger material that maintains upstream depth at low flows. The strong willow bank serves as an ideal “hard point” at the constriction (yellow line) and also maintains an undercut bank.

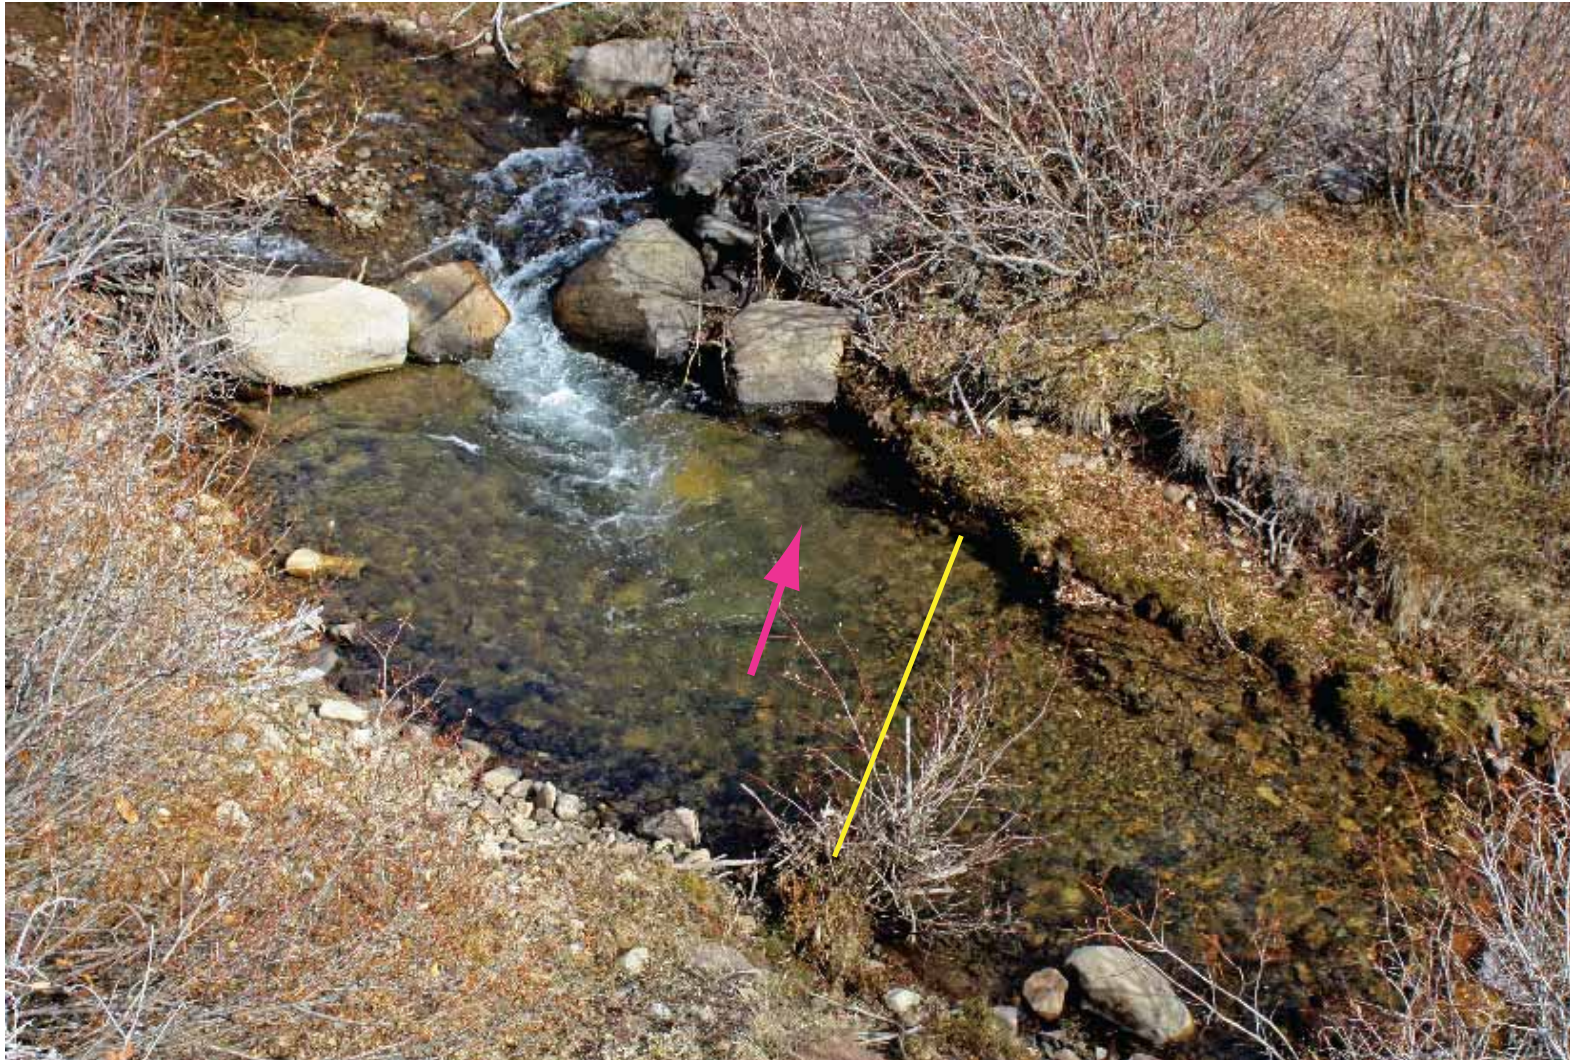
**Figure D-5: Constriction Pool in 2011 Project Area**

Large dredge tailings (boulders) in the channel serve as hard points for this small constriction pool located in the 2011 project area. The thalweg offers considerable depth (24") and turbulent in-stream cover for fish. Larger trout were observed feeding in the slack water (red arrow) in October 2011. A natural riffle crest (yellow line) is apparently maintaining a stable pool elevation below the scour area. This type of feature will be replicated using boulders as constriction materials at several locations in the 2012 project area. However, boulders will be embedded and keyed into very strong banks to create more natural looking pool features.

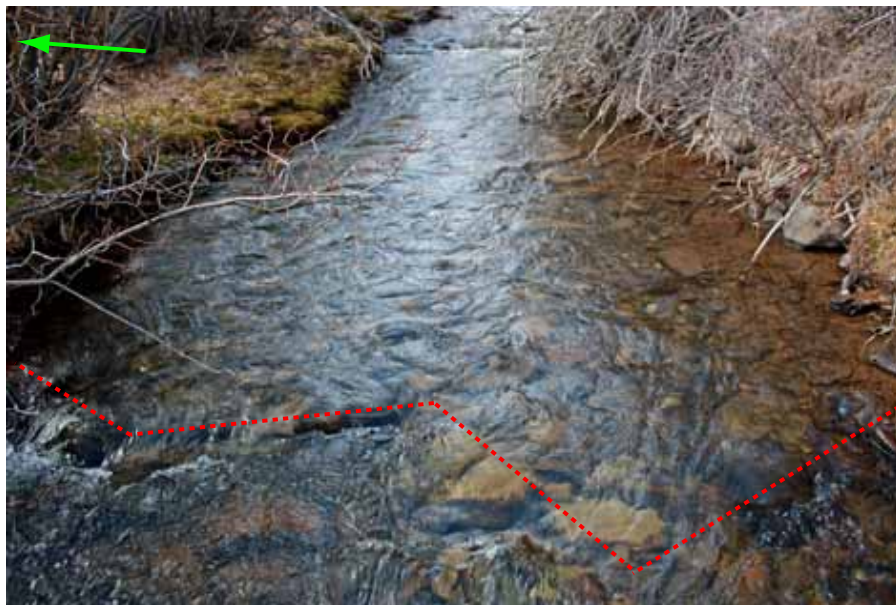
This is a typical location where incipient pools could be enhanced with subtle constriction structures in the central reach. Embedded boulders near the head of the pool will be used to create contraction scour and maintain greater pool depth. The pool tail out (red line) would be elevated several inches by embedding small boulders to increase depth. Additionally, the small floodplain area will be enlarged by pushing the tailings south 5-10 feet and grading a wider riparian bench (green arrow).

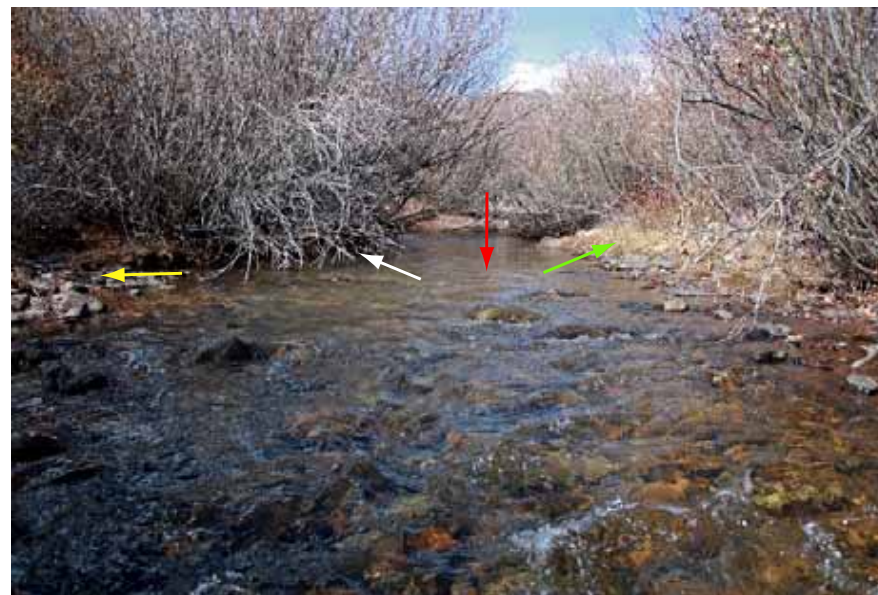
**Figure D-6: Proposed Pool Enhancements in the Central Section**

Overhanging willows along the south bank (white arrow) provide fish cover and shade. At high flows, a small floodplain along the north bank (green arrow) and cove on the south bank (yellow arrow) dissipate stream energy and provide quiescent aquatic habitat during runoff.

The largest brown caught to date in the tube section (15") was surface feeding near the tail of this pool during August 2011 (red arrow).

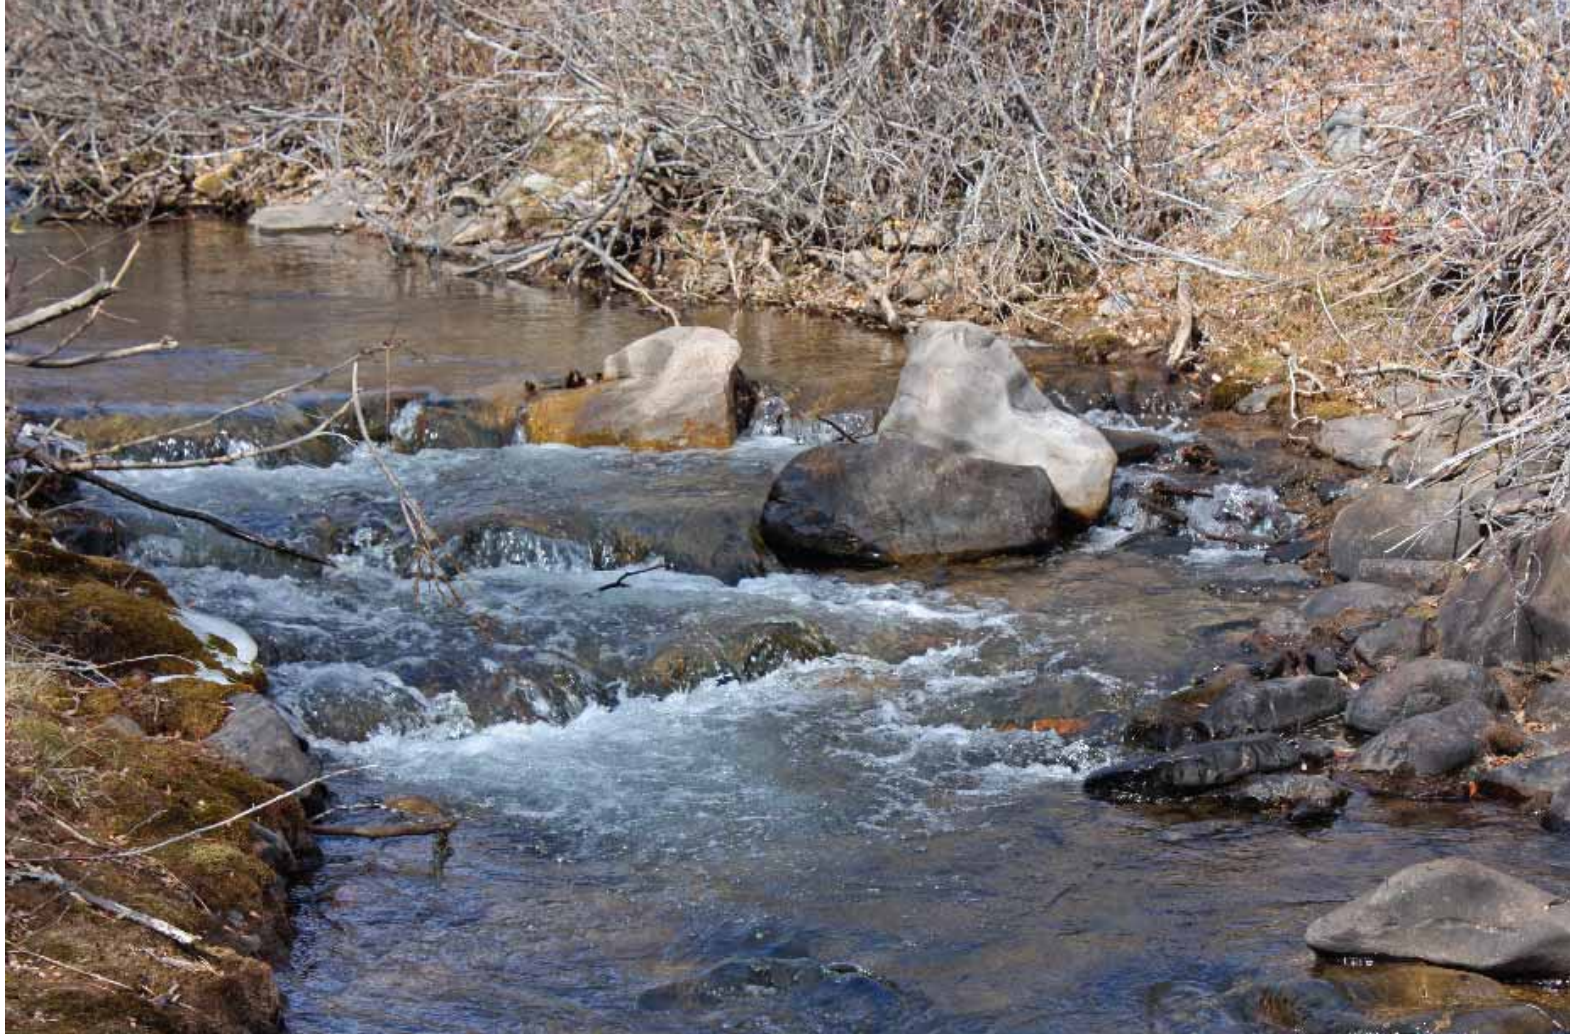
**Figure D-7: Existing Step Feature in the 2011 Project Area**

In the photo above, an assortment of boulders and cobbles maintains an impound pool above, and small plunge pools below each of three hydraulic jumps or “steps.” Similar features will be constructed within the steepest reaches of confined channel during 2012. The longitudinal distance between steps will be increased to provide larger plunge pool areas below each drop.

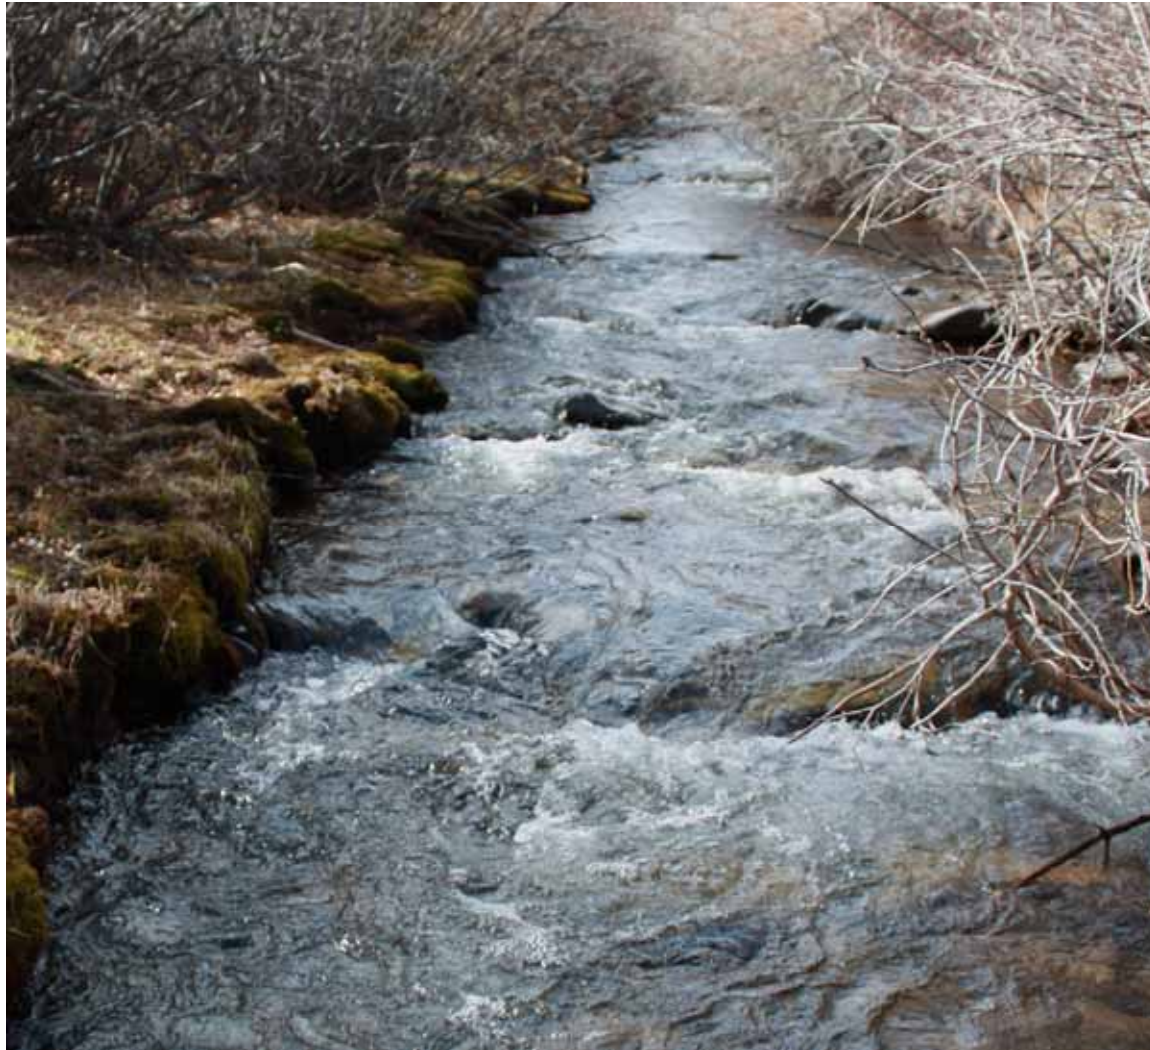
**Figure D-8: Proposed Pocket Water Enhancements in Riffle Sections**

This photo demonstrates how scattered boulders have formed small plunge pools or “pocket water” in a fast riffle. Flat boulders will be placed strategically in riffle sections to mimic this natural type of aquatic habitat structure. Willow trimming along the north (right) bank will facilitate stream access in this reach.

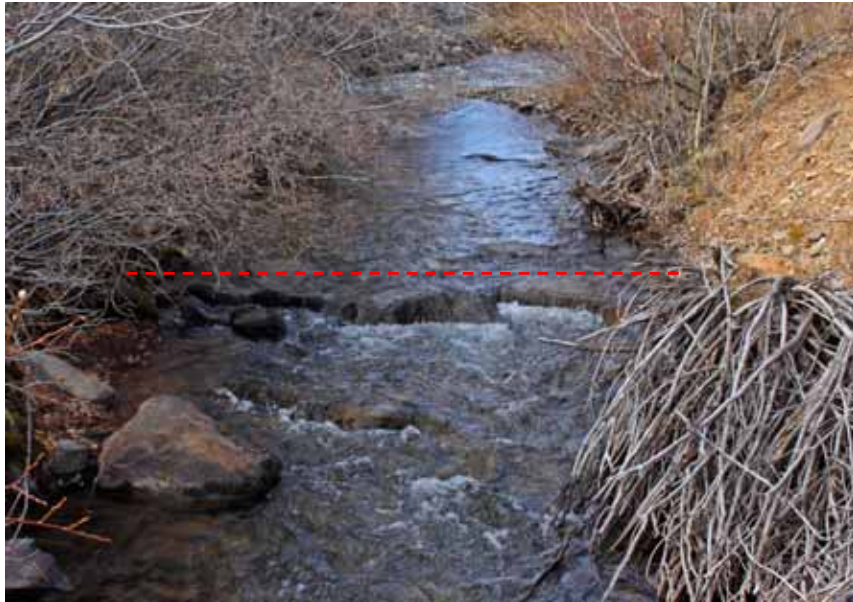
In this image of a natural impound pool, several boulders have become embedded across the channel to form a grade control or “dam” structure (red line). Here a small plunge pool has formed below the natural control structure. Pool area and depth may be increased by simply elevating the structure a few inches.

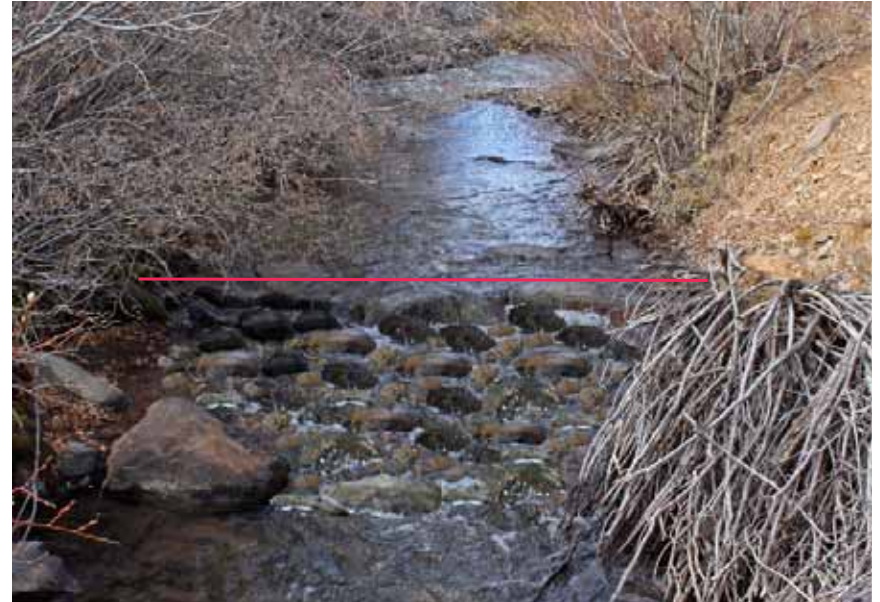
In this image, cobbles have been added in PhotoShop to demonstrate how materials might be arranged below the same grade control structure to form an inclined riffle below the impound pool. While this would eliminate the downstream plunge pool, it would also create a more gradual stream elevation change.

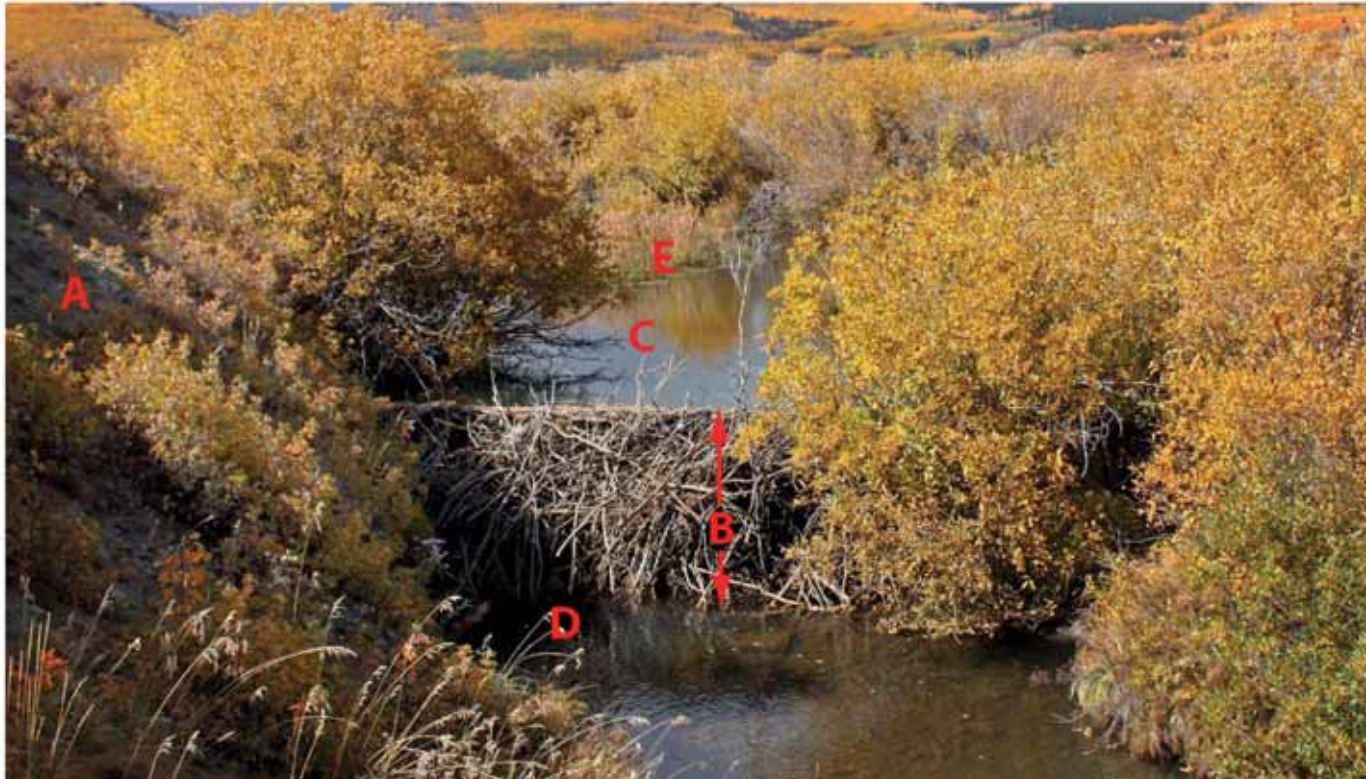
**Figure E-1: Reference Area for Beaver Colonization**

This reach of Tarryall Creek is immediately below the 2012 project area. Here the stream is confined by historic dredge workings along the south bank ("A"). Beaver effectively have created a series of steps in this confined channel. This, in turn, has raised the water elevation ("B"); created deep ponds ("C") and plunge pools ("D") that now provide trout and water bird habitat. Moreover, wetland (mainly sedge) communities have become established on sediment bars and floodplain benches that have formed along the channel ("E").

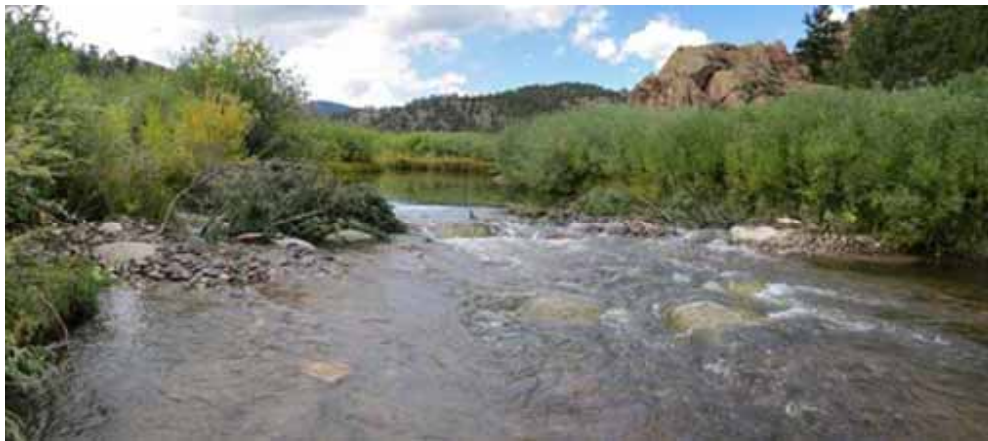
This photo shows a low profile beaver “start” immediately after it was constructed at the Williams Ranch on lower Tarryall Creek. In this example, pine trees with limbs attached were embedded into the structure. This site was selected, in part, because of the abundance of dam building materials available to colonizing beaver.

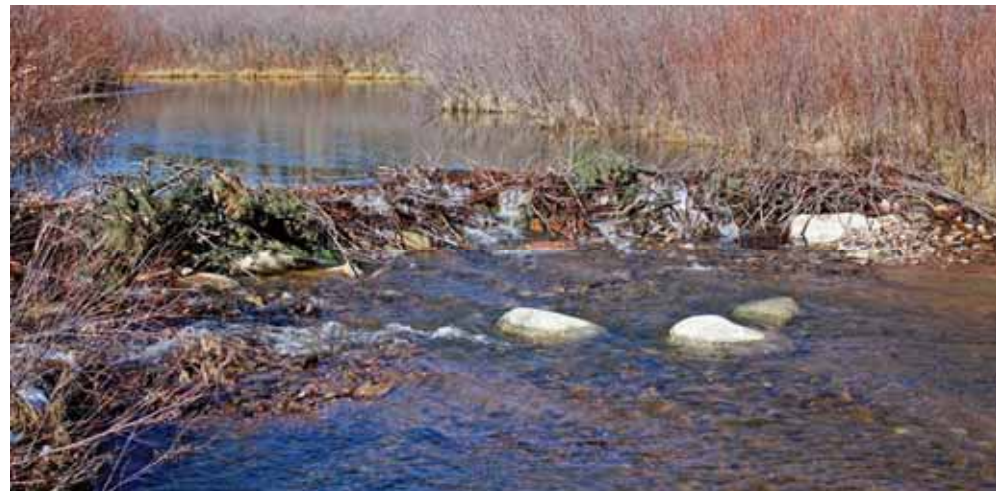
This is the same structure two weeks after beaver utilized available building materials to elevate the dam and pond elevation by two feet. If the beaver dam fails during runoff, the base structure (“start”) will continue to maintain residual pool depth upstream.

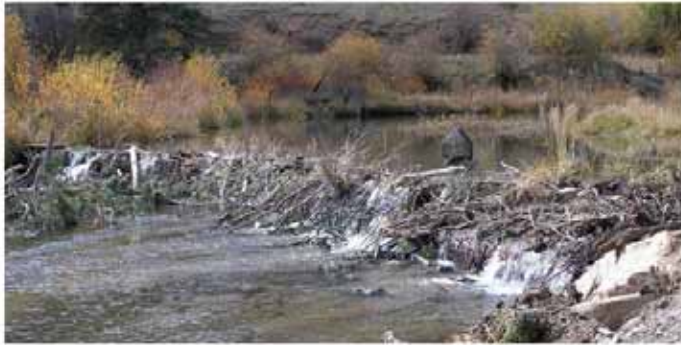
This sprawling beaver dam appeared one week after constructing a beaver start at Ute Creek Ranch in 2010.

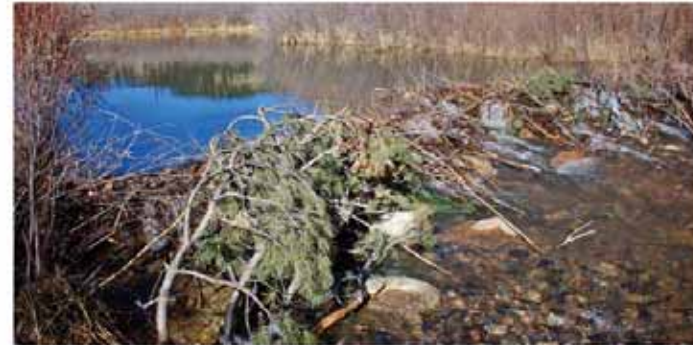
This new beaver pond at the Williams Ranch has inundated a long section of river and adjacent meadows above the dam.

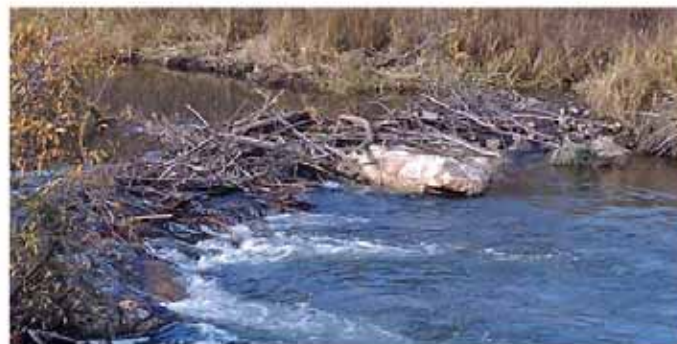
This beaver start at Allen Creek Ranch encouraged both dam construction and scour pool formation in 2011.

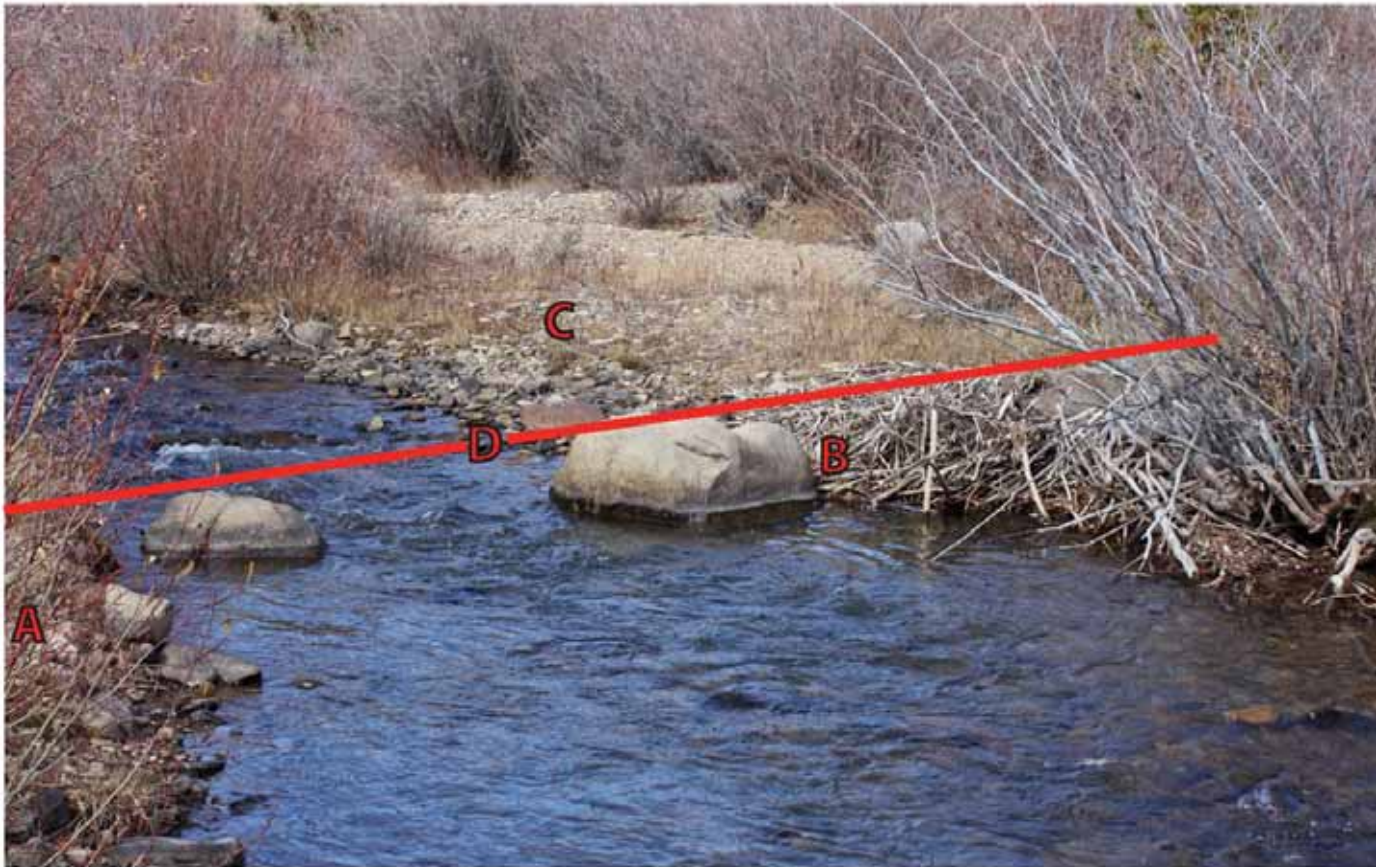
**Figure E-4: Typical Beaver Start Location on TMR**

This photo depicts one of several locations where beaver colonization may be encouraged by constructing beaver “starts” and stockpiling fresh cuttings within the project area. This location is strategic because the channel is confined by tailings along the south bank (“A”); it contains several large boulders and remnant beaver dam materials (“B”); and a broad riparian bench exists along the north bank (“C”).

- Identifying suitable cross sections based on multiple criteria (Figure E-4);
- Using cut or fallen trees (with branches intact) as foundational materials; and
- Stockpiling green aspen or willow cuttings to attract beaver to these sites. An abundance of cuttings will be generated from the riparian edge community enhancements proposed under Goal 2.
