# Slate River, Peanut Lake Reach

*Assessment, Restoration, and Monitoring*

*To Protect Peanut Lake and Improve River and Wetland Function*

**December 22, 2014**

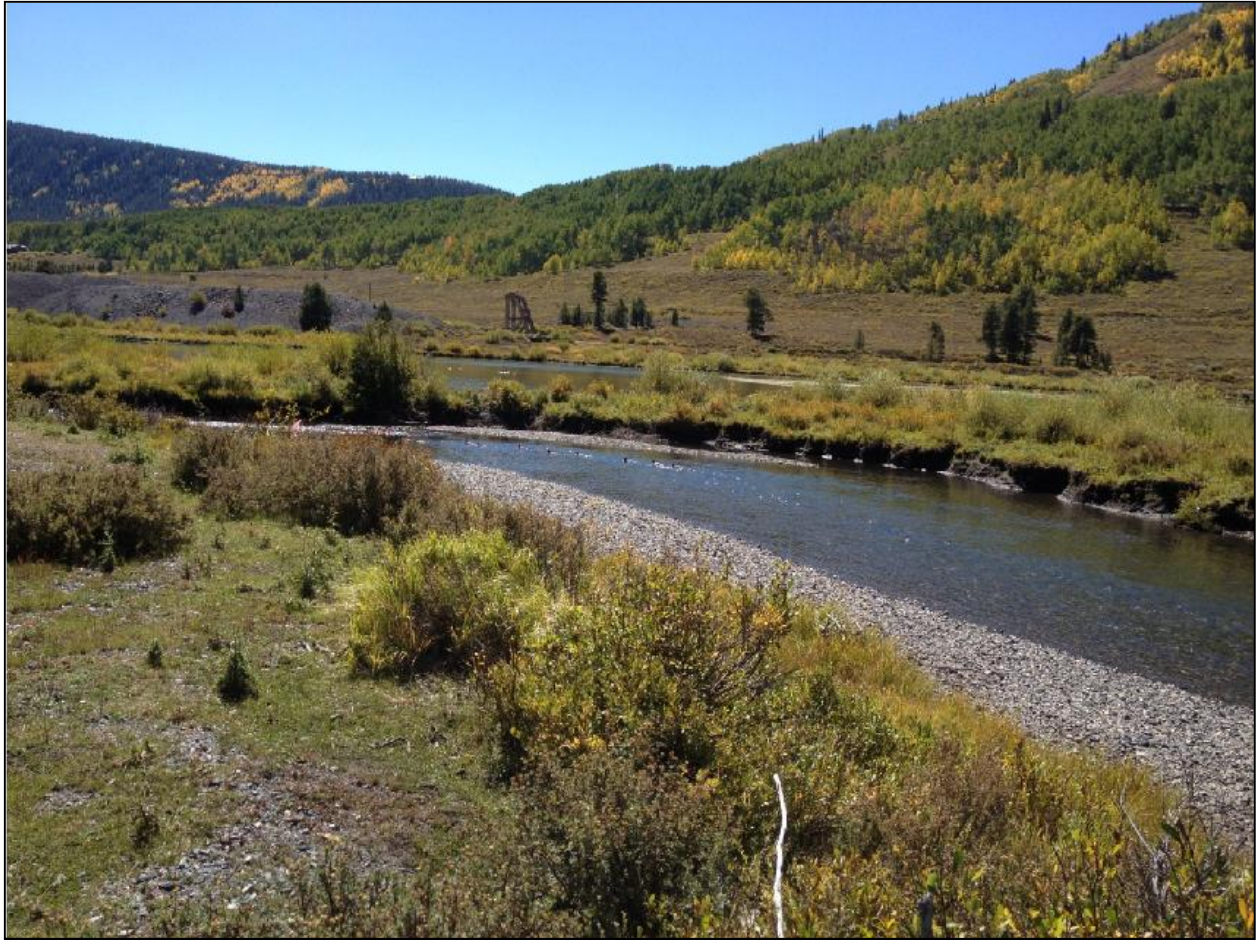
*Above: The Slate River where it is almost breached into Peanut Lake (background). The sparsely vegetated gravel in the foreground is a constructed berm that runs along the left bank.*

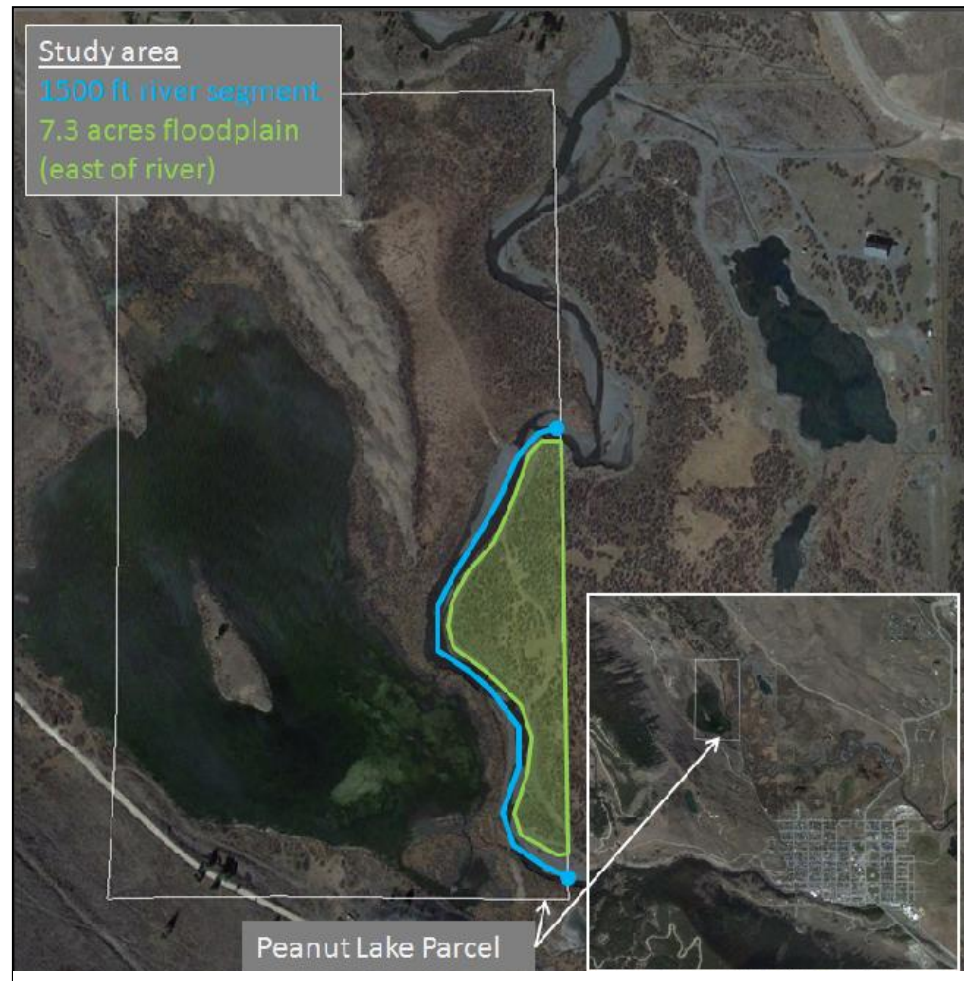
**Figure 1: The study area includes a 1500 ft segment of river and 7.3 acres of floodplain area on the Peanut Lake Parcel northeast of Crested Butte.**

The assessment area for this study includes a segment of the Slate River and adjacent floodplain wetlands on CBLT property known as the Peanut Lake Parcel (Figure 1). The length of river in the assessment area is approximately 1500 ft with a valley length of 1300 ft. The floodplain area assessed east of the current river alignment includes about 7.3 acres of historic wetland area. Access to the site from the Slate River Road is along the river from the CBLT Rice Parcel, but this requires crossing through the neighboring McGill Property. Access from the Peanut Lake Road would require crossing Peanut Lake.

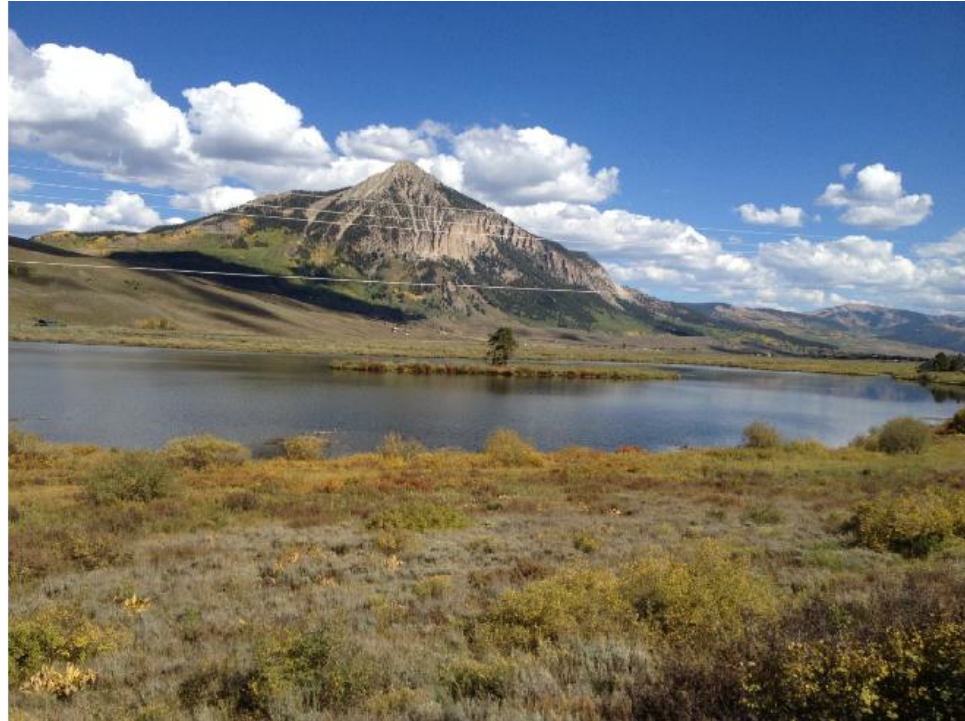
*Figure 3: Peanut Lake viewed from the north with Mt. Crested Butte in the background.*

Peanut Lake is about a 40 acre lake situated on the western edge of the Slate River Valley (Figure 3). At first glance, the origins of the lake are suspicious, and we initially expected to find that it is artificial or at least that it had been

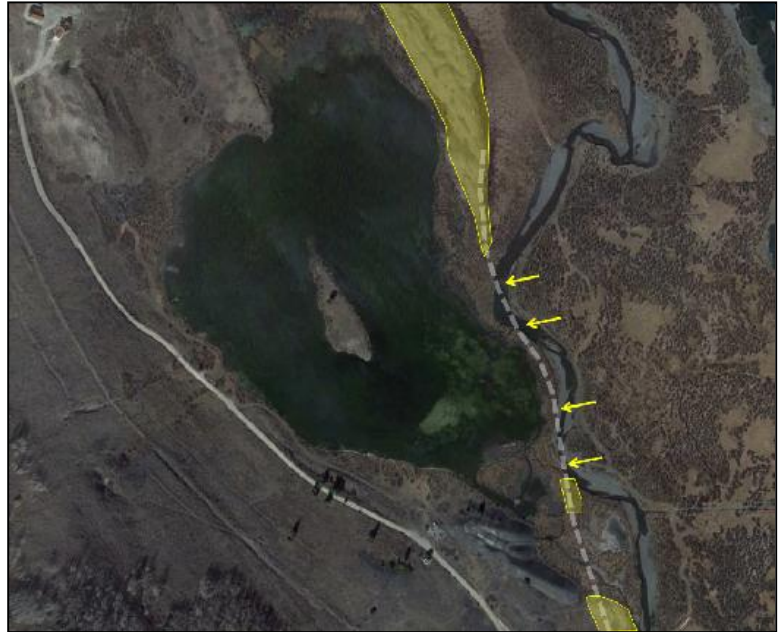
**Figure 4: Peanut Lake showing the prominent bedrock ridge. Areas where the ridge is exposed are shaded in yellow. The yellow arrows show where the bedrock is exposed in the banks and bed of the river. The river has crossed the ridge at these two locations and is now on the same side as Peanut Lake.**

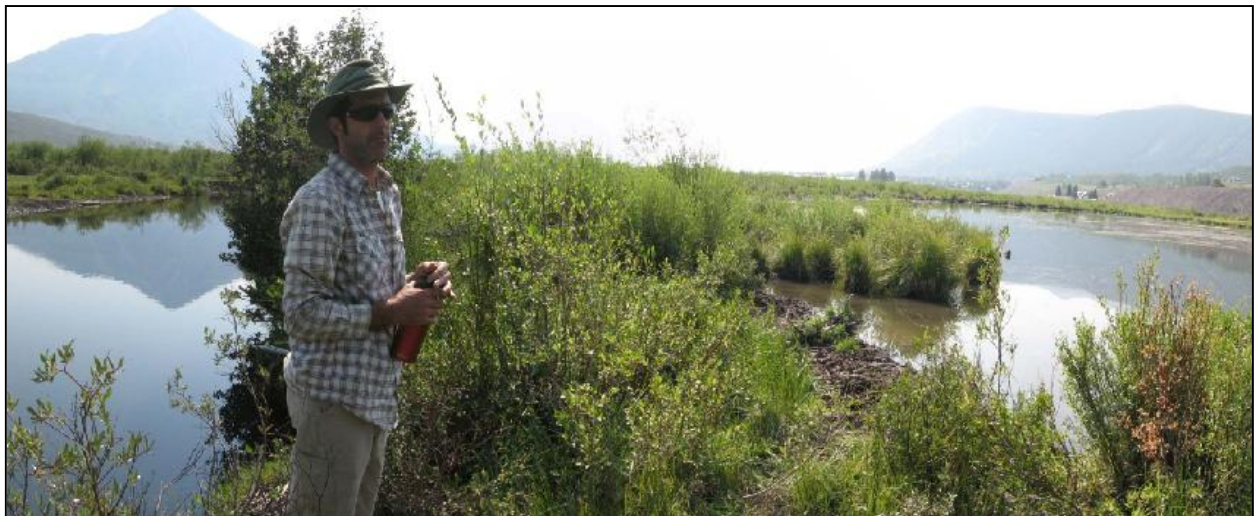
**Figure 5: The dam surrounding Peanut Lake is maintained by beavers. In this photo, a recent beaver dam in front of Andy is all that is preventing the lake (right) from draining into the river (left).**

We mentioned earlier that beavers are critical for maintaining the natural dam and banks of Peanut Lake. This has to do with the second potential mechanism of failure leading to a breach which is the failure of the dam and subsequent erosion caused by evacuation of the lake. Water continually flows over and through the dam from the lake to the river in multiple spots, including the two "close points." Should this flow ever become concentrated into a channel through the dam, it could easily erode the dam and cause a large breach in a very short order of time (days). By constantly surveilling the dam and patching small areas that concentrate flow, beavers are naturally wired to prevent this from occurring. Loss of beavers from the site, by disease or trapping or whatever means, would greatly increase the vulnerability of the lake.

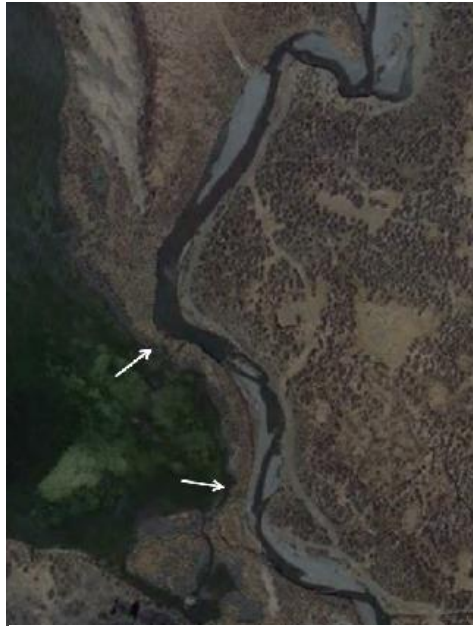
The Slate River runs right along the southeast end of Peanut Lake on this reach for about 700 feet, coming extremely close to the lake at two points. At the upstream "close point" the river is cutting into the Peanut Lake beaver dam and the river bank comes as close as 6 feet from the perimeter of the lake (Figure 7). At the lower point, the normal high water edge of the river is against the dam, and only 9 feet from the edge of water in the lake. Interestingly, historical aerials show that the river has been roughly in this position for at least 54 years.

***Figure 6: Slate River and Peanut Lake. The arrows indicate the two "close points".***

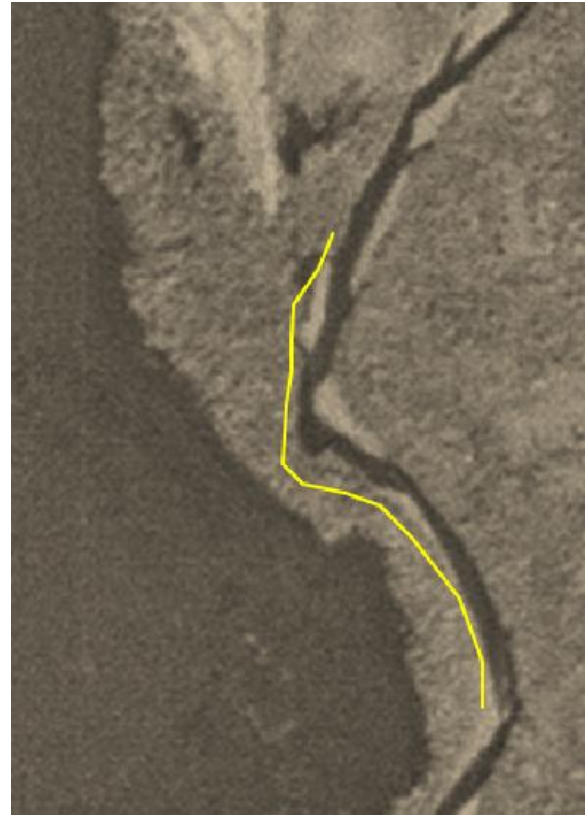
This channel position is evident in the oldest available aerials for the site from 1958 (Figure 8). In that time, the channel has moved about 30-40 feet closer to the lake, but it has not yet breached.

*Figure 8: 1958 aerial showing the relatively similar alignment of the Slate River relative to Peanut Lake. The yellow line is an overlay of the right bank position in 2012 showing that the river has migrated 30-40 feet closer to the lake in 54 years.*

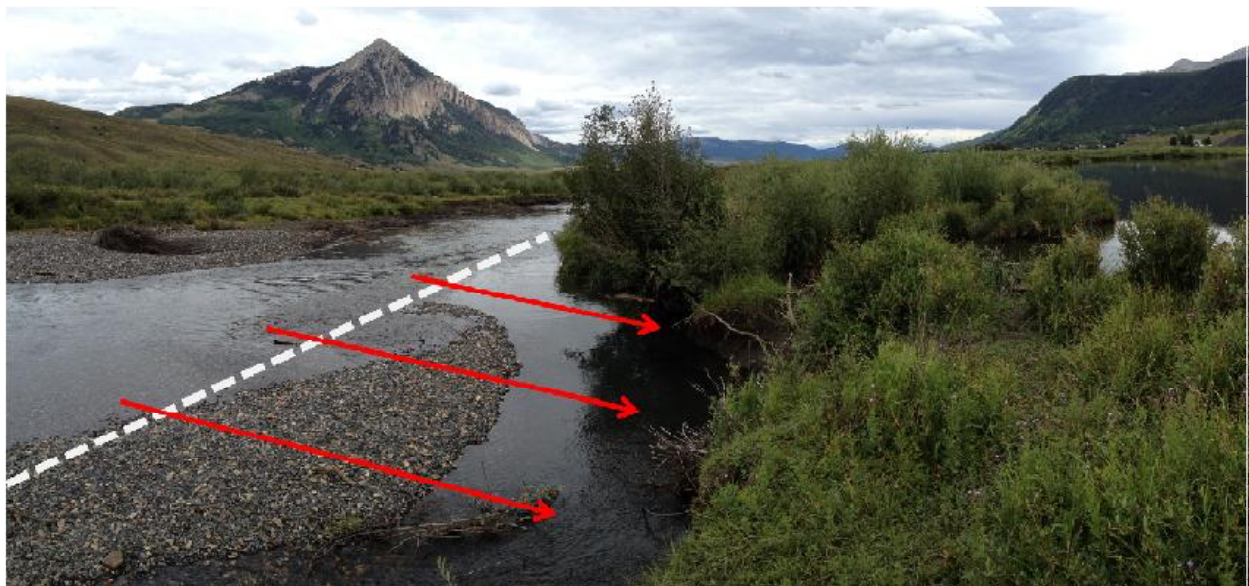
This situation is set up perfectly at the upstream "close point" where the river has migrated to the Peanut lake side of the bedrock ridge. The bedrock is forming a scour point that concentrates energy along the right bank which is already eroding into the dam (Figure 9). This condition is also clearly seen on XS surveys (see appendix 5).

**Figure 9: Concentrated energy along the back side of the bedrock ridge (dashed line) is increasing scour of the bed and banks on the right side of the channel causing accelerated migration towards Peanut Lake (right).**

The right bank will continue to erode to the west, towards Peanut Lake. The width of the land between the river and the lake at this point is only 6-10 feet, an amount that could easily be eroded in a single high flow event, especially if scour were increased further by the chance deposition of a log jam, debris jam, or failing beaver dam.

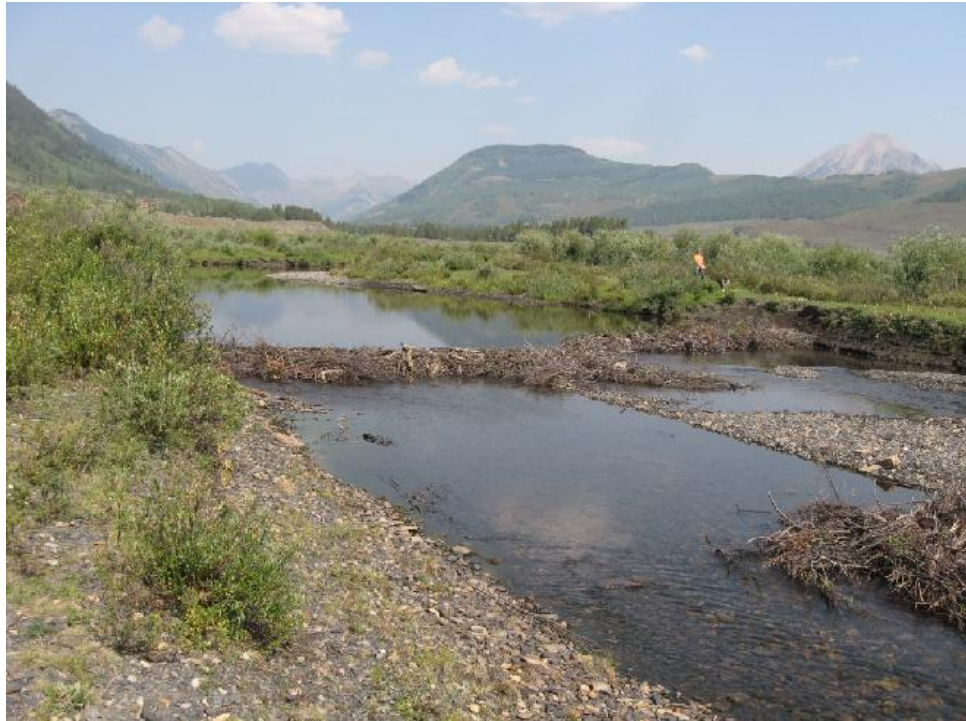
Finally, there is the issue of beaver dams in the river channel (Figure

10). Beavers routinely build dams on this section of the Slate, and these structures are critically important for maintaining many basic ecological functions. They also introduce another element of dynamicity or stochasticity to river geomorphology. These dams regularly get blown out during peak flows in the spring, and when this happens, near one bank or the other, there is often a great deal of bank erosion as the river works its way around the dam. These are perfectly natural processes that actually have value in the system. But it is also another factor to consider in assessing the likelihood of a Peanut Lake breach since it is a mechanism for rapid bank erosion. An ideal solution for protecting Peanut Lake would allow for these natural processes to continue to occur.

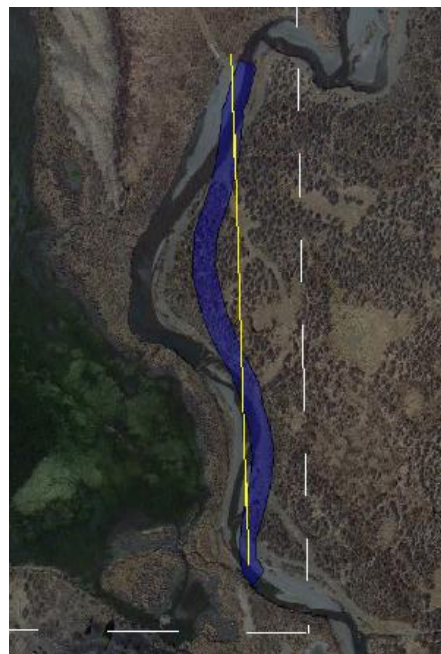
**Figure 12: Valley length is used to calculate functional units for stream habitat, shown as the yellow line which measures 1300 ft.**

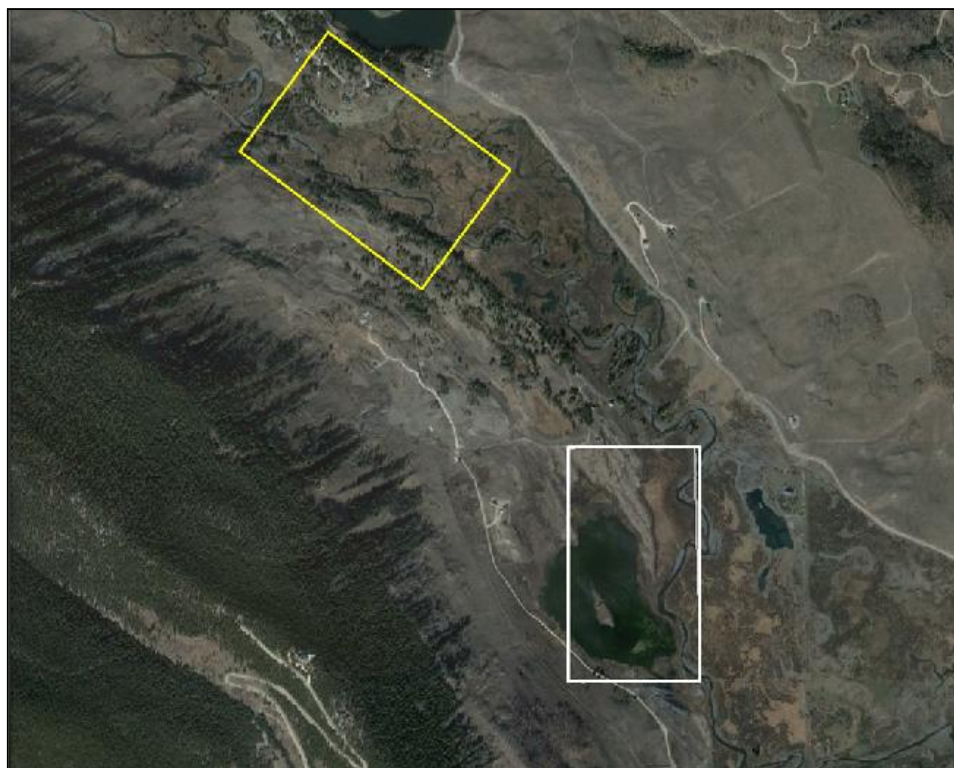
**Figure A1-1**  
**Aerial photo**  
**showing the**  
**location of the**  
**reference reach**  
**(yellow**  
**rectangle)**  
**relative to the**  
**peanut Lake**  
**reach (yellow**  
**rectangle)**  
**and the Wildbird**  
**Bridge (white**  
**arrow).**

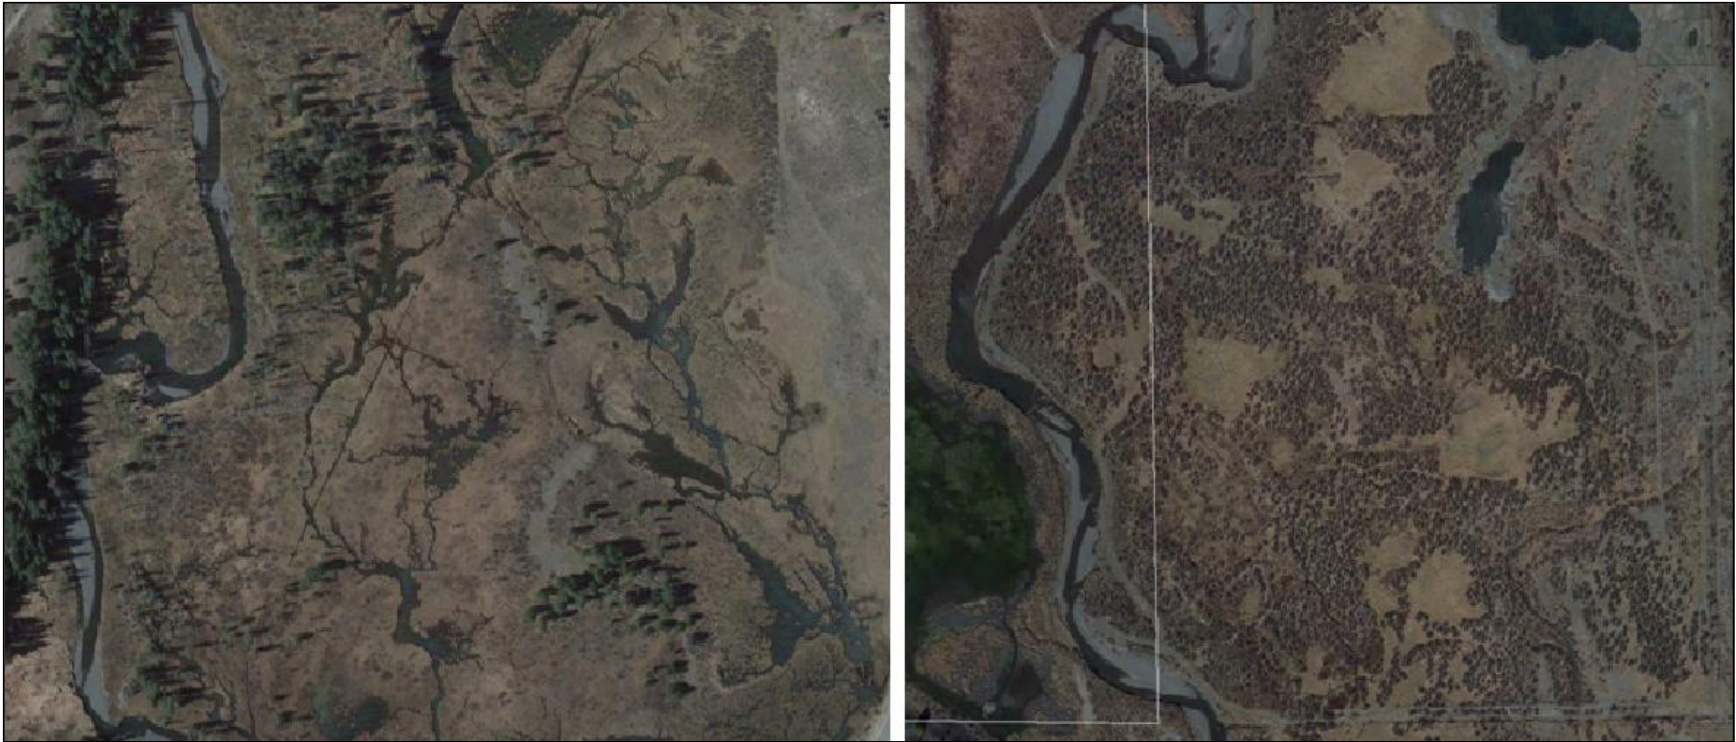
*Figure A1-2: Closer views of the reference reach (left) and Peanut Lake Reach (right) show the very different condition of floodplain wetlands. As Cooper described in his 1993 report, the floodplains wetlands differ markedly upstream and downstream of the Wildbird Bridge. At the reference reach, the distributary channel network is still very much intact with hydrology supplied by overbank flows and groundwater. Floodplain conditions are much dryer on the project reach, with a disconnected distributary network, owing largely to the berm. The geometry of the primary channel is remarkably similar between the reference and project reaches.*

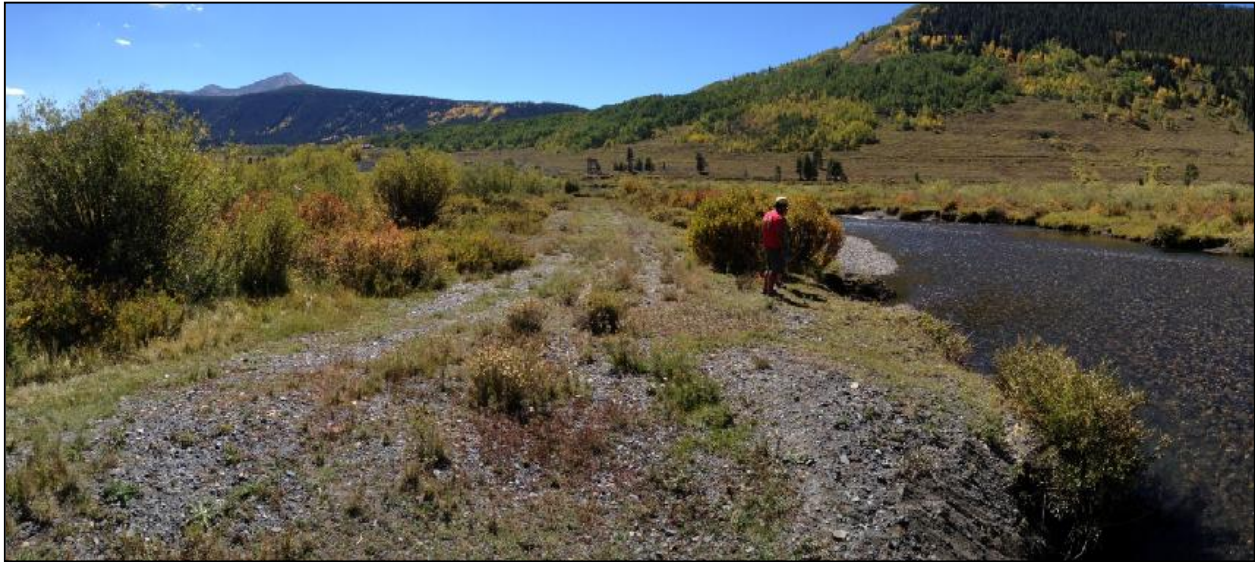
to grassy pastureland the way the Slate has. Nevertheless, the valley does contain some acute areas of vegetation impact, and unfortunately one of those areas is focused along the left bank of the Peanut Lake Reach where a 20-ft wide berm and road were constructed alongside the river. The elevation of the berm is high enough above the river and the surrounding water table, that hydrophytic plants have not established. The nature of the fill material (mostly compacted fine gravel) is also not conducive to plant growth. As a result, the vegetation on the berm is sparse and mostly xeric. (Figure A2-1)

***Figure A2-1: The berm is constructed mostly of compacted gravel and is about 1.5-2.5 higher than surrounding floodplain area, making it difficult or impossible for riparian vegetation to establish. As a result, the vegetation on the berm is sparse and mostly xeric. Vegetation to the right of the berm and on the other side of the river is more typical of a healthy riparian area.***

The berm also has the effect of limiting water transport from the river to the adjacent floodplain. The dryer conditions on the back side of the berm is causing a subtle shift in species composition and plant condition in this area which became evident during the wetland delineation. There is a distinct gradation of plant types as one goes from the greater floodplain to the areas near the berm reflecting the dryer and more disturbed conditions there.

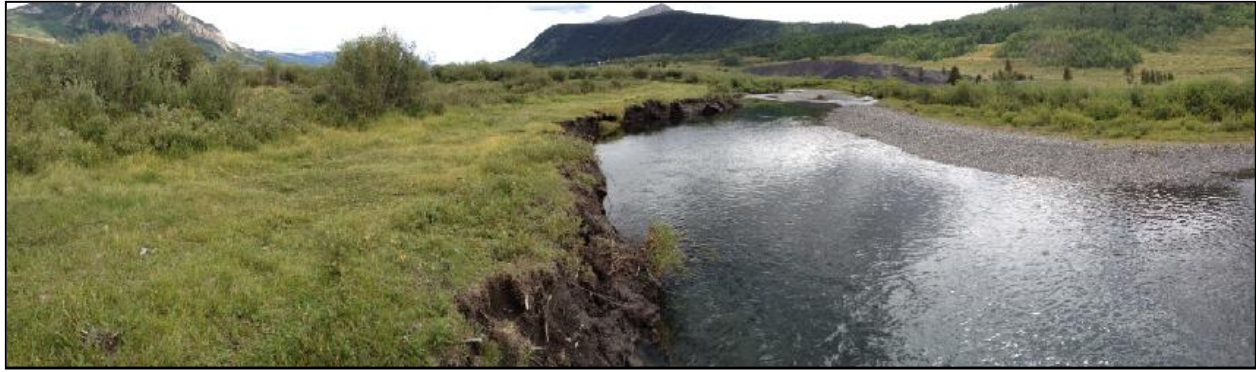
**Figure A2-2: Bank erosion is accelerated along the left bank due to increased bank height and poor vegetation caused by the berm.**
