## 2009 Rio Grande Riparian Stabilization Project – Phase 4

Final Report prepared for CWCB - December 2014

### **Project Title: 2009 Rio Grande Riparian Stabilization Project – Phase 4**

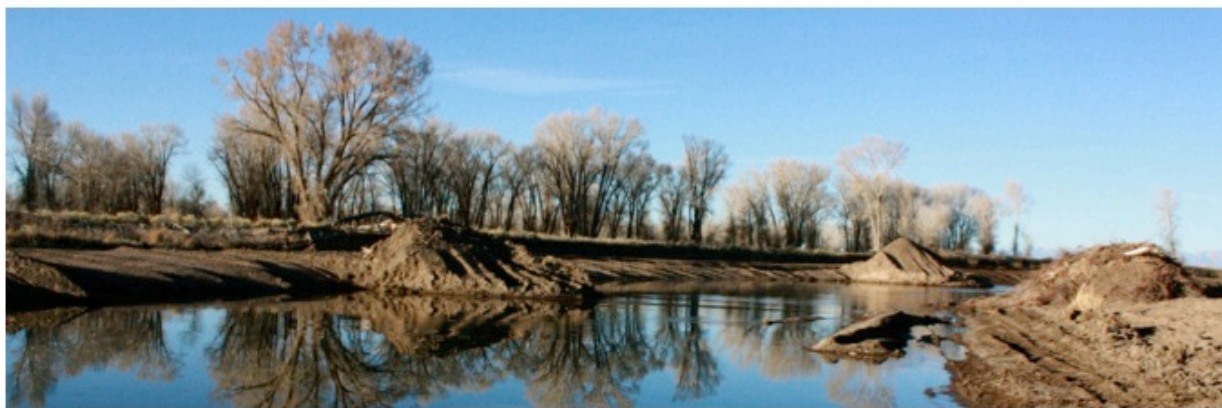
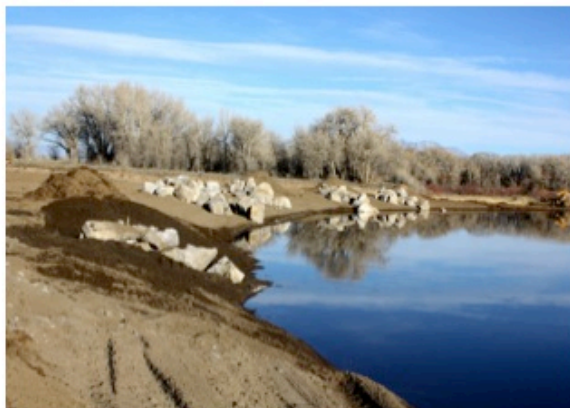
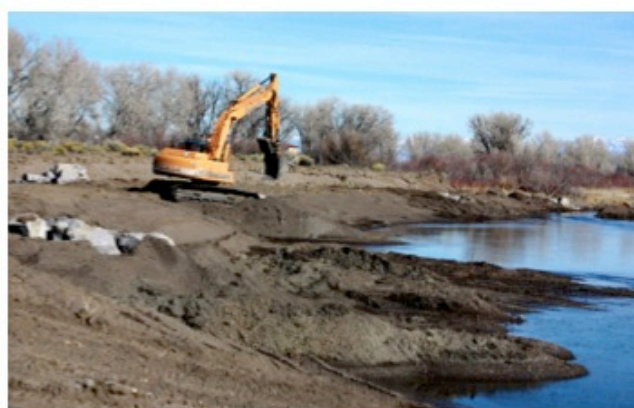
Figure 4. Streambank Stabilization Techniques.

*Shaping Streambanks and Piling Topsoil to Spread on Finished Benches and Streambanks.*

*Rock Barb Installation.*

*Rock Barb Installation and Topsoiling.*

Completed Task 1 Activities – Streambank Stabilization: The RGHRP hired third party engineering firm, Riverbend Engineering, and restoration contractors, Robins Construction, to design and implement streambank stabilization methods on 1.75 miles of riparian area. The methods utilized included sloping and shaping banks, building floodplain benches, reconfiguring the channel to move the thalweg away from the bank, and installing rock barbs to move water away from and stabilize the streambanks. Based on erosion rates calculated in the 2001 Study, the estimated reduction in sediment loading from these efforts is 16,120 cubic feet per year. These efforts resulted in improved water quality, reduced erosion, increased sediment transport capacity, increased quality of riparian areas and habitat, and proper functioning floodplains.

Streambank Stabilization was completed on 1.75 miles of riparian areas on 5 privately owned sites. The methods utilized included sloping and shaping banks, building floodplain benches, reconfiguring the channel to move the thalweg away from the bank, and installing rock barbs and root wads to move water away from and stabilize the streambanks. Based on erosion rates calculated in the 2001 Study, the estimated reduction in sediment loading from these efforts is 16,120 cubic feet per year.

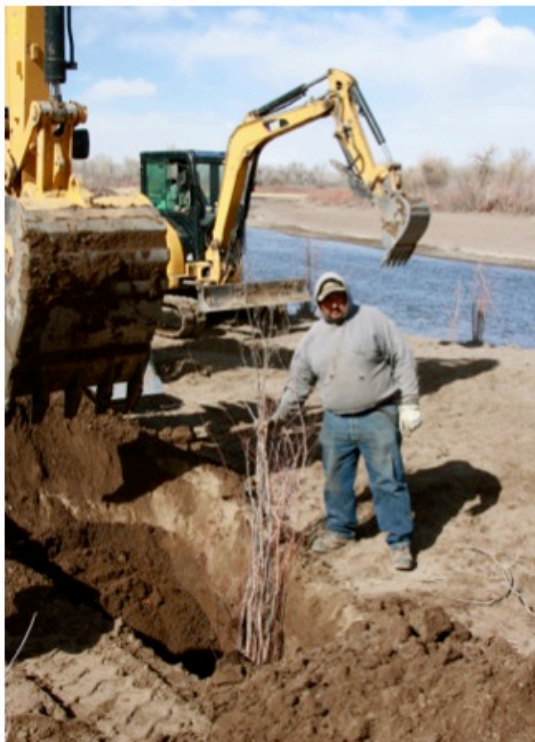
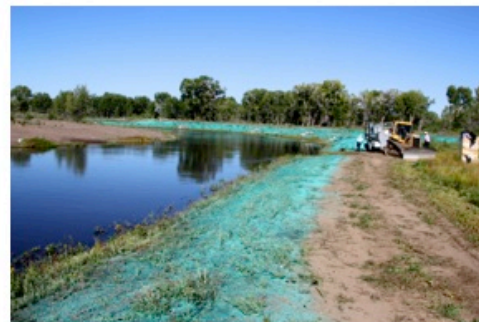
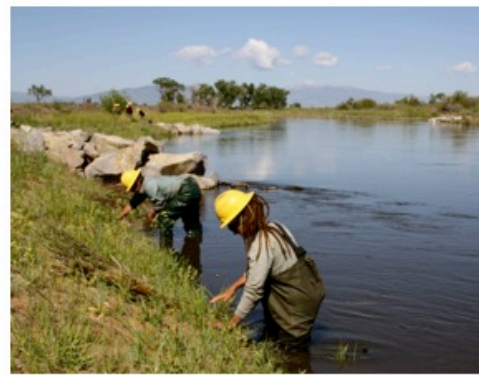
**Figure 5. Bioengineering Methods.**

*Robins Construction Planting Willow Clumps.*

*Applying Hydromulch.*

*Southwest Conservation Corps Planting Willow Bundles.*

Completed Task 2 Activities – Bioengineering: The RGHRP hired Riverbend Engineering and Robins Construction to design and implement bioengineering techniques in order to further stabilize the streambanks following construction in Task 1. Techniques used in the riparian areas included, mechanically planting 830 willow clumps and reseeding 11 acres of riparian areas with grasses and forbs through hydromulching. Upland areas disturbed during onsite activities were reseeded with appropriate species through drill seeding. The RGHRP organized 2 volunteer revegetation events: in August 2013, 7 volunteers from the community and the Southwest Conservation Corps trimmed willow clumps to increase vigor. In October 2013, 9 volunteers trimmed remaining willow clumps. In June 2014, a crew of 8 young adults planted 1,050 willow bundles in the project area.

Bioengineering techniques were implemented on 11 acres of riparian areas in order to further stabilize the streambanks and improve riparian habitat. Techniques used in the riparian areas included stockpiling and spreading topsoil, willow clump plantings, and grass and forb seeding through hydromulching. The decision to stockpile and spread topsoil was derived from a lesson learned in Phase 3. This action greatly increased organic matter and willow propagules. Additionally, the Technical Advisory Team recommended hydroseeding to further increase organic matter and seed coverage. Upland areas disturbed during onsite activities were reseeded with appropriate species by drill seeding. Additional upland areas were treated for a severe Russian knapweed infestation. As such, a total of 80 upland areas were reseeded.

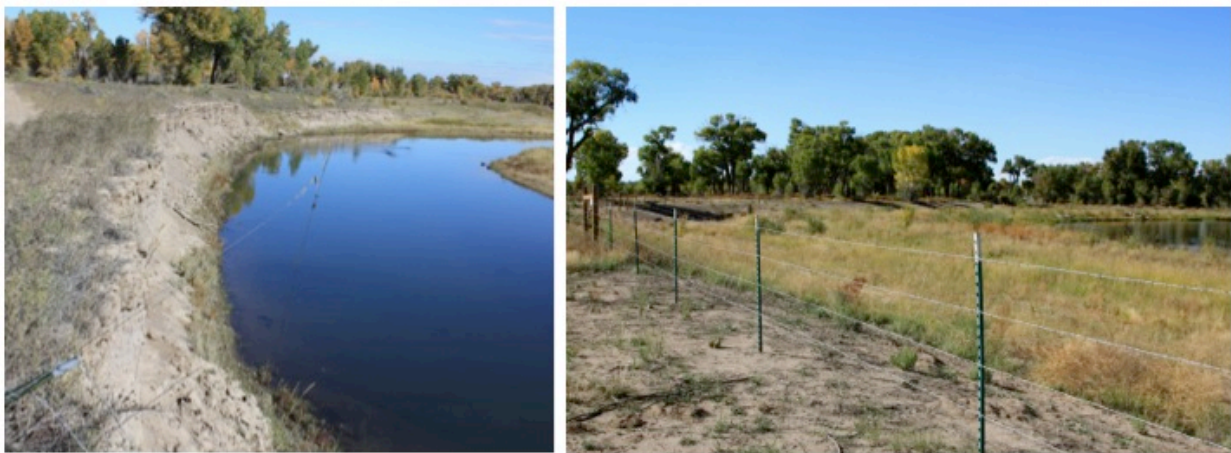
Figure 6. Grazing Best Management Practice, Fencing, Implemented at Site 5.

*Before: Fence Hanging in River.*

*After: Completed Riparian Fencing.*

Completed Task 3 Activities – Grazing Management: Riparian fencing was completed on all project sites. Only one of the owners currently graze livestock on their property. Fencing will help protect the riparian areas from overgrazing while vegetation becomes established. Because the potential for grazing in the future exists, the other riparian areas were also protected from overuse through fencing. Furthermore, two of five sites receive use from public recreators as the landowner allows public access. As such, the fencing will protect riparian areas from overuse by walkers, runners, and ATV users.

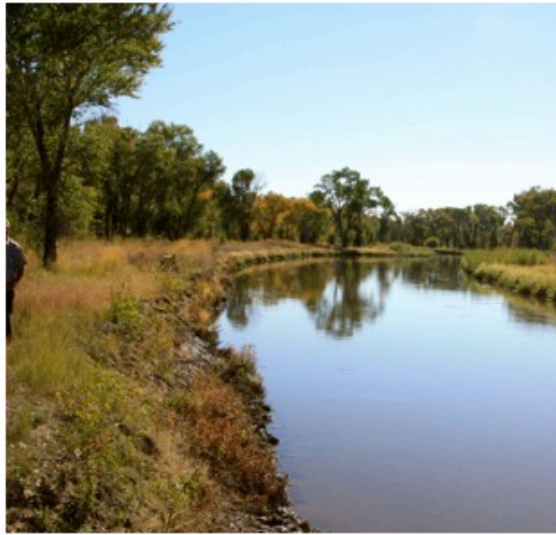
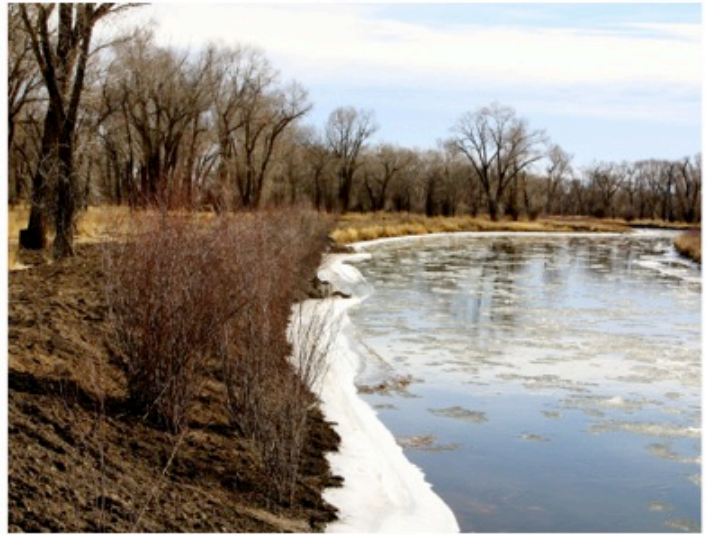
Figure 10. Site 1 (Upper) Photos Before and After Construction.

Before - October 2014

After - December 2014

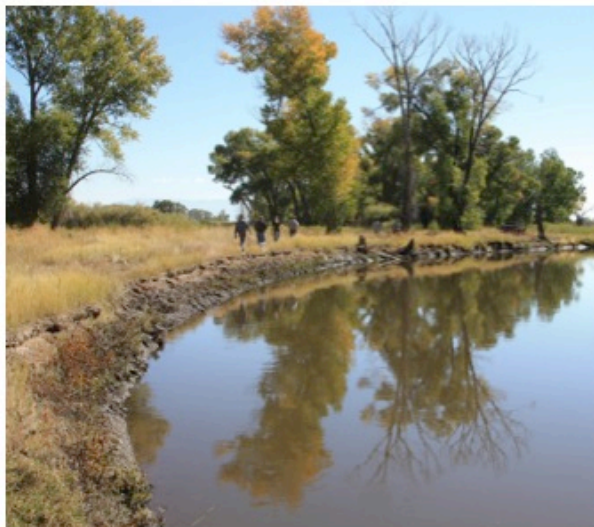
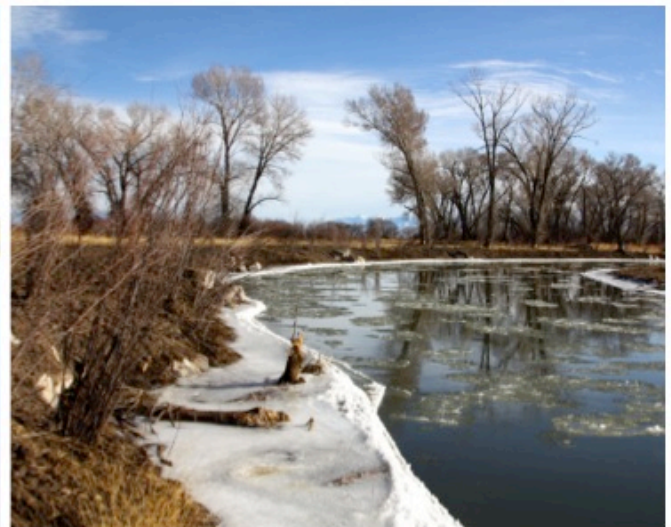
Figure 11. Site 1 (Lower) Photos Before and After Construction.

Before - October 2014

After - December 2014

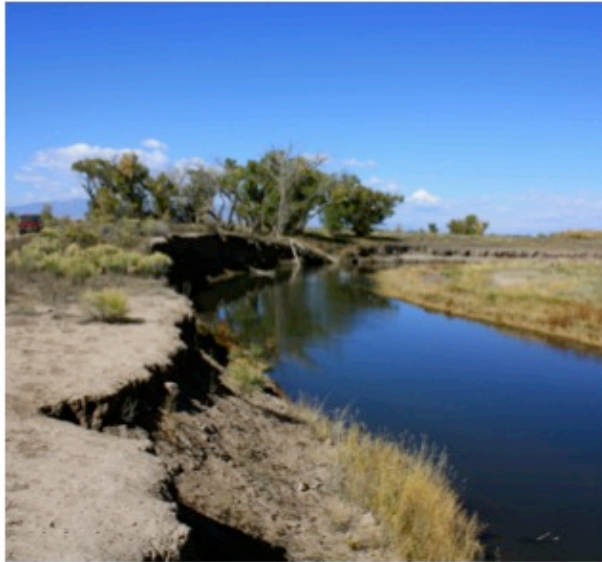
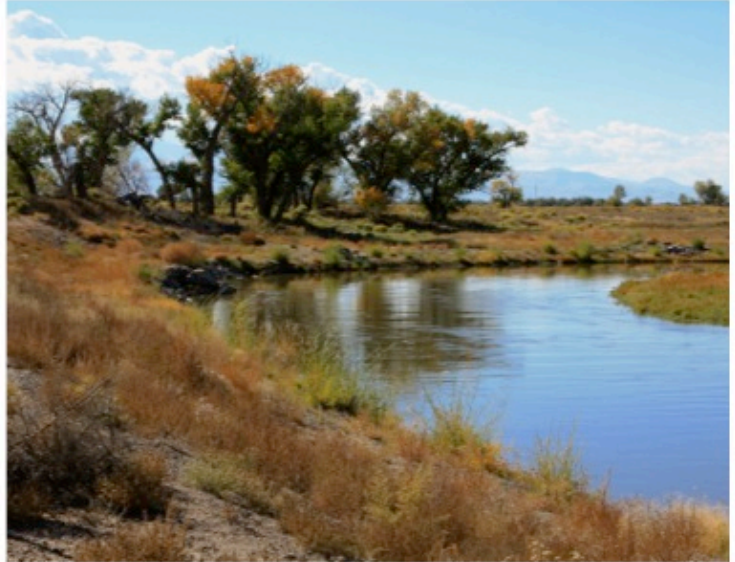
Figure 14. Site 2 (Upper) Photos Before and After Construction.

Before - October 2012

After - October 2014

Monitoring showed an area of scour within Site 2 approximately one year after project completion. The Project engineer, contractor, and RGHRP reviewed the problem and determined a rock barb was installed such that it pushed the flow upstream, forming an erosive eddy. The contractor hauled additional rock and rebuilt the poorly functioning barb, adding more rock to the footer and toe of the slope. The fix appears to be holding and will be monitored annually.

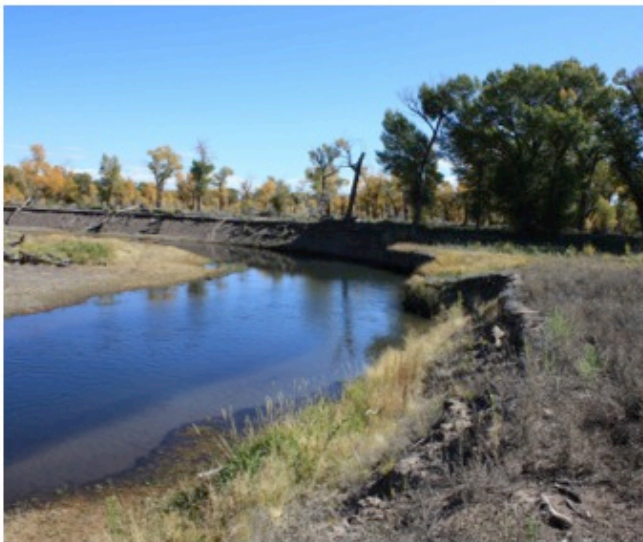
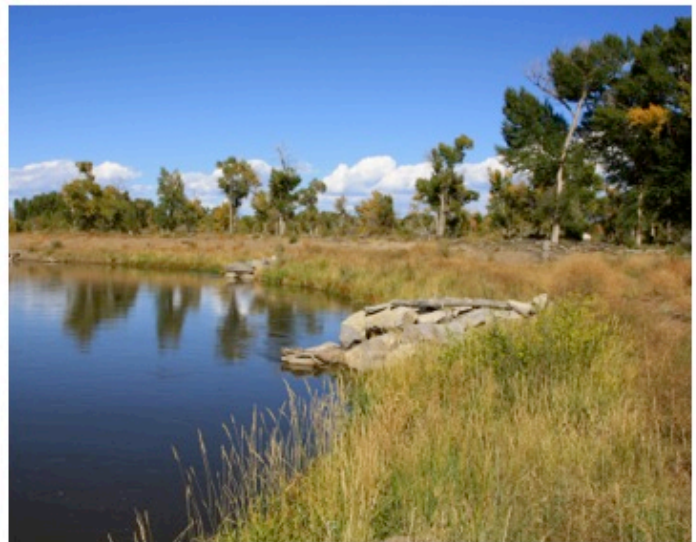
Figure 15. Site 2 (Lower) Photos Before and After Construction.

Before - October 2012

After - October 2014

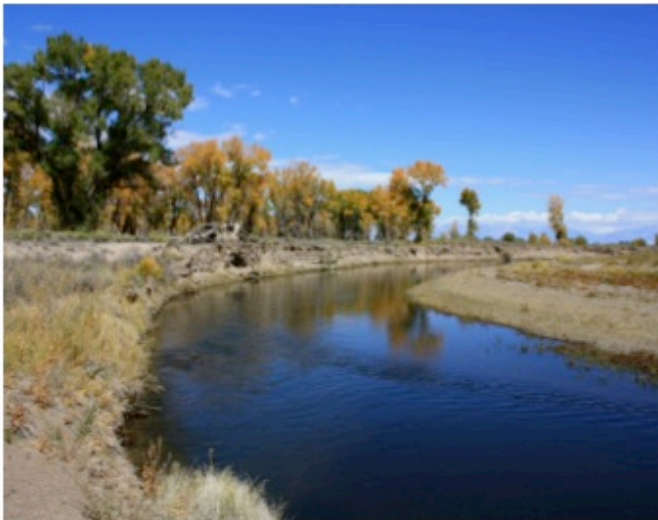
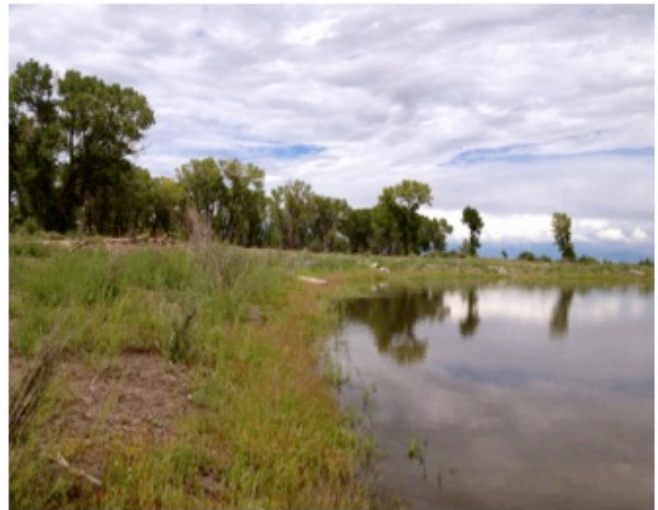
Figure 18. Site 3 Photos Before and After Construction.

Before - October 2012

After - August 2013

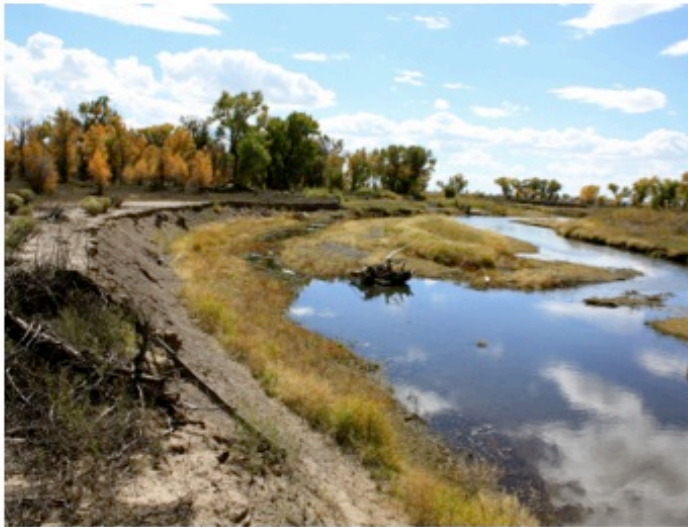
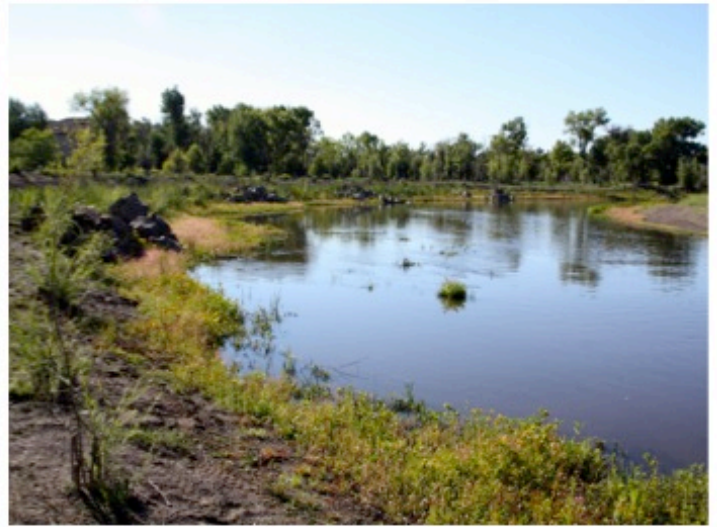
Figure 21. Site 4 Photos Before and After Construction.

Before - October 2012

After - August 2013

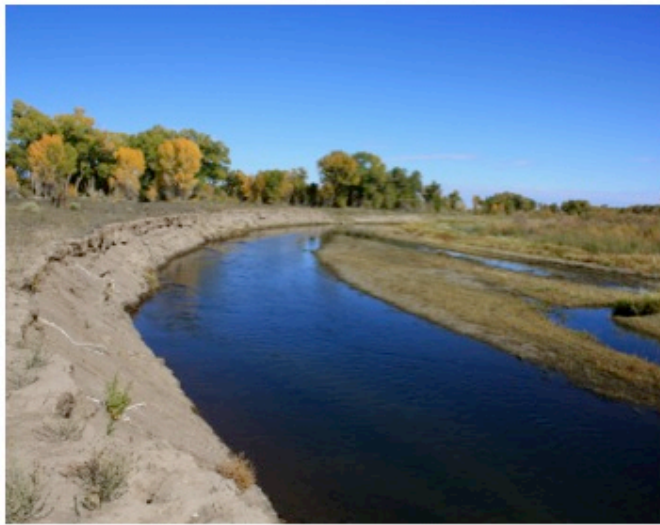
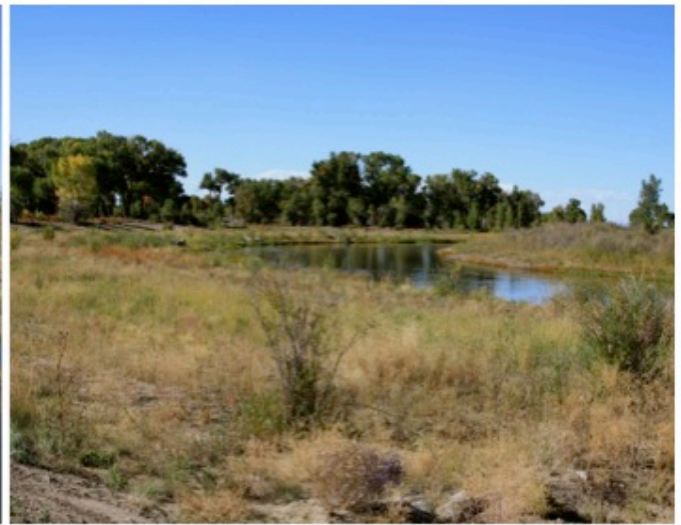
Figure 24. Site 5 Photos Before and After Construction.

Before - October 2012

After - October 2014
