Mancos River Habitat and Diversion Project – Phase 2
Final Report
Mancos Conservation District
March 2, 2013

Colorado Water Conservation Board (CWCB) Contract C150511

Mancos River Habitat and Diversion Project – Phase II

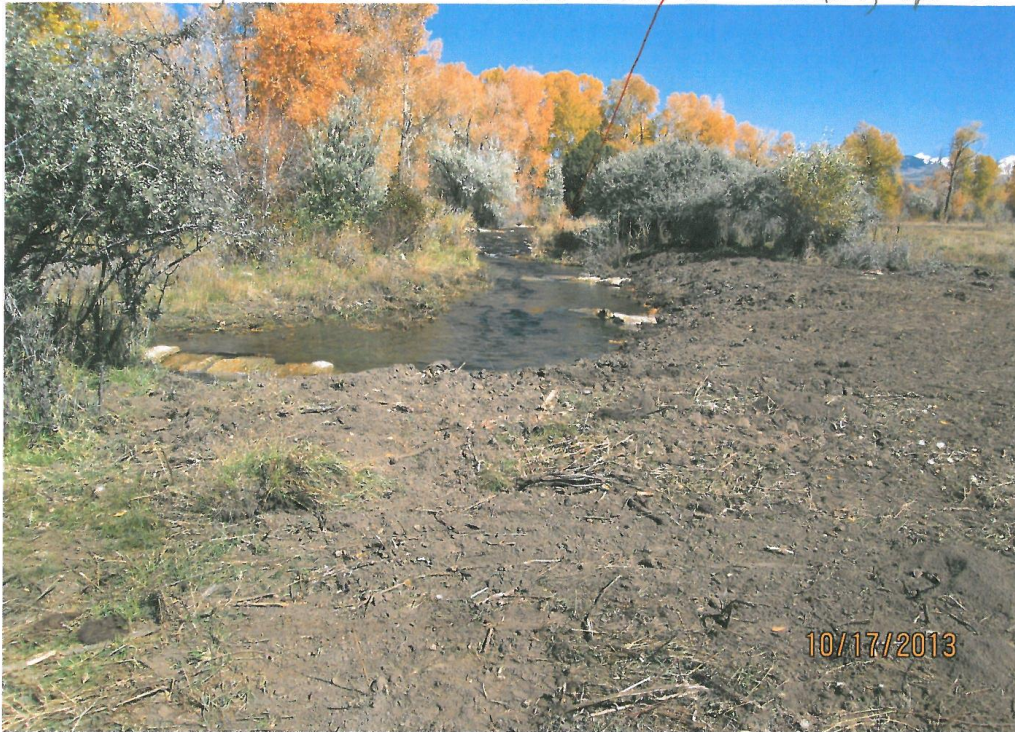
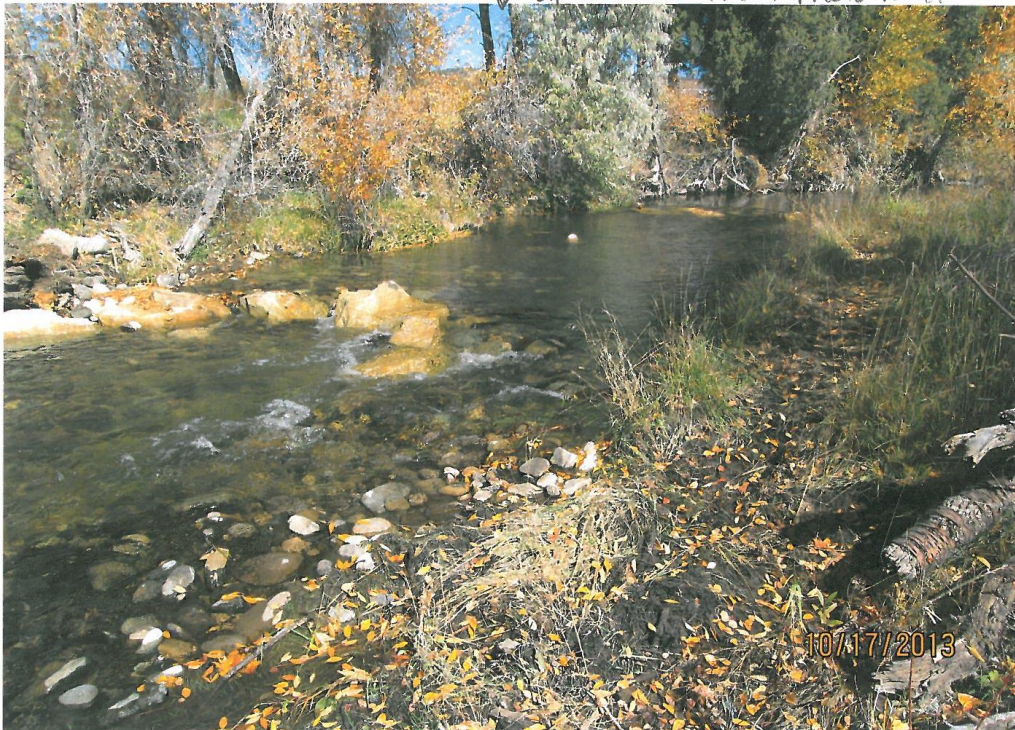
Photos 3 and 4

Photo Point 1

Looking upstream towards

Re-slope
bank

↑ upstream from Photo Point 1

In 2013, NRCS/MCD technician Russell Klatt completed a GPS survey of the project and in September 2013, the design drawings for the habitat improvement portion of the project. The project obtained the required Army Corps permit (SPK-2013-00217-DC) for the designed habitat improvements. These improvements were installed in October and November 2013. They included installation of j-hooks, bank barbs, willow cuttings, weirs, rock clusters and log complexes, along a total of approximately 6500 feet of the Mancos River across five different properties within the South Town to Exon project reach. The NRCS certified “Habitat Restoration Design” with photo points mapped is attached below. Photos 3 thru 22 document these habitat improvements.

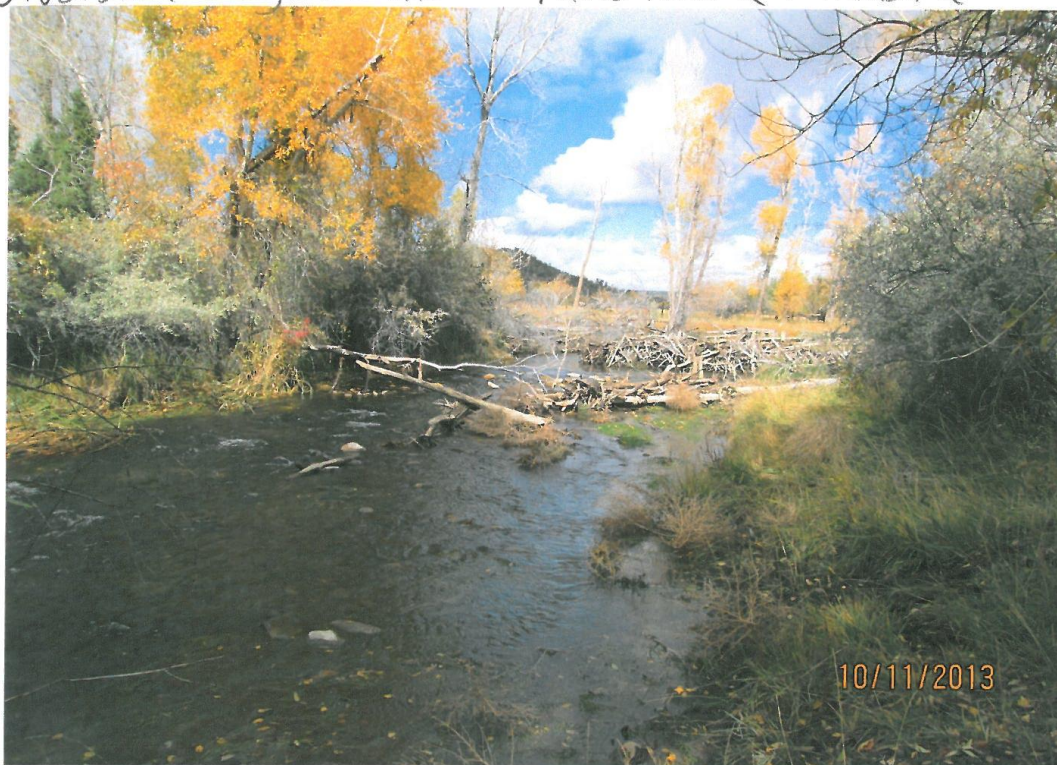
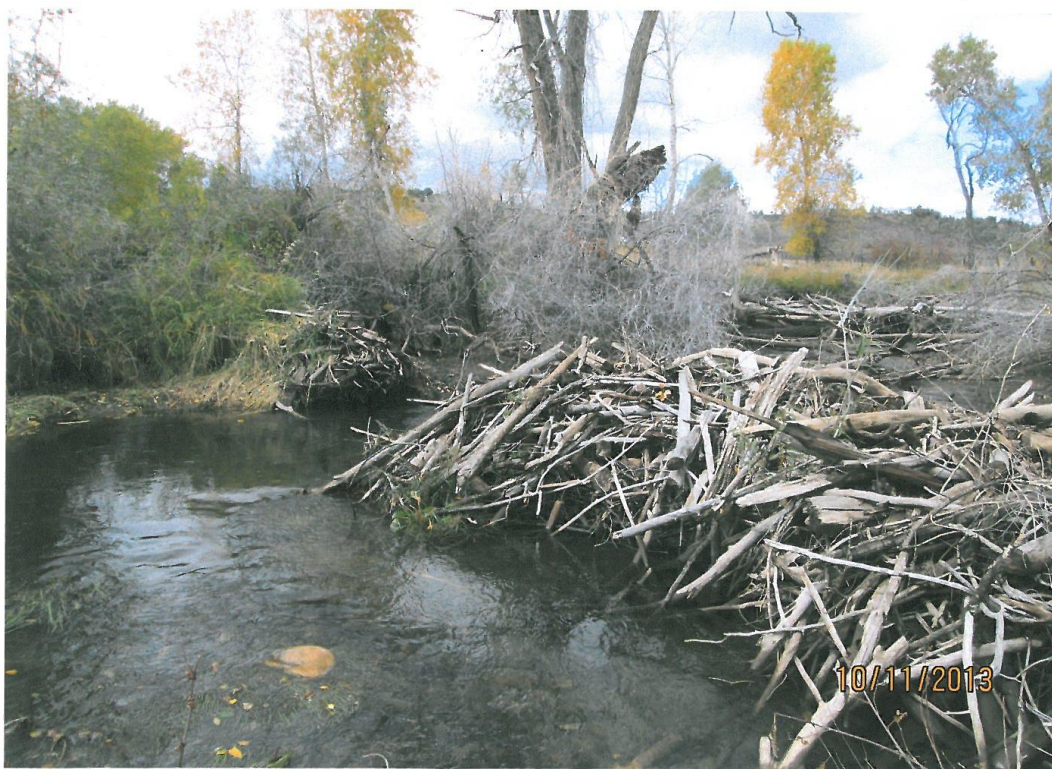
Photos 5 and 6

Photo Point 2 - Reach 2

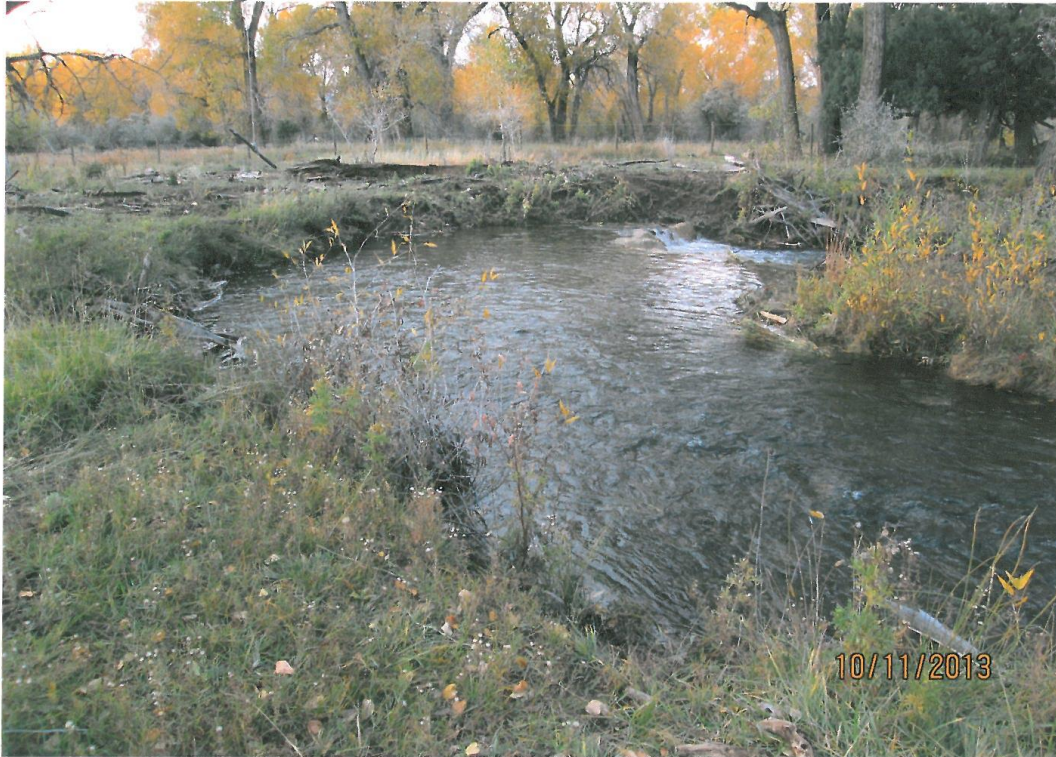
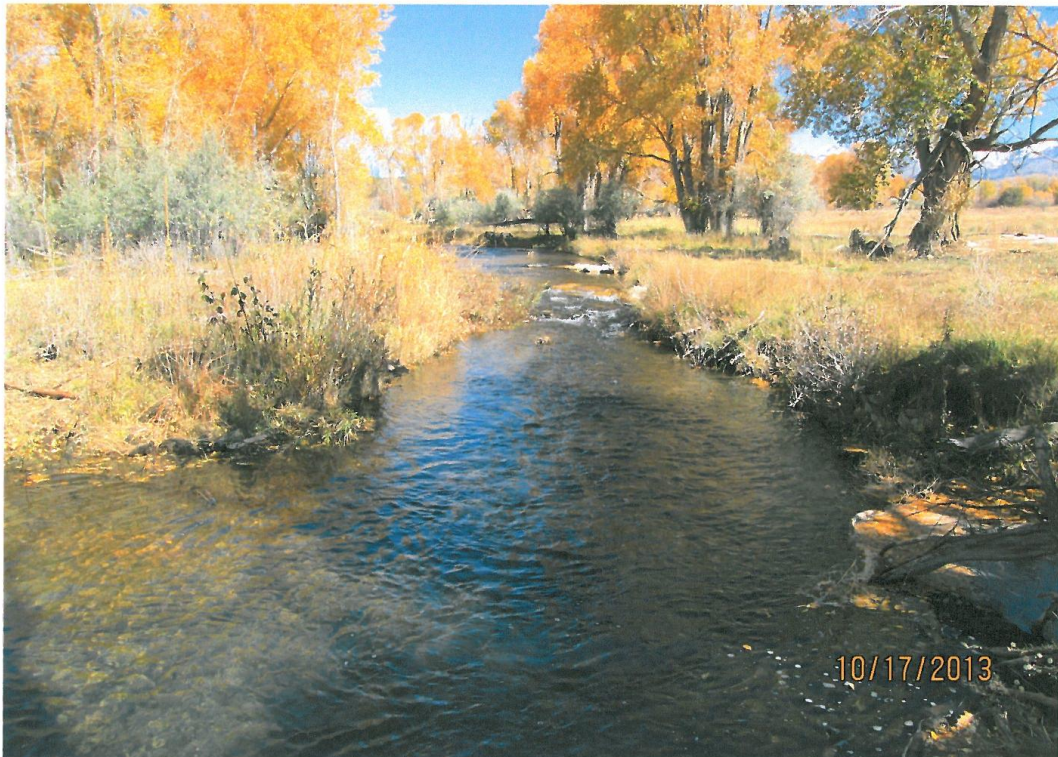
Photos 7 and 8

Photo Point 3- Reach 2

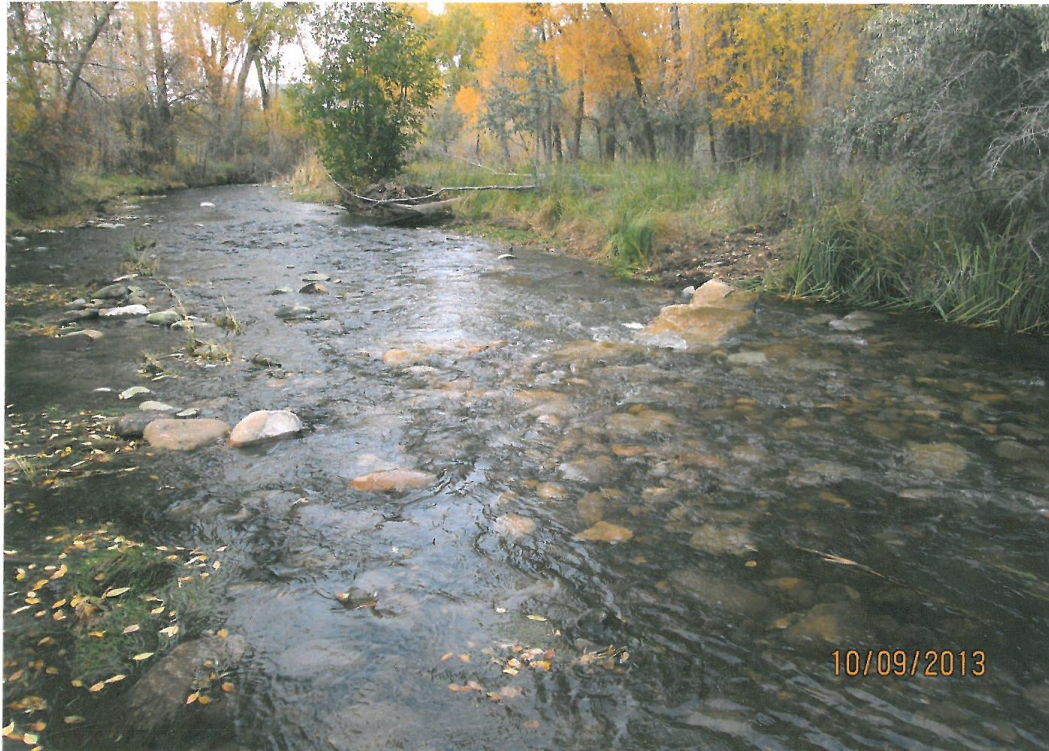
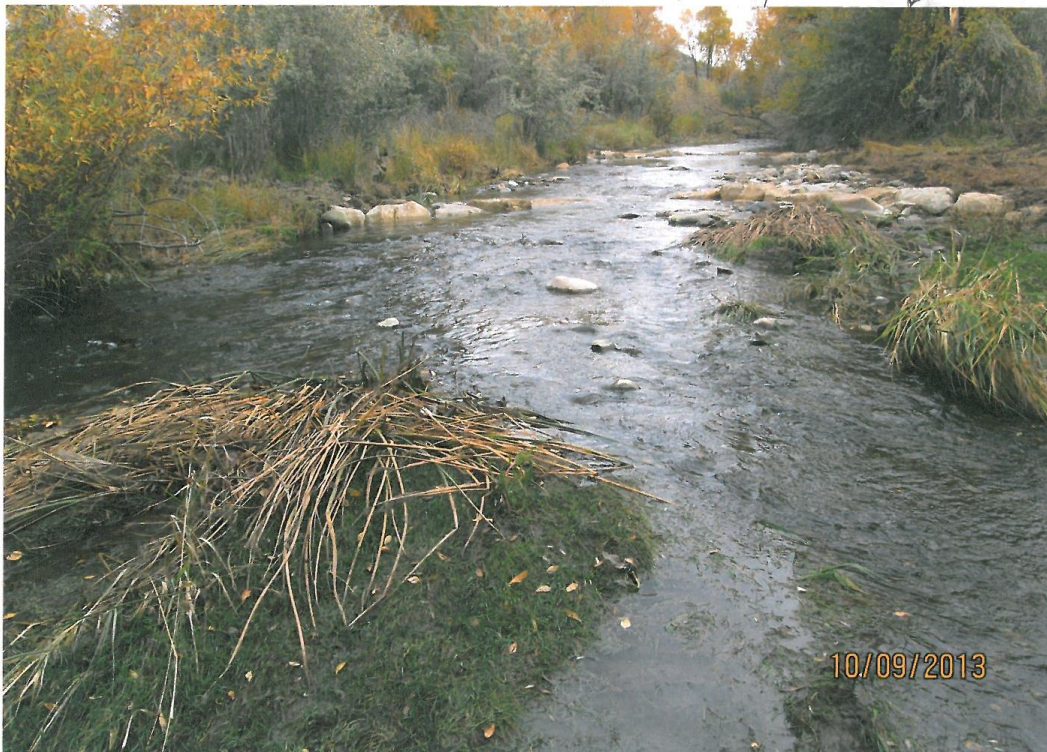
Photos 9 and 10

photo Point 4 - Reach 3

downstream ↙ upstream ↗

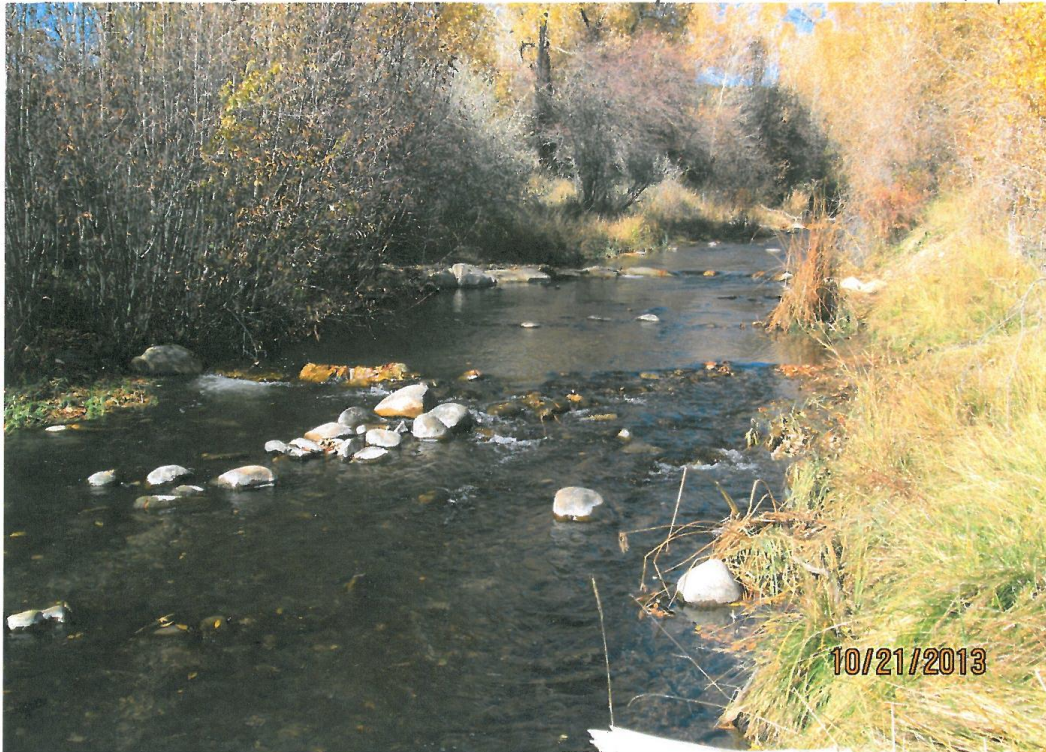
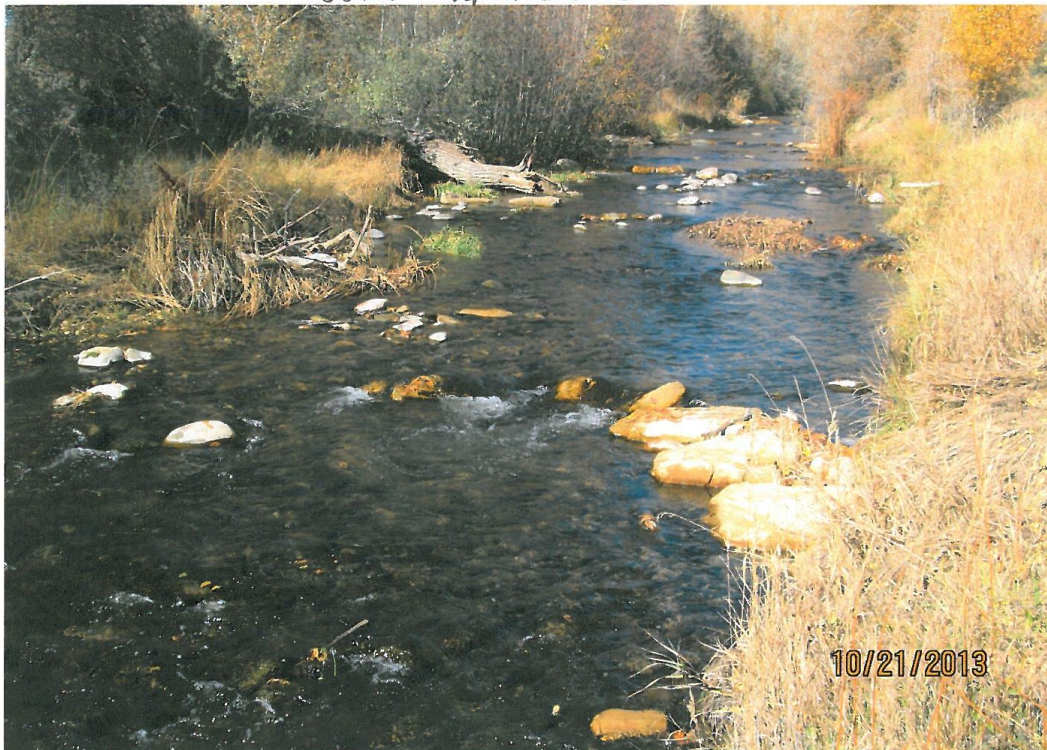
Photos 11 and 12

photo point 5 - Reach 4

both - upstream

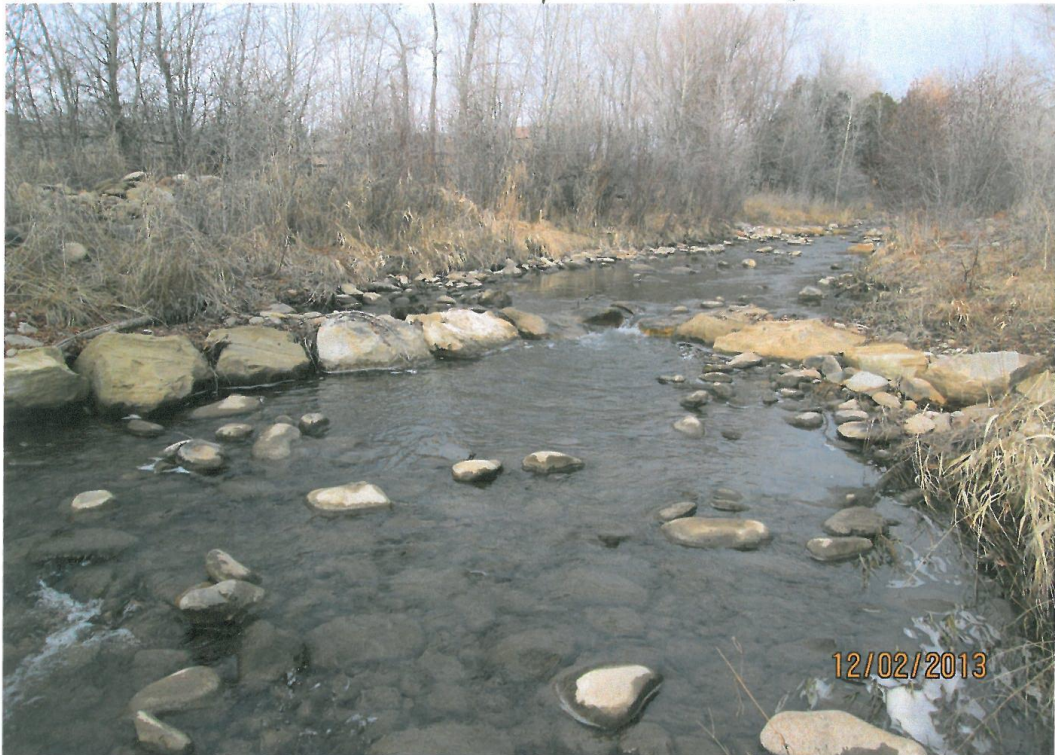
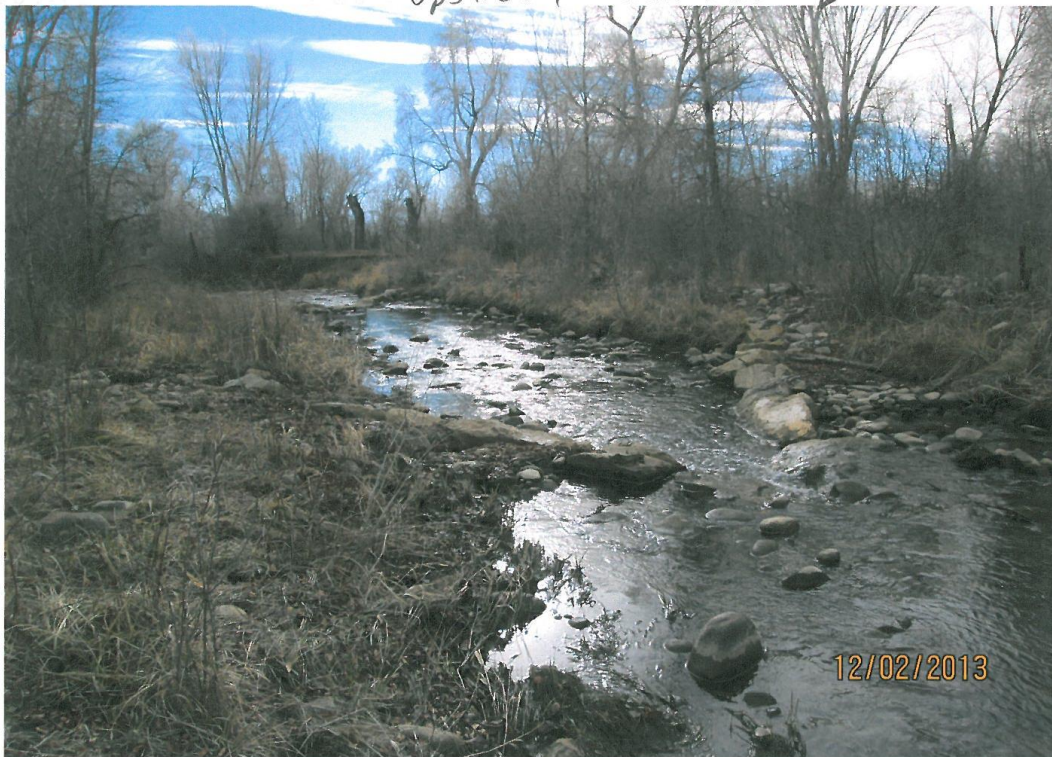
Photos 13 and 14

Photo Point 6

Reach 5

Upstream downstream

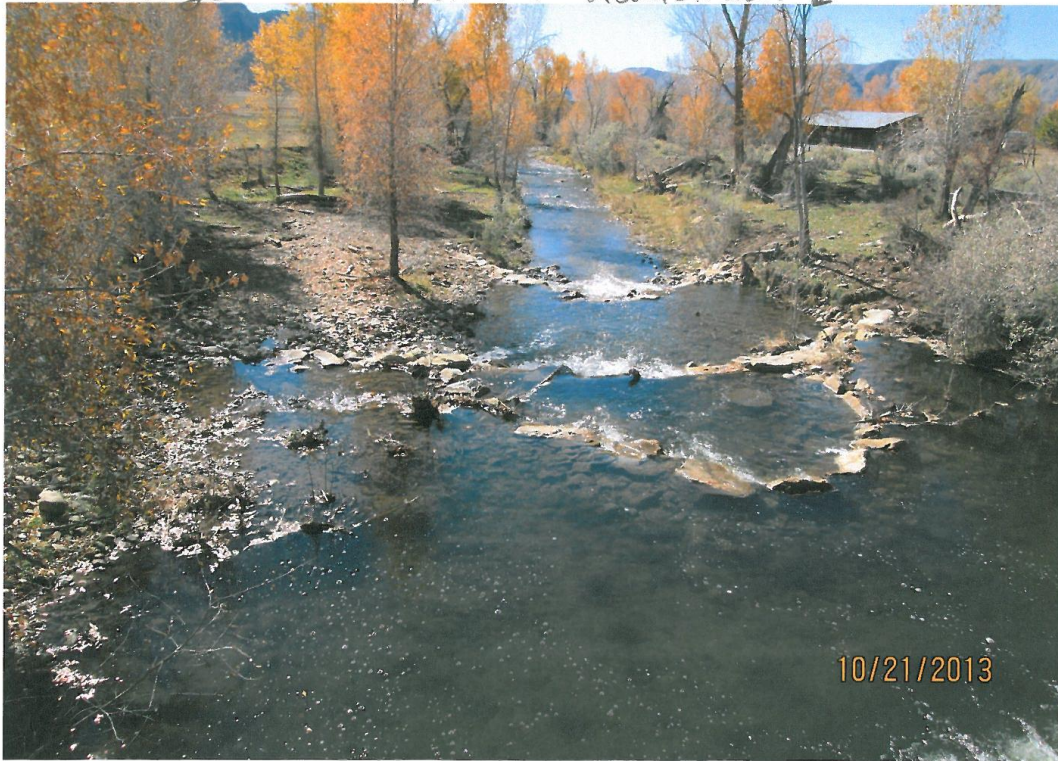
Photos 15 and 16

Photo Point 7 Reach 6, 7

Road J Bridge

↑ upstream ↓ downstream

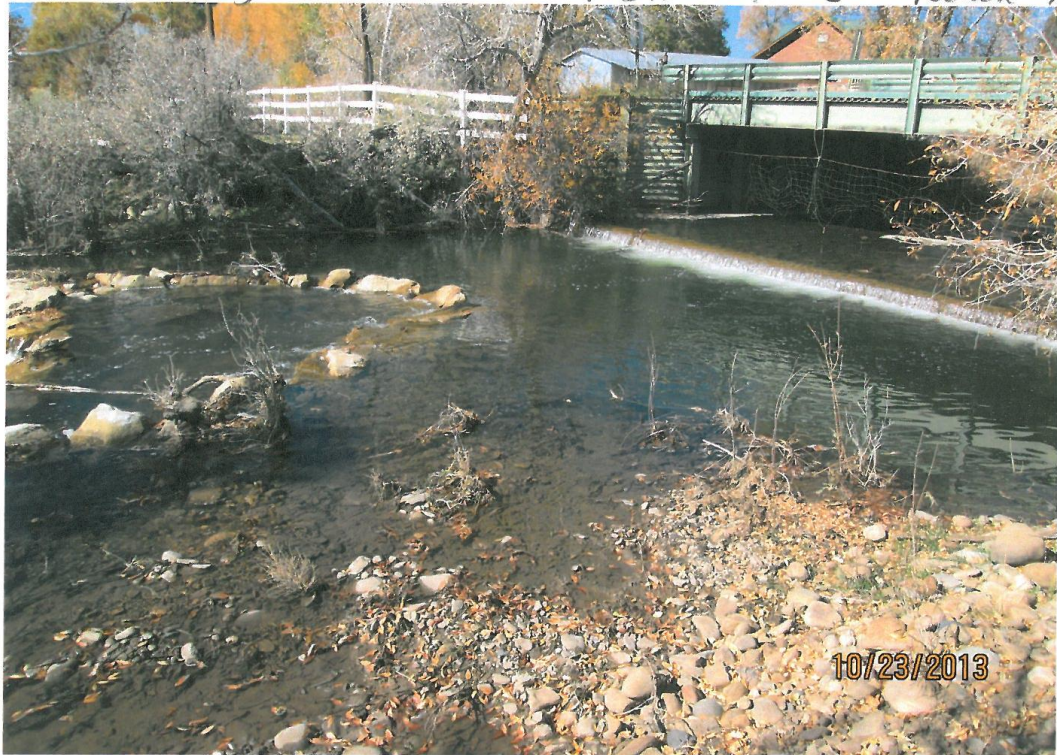
Photos 17 and 18

Photo Point 8 Reach 7

6 inch waterfall

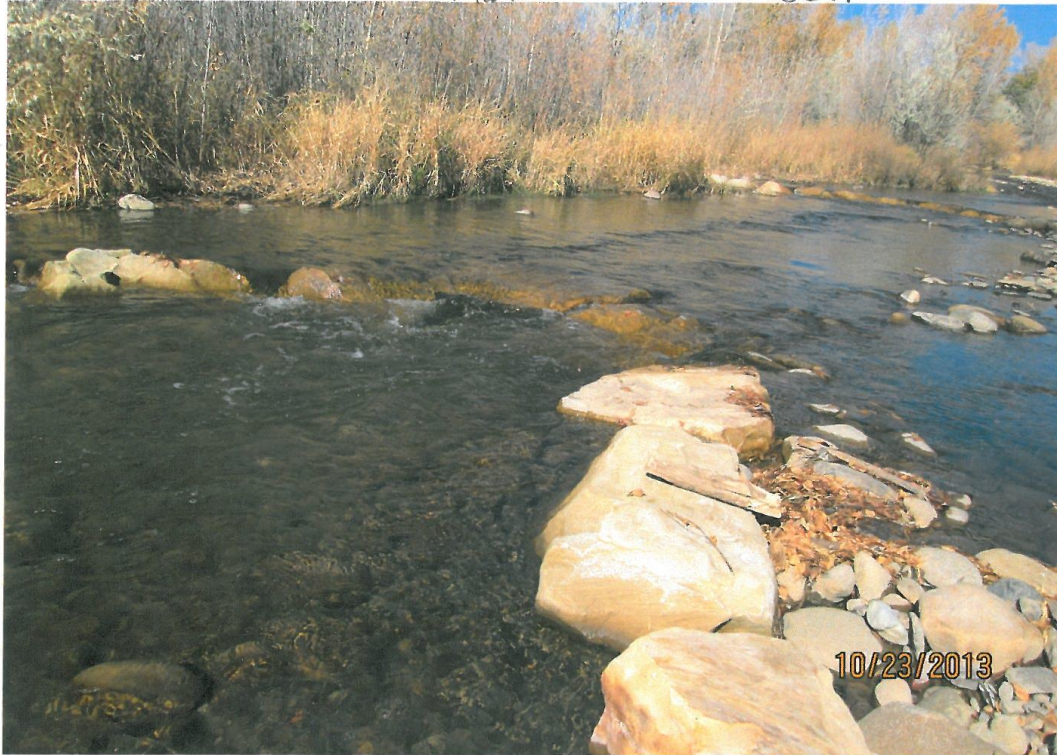
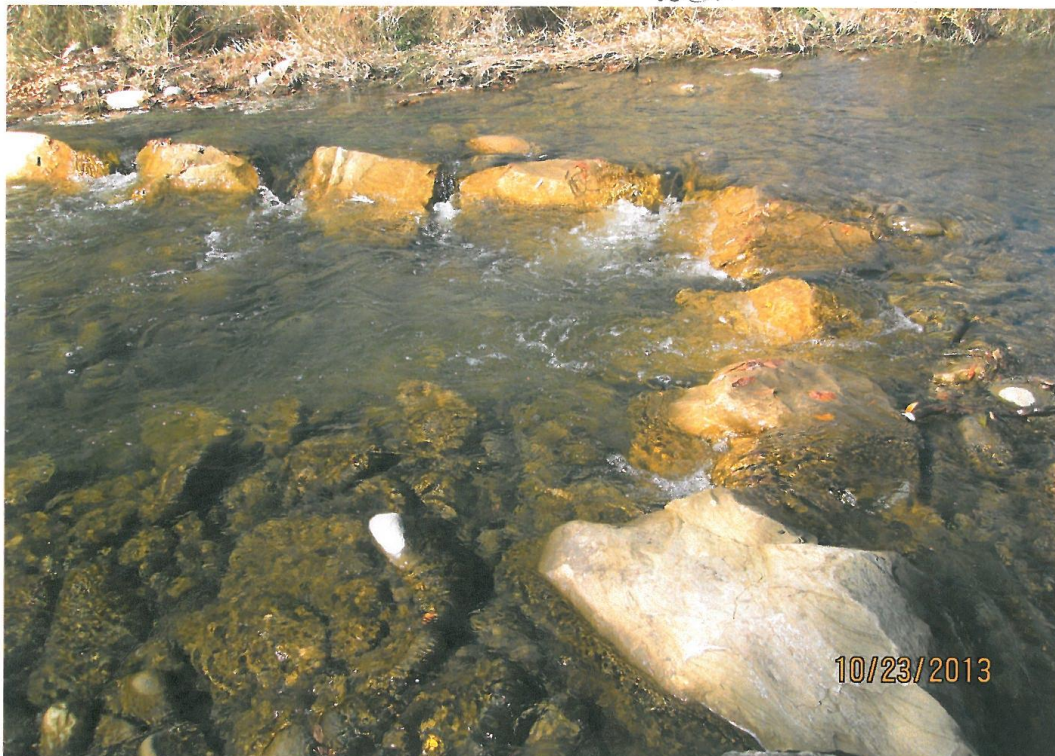
Photos 19 and 20

Diversion Project II Mancos River weir

weir

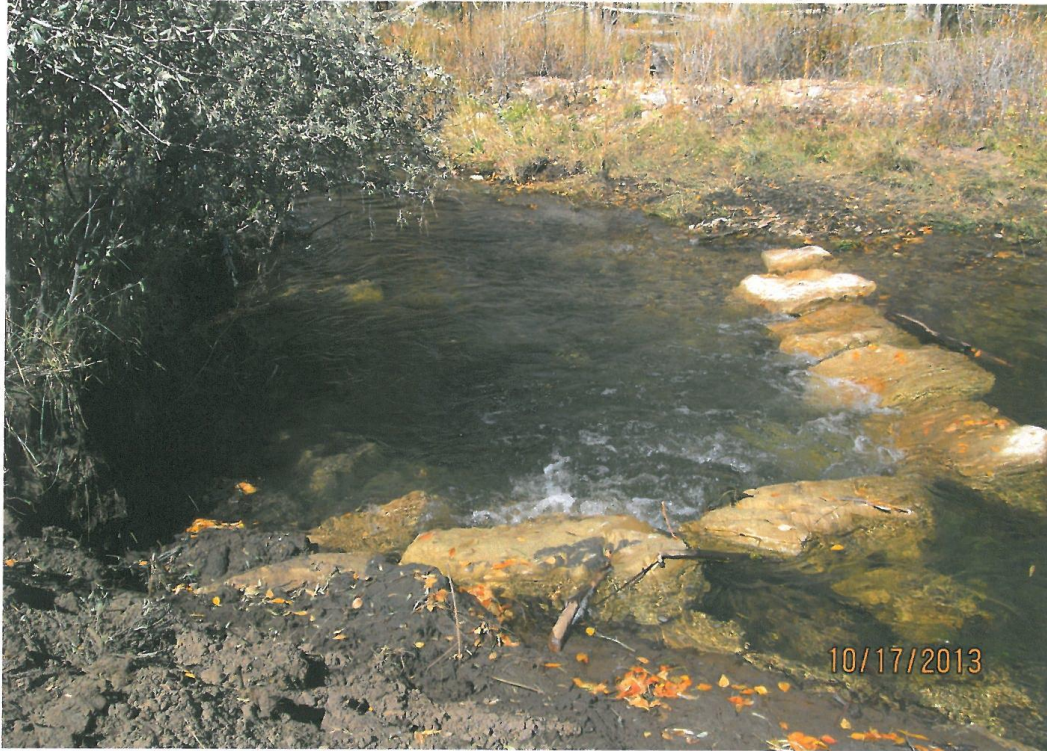
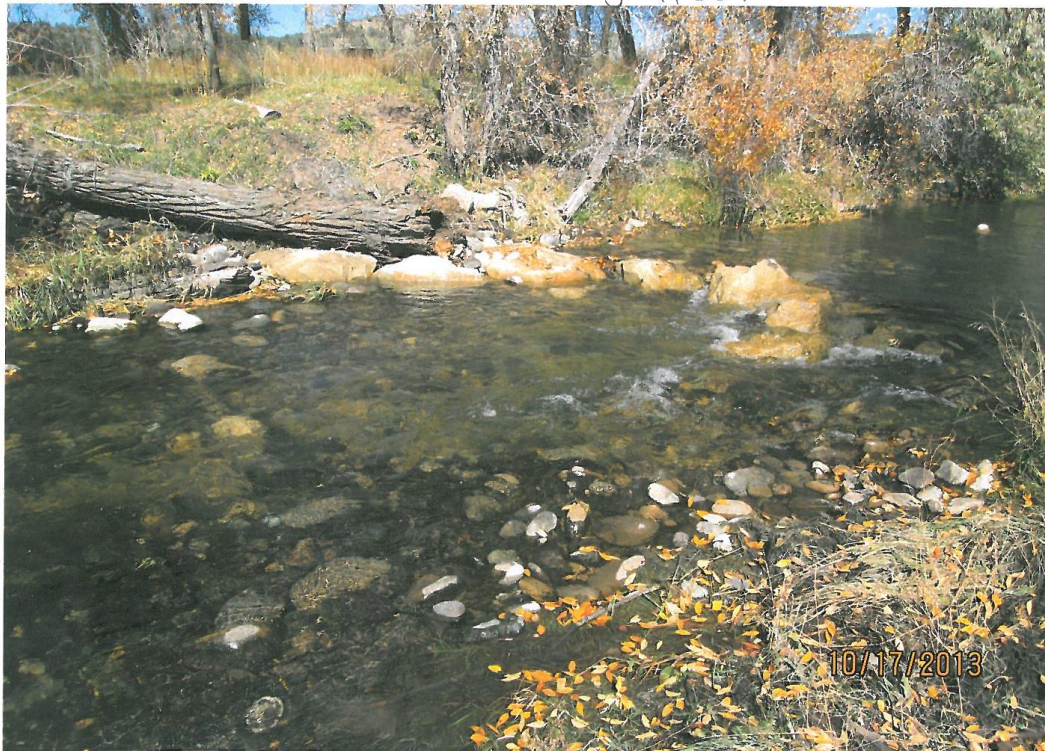
Photos 21 and 22

Diversion Project II Mancos River Weir

J. Hook

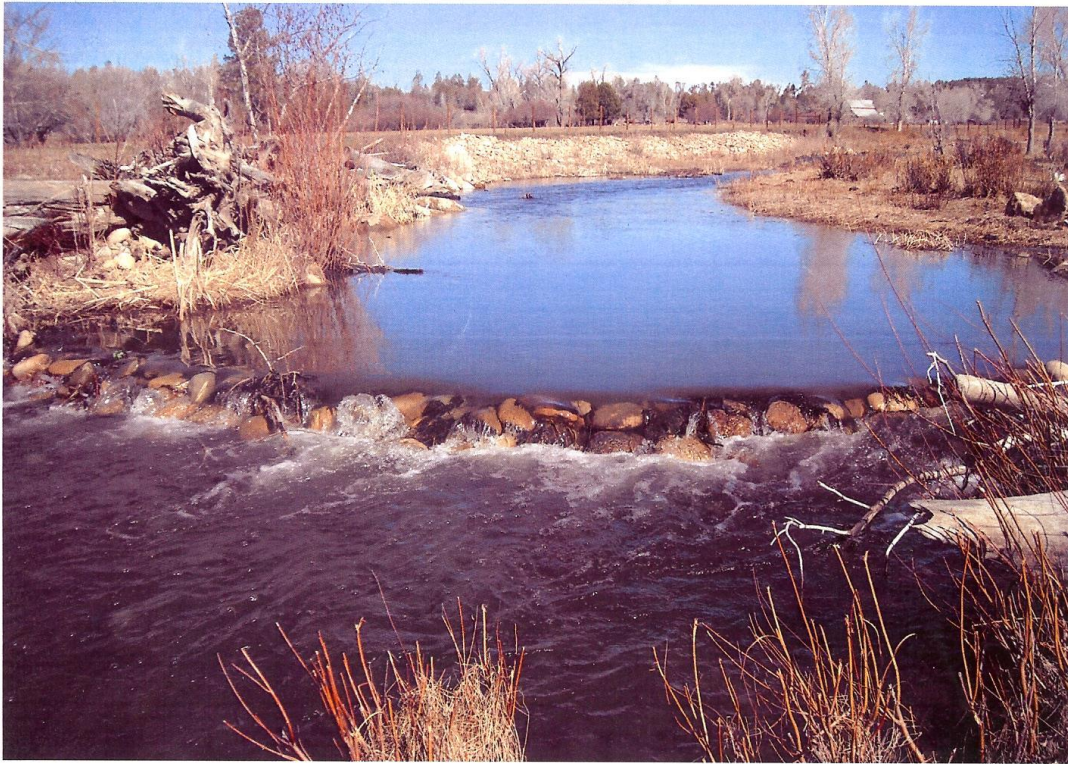
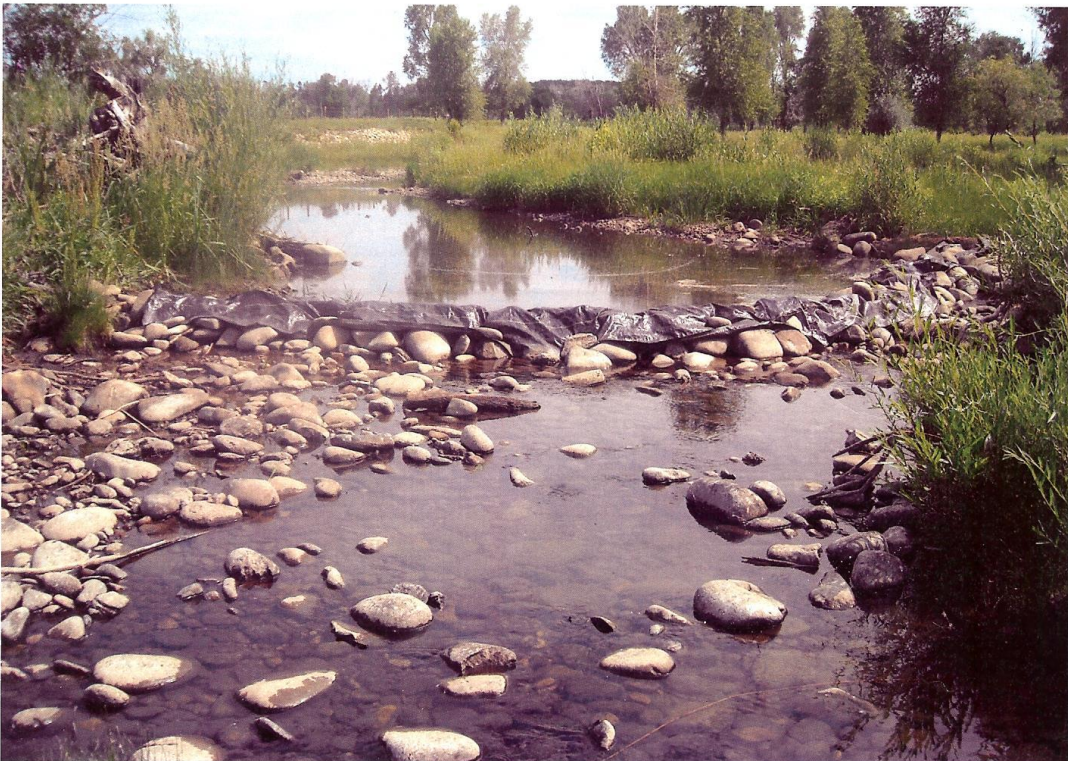
Photos 23 and 24: Pre-project

Bolen Diversion

Phase II
Diversion 5

In October 2013, the rock diversion to replace the cobble dam at the Bolen Diversion was installed along with the diversion box, culverts and measure box. See photos 23-26.

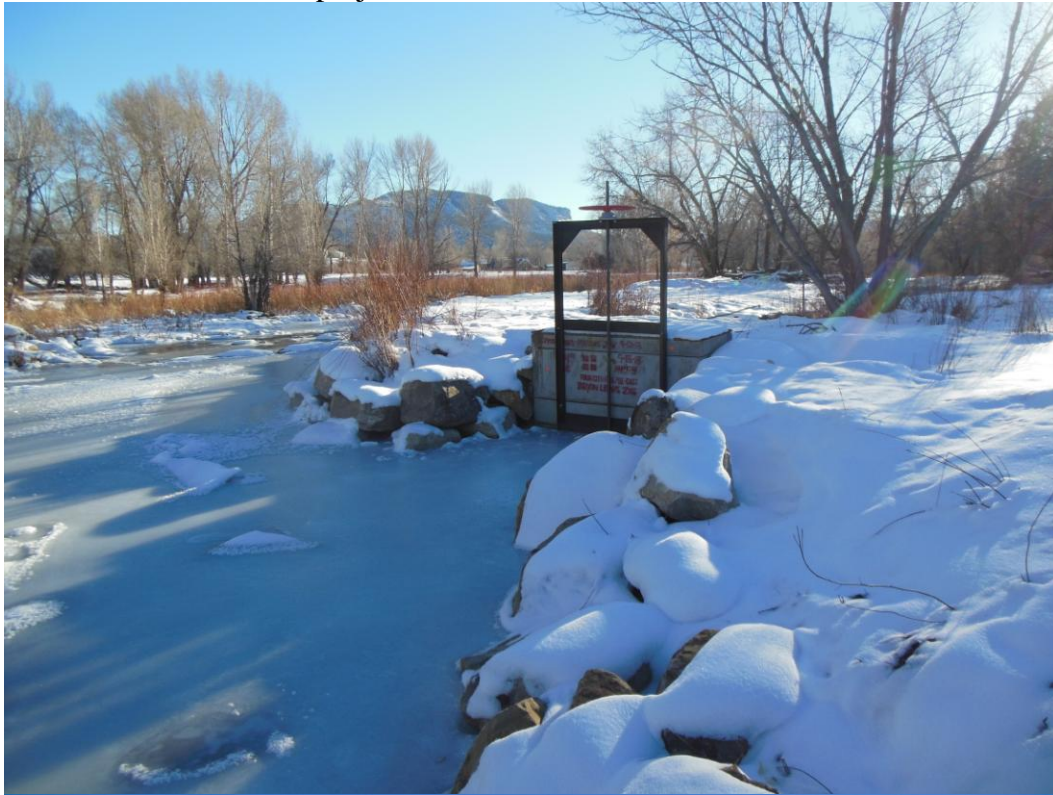
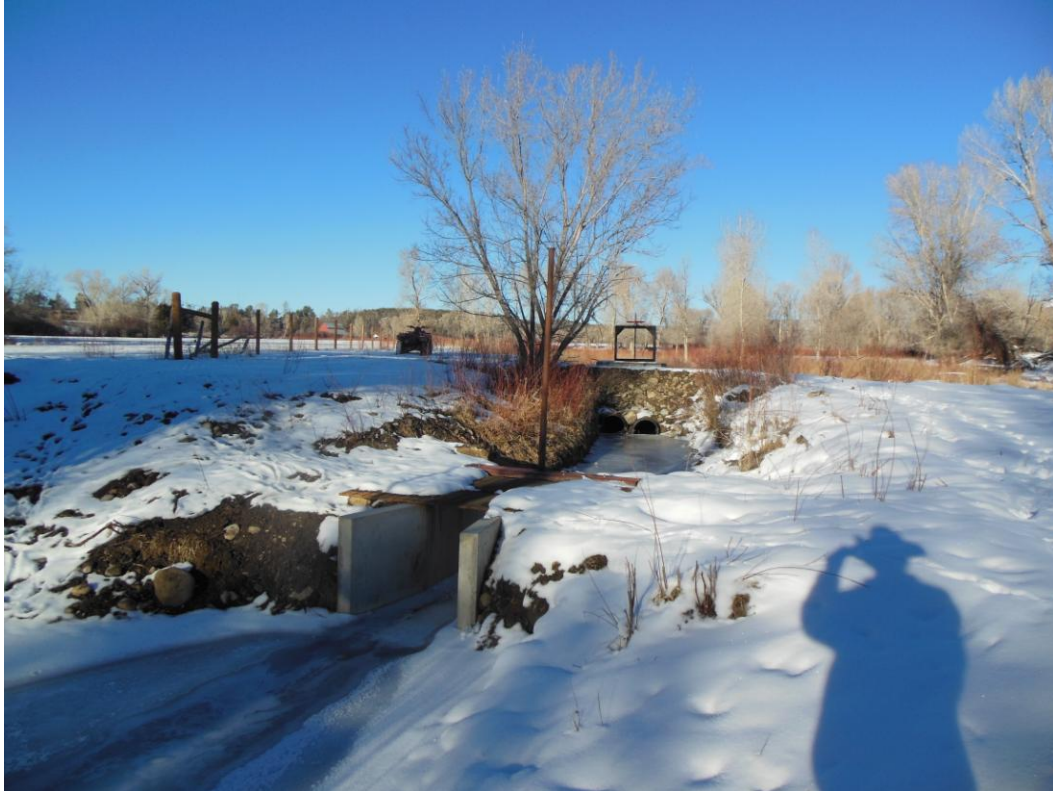
Photos 25 and 26: Post-project

Bolen Diversion

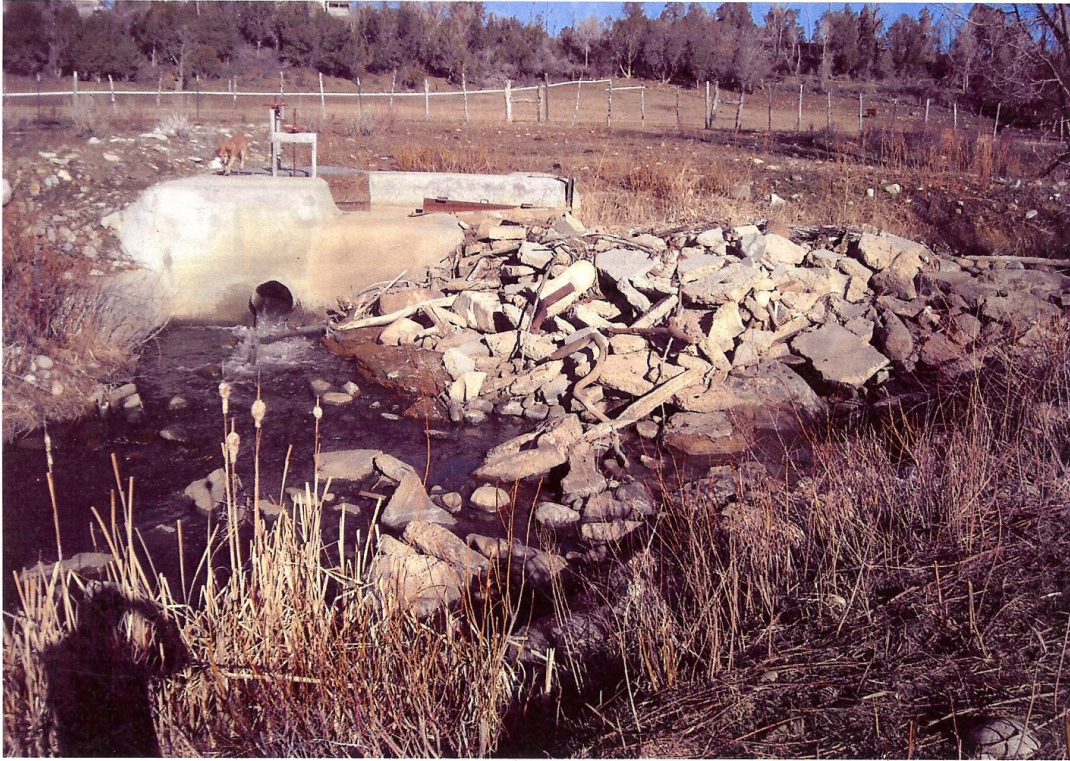
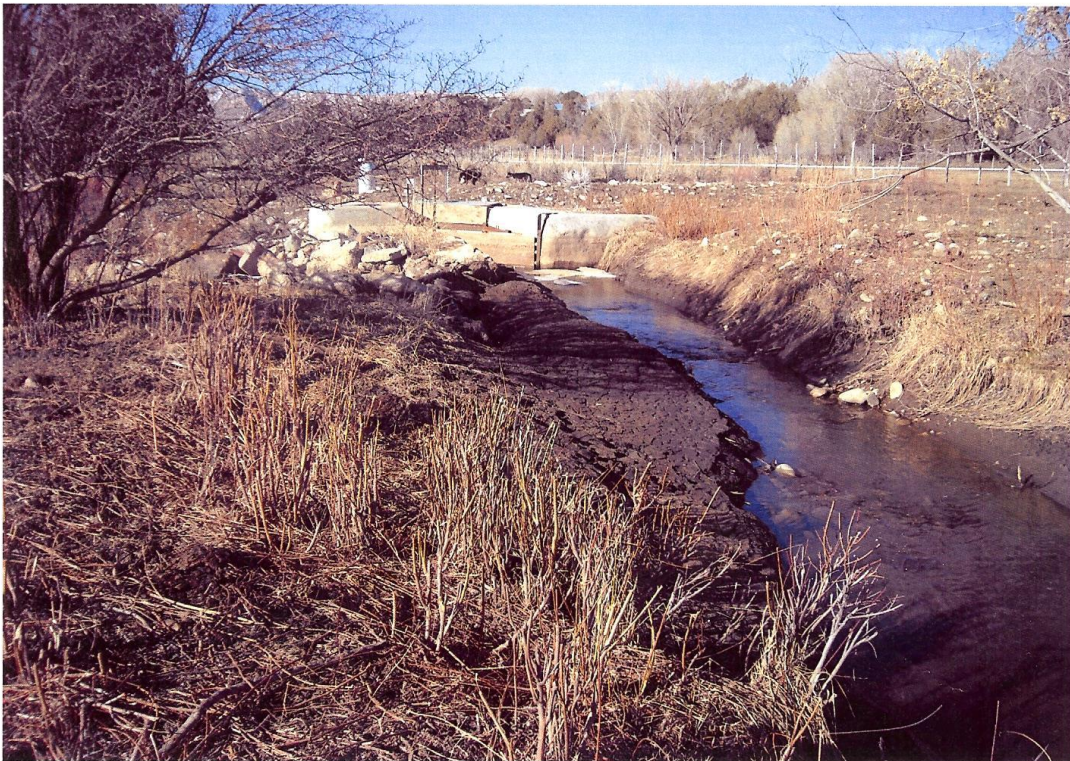
Photos 27 and 28: Pre-project:

sheek Diversion

Plans for the Sheek Diversion were certified by NRCS on September 13, 2013. In October 2013, the flow measuring equipment and headgate were installed at the Sheek Diversion. See photos 27-30.

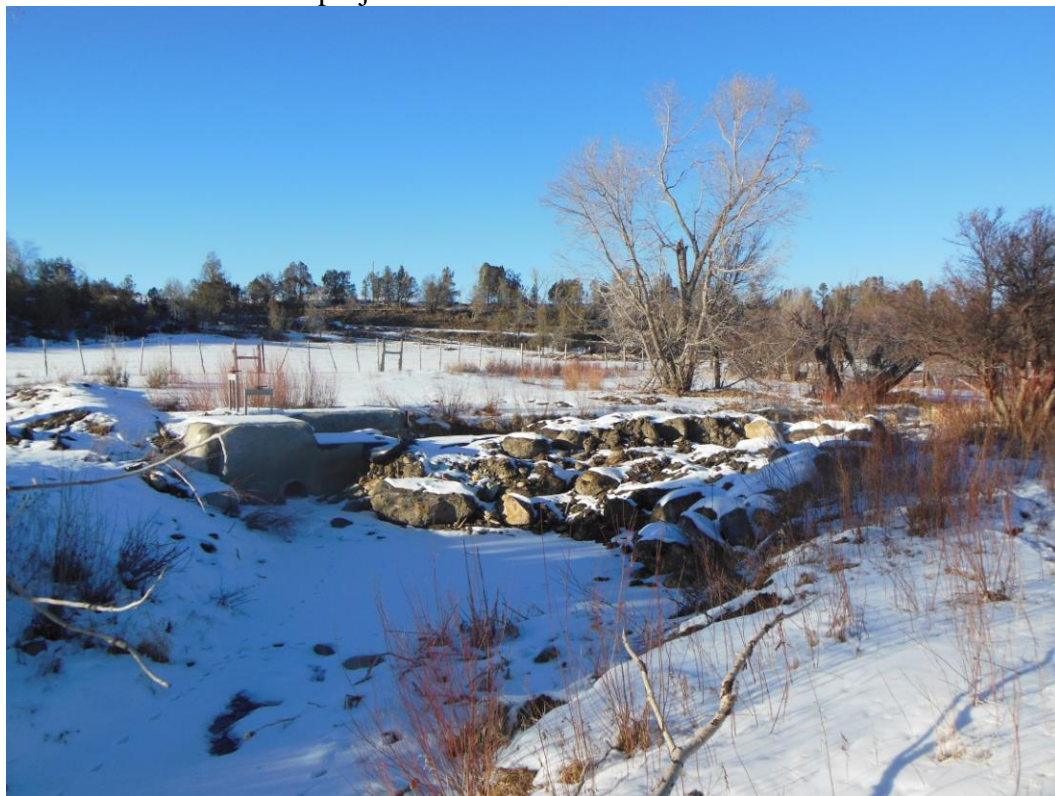
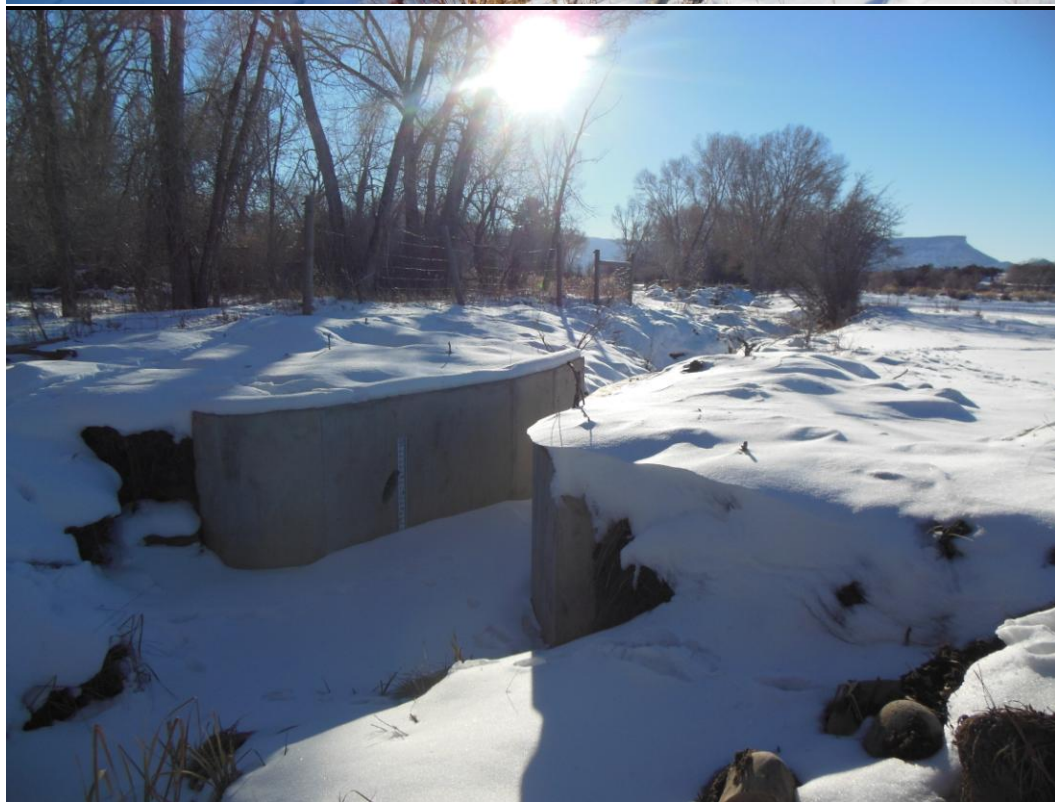
Photos 29 and 30: Post-project:

Sheek Diversion

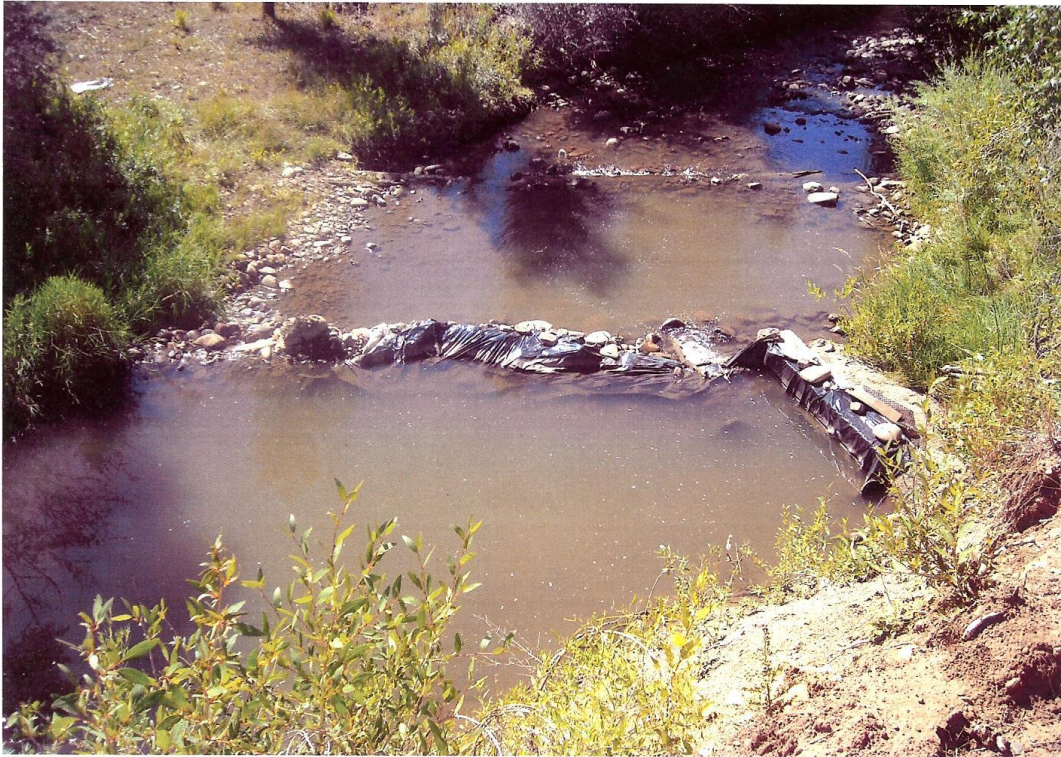
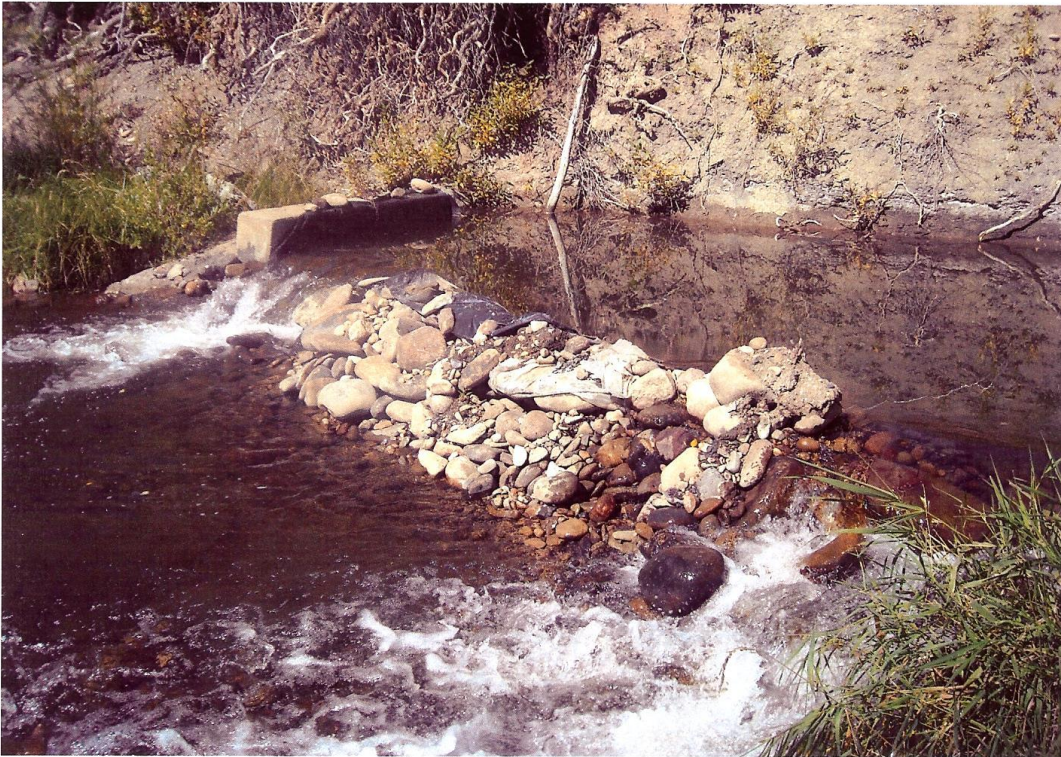
Photos 31 and 32: Pre-project

Exon Diversion

Plans for the Exon Diversion were certified by NRCS on September 3, 2013. In October 2014, the permanent rock structure at the Exon Diversion was completed according to those plans. See photos 31-34.
