Mancos River Habitat and Diversion Project – Phase 2
Final Report
Mancos Conservation District
March 2, 2013

Colorado Water Conservation Board (CWCB) Contract C150511

Mancos River Habitat and Diversion Project – Phase II

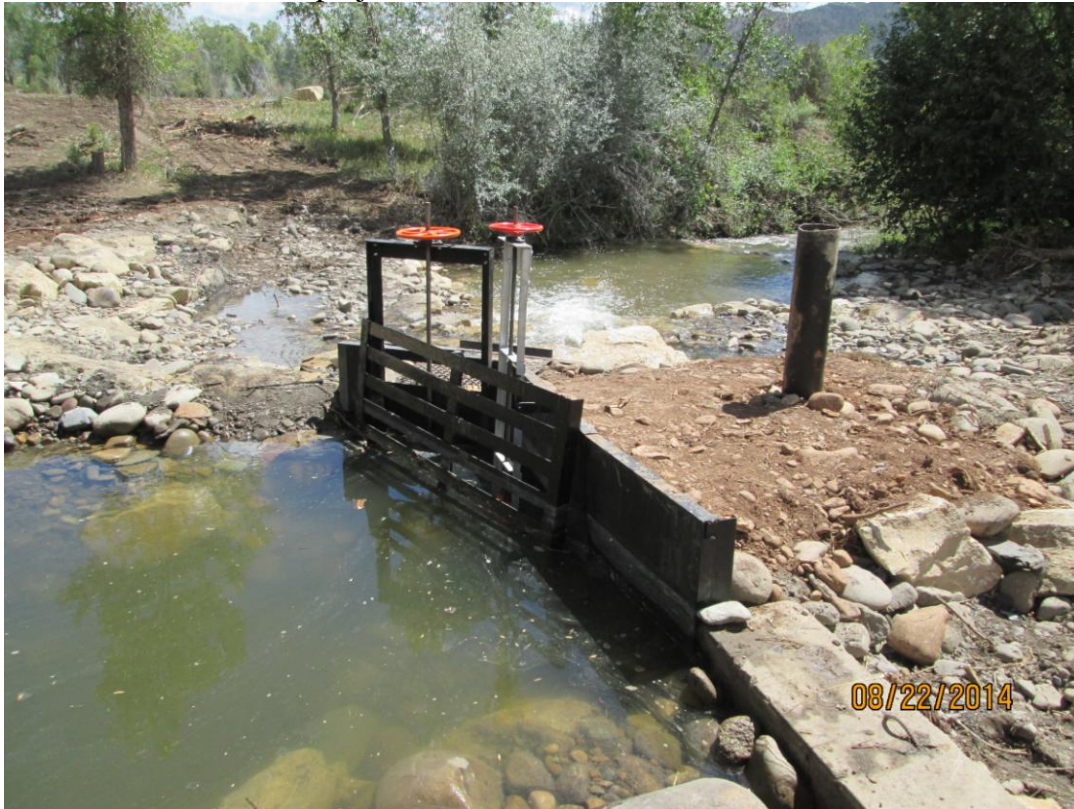
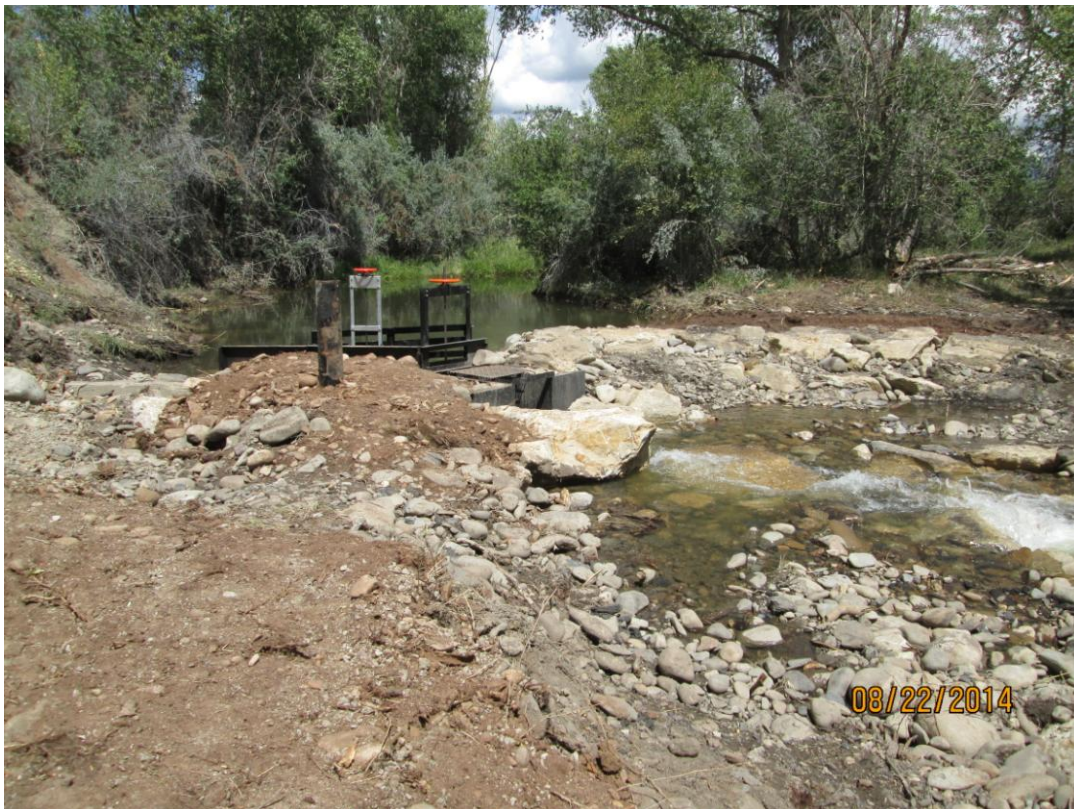
Photos 33 and 34: Post-project

Exon Diversion

Plans for the Exon Diversion were certified by NRCS on September 3, 2013. In October 2014, the permanent rock structure at the Exon Diversion was completed according to those plans. See photos 31-34.

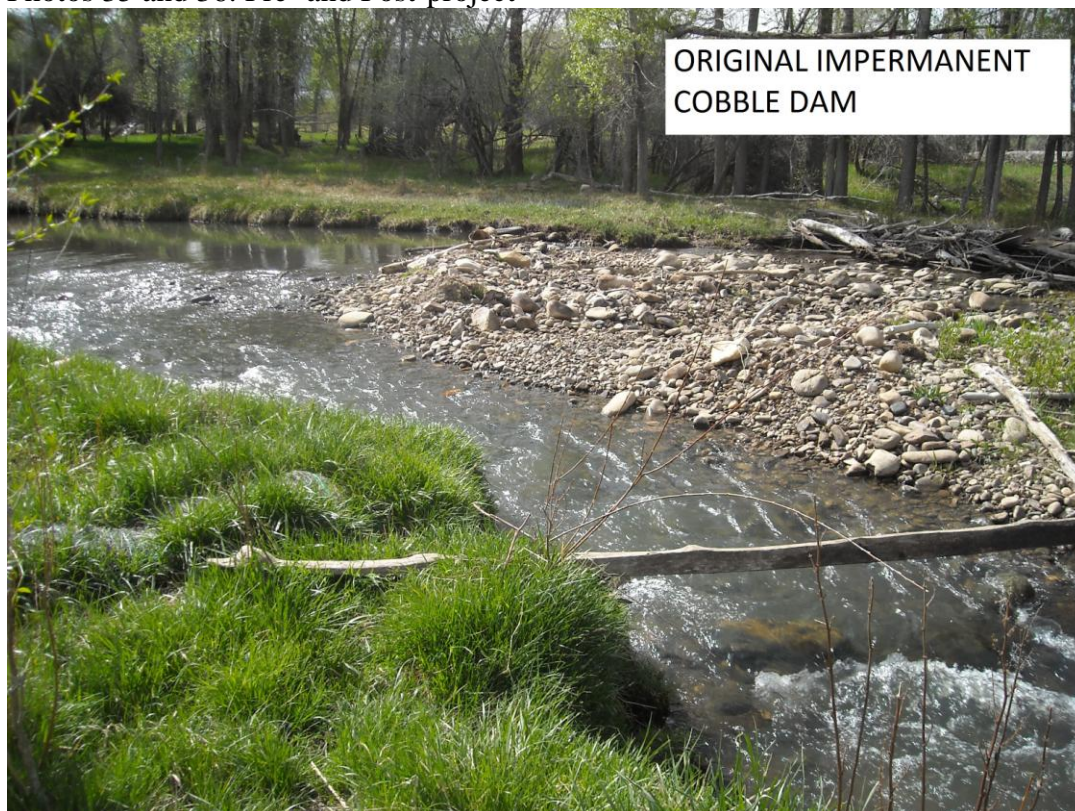
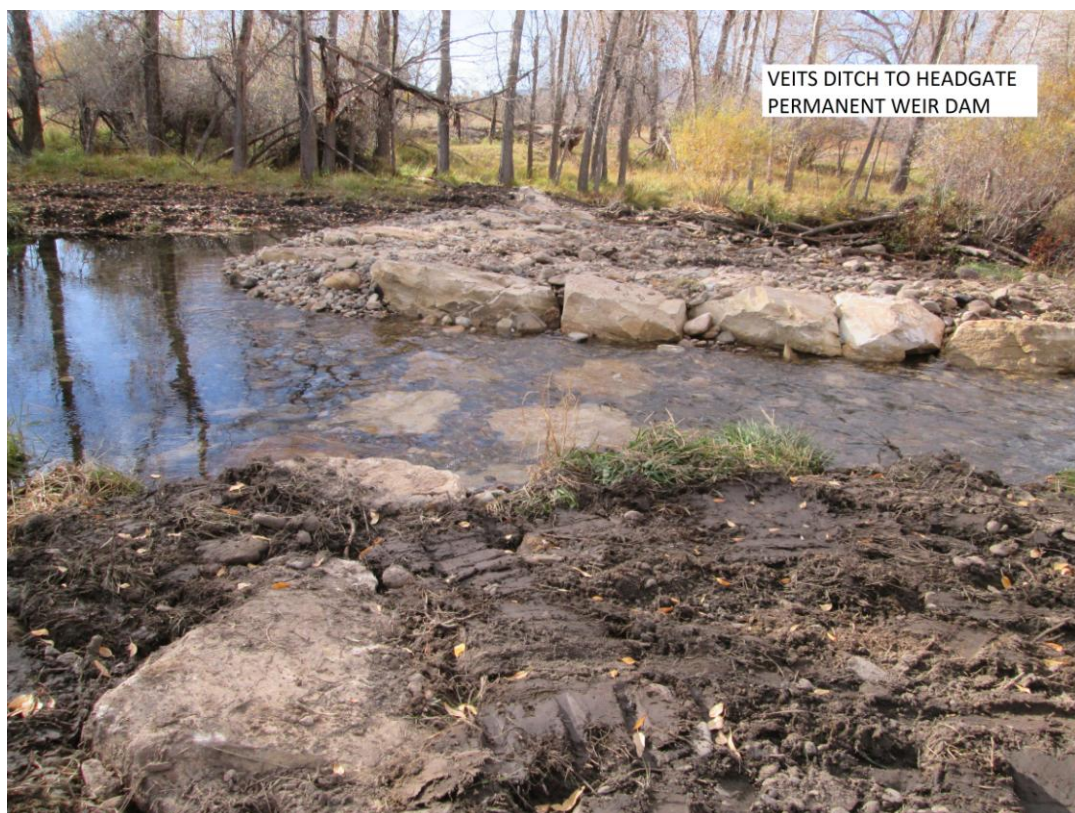
Photos 35 and 36: Pre- and Post-project

Veits Diversion

Plans for the Veitz diversion structure were completed in October 2014. In November 2014 the permanent rock structure was completed at the Veitz Ditch. See photos 35-38.

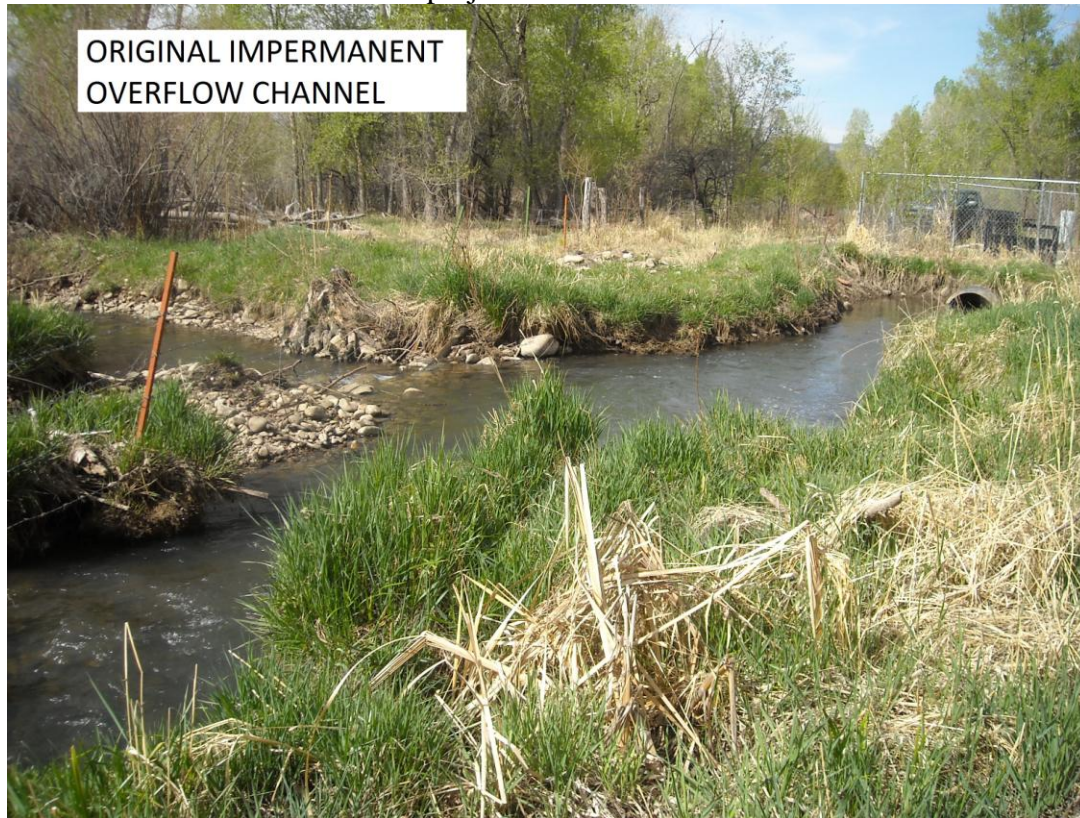
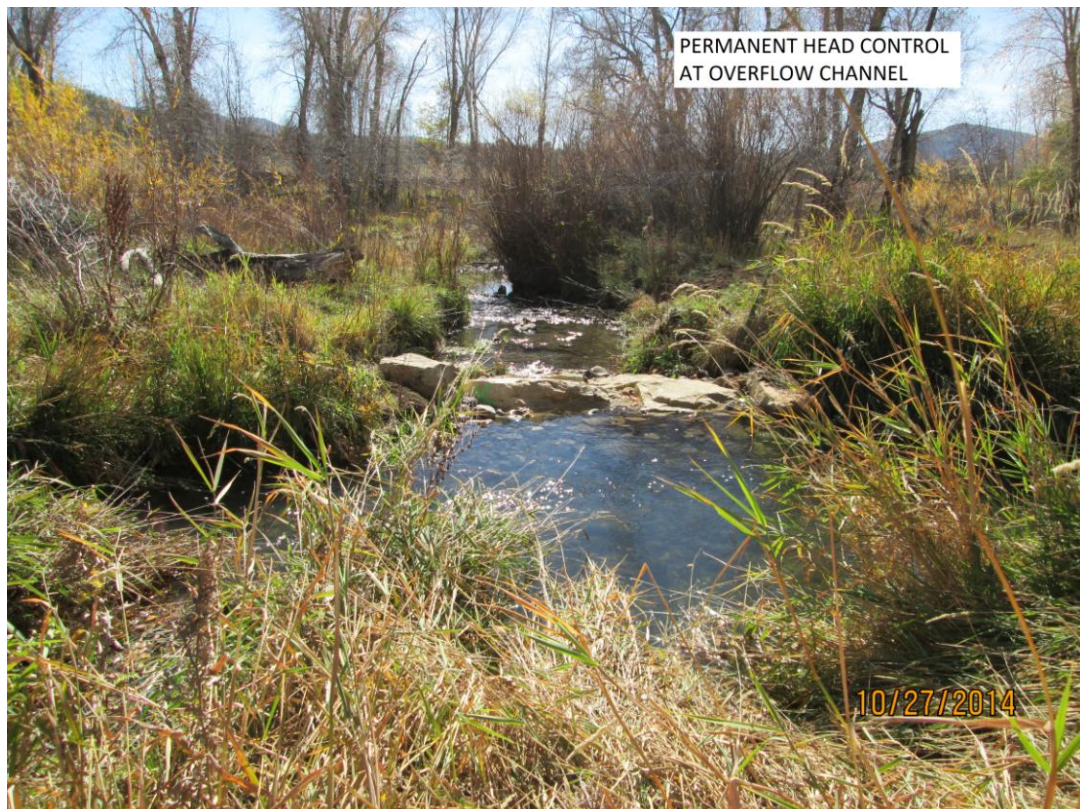
Photos 37 and 38: Pre- and Post-project

Veits Diversion

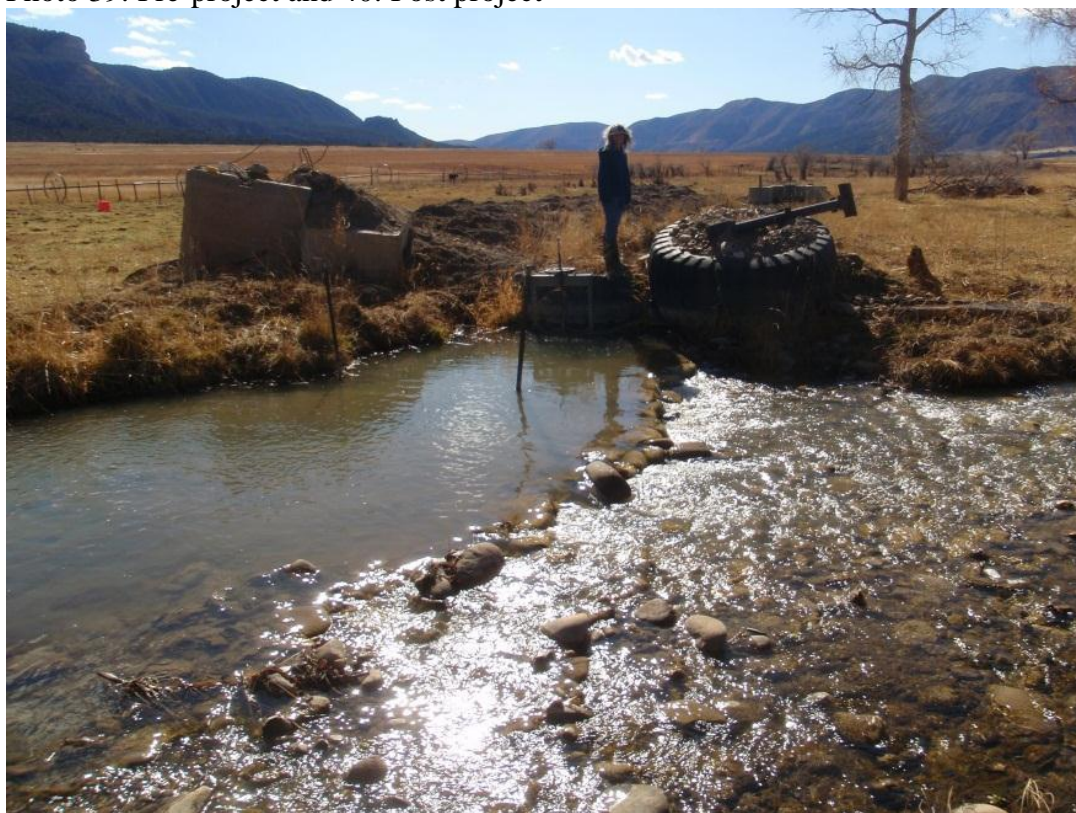
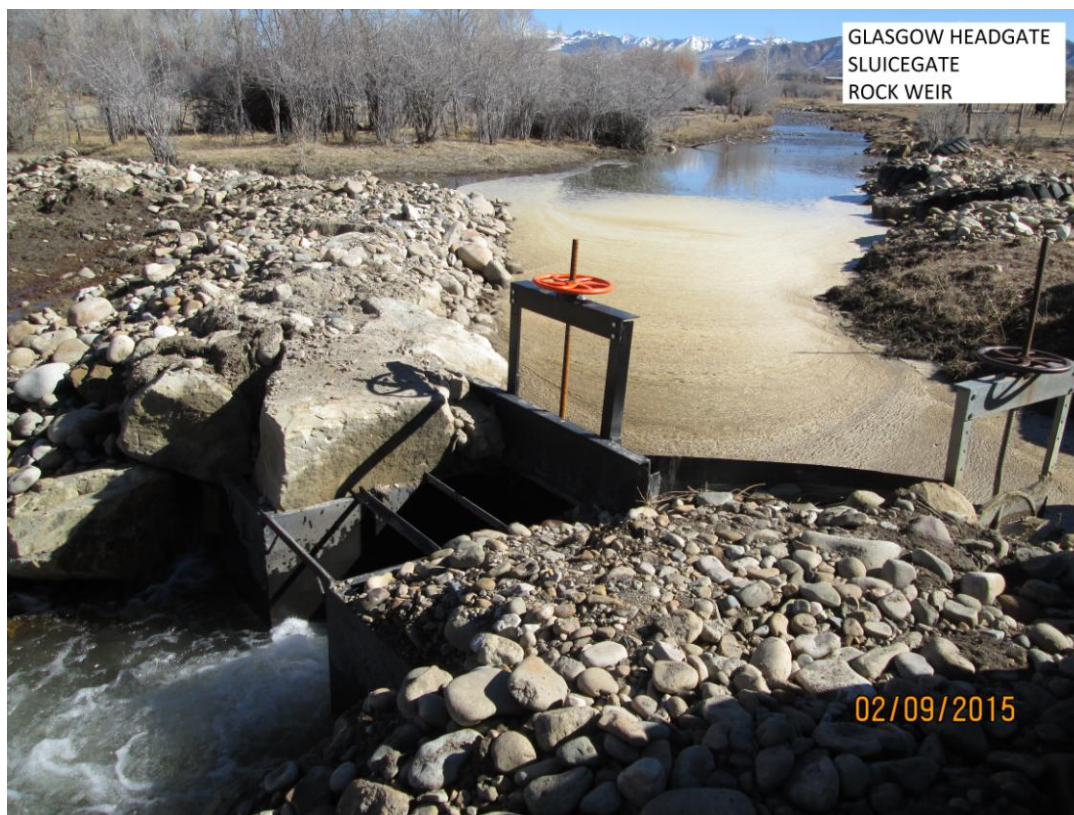
Photo 39: Pre-project and 40: Post project

Glasgow & Brewer Diversion

Plans for the Glasgow & Brewer Diversion structure were completed in October 2014. In November 2014, the permanent rock structure was completed at the Glasgow & Brewer Diversion, as outlined in the amendment to Task 5 Scope of Work submitted December 5, 2014. With the completion of the Glasgow & Brewer Diversion all deliverables under Task 5, as amended were completed. See photos 39-40.

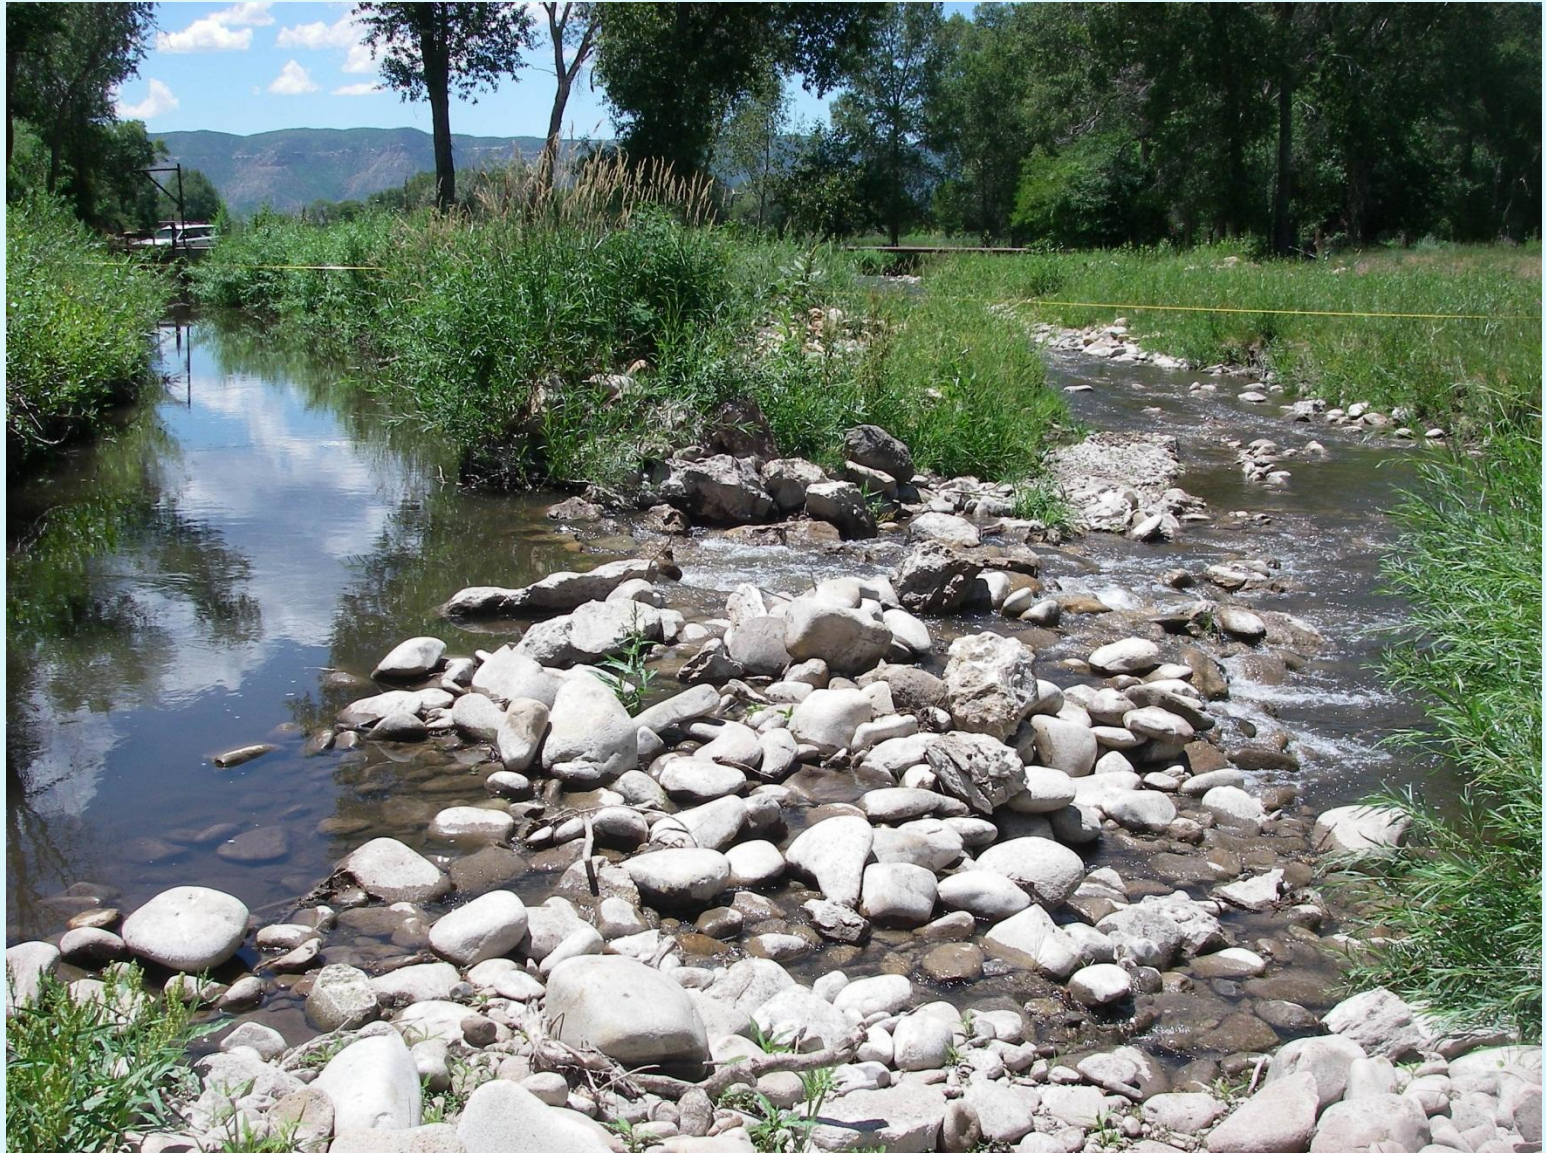
Beaver Diversion - preconstruction

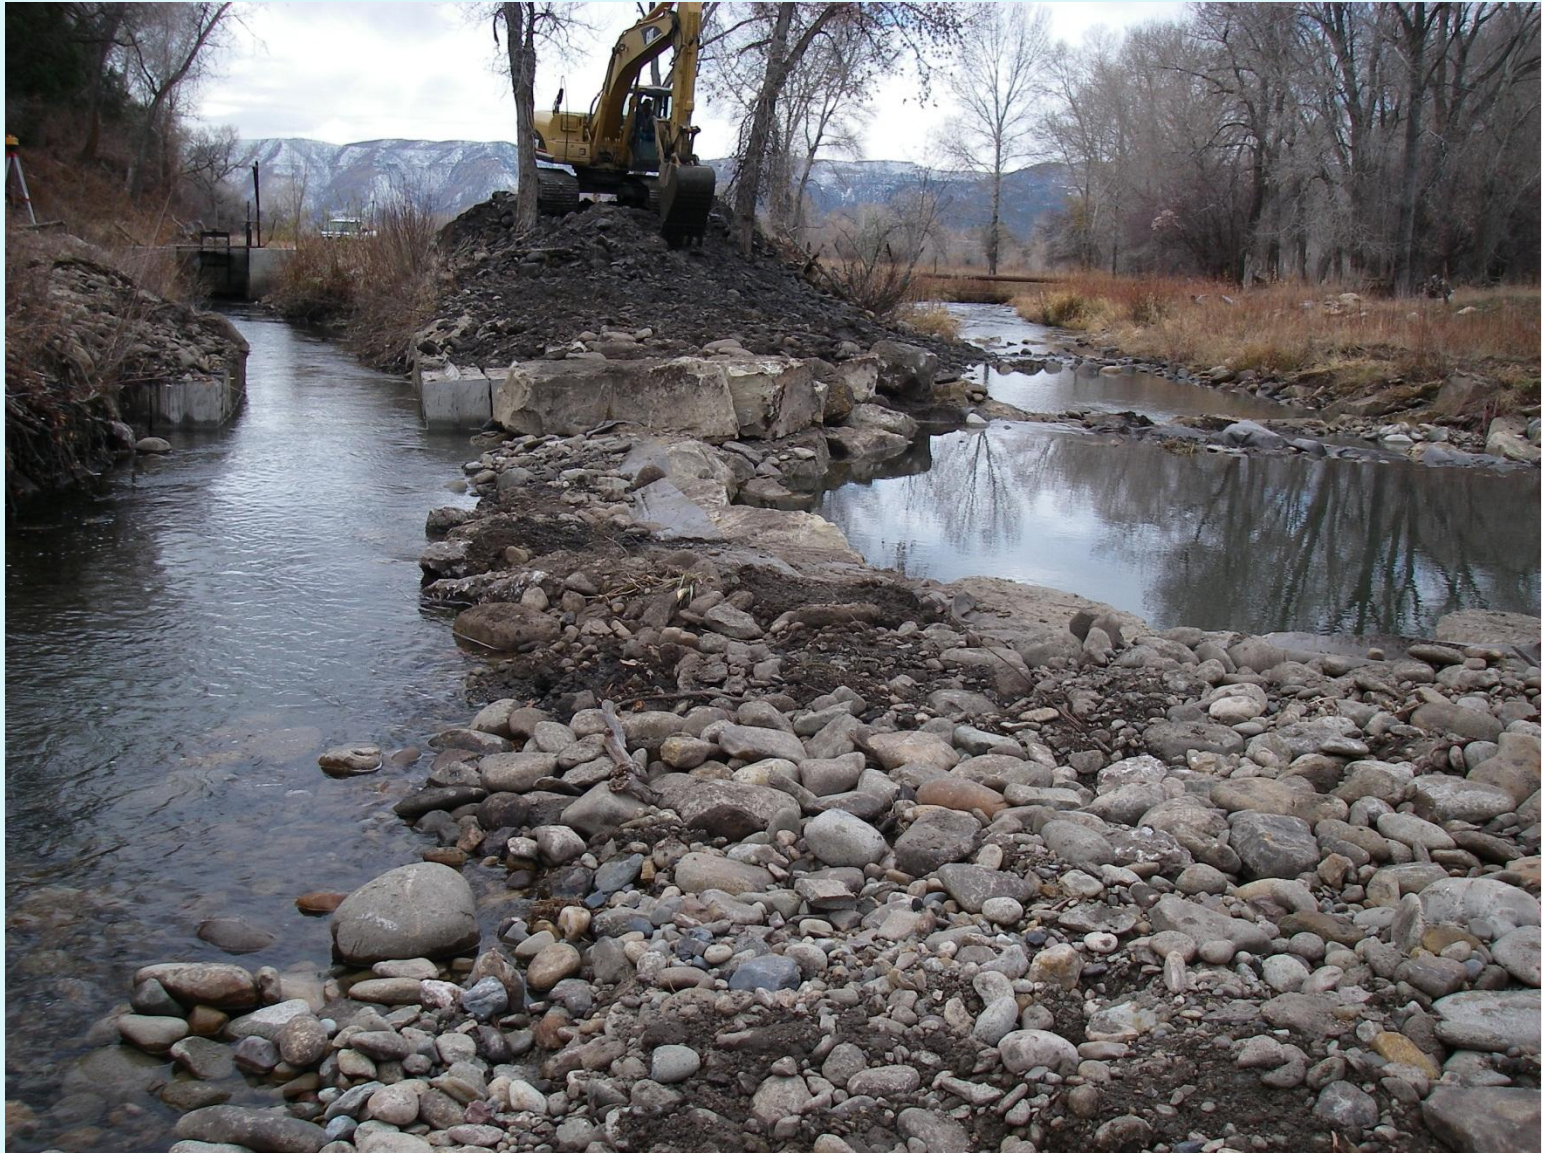
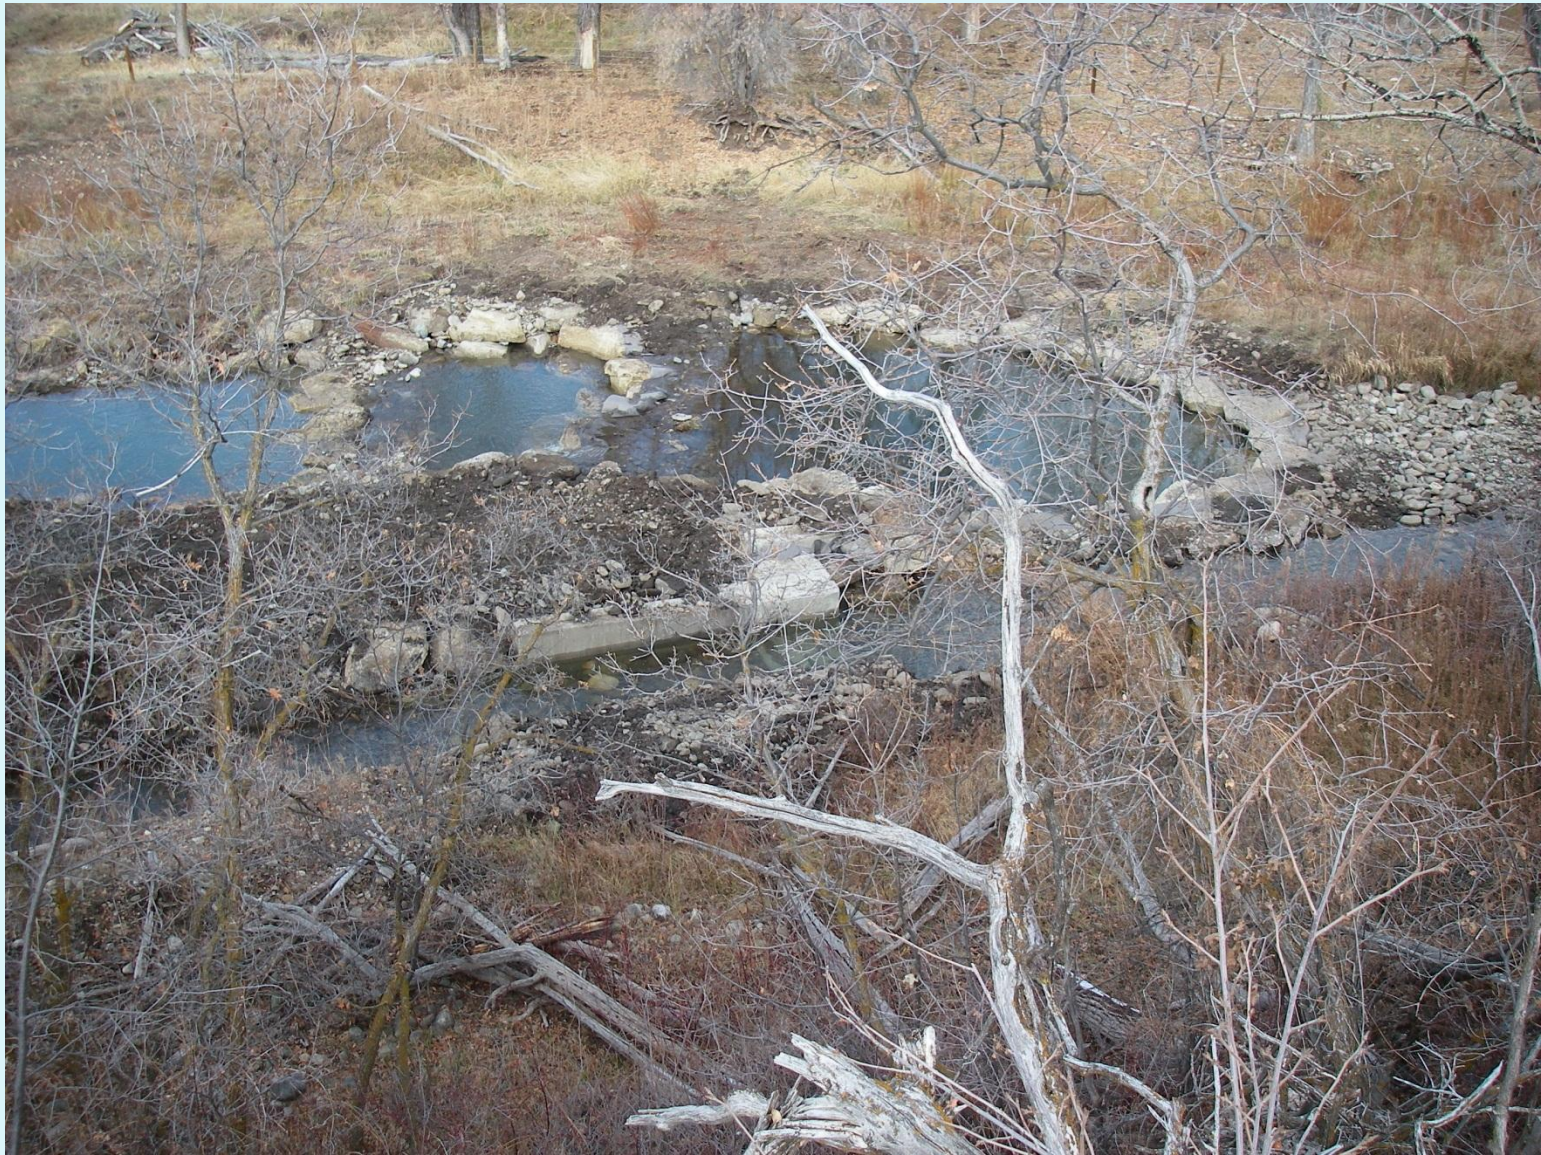
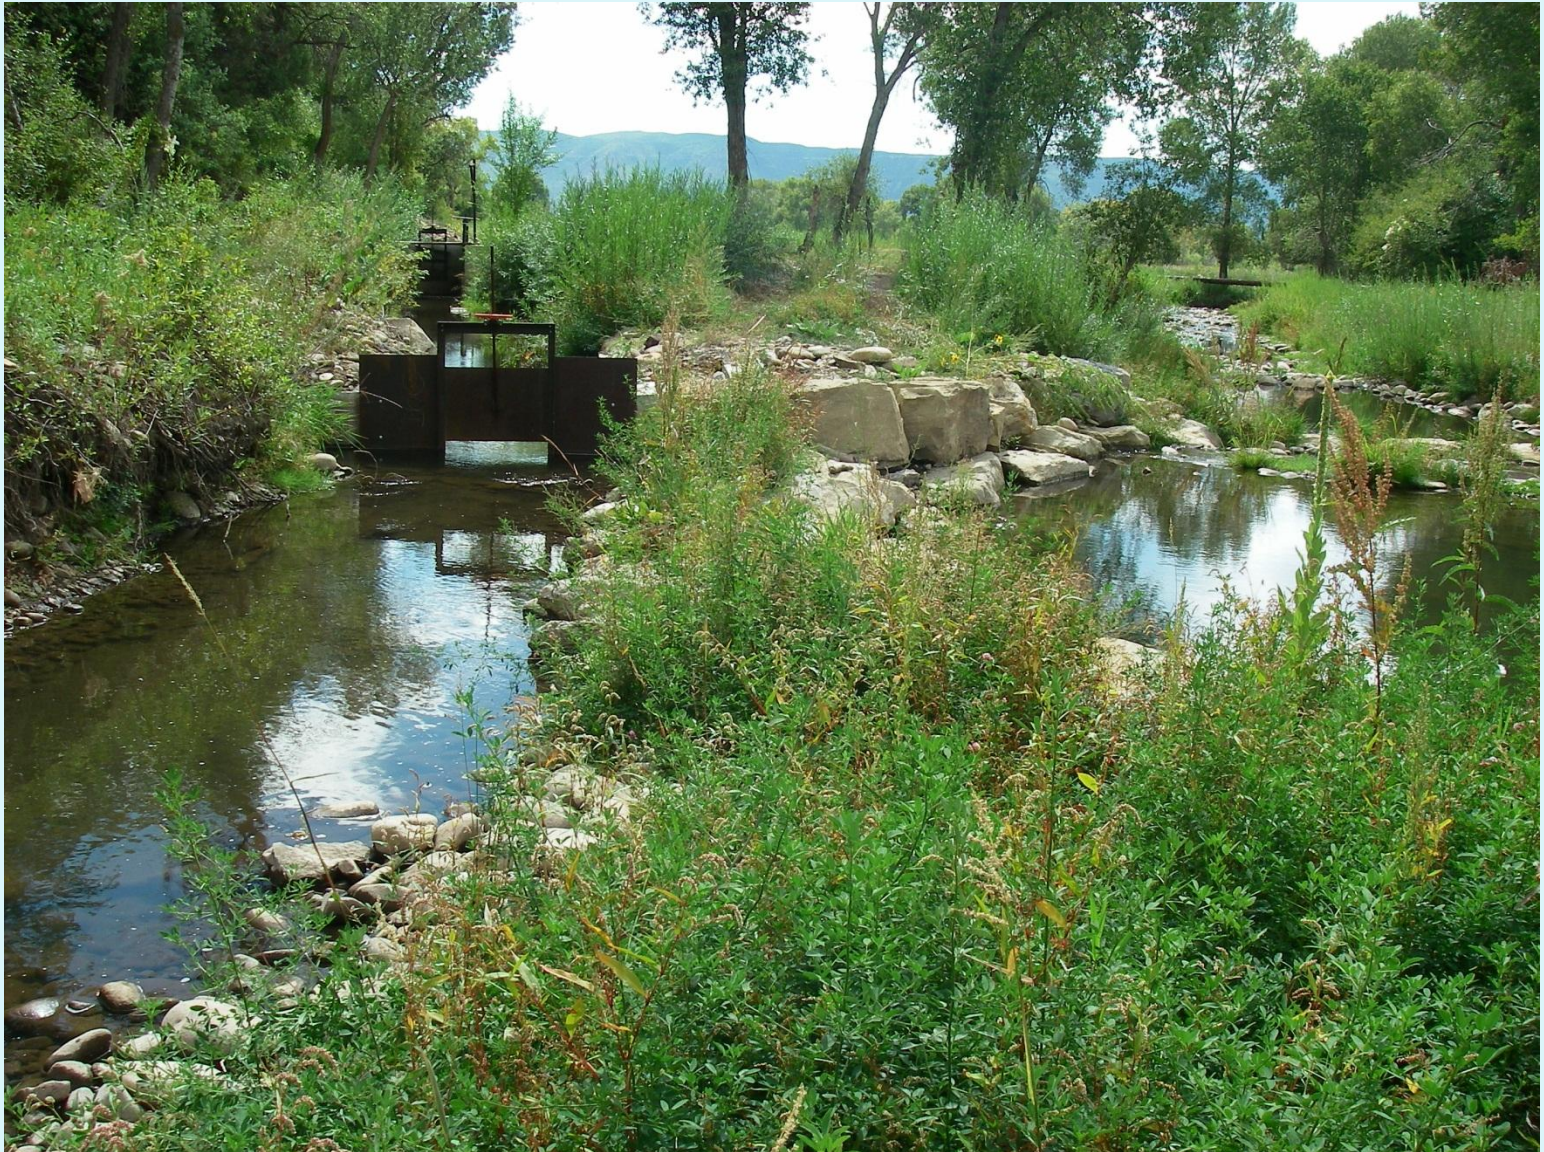
Beaver Diversion – post construction

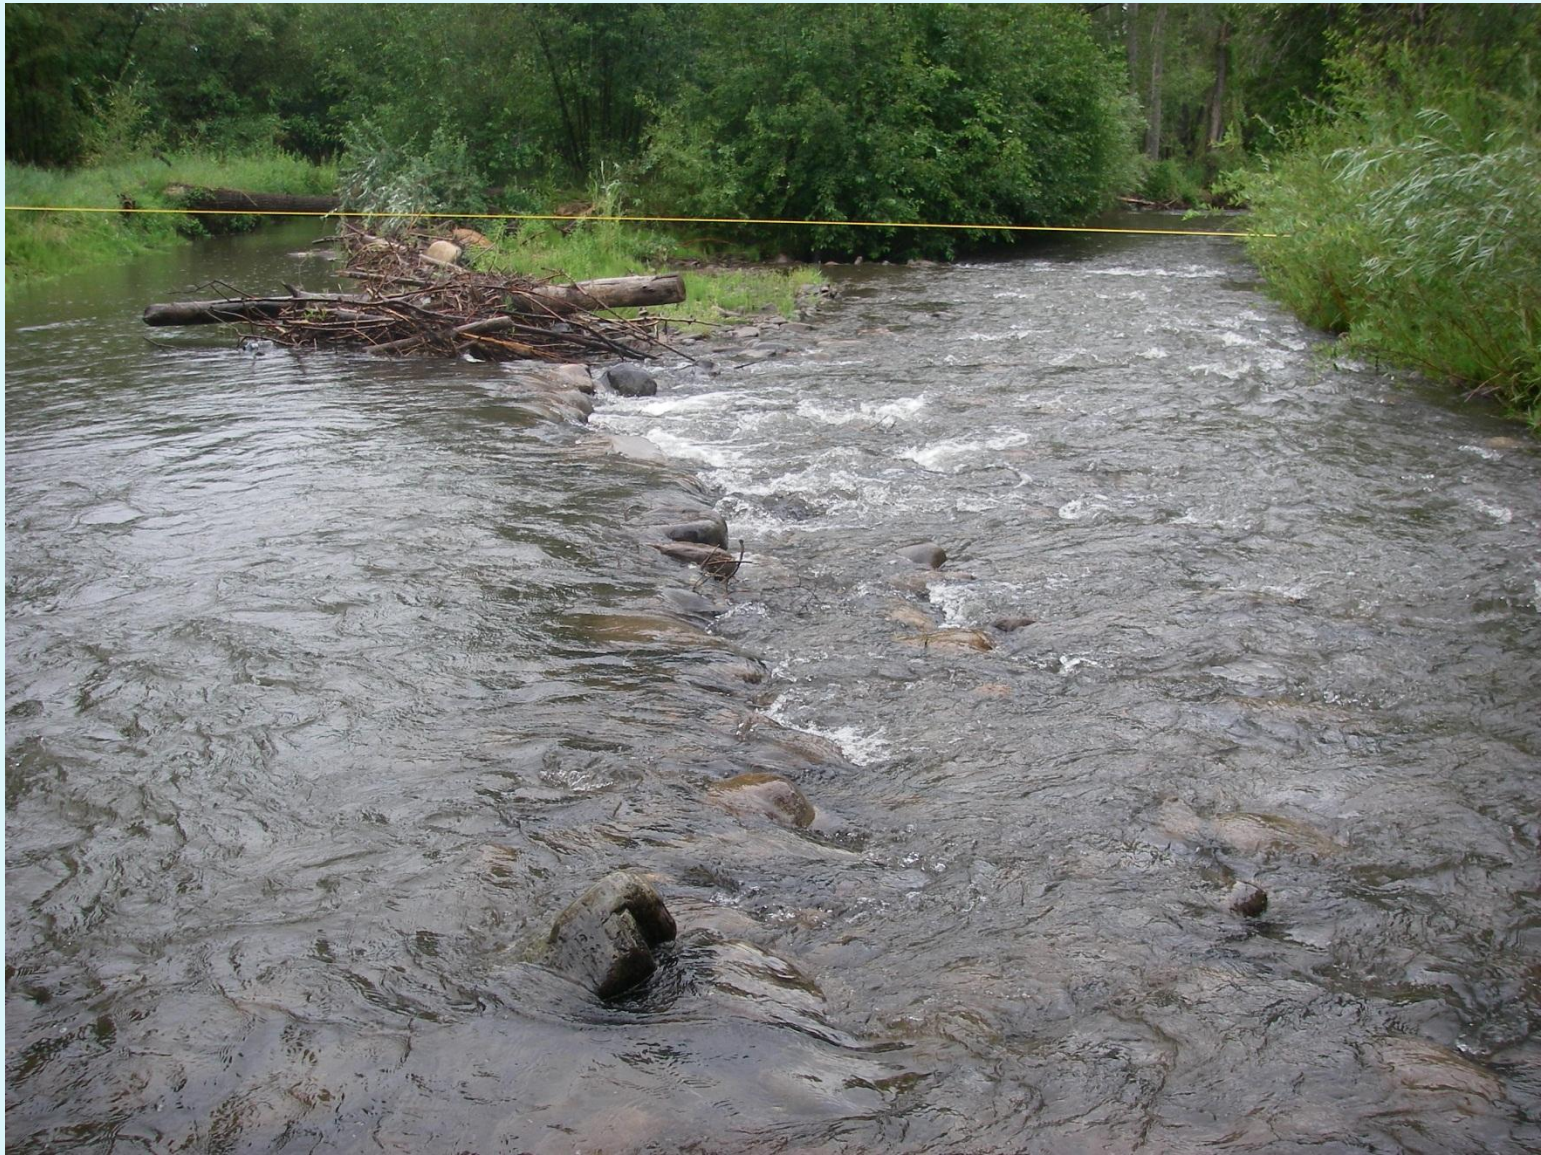
Willis Diversion – preconstruction

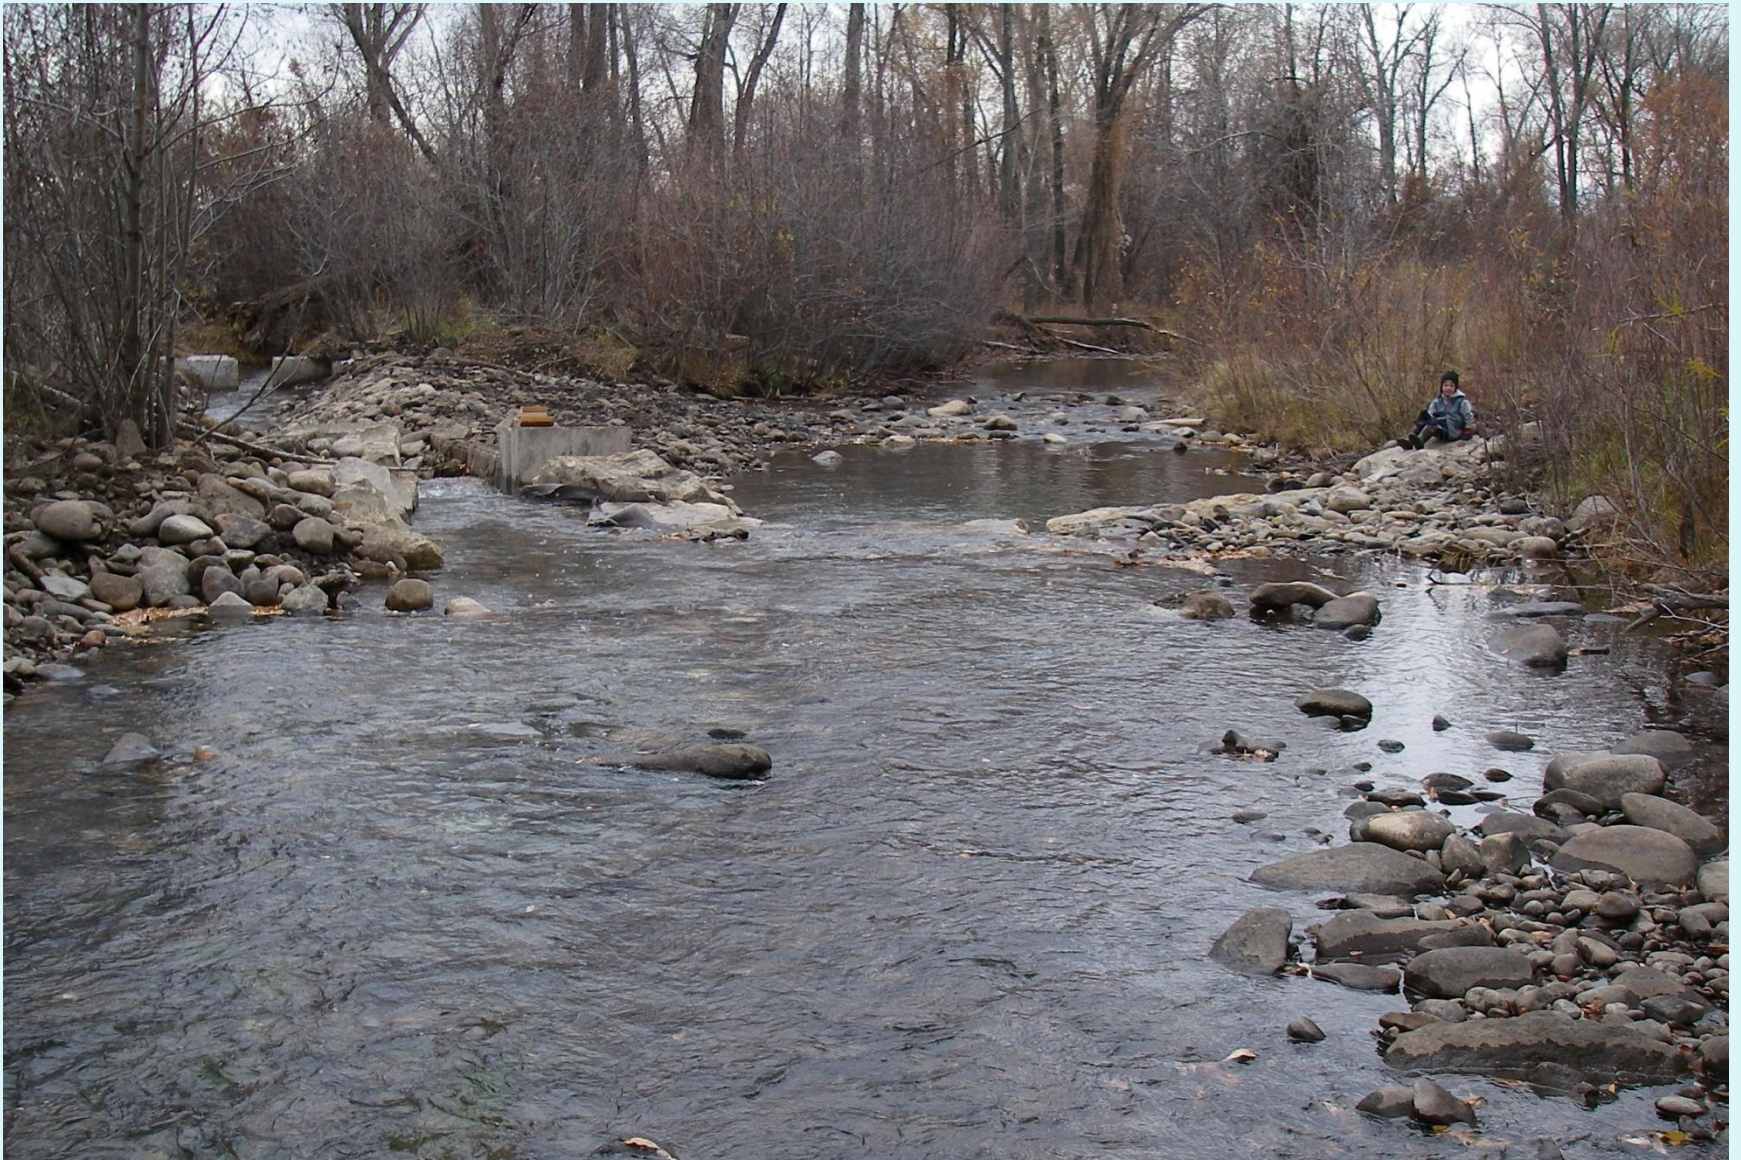
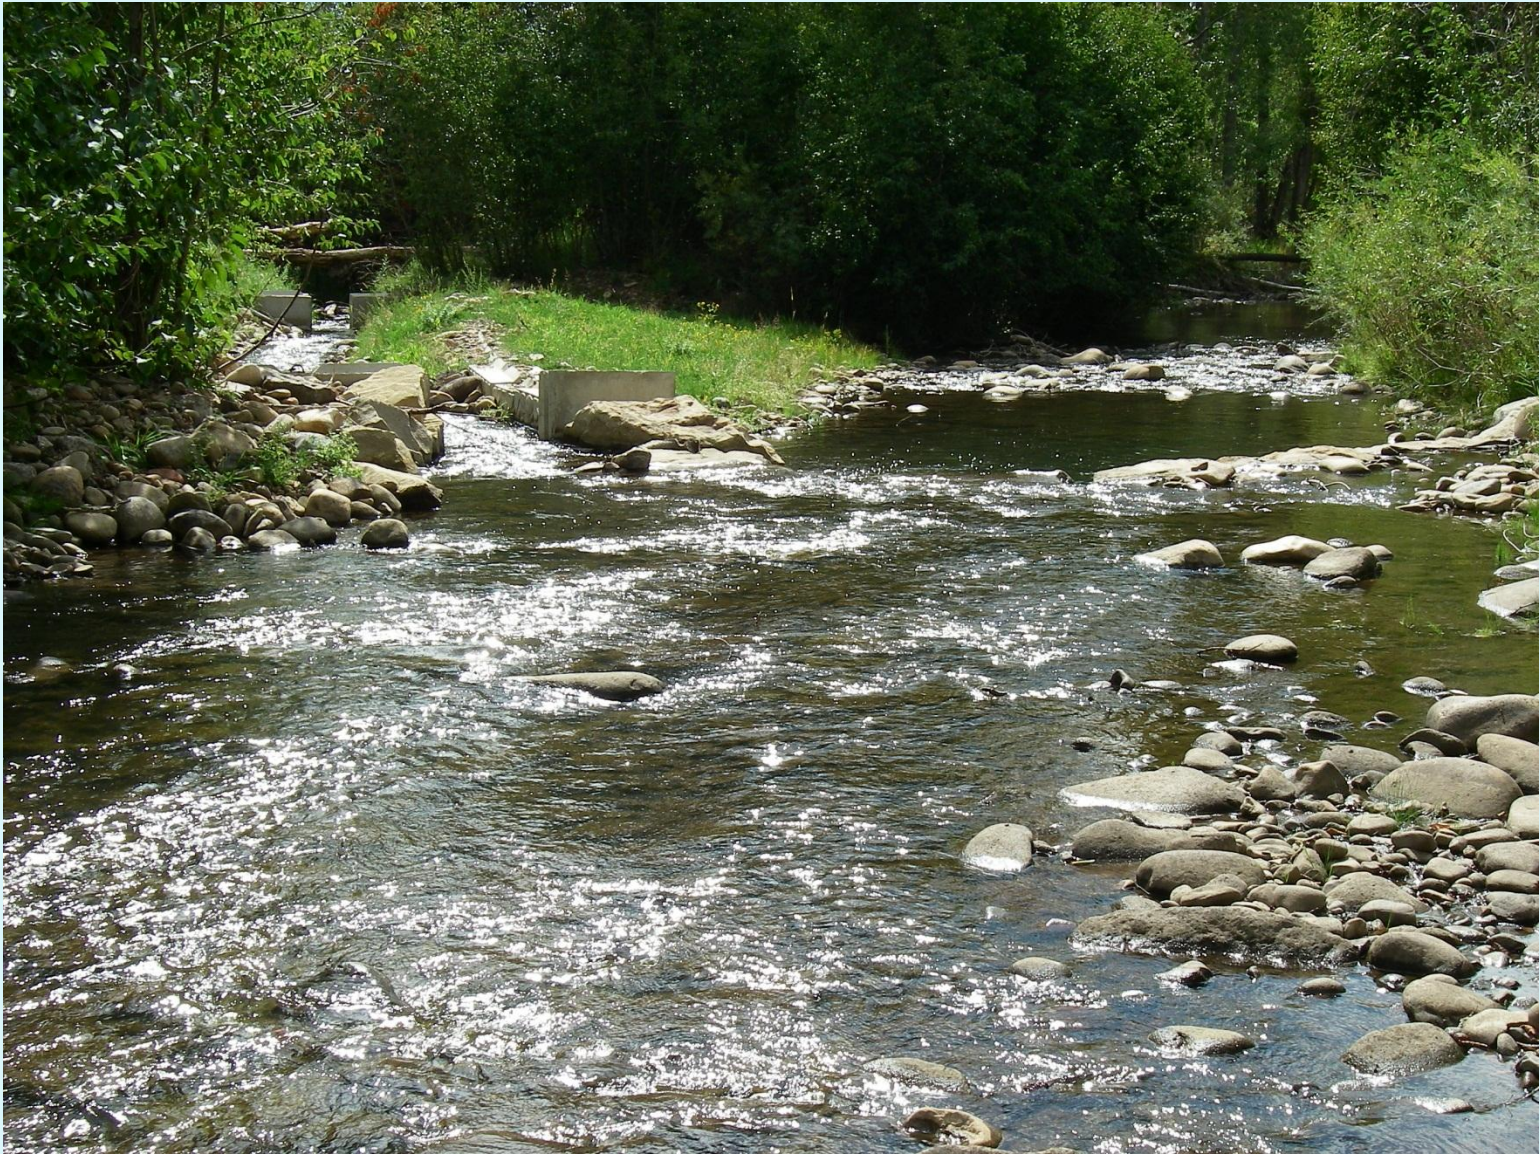
Willis Diversion – post construction
