**Post-Construction Project Report:
Meadow and South Ledge Diversion
Reconstruction and Fish Passage Demonstration
Project**

October 2015

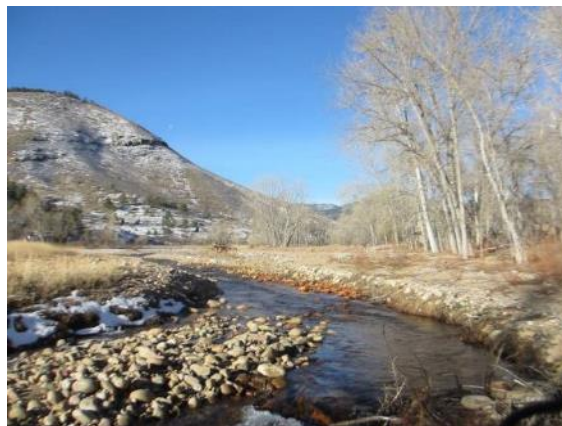
Manning's "n" values, or roughness coefficients, were assigned based on field inspection of the floodplain areas within the project footprint (Figure 4). Standard roughness coefficient values for the main channels and overbank areas range from 0.030 to 0.040 and 0.040 to 0.060, respectively (FEMA 2012; ODOT 2014). The values used in this study are shown in Table 2. In addition to the modified cross-sectional geometry at the diversion structure, the installed rootwads and riffle hardening in the main channel are reflected in the model as increased roughness within the main channel of XS 3081.5.

Figure 4. Typical channel and floodplain conditions

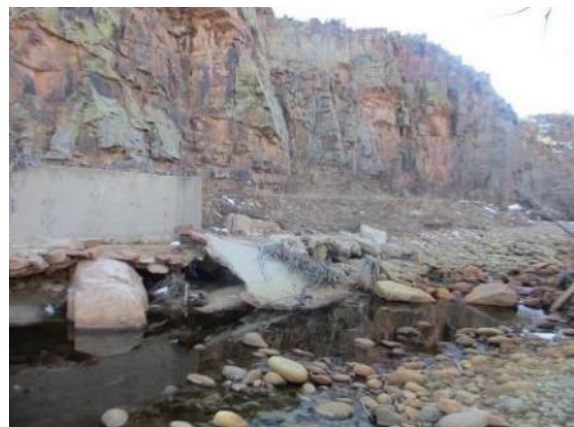
The South Ledge diversion structure was also destroyed as a result of the flood (Figure 5). Although most of the head gate remained intact following the flood, it was undermined on the uphill side and one wall had collapsed into the river. The ditch also sustained severe damage with approximately 1,500 feet of failed ditch (Figure 6). As in the case of the Meadow diversion, bank stabilization was necessary as well (SVLHWCD 2014).

Figure 6a. South Ledge ditch prior to construction

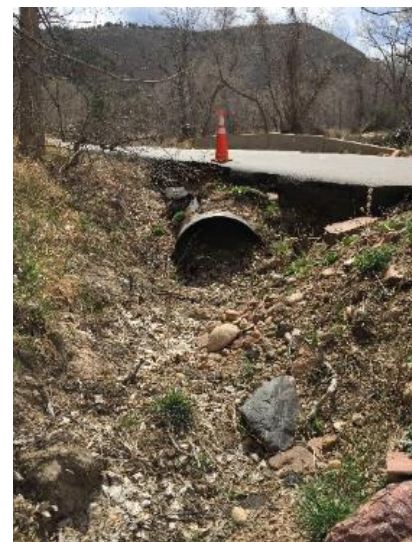
Figure 6b. South Ledge ditch prior to construction

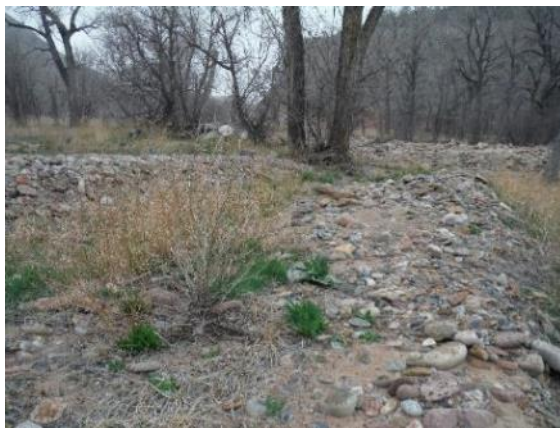
Figure 7. South St. Vrain riparian floodplain deposition and riparian vegetation cover

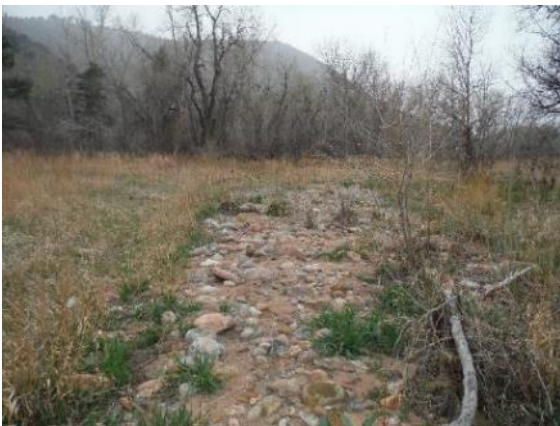
Figure 8. Example of sand and cobble windrow on South St. Vrain floodplain

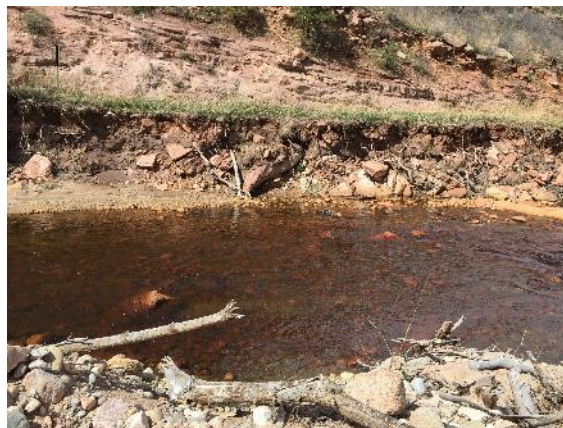
As a result of the flood, the main channel and side channels of South St. Vrain Creek experienced significant channel and bank erosion (Figure 9), as well as extensive areas of sediment and debris deposits throughout the project area. Unstable banks characterized much of the creek, and in some cases banks were even scoured to bedrock. Mid-channel gravel bars were evident in some areas as well.

South St Vrain Creek splits approximately one half mile upstream of the project site. The main channel occupies the left branch, while the side channel at the construction site receives flows from the right branch. Following the flood, Boulder County Parks and Open Space staff installed large boulders in the right channel to maintain the left channel as the primary. Although Boulder County Parks and Open Space staff would have preferred to wait to study channel morphology, sediment transport, and the riparian ecosystem in Hall Meadows upstream of the project, the ditch companies had already postponed diverting water for a full year in an effort to raise funds and build a resilient project. Coordination between the ditch companies, funders and the staff was a primary concern in identifying the appropriate location for the diversion. As a result, a decision was jointly made by the ditch companies and staff to locate the project in the existing primary channel.

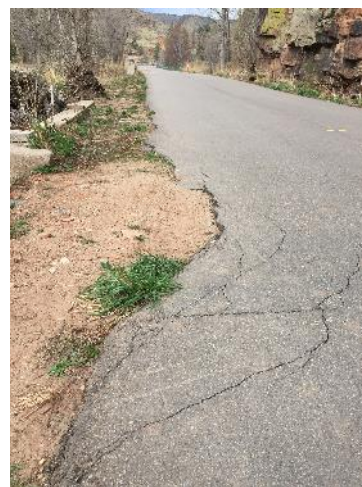
The project site is bordered by Highway 7 to the west and Old South St. Vrain Road to the east. Portions of Old South St. Vrain Road were damaged as a result of the flood, particularly in the vicinity of the new underground pipeline (Figure 10). The project is located in an area where the South St. Vrain Creek side channel is close to the road (less than 5 feet from the edge of the road in some locations). The flood overtopped the road and washed out large sections of asphalt in several locations adjacent to the project. It was also determined that the asphalt was laid on little to no road base, which may have contributed to the failure of the road.

Figure 10. Example of damage to Old South St. Vrain Road east of South St. Vrain Creek side channel

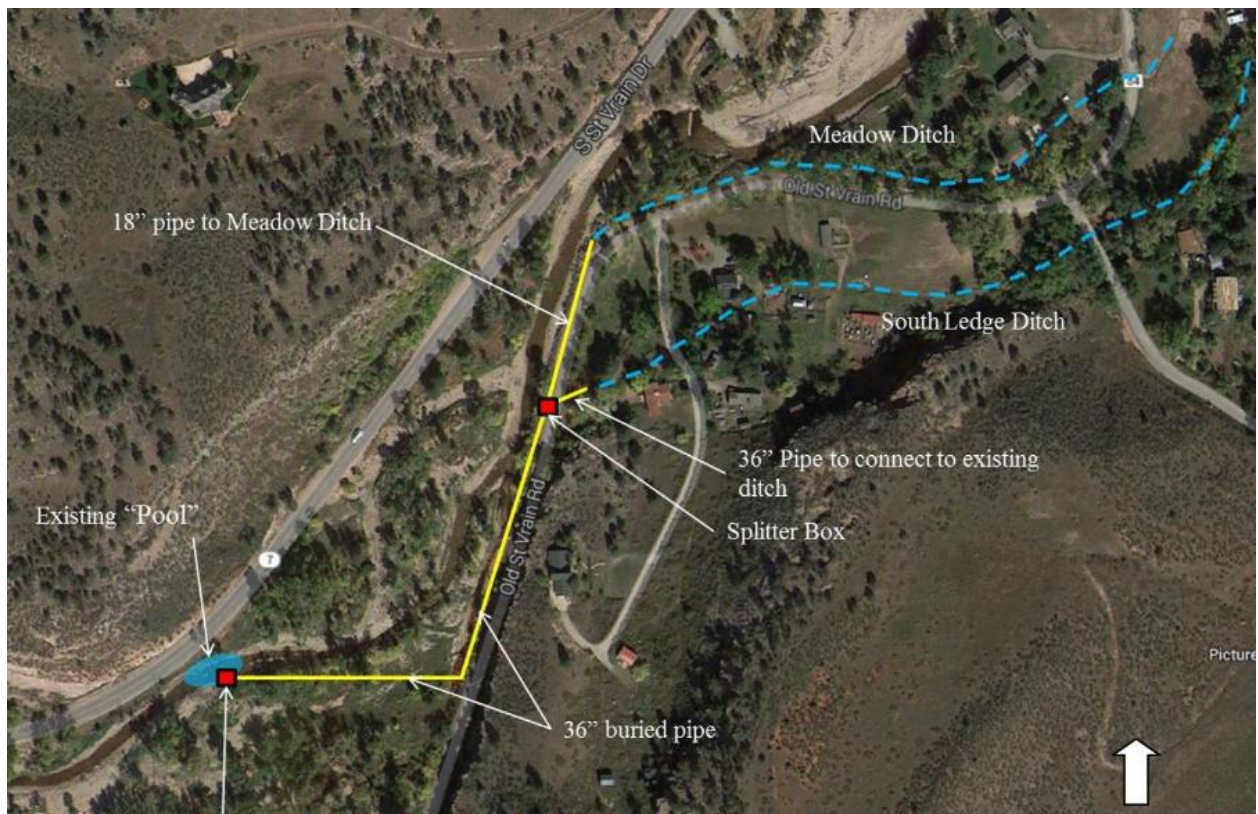
A schematic aerial photograph of the site and project design is presented in Figure 11, and the project design is described in this section. A complete set of construction drawings and project plans is provided in Appendix C.

Figure 11. Schematic aerial photograph of project site and design

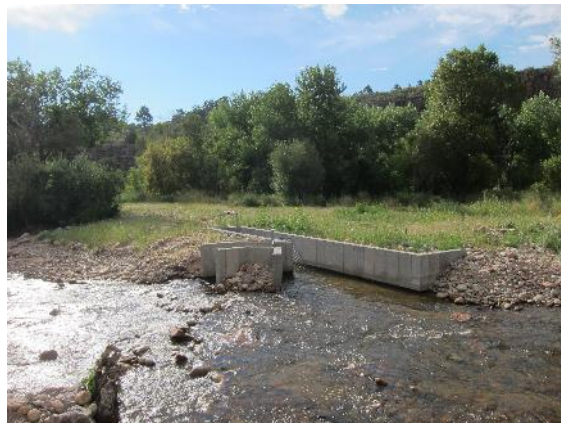
Figure 12. New intake structure and head gate on South St. Vrain Creek (river right)

A concrete inlet structure was constructed on the right streambank to facilitate the diversion of the irrigation water (Figure 12). It serves as a flow-controlling headwall for the subsurface irrigation pipeline, a sediment sluice during high-flow conditions and a trash rack for debris. The structure was designed and aligned in a manner that would encourage sediment to pass through the sediment sluice during high flows. It will not keep all sediment out of the inlet pipe but will divert the majority of it back to the stream. A slide gate installed at the sluice structure can be closed at low flow conditions to maintain water flow into the irrigation pipeline. A galvanized trash rack installed in front of the pipe inlet will prevent large debris from entering the pipeline and will require routine maintenance.

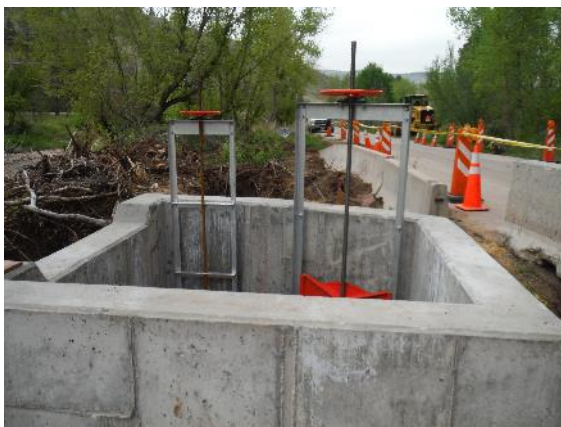
Figure 13. Splitter box that diverts water to Meadow and South Ledge ditches

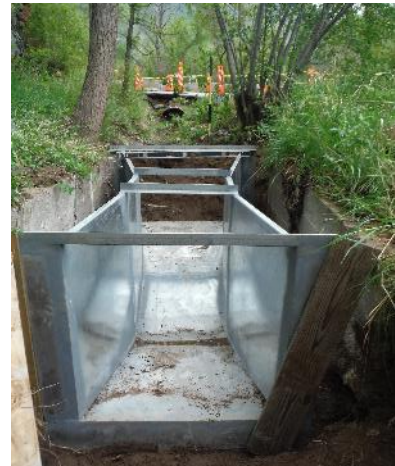
Figure 14. South Ledge diversion Parshall flume

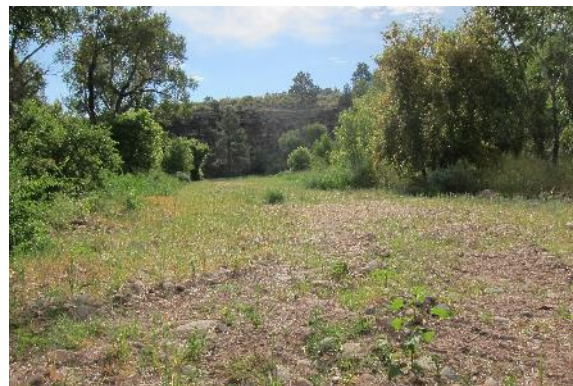
Figure 15. Post-project revegetation conditions approximately 6 weeks after seeding.

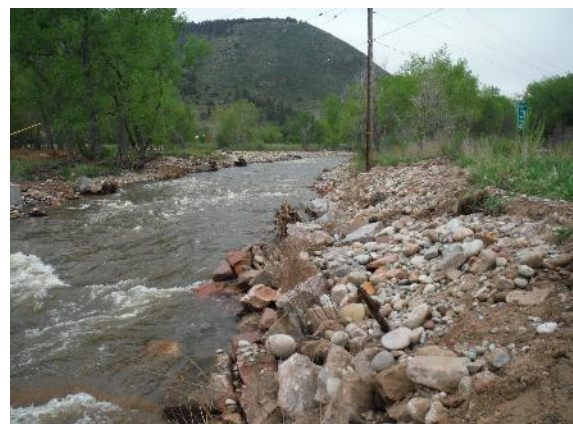
Figure 16. South St. Vrain Creek looking downstream at eroded bank on river left prior to bank stabilization and root wad installation activities.

Minor adjustments to the channel alignment upstream of the structure moved the channel slightly to the south toward the right bank (up to 20') and away from the highway to encourage flows along the outside bend of the right (south) streambank. The adjustments also help to reduce shear stress and erosion along the left (north) streambank where bank erosion following the flood

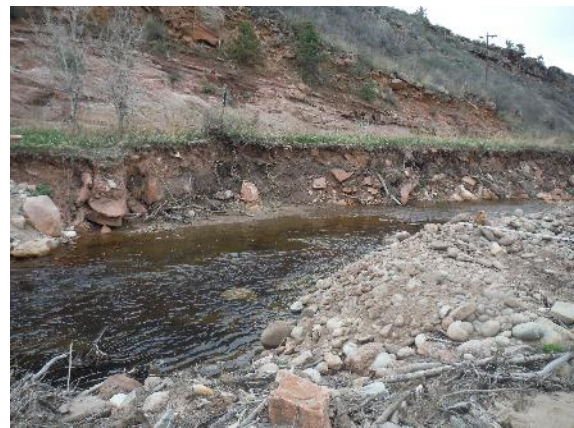
Figure 15. South St. Vrain Creek looking upstream at water supply pool. Note bank stabilizing root wads and coyote willow poles planted at the bank.

Following the flood, a mid-channel bar formed in the center of the channel downstream of the intake structure (Figure 17). This mid-channel bar was removed, the width of the channel was reduced by approximately 15 to 20 feet, and large woody debris were installed on river left to conform to the natural channel morphology upstream and downstream of the reach below the intake structure. Several boulder clusters were also installed both upstream and downstream of the intake structure to provide additional aquatic habitat.

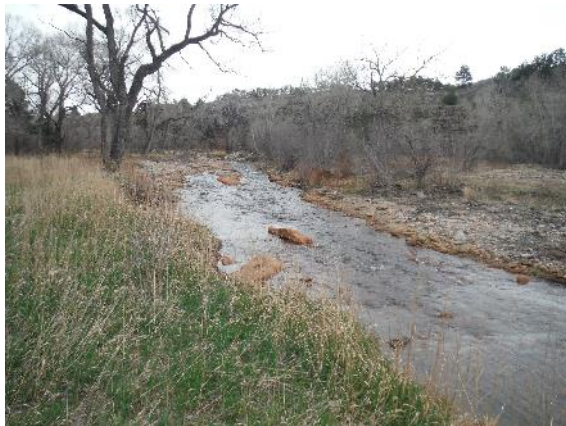
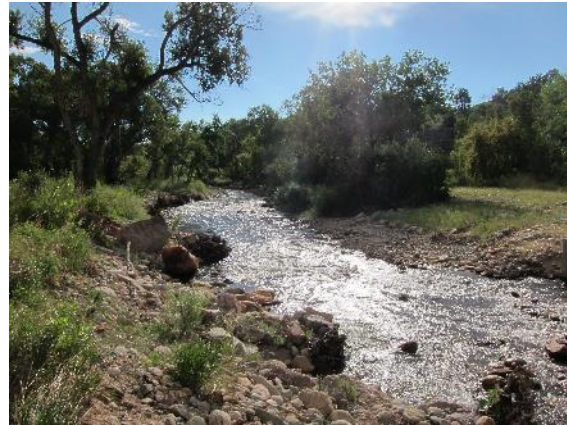
Figure 17. Pre-construction (left) and post-construction (right) photographs from Highway 7 mile marker 32 looking downstream. Note the removal of the mid-channel berm, the bank stabilization using root wads, and addition of boulder clusters and riffle complexity.

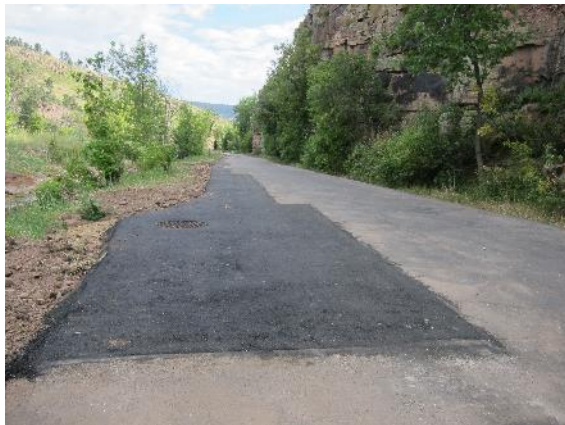
Figure 18. Road repair on Old South St. Vrain Road at manhole location.

Following construction, crews repaired the portions of Old South St. Vrain Road that were damaged as a result of the underground pipeline construction (Figure 18). As required, the entire length of the roadway in the vicinity of the project area was much improved compared to post-flood, pre-project conditions.
