United States  
Department of  
Agriculture

Forest  
Service

San Juan National Forest

Subject: Draft Recommendation for Rio Lado Creek, San Juan National Forest

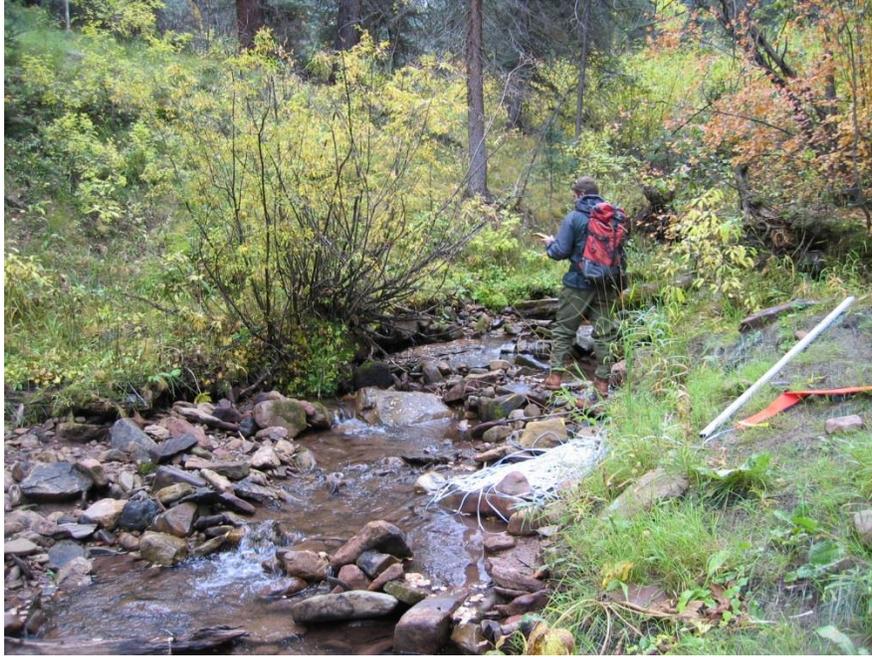
Typical channel conditions for the first 0.7 miles Rio Lado Creek above the confluence with East Fork Dolores River.

The Forest Service conducted a detailed aquatic habitat survey in 2005. Stream gradients are low to moderate for the first 0.75 miles near the confluence with Dolores River, and the substrate is dominated by coarse gravel and small cobble. Beaver dam complexes located on Rio Lado Creek above the confluence provide natural seasonal barriers to fish migration from the Dolores River. The beaver dams have created a large and complex wetland area which provides excellent

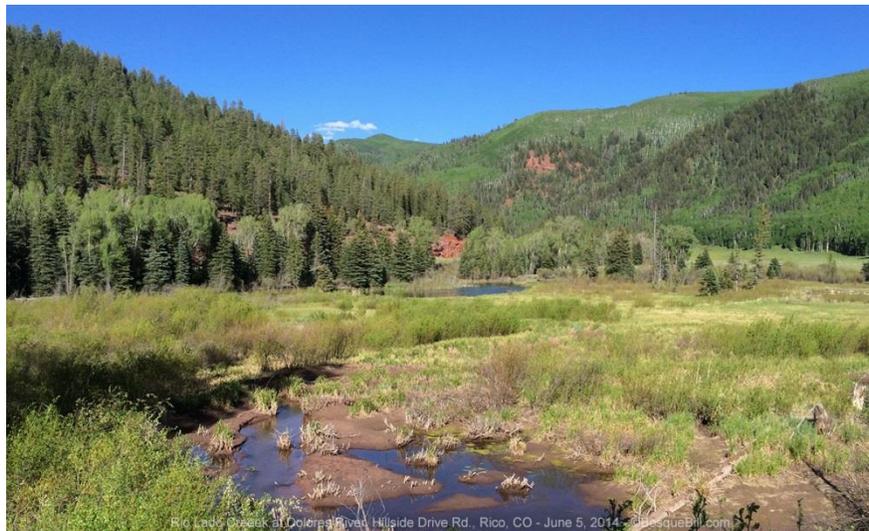
Rio Lado Creek on the National Forest near the East Fork Dolores River confluence showing large beaver dam complexes.

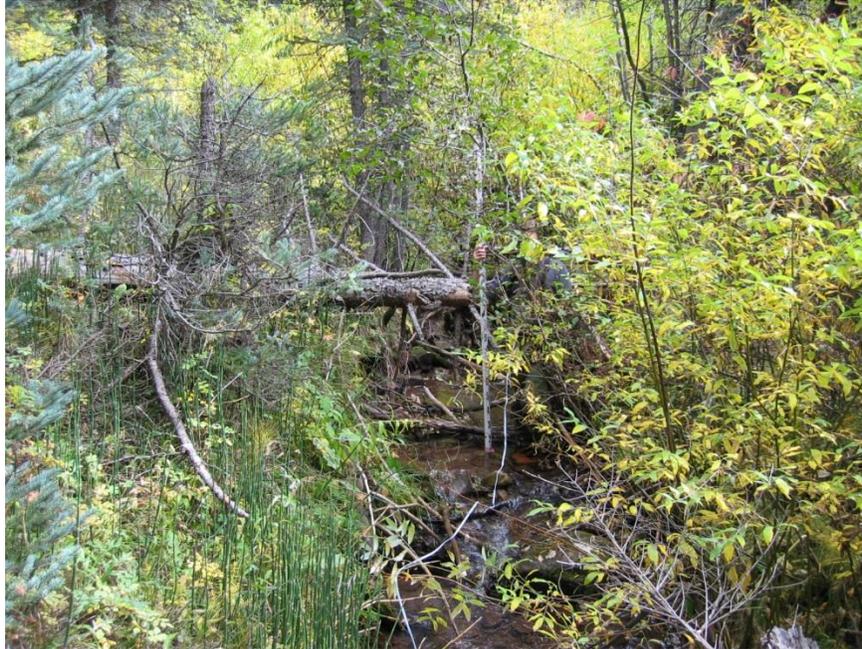
Riparian vegetation on Rio Lado Creek consists of a mix of native graminoids, forbs, shrubs, conifer and deciduous trees.

Riparian condition is good and a critical part of stream health in this alluvial channel. It provides woody debris, cover, shade, nutrients, bank stability, and aquatic habitat. The riparian consists of a mix of conifers, aspen, dense willow, rush, sedge, grass and forbs.

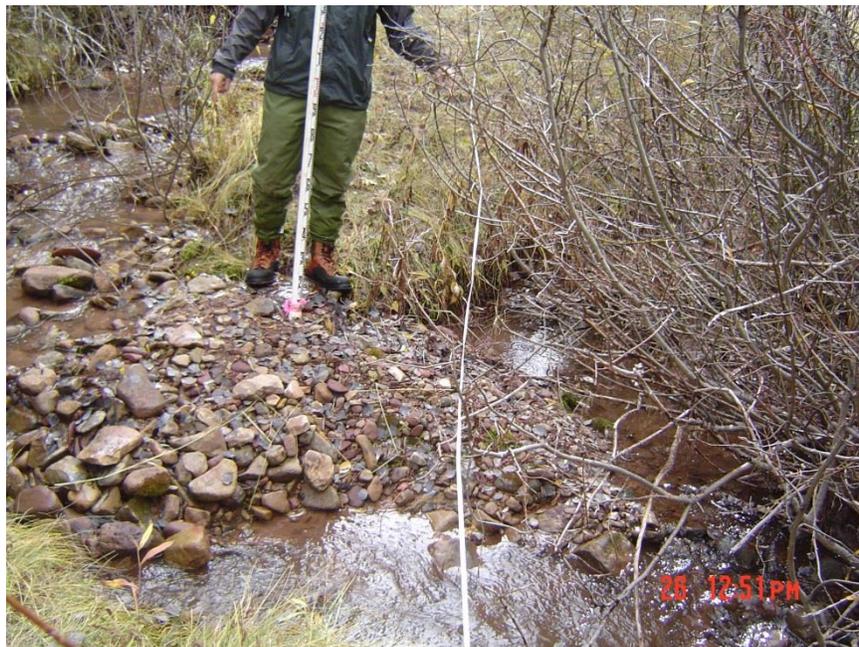
Typical channel substrate sizes present in lower gradient portions of Rio Lado Creek.
