Lower Willow Creek Restoration Project: Phase 2
Final Report

Prepared for:
Water Supply Reserve Account Rio Grande Basin Account
Attn: Chris Sturm

December 13, 2016

Lower Willow Creek Restoration Company
Grant Amount: \$55,000
Prepared by: Guinevere Nelson Freer

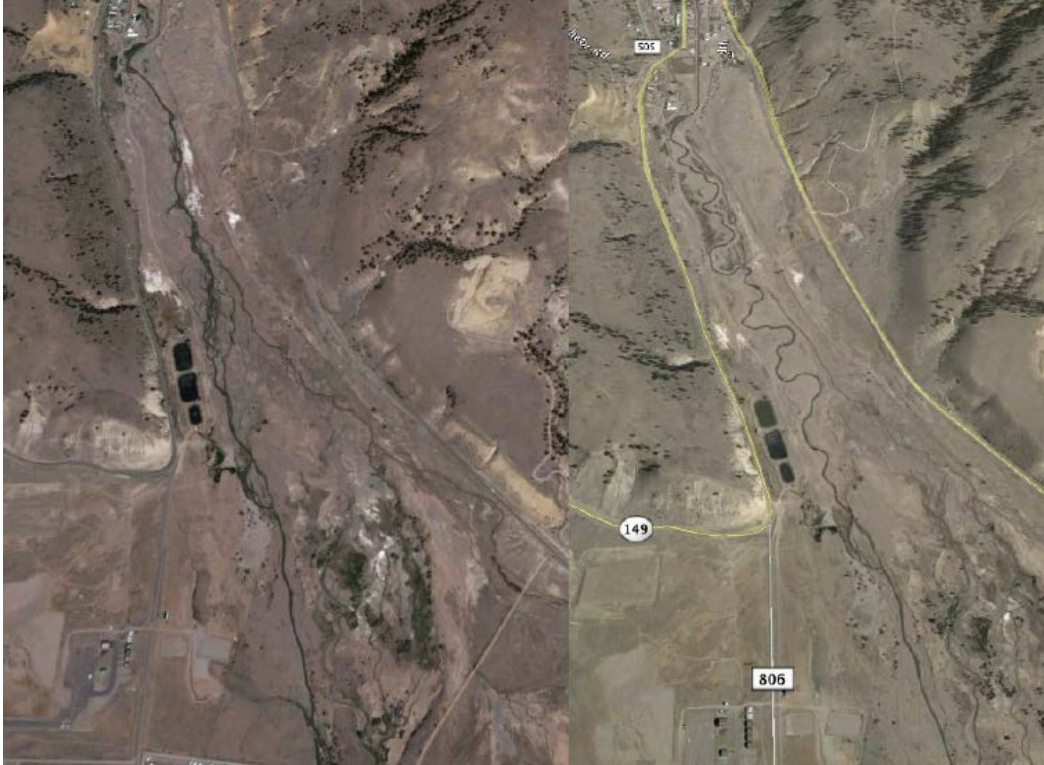
Figure 1: Photograph depicting the change in the Lower Willow Creek channel as part of Phase I. The photo on the left is the condition of the channel from 1939 to 2012. The photo on the right is the channel after Phase II was completed (photos courtesy of Google Earth).

- **Phase I** accomplishments, completed in 2014, include the creation of a new creek channel to restore the function of Willow Creek to the floodplain. The previous channel had long served as conveyance for water to downstream water users, without consideration to the ecological function of the water and the floodplain itself. This was due to the perpetually degraded terrestrial ecosystem that had persisted since mining began in the area during the 1890's and the very senior water right of downstream users. The activities completed as part of this phase included creating a sinuous channel that increased the creek length from 5,290 lineal feet to 7,200 lineal feet and the relocation of nearly 15,000 cubic yards of onsite soil. The installation of 15 rock vanes and two water diversion structures, the creation of a boulder bank rock wall, and a new ditch for diversion water delivery were tasks completed in this phase of the Lower Willow Creek Restoration Project.

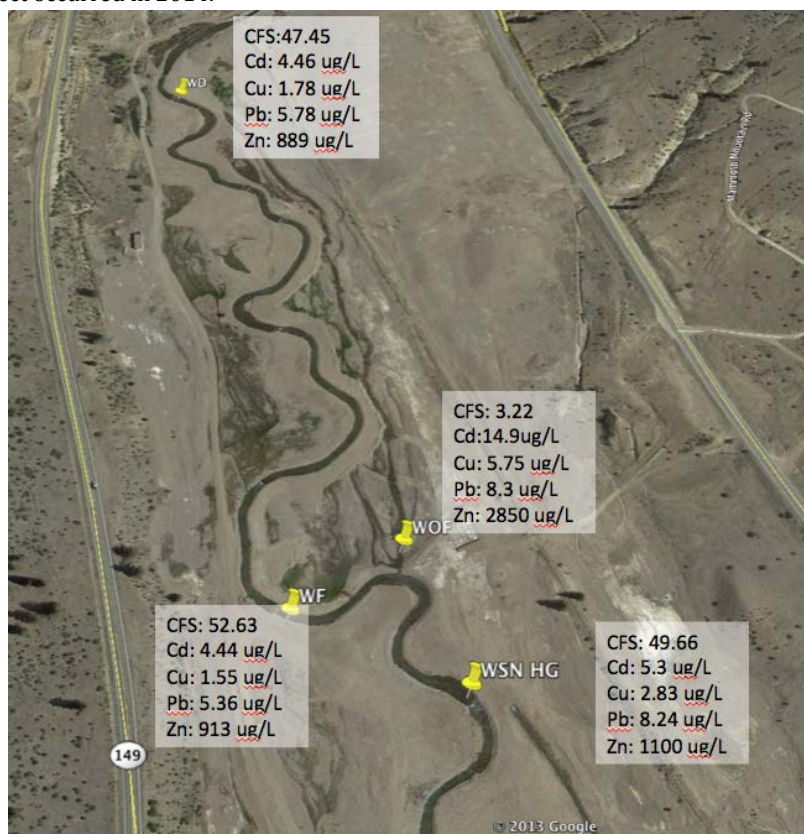
Figure 2: Summary of data collected on the Lower Willow Creek Floodplain since Phase I of the Lower Willow Creek Restoration Project occurred in 2014.

The WCRC has monitored water quality since 1999 on a biannual cycle to coincide with high and low flow of the creek. After Phase I of the project, WCRC identified a new trend in water quality on the floodplain. Data indicated that the historic channel that is still being sourced from groundwater, was contributing significant loading of heavy metals. In Figure 2, a snapshot of the new trend in water quality results is depicted from data that was collected on the project site. The yellow tacks are permanent sampling locations established and continually monitored by the WCRC. Sites W-D and W-OF bracket the old channel, whereas W-D and W-F bracket the new channel. Sample site WSN-HG is downstream from both channels in a well-mixed area and demonstrates the impact of the historic site conditions on the creek. The marked improvement to water quality within the new channel, a decrease in all metals, and a 1,937 ug/l decrease of zinc is what we hope to see in coming years, since the largest source of discernable metals loading has been addressed in Phase II. Phase II mitigated the impact of the old channel on water quality by covering the channel with soil and reducing the water that returns to the mainstem of Willow Creek. The concentrations are elevated due to the background of the Nelson Tunnel input. Averages of concentrations of cadmium, copper, lead and zinc exceed table value standards for chronic impairments and negatively impact the composition of aquatic life. This segment of creek is listed on the 303 d list for impaired waters for cadmium, zinc, and pH. However, in the fall low flows of the creek fish have been spotted in the upper reaches of the creek since the new channel was created.

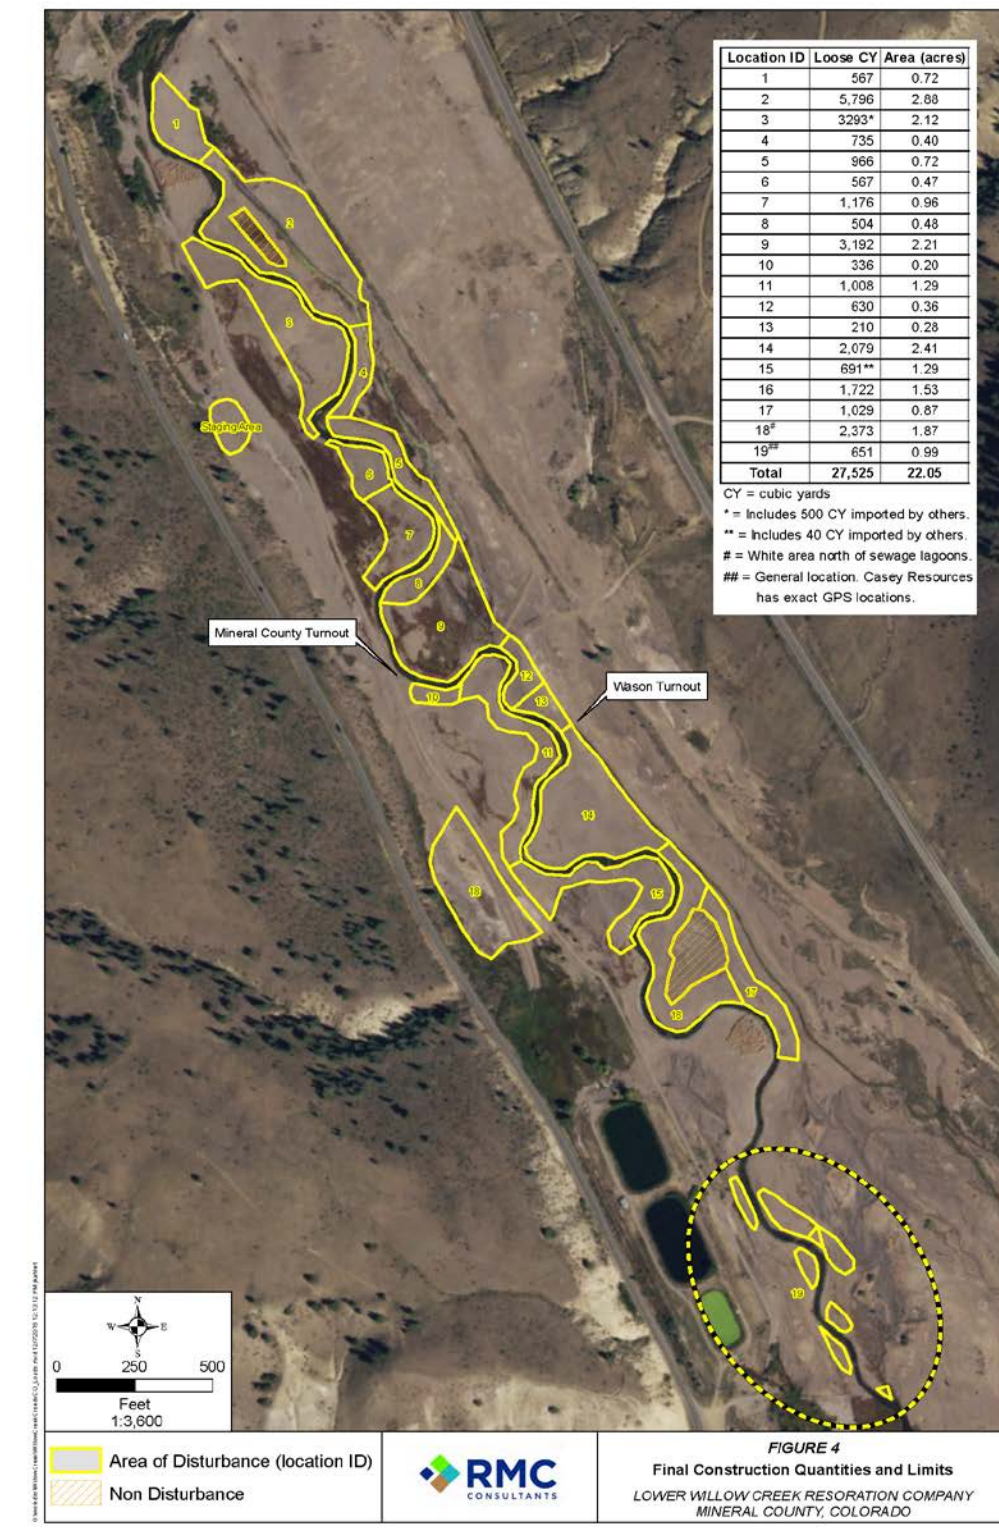
Figure 3: The final volumes of acres capped on the Lower Willow Creek Restoration Project site by RMC in 2016.

The current results demonstrate qualitative changes to the floodplain but the outcomes remain impressive. RMC was able to excavate, haul and grade 27,525 cubic yards of soil to meet the Lower Willow Creek Restoration Project goals. In Figure 3, the map indicates the areas covered during the project. Areas 1-9 received substantially more soil than the other areas, due to the need to get the project site to grade as well as meet capping requirements in the VCUP. Areas 1, 4, 5, 8, and 9 covered the historic channel that has demonstrated additional loading to the creek, as demonstrated in Figure 2. Areas 10-19 covered with an average of 6 inches of soil in accordance with the VCUP specifications to meet open space standards. The targeted area of the cap was based on XRF readings that indicated an increased concentration of lead. The non-capped areas in the region next to area 19 met the action level of 1,500 mg/kg of lead in the soils. Although full-scale sampling of the new cap will occur in the spring, the LWCRCo sought to maximize the resources and prioritize the areas of high lead levels.

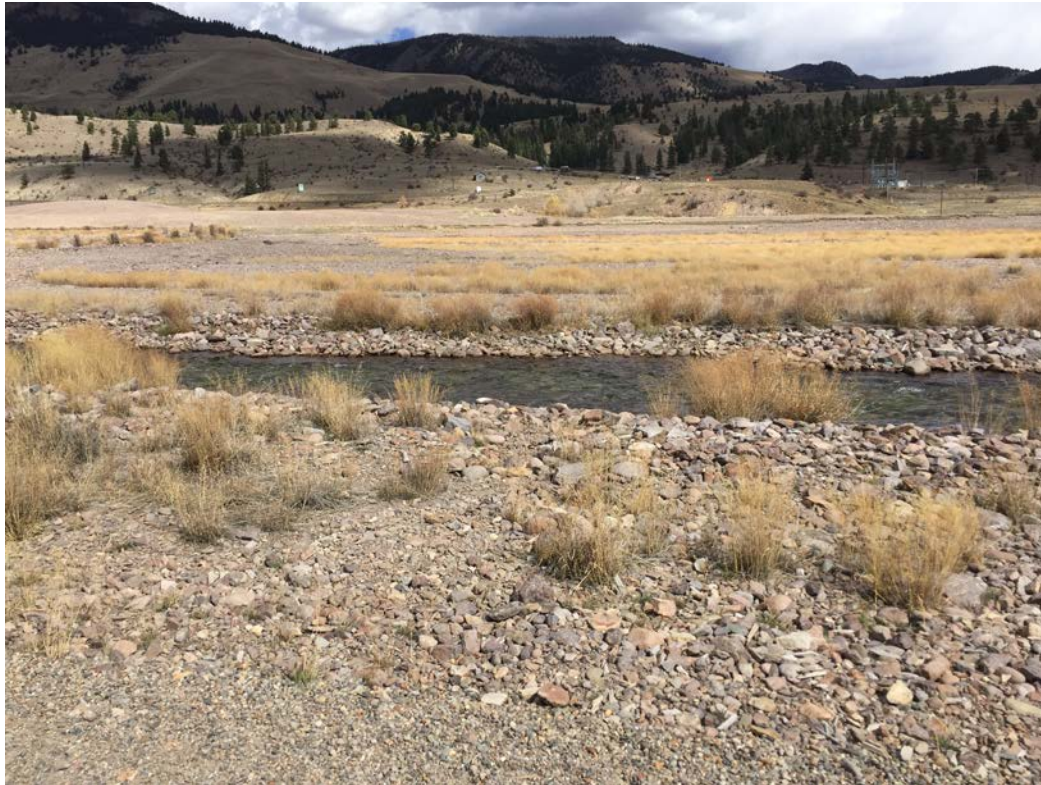
Representative condition of the soils along Willow Creek within the Lower Willow Creek Restoration Project Site before Phase II.

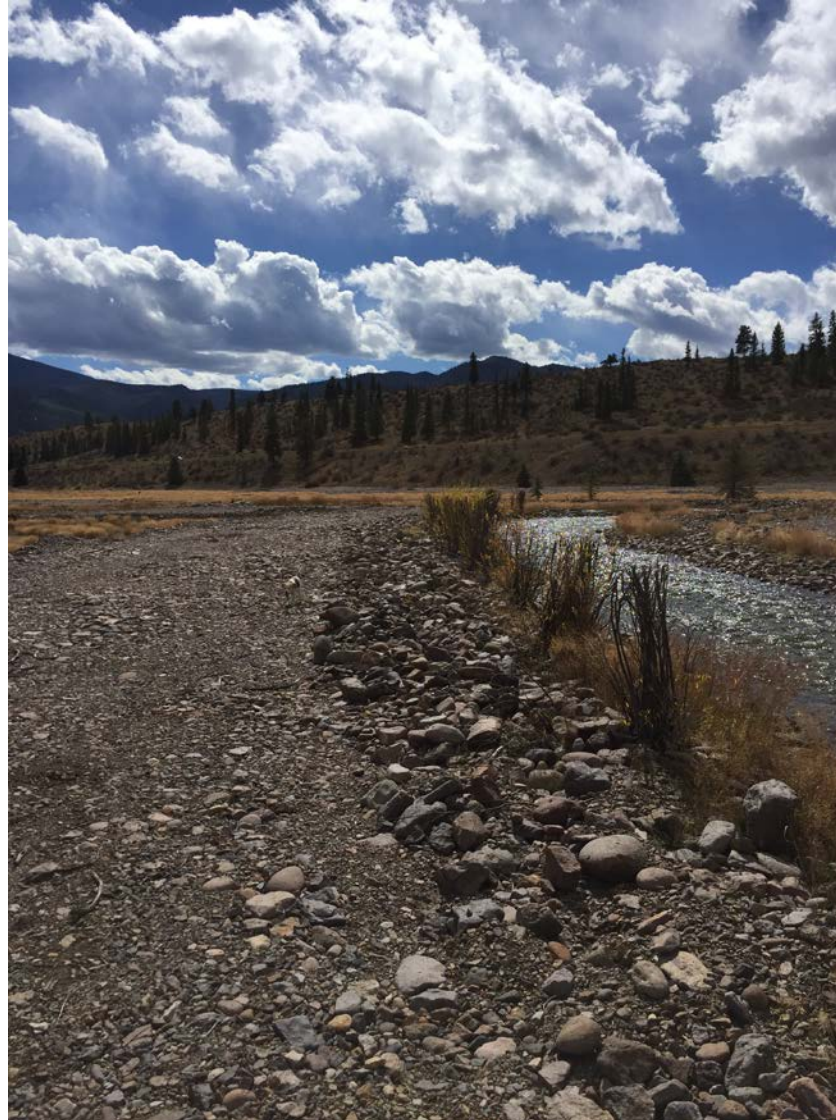
Representative condition of the soils along Willow Creek within the Lower Willow Creek Restoration Project Site before Phase II.

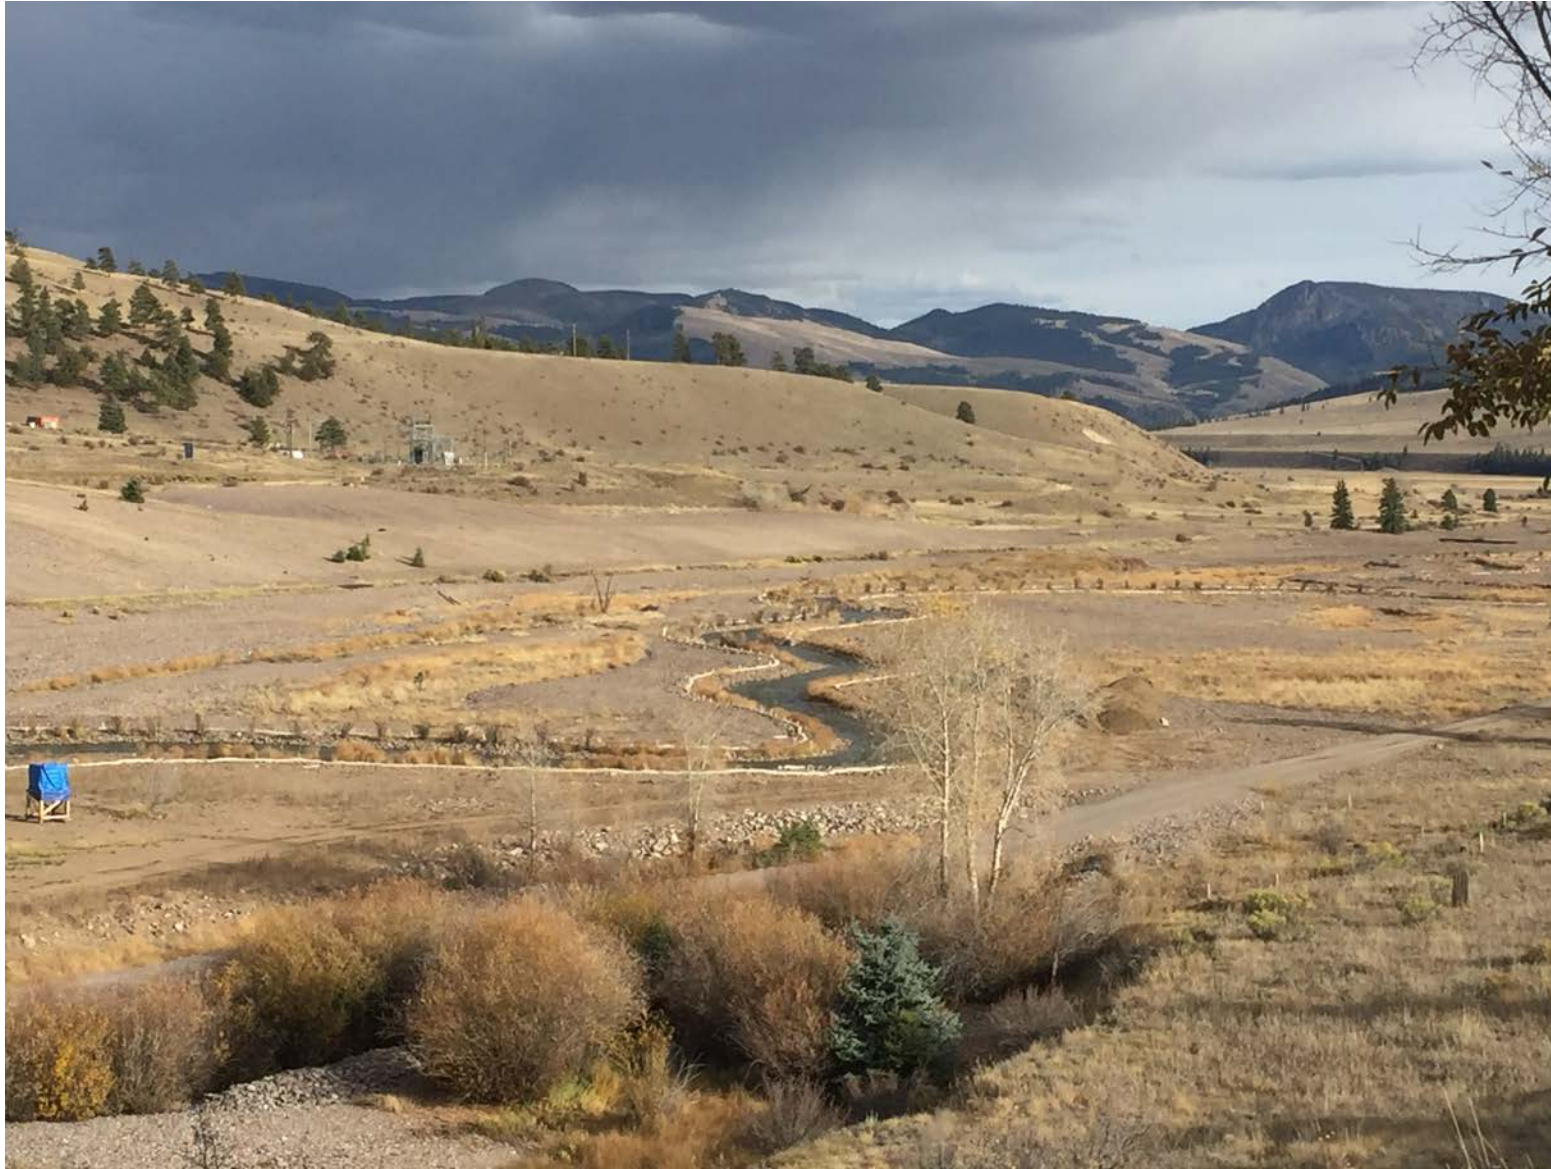
Pre-project SWMP installation of straw wattles along Willow Creek

The borrow site was excavated during construction to a 2H:1V slope that ties into the remaining hillside. The CDOT ROW was excavated and backfilled into the hillside and created a sloping drainage that directed water toward the existing CDOT culverts. Upon completion of this work, 375 linear feet of straw wattles for SWMP control were installed.

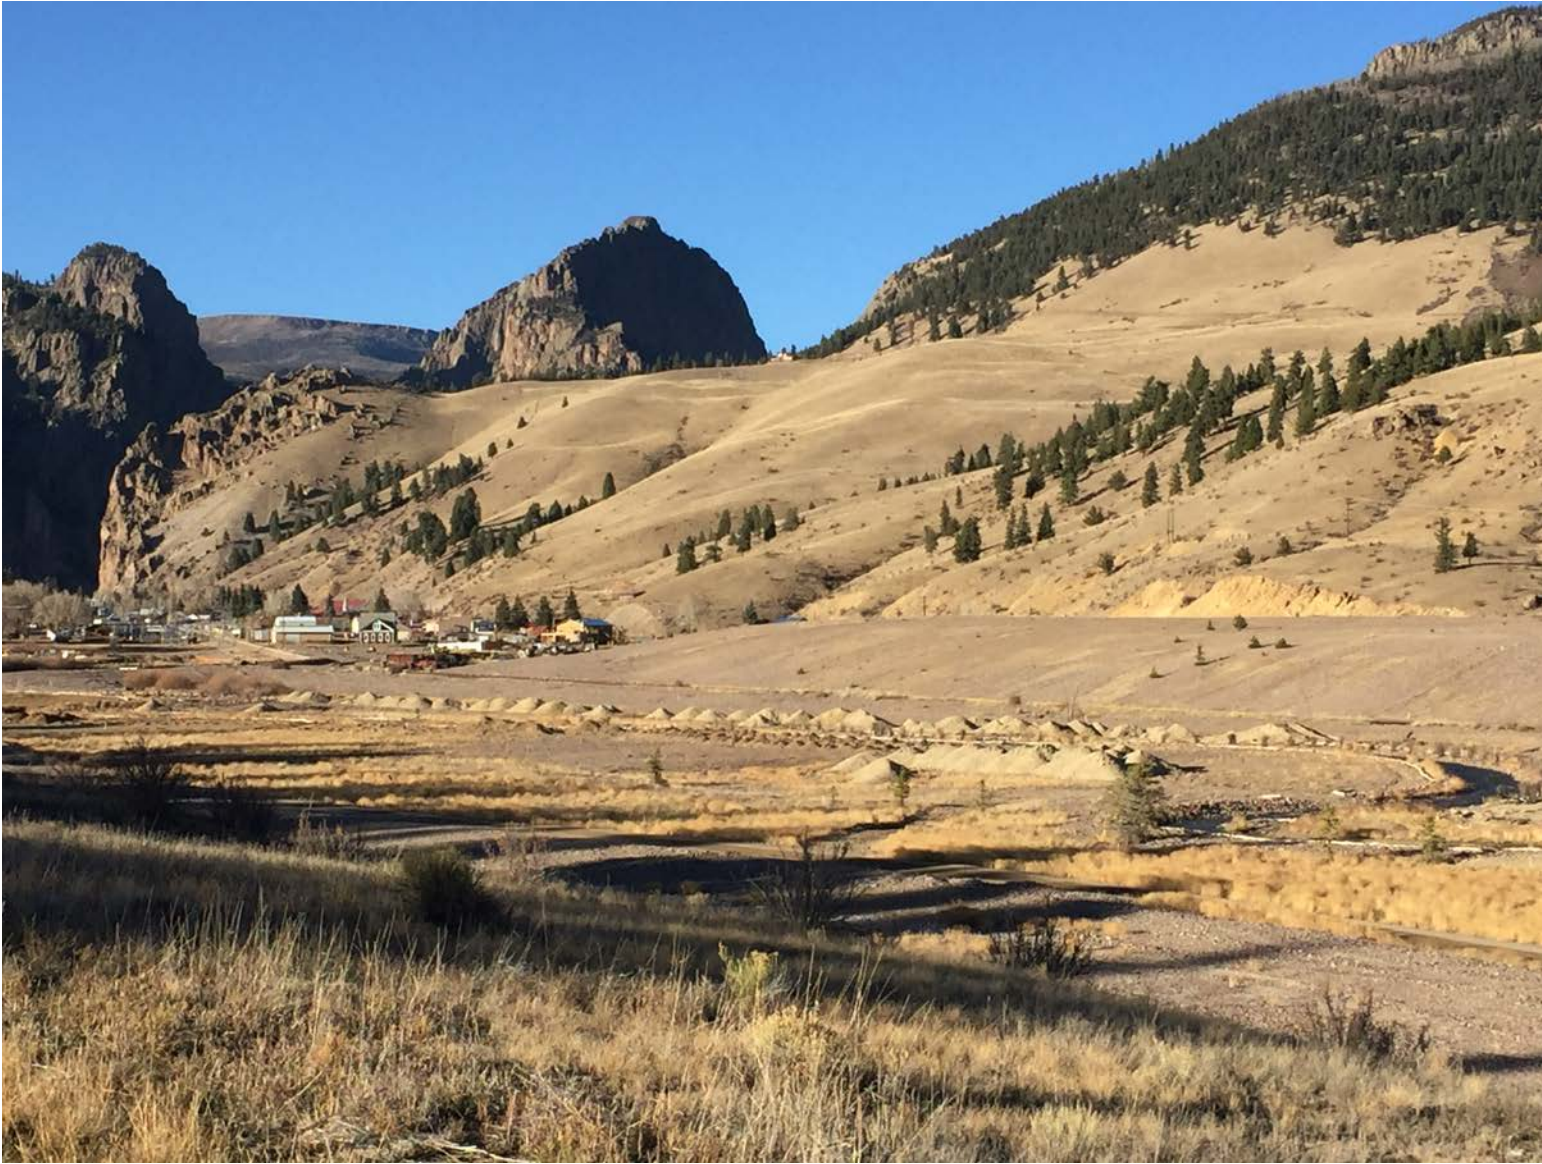
Staging of soil from the borrow site on the Lower Willow Creek Project site.

Soil was excavated from the borrow site and loaded into the 30 ton haul trucks and placed into 18 areas to track and control quantities of soil. The soil was then bulldozed into place and compacted by the sheep's foot. A total of 26,334 loose cubic yards were transported from the borrow site to the floodplain site and indicated in Figure 3. An additional 1,191 loose cubic yards were transported by RMC from stockpiled soil on the floodplain from a previous donation of soil. Six stream crossings were created in accordance with the 404 permit to transport soil across the creek as needed. These stream crossings were repaired after hauling, placing, and grading were complete. RMC used 114,300 gallons of water donated to the project by the City of Creede to mitigate dust, per the Material Management Plan. LWCRCo identified an area of 1.87 acres where white precipitate persisted, north of the Creede Sewer lagoons. In Phase I a cobble berm was created adjacent to this
