## **Final Report for Drip Irrigation Field Trial for Sustainable Potato Cropping in the San Luis Valley**

## AGRONOMIC MONITORING REPORT FOR DRIP IRRIGATION TRIAL 2013

Beiriger Farm, San Luis Valley of Colorado

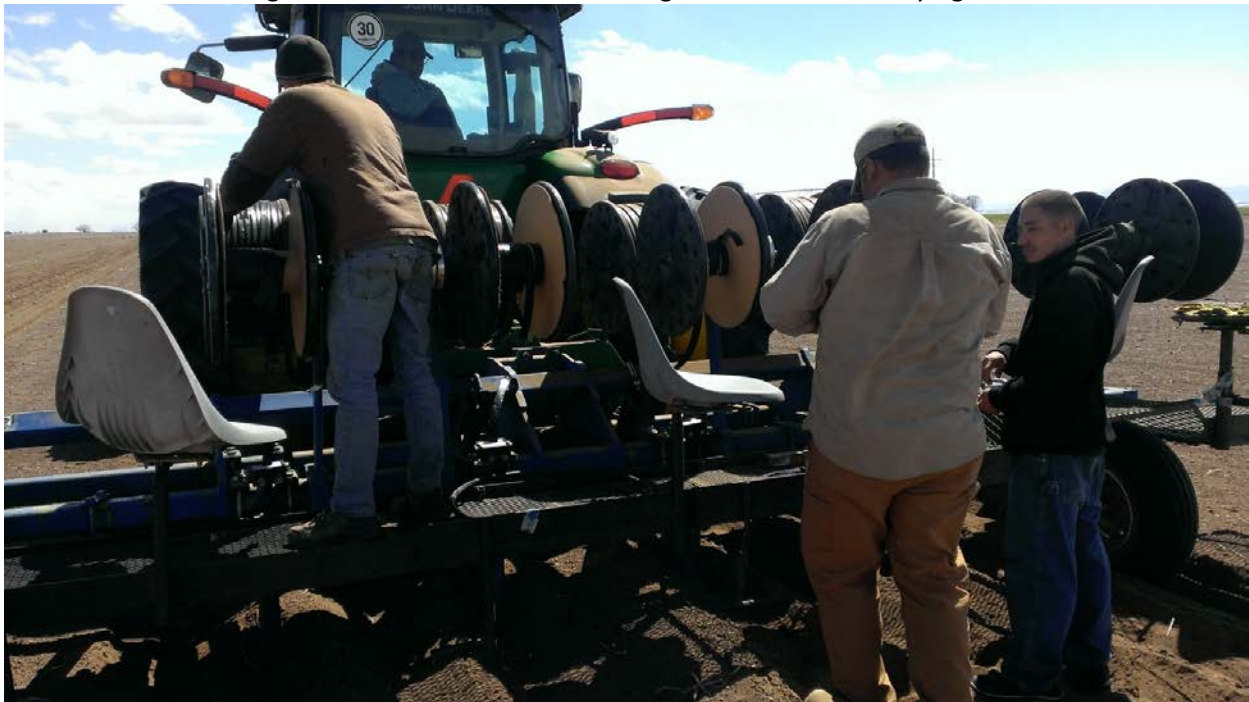
**Figure 1 Installation at Beiriger farm**

In April both sites had their systems installed with relatively few problems. Minor adjustments were made in the layouts as the design was being put in place. Weather delayed the Christensen site installation for over a week but it was still ready at planting time. Both systems were tested prior to planting and some adjustments were made at both sites after the irrigation wells were on line and system testing verified the quantity of water available to irrigate with. Additional zones were added to the north field (#7) at the Beiriger site, and additional filtration equipment was added to the Christensen site because of the larger volume of water from the irrigation well after verifying the water flow.

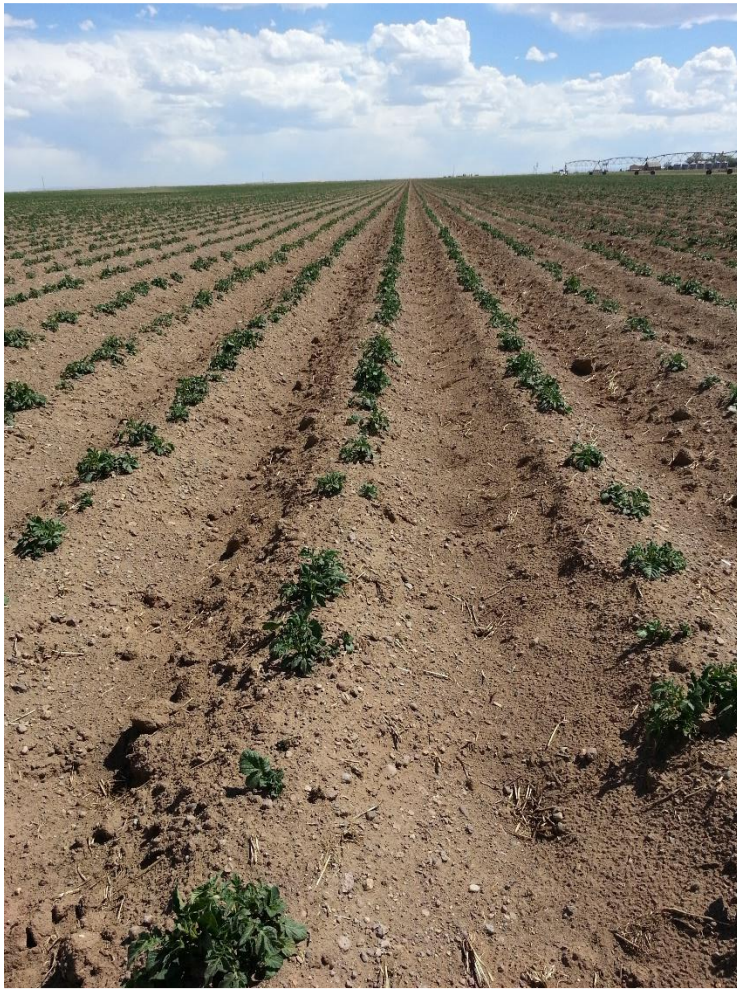
**Figure 6: Dry soil surface prevailed on Subsurface Drip trial until rainfall event in Late July. Low residue crop the prior year aggravated water holding capacity and capillary movement of water.**

Weeds were not an issue in the subsurface drip trial until very much later in the season, when it rained, due to the dry surface of the soil to 10 inches (see Figure 6). The surface Drip trial had a serious weed infestation that required manual weeding by a crew. For future surface drip installations, a banded application of herbicide along the drip tape is recommended, which still reduces chemical costs by at least 50%.

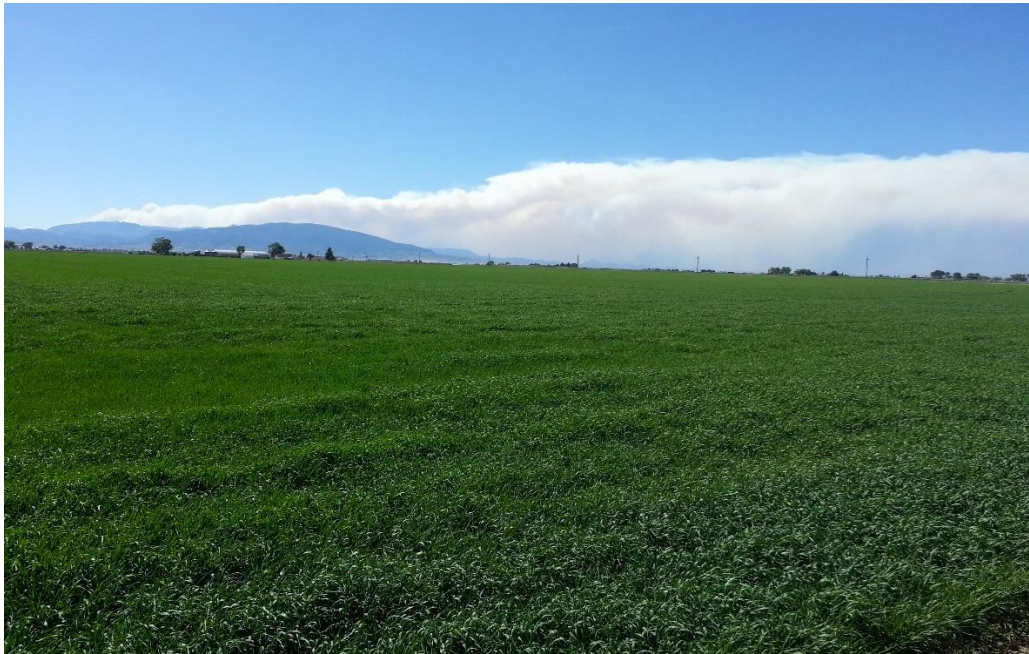
**Figure 7: Drought stripes in Barley on Field 7**

In 2014, both fields were planted to Coors C69 malting barley, and an attempt was made to grow field 7 using the buried drip. Field 6 was watered using only center pivot overhead sprinkler irrigation. Barley was established using center pivot irrigation on both fields and then on field 7, switched to subsurface drip. Immediately a new problem was discovered with subsurface installations and that was the perforation and damage due to pocket gophers. Various repellents were tried to no avail. Again, the lack of upward capillary movement of water resulted in severe banding of drought stressed barley (See Figure 7) and after 3 weeks, the field was switched to sprinkler irrigation.

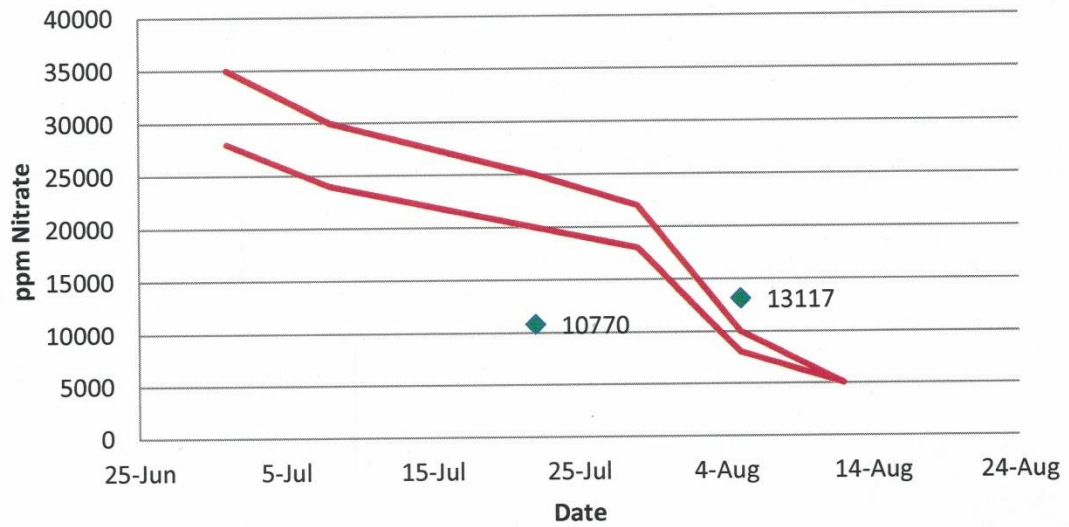
AMP  
Field Subsurface Drip  
Norkota 3

### Petiole Nitrate

### Petiole Phosphate

Appendix C includes soil test results and the tissue testing results from the 2 sampling events in 2013. What these graphs show is that in the subsurface drip trial, the fertilizer band was inaccessible to the deeper root system since it was never wetted. In order to fertilize shallow rooted potatoes under drip irrigation, it may be preferable to change the placement of the fertilizer band. For sub-surface installations, a deeper band may be preferable. For surface drip, especially in alternating rows, a single band placed on the wet side of the two row "bed" would also be better, as would a bed system, rather than the standard row system that prevails in the San Luis Valley.
