High Country Conservation Advocates (HCCA) and Western Resource Advocates (WRA) submit this instream flow recommendation for Dutchman Creek, located in Saguache County, Water Division 4.

ENCLOSURE - INSTREAM FLOW RECOMMENDATION FOR DUTCHMAN CREEK

Preliminary R2CROSS Analysis

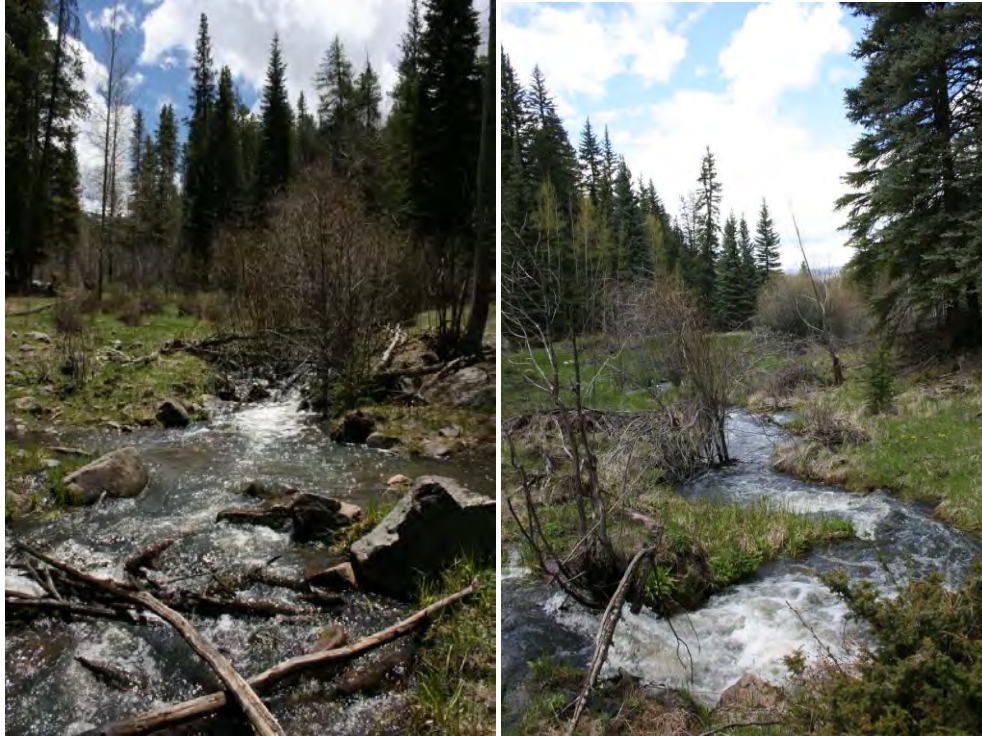
Photographs 1 and 2 show Dutchman Creek approximately two miles downstream from the headwaters during of May runoff. May mean flow according to StreamStats is 14.2 cfs.

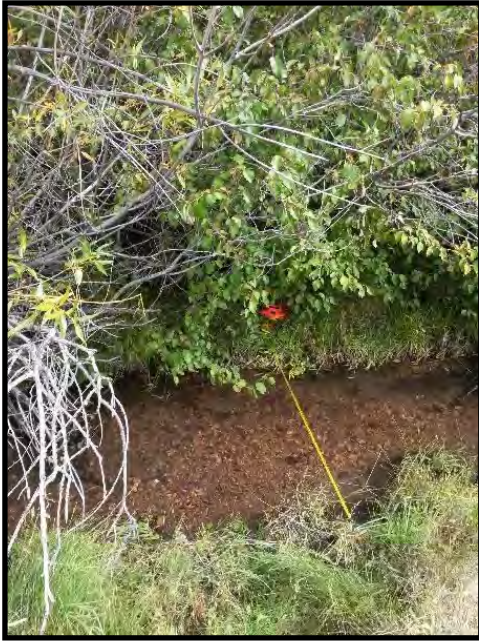
Left bank facing towards cross section

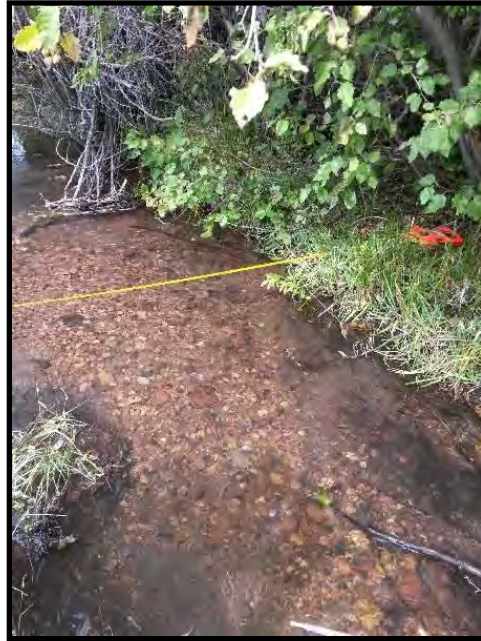
Left bank facing downstream of cross section

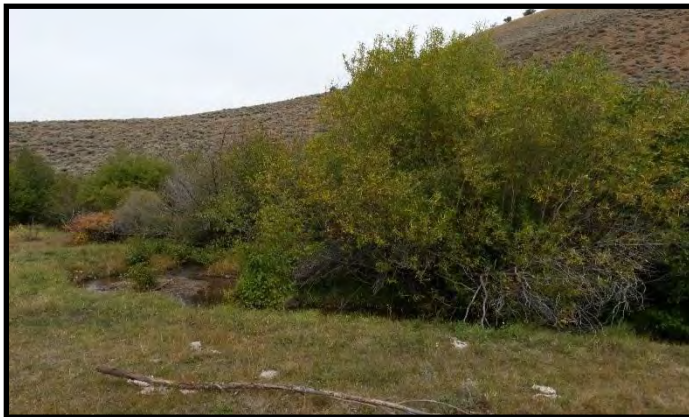
Left bank facing downstream at the assessment site

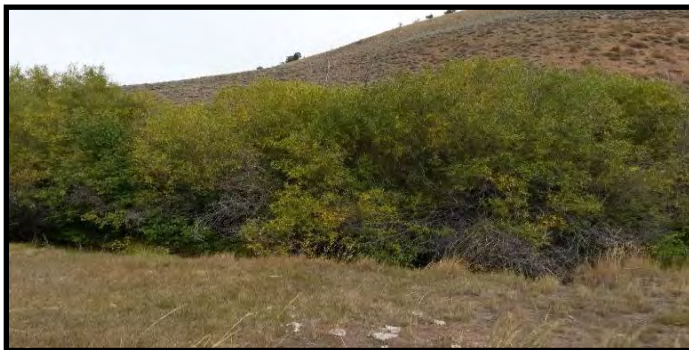
Left bank facing perpendicular to assessment site

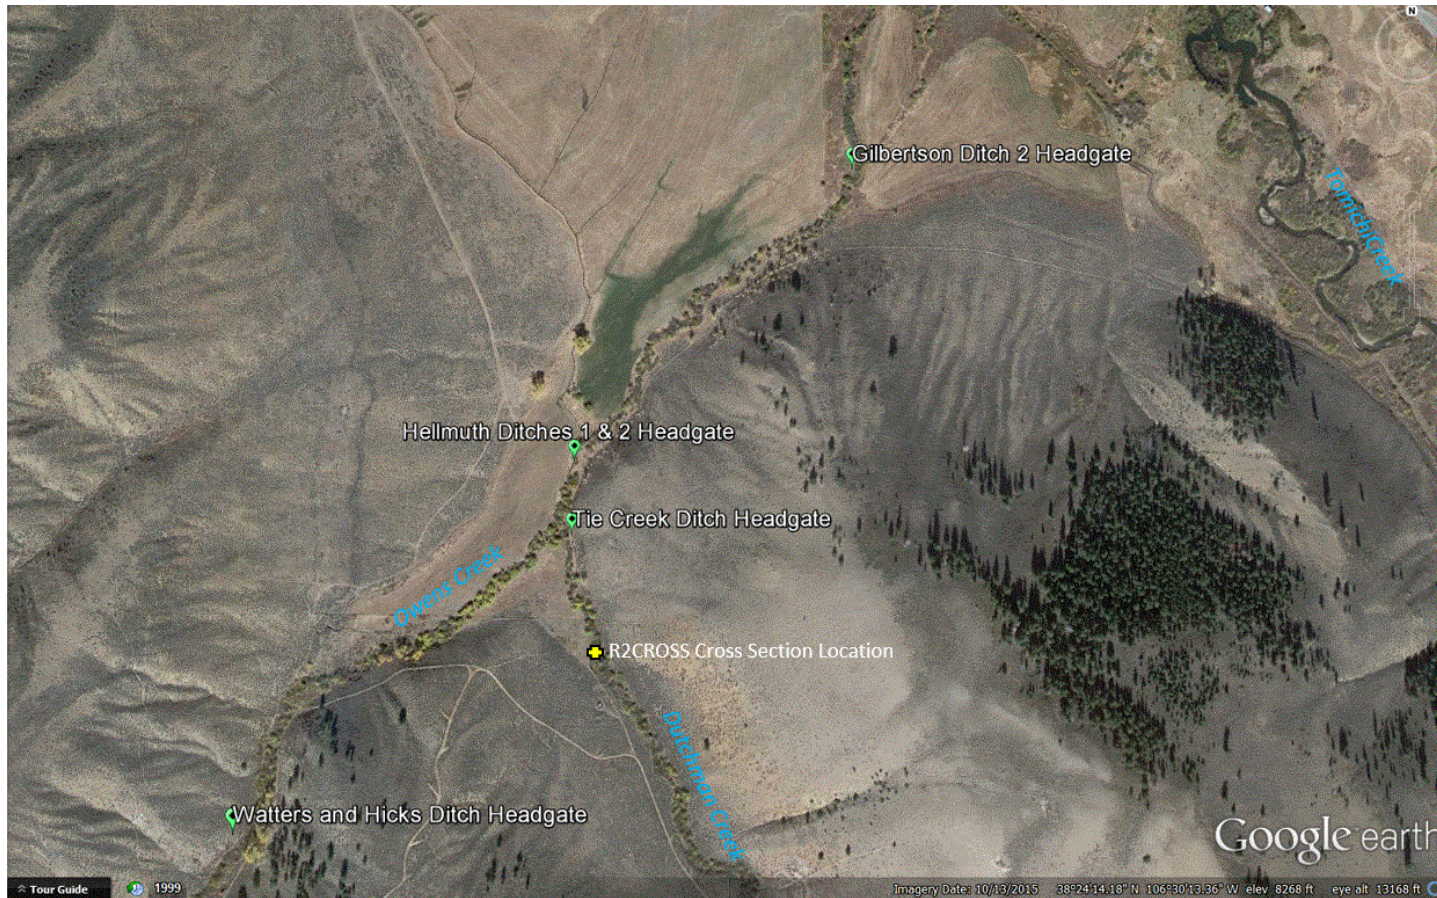
Diversions are shown on the map below. There are no decreed active water rights within the proposed instream flow reach between the headwaters of Dutchman Creek and the confluence with Owens Creek. However, records for diversions below where the two creeks meet list Dutchman Creek as the water source for these rights. The USGS cites the same source as Owens Creek. The map and diversion information below clarifies the location of these ditches as diverting from Owens Creek.

Map of Dutchman Creek Area Diversions and R2CROSS Cross Section Location

Diversions on Owens Creek and below the proposed ISF reach are shown on the attached diversion map (Attachment D). There are no decreed active water rights within the proposed instream flow reach from the headwaters of Dutchman Creek to the confluence with Owens Creek. A copy of the water rights search on Dutchman Creek is included in Attachment D (these ditches refer to Dutchman and Owens as a source but are located off of the proposed instream flow reach). There is also a map of the headgate locations that demonstrates that these diversions are not on the proposed instream flow reach but are either located on Owens Creek above the confluence or below where Dutchman Creek joins Owens (Attachment D).

See map with R2CROSS location below in Attachment D, Legal Availability
