**Bluff Lake Nature Center**  
**Final Grant Report to the Colorado Water Conservation Board**  
**Bluff Lake Nature Center Aquatic Habitat Improvement Project**

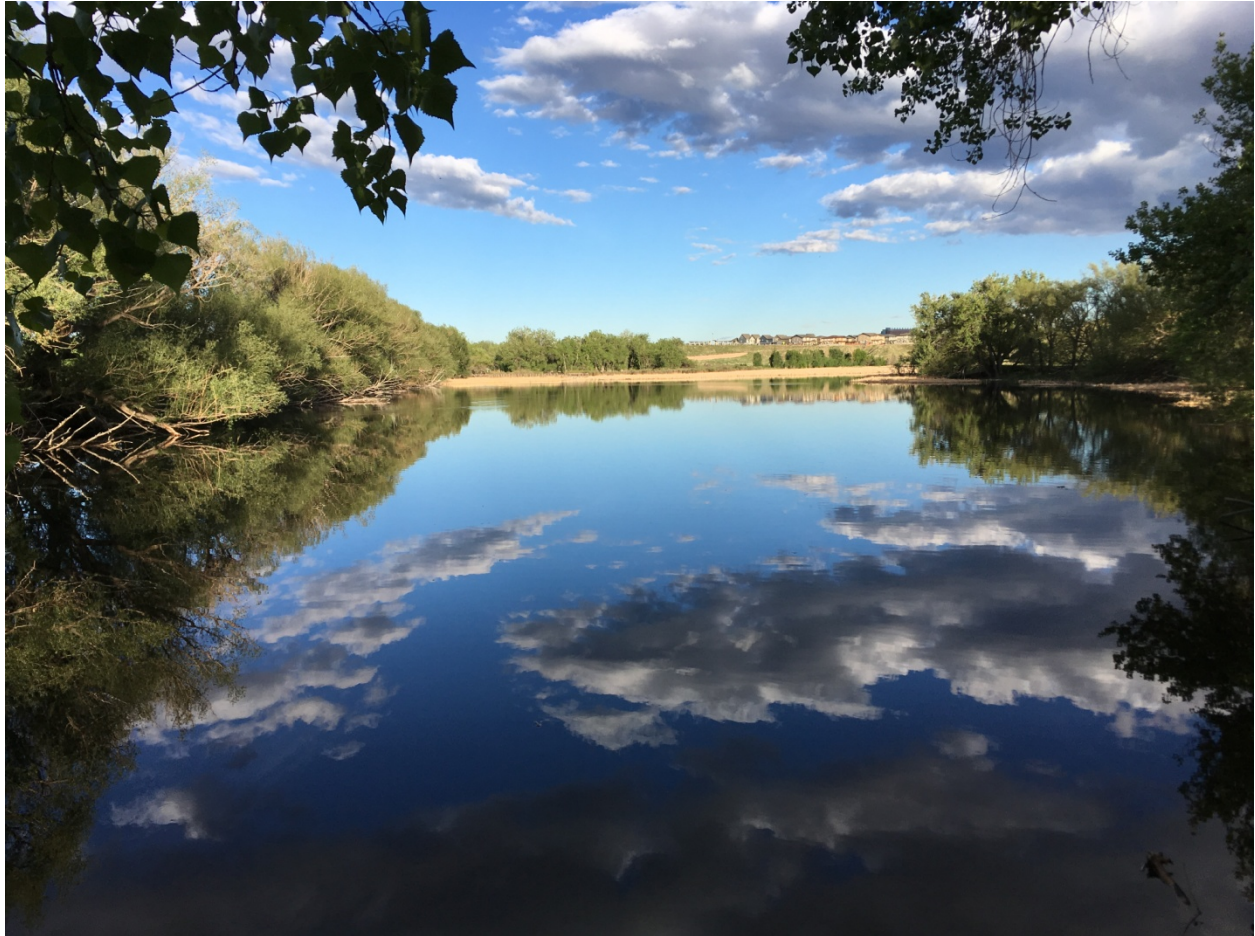
*Bluff Lake after the conclusion of the Lake Project*
