Final Report

Mancos River Habitat and Diversion Project

Phase III

Ann Oliver, Project Manager
Mancos Conservation District
March 14, 2018

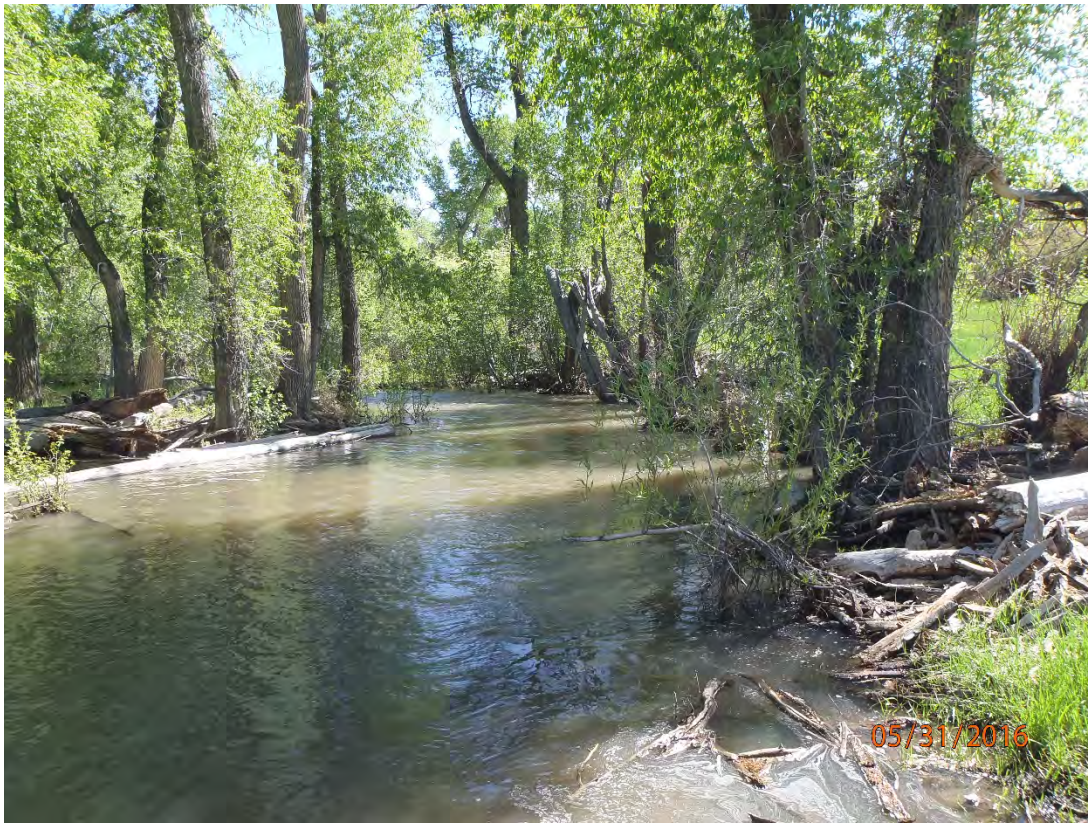
Figure 3 Graybeal Diversion BEFORE (May 31, 2015).

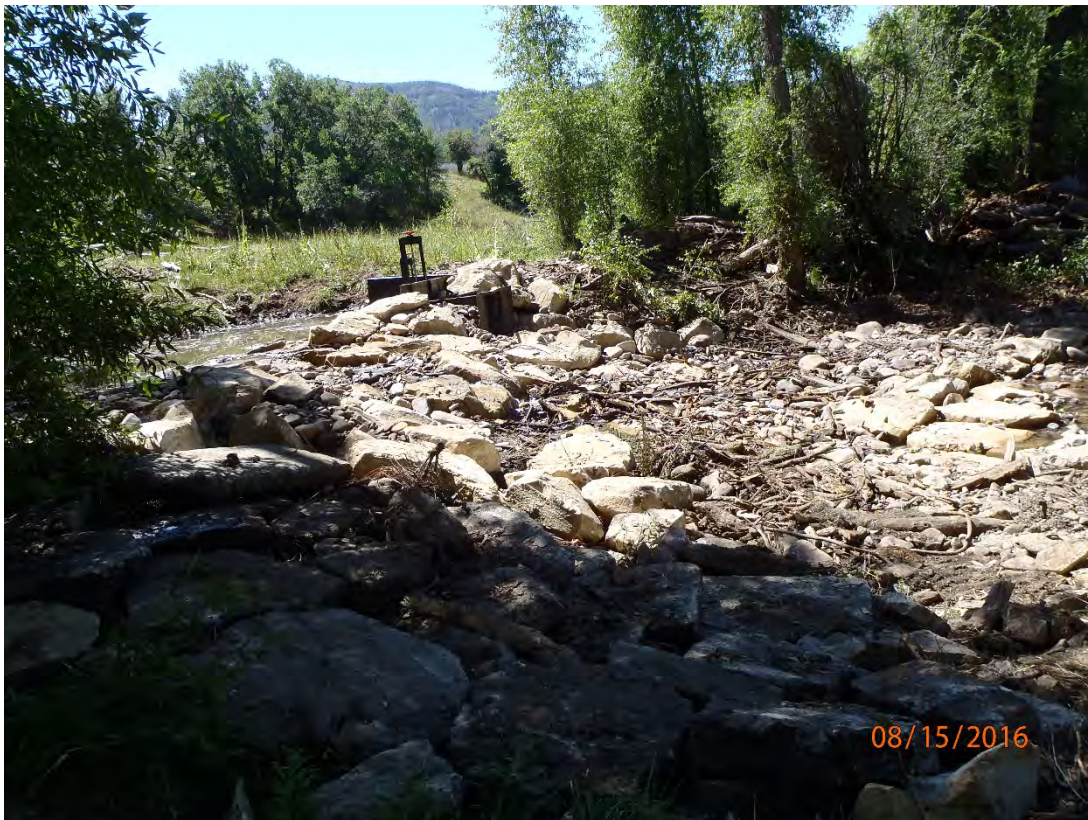
Figure 4 Graybeal Diversion AFTER (August 15, 2016).

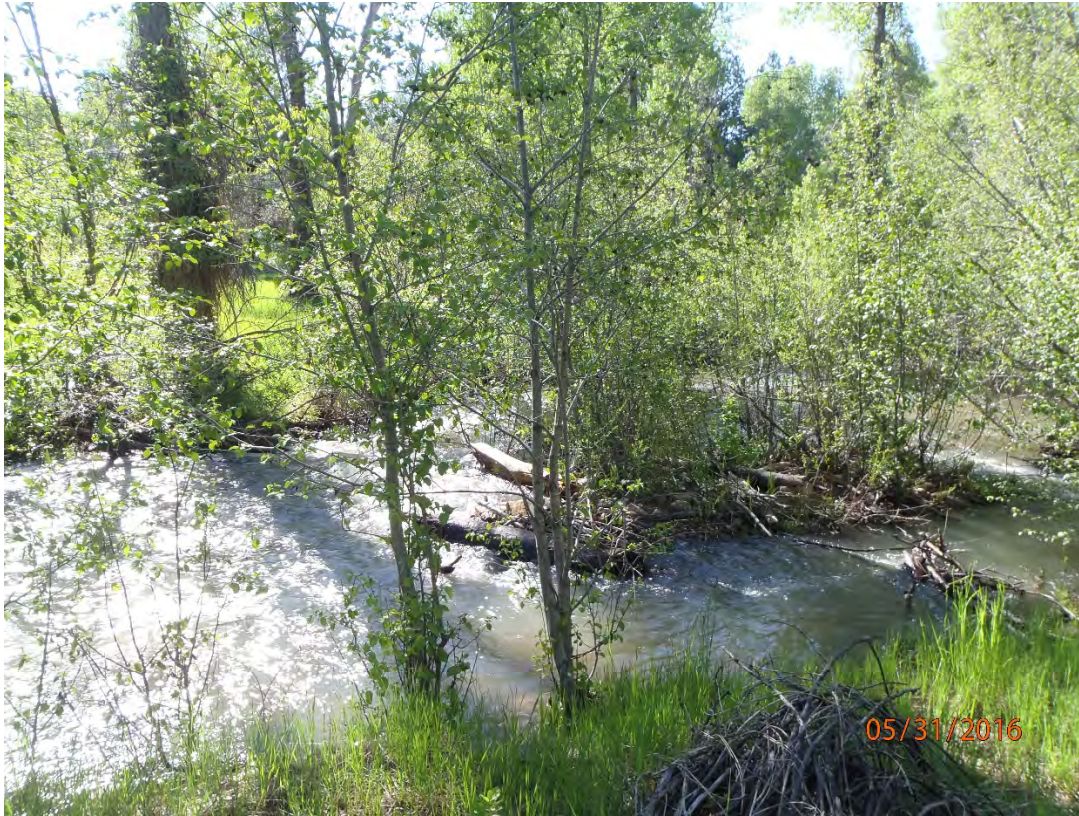
Figure 5 Giles Diversion BEFORE (May 31, 2016).

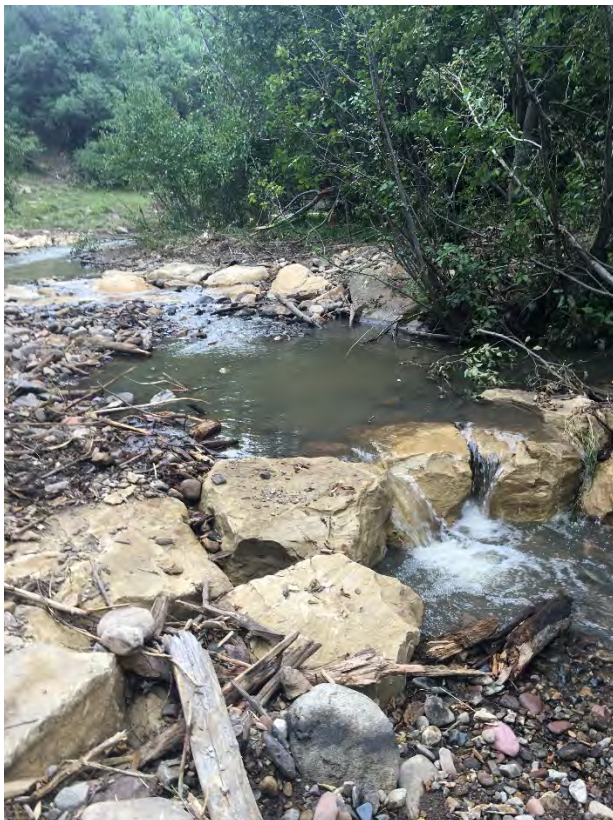
Figure 6 Giles Diversion AFTER.

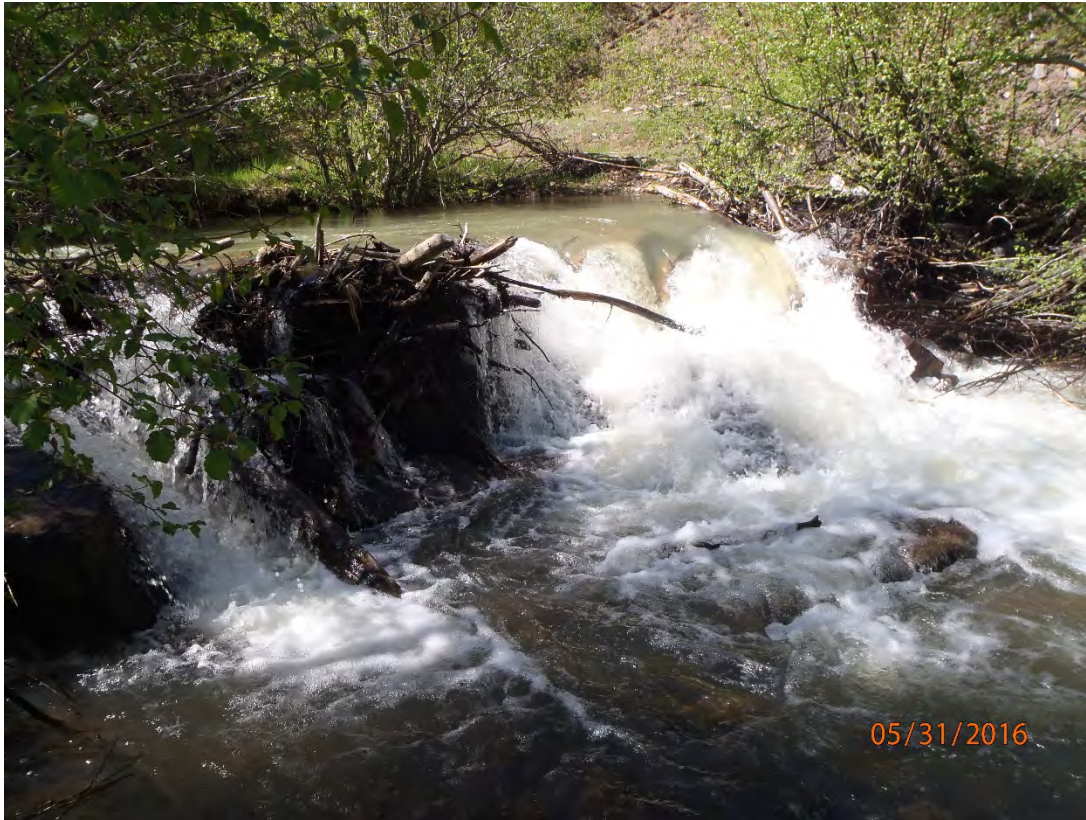
Figure 7 Samson Diversion BEFORE (May 31, 2016).

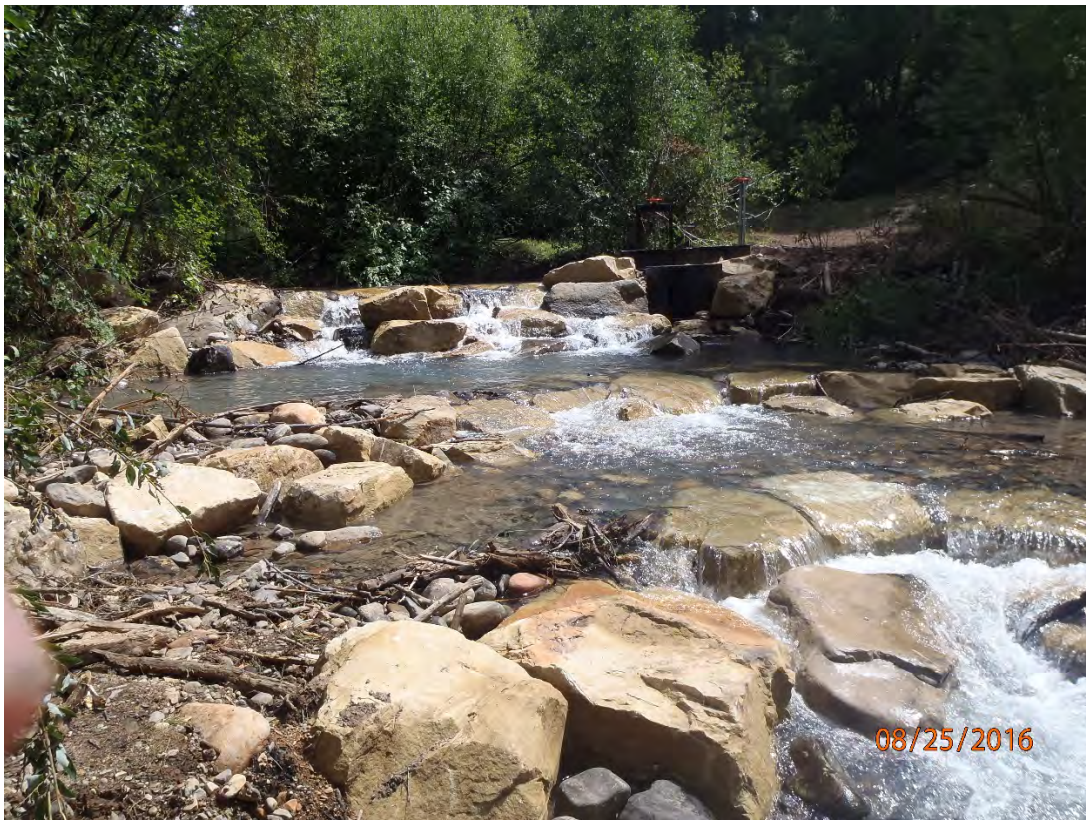
Figure 8 Samson Diversion AFTER (August 25, 2016).

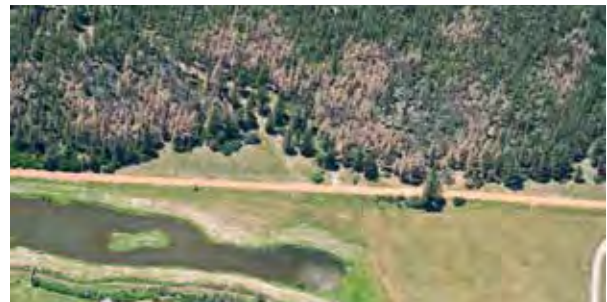
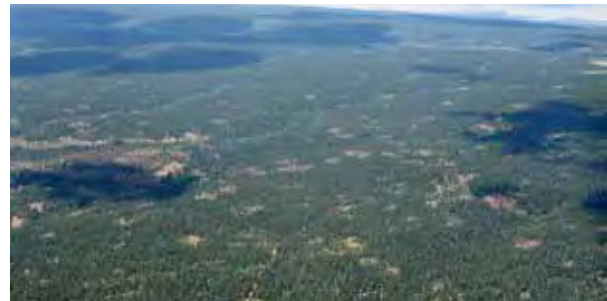
Above: Round-headed pine beetle outbreak in Cherry Creek, 2016

Below: scattered pockets of round-headed pine beetle across the Dolores Ranger District of San Juan National Forest, 2017.
