**Water Supply Reserve Fund
Water Activity Summary Sheet
September 19, 2018
Agenda Item 12(k)**

Water Activity Name: Investigations & Engineering Design of Kendall Reservoir Rehabilitation Improvements

DAM NAME: KENDALL T: 110S R: 0930W S: 8 COUNTY: MESA DATE OF INSPECTION: 6/14/2016
DAM ID: 720203 YRCompl: 1926 DAM HEIGHT(FT): 16.0 SPILLWAY WIDTH(FT): 12.0 PREVIOUS INSPECTION:
CLASS: Low hazard DAM LENGTH(FT): 420.0 SPILLWAY CAPACITY(CFS): 402.0 NORMAL STORAGE (AF): 76.0
DIV: 5 WD: 72 CRESTWIDTH(FT): 6.0 FREEBOARD (FT): 4.0 SURFACE AREA(AC): 14.0
EAP: Not Required CRESTELEV(FT): 9903.5 DRAINAGE AREA (AC.): 1664.0 OUTLET INSPECTED:

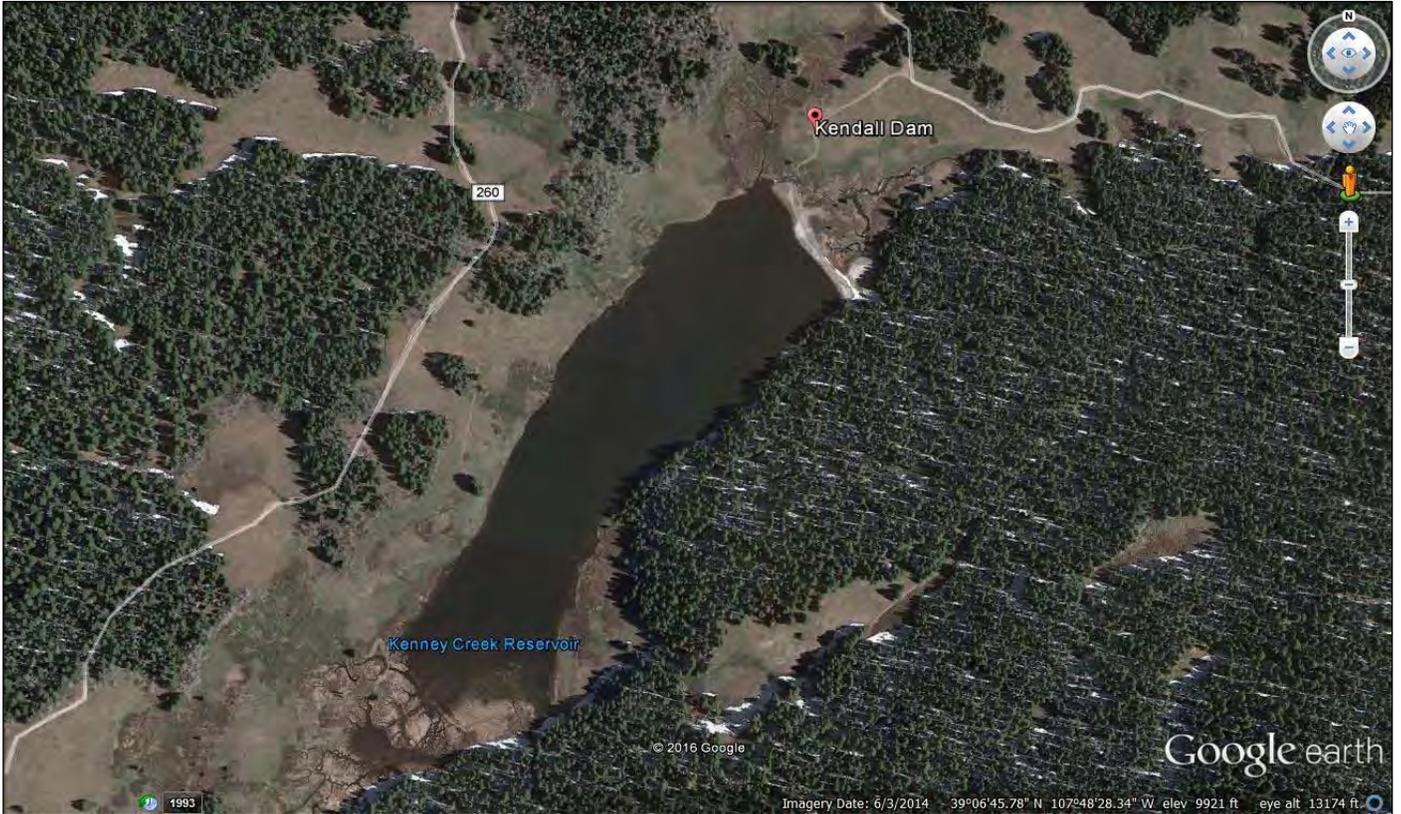
DAM OVERVIEW

Overall, the dam is in poor condition. The crest width has been narrowed due to wave erosion and lack of adequate riprap cover on the upstream slope. Seepage and ponded water is prevalent across the entire toe and area downstream of the dam. And, it has previously been reported that the outlet pipe may be collapsing.

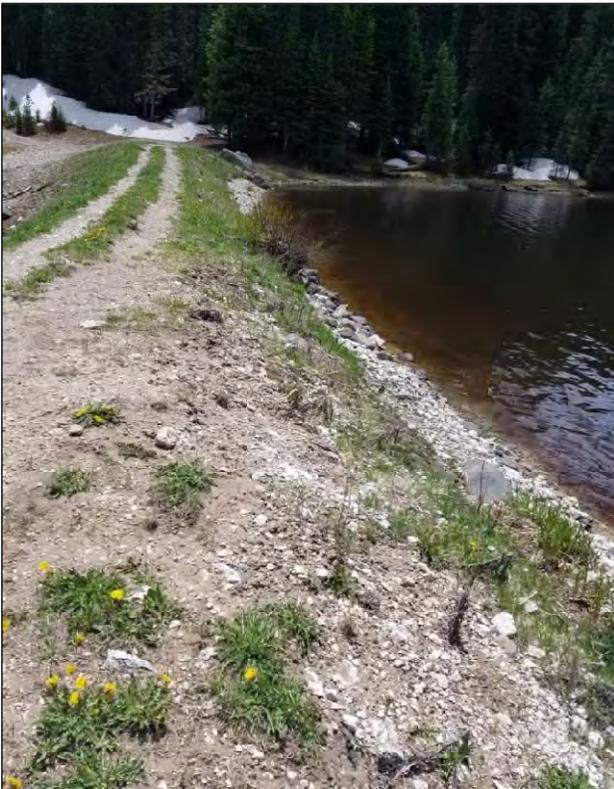
PHOTO #1 UPSTREAM SLOPE

(1) and (2): Missing and sparse riprap has allowed wave erosion damage to occur. Upstream slope very steep and narrow on right side.CONDITIONS OBSERVED: Good Acceptable Poor

Overview of upstream slope. Note sparse and missing riprap and steepened slope due to wave erosion.

- (80) PROVIDE ADDITIONAL RIPRAP: _____
- (81) LUBRICATE AND OPERATE OUTLET GATES THROUGH FULL CYCLE _____
- (82) CLEAR TREES AND/OR BRUSH FROM: **spillway** _____
- (83) INITIATE RODENT CONTROL PROGRAM AND PROPERLY BACKFILL EXISTING HOLES: _____
- (84) GRADE CREST TO A UNIFORM ELEVATION WITH DRAINAGE TO THE UPSTREAM SLOPE: _____
- (85) PROVIDE SURFACE DRAINAGE FOR: _____
- (86) MONITOR: **right side of dam for signs of instability, seepage areas for increased flow, and outlet pipe for signs of distress or further deterioration**
- (87) DEVELOP AND SUBMIT AN EMERGENCY ACTION PLAN: _____
- (88) OTHER **maintain the reservoir at the restricted level**
- (89) OTHER _____

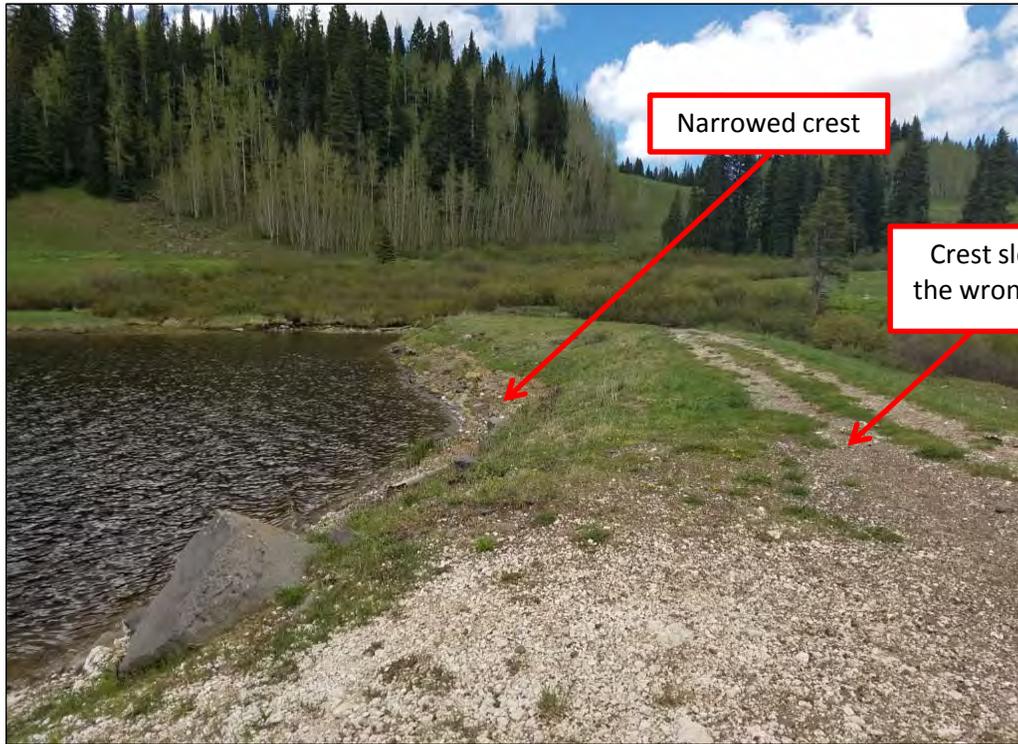
PHOTO #2
CREST

Narrow crest on right side is a concern for dam stability.**(16): Low area around outlet operator persists.****(18): Crest drains to the downstream slope (opposite the direction it is supposed to) in the area of the outlet operator.**CONDITIONS OBSERVED: Good Acceptable Poor

Crest on right side is narrow and slopes toward the downstream side of the dam.

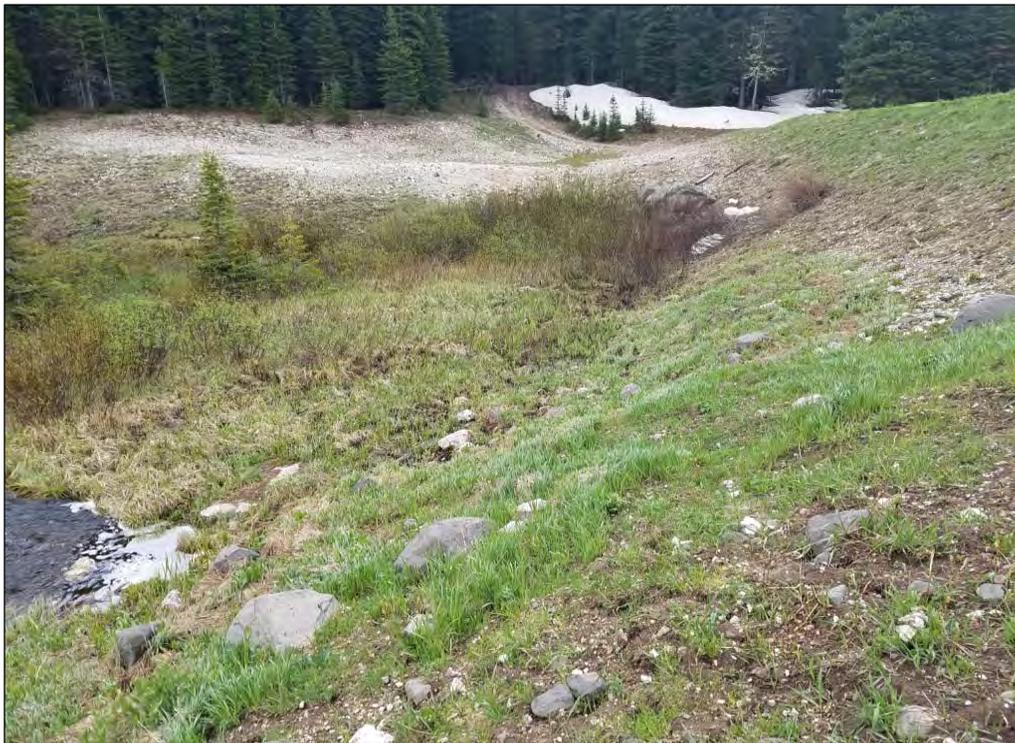
PHOTO #3
DOWNSTREAM SLOPE

(21): Livestock damage across entire downstream slope.**(25): Slope on right side appears too steep, contributing to overall dam stability issues.****(27): Previously observed slide/slough area to right of outlet near top of dam persists, with no apparent change.****(28): Ground downstream of toe across entire length of dam was saturated. Some standing water observed.**CONDITIONS OBSERVED: Good Acceptable Poor

Downstream slope is steepened on right side of dam.

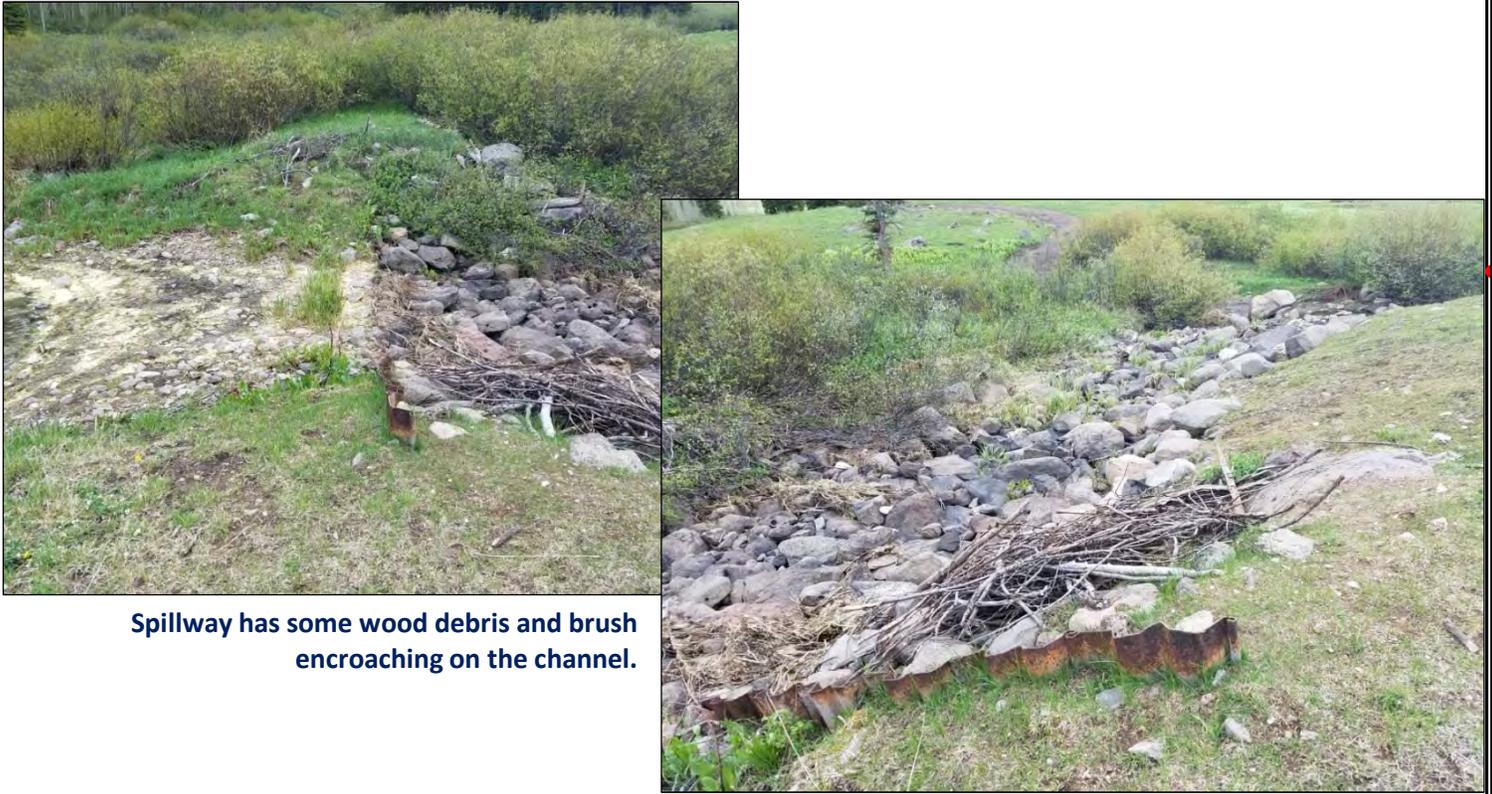
PHOTO #4
SPILLWAY

(57): Debris observed on right side of mouth of spillway.

(59): Brush observed in and encroaching on spillway channel.

Spillway has some wood debris and brush encroaching on the channel.

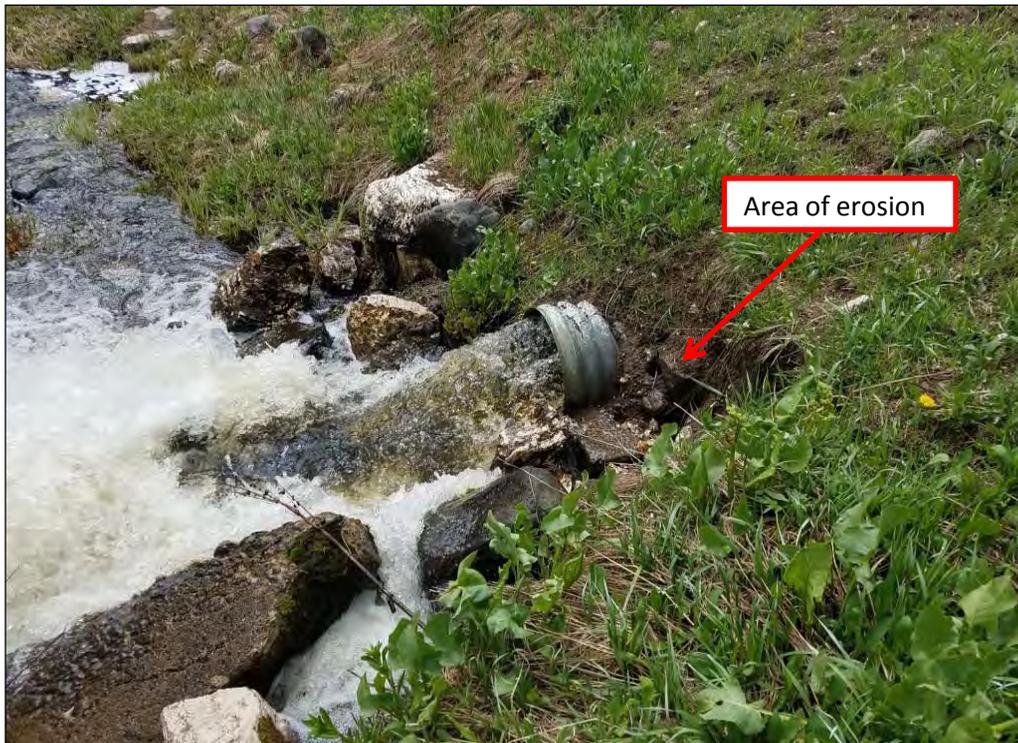
PHOTO #5
OUTLET

(49): Erosion observed on left side of downstream end of outlet pipe.

Outlet pipe flowing full at time of inspection. Note area of erosion on left side of pipe.

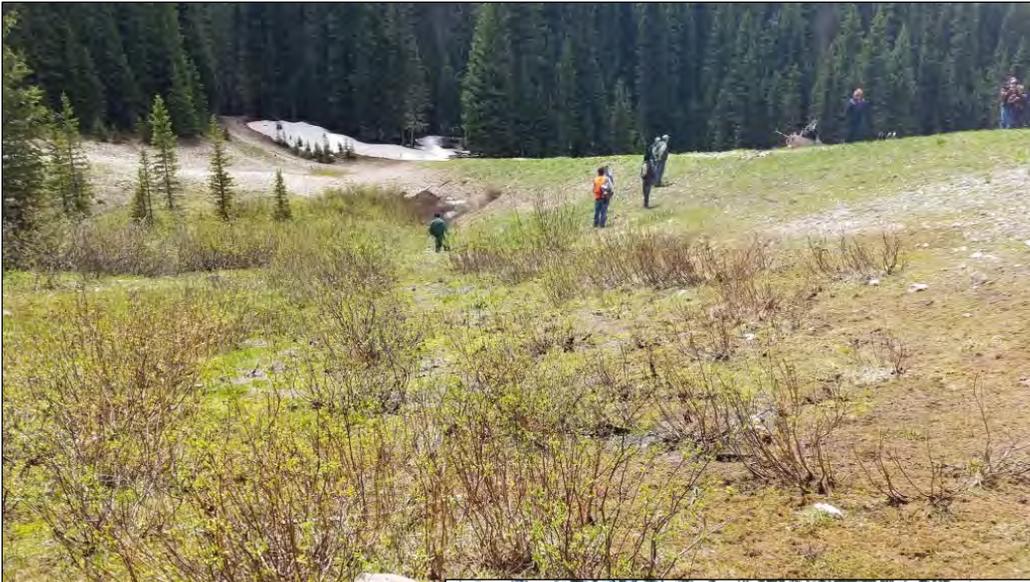
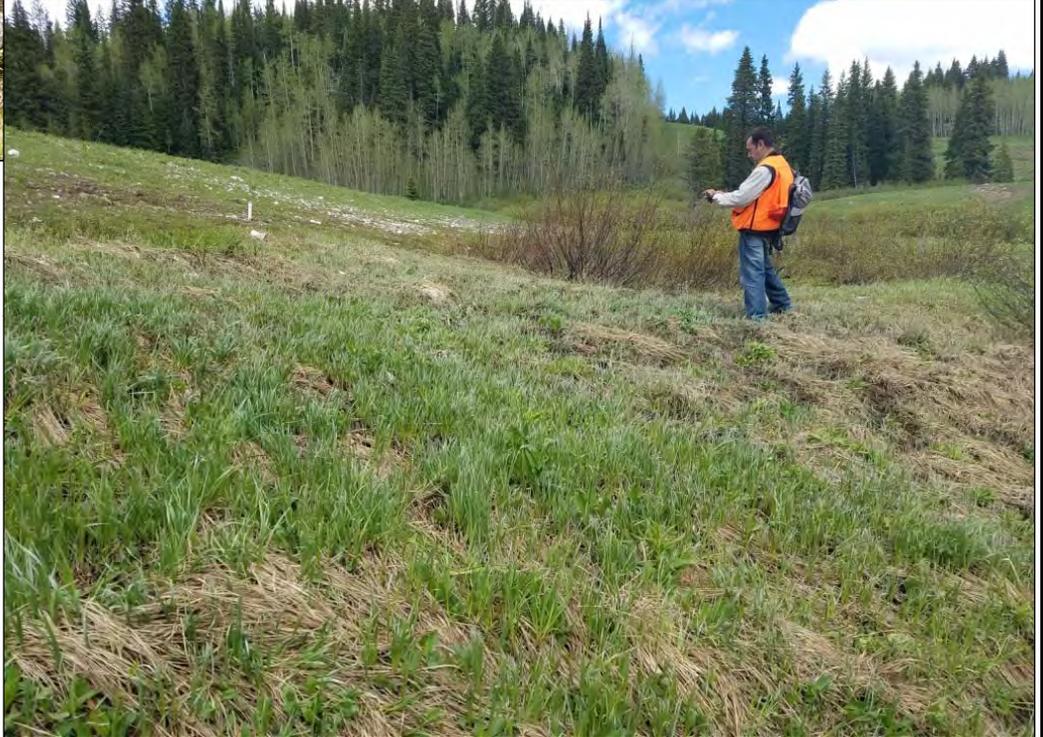
PHOTO #6
SEEPAGE

(34): Entire area downstream of the toe was saturated with seepage and standing water was observed in multiple locations.CONDITIONS OBSERVED: Good Acceptable Poor

Prevalent seepage and areas of ponded water. Ground surface was spongy in some spots.
