Colorado Water Conservation Board

Water Plan Grant Application

Name of Applicant	Colorado Open Lands	
Name of Water Project	Riparian Reconnect Project Implementation	
CWP Grant Request Amount		\$ 84,290
Other Funding Sources: <u>Park County Land & Water Trust Fund</u>		\$ 106,798
Other Funding Sources: <u>Participating Landowners</u>		\$ 73,600
Other Funding Sources: <u>EcoMetrics (in-kind)</u>		\$ 6,000
Applicant Funding Contribution		\$ 0
Total Project Cost		\$ 270,688

Twelvemile Ranch:
A reconnaissance assessment of stream and riparian condition for the Riparian Reconnect project with recommendations for restoration and management

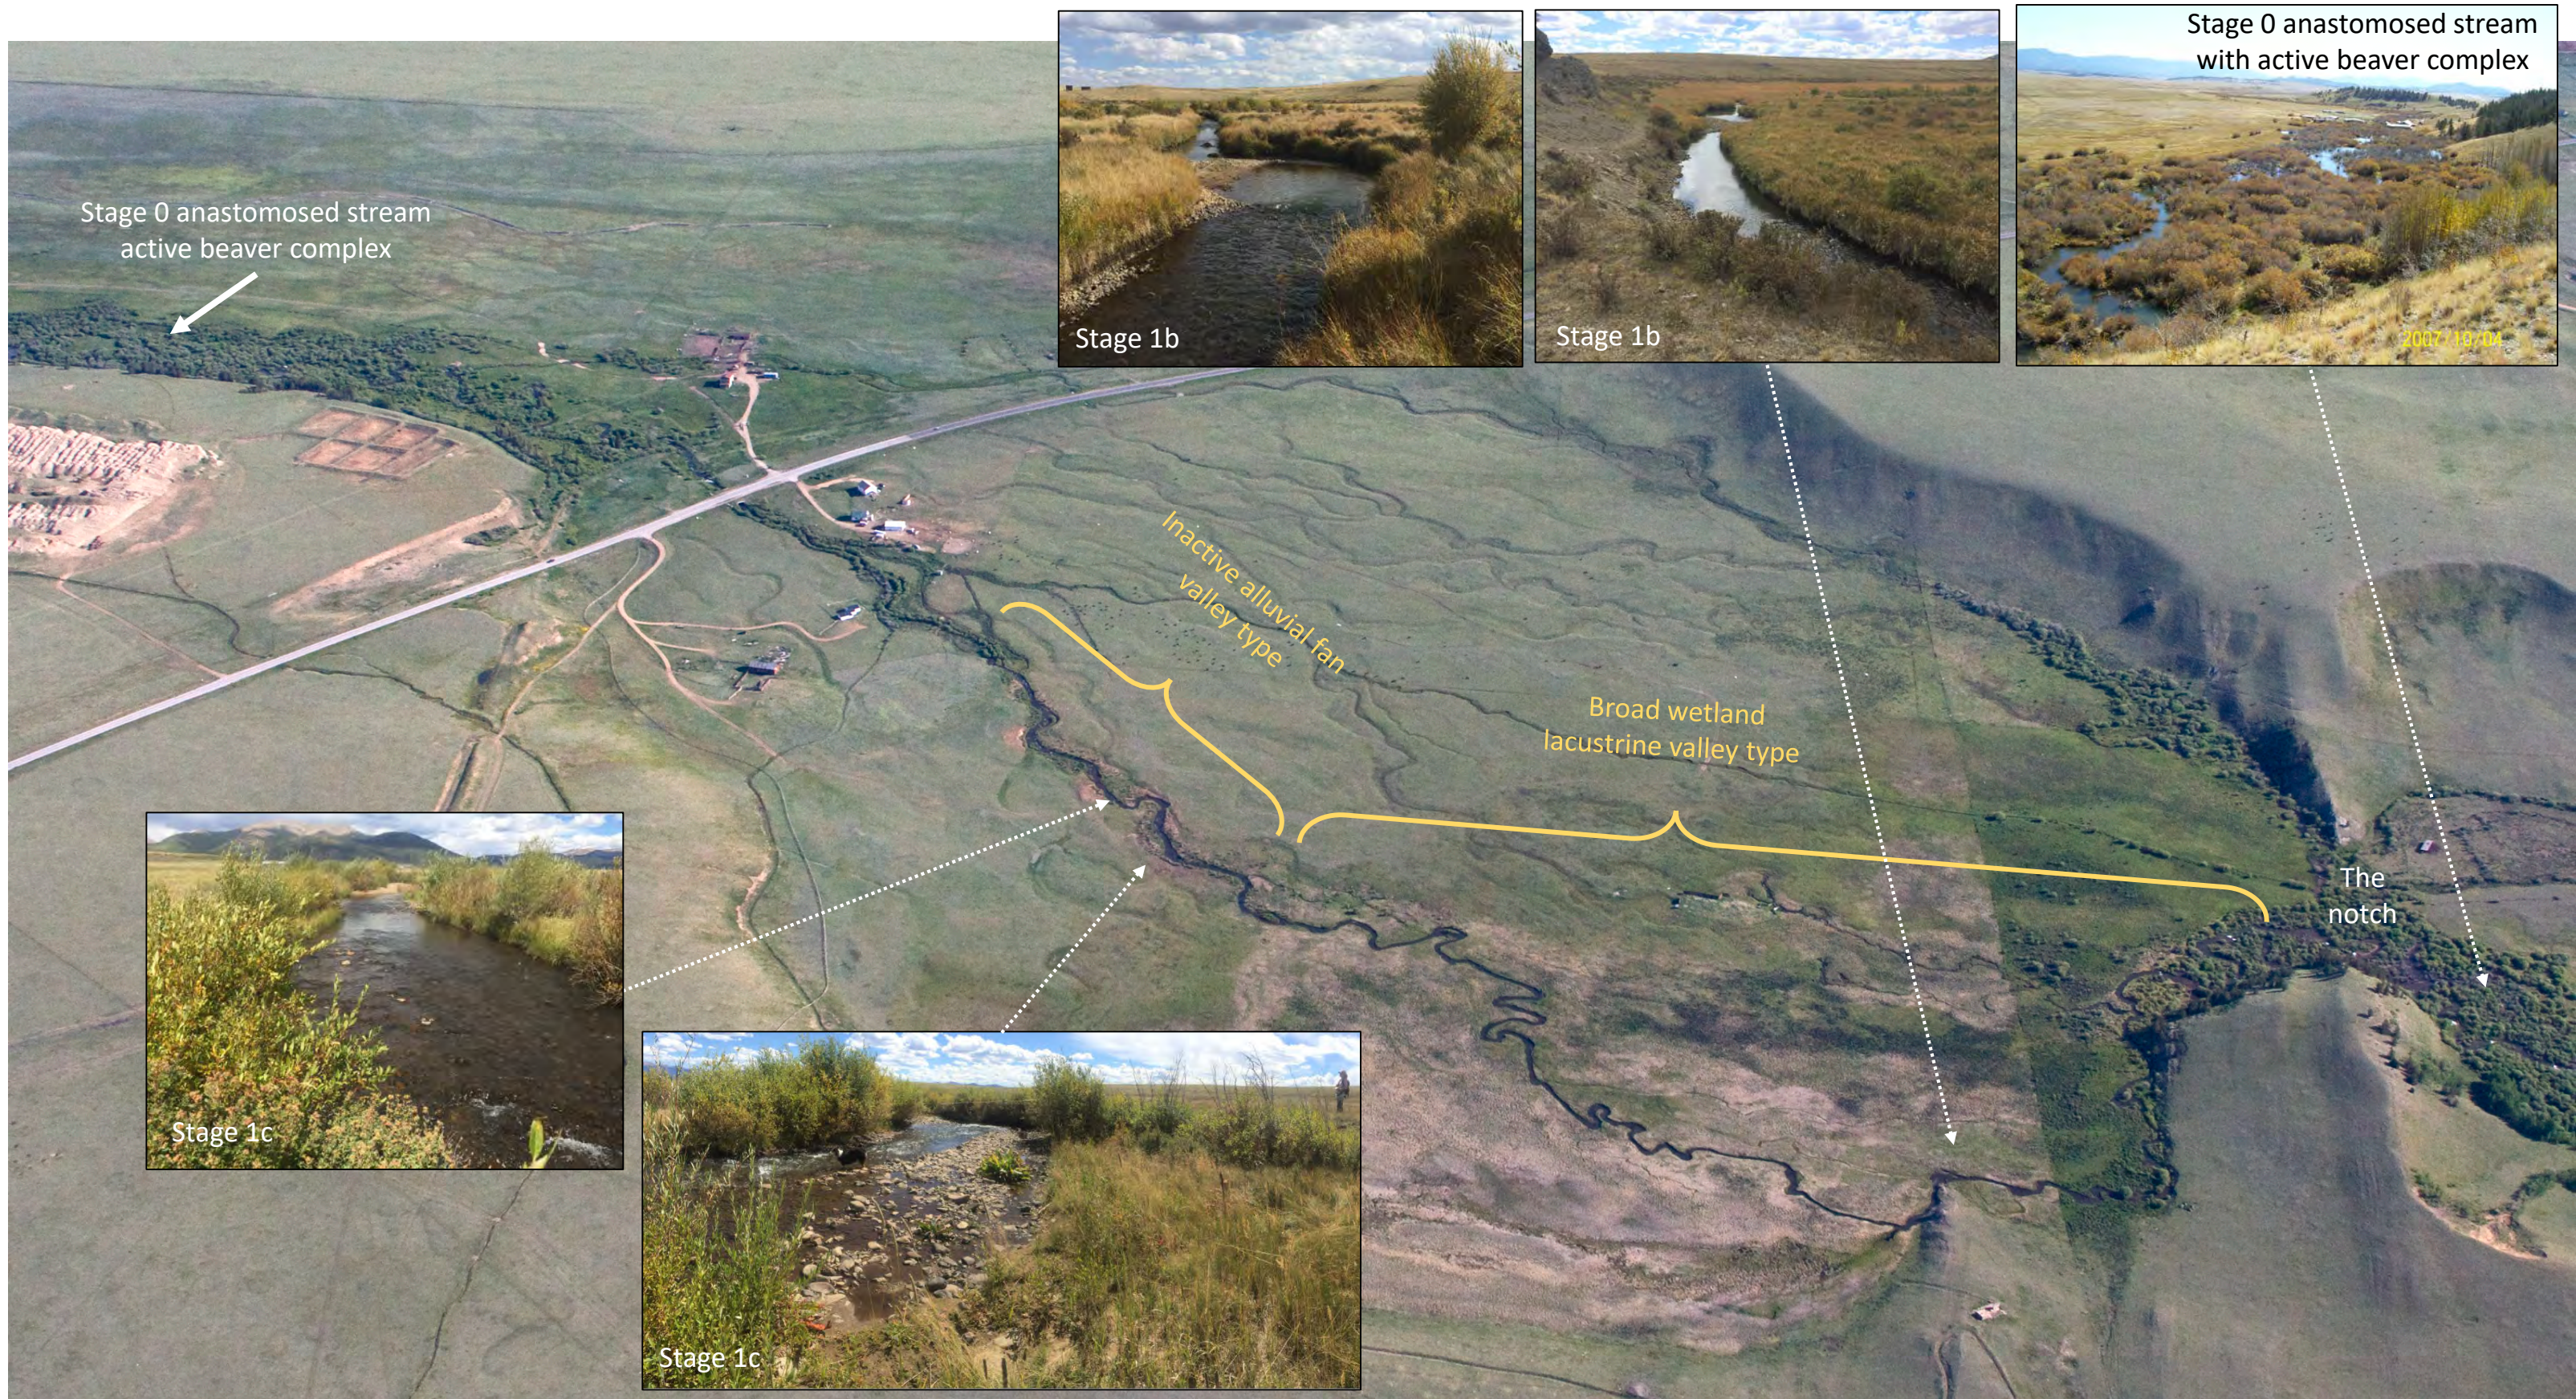
The property has two distinct reaches. On the upper 1/3 Tarryall Creek flows down a relatively high gradient relict alluvial fan in a well-defined trench that effectively constrains the riparian area within it to about 60-150 feet wide. At the toe of the fan, the valley flattens out into a very wide low-gradient wetland complex where the whole valley is backed up behind tight geological control at the notch and riparian width is completely unconfined. The reaches were subject to similar land use history and the same stressors, but they differ in character. The alluvial fan reach is a relatively steep, straight, wide, and shallow Stage 1c stream with bank heights 1.0-1.5 ft and widths 20-35 ft. The lower reach is a much lower gradient meandering Stage 1b stream that is narrower and deeper with bank heights 1.5-2.5 ft and widths 6-12 ft. Both reaches are moderately entrenched single-thread channels. Most of the lower reach runs along the valley edge. The properties just upstream and downstream have intact Stage 0 beaver complexes.

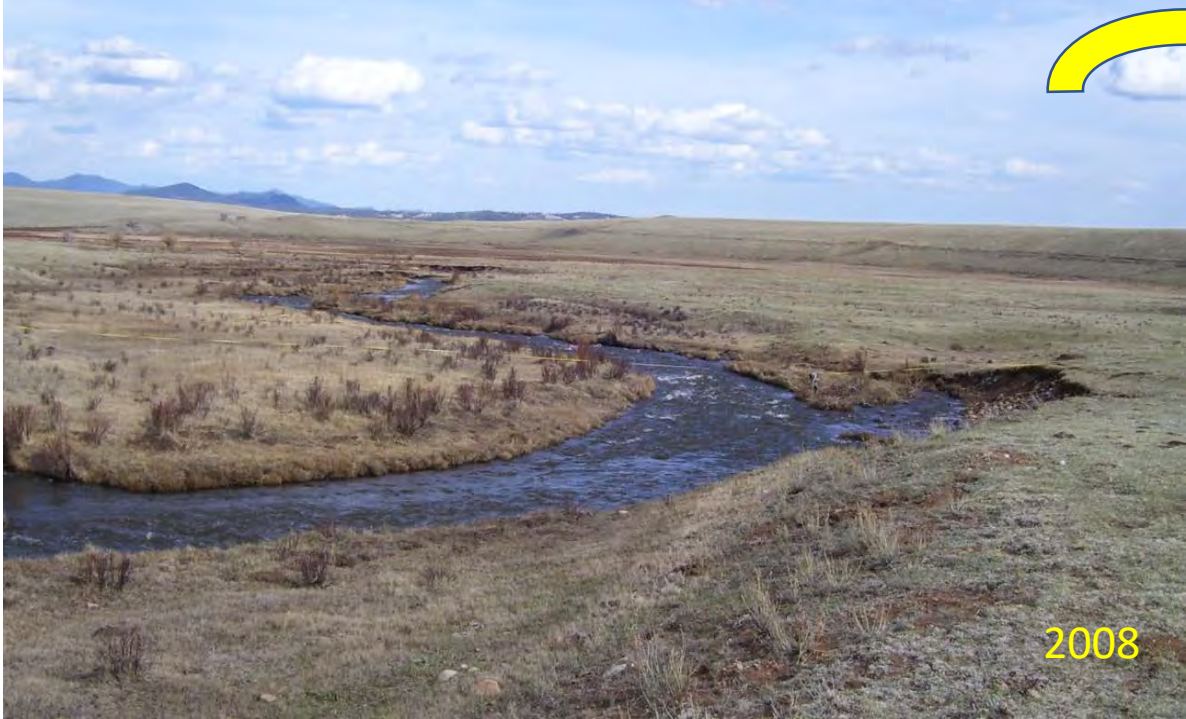
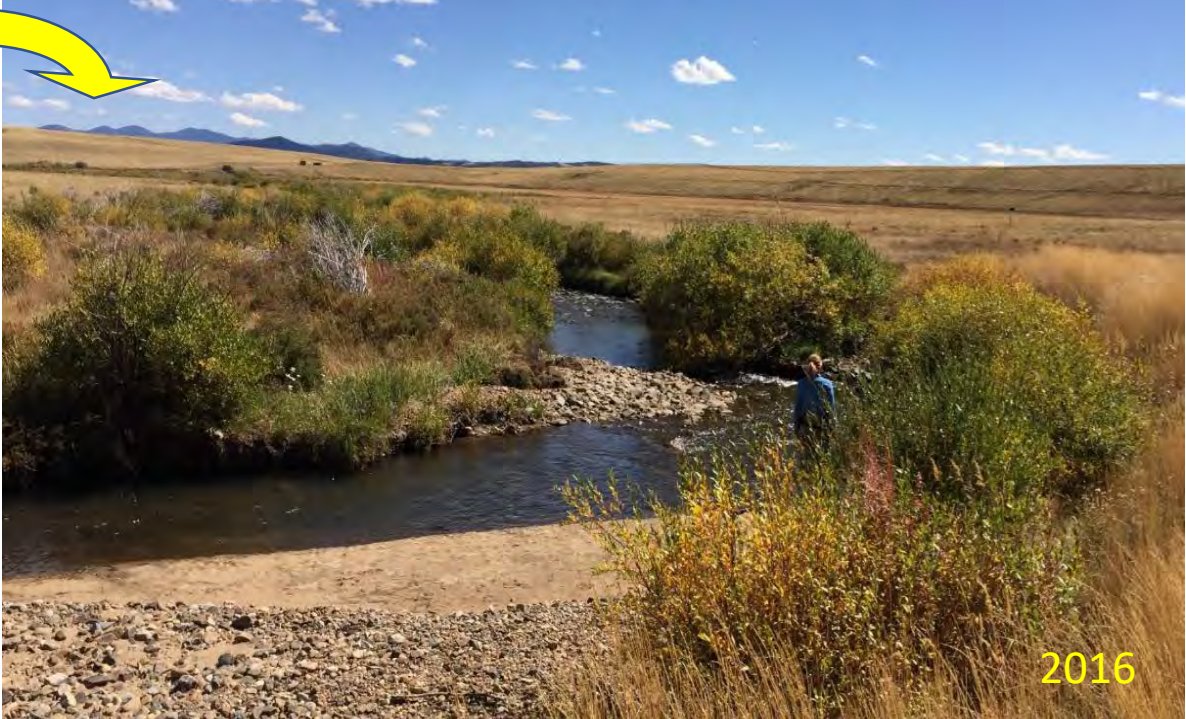
Restoring riparian shrubs

When we first evaluated the Tarryall Notch Ranch in 2007, the immediate restoration priority was to reestablish riparian shrubs. At that time, there were almost no shrubs taller than a few inches due to extreme livestock grazing pressure. Livestock were excluded from the riparian zone from 2008 through 2018 and major willow planting efforts were made in 2008 and 2009. 600 whole willow shrubs and about 1000 willow stems were planted on the alluvial fan reach, and about 1750 willow stems were planted on the upper half of the broad wetland reach. These treatments succeeded in restoring dense shrub cover to the riparian area on most of the property.

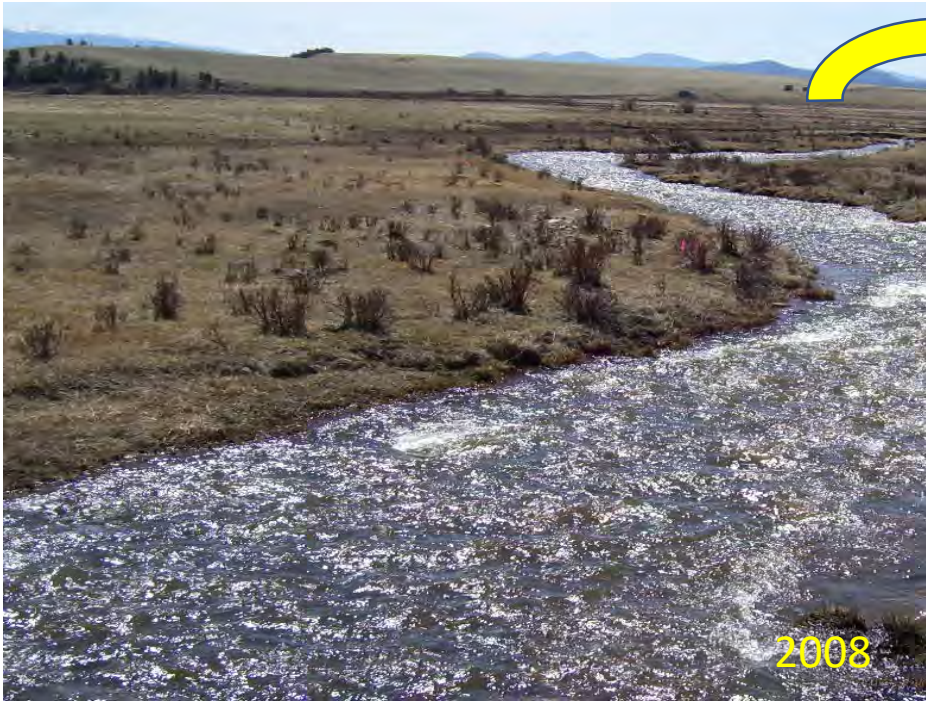
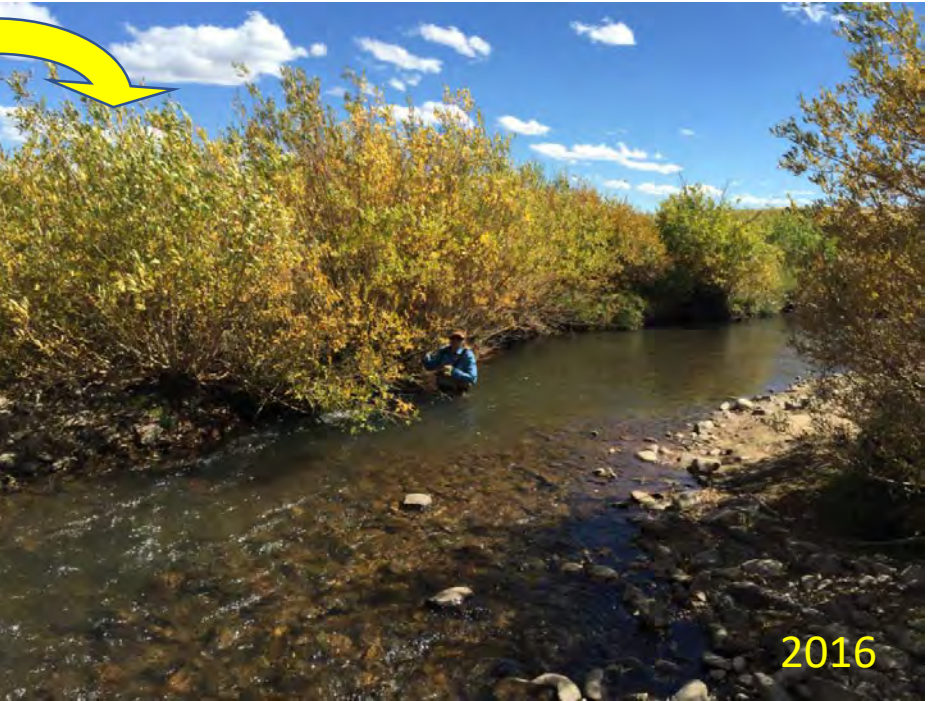
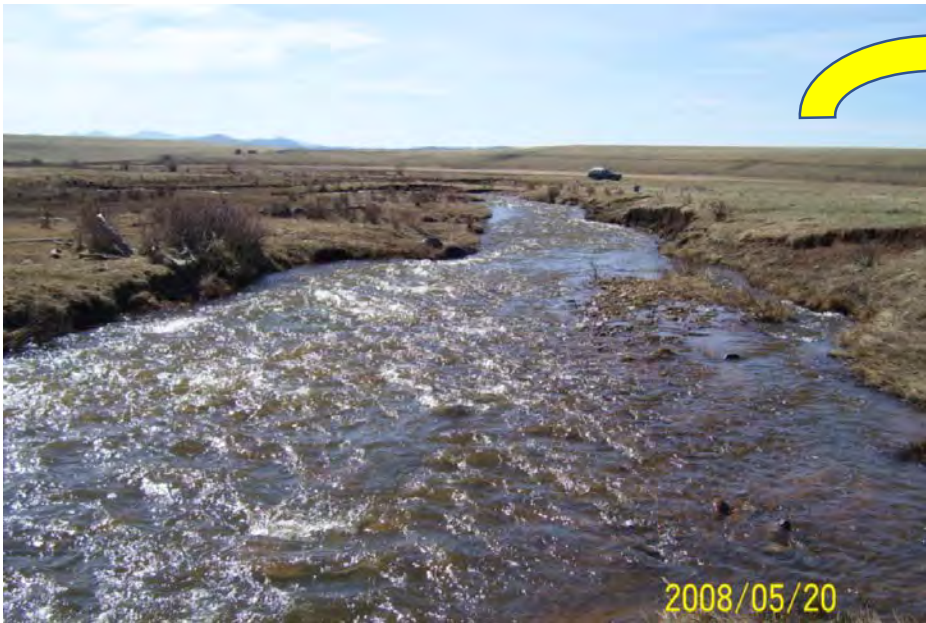
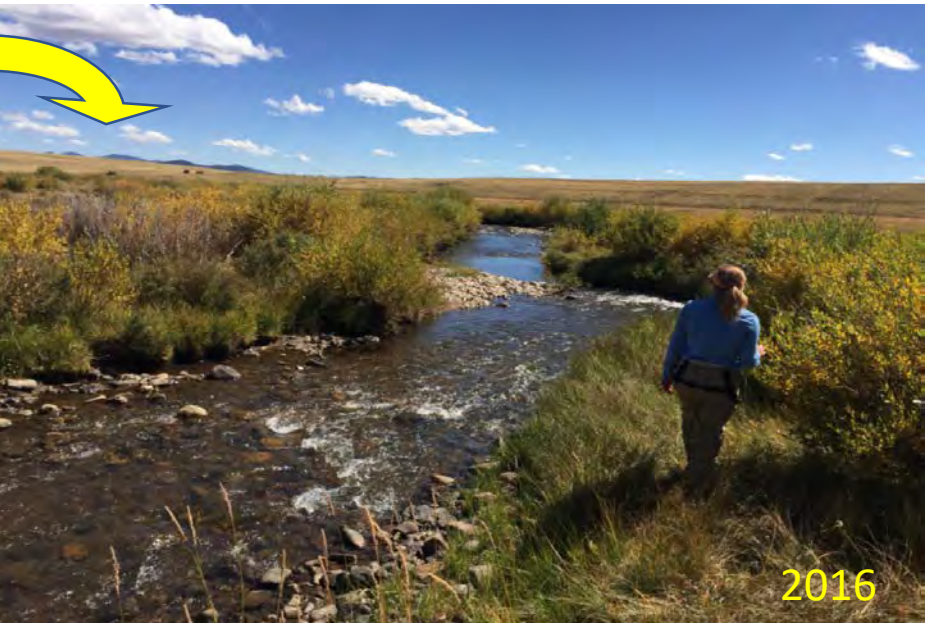
On to step 2. Restoring hydrology

Despite the riparian vegetation improvements, hydrological recovery has yet to respond. The stream on both reaches is still a moderately entrenched single-thread channel that rarely overbanks. Water table in the adjacent riparian zone and wetland is depressed as a result, and the site still has a long way to go to achieve reference-standard hydrological, ecological, habitat, and fishery benefits.

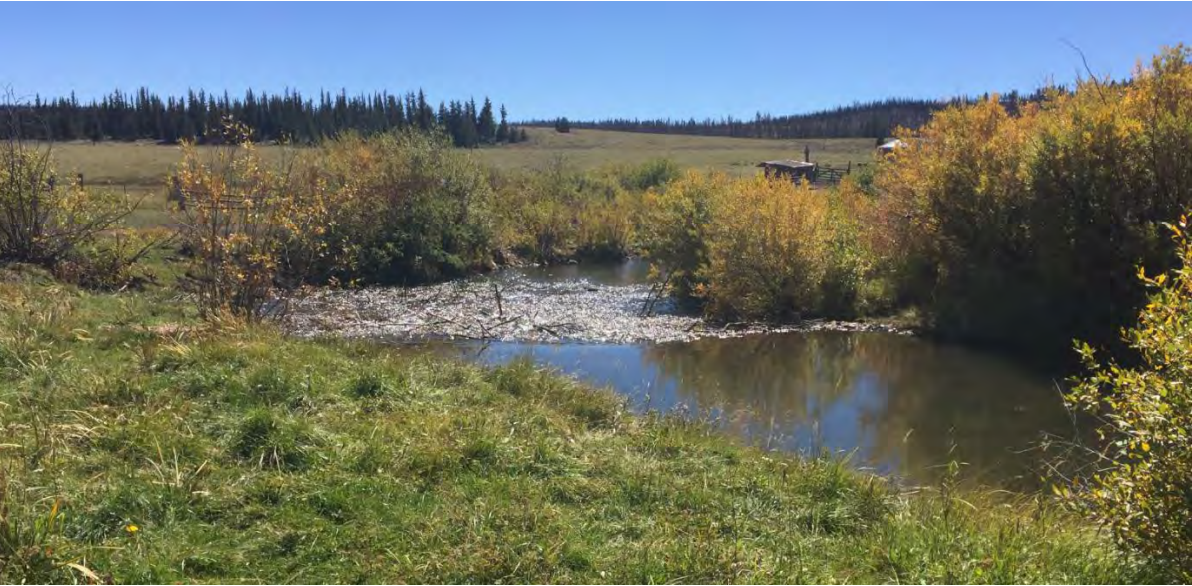
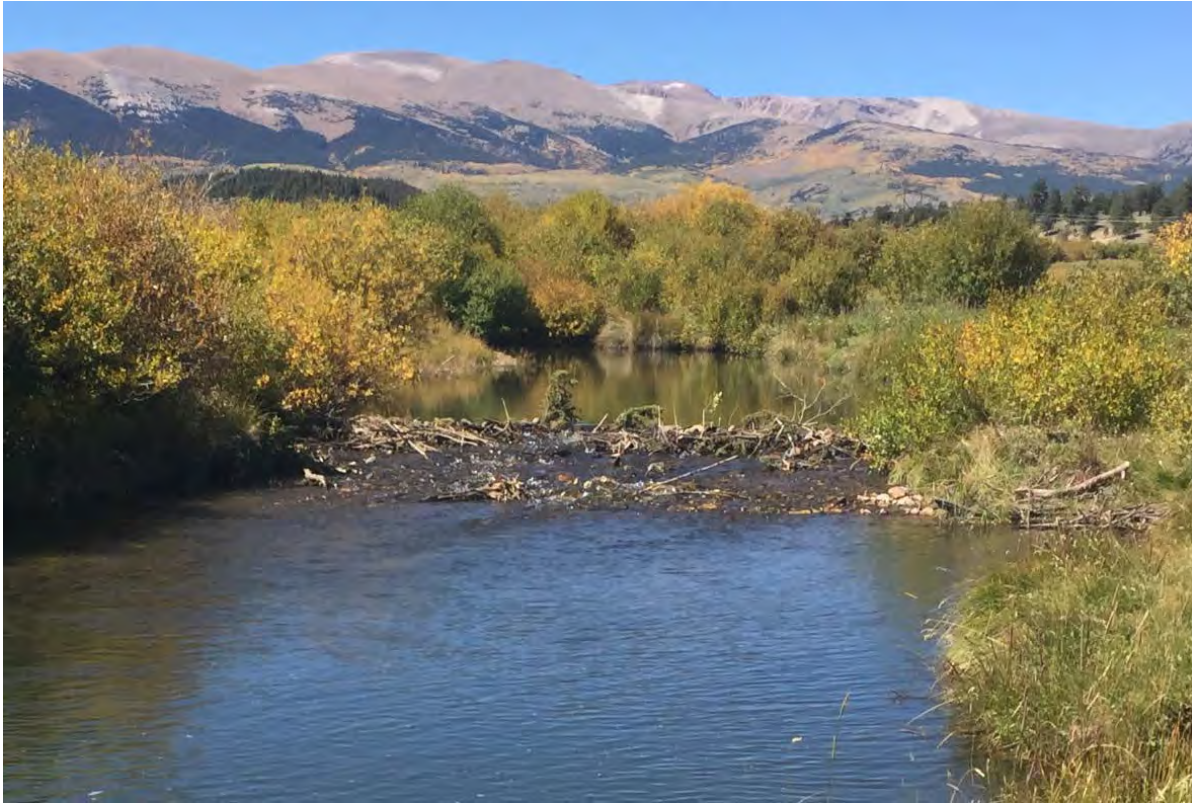
Mimicking beaver dams: Typical BDAs on DM Ranch viewed from upstream (upper right) and downstream (lower right) raise water stage and reconnect floodplain swales and off-channel wetland habitat (left). The BDAs on Tarryall Notch Ranch will be similar to these, but scaled to match the smaller size of Tarryall Creek.

The proposed Riparian Reconnect project on Tarryall Notch Ranch aims to speed the passive restoration process in two ways. Beaver dam analogs fulfill the roles of natural beaver dams until a sustainable population of beavers returns. At the same time, BDAs create deep water habitat and cover that will entice migrating beavers to settle on site. Several small feeder cuts are also planned to reconnect overflow channels and floodplain swales, initiating the development of high-flow channel branches and anastomosis typical of the natural Stage-0 beaver stream form. The proposed Tarryall Notch Ranch project is like the DM Ranch project in that it involves simple construction of BDAs and subtle feeder cuts, without the need for major channel work, floodplain re-grading, or riparian revegetation that we did on Upper Fourmile. It would be similar to the Lone Rock project in terms of scale and construction methods. The BDAs on Tarryall Notch Ranch would be much smaller than those on DM and could be built using a small track hoe and without having to bring in large trees or logs.

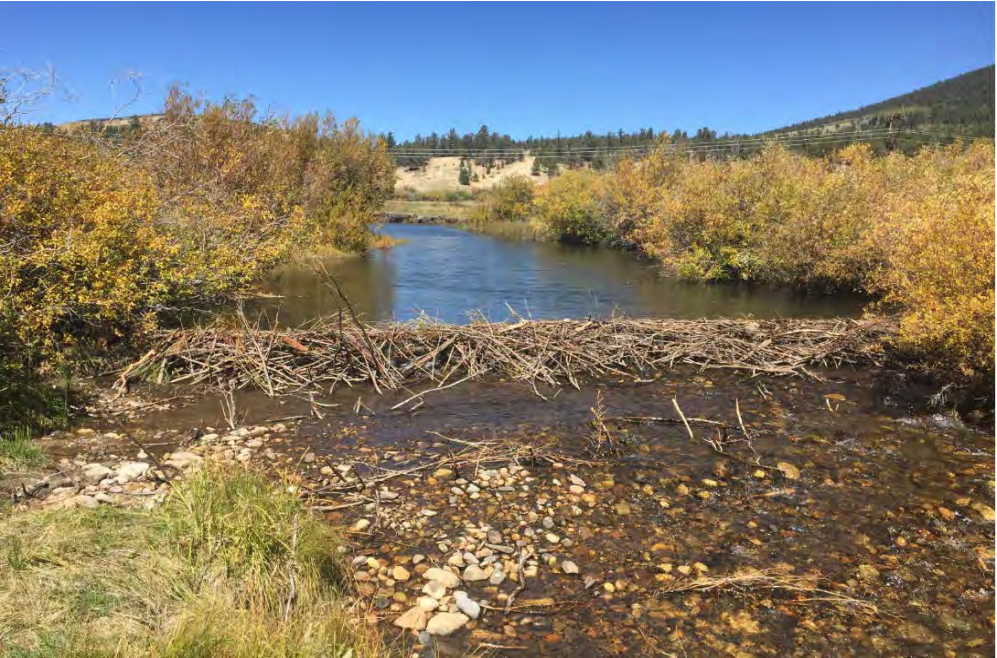
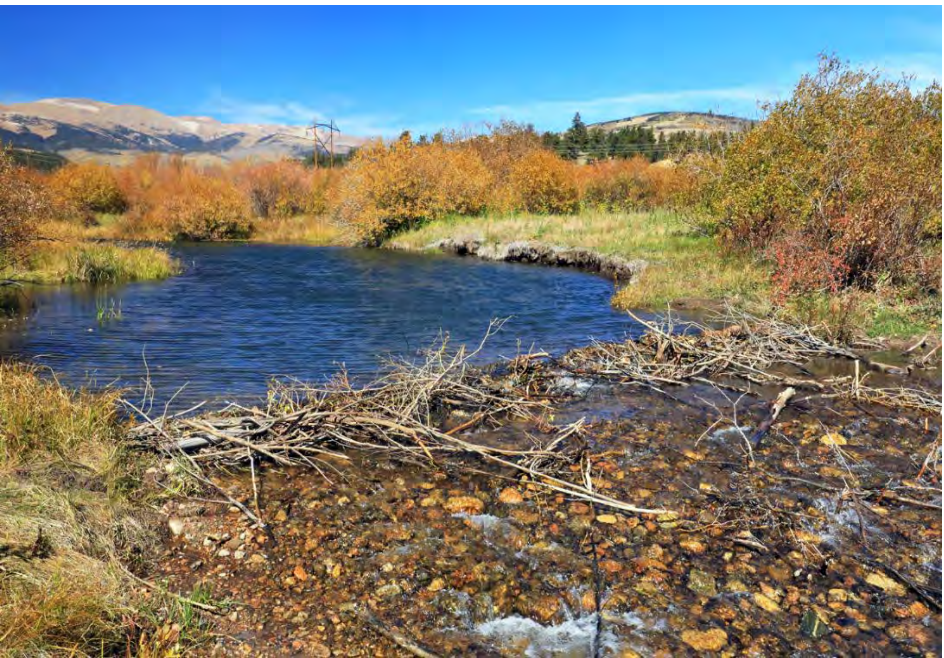
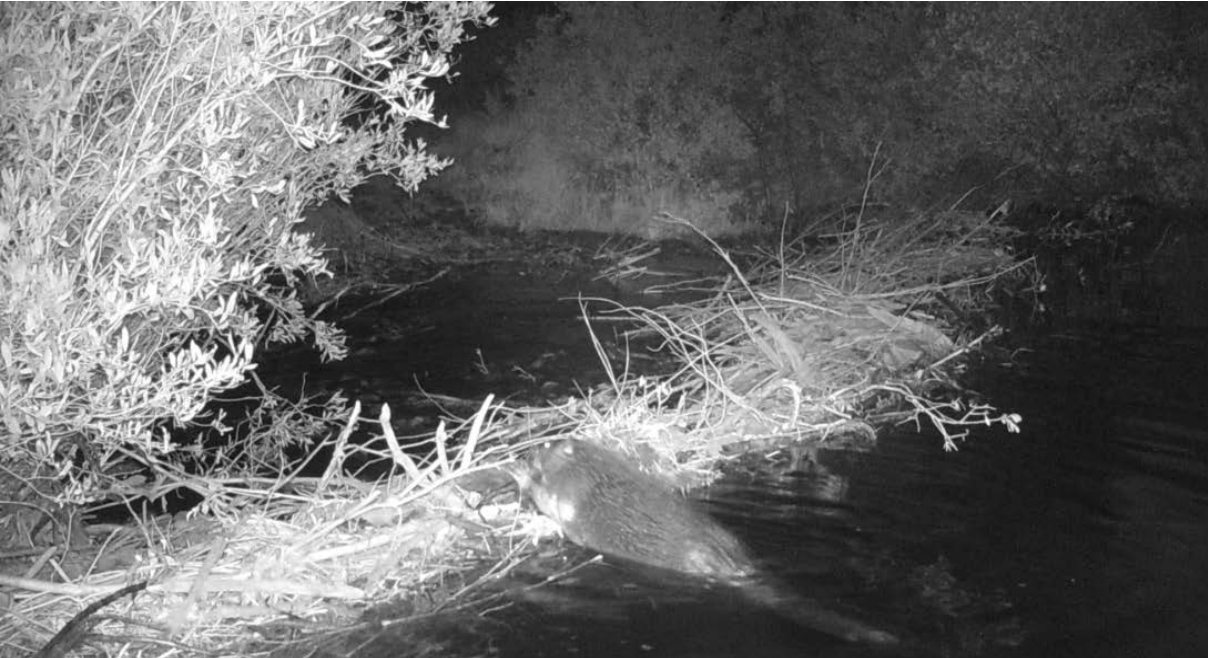
Enticing beaver: BDAs also provide deep water habitat and cover that entice migrating beavers to settle on the site. Several of the BDAs on DM Ranch were occupied by beavers in the first season. We suspect this would be the case at Tarryall Notch Ranch as well, given that there are active beaver colonies nearby both upstream and downstream.

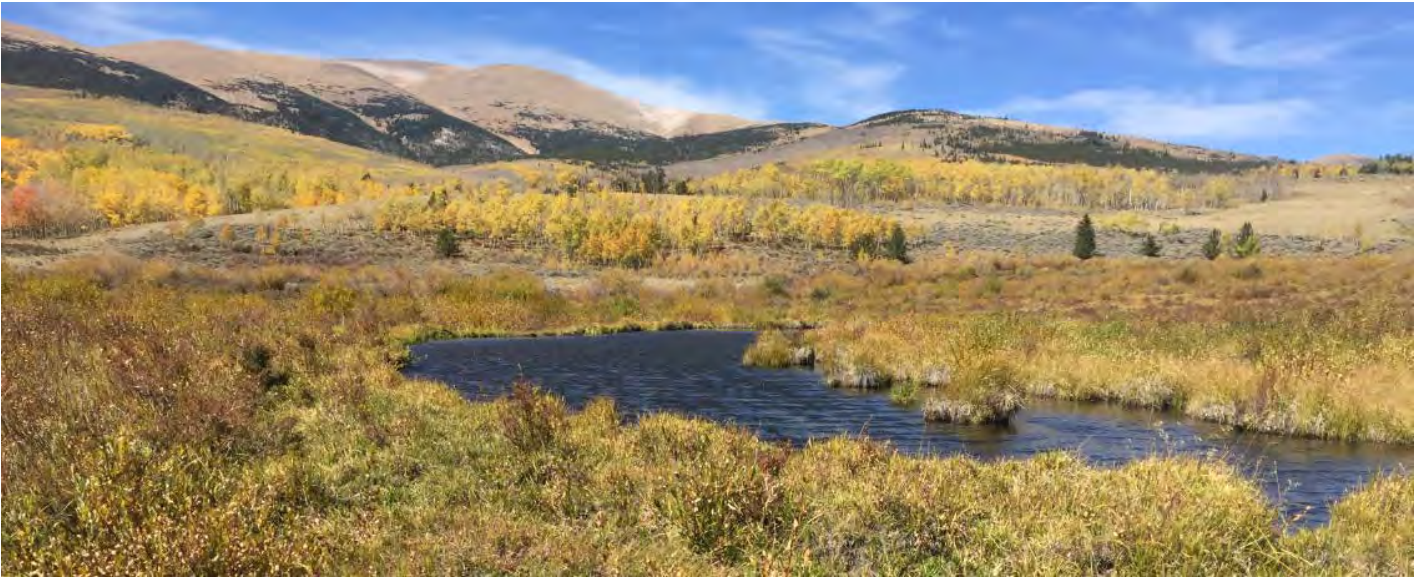
← Looking upstream on Twelvemile Creek. Most of the 9.5-square-mile contributing watershed is in the alpine and subalpine terrain in the background.

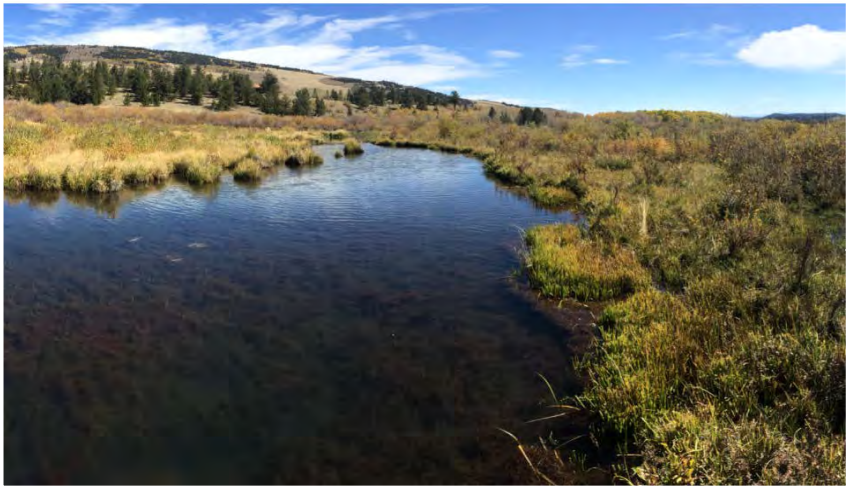
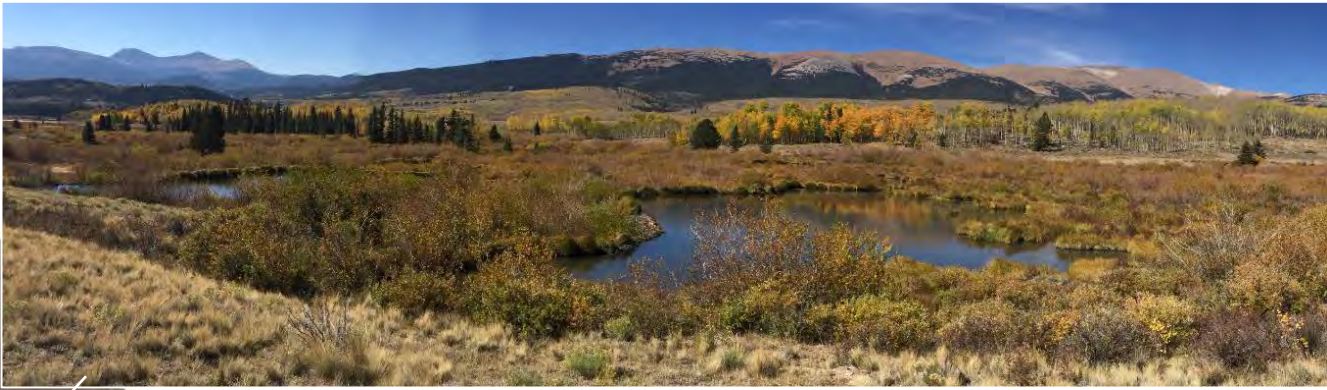
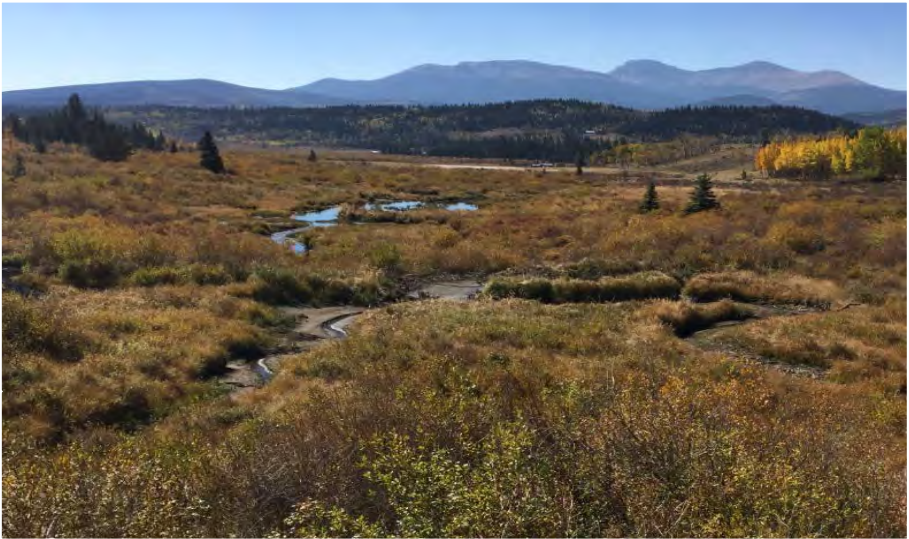
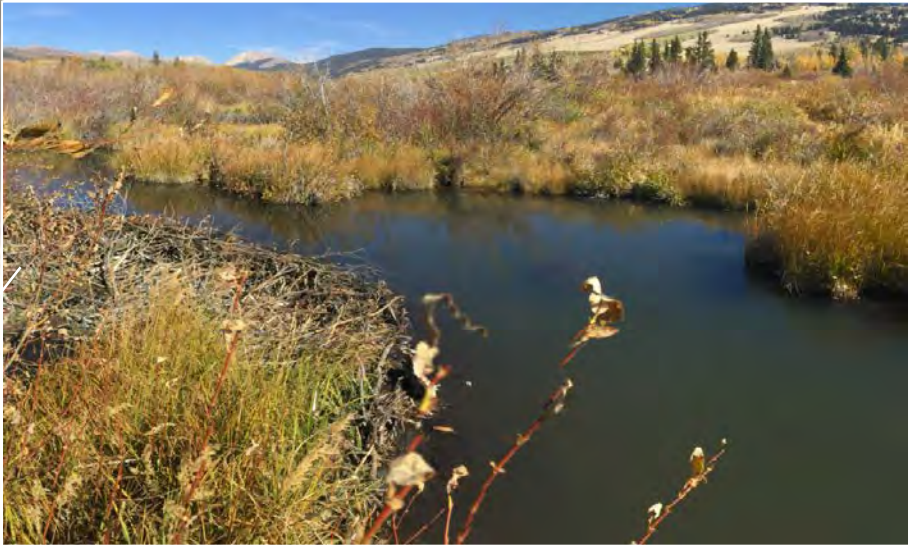
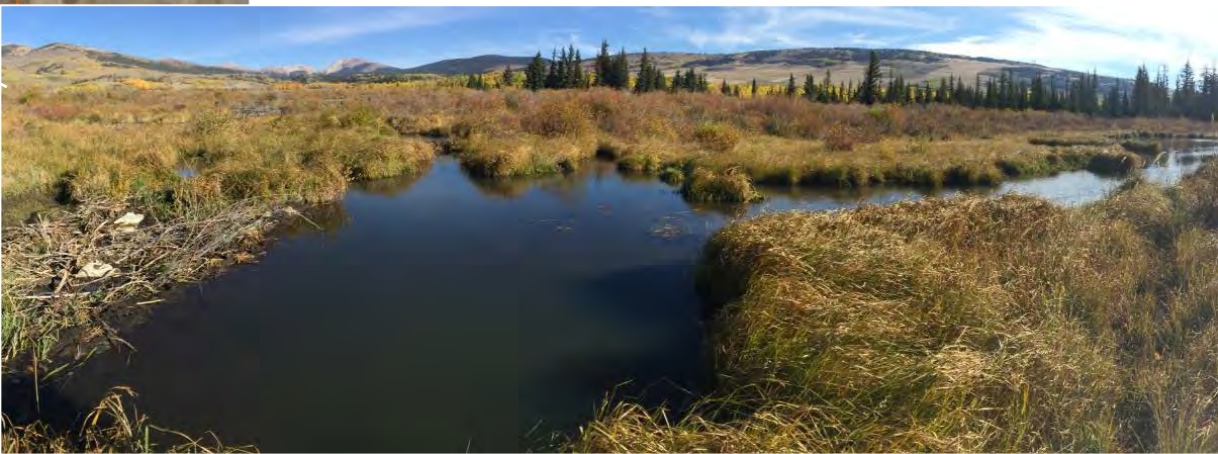
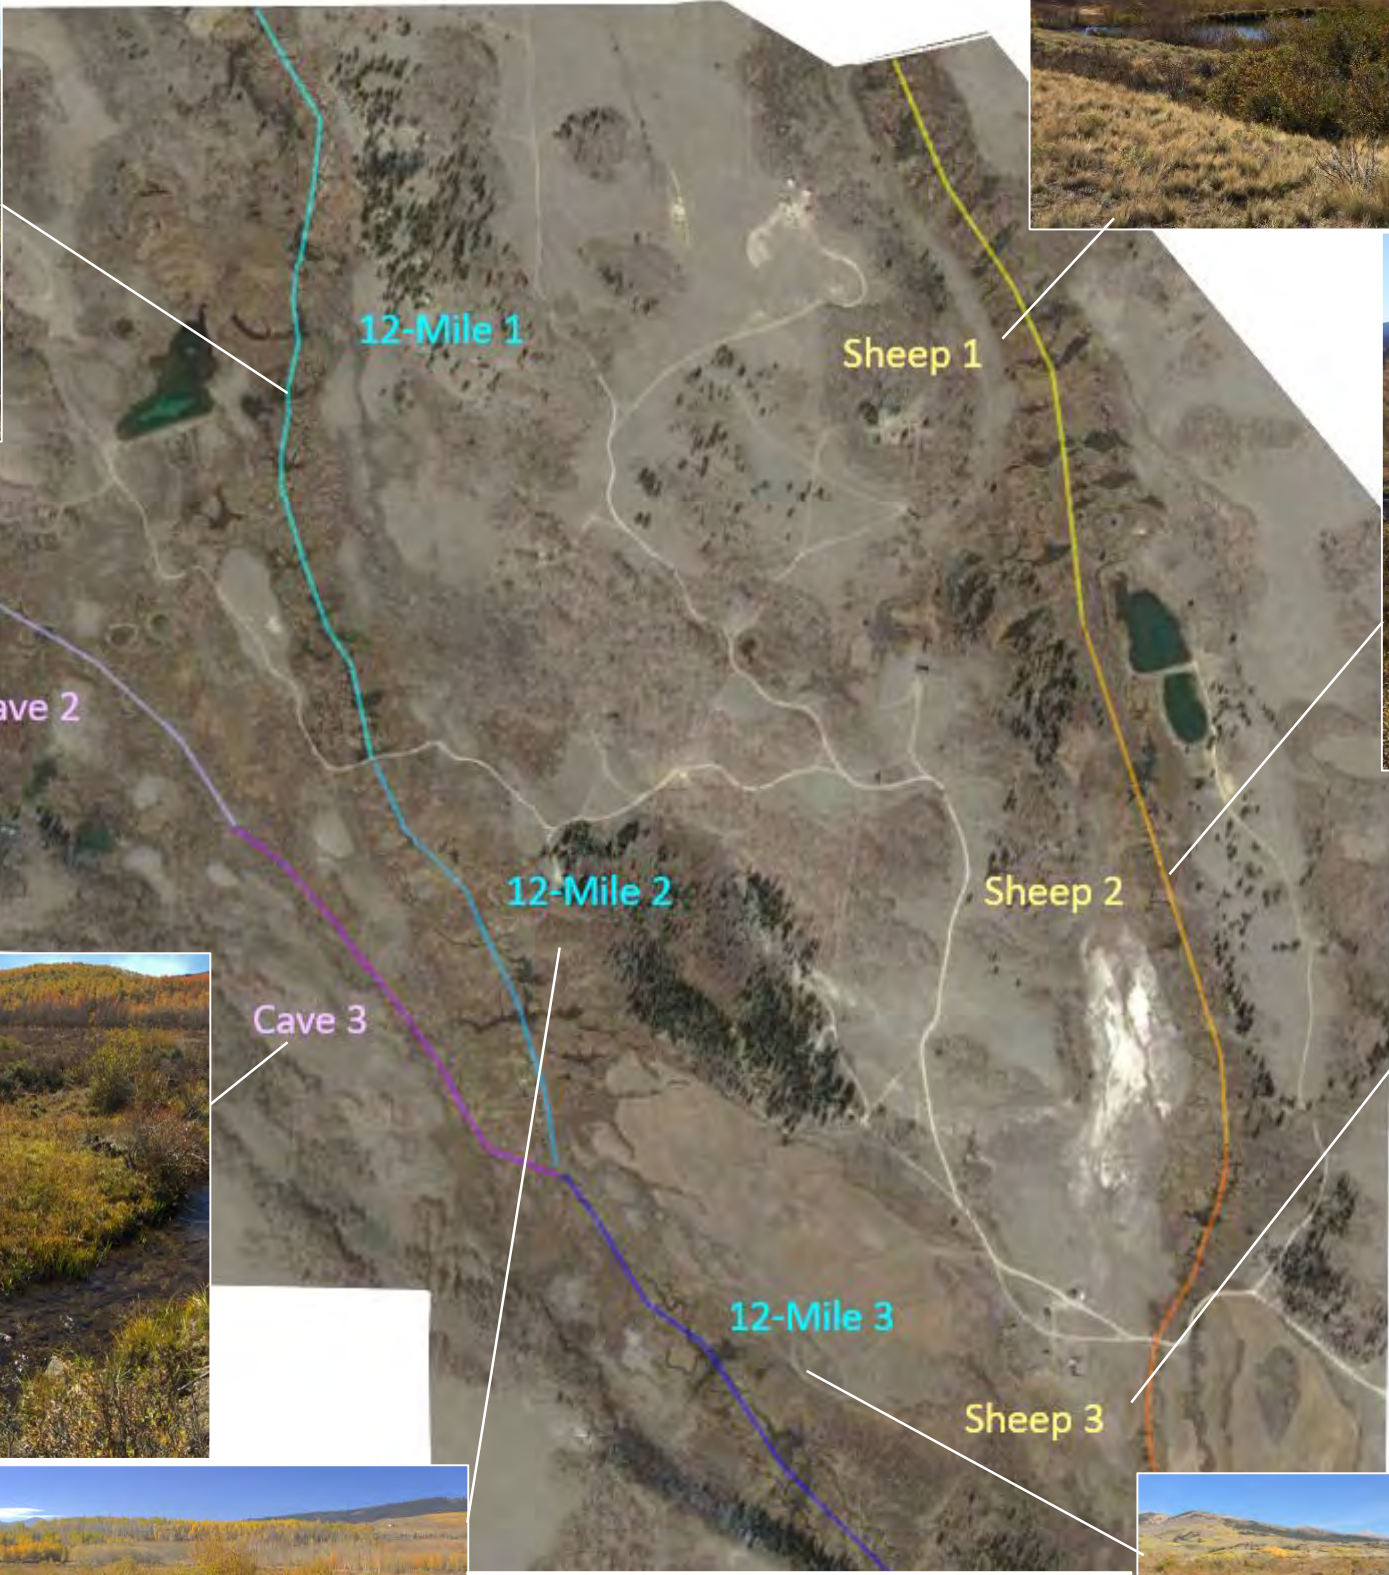
Stream functional assessment reaches

Assessment Reaches
Streams and riparian areas were divided into eight reaches, as shown here. Each reach is evaluated independently.

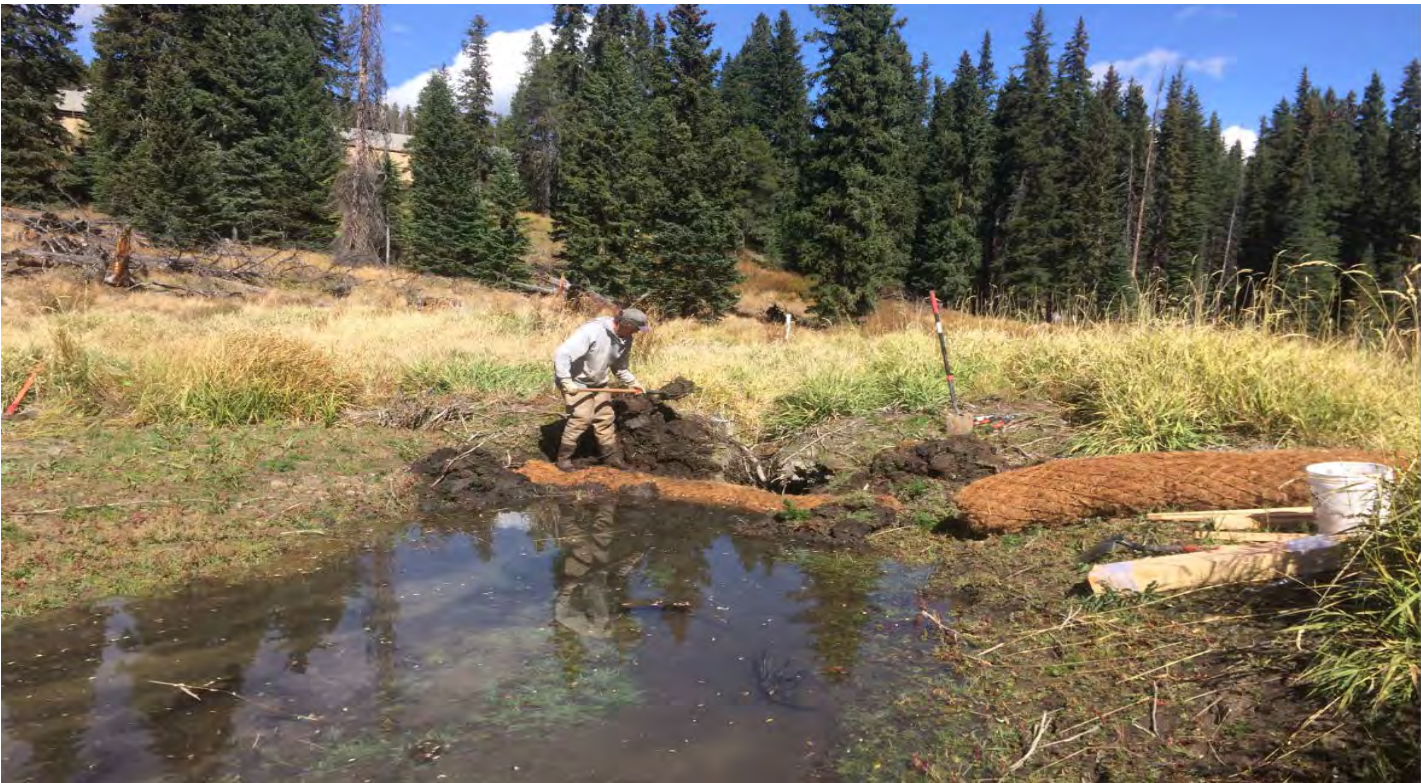
↑ Repairing breached beaver dams with coir logs and sod. ↓ Before and after.

Repairing or reconstructing beaver dams in places where beavers have been inactive is a good way to ensure continued function and habitat benefits during periods of prolonged beaver absence. Repaired dams also create deep water and cover that attracts dispersing beavers and entices them to recolonize an area. These treatments are highly recommended on Cave Creek, and could also be employed a spot treatments along Sheep and Twelvemile Creeks.

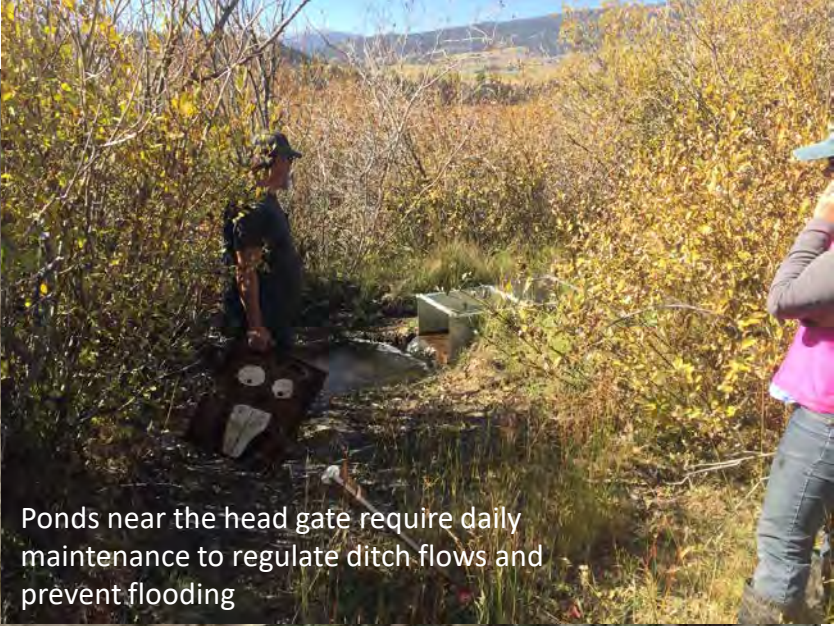
Ponds near the head gate require daily maintenance to regulate ditch flows and prevent flooding

- A series of flow devices on the ponds on the west branches of Sheep Creek (point A) and at the head gate (point B) may help alleviate the daily maintenance burden ranch managers currently expend to:
 - (1) manage ditch flows,
 - (2) prevent flows entering ditch via path 3, and
 - (3) maintain perennial flow through both branches of Sheep Creek.
- Additional flow devices at the stream culverts (points C and D) may alleviate the need for daily maintenance to:
 - (1) prevent road flooding and erosion, and
 - (2) maintain perennial flow on Sheep Creek.
- Continue maintaining the ditch culver (point E) manually while the ditch is flowing.

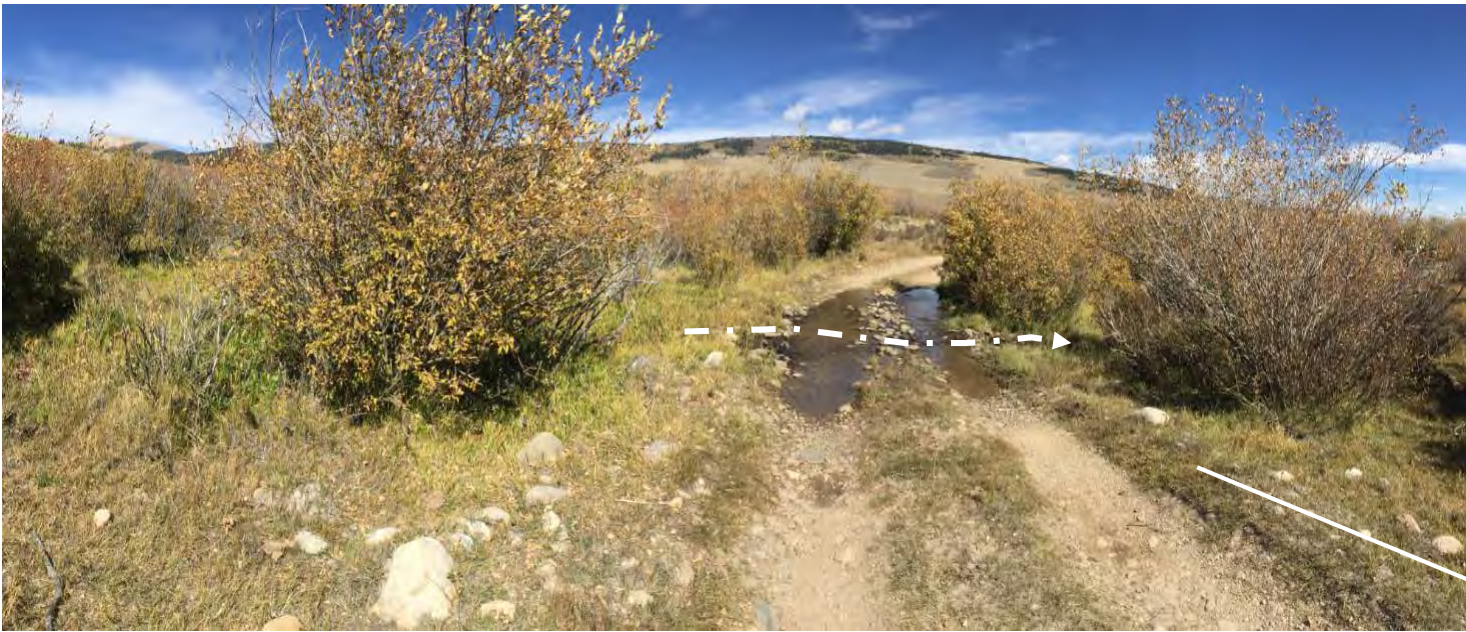
Concepts:

- Flow devices at points A and B would help protect the road by keeping flows directed towards the culverts via flow paths 2 and 3 rather than over the road (paths 4 and 5).
- A flow device at the existing culverts (point C) would reduce maintenance burden to keep them open.
- Additional culverts across the road at points D and E (with or without flow devices) would:
 - (1) provide redundancy,
 - (2) allow flows to activate the floodplain area downstream from the road, and
 - (3) restore hydrology to the dried wetland area downstream of the road.

Road flooding and road damage are common where the road crosses Twelvemile Creek.

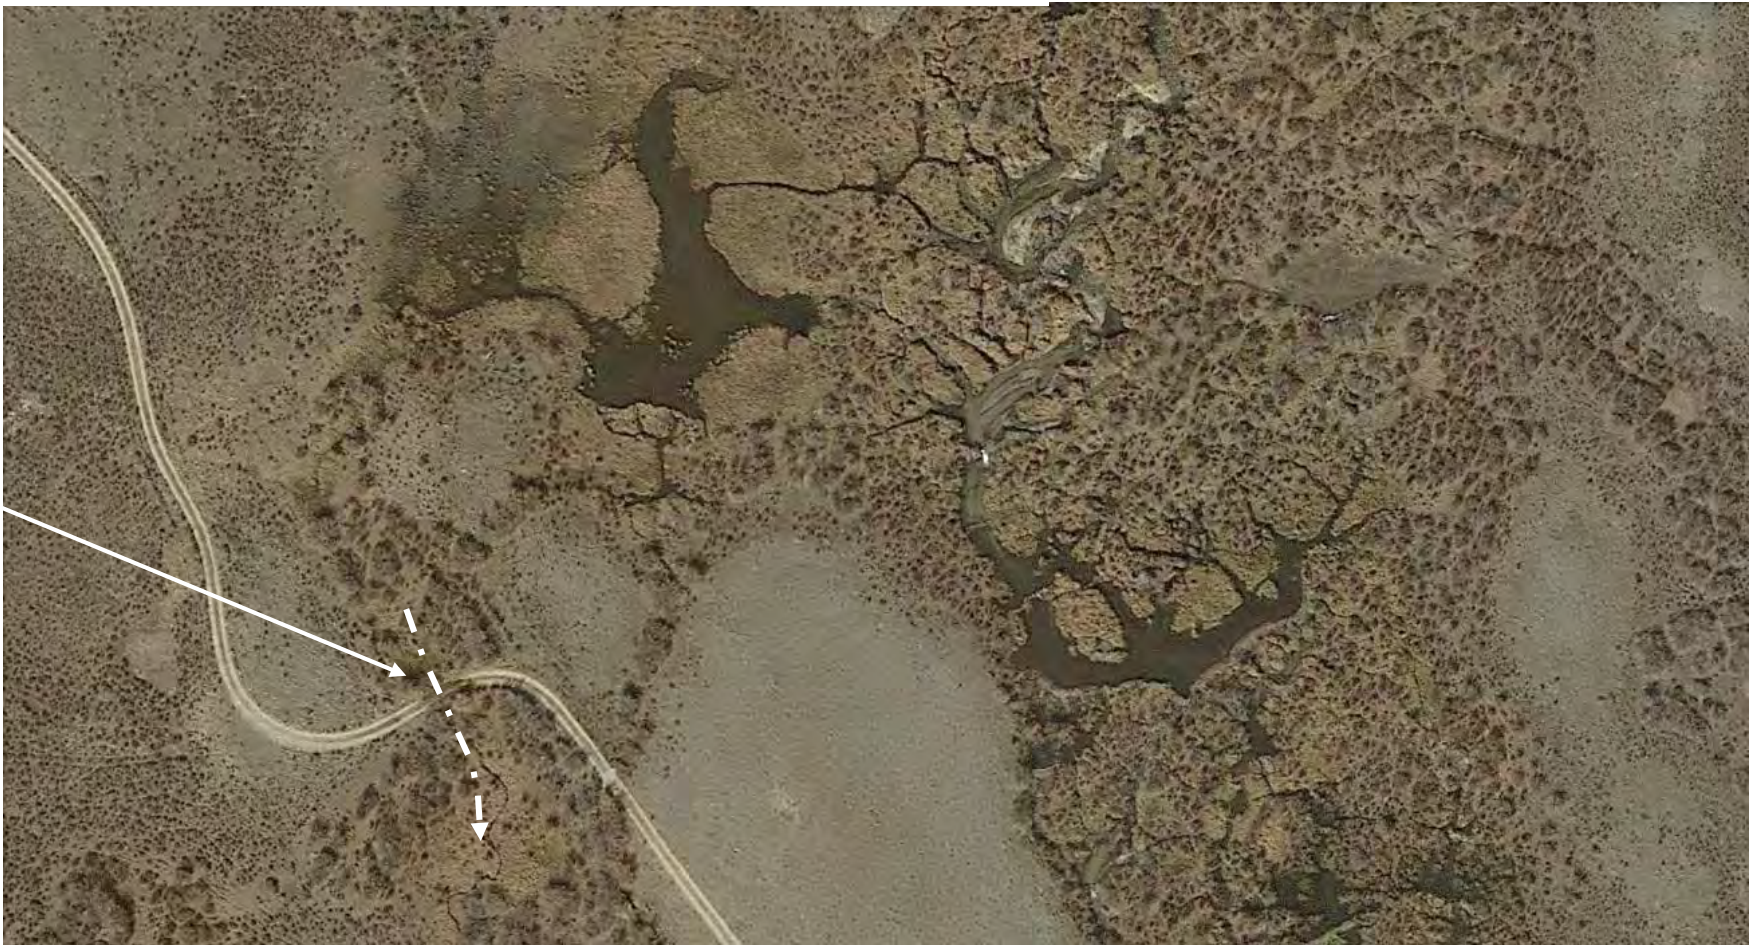
Management concepts: Upper ranch road crossing

Upper ranch road crossing

Depending on beaver activity upstream, a portion of Twelvemile Creek flows follow the flow path shown, flooding the road as it was in 2018. A culvert and possibly a flow device could help manage this situation.
