Colorado Water Conservation Board

Water Plan Grant Application

Name of Applicant	Colorado Open Lands	
Name of Water Project	Riparian Reconnect Project Implementation	
CWP Grant Request Amount		\$ 84,290
Other Funding Sources: <u>Park County Land & Water Trust Fund</u>		\$ 106,798
Other Funding Sources: <u>Participating Landowners</u>		\$ 73,600
Other Funding Sources: <u>EcoMetrics (in-kind)</u>		\$ 6,000
Applicant Funding Contribution		\$ 0
Total Project Cost		\$ 270,688

Twelvemile Ranch:
A reconnaissance assessment of stream and riparian condition for the Riparian Reconnect project with recommendations for restoration and management

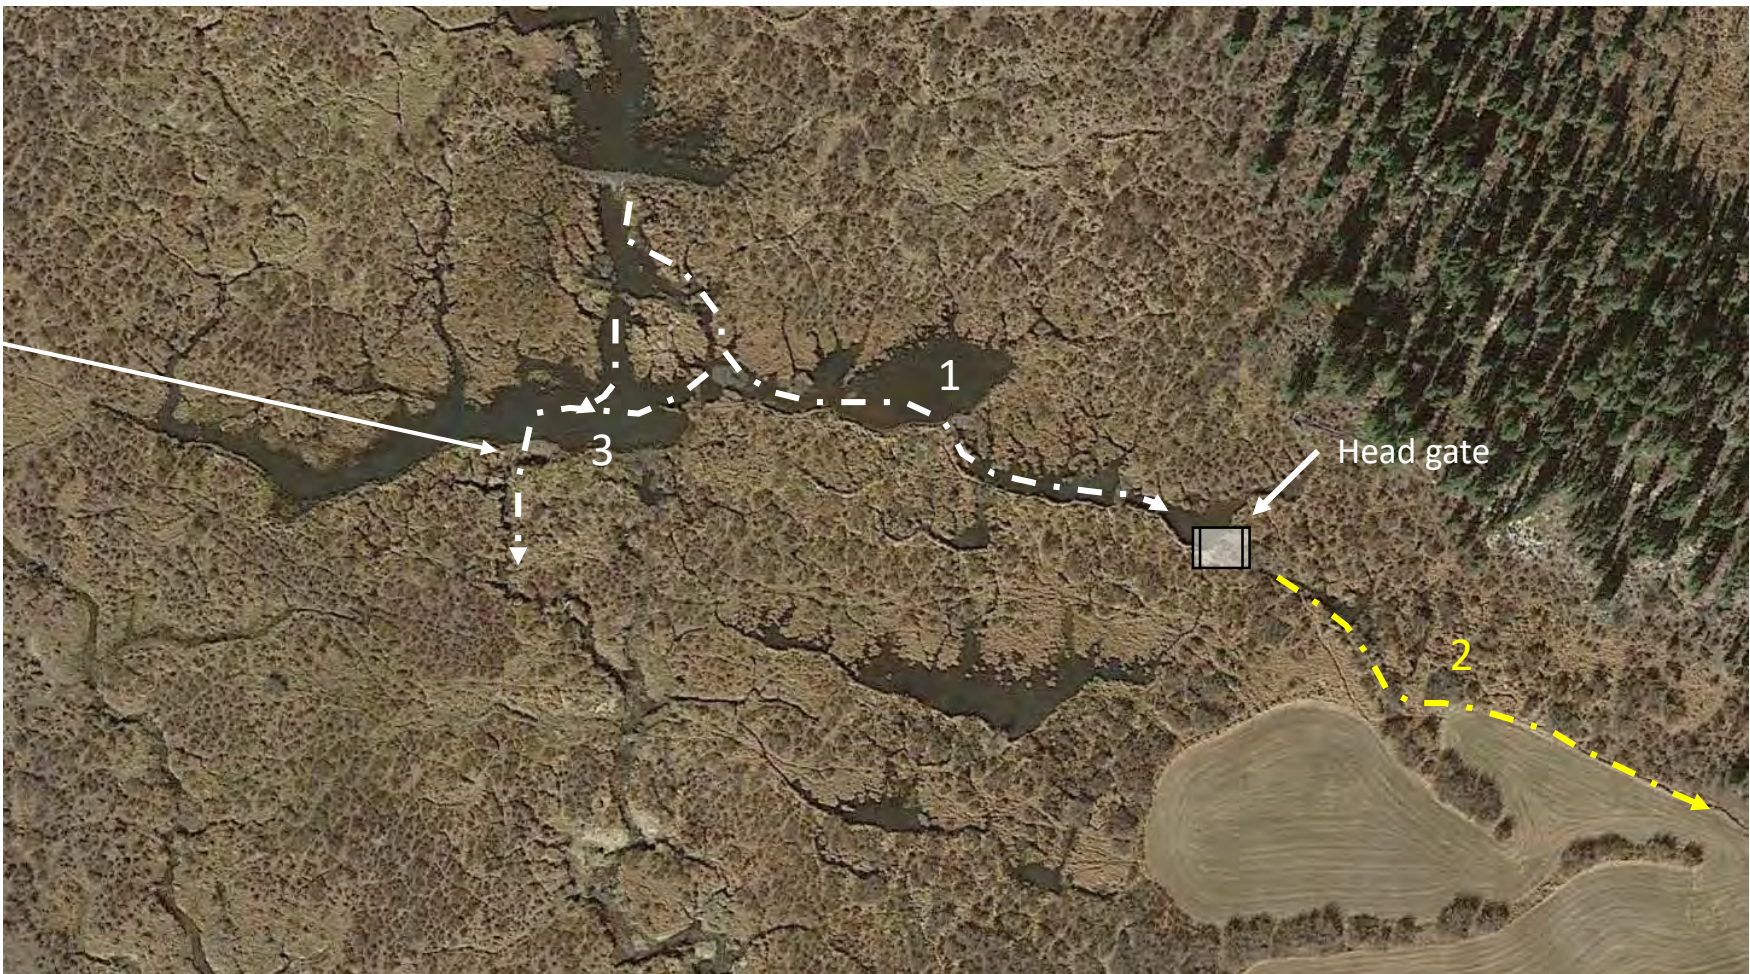
Management concepts: Twelvemile diversion

For the diversion to function, some portion of flow must follow path 1 to the head gate and ditch (path 2). A beaver dam that failed in 2018 greatly increases the risk of this path drying up, as flows preferentially direct towards path 3. Repairing this dam would mitigate this risk to the water right. Flow devices could also be considered if necessary.

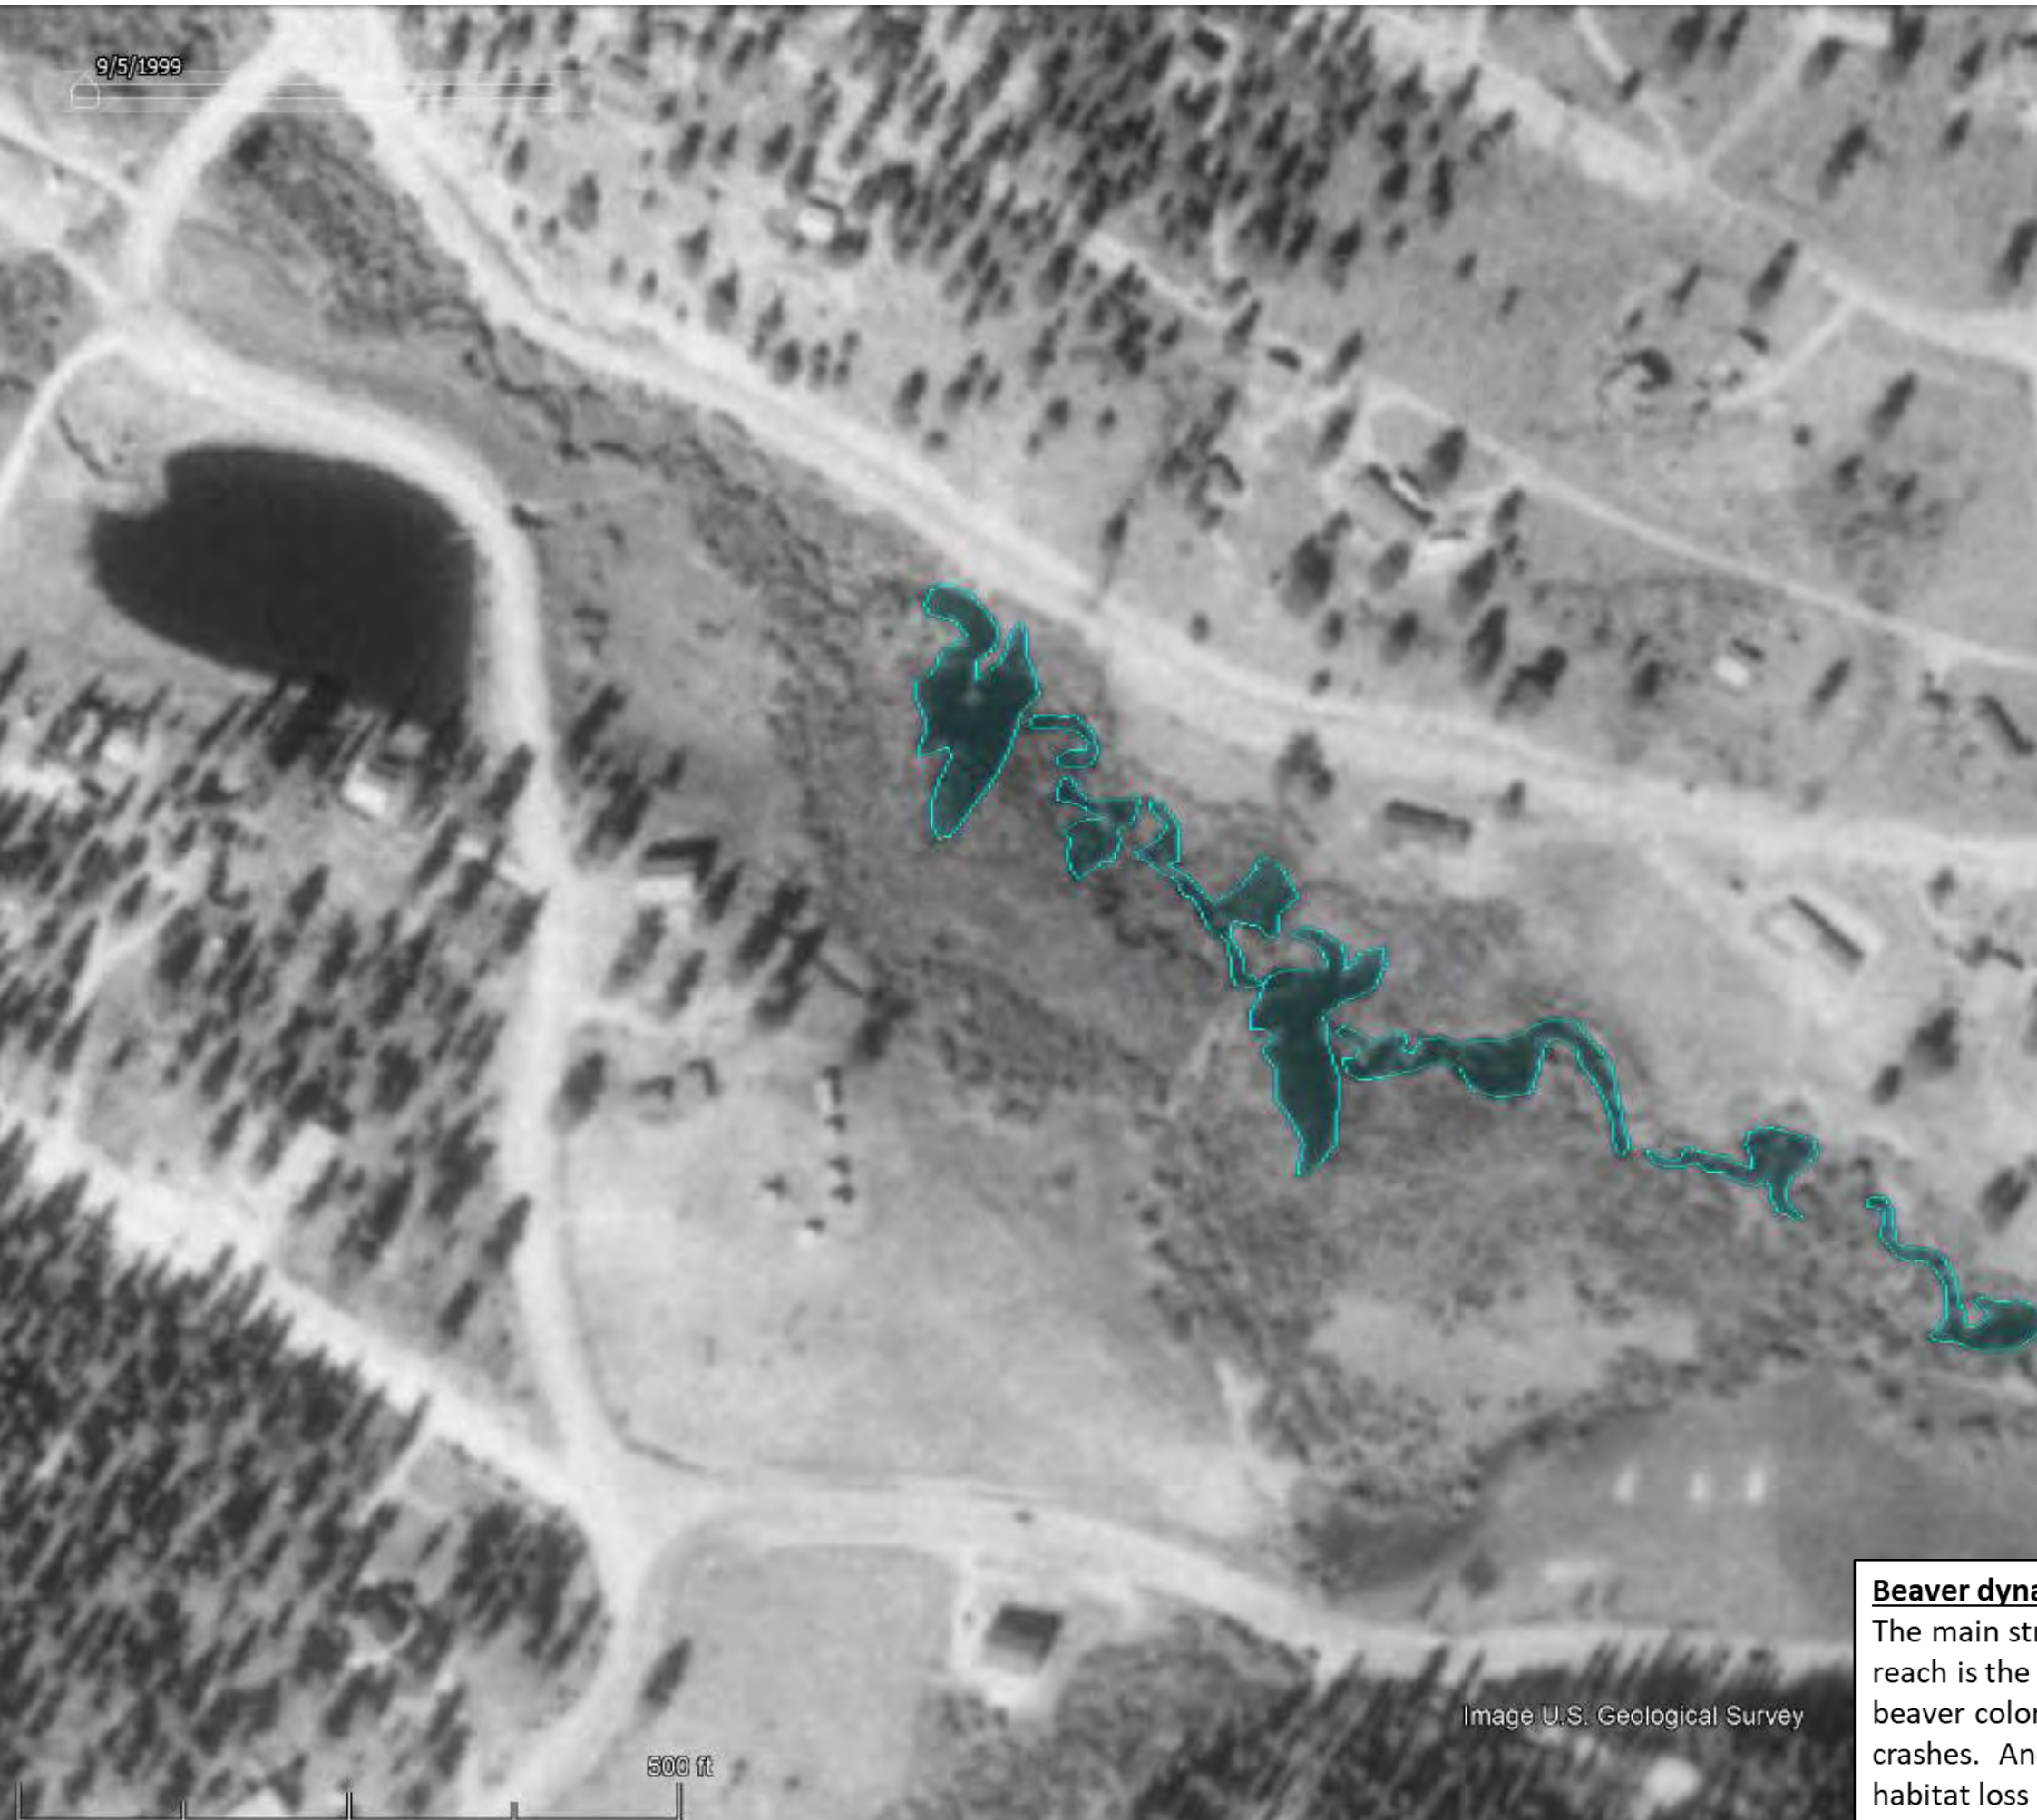
Beaver activity — 1999

The main stressor affecting stream and riparian health on the ECHPOA reach is the prolonged absence of beaver activity. Our hypothesis is that beaver colonies have become unnaturally susceptible to population crashes. And when populations do crash, they are slow to recover due to habitat loss and fragmentation at the landscape scale.

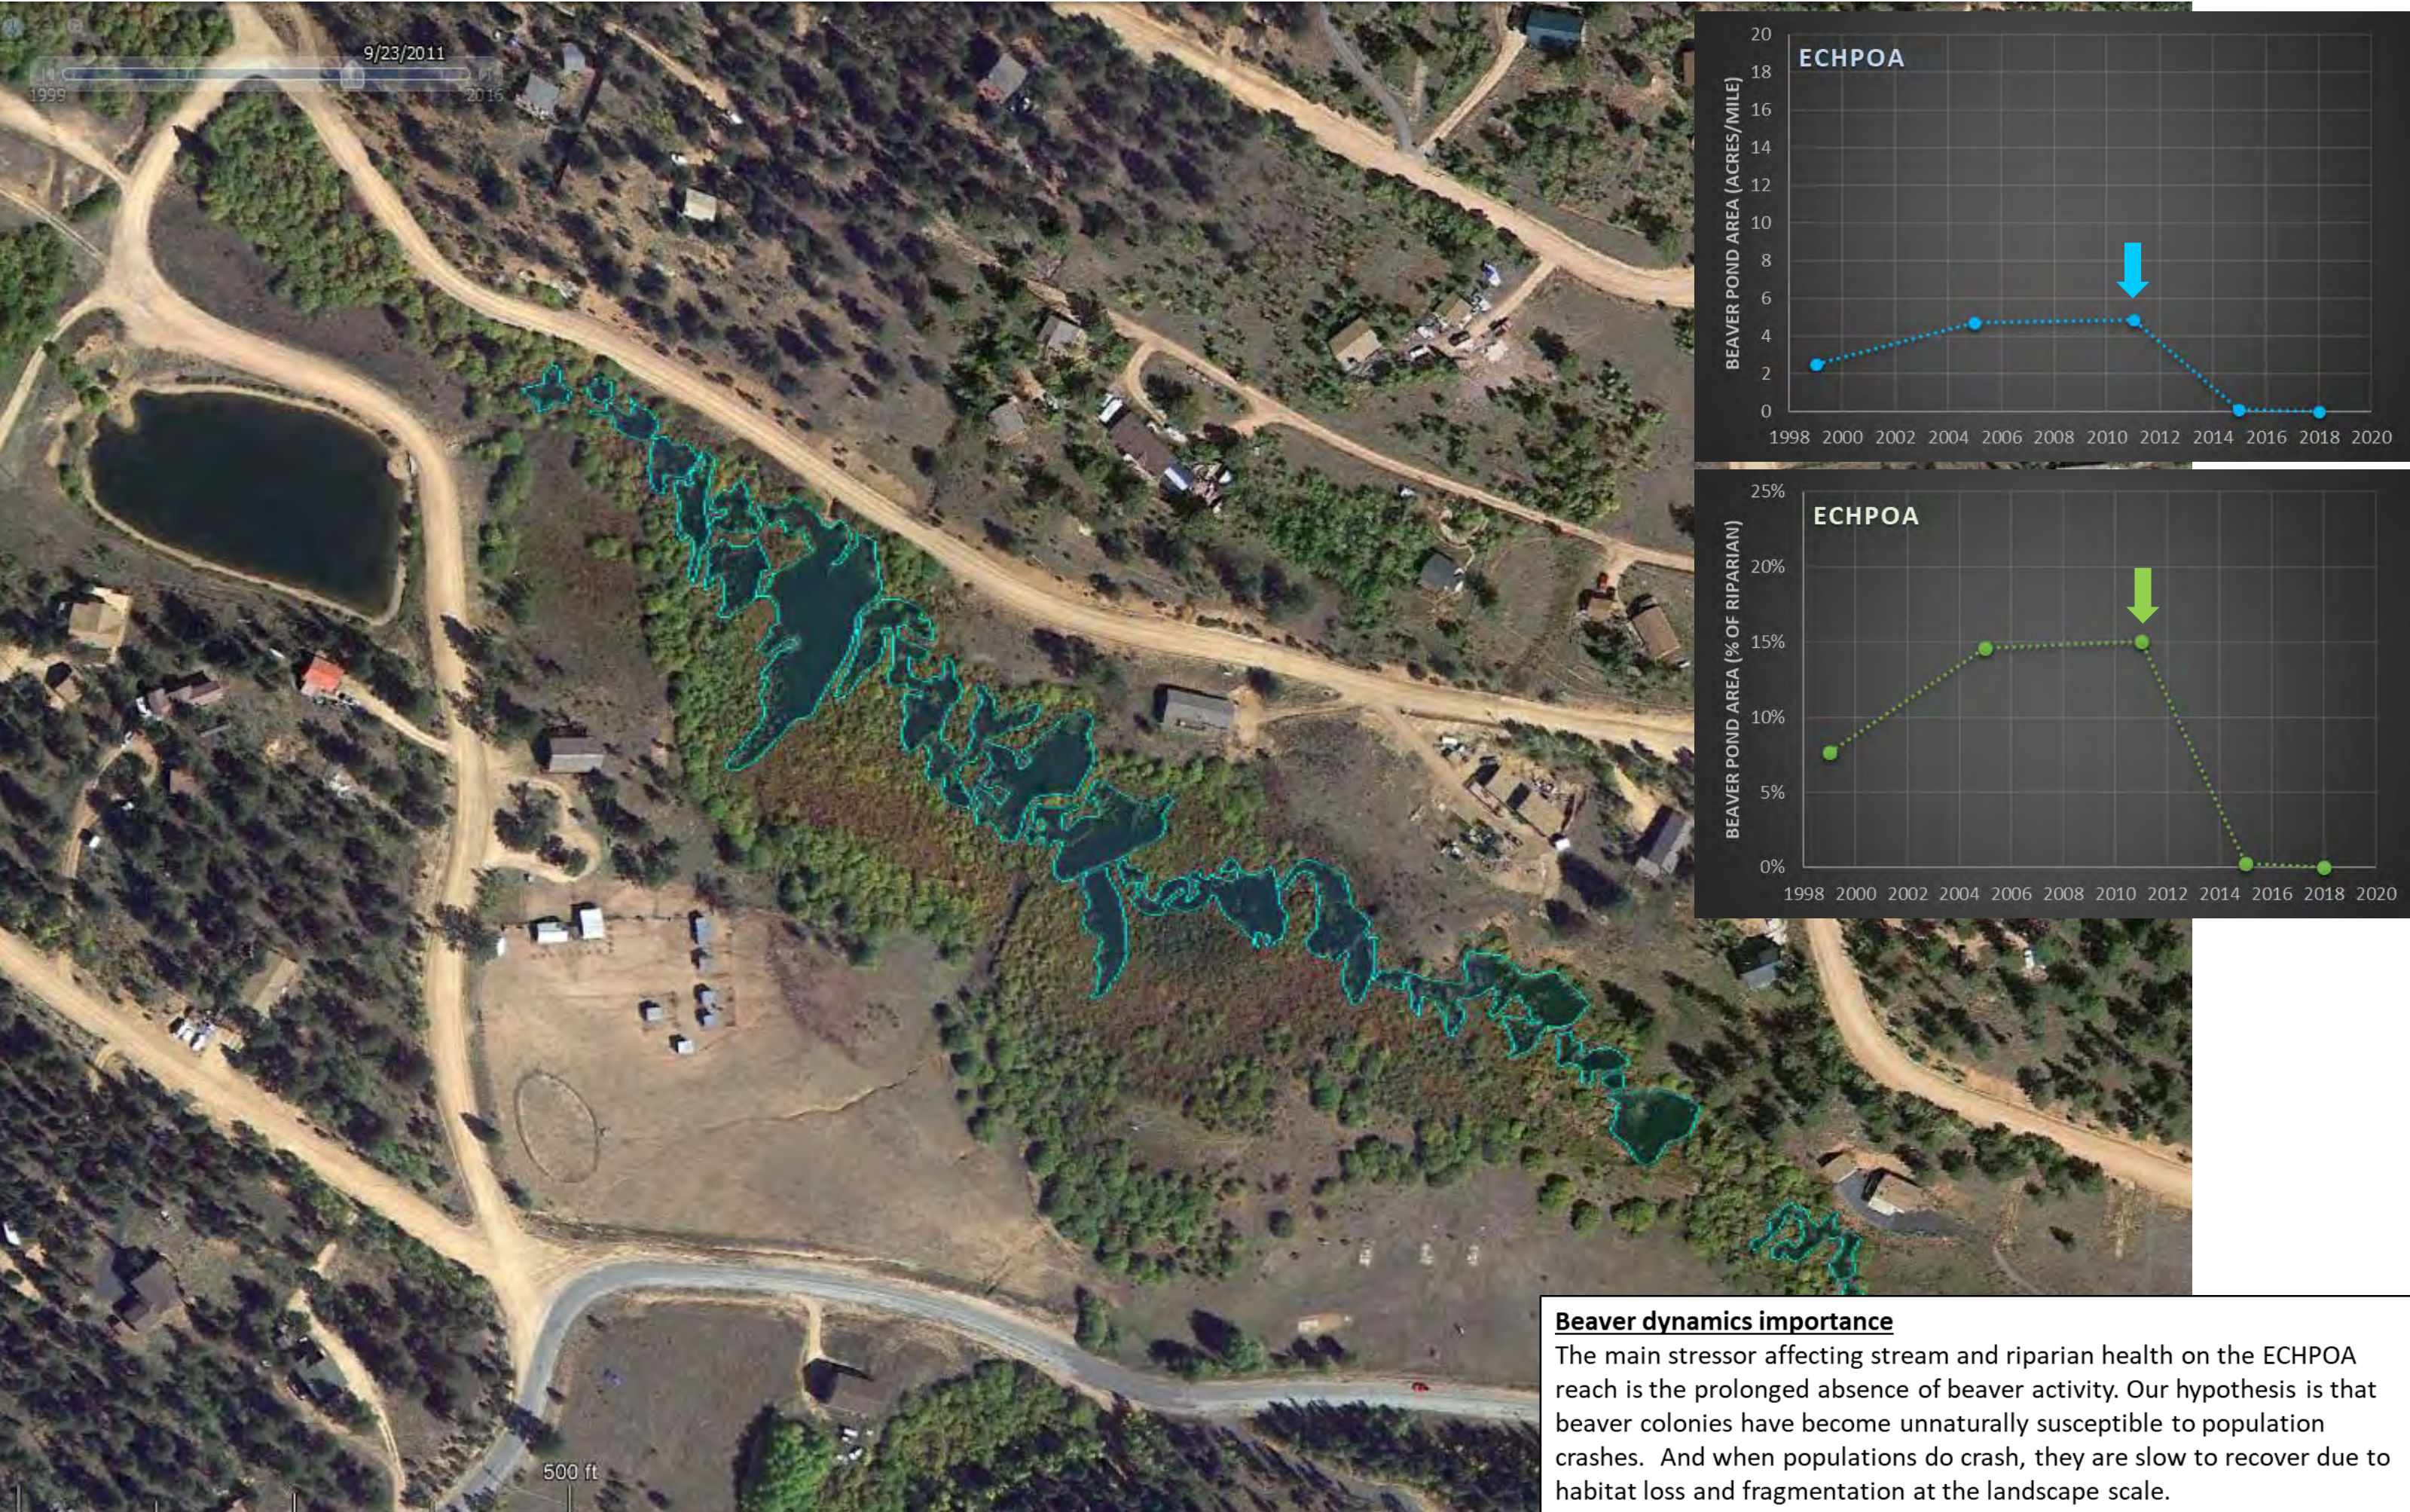
Beaver activity — 2011

The main stressor affecting stream and riparian health on the ECHPOA reach is the prolonged absence of beaver activity. Our hypothesis is that beaver colonies have become unnaturally susceptible to population crashes. And when populations do crash, they are slow to recover due to habitat loss and fragmentation at the landscape scale.

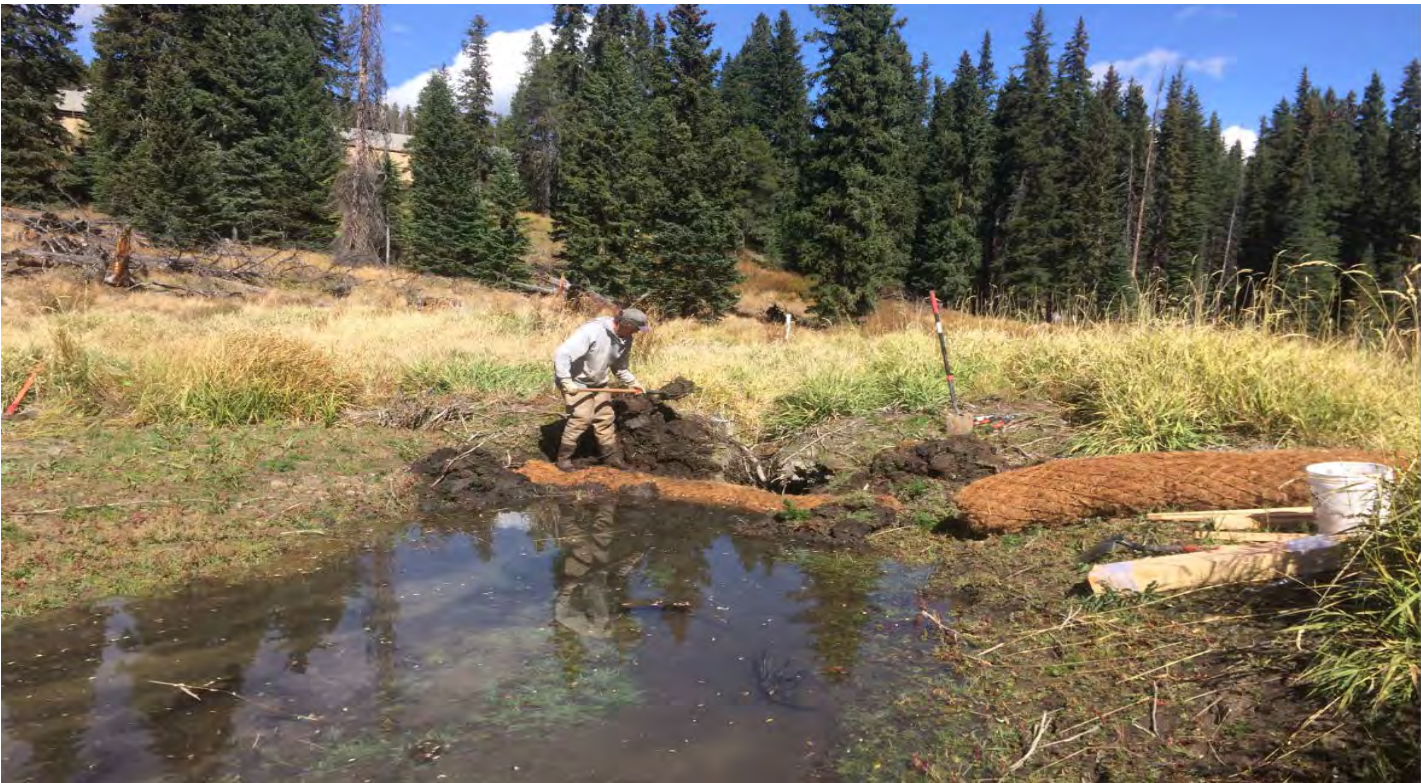
↑Repairing breached beaver dams with coir logs and sod.

Repairing or reconstructing beaver dams in places where beavers have been inactive is a good way to ensure continued function and habitat benefits during periods of prolonged beaver absence. Repaired dams also create deep water and cover that attracts dispersing beavers and entices them to recolonize an area.

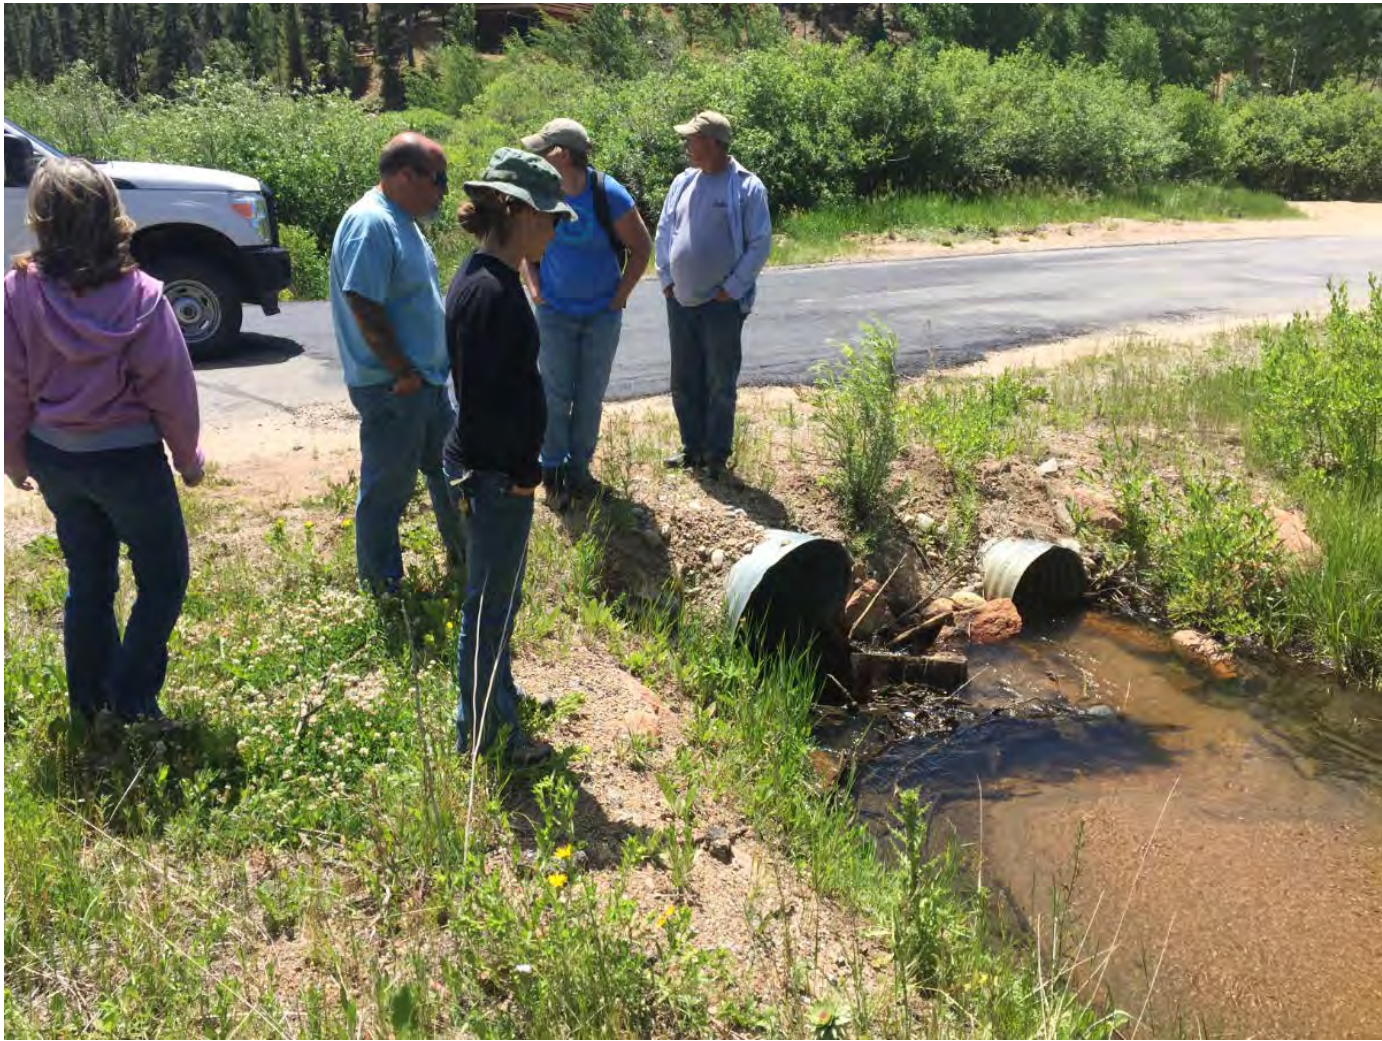
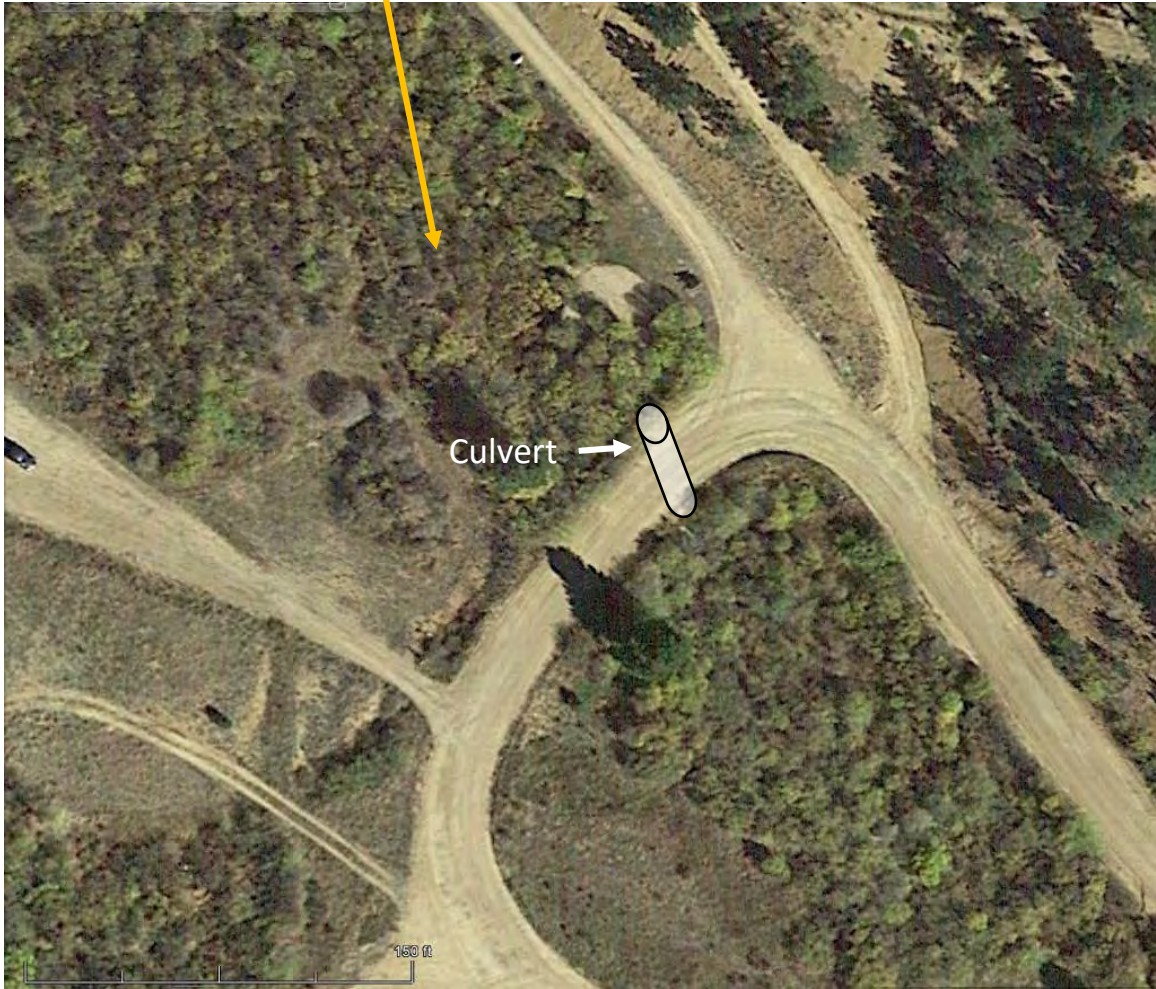
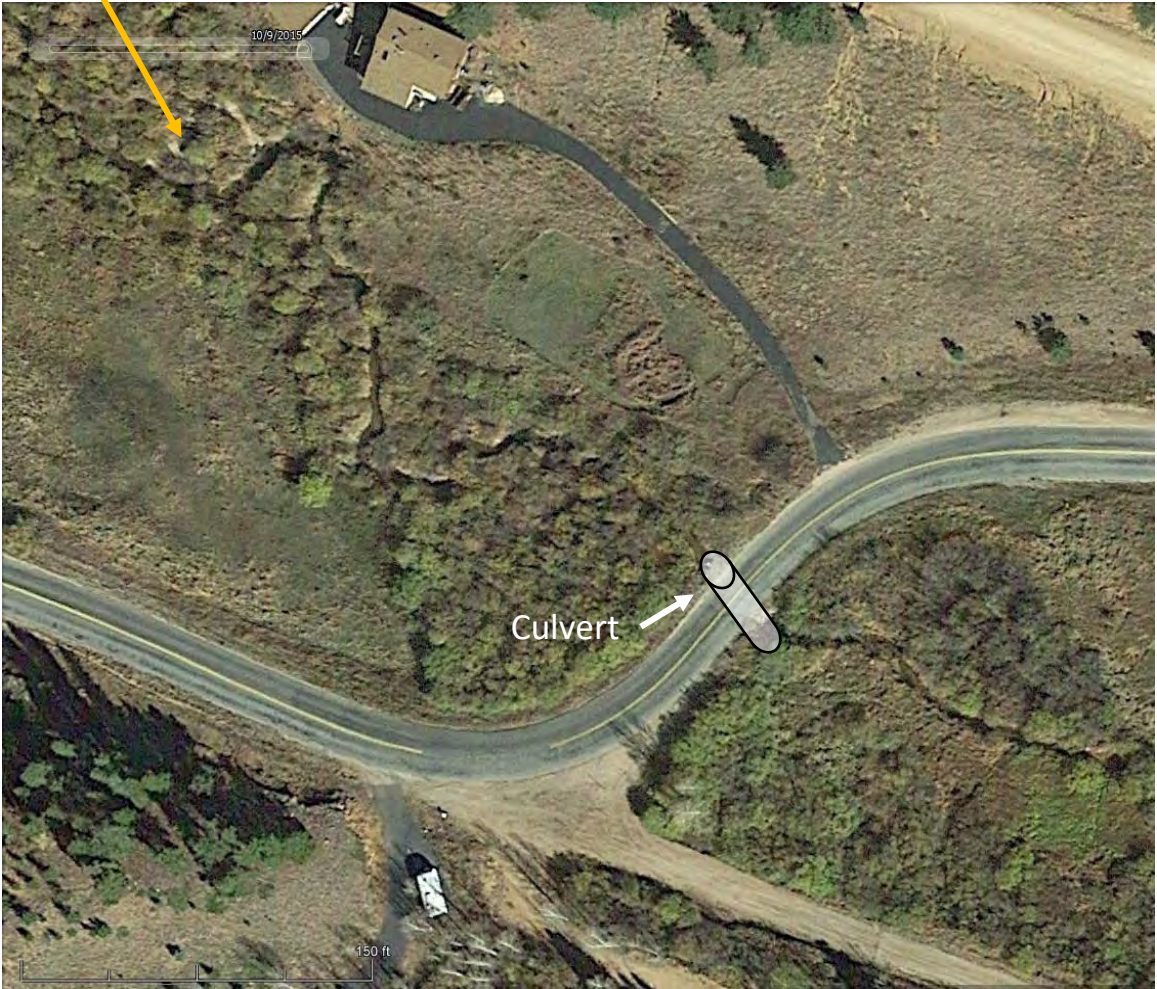
↓ Elk Creek culvert at the upper road crossing

Maintaining culverts in beaver habitat
Restoring beaver habitat on the ECHPOA reach could mean an increased risk that beavers will plug culverts. Identifying these potential conflict areas allows us to prepare for potential issues and prepare in advance to reduce the risk of damage or maintenance issues.

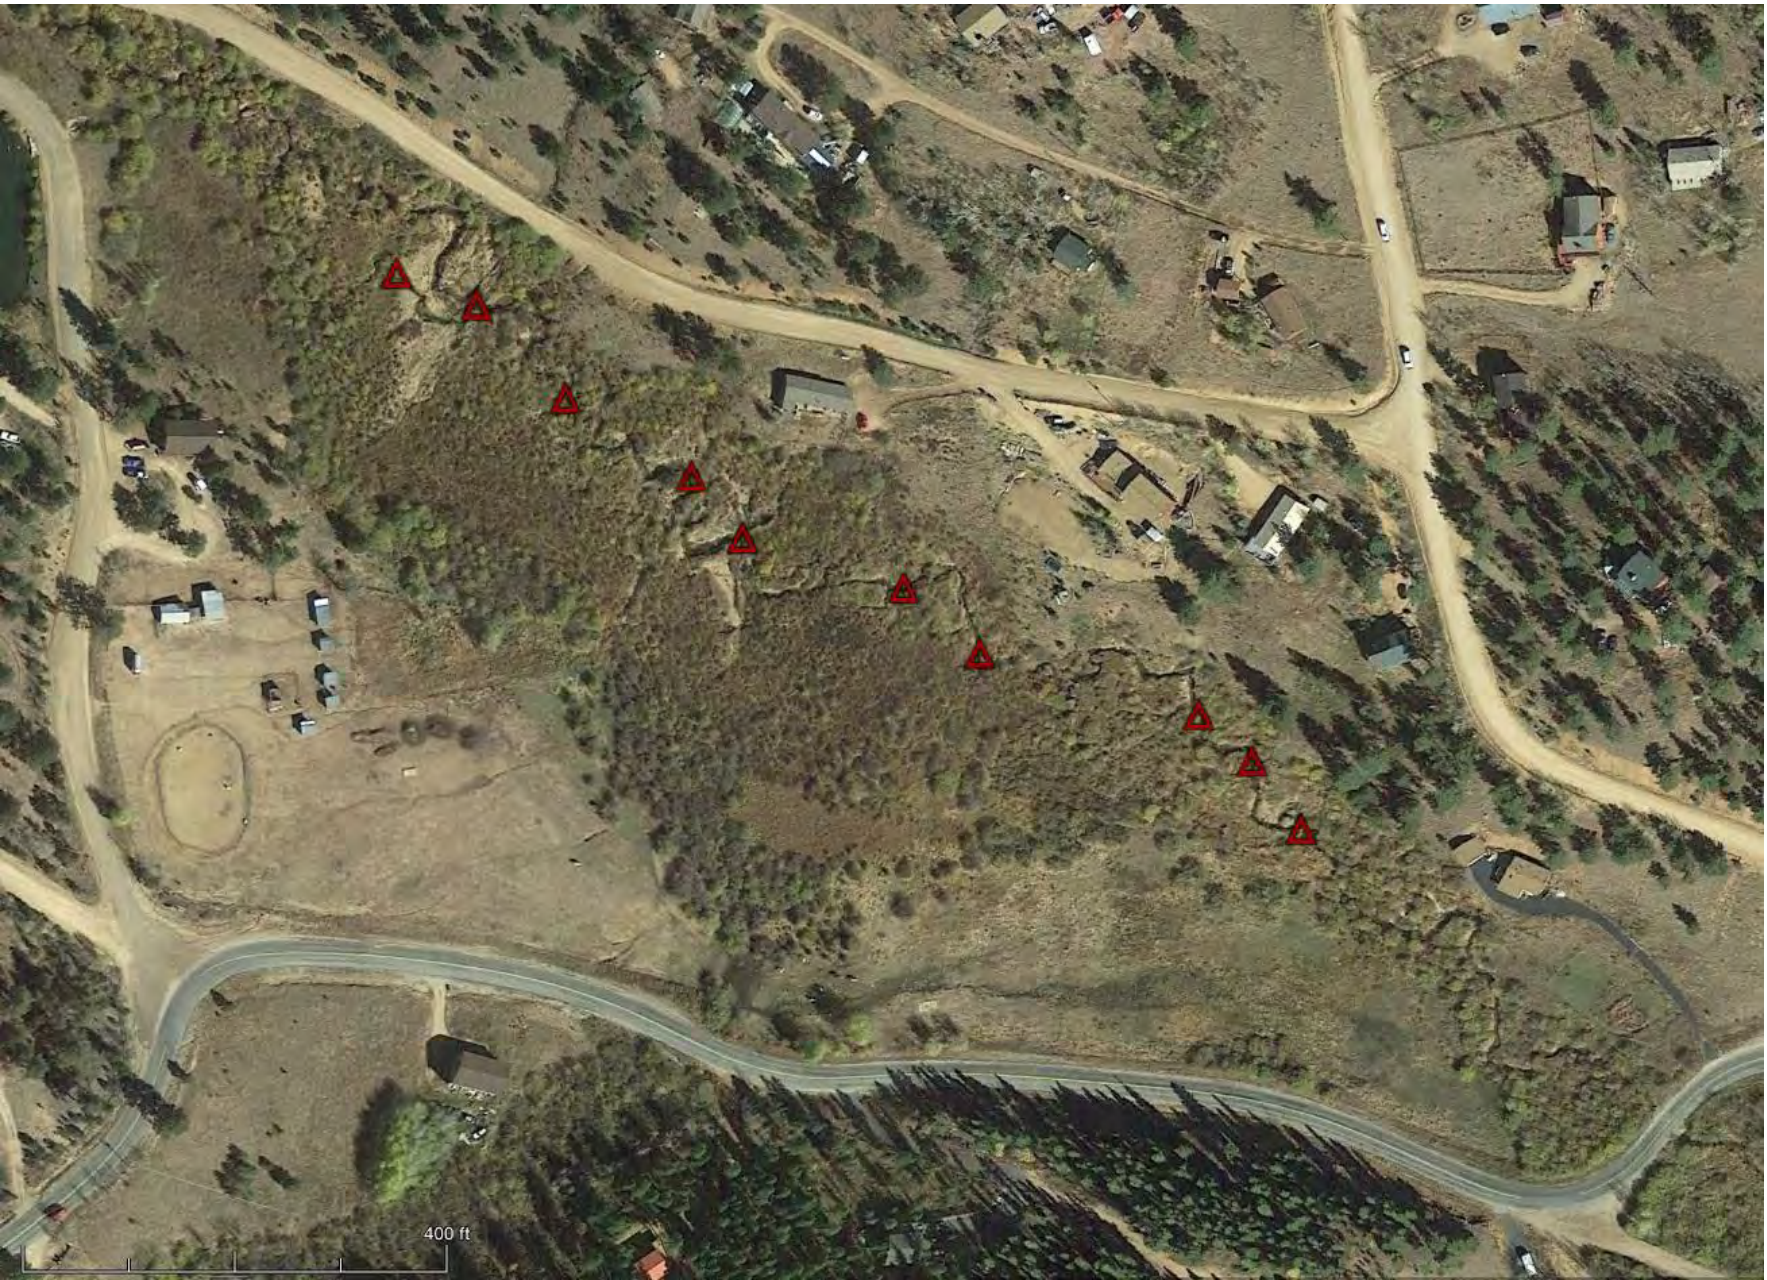
The **stream and riparian restoration plan** would repair about 10 breached beaver dams, allowing them to continue functioning during prolonged absence of beaver. Dam repairs would be made using native materials (sod, willow stems, willow fascines) and soft biodegradable coir logs that will grow and assimilate into the landscape. Dam repairs aim to restore up to about 2.5 acres of pond area and about 5 acres of wetland, creating habitat ideal for recolonization by beaver.
