Natural Resources Department END OF PROJECT REPORT

**Repair and Rehabilitation of Montezuma Valley Irrigation
Company Flume No.6- McElmo Creek Flume –Flume #6**

PDAA 2500 WSRF Grant Montezuma County to Fund McElmo Rehab

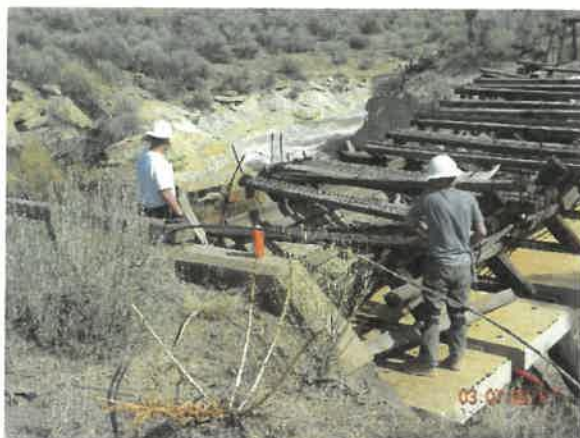
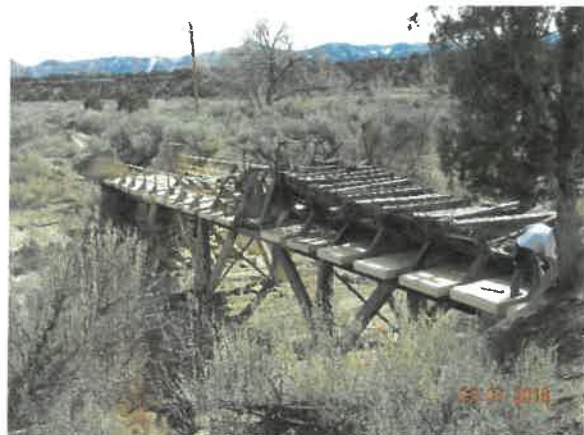
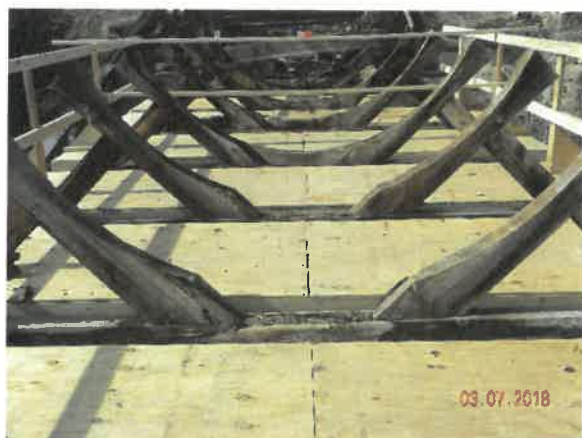
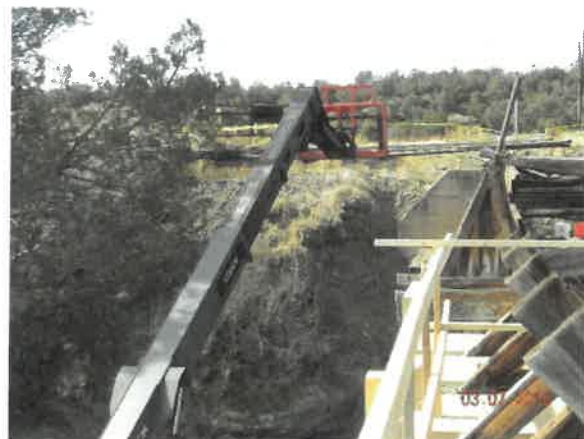
Photos showing the disassembly process

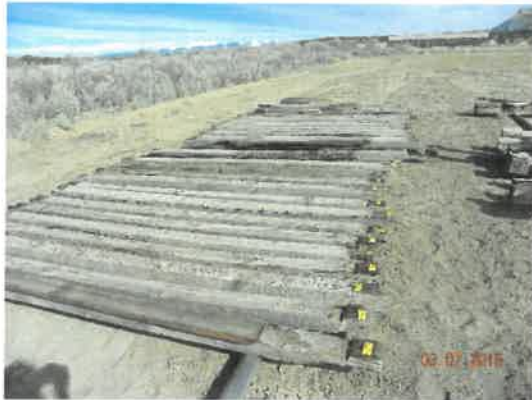
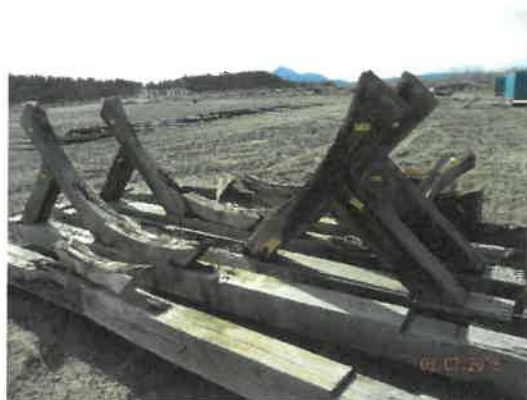
Parts being labeled for reassembly

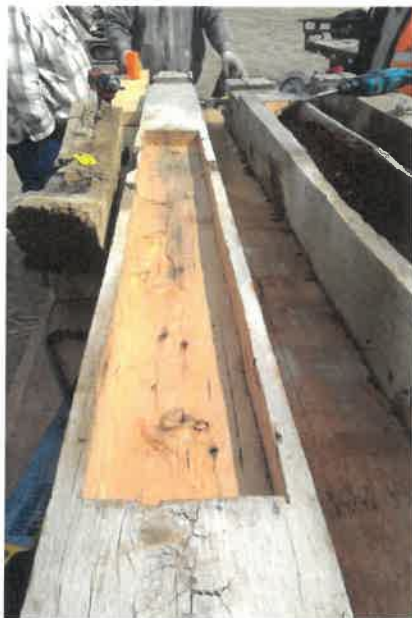
Figure 8. Dutchman repair at sill. Deteriorated wood removed to sound material. Pocket to be filled with new lumber.

Work then began on the splicing of wooden parts that had deteriorated badly enough to require replacement. In many cases new wood that matched the old wood was “spliced” into the existing pieces using a “Dutchman” splice. These splices are essentially an inlay technique that treats a localized area of deterioration by cutting out the decayed wood and carefully carving and installing a matching plug or “splice”.

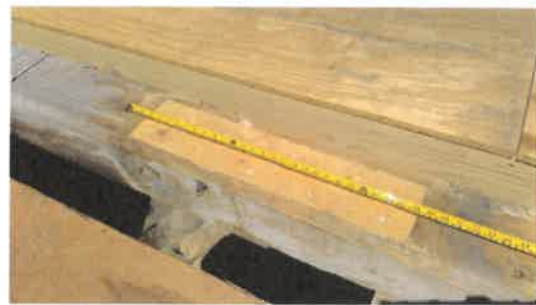
Figure 6. View of repair work at sills.

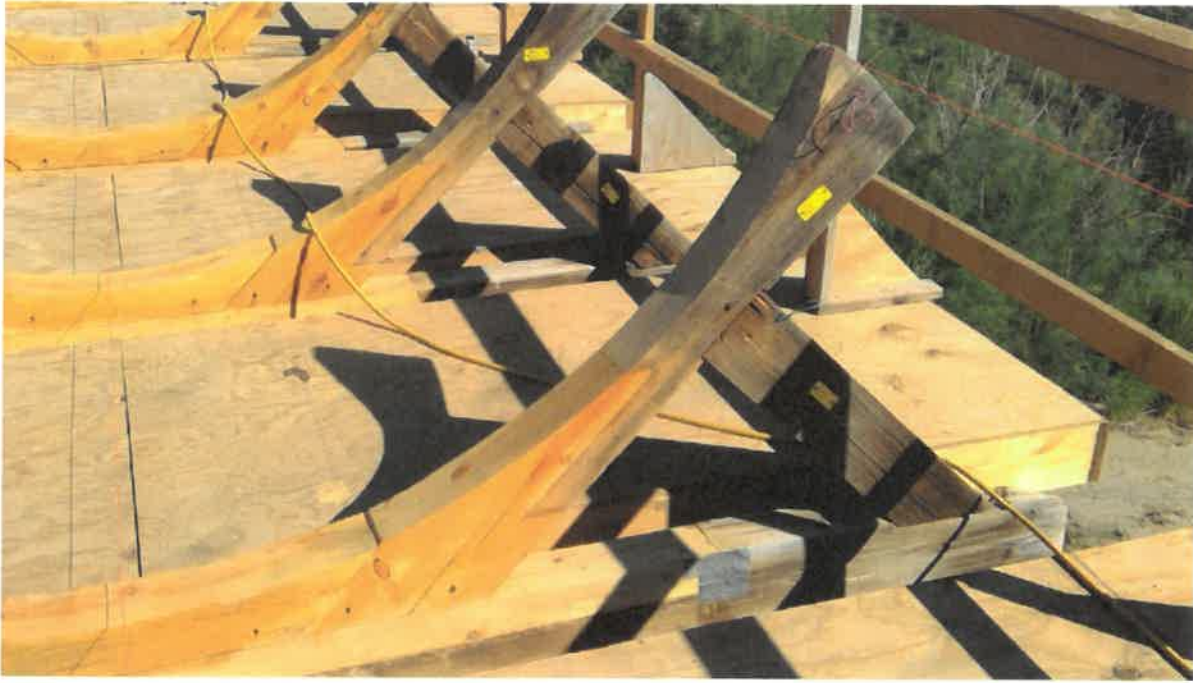
Figure 2. View of splice repair at segments.

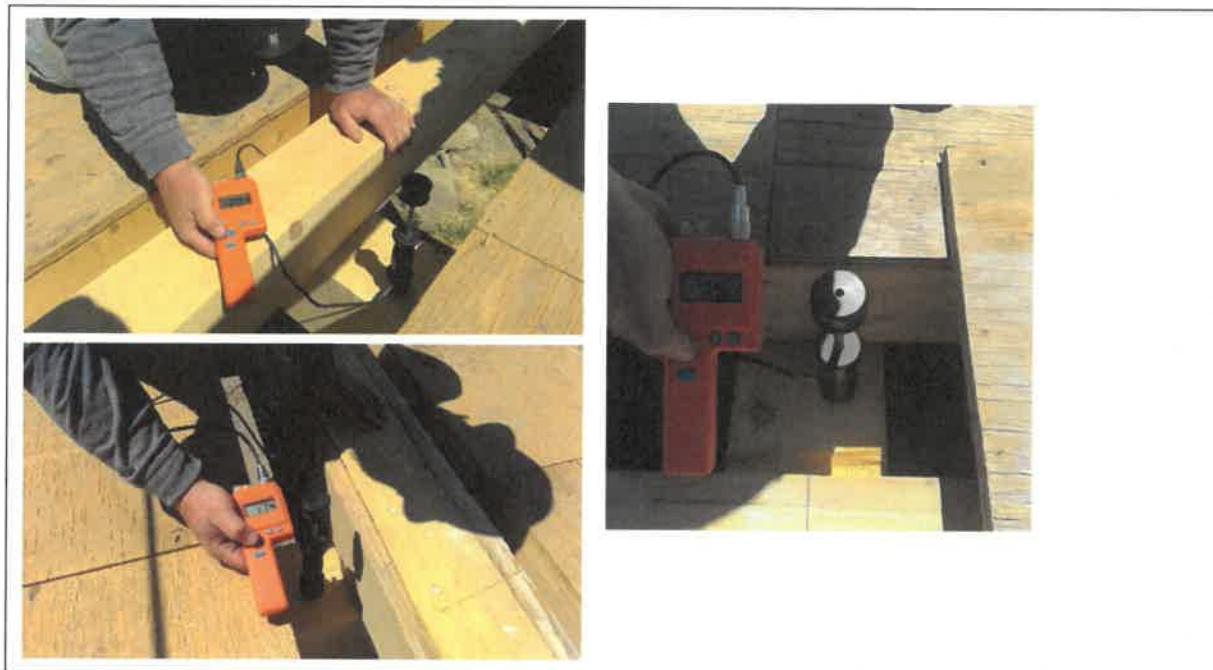
Figure 8. Moisture readings at stringers. Moisture content varies from approximately 17% to 20%.

Controlling moisture content was a very important element of this project because matching pieces of new wood with old wood could result in cracking and shrinkage if the moisture content of both pieces of wood were not relatively close. Most pieces of wood were stored on site in a shipping container to dry until the moisture content had been reduced to around 20%.

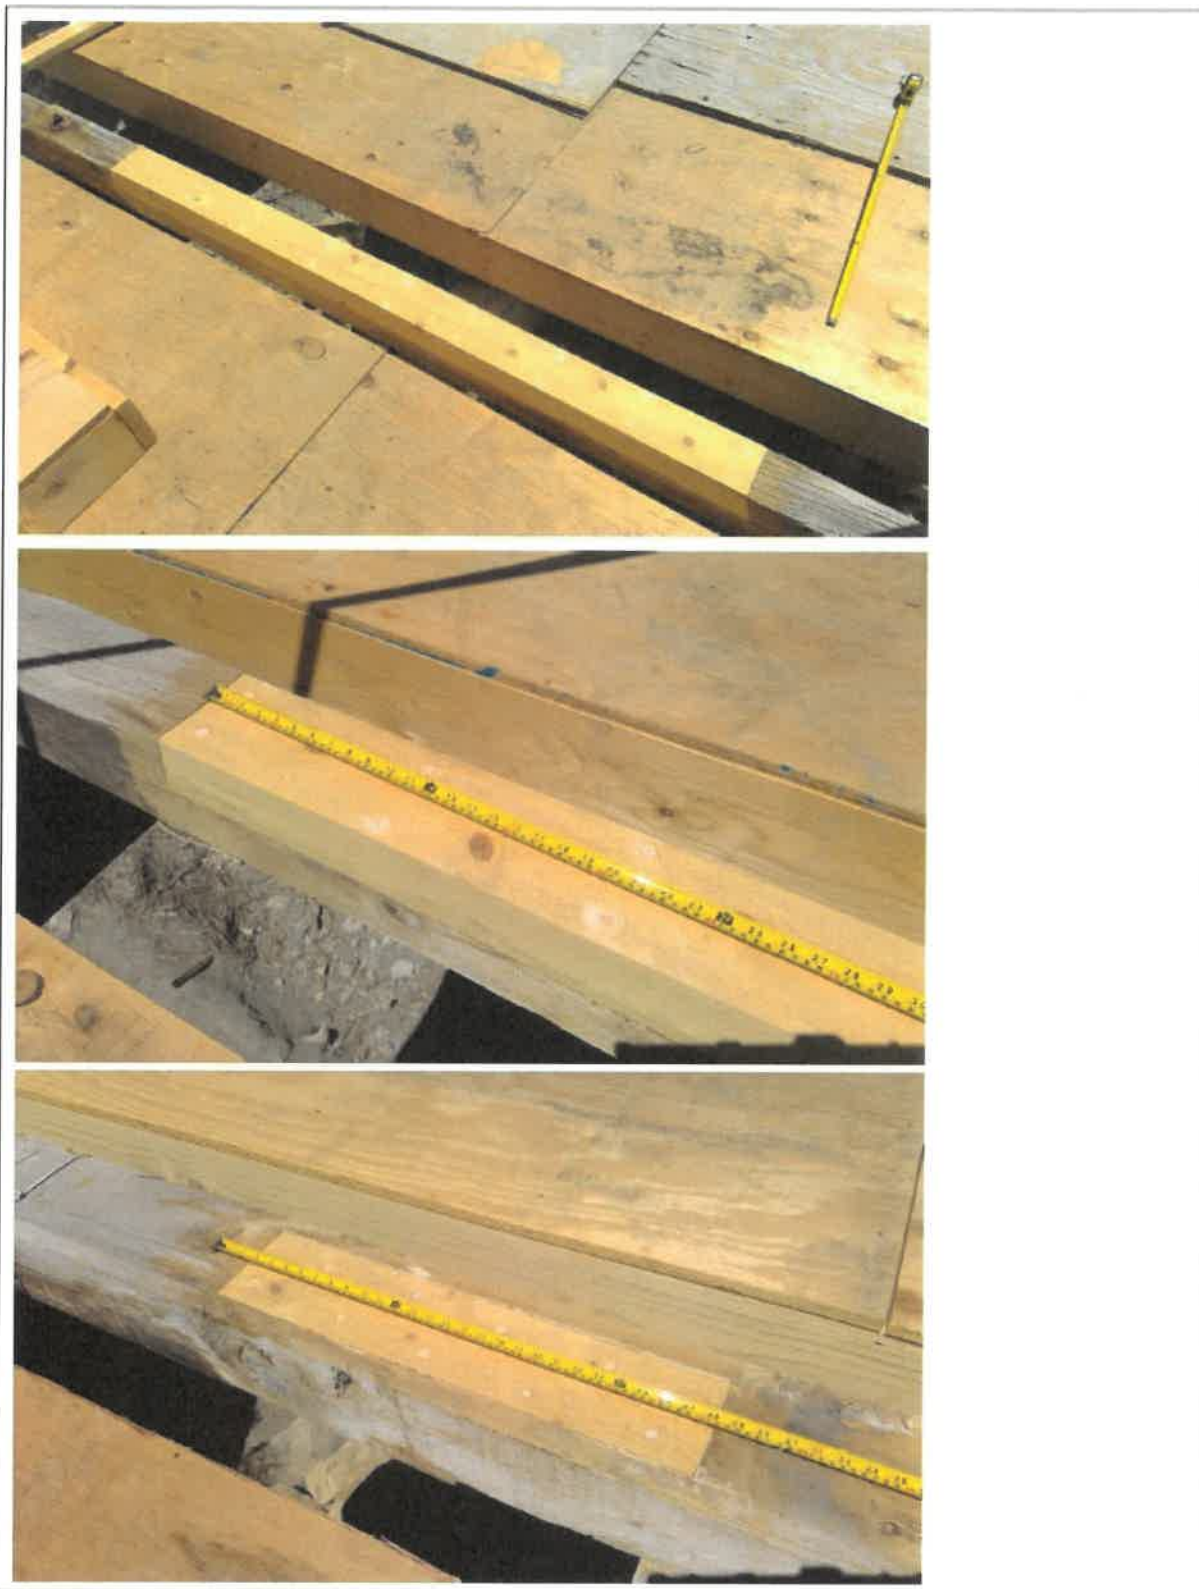
Figure 6. View of repair work at sills.

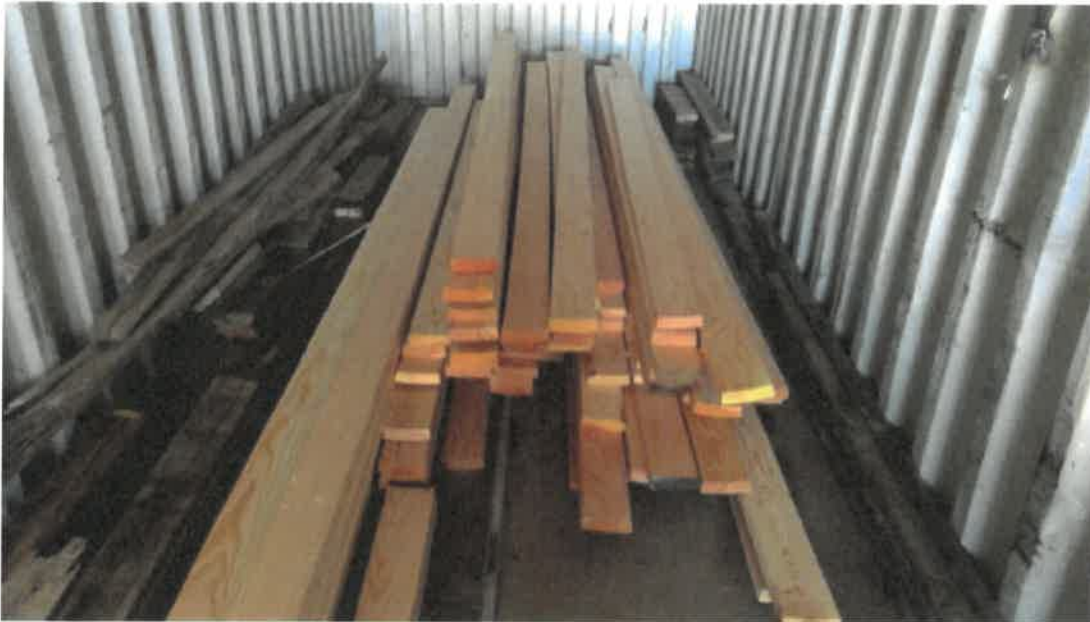
Figure 1. New staves stored on site.

As work progressed many of the staves were found to need complete replacement. The original staves themselves were the wood that carried the water and were a higher grade of wood than the sills and bents. In order to match the wood as closely as possible RAMCO had to special order wood from Washington State. The wood ordered had to be milled so that it would form a half barrel when it was installed. The milling process went very quickly but again moisture content was very important and therefore a careful drying process was required. In addition the staves had to fit together nearly perfectly and any warpage or cracks would not have been suitable for National Historic Preservation Standards. In this case the drying process took several months in carefully controlled climatic conditions. After the drying process ended we also had to have the product shipped from Washington which also took several weeks.

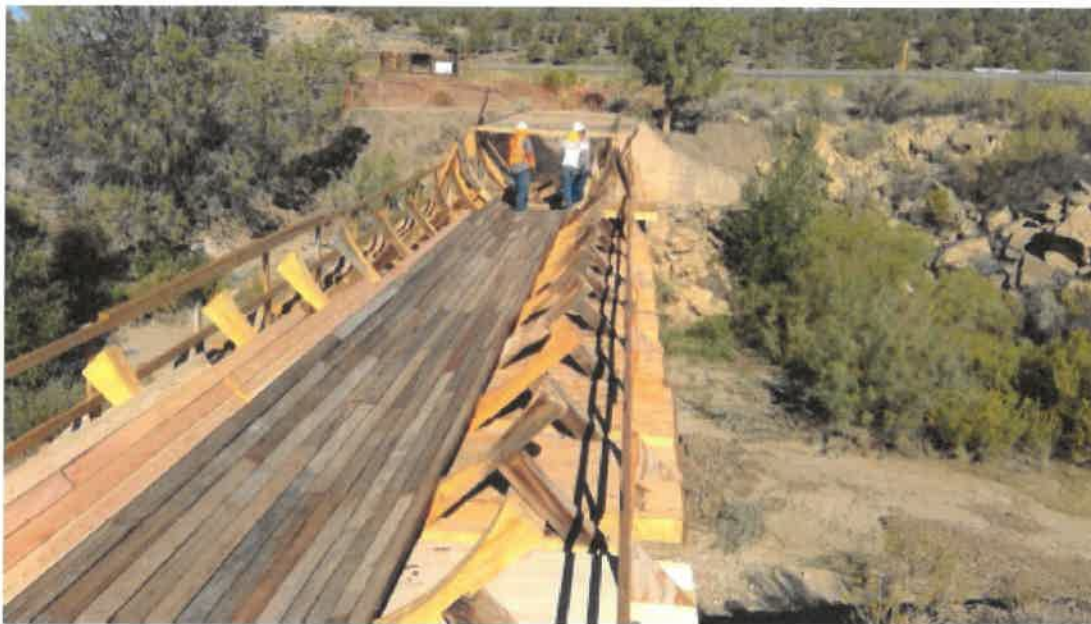
Figure 2. Overall progress on site.

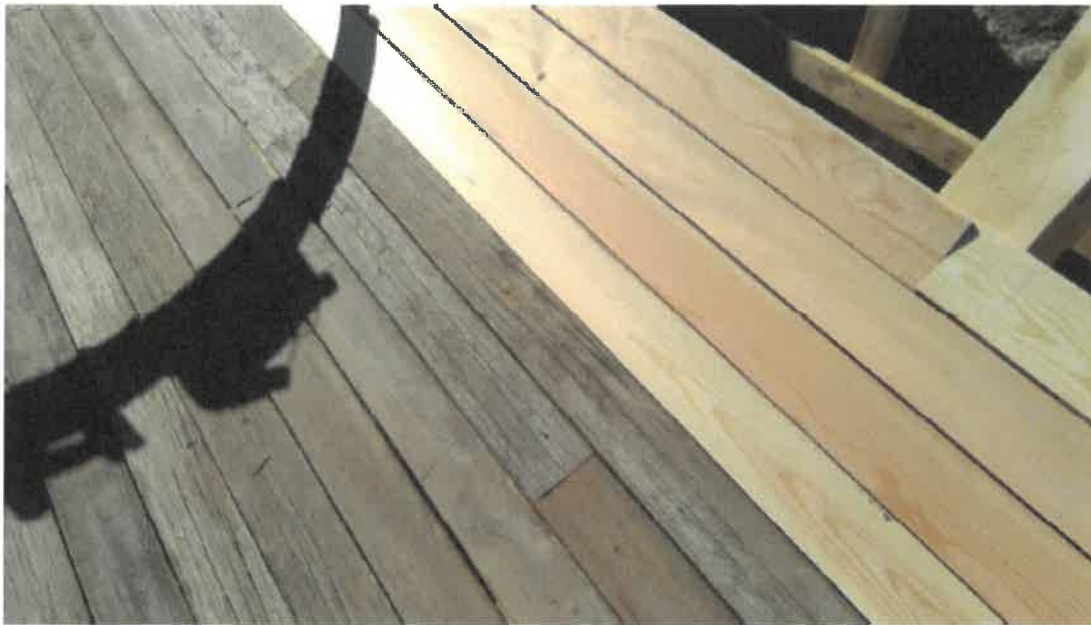
Figure 3. Grain structure and profile of new staves closely matches the original material.

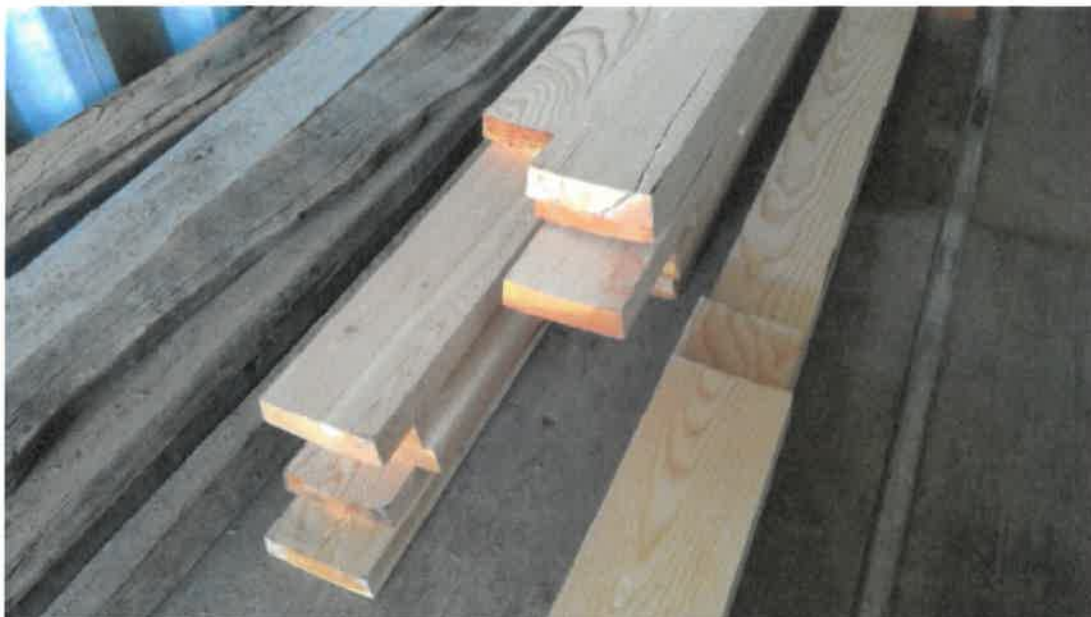
Figure 4. An example of a new stave with large end split.

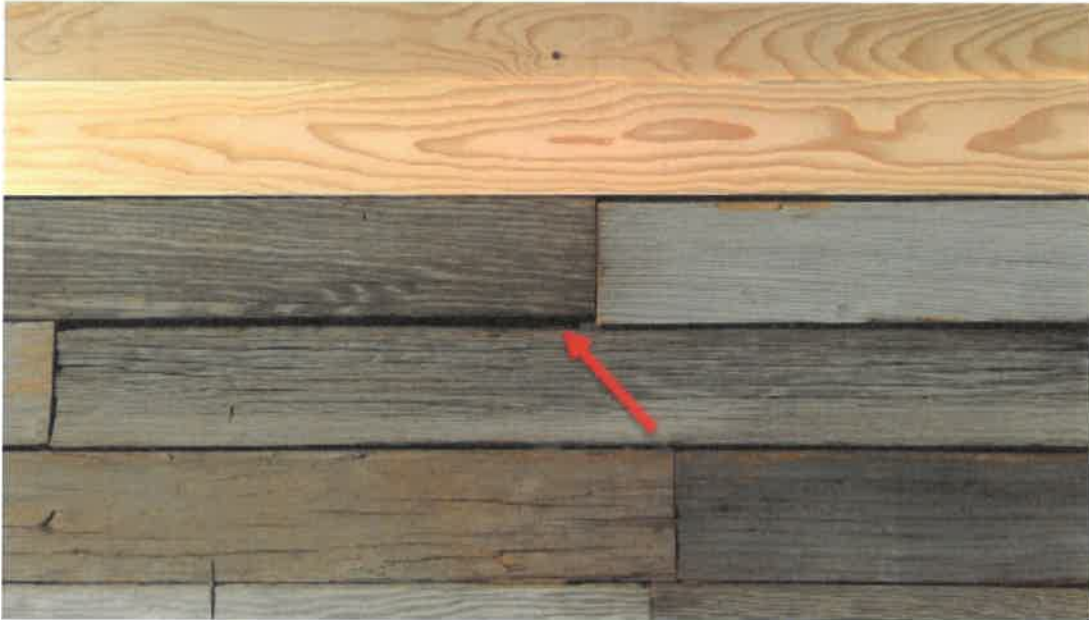
Figure 5. Misaligned staves, leaving large gaps in the half-pipe.

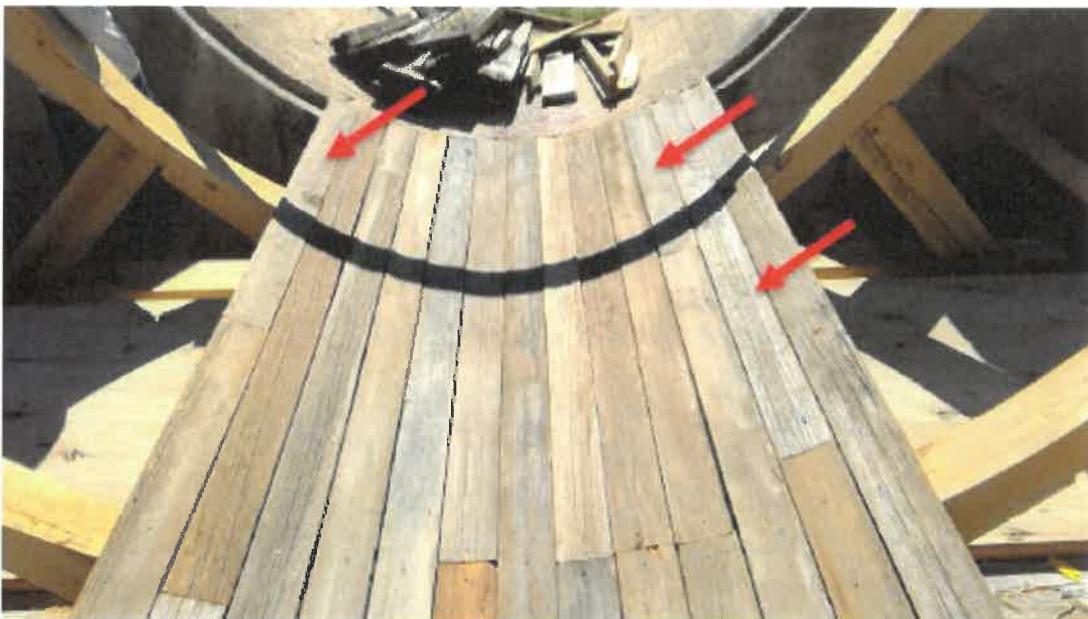
Figure 6. Short staves installed at the southeast end of the Flume. These staves will need to be removed and replaced by longer staves, spanning at least across two bends.

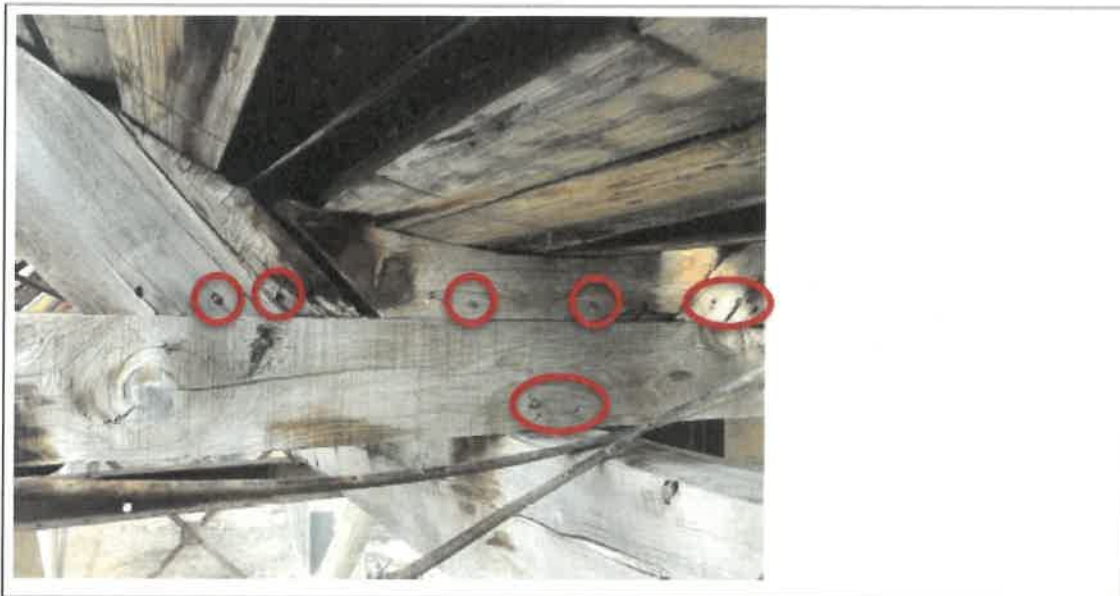
The original construction of the flume was completed using toe nails to fasten members together. While this technology worked well for the time period, we realized that much of the deterioration of the flume was now associated with large wind events and lacking regular maintenance a better fastening system was recommended to be used to help protect against wind loading. Therefore Headlok screw were used for reassembly. The new anchoring plan is shown below.

Figure 9. Typical toe-nail connections at Flume bent.

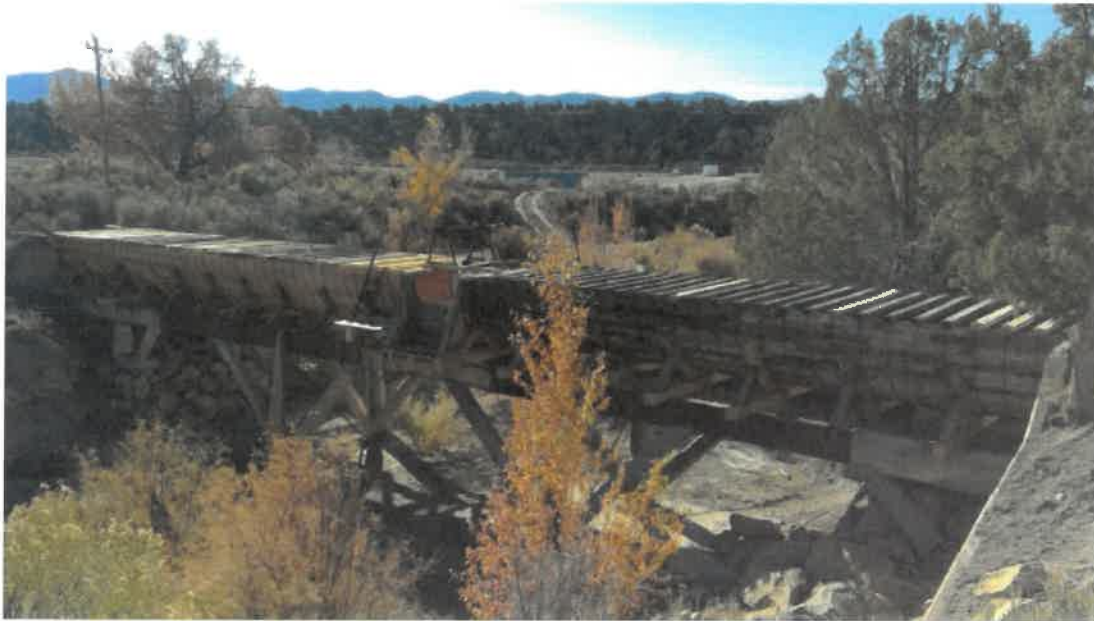
Figure 1. Overall view of northeast elevation of the Flume.

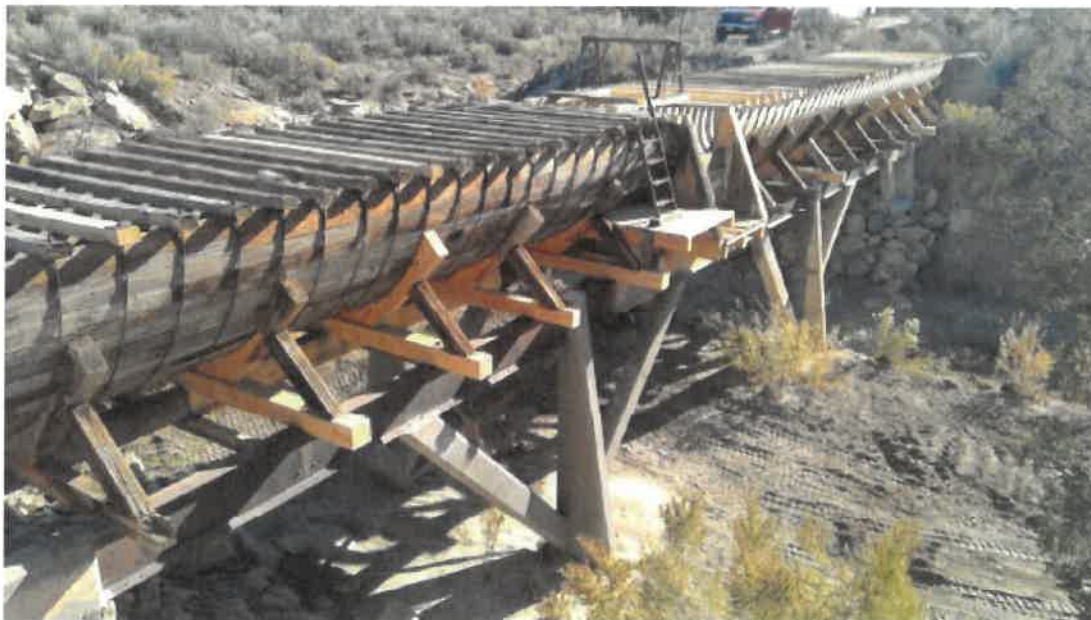
Figure 2. Overall view of southwest elevation of the Flume.

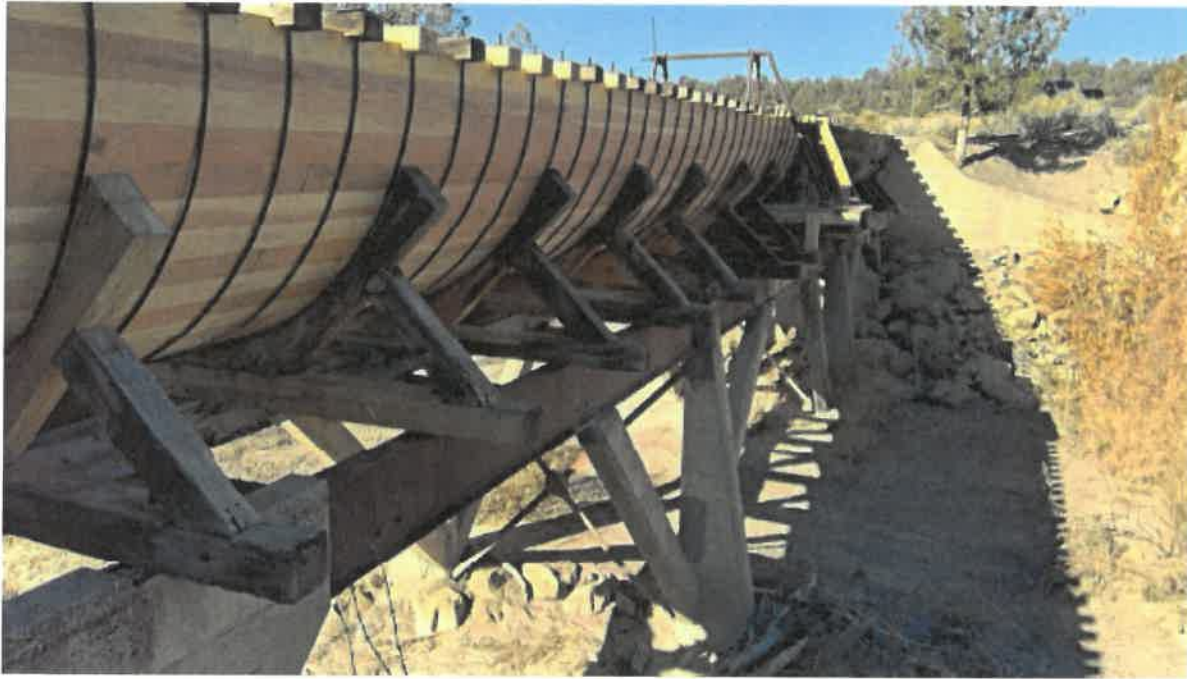
Figure 3. Closeup view of northeast elevation of the Flume from southeast abutment.

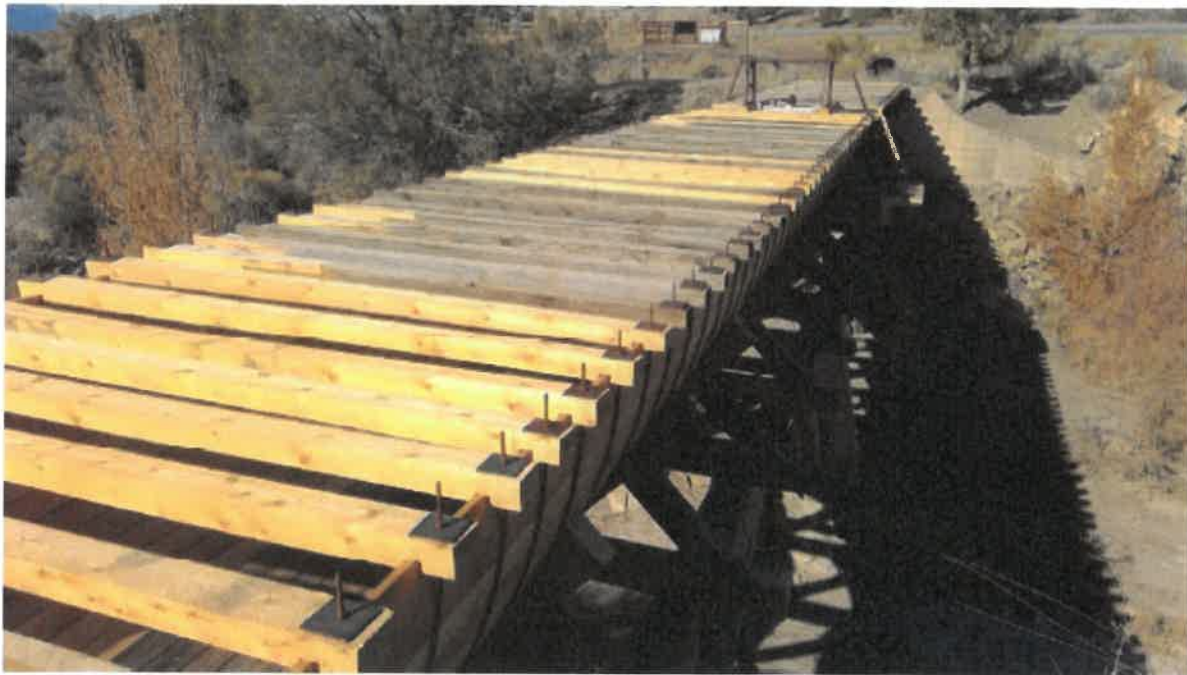
Figure 4. Top view of the Flume from southeast abutment.

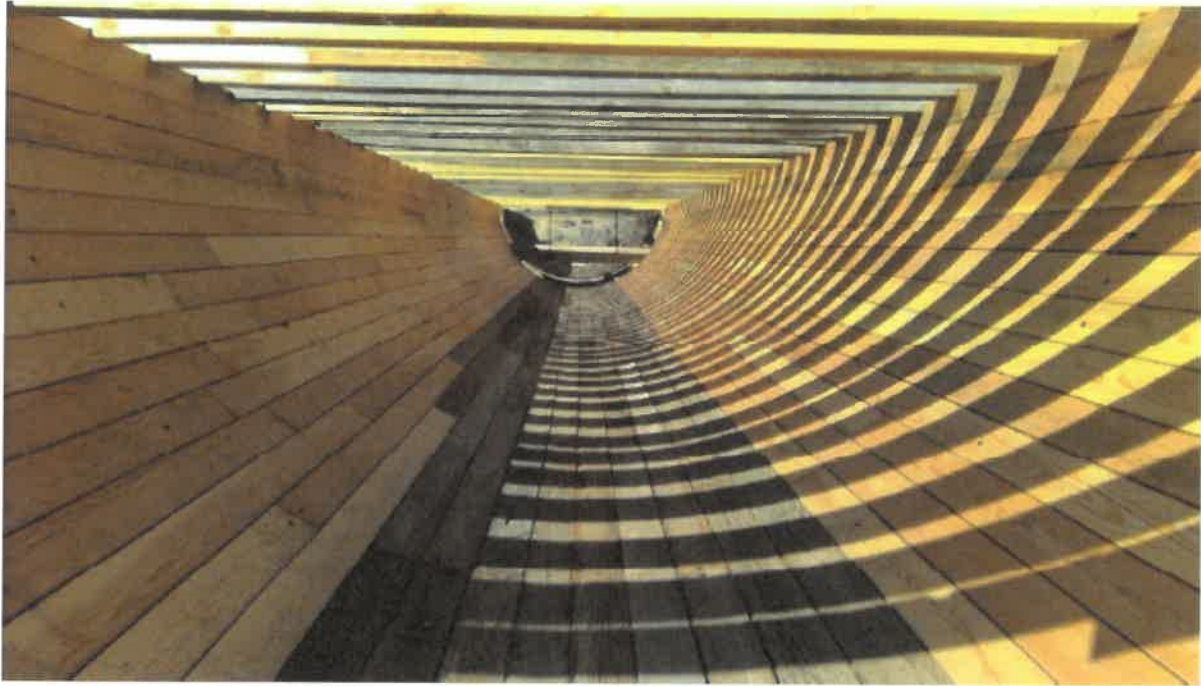
Figure 5. Interior view of half-pipe from southeast abutment.

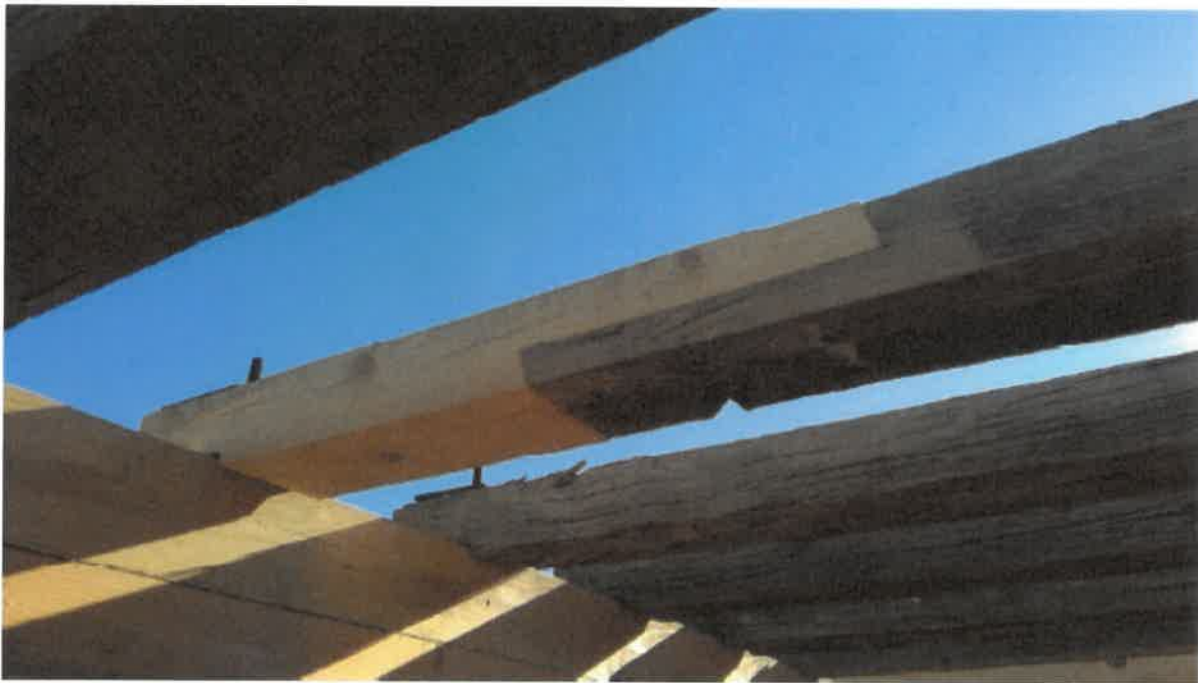
Figure 6. Closeup view of splice repair at spreader's end.
